Centrifugal Compressor High Sub-Synchronous Vibration (SSV) During Higher Load and Speed

Mohd Faizal Mohamed –
PETRONAS
Mohd Hafiz A Manan –
PETRONAS

Executive Summary

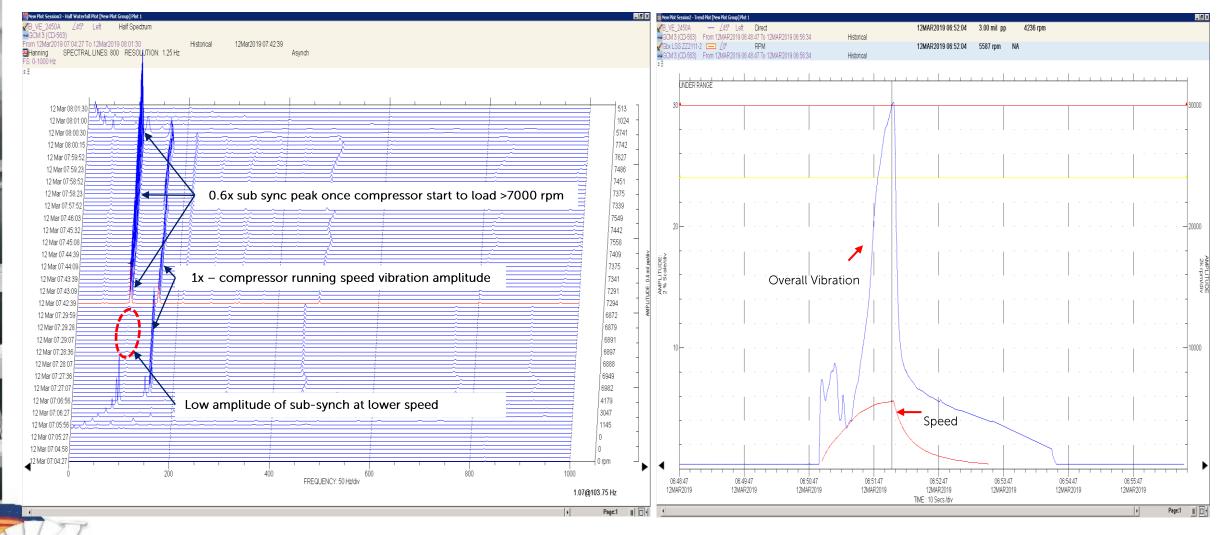
Vibration Data – Sub Synchronous

SSV only dominant once compressor load at higher speed

Overall vibration rapidly increase when speed is higher than 7000 rpm

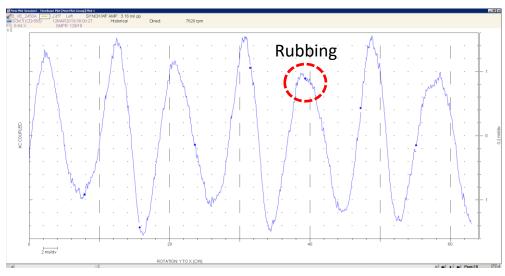
Vibration Data – Evidence of Rub

Indication of rub

Different rotor path between running & coast down

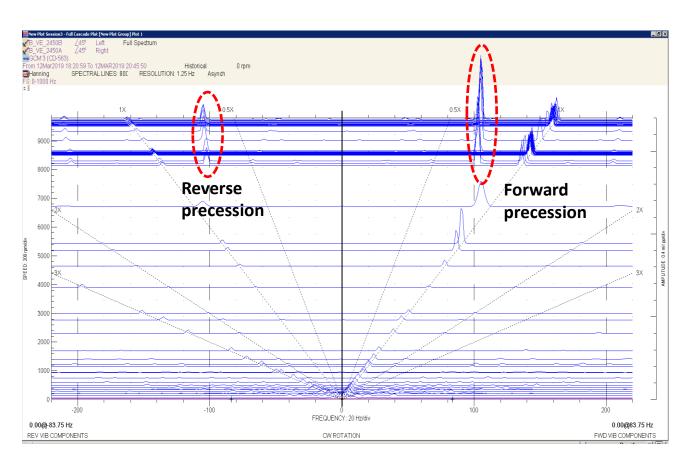
Waterfall plot: Reverse precession indicate sign of rub

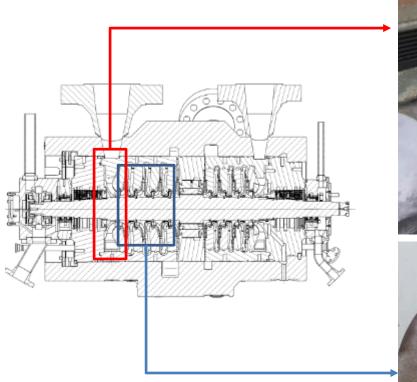
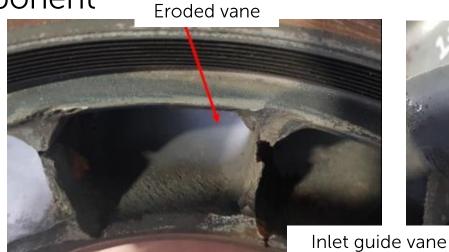
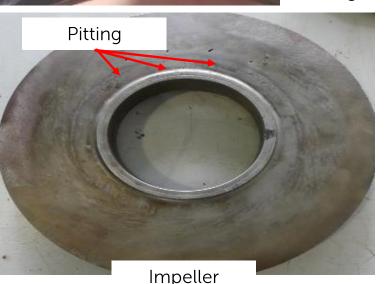
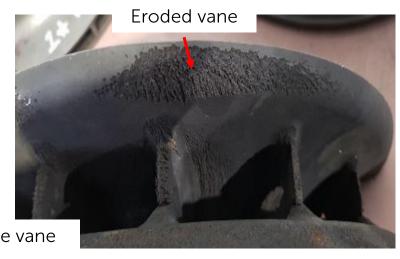
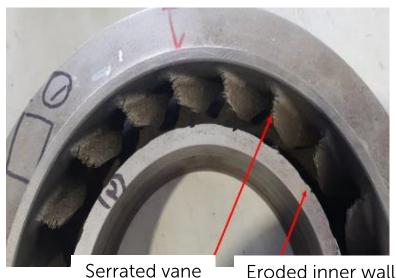
No blockage, however severe erosion & pitting

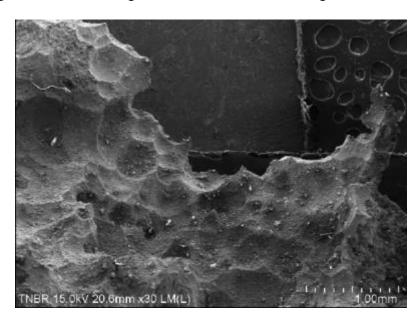
Erosion

- Liquid droplet impingement
- Repeated impacts caused depression and metal flow
- Asperities formed between depressions
 - Asperities cracked and removed metal

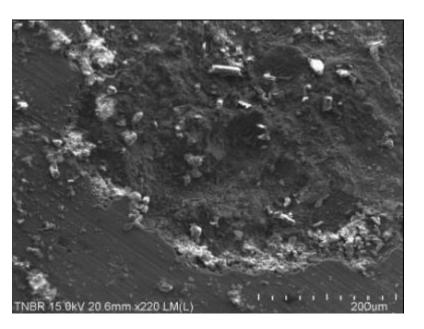
- Areas with dark deposit accumulation
- presence of corrosion products
- Corrosion attack form crack / fatigue

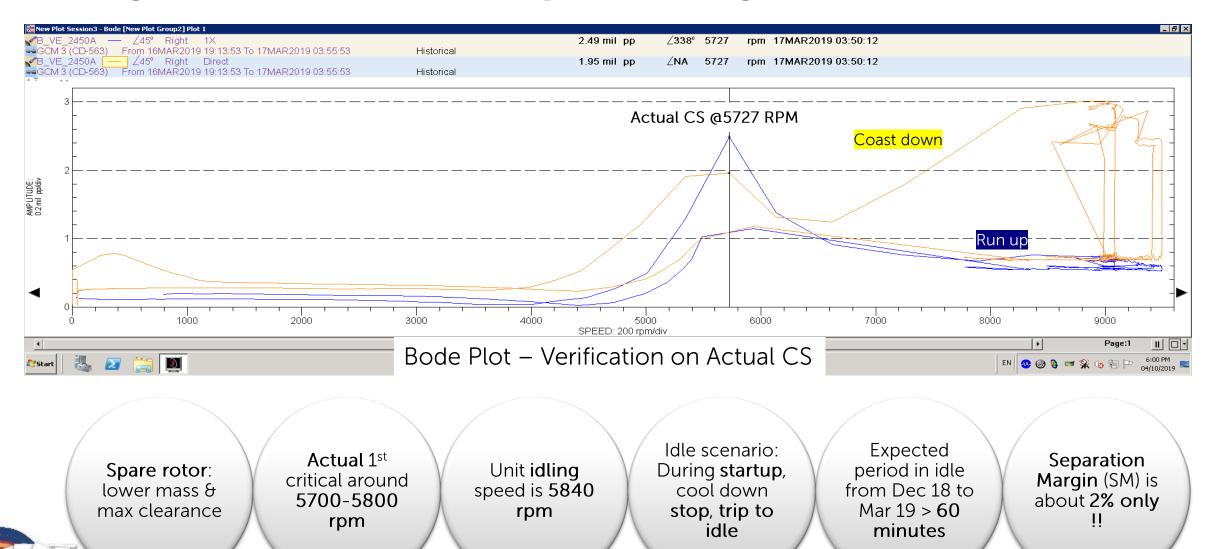
Finding on Rotor 1st Critical Speed Changes

Critical Speed	
Idling speed	 5840 rpm (during in operation)
Other information	 Spare rotor weight different about 10% 566 lbs (original) . vs 510 lbs (spare) Past record original bundle went for impeller trim / minor modification to address discharge temp issue It was suspected that the clearance used for spare rotor is towards maximum value

- Such debris & contaminants unfortunately pass thru & stuck at critical area ie.
 center seal clearance creating some rubbing effect
- In addition, the situation worsen when spare compressor installed in 2018 having different rotor 1st critical speed which is 5727 rpm vs. 4800 rpm (original)

- This resulting rotor resonate whenever unit at idle speed (5840 rpm, <2% seperation margin). The rotor resonance at 1st CS with first mode shape will have largest deflection on the center leading to more exposure towards rubbing and causing severe damage to center seal

Adjust compressor idling from 5840 rpm to 6420 rpm (>15% separation margin)

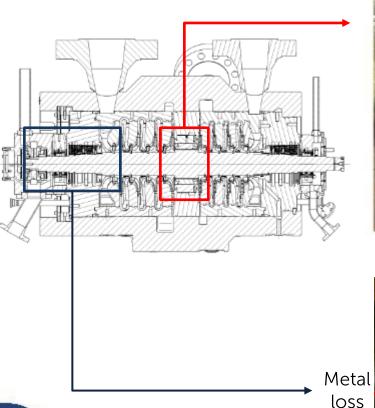
Excessive clearance at center seal due to rubbing

3rd & 4th stage compressor centre seal (honey comb) badly rubbed & sleeve materials loss

- Excessive clearance at damaged center seal behave like "third bearing" effect and causing machine experiencing stall and/or aerodynamic instability as observe from <u>sub-synchronous vibration (SSV)</u>

Bundle replacement with better materials grade SS 17-4PH, NACE compliance [completed]
