## ASIA TURBOMACHINERY & PUMP SYMPOSIUM

# PITTING CORROSION LED TO CATASTROPHIC GAS TURBINE COMPRESSOR BLADE LIBERATION

FADLIL HAFEEZ – PETRONAS  
MOHD FAIZAL – PETRONAS

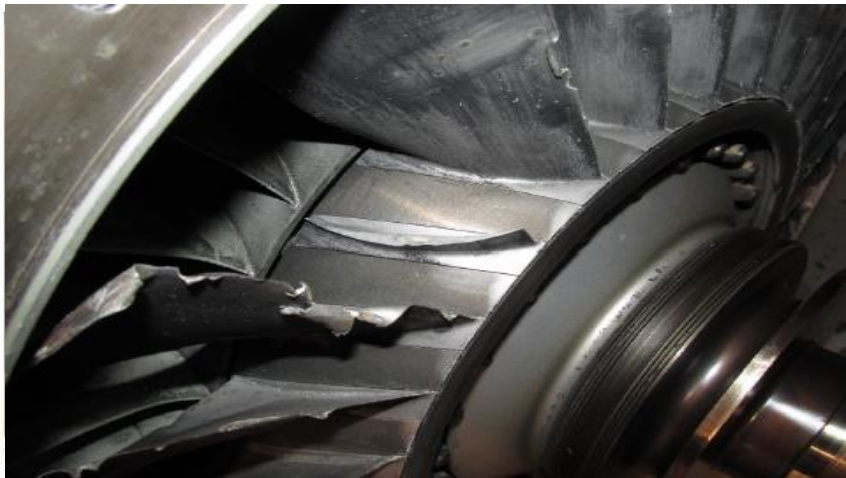
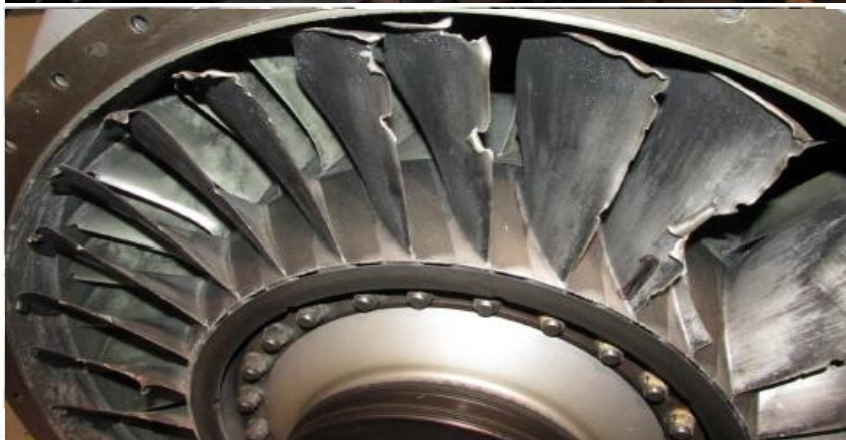
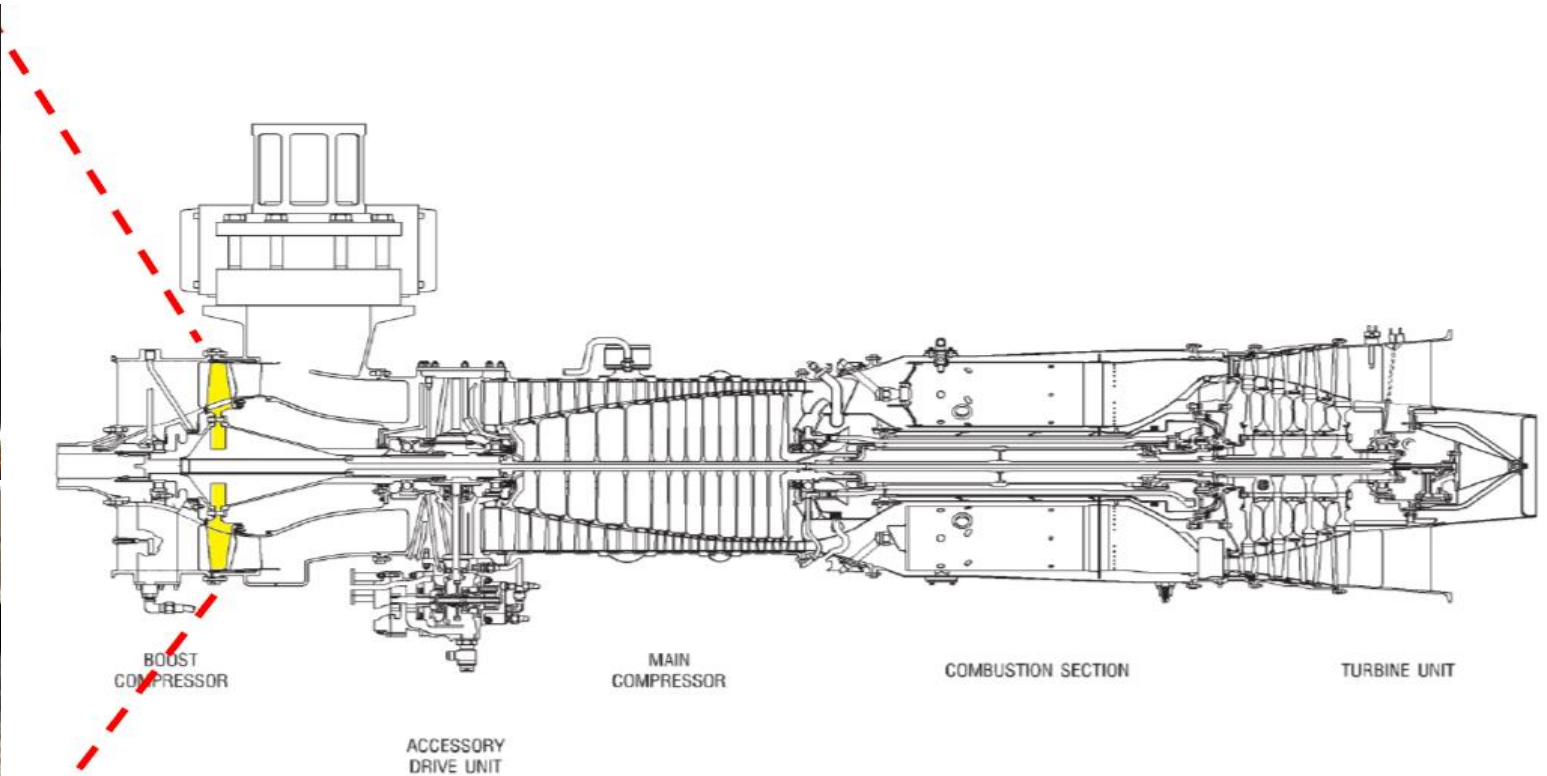
Figure 1: Engine Cutway and Area of Damage

One boost compressor blade liberated with the remaining blades exhibited impact damage.

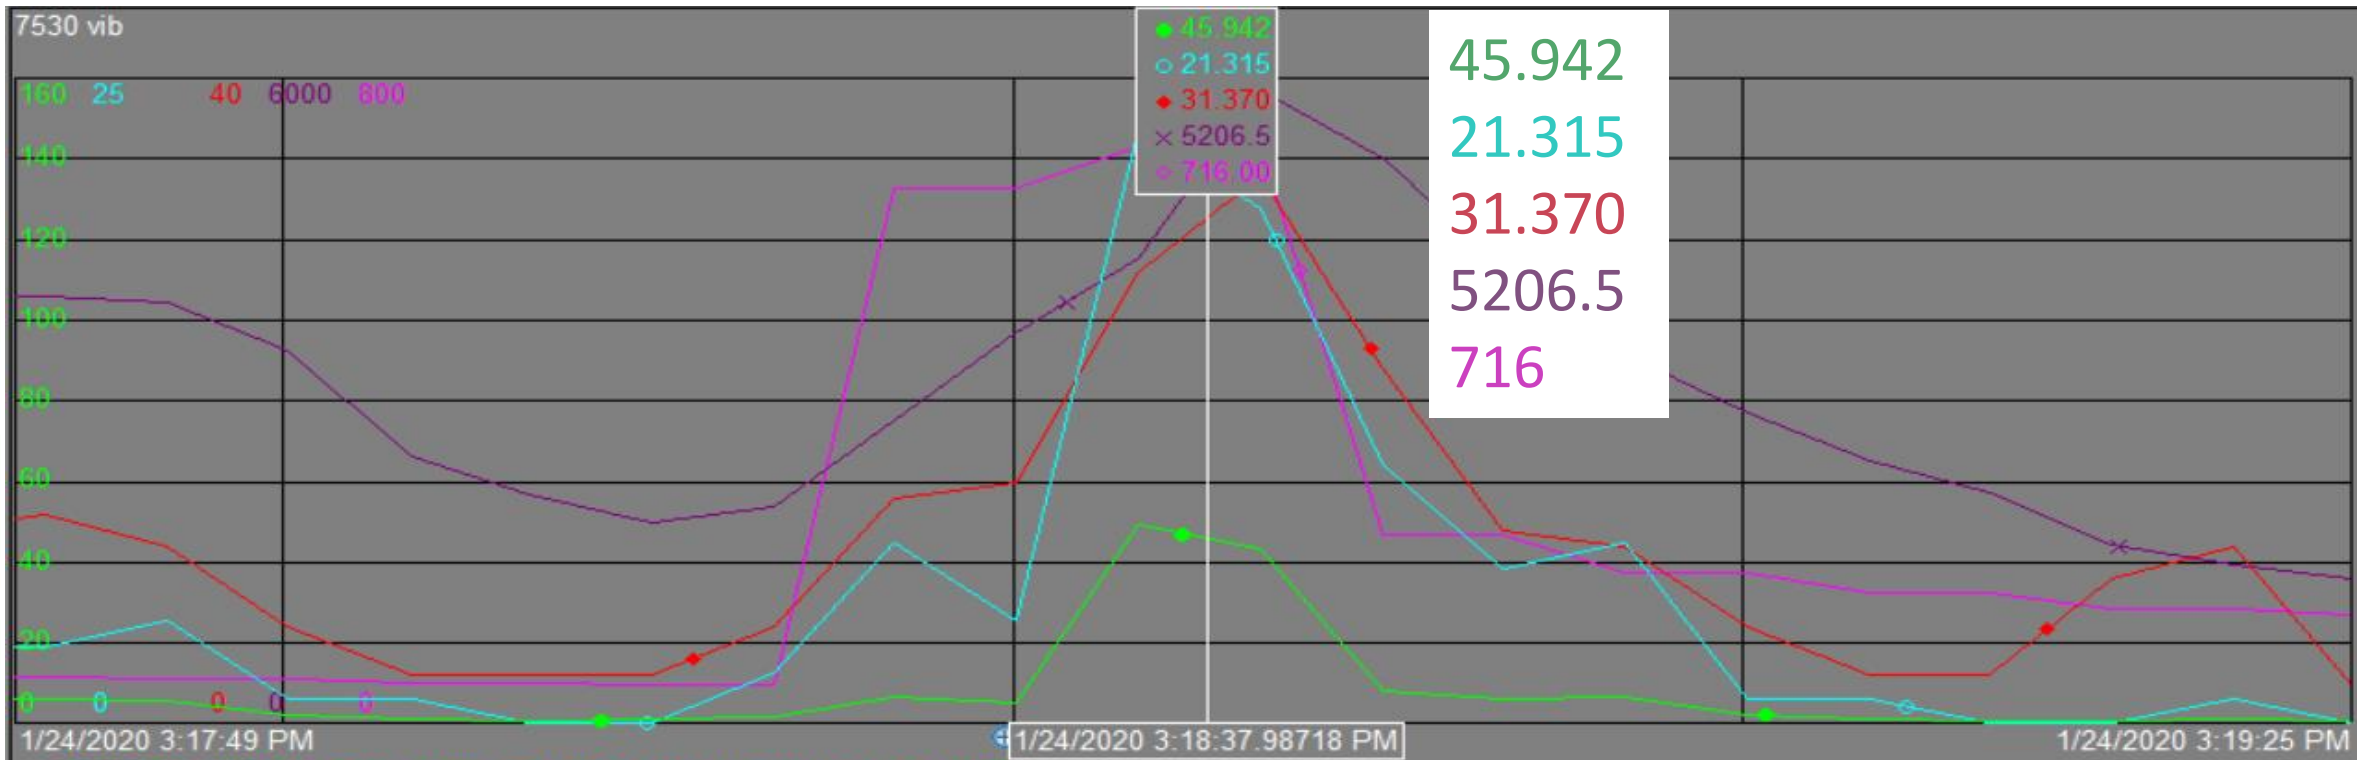
- Turbine outlet temperature showing high reading during engine start up.
- VE-65 Power take off (PTO) vibration reading increase significantly.

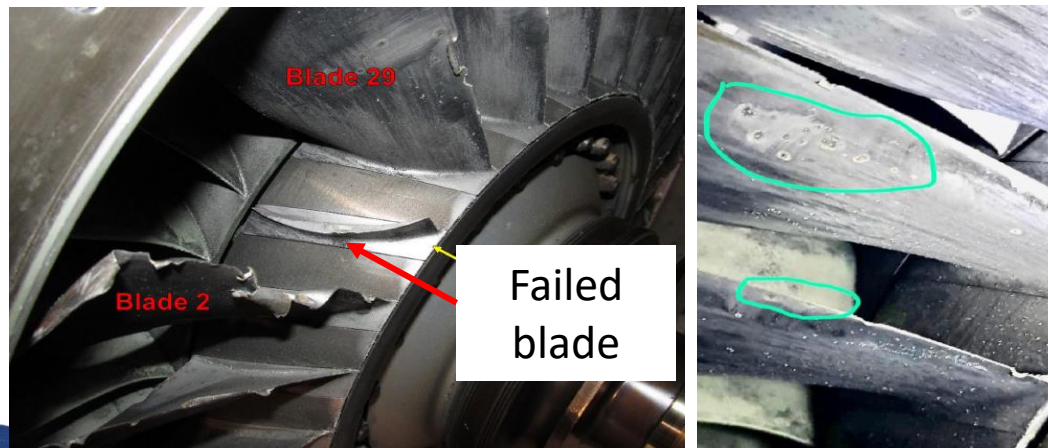
Figure 3: Booster Compressor Blade During Teardown

Figure 3 – Exhibited a complete, transverse separation through its airfoil just above its platform. The airfoils of the remaining non-fractured blades exhibited considerable impact damage. Failed blade designated as Blade 1 and the adjacent blades designated Blades 29 and 2.

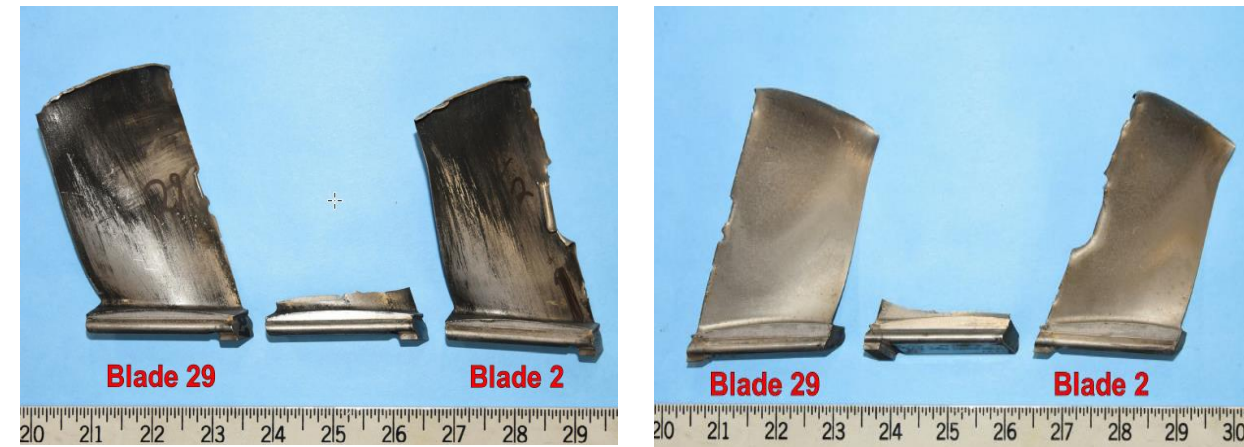
Figure 4: Booster Compressor Blade Surface

Figure 4 – The airfoils of Blades 2 and 29 exhibited considerable impact damage. Most likely from contact with the liberated airfoil following separation along their leading edges and tips.

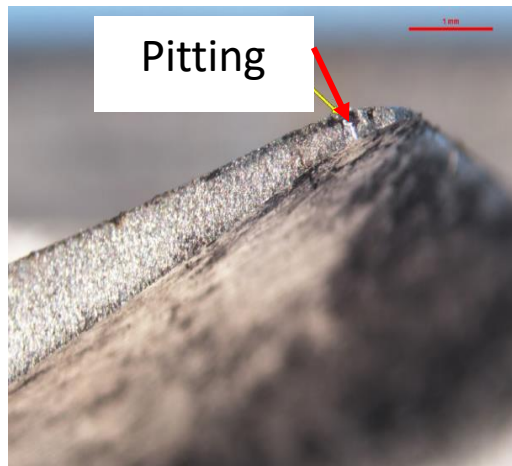
Figure 5: Blade 1 Separation Surface at Leading Edge

Figure 5 – A relatively flat fracture profile was observed.

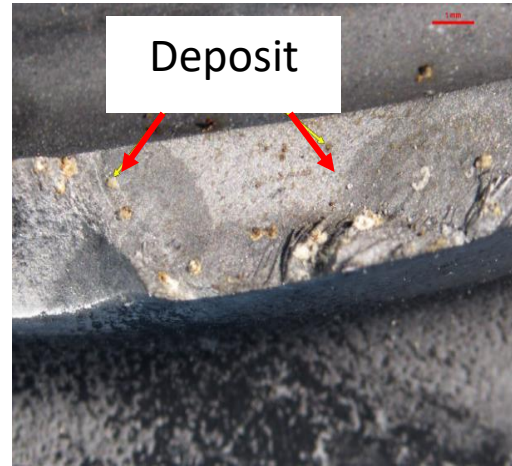
Figure 6: Blade 1 Separation Surface at mid-chord

Figure 6 – At the mid-chord, a more irregular fracture profile was observed, whereas the fracture from the mid-chord to the trailing edge exhibited a slanted profile consistent with overload failure.

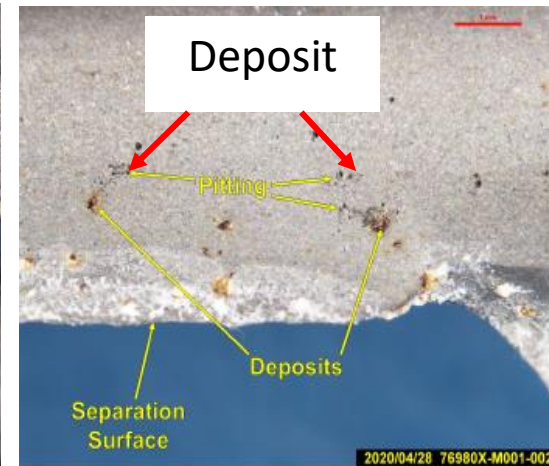
Figure 7: High-Pressure Surface of Blade 1

Figure 7 – show red-orange deposits on the high-pressure surface of the remaining airfoil segment.

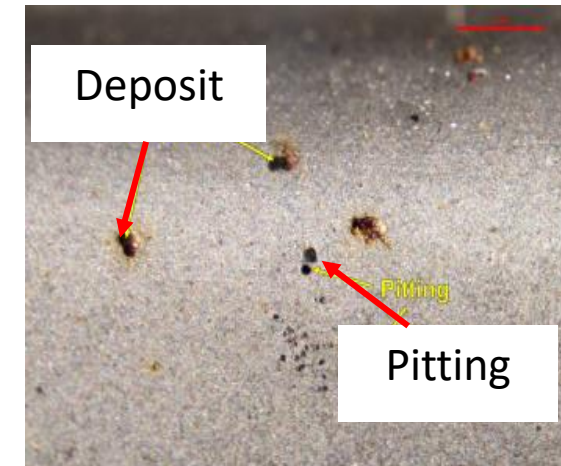
Figure 8: High-Pressure Surface of Blade 2 & 29

Figure 8 – Isolated pitting, mostly associated with the deposits, was also noted. Blades 2 and 29 have similar deposits and pitting along the platforms

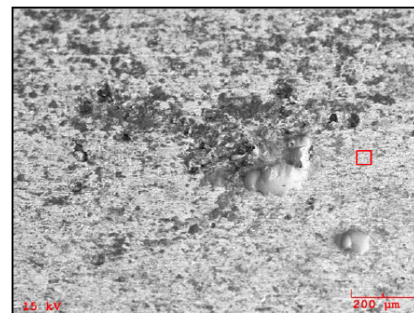
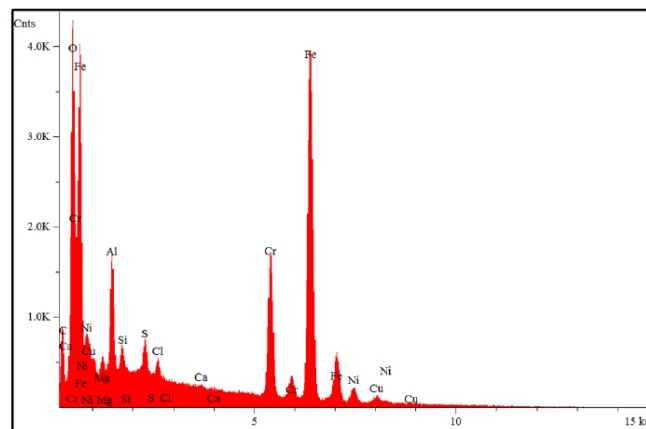
Figure 9: EDS Analysis of Clean Non-Pitted Surface

- Multiple deposits observed immediately adjacent to the separation on the high-pressure surface of Blade 1.
- Figure 9 – EDS test on “clean” non-pitted surfaces of the airfoil was used as a reference.
- Figure 10 – Pitted area revealed the presence of high concentrations of oxygen and chlorine.

Elt.	Line	Conc.	Units
O	Ka	13.82	wt. %
Mg	Ka	0.47	wt. %
Al	Ka	4.34	wt. %
Si	Ka	0.76	wt. %
S	Ka	1.28	wt. %
Cl	Ka	0.66	wt. %
Ca	Ka	0.11	wt. %
Cr	Ka	12.99	wt. %
Fe	Ka	58.88	wt. %
Ni	Ka	4.10	wt. %
Cu	Ka	2.59	wt. %
		100.00	Wt. %

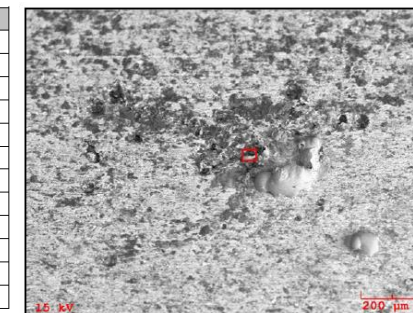
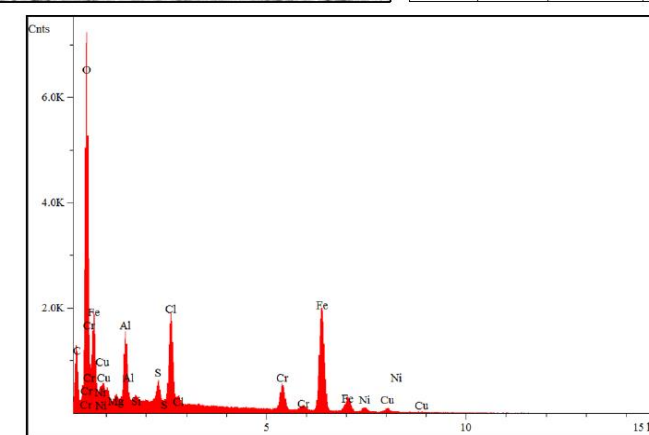
Figure 10: EDS Analysis For Deposits Within Pitted Surface

Elt.	Line	Conc.	Units
O	Ka	36.07	wt. %
Mg	Ka	0.33	wt. %
Al	Ka	5.18	wt. %
Si	Ka	0.30	wt. %
S	Ka	1.46	wt. %
Cl	Ka	7.26	wt. %
Cr	Ka	5.42	wt. %
Fe	Ka	38.39	wt. %
Ni	Ka	2.65	wt. %
Cu	Ka	2.94	wt. %
		100.00	Wt. %

- ❑ A large corrosion pit was observed at the fatigue crack initiation site on the high-pressure surface of the Blade 1 airfoil.
- ❑ Deposits exhibited elevated concentrations of chlorine, an element known to facilitate pitting in ferrous alloys. Thus, localized corrosion attack, or pitting, from exposure to a chlorine-rich environment most likely caused the pitting that served as the fatigue crack initiation site.

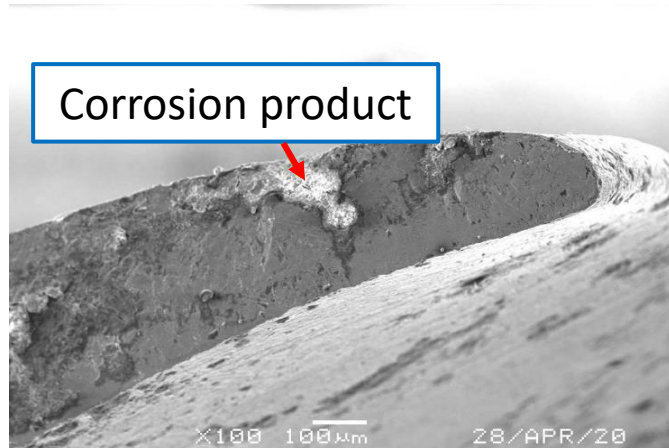
Figure 11: Blade 1 Separation Surface

Figure 11 – Build-up of corrosion product was observed. No evidence of mechanical damage from impact was observed at the leading edge.

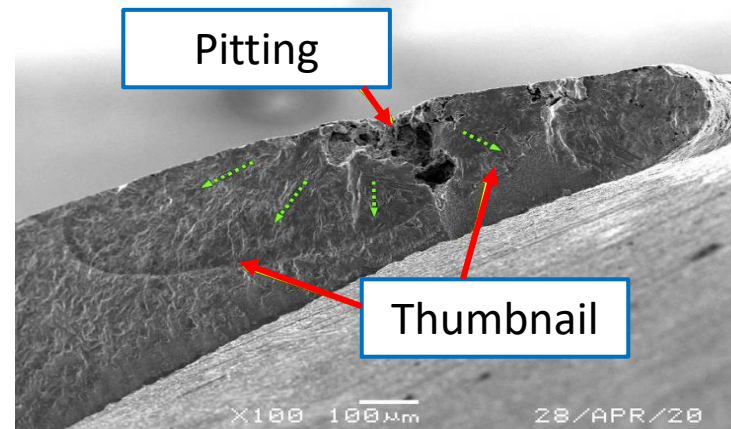
Figure 12: Blade 1 Separation Surface at Leading Edge

Figure 12 – At the leading edge of the separation surface, a prominent pit was observed. A thumbnail-shaped feature appeared to surround the pitting. This fracture feature commonly illustrates the direction of progressive crack growth.

- ❑ A thumbnail surrounding the pitting indicated that a fatigue crack initiated at the pitting and microscopic parallel striations confirmed that the crack continued from the leading edge to the mid-chord.

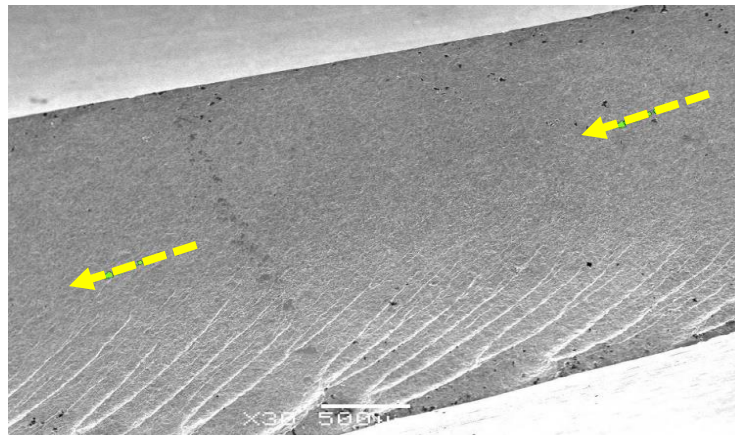
Figure 13: Blade 1 Separation Surface, Between Leading Edge And Mid-chord (Profile)

Figure 13 – Closer to the mid-chord, the separation surface of Blade 1 exhibited a relatively smooth fracture profile.

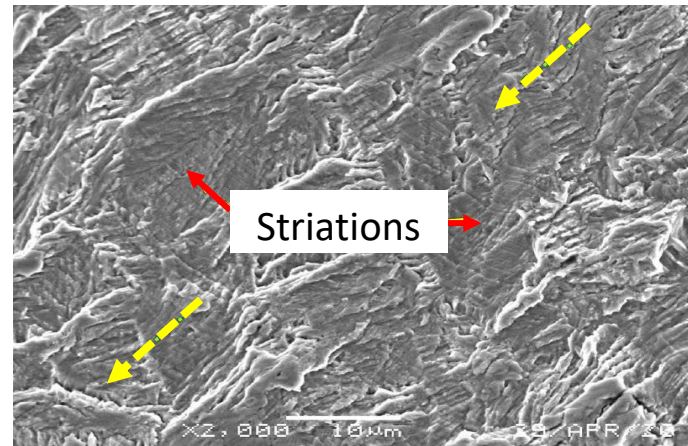
Figure 14: Blade 1 Separation Surface, Between Leading Edge And Mid-chord (Striations)

Figure 14 – Closer examination of the fracture features within this area revealed the presence of microscopic parallel features, known as striations. The orientation of these striations indicated crack propagation from the leading edge to the mid-chord.

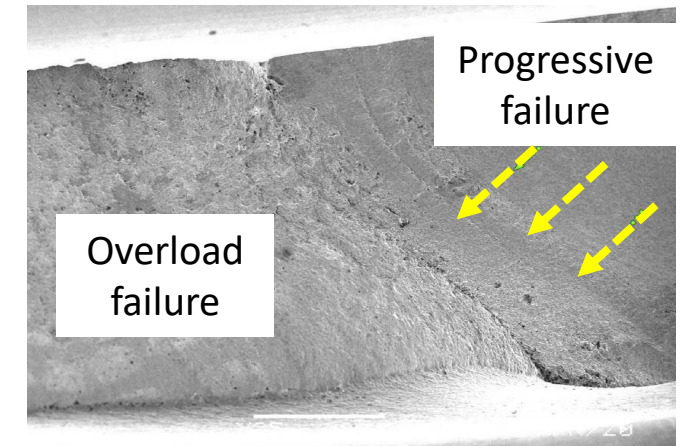
Figure 15: Blade 1 Separation Surface, Mid-chord

Figure 15 – At the mid-chord of the blade, a distinct demarcation in fracture features was observed, as the crack propagation transitioned from progressive to single-event fracture, as identified.

- ❑ The remaining airfoil cross section was insufficient to withstand the imposed service loads and failed in single-event overload. This liberated airfoil then caused the impact damage observed on the other boost compressor blade airfoils.

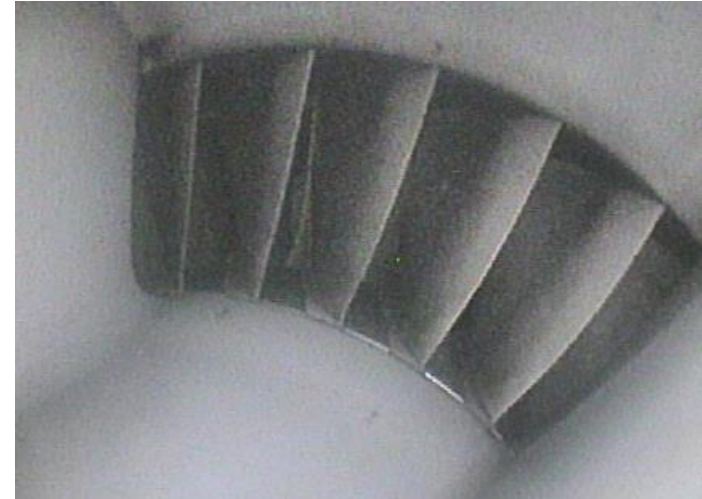
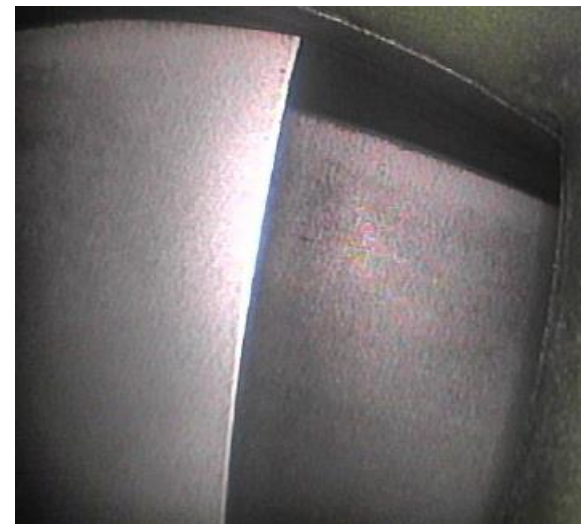
Figure 16: Booster compressor blade

**After one year of operation, the strategies have proven to be successful, with very little corrosion seen on a stainless steel MVS and turbine compressor blade.**

1. Upgrade MVS material to stainless steel

2. Upgrade intake system to EPA/HEPA Class
