ASIA TURBOMACHINERY & PUMP SYMPOSIUM

Gas Turbine Load Limited due to High Exhaust Temperature Deviation

ExxonMobil

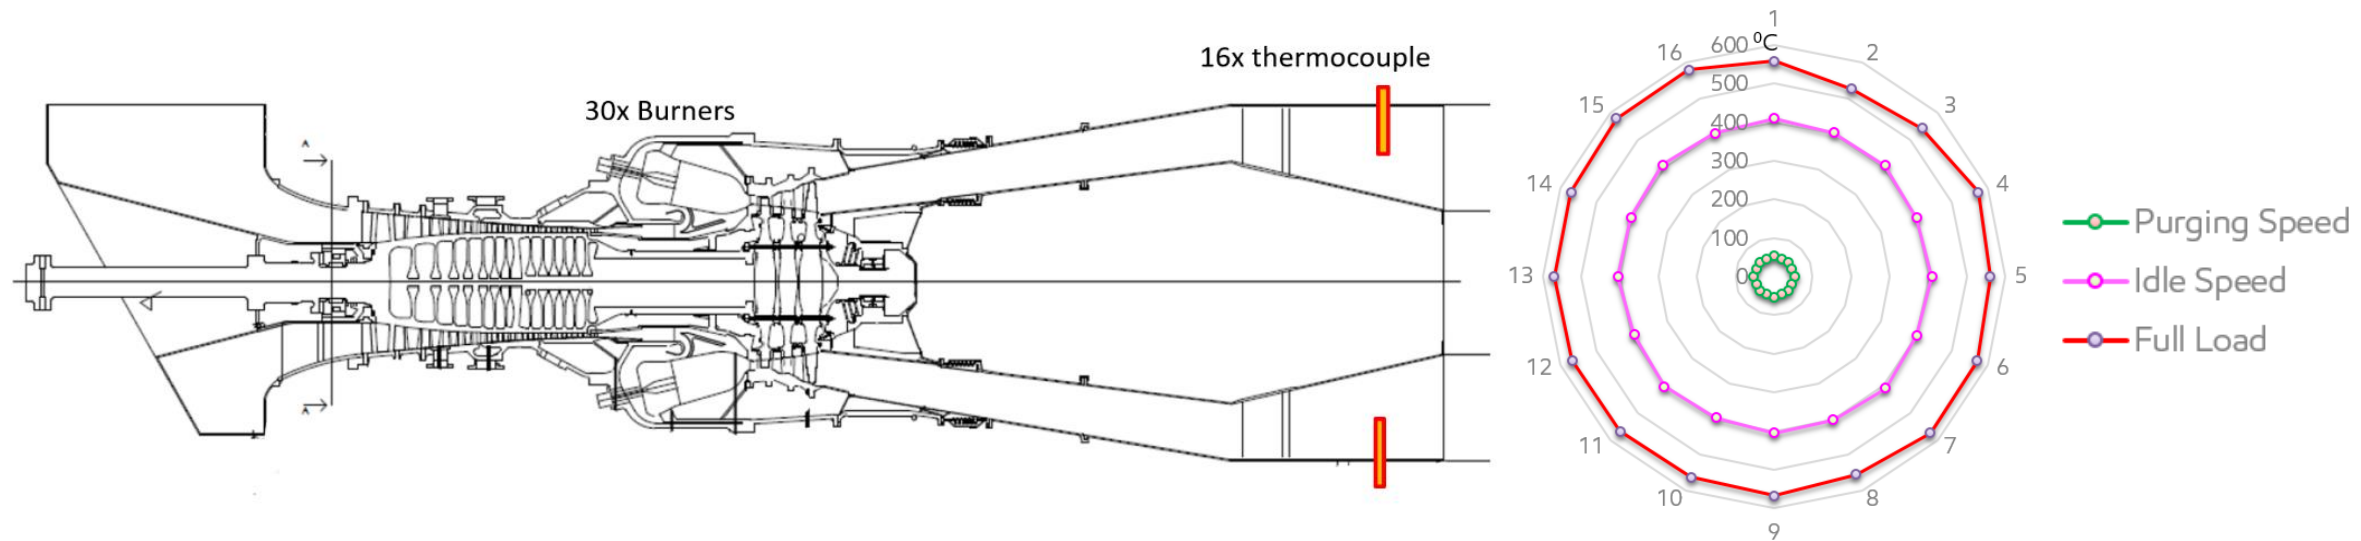
Turbine exhaust temperature spread during normal operation in May 2020

1. The turbine exhaust temperature (T7) is measured by 16 thermocouples installed at about 5m away from the 30 burners.
2. The overall T7 trends prior to auto unloading was studied and used as a base line reference.
3. The T7 distribution was presented in polar plot to provide an overview of the temperature spread.
4. The exhaust temperature deviation is within acceptable range and the overall temperature profile is close to circular shape at any loading.

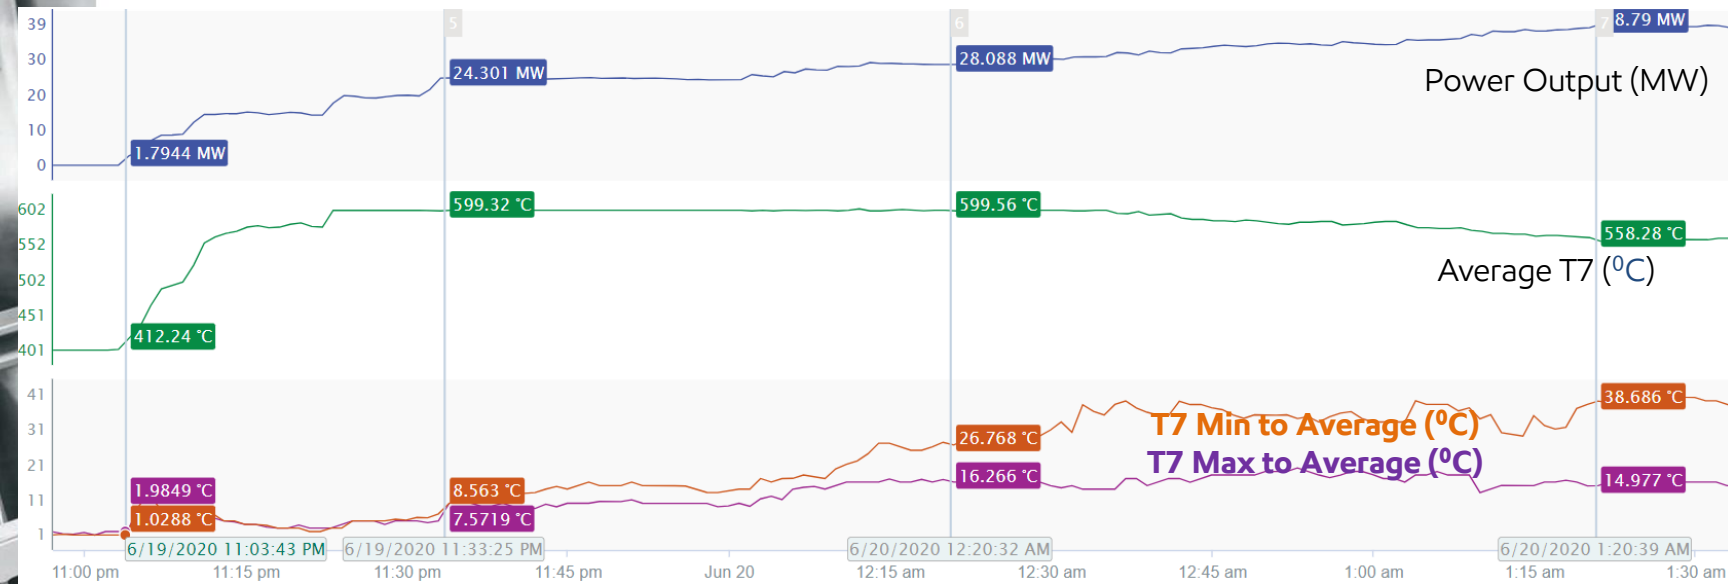
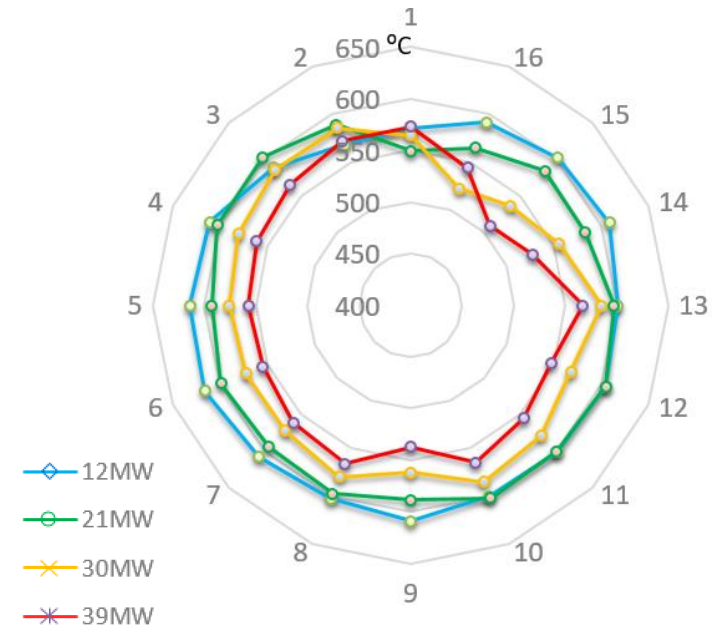
Turbine exhaust temperature spread at different loads

1. The turbine exhaust temperature (T7) when auto unloading occurred was then analyzed.
2. At low load, the T7-to-max (hot spot) and T7-to-min (cold spot) deviation were low below 10°C
3. Above 50% load, the T7-to-max (hot spot) and T7-to-min (cold spot) deviation increased with load drastically.
4. The T7 spread profile deformed significantly at high load operation.

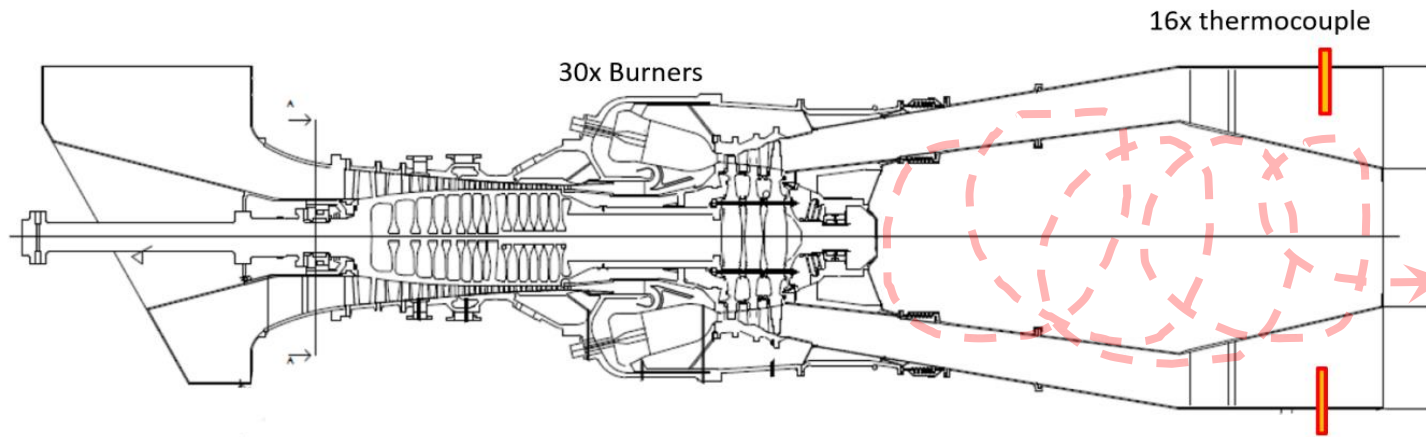
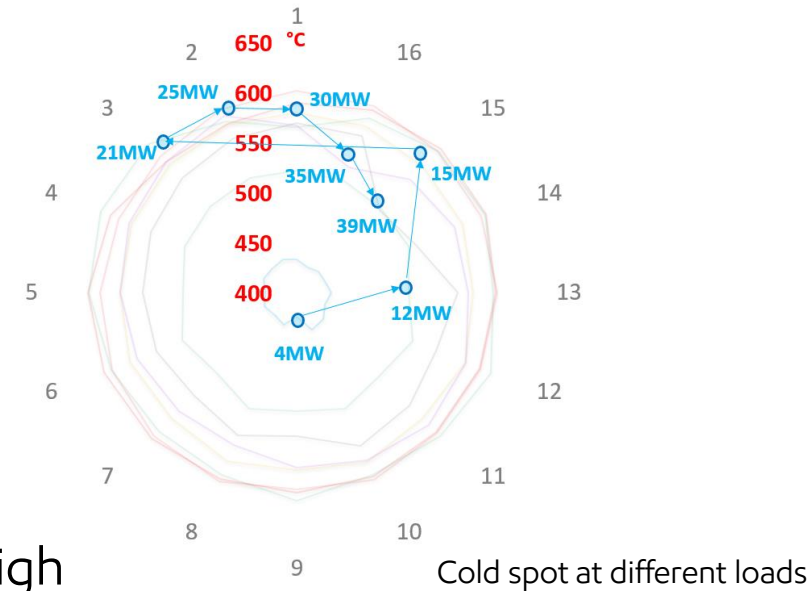
1. At low load operation, the T7 spread is almost uniform; at high load operation, the T7 spread profile is deformed.
2. The cold spots at different loadings were provided to OEM to perform a joint diagnosis.
3. The thermocouples readings are not directly linked to the firing from burners at their physical location. This is due to the swirling effect of the exhaust flow in the diffuser ducting.
4. Coupled with the understanding of the gas flow path into the manifold, a number of burners were removed for inspection in the subsequent planned maintenance window.

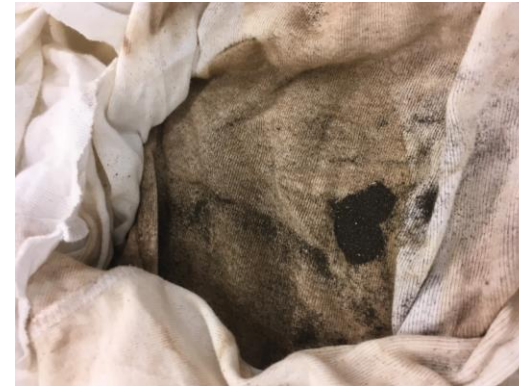
1. At the fuel gas manifold, residue dirt was observed sticking to wall.
2. A number of burners orifice plates were found plugged with particles
3. Sample collected and sent for EXD testing which revealed presence of rust particles.

Magnetic particles

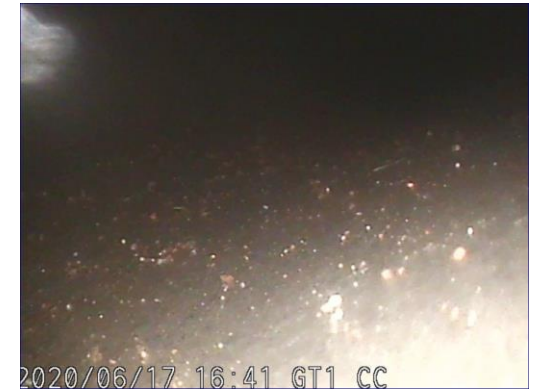
Dirt in fuel gas manifold

1. 11 number of burners were also removed, inspected and purge clean with instrument air.
2. Vacuum was used to suck the dirt and particle.
3. Multiple purging with plant nitrogen was also performed from the filter coalescers up to fuel gas manifold.

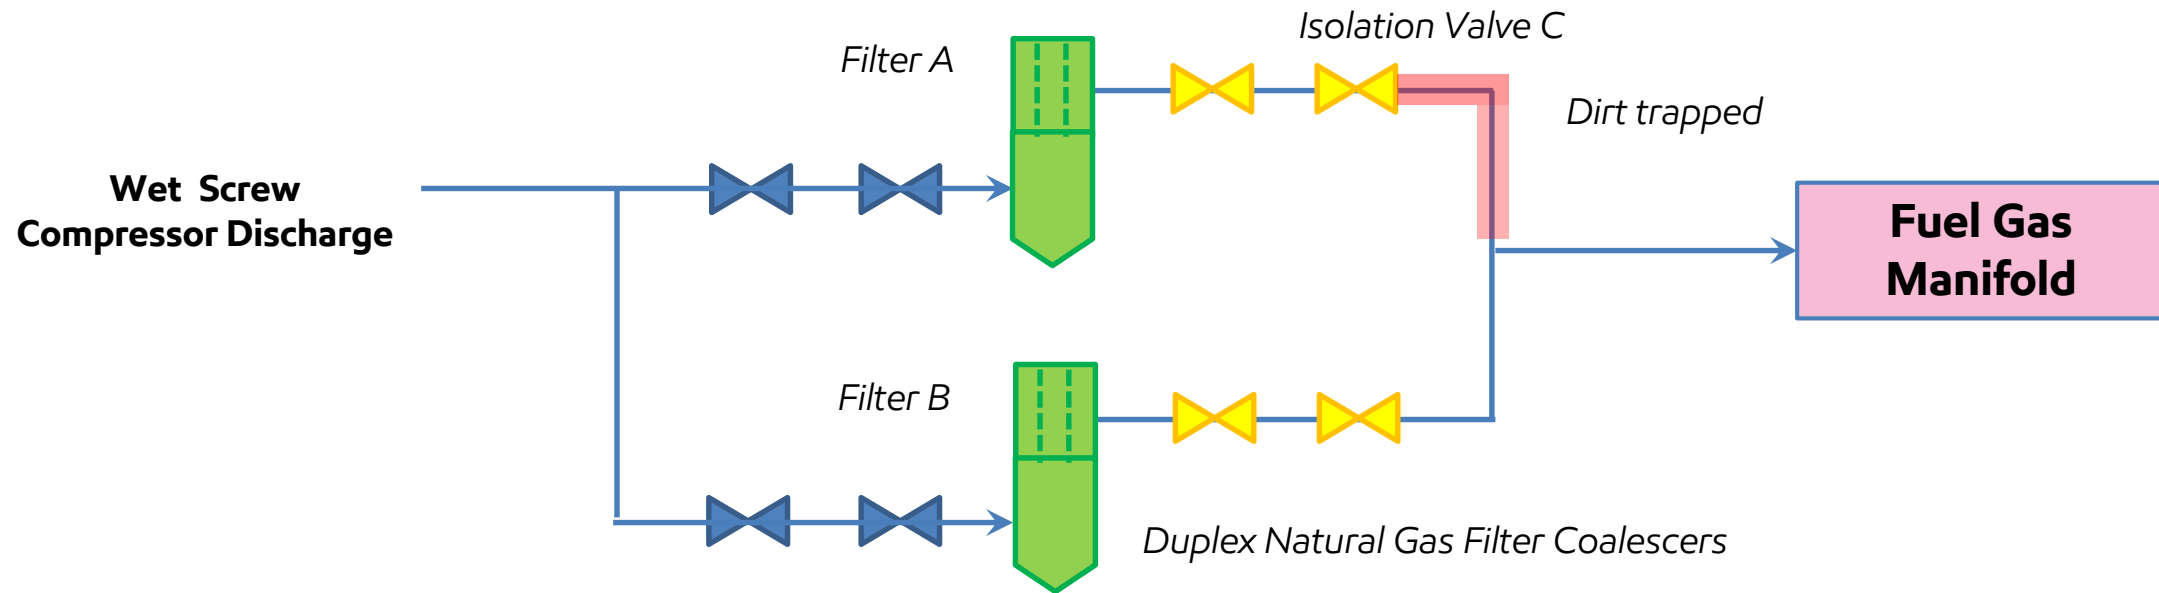
- Based on operation record, the external fuel gas filter coalescer was swung from Filter B to Filter A prior to startup in April 2020.
- Remnant dirt was found on the section downstream of the Isolation Valve C as shown above.
- Prior to GTG first commissioning, both lines of natural gas filter coalescer lines was purged clean. Temporary strainer was in place to trap dirts.
- One of the lines was purged up to GTG full load operation, however, the other line was purged at GTG idle speed. The temporary strainer was removed after that.
- Dirt was most probably pushed to fuel gas manifold and burners when Filter A was put in operation.
