Relation between wear ring clearances & non-synchronous vibrations in BFW centrifugal pump

Waqar Ahmad-Engro Fertilizers

A de-superheating boiler feed water pump was facing high vibration issue for last 19 years.

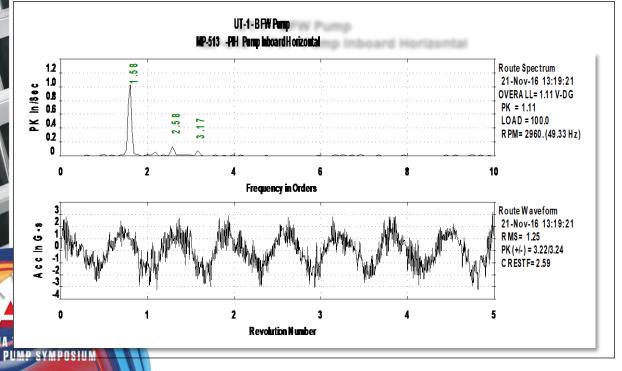
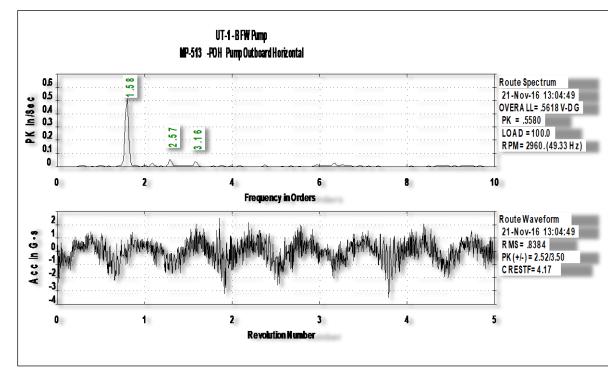
Vibration Analysis data was reviewed, and it revealed predominant vibration at 1.58X(non-synchronous). Pointing out to 3 possible issues as per vibration literature

- ✓ Bearing fault frequencies (Bearings Nos & fault frequencies are provided in slide 11)
- √ Transmitting vibration from neighboring machines
- ✓ Resonance frequencies

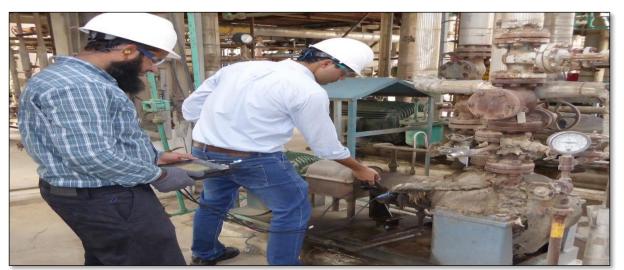
Bump Test

Bump test revealed resonant frequency at 3.6X & 5.7X order.

It confirms that issue is not related to pump's natural frequency or resonance.

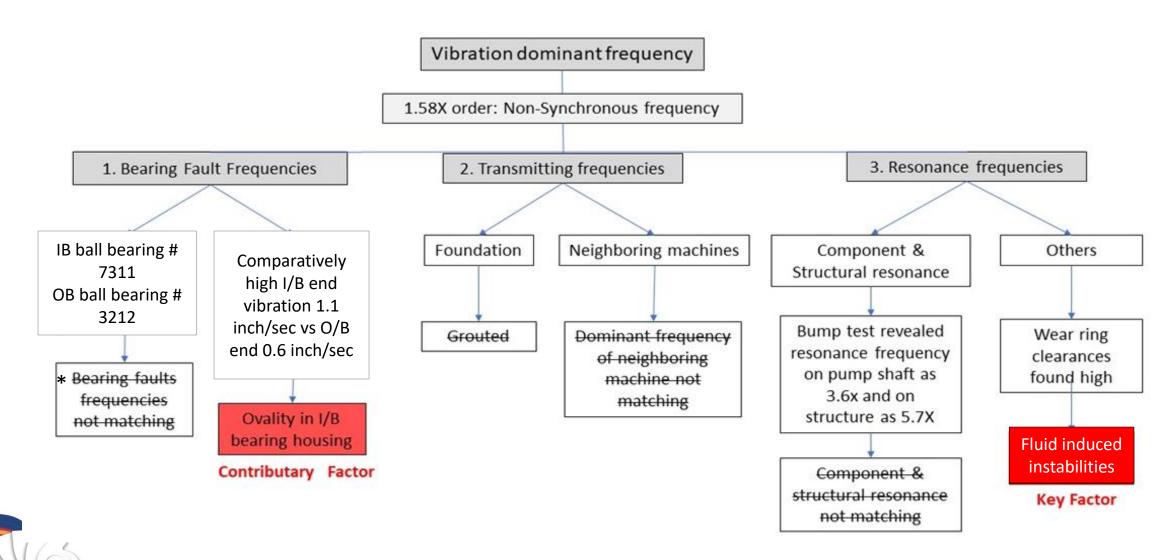
Fault Tree Analysis (FTA):

Method of rule of elimination was utilized to identify the cause of the problem. Based on analysis, it revealed that dominant frequency 1.58X was appearing in vibration spectrum, due to increased impeller wear ring(both) clearances (key factor) & issue of comparatively high vibration at pump I/B end (vs O/B end) was caused by ovality in bearing housing (contributing factor).

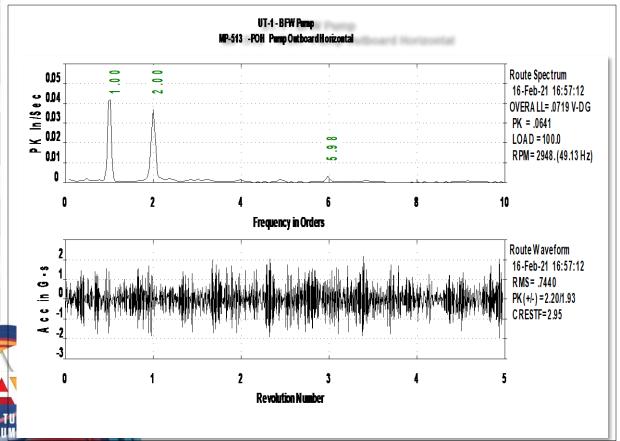
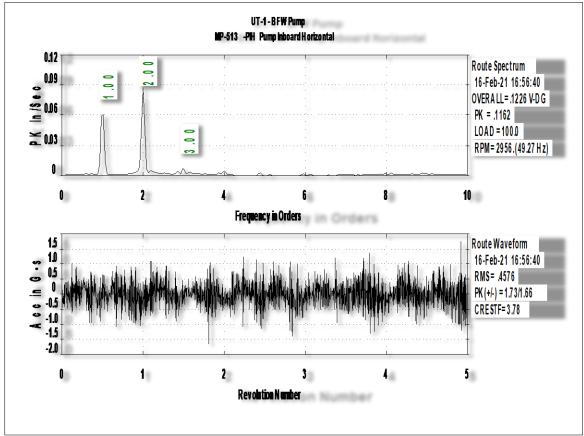
Spectrums after overhaul

Machine was started on 16 Feb-2021, after performing corrective actions. Vibration values of pump were reduced from 1.1 inch/sec to 0.10 inch/sec pk at same operating parameters. Dominant frequency of 1.58x order present in previous spectrums was completely vanished. Currently, vibrations of machine are running normal.

- 1. Wear ring clearances were newly fabricated to maintain correct clearances. Moreover, wear ring were additionally fabricated and introduced in warehouse as spare item.
- 2. Machining of I/B bearing housing and installation of sleeve ring was done, to address ovality issue. Moreover, I/B bearing was modified with steel caged ball bearing.
