ASIA TURBOMACHINERY & PUMP SYMPOSIUM

Case Study 39: Pump Vibration due to Reciprocating Engine Balance Gear Issue

SEBASTIAN ANAK SIDI
PETRONAS CARIGALI SDN BHD

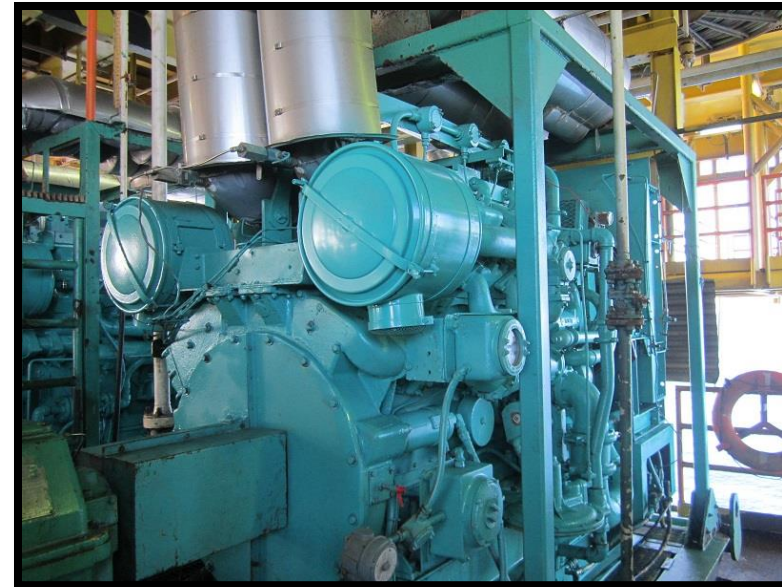
Point Description	Point ID	14/10/15	Unit
Engine Outboard	Hori	6.43	mm/s RMS
	Vert.	10.73	mm/s RMS
	Axial	2.87	mm/s RMS
Engine Inboard	Hori	7.95	mm/s RMS
	Vert.	11.90	mm/s RMS
	Axial	3.65	mm/s RMS
Low Speed Gear DE	Hori	6.65	mm/s RMS
	Vert.	7.30	mm/s RMS
	Axial	7.47	mm/s RMS
Low Speed Gear NDE	Hori	8.06	mm/s RMS
	Vert.	6.53	mm/s RMS
	Axial	10.8	mm/s RMS
High Speed Gear NDE	Hori	7.61	mm/s RMS
	Vert.	7.63	mm/s RMS
	Axial	7.04	mm/s RMS
High Speed Gear DE	Hori	7.68	mm/s RMS
	Vert.	6.68	mm/s RMS
	Axial	8.04	mm/s RMS
Pump DE	Hori	3.29	mm/s RMS
	Vert.	4.12	mm/s RMS
	Axial	3.31	mm/s RMS
Pump NDE	Hori	5.99	mm/s RMS
	Vert.	2.28	mm/s RMS
	Axial	5.58	mm/s RMS
Engine Speed		900	RPM

- Significant high vibration across engine, GB and pump assembly post engine major overhaul and radiator fan replacement

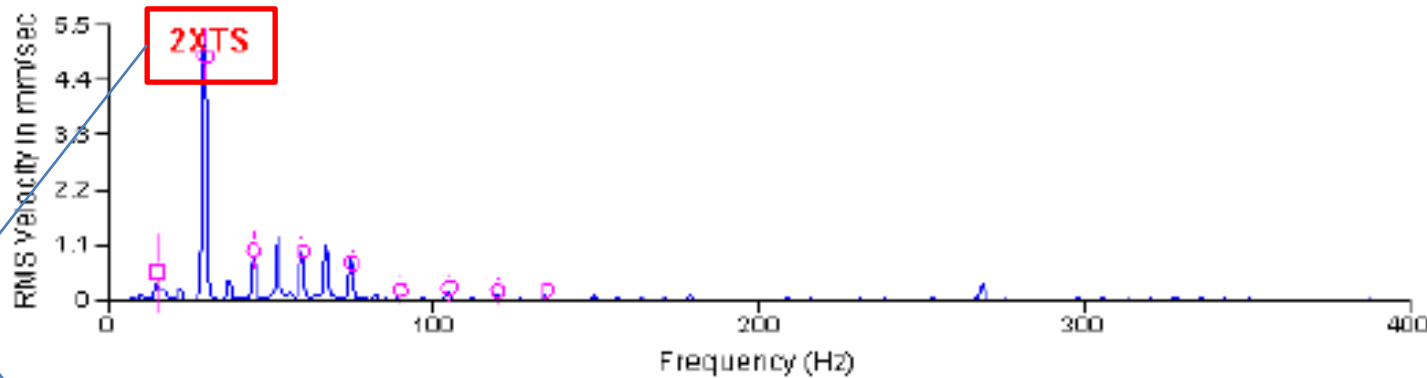
EOH - ENGINE OUTBOARD HORZ

Spectrum observed high amplitude of 2XTS at both direction DE and NDE points

Route
6.439 Y -DG
RMS = 6.452
LOAD = 100.00
RPM = 909.34
(15.16 Hz)
ENG. HARMON
C-ENG. HARMO
15.16 Hz
Freq:15.00
Ord:0.990
Amp: 0.402

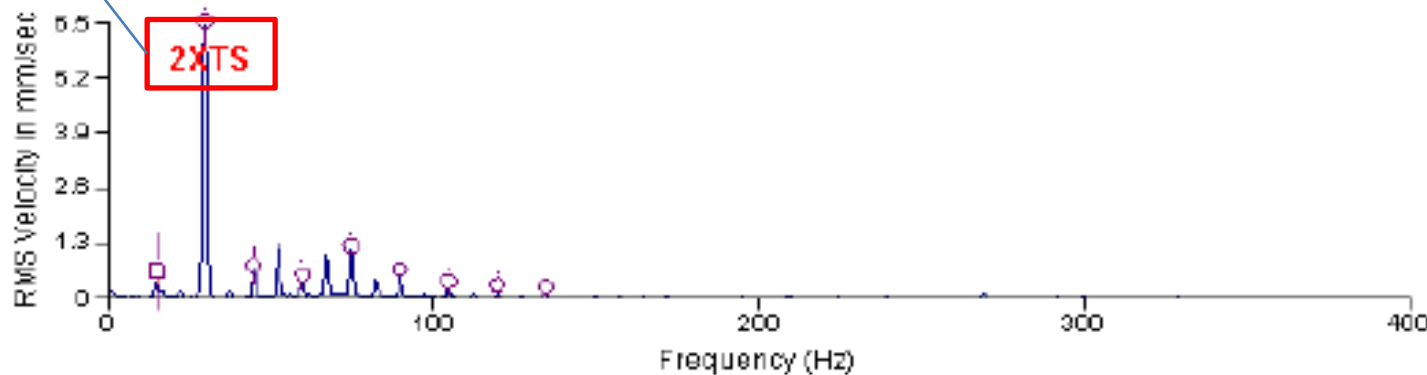
EH - ENGINE INBOARD HORIZONTAL

Route
7.957 Y -DG
RMS = 7.960
LOAD = 100.00
RPM = 909.34
(15.16 Hz)
Freq:14.96
Ord:0.967
Amp: 0.458

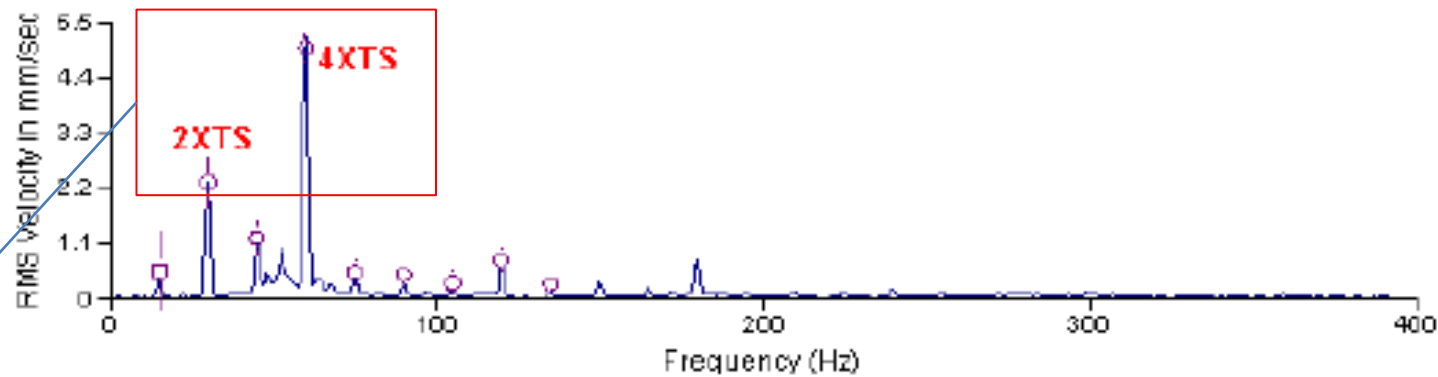
G1H - LOW SPEED GEAR DE BEARING HORZ

Spectrum observed 2X and 4X dominant peaks correspond to Engine running speed

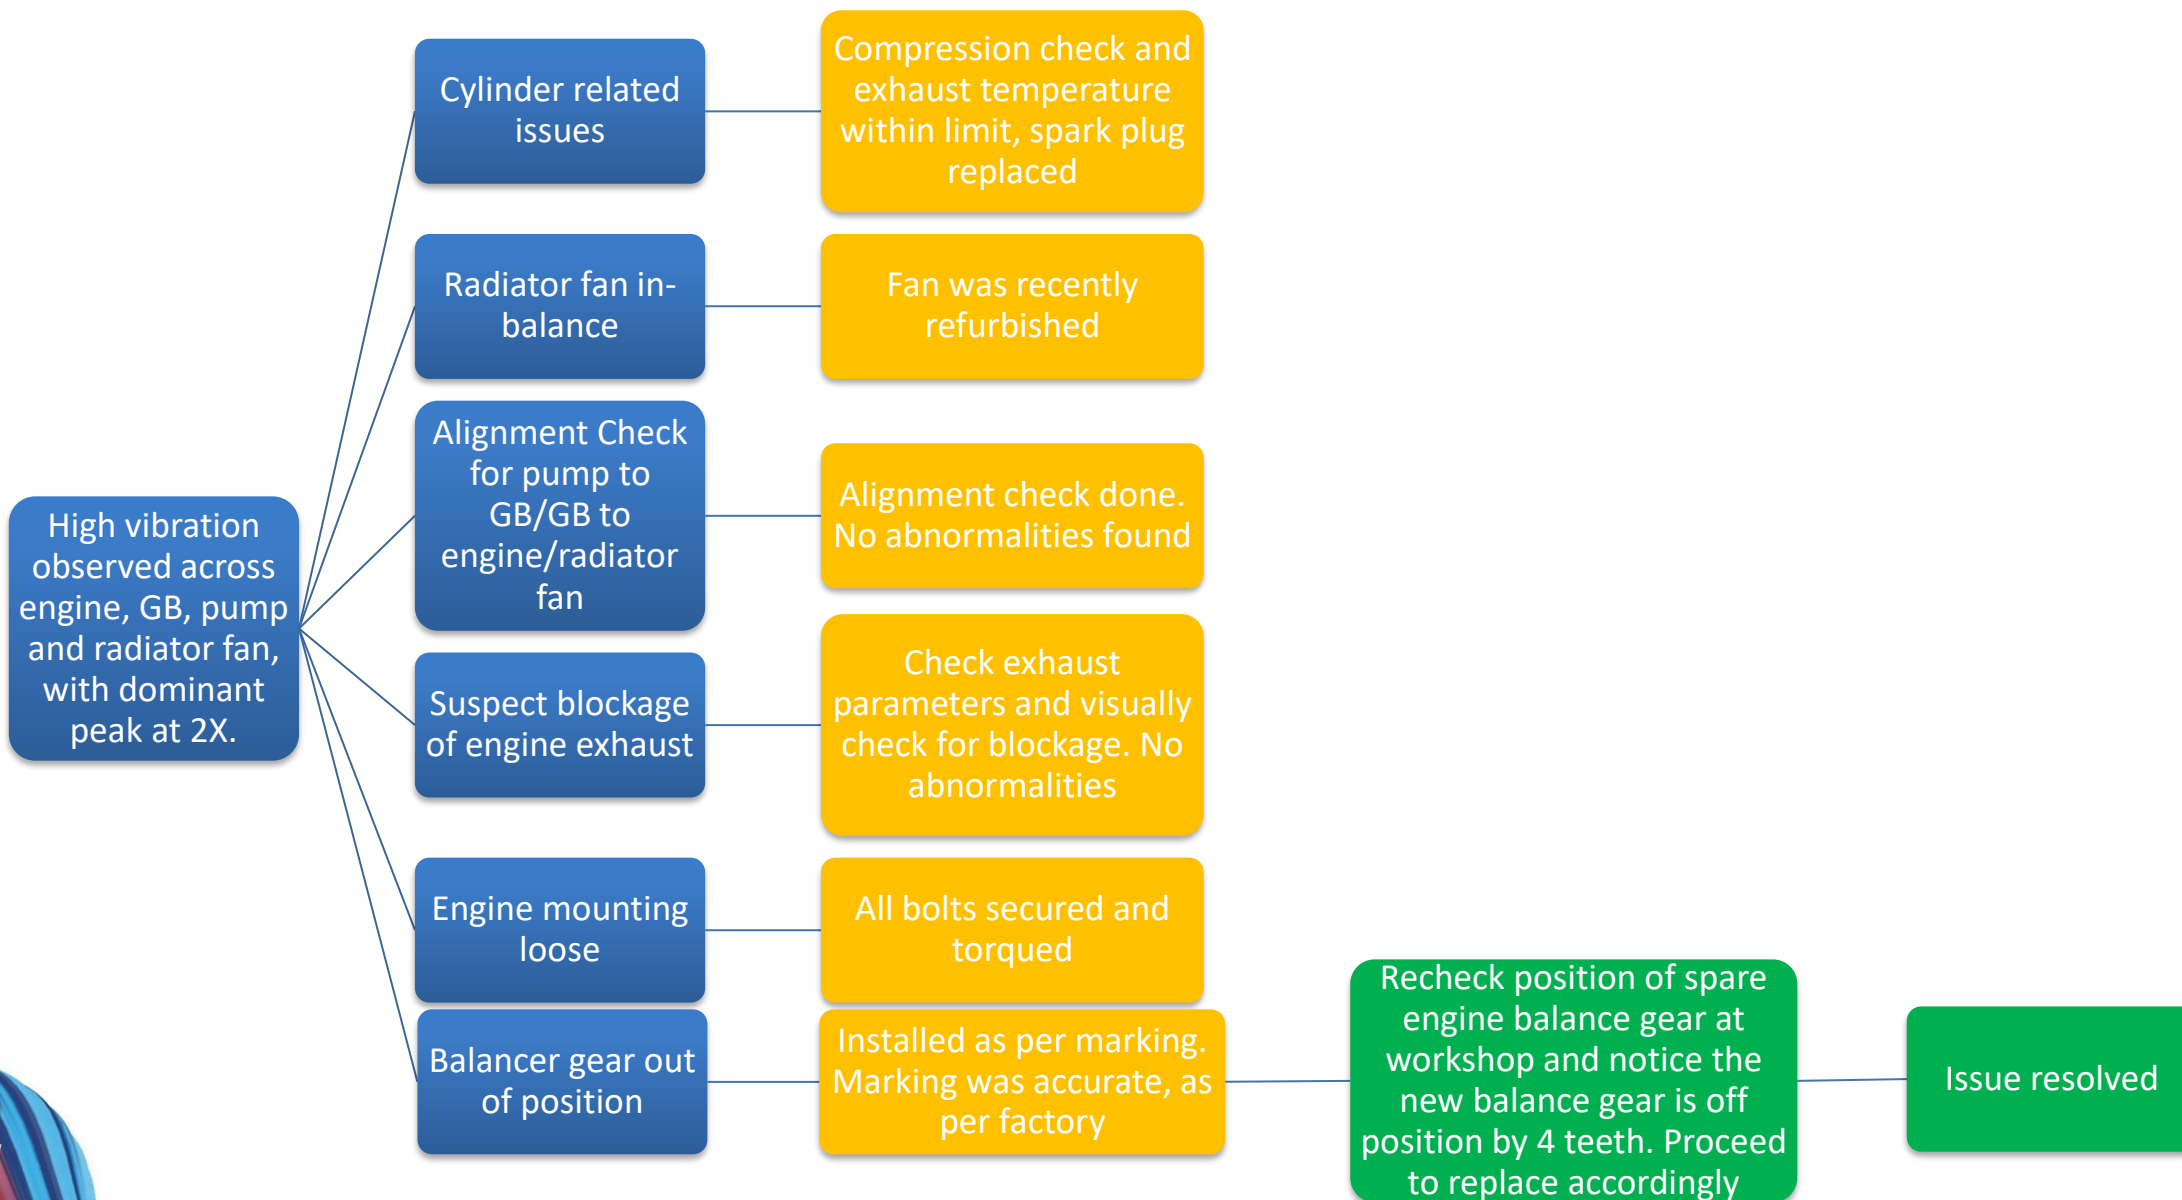
FAILURE ANALYSIS CHART

- Based on data acquisition, vibration increase significantly when speed reached 850rpm and above. Amplitude difference show more than twice increment.
- Suspected engine unbalance which create high vibration on engine and transmitted to all related component including radiator fan, gearbox and pump

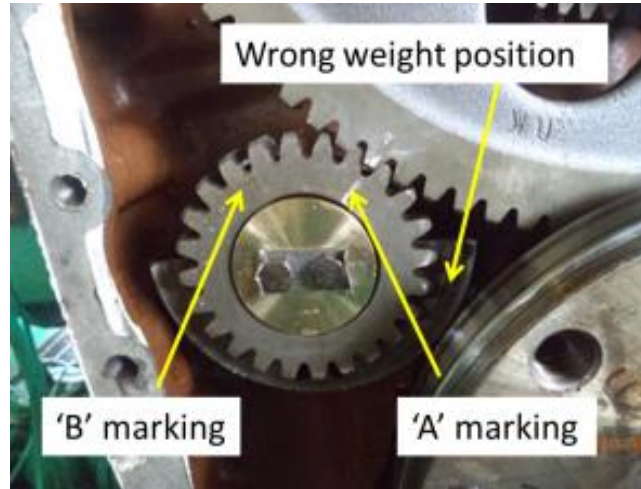
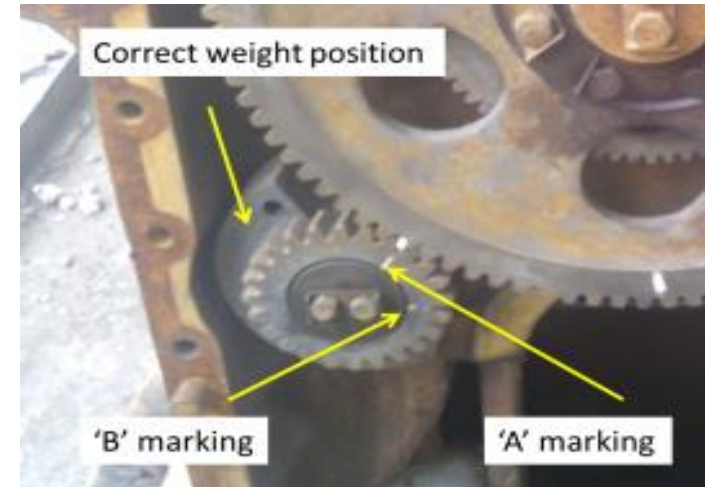
The balance gear act as a counter-force to the unbalance forces produce by engine during rotation, which results in balanced engine. The balance gear is installed as per marking, in this case, as per factory marking. Failure to take note on the as found position of the gear lead to this common mistake, especially on work seldom done, since replacement of balance gear only happens during major overhaul.

The balance gear was replaced and installed as per the correct position
