Offline Chemical Wash for Internal Fouled Multistage Pump

High pressure lean amine pump performance dropped within a span of about 1 month due to internal fouling. Fouling was caused by accumulation of iron sulphide. To address the fouling, pump would have been to taken out of service for a full overhaul, resulting in extended downtime and high cost of repair.

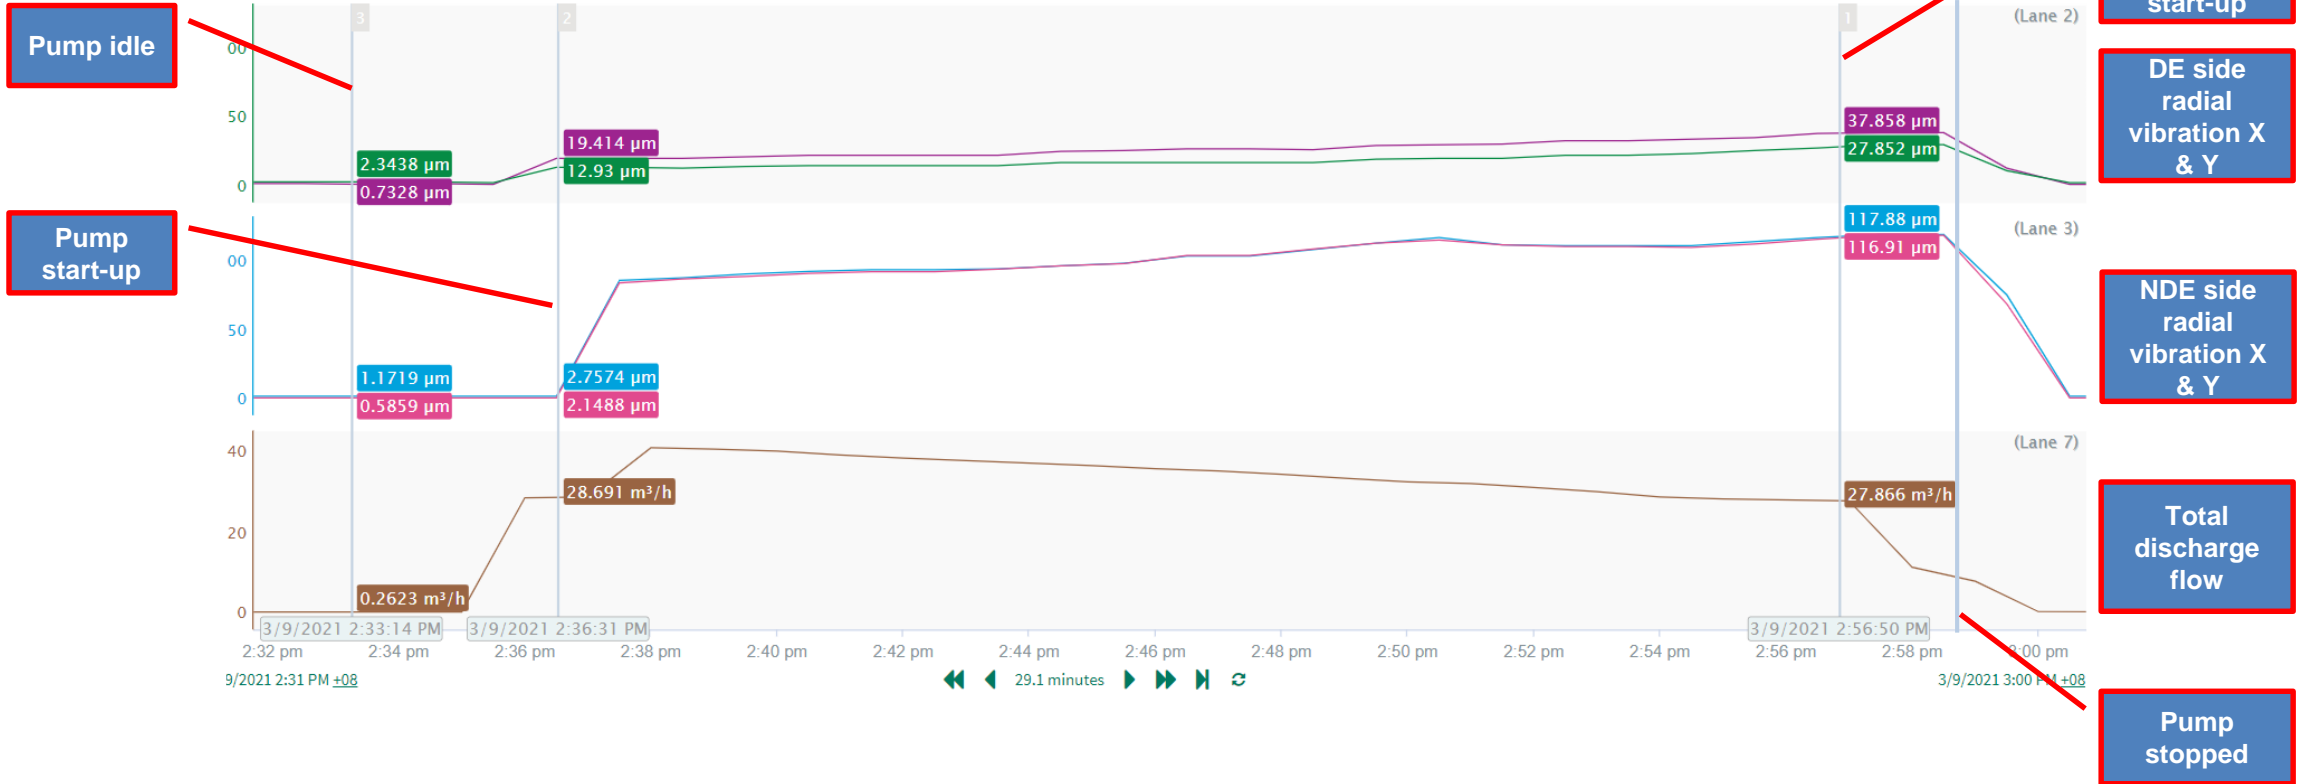
1. High pressure lean amine pump failed to deliver during start-up (ie. During switchover from in-operation B pump to standby A pump)
2. Even with the discharge valves fully open, pump flowrate and discharge pressure dropped below pump performance curve. Discharge pressure was 23,200 kPag vs 21,500 kPag and flowrate dropped to below MCSF of 35 m³/hr.
3. Bearings radial vibration also increased and pump overheated.
4. Pump switch-over aborted to prevent any further damage to the equipment.

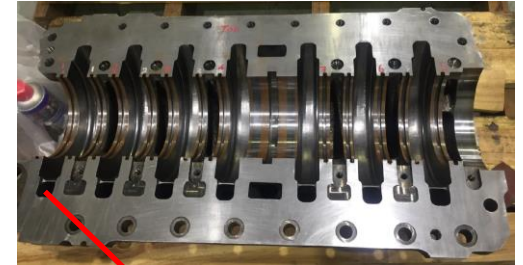
1. Presence of foreign material was also causing failures in upstream pumps and circuit.
2. Foulants from the lean amine circuit were collected and analyzed by Process Engineers. Based on lab test results, foulants are deemed as iron sulphide sludge.
3. As such, pump's failure to deliver was concluded as due to accumulation of iron sulphide sludge in the internal flow passage, partially blocking the flow.
4. Accumulation of iron sulphide sludge occurred when pump was on standby (~ 1month) whilst packed with lean amine fluid.
5. Partially blocked internal flow passage cause the total flow through the pump to drop below the pump MCSF (minimum continuous stable flow).
6. With total flow below MCSF, radial vibration increases.

Pump internal volute flow passage partially blocked by iron sulphide sludge

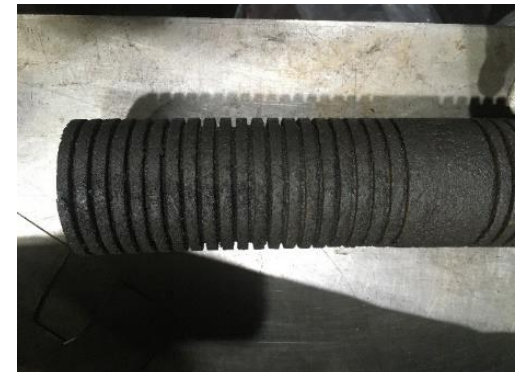
Iron sulphide sludge observed on upstream cartridge filters

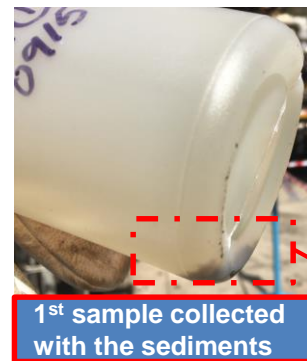
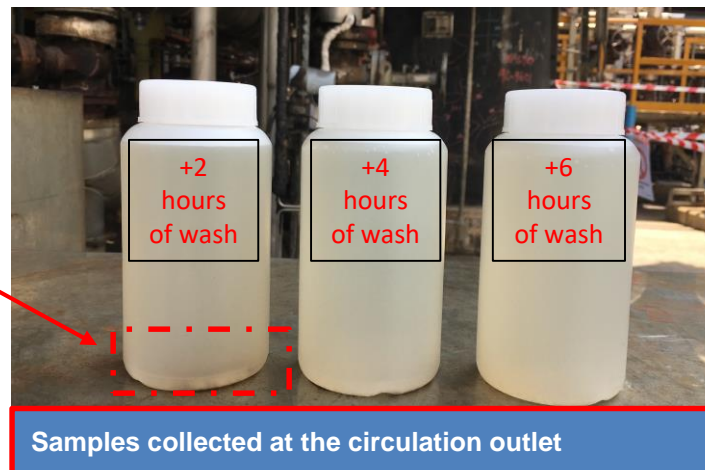
1. Appearance of samples collected at the circulation outlet improved through out the chemical wash. Lesser sediments were also observed in the liquids. Liquid clarity improved.
2. Pump performance recovered upon completion of the chemical wash. Pump discharge pressure and flowrate was as per performance curve.
3. High vibration or pump overheating was not observed during the pump start-up.
