Wet Refrigeration Screw Compressor Failure due to Liquid Slugging

Matthew Zhang -
ExxonMobil Singapore

ASIA TURBOMACHINERY & PUMP SYMPOSIUM

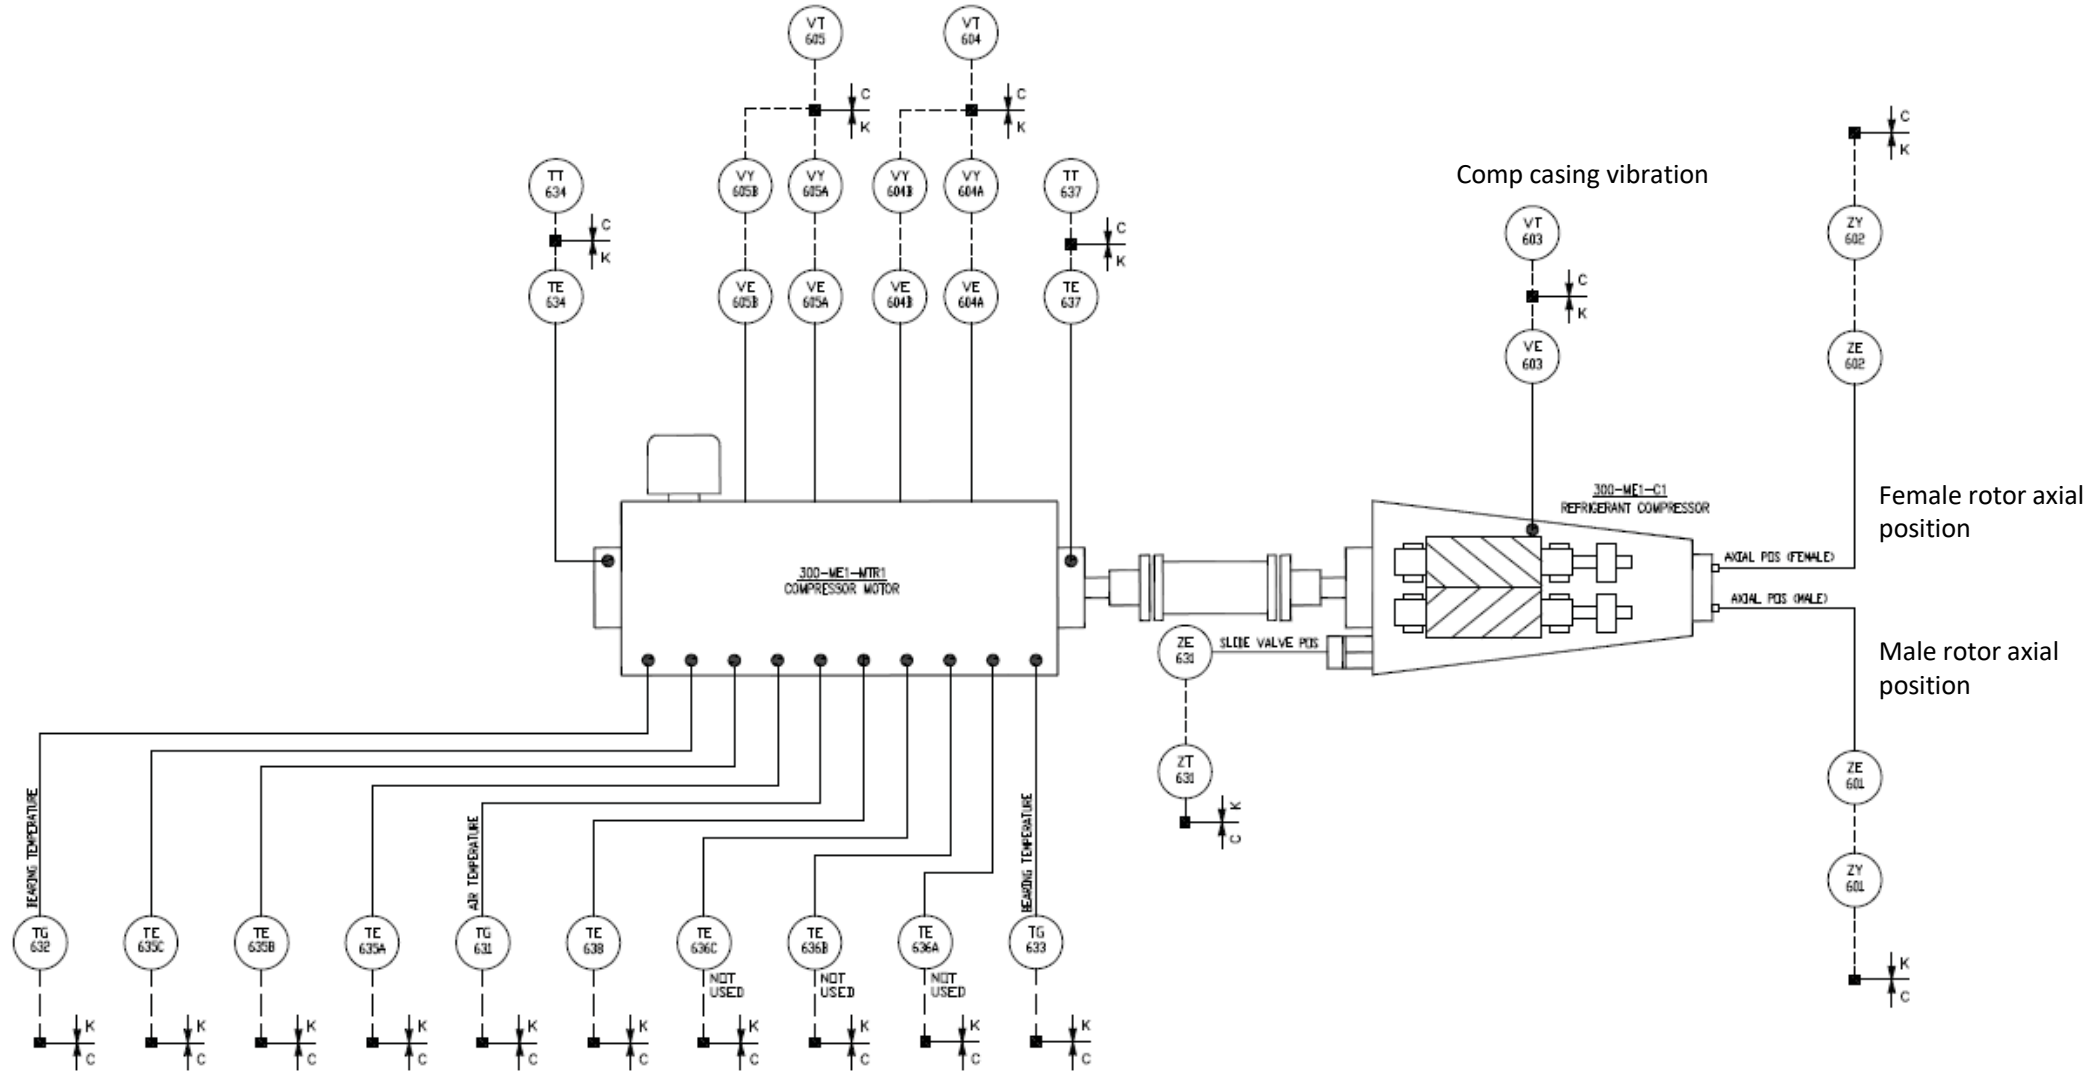
- Compressor tripped on male rotor high-high axial displacement, an alarm was triggered less than 1 second before the trip.
- Male rotor active thrust bearing pads were worn out.
- No indication of gradual degradation of the bearing.
- Suction temperature had narrow margin to propane condensing temperature. Suction temperature is impacted by the combined chiller design, showing dips on a daily basis.
- Sudden failure of thrust bearing indicated an abrupt excessive axial force upon the rotor.

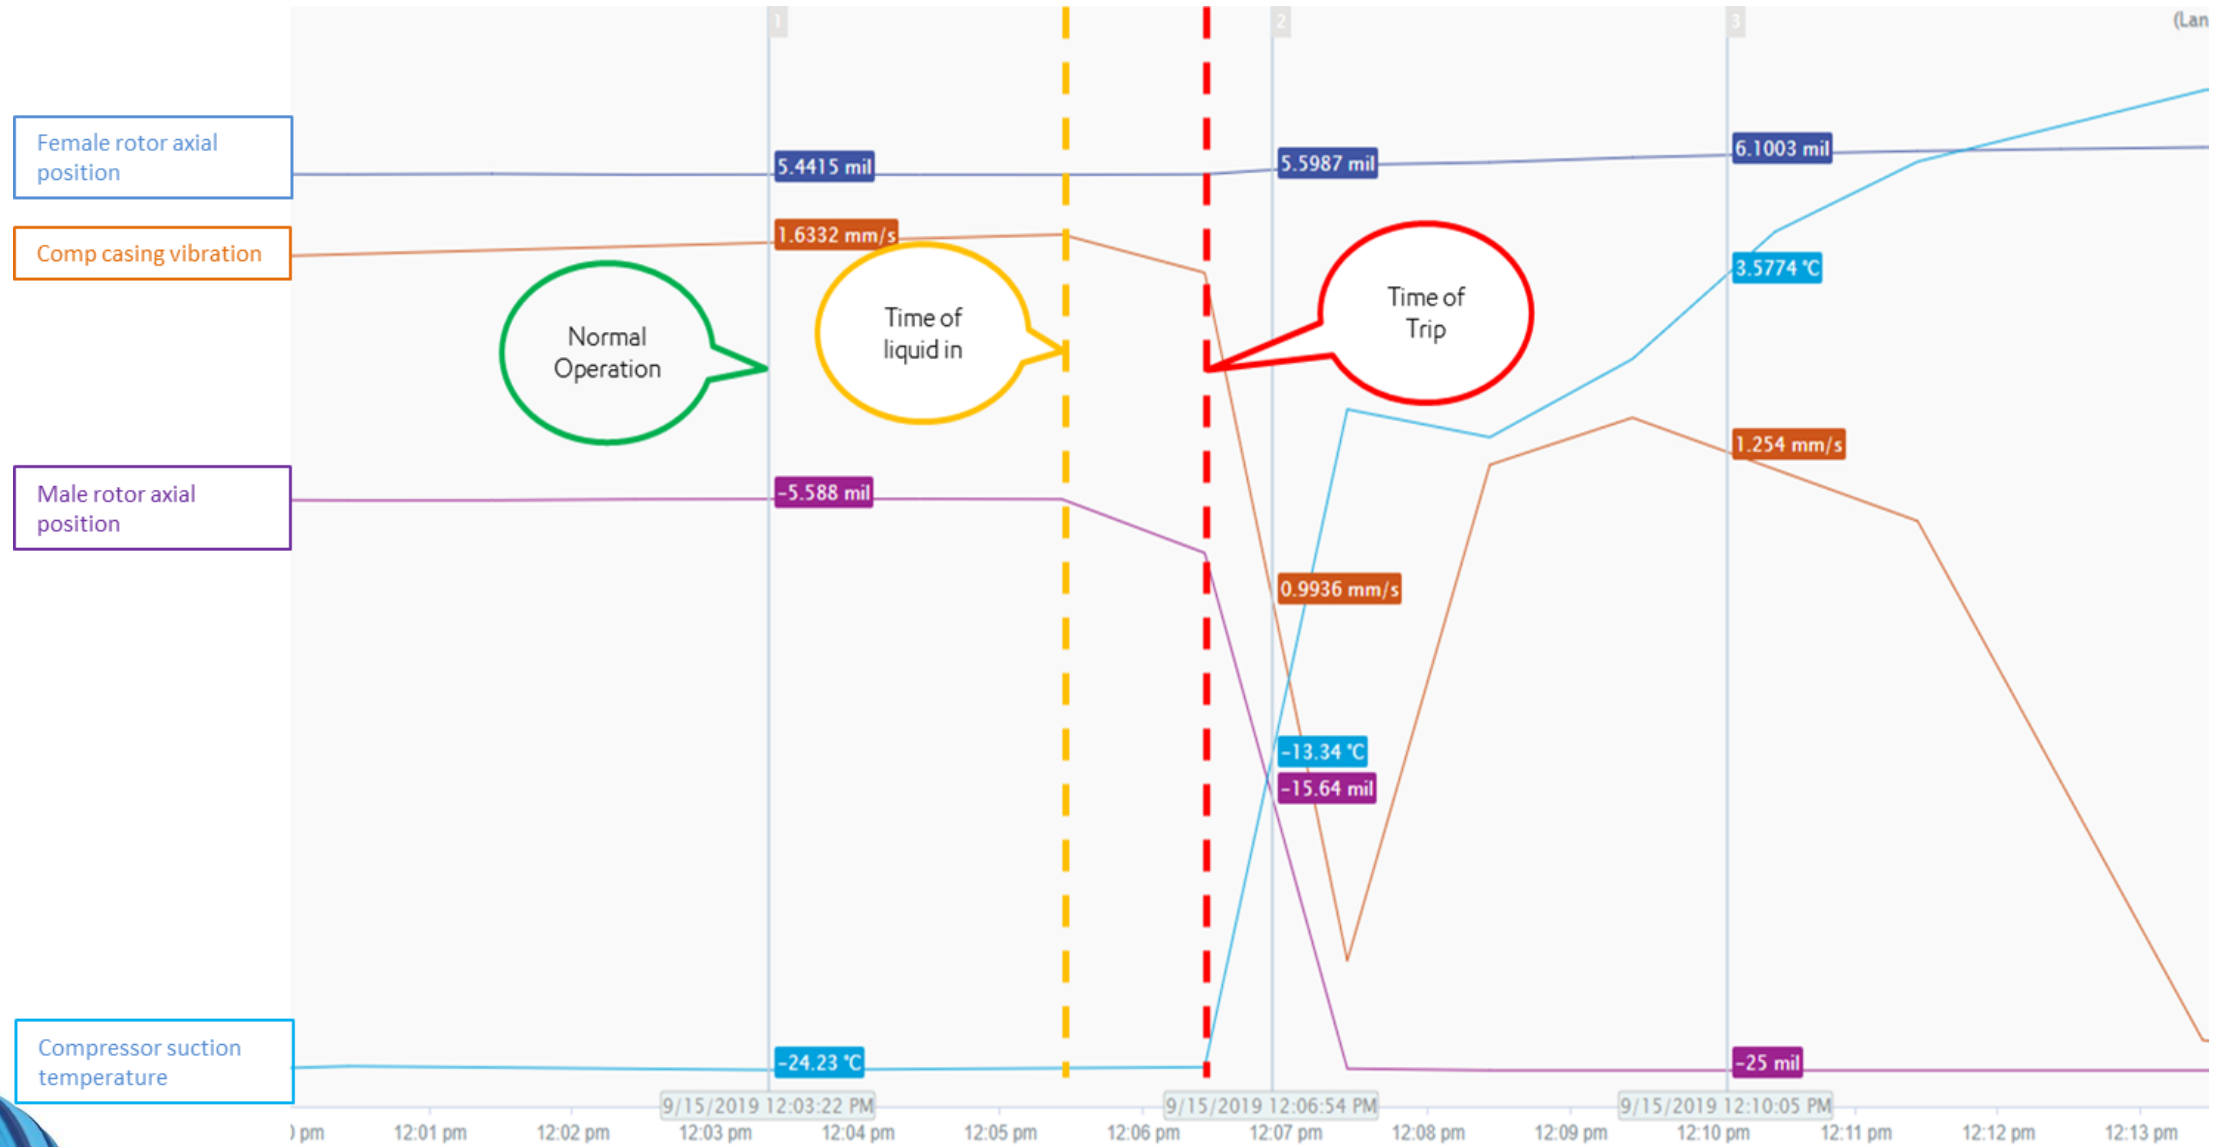
Trend

- Before compressor tripped, rotor position indicators were stable.
- Compressor suction temperature was showing ~ -24 degC, while a faster-sampling trend shows frequent drop below -25 degC.
- Propane vapor pressure chart shows condensation point was approximately -25 degC at 1 barG suction pressure.
- The entire propane refrigeration system had operated in saturation and encountered excessively sub-cooled condition at the time of failure.
- The combined chiller upstream of the compressor was configured as shown in the following slide.
- Liquid propane is preheated in the knockout drum so the gaseous propane will be sent to compressor suction.

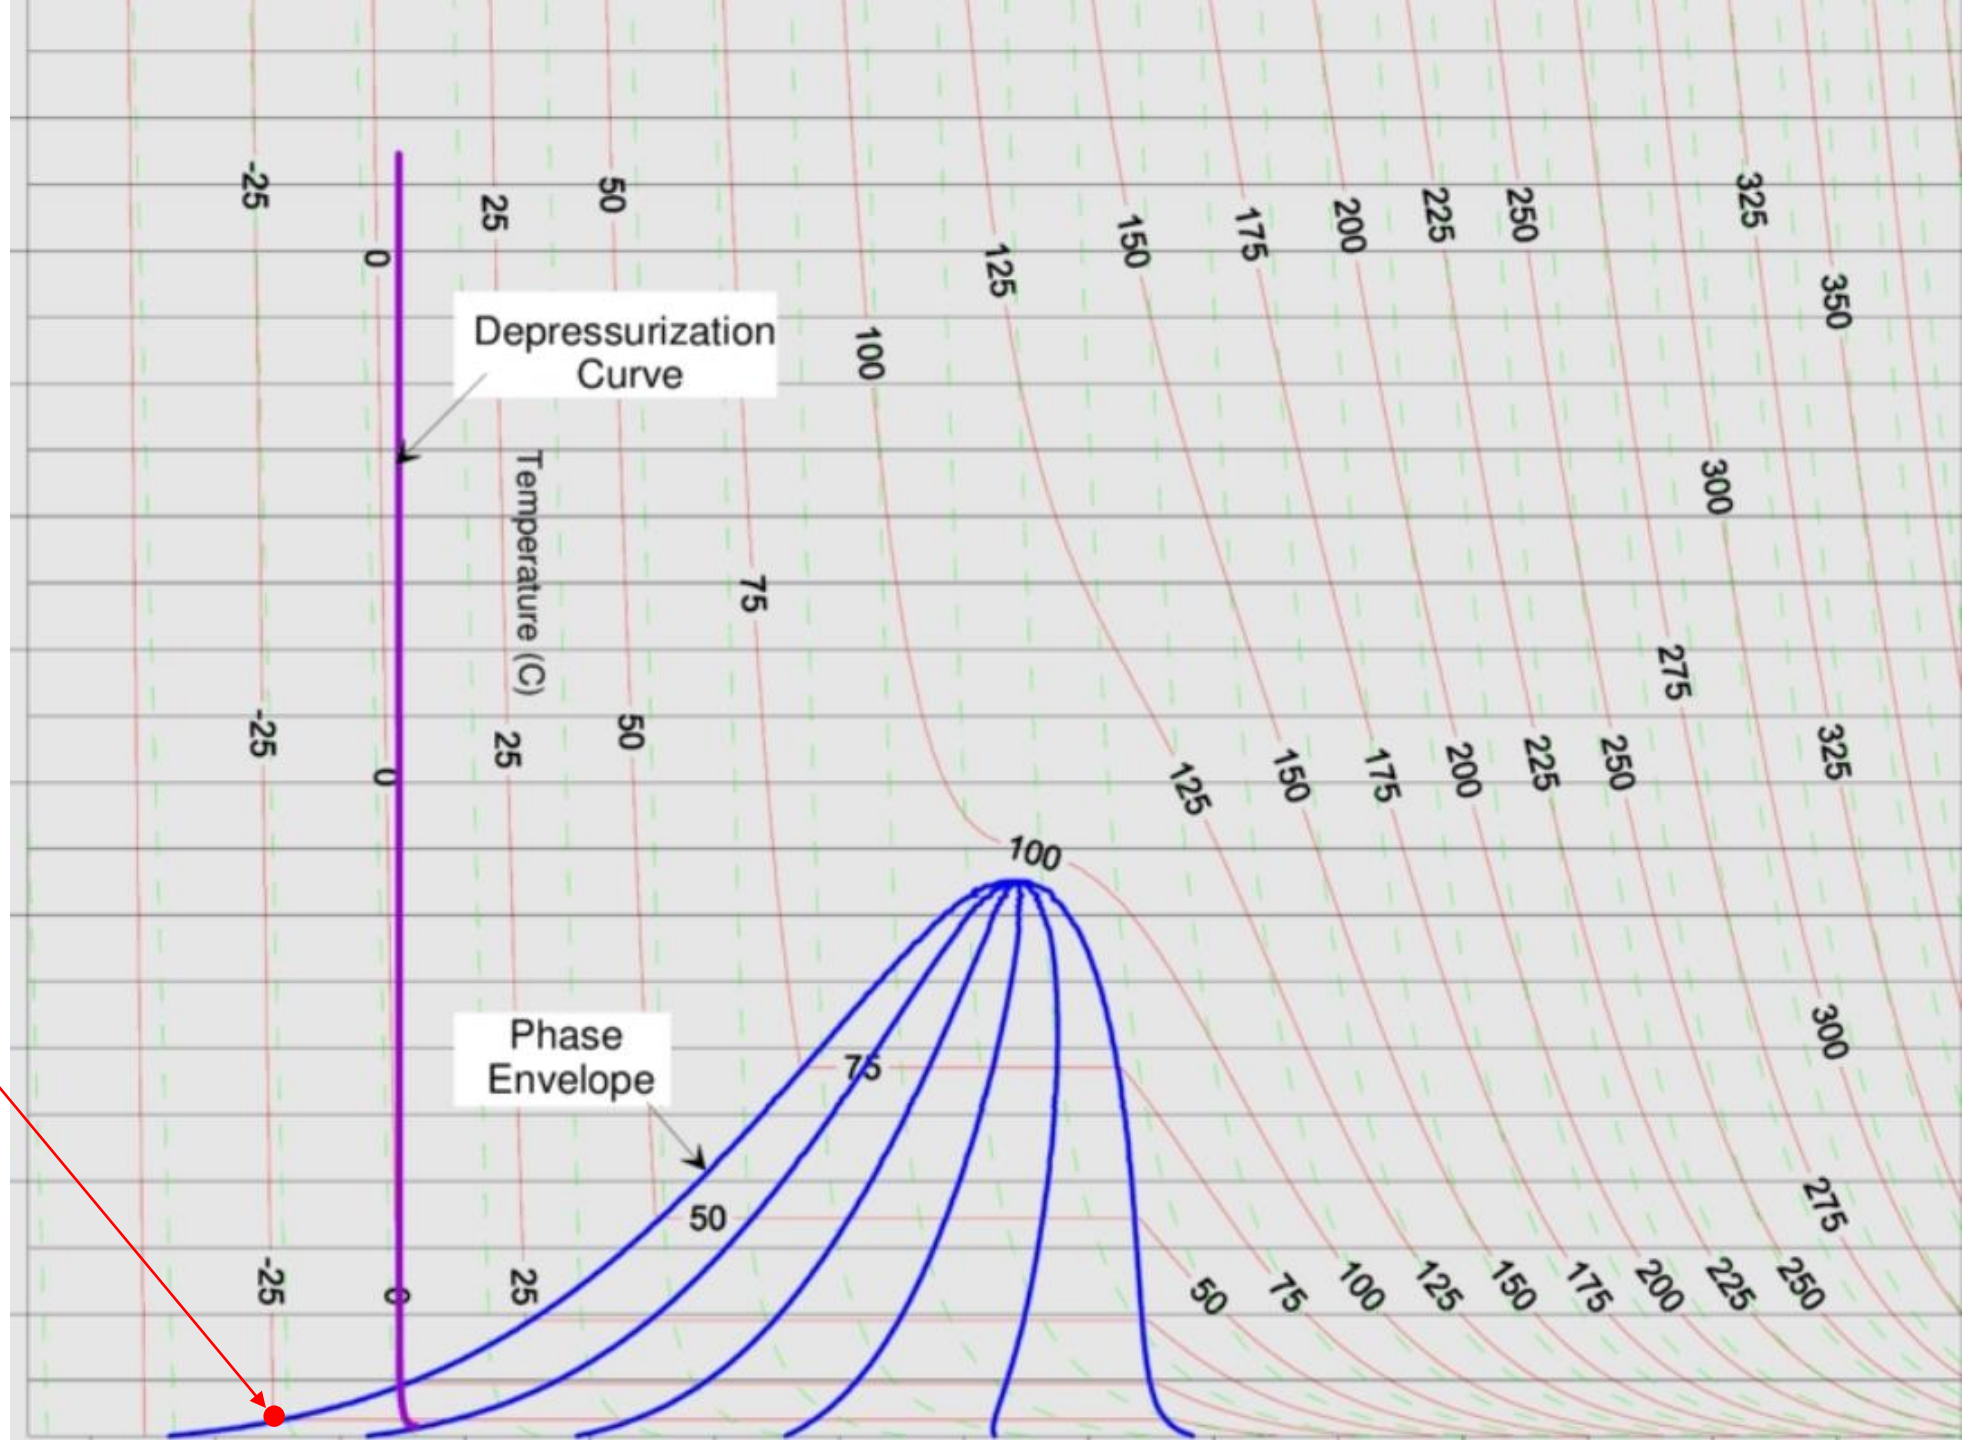
Two-phase (Liquid - Gas) Diagram for Propane

Operating Point close the phase change.

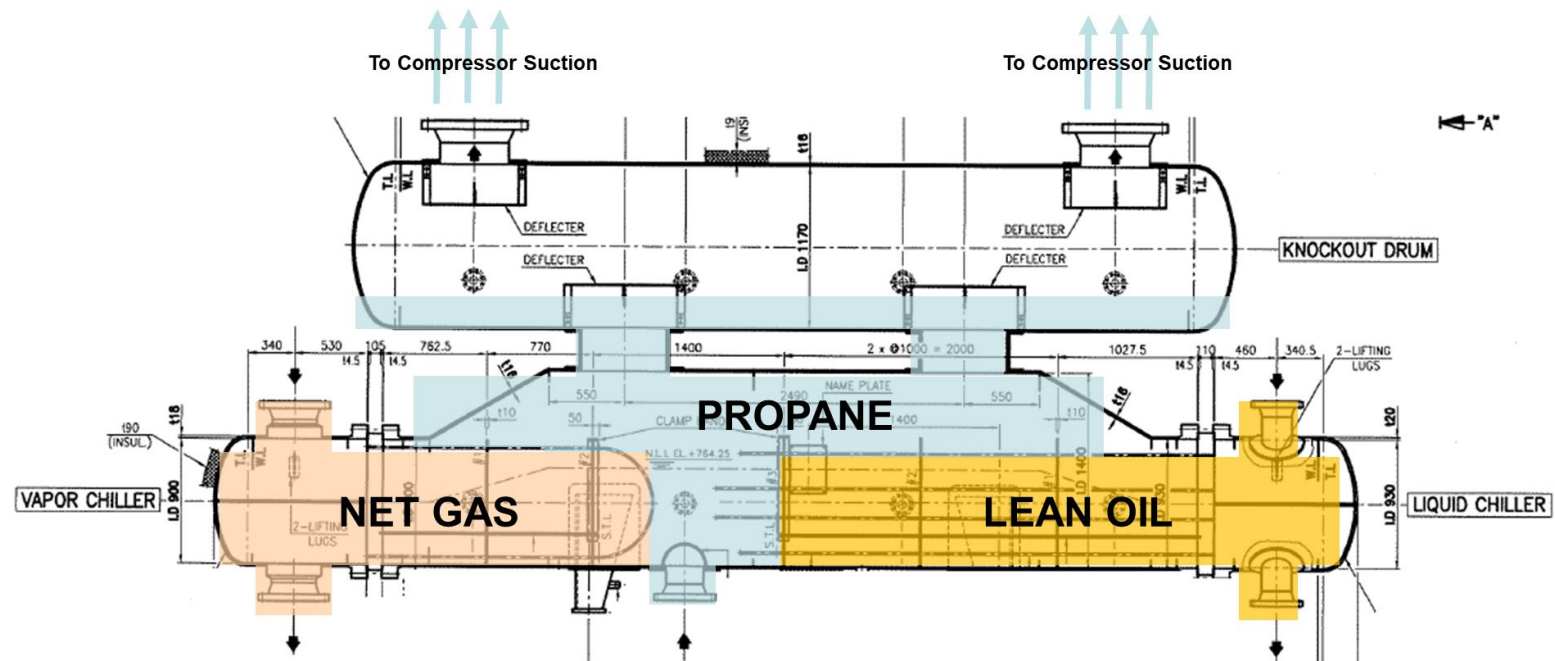
- Temperature and liquid level control of the Knockout Drum are critical to ensure no liquid propane carryover to the compressor suction. However, the operating suction temperature at ~ -24 degC and its fluctuation resulted in liquid propane formation at compressor suction.
