ASIA TURBOMACHINERY & PUMP SYMPOSIUM

Vibration Diagnostic of Steam Turbine Intermittent Rubbing

KER PIN JUN – EXXONMOBIL
NG WEI SING - EXXONMOBIL

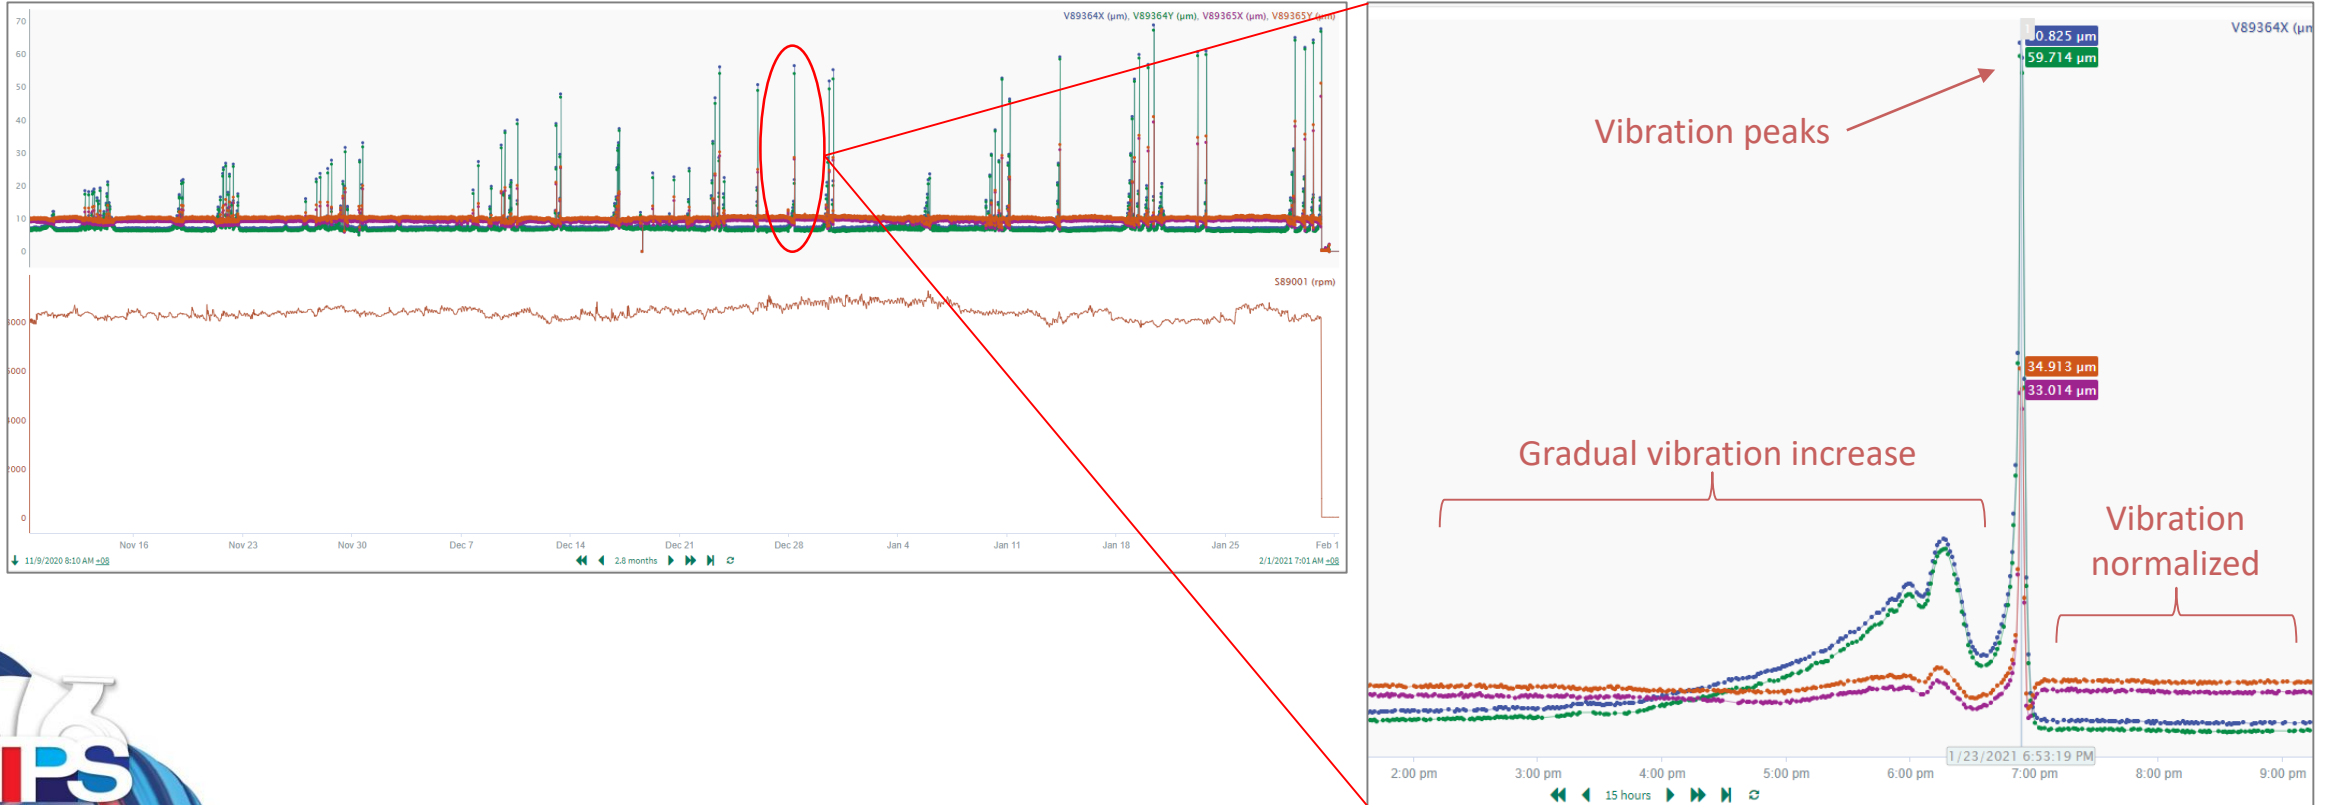
- The steam turbine was last overhauled in April 2019. The turbine typical overhaul interval is between 12 – 15 years. Rotor, bearings, casing and inter-stage seals were replaced with new. Internal clearances were restored back to within OEM design limits. Turbine vibration was healthy and stable during commissioning.
- After about 1.5 years of operation, the turbine started to experience intermittent vibration spikes. The amplitude of spikes on steam end were consistently observed to be higher than exhaust end.
- The increase in vibration amplitude was observed to be gradual, and return to 'normal' level every time the vibration peaks.

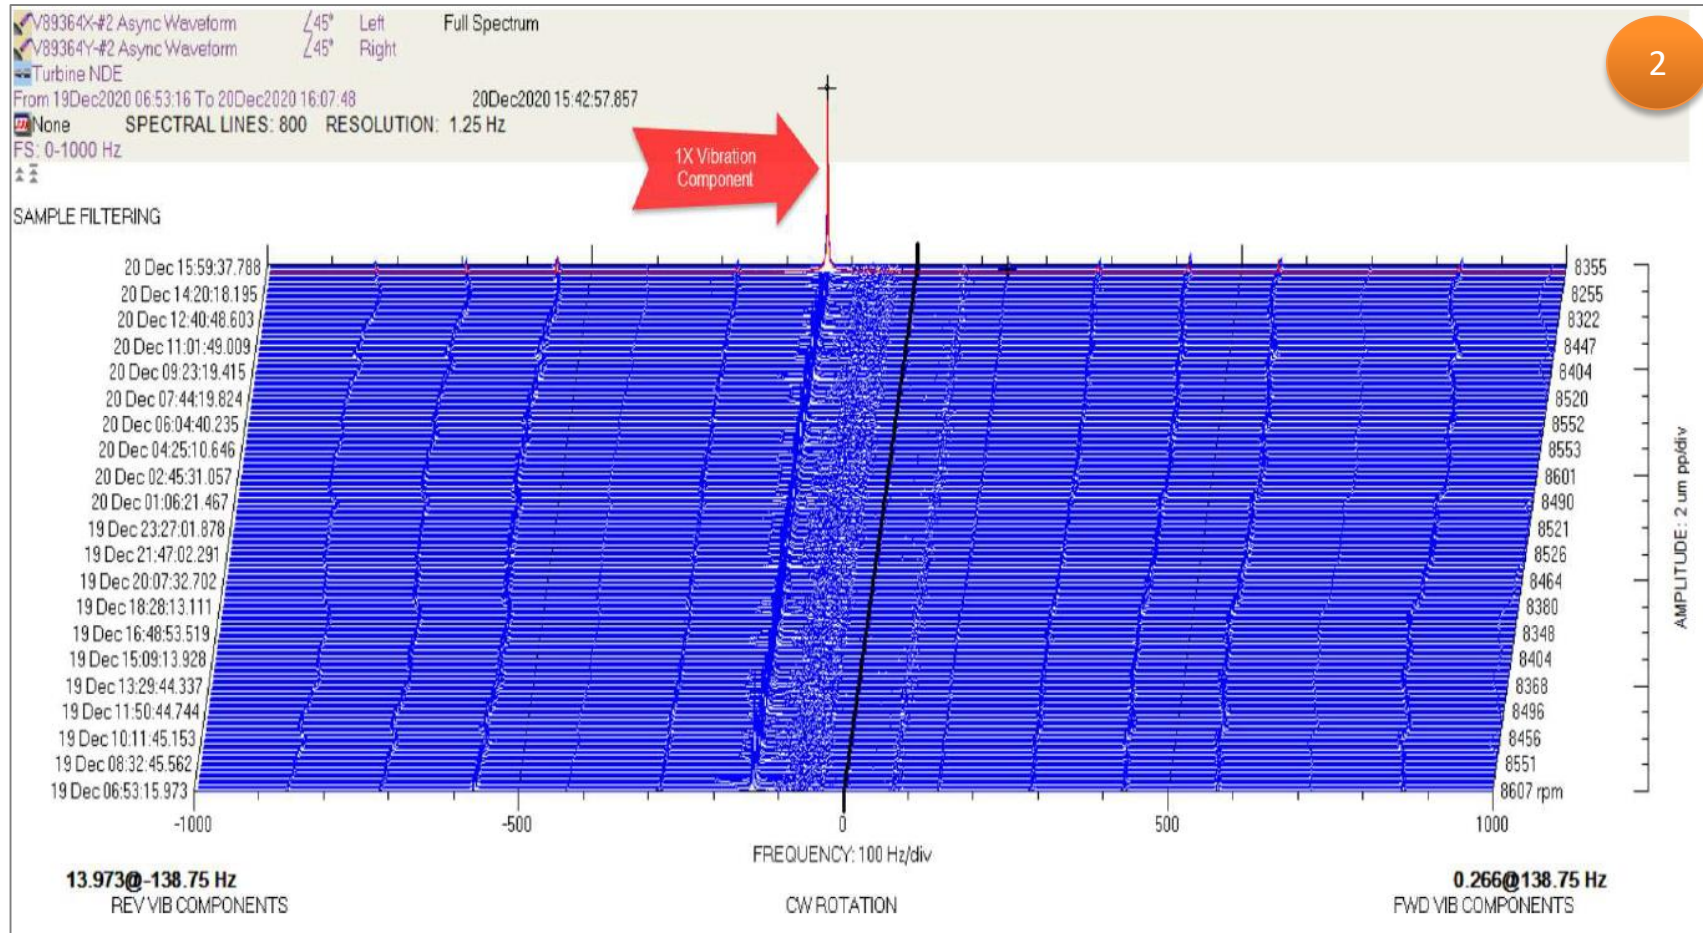
Fig. 2: Full spectrum during vibration spike

1. ADRE 408 external data acquisition and diagnostic system was used to collect the steady state vibration data for further troubleshooting.
2. Dominant 1x peak during vibration spike , with clear reverse component observed on full spectrum.

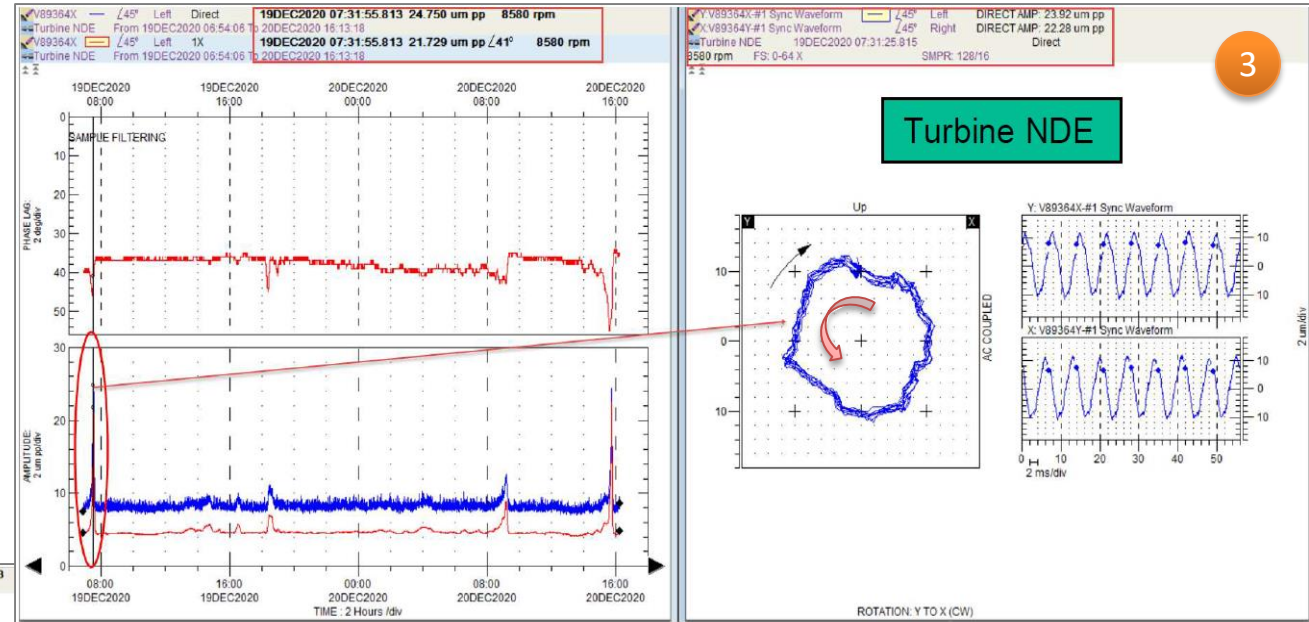
3

3. Significant phase angle change observed during vibration spike indicating a shift of rotor heavy spot. Reverse precession (vs. direction of shaft rotation) was observed on orbit plot.
4. Polar plot shows random shift of phase angle during vibration spike event.

Fig. 3: Phase angle change in Bode and reverse precession in orbit observed

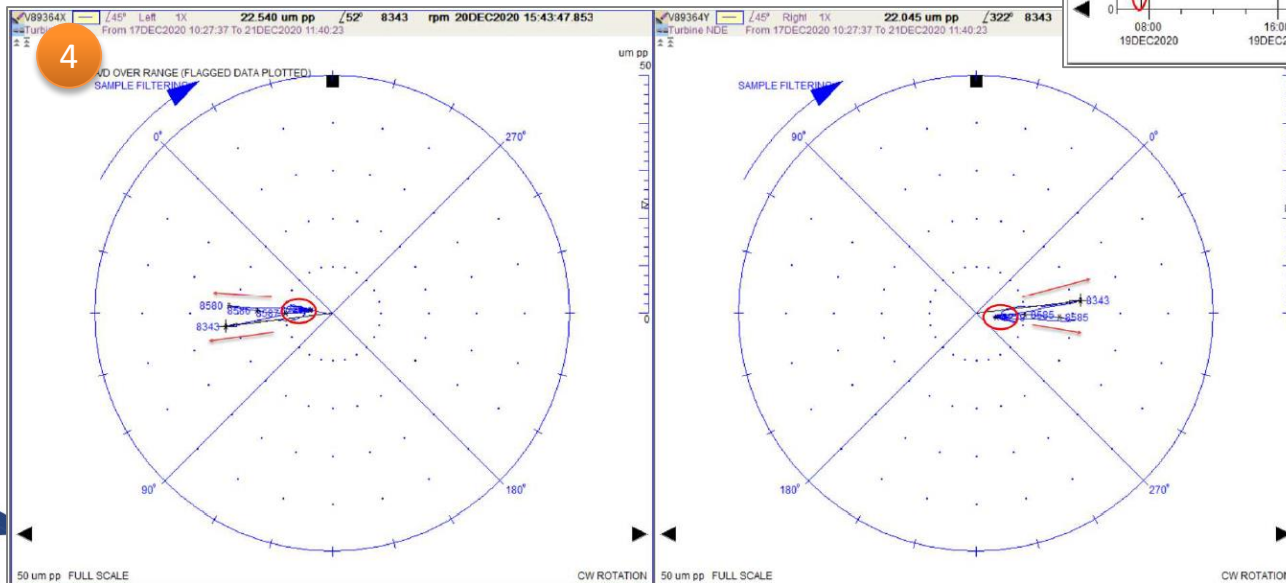
4

Fig. 4: Polar plot with phase shift during vibration spike

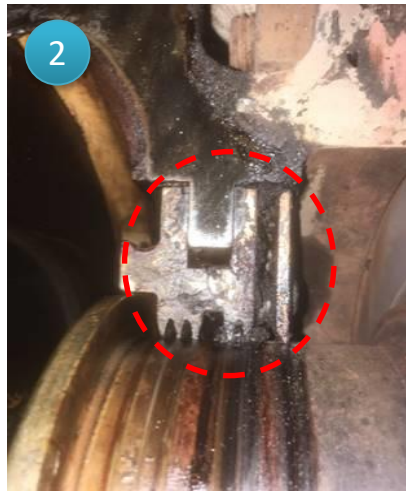
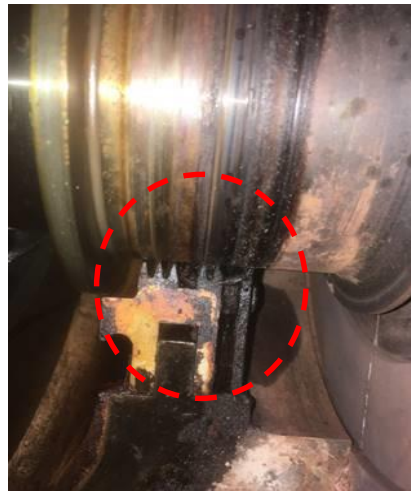
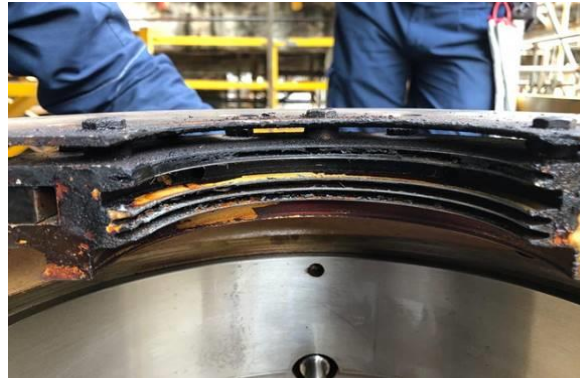
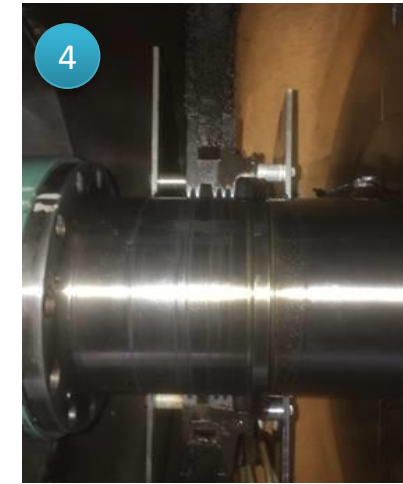
1. After the trip event, the turbine bearing housing was opened for inspection.
2. Steam end bearing housing oil baffle was badly clogged with carbonized oil. Clear rubbing sign on turbine shaft.
3. The sealing air injection port was also fully plugged which explain the reason why recommissioning of sealing air does not help to prevent the trip.
4. Exhaust end bearing housing oil baffles were significantly cleaner as they were exposed to much lower temperature; hence no carbonized oil.
5. All oil baffle were cleaned before reassembling of the bearing housing.

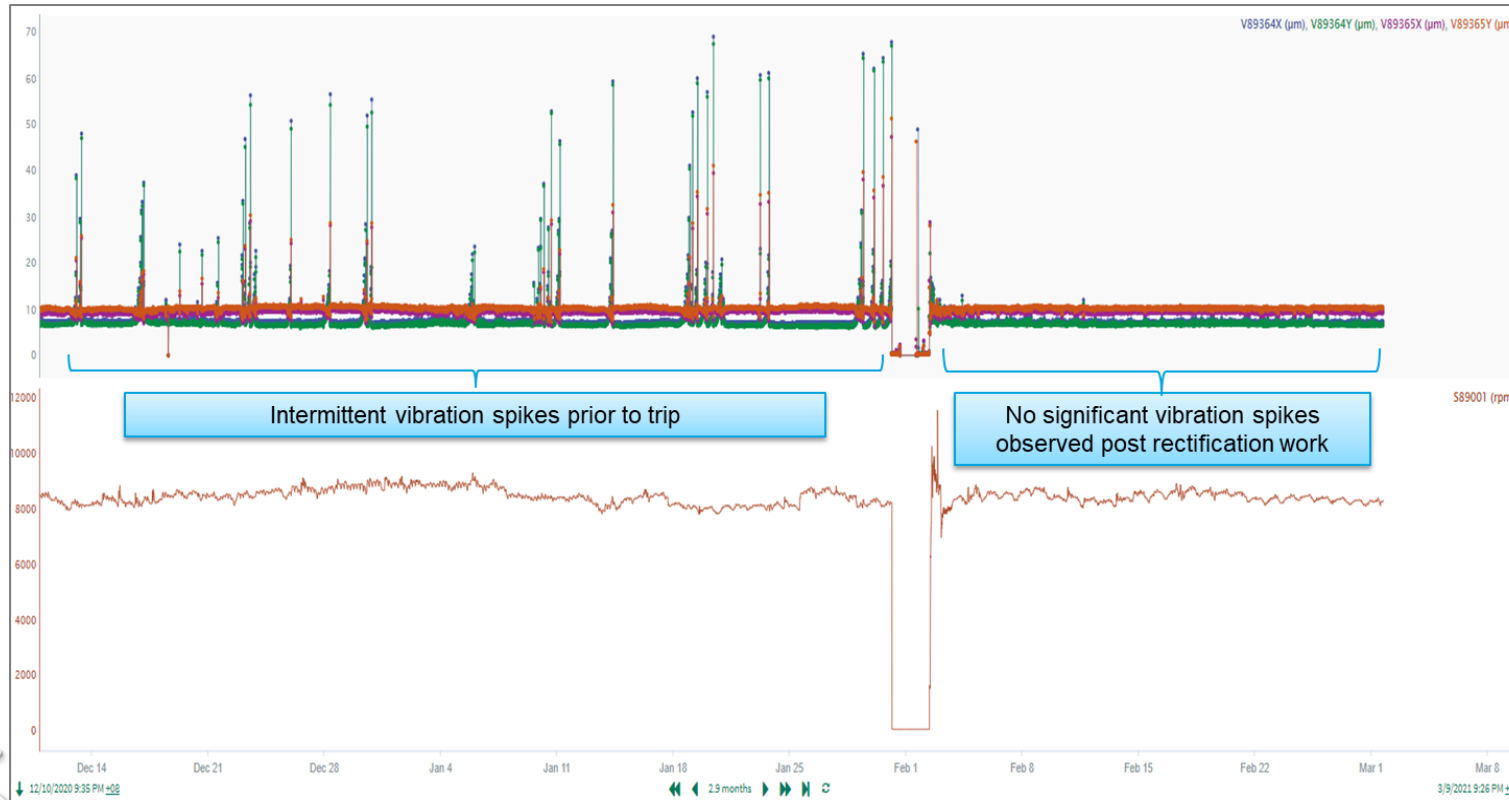
- As the vibration analysis and troubleshooting was completed prior to the trip event, the total downtime was significantly reduced to only 2 days (including unit restart). Targeted rectification work can be performed immediately after the trip.
- Post restart, the vibration trend was healthy and stable. No vibration spikes observed.
- Site visual cue / signage was put up to remind operators the importance of commissioning the sealing air to the bearing housing oil baffle.
- Similar "Caution" remarks was updated into the turbine start-up procedure for long term sustainability.
