**24-26 MAY 2022**  
**SHORT COURSES: 23 MAY 2022**  
**KUALA LUMPUR, MALAYSIA**

## COMPRESSOR ROTOR CRACK CASE

The case study describes rotor crack detection using vibration measurements, documented on real case of Induction Motor driven Compressor Unit. The study highlights the complexity of rotor crack diagnostics as the primary problem as it can be often masked by other existing machine malfunctions.

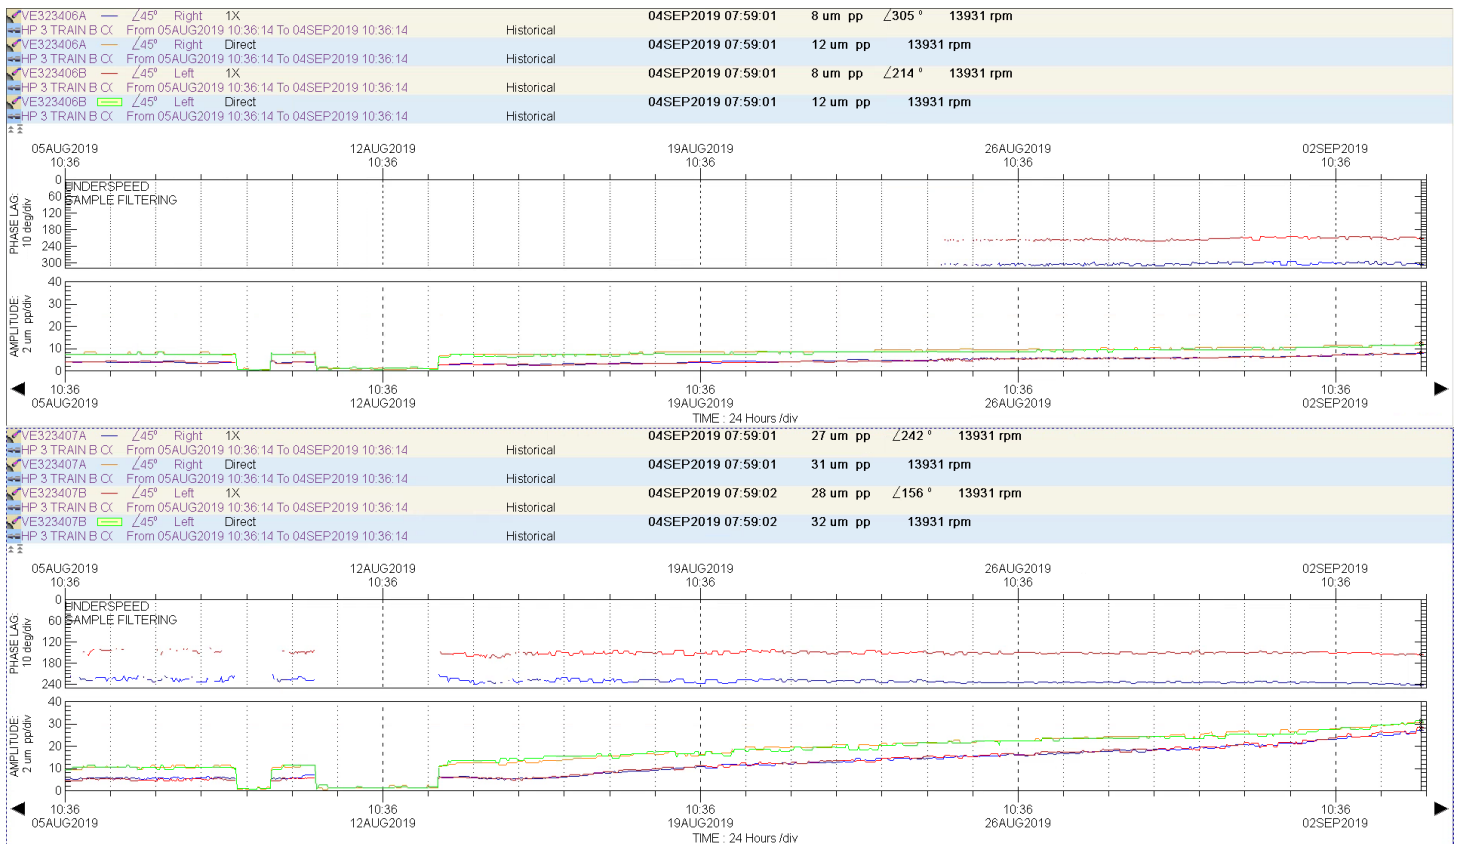
Figure 2: Compressor DE & NDE Radial Vibration Direct & 1X Trend

- Radial vibration gradually trended upwards on the Compressor NDE and to a lesser extent on the DE since the restart of the machine. The increase was predominantly 1X frequency component and no significant phase changes on both bearings (Figure 2).

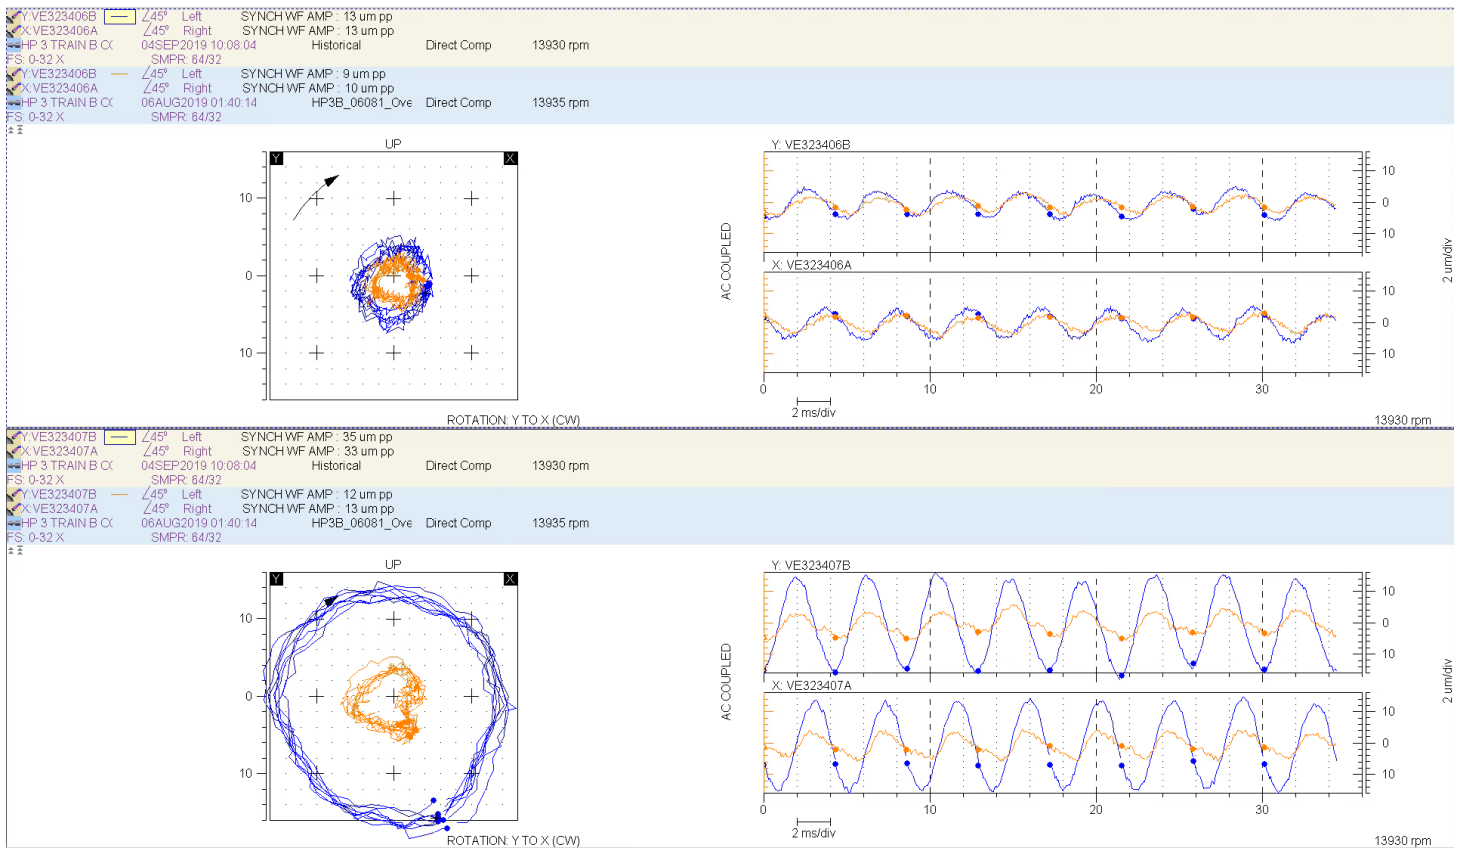
Figure 3: Compressor DE & NDE Compensated Direct Orbit Timebase plot comparison (Pre/ post re-start)

- Shaft Center Line (SCL) plots show no evidence in a change in external alignment (GB-Comp) or internal alignment (Comp)
- The compensated direct and 1X orbit timebase plots show and increasingly circular shape when compared to running data prior to the restart. (Figure 3)

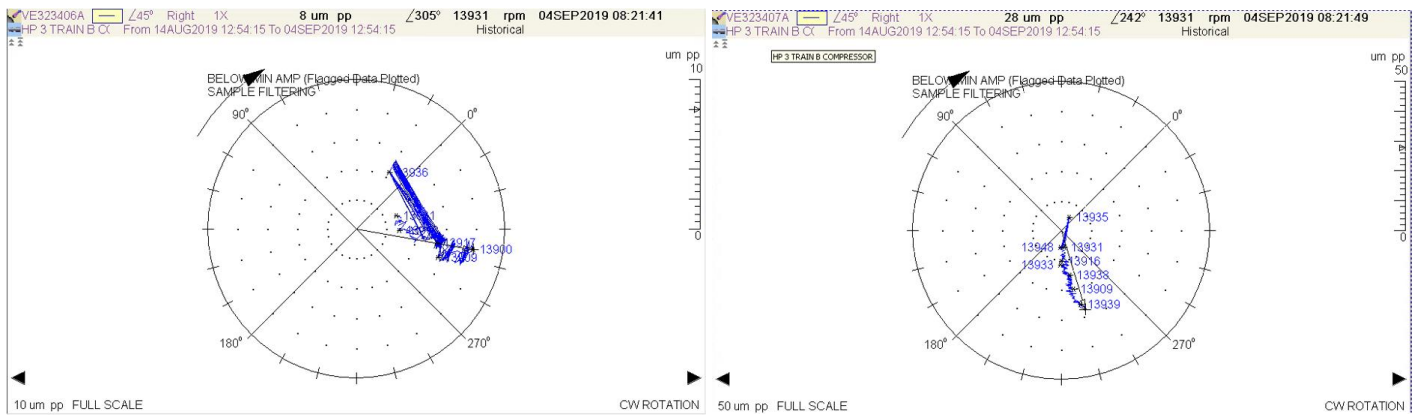
Figure 4: Compressor DE & NDE Polar plot (post re-start)

- The 1X Polar plot for Compressor NDE bearing shows unusual unidirectional 1X vector change, with increasing amplitude but constant phase. This would suggest change in mass or stiffness in one direction, which is unusual and can be serious. (Figures 4)

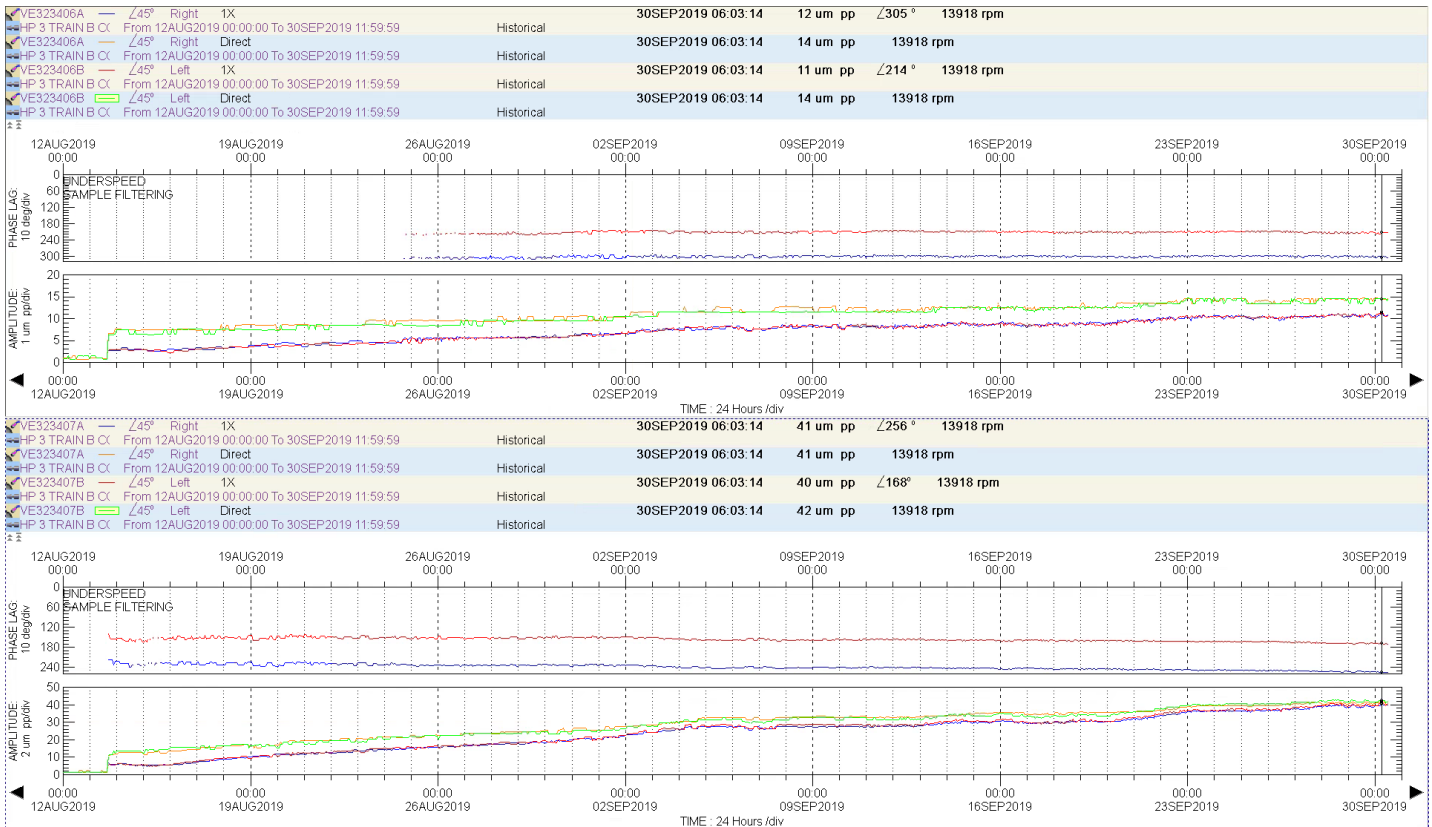
**Figure 5: Compressor DE & NDE Radial Vibration Direct & 1X Trend**

- Compressor DE/NDE Radial Vibration has continued to trend upwards with the most significant increases visible on the NDE. The prominent frequency component remains 1X and there is very little corresponding phase change (Figure 5).

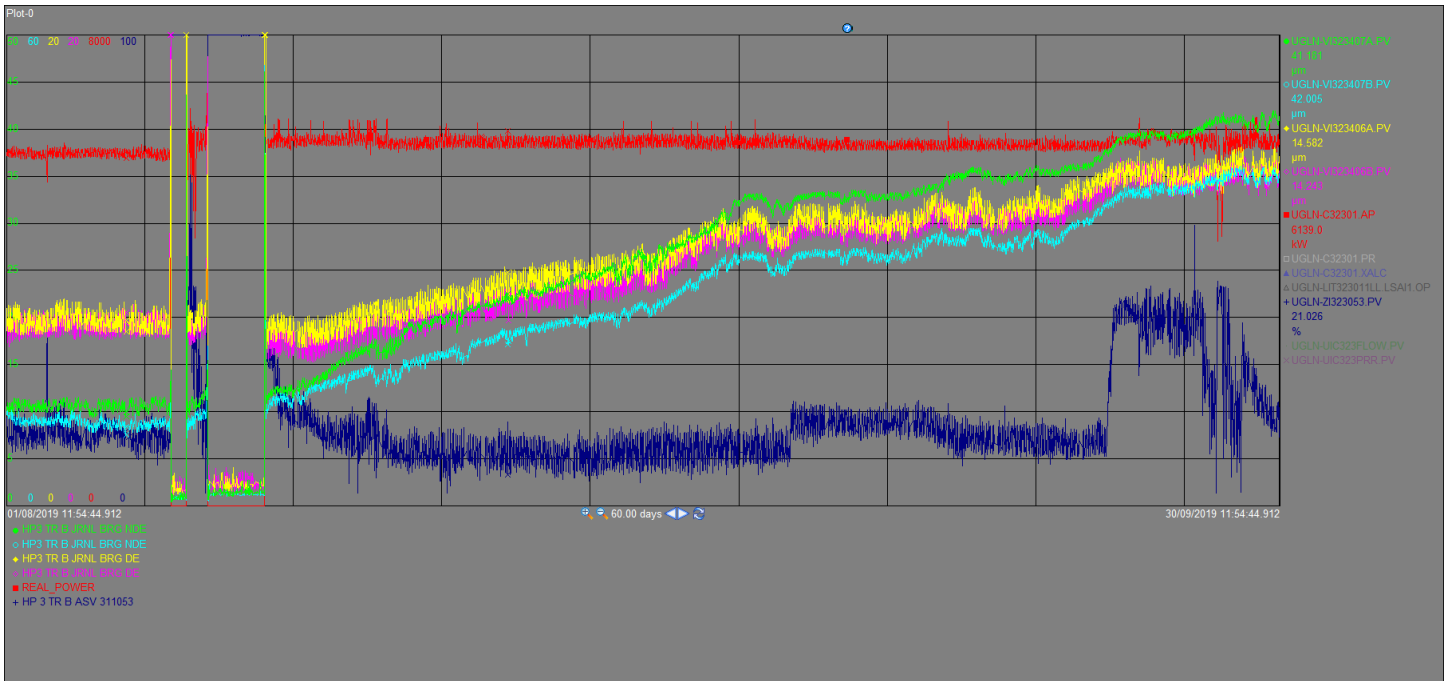
Figure 6: Compressor DE & NDE Radial Vibration Direct Vs Load (Anti-Surge Valve Position dark blue increased % = higher load)

- There is no evidence of a direct correlation between the increased loading of the compressor and the vibration increase. The compressor vibration reacts abnormally to changing load conditions as it continues to increase at varied rates, with increased or decreased load. The load can be derived from the ASV position. Higher ASV value means higher load (Figure 6).

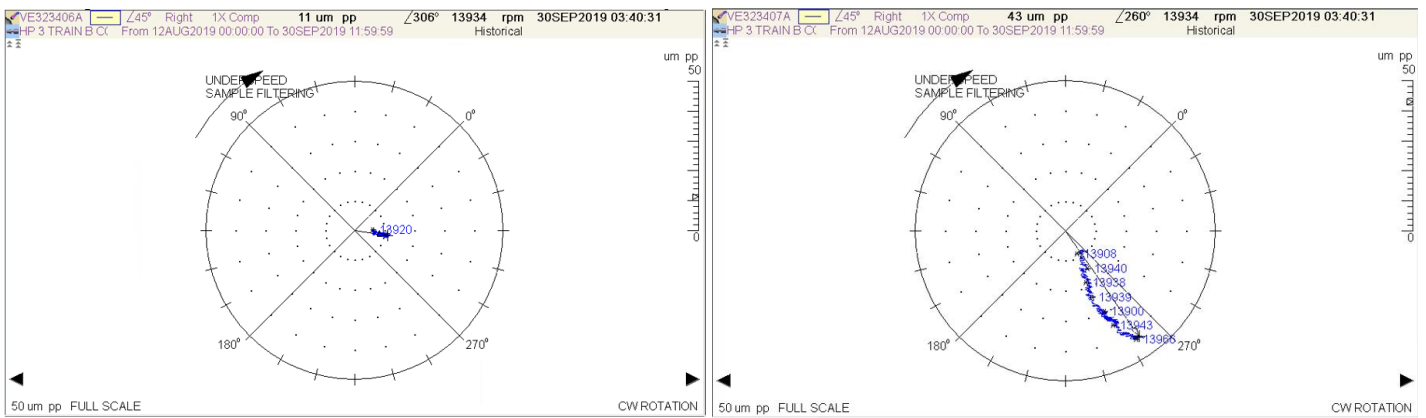
Figure 7: Compressor DE and NDE Compensated 1X Polar Plot

- Compensated 1X polar plot plots show the continued unidirectional increase in 1X vibration on the Compressor NDE. This would suggest change in mass or stiffness in one direction (Figure 7).

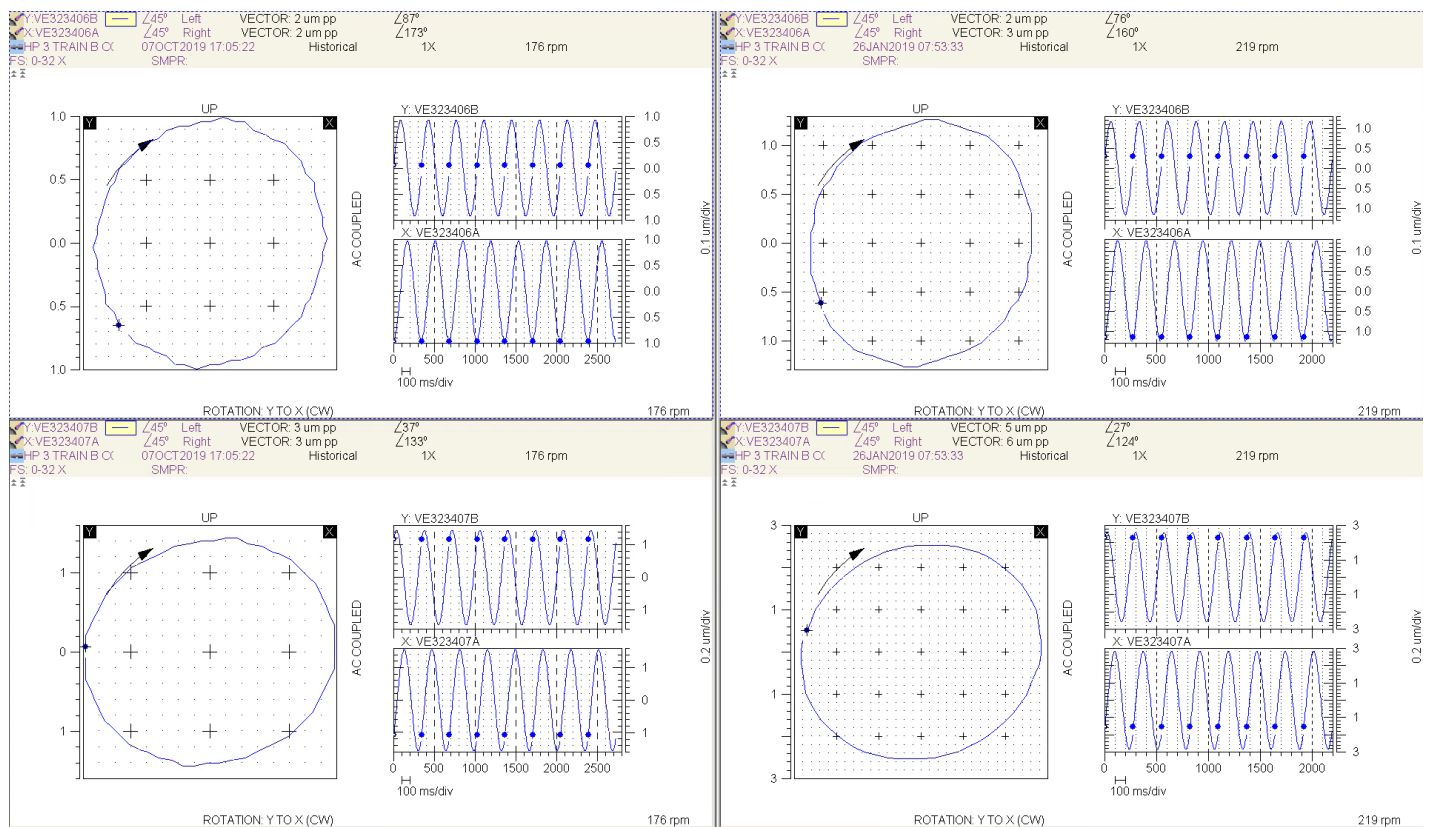
Figure 8: Compressor DE (top left) and NDE (bottom left) slow roll 1X orbit 7th Oct Vs Compressor DE (top right) and NDE (bottom right) slow roll 1X orbit 26th Jan

- There was no evidence of a change in slow roll conditions, the amplitude and phase remained consistent when comparing with slow roll data from January (Figure 8). This indicates that there is no rotor bow. Rule #1 for rotor crack was not confirmed.

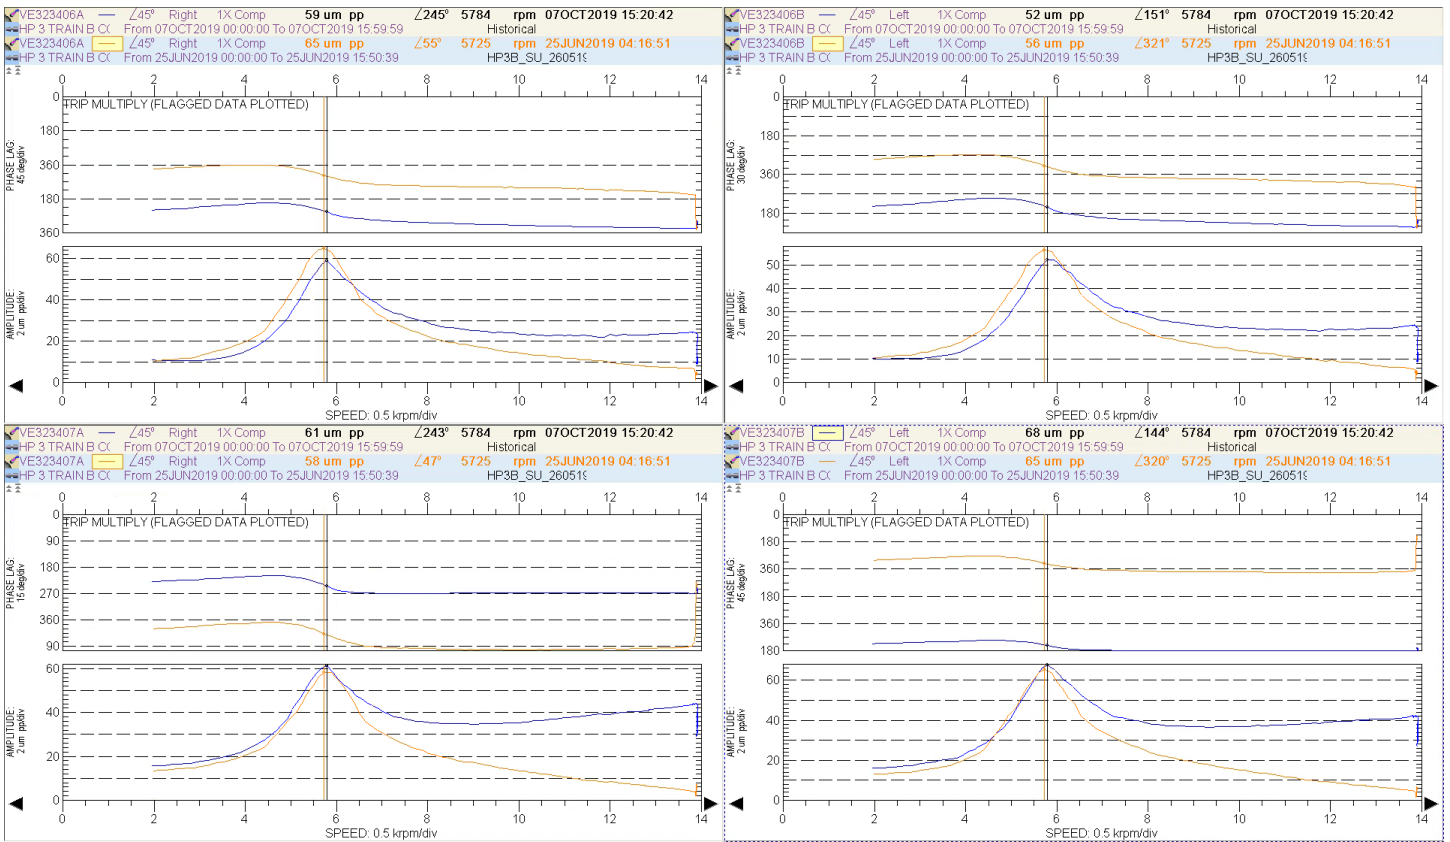
Figure 9: Start up Bode comparison 7th October (blue) and 25th June (orange)

- There is no evidence of a change in the first balance resonance when comparing the two starts (Figure 9). Rule #1 for rotor crack was not confirmed.
- There is a visible change in unbalance (increase) at operating speed which is not visible at resonance and this change is not permanent (Figure 9).
- The unbalance only begins to increase after some time at operating speed, the increase is unidirectional (Figure 10). This could indicate cracked rotor thermal sensitivity, demonstrated by unidirectional change as stated in Rule #3.

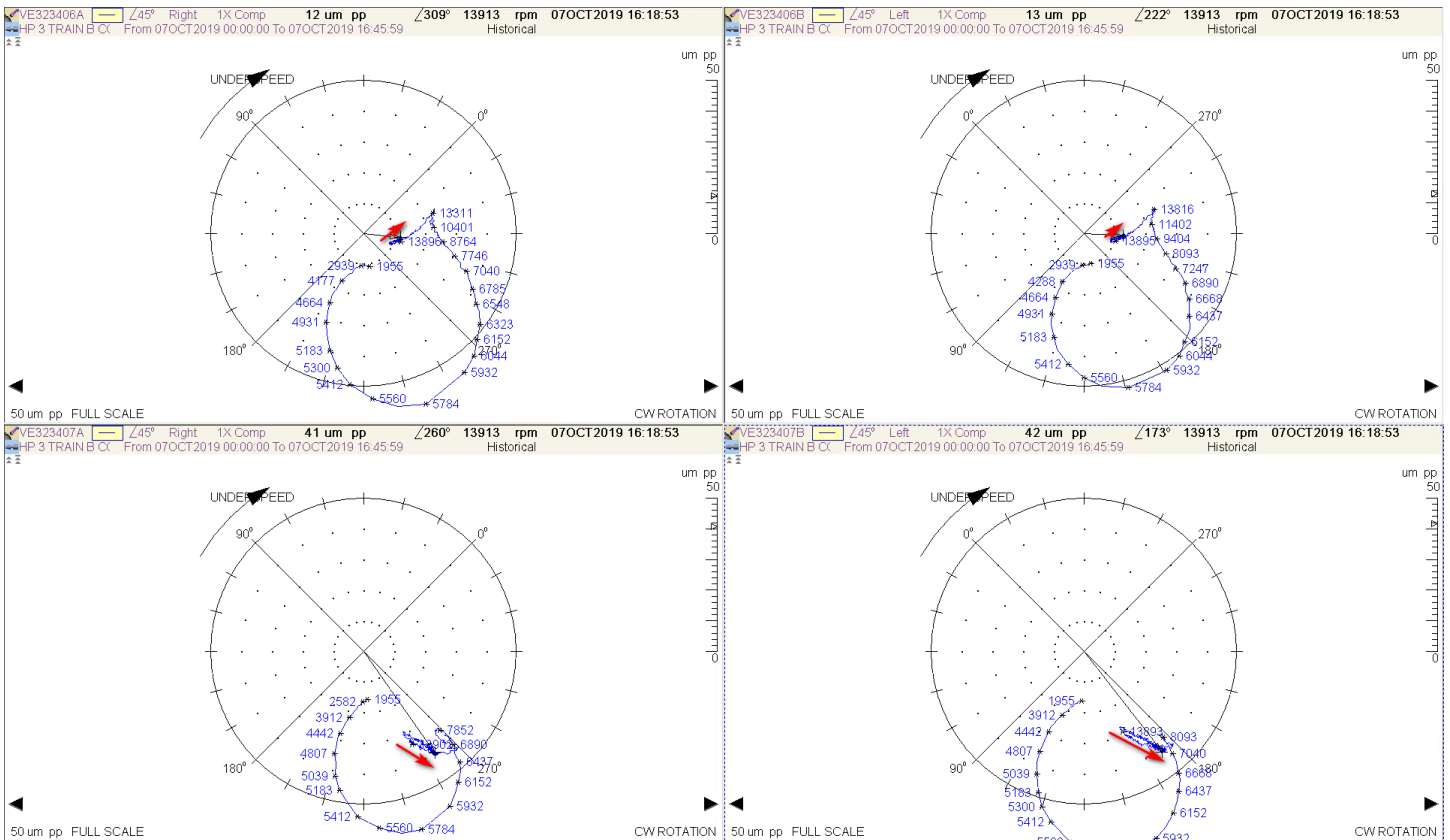
Figure 10: 7th October Start up Compensated 1X polar Plot (unidirectional increase following SU)

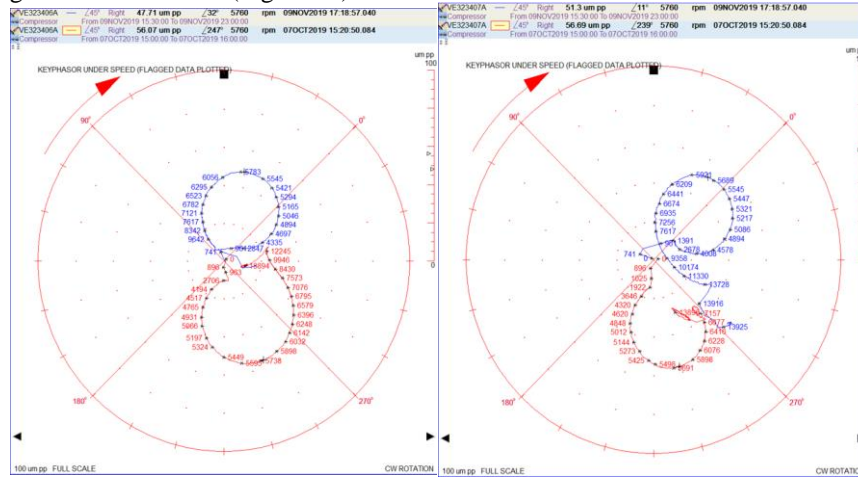
**Figure 13: Compressor DE and NDE Polar plots comparison 7th October – start up (red) vs 9th November Start up (blue)**

Following a plant trip on the 8th November which resulted in a controlled shutdown of the compressor, the machine was restarted on the 9th November. The transient data captured during this event was reviewed. Comparing the latest start up with the start up from the 7th October, there is evidence of a significant change to the rotor response occurring from run to run (Figure 13) with the following conclusions:

- During the last start up changes to the rotor mass and shift of the rotor heavy spot have occurred, resulted in balancing the rotor at around 9000rpm, causing the amplitude almost to go to zero at this speed, but with significant phase change (120°). Above this speed the amplitude and phase return to the original values.

- The latest data shows a reduction in the overall amplitudes through the resonance, but the whole rotor transient response has shifted 90-120°, when compared to the previous start up. There has been a significant change in the heavy/high spot location.

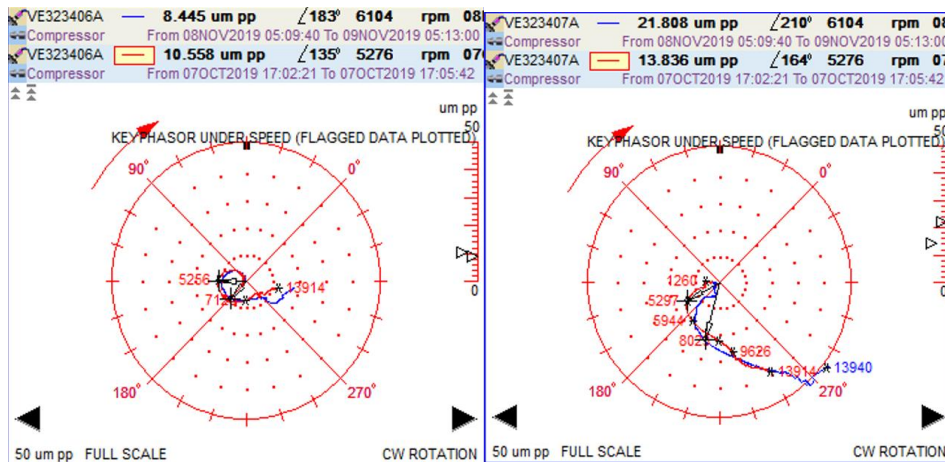
**Figure 14: Compressor DE and NDE Polar plots comparison 7th October – Shut down (red) vs 8th November Shut down (blue)**

- Comparing the shutdown Polar on the 9th November with the shut down on the 7th October, there is no evidence that any changes to rotor occurred during the last shut down (Figure 14)

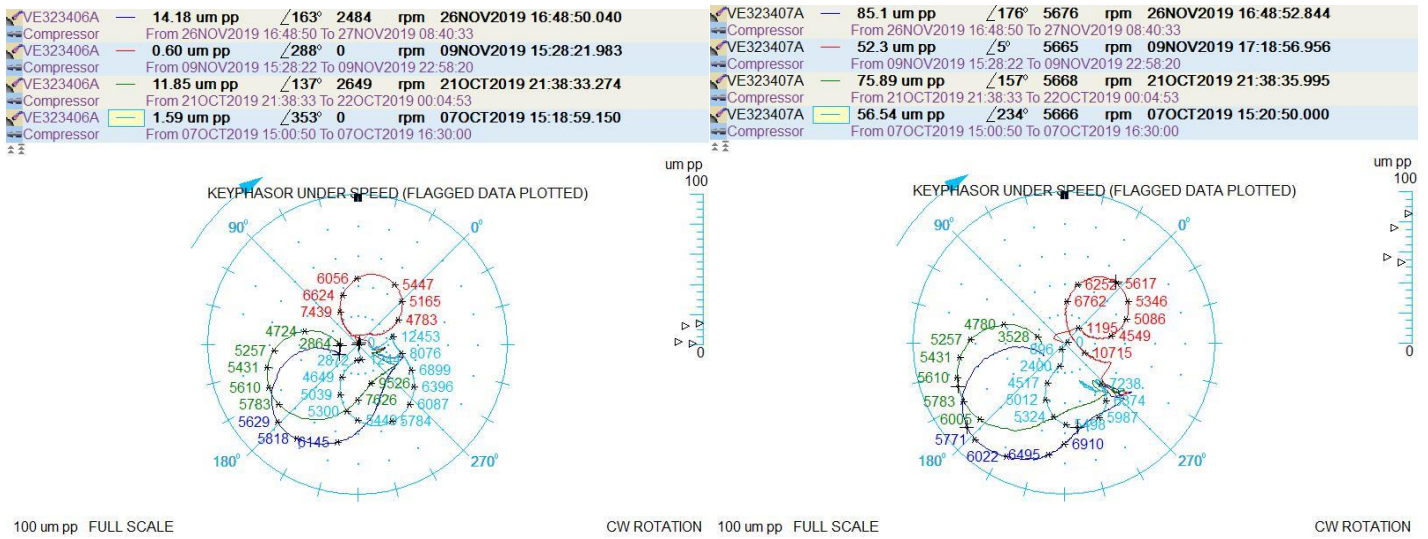
- The rotor transient response has shifted back 135° against rotation, when compared startups (NOV09 and NOV26, 2019).
- The same changes are observed on the Compressor DE and NDE side.

- But what is very strange, despite the different startup's rotor transient response, once the machine reaches steady state there is always, the change to the exact same 1X rotor response (15.5umppp @ 222° for VE323406B reference and (50.5umppp @ 181° for VE323407B reference) and stabilizes exactly on the same value for each different start up.

**Figure 15: DE and NDE Startup Polar plot comparison from four most recent starts showing change in high / heavy spot relationship between starts.**

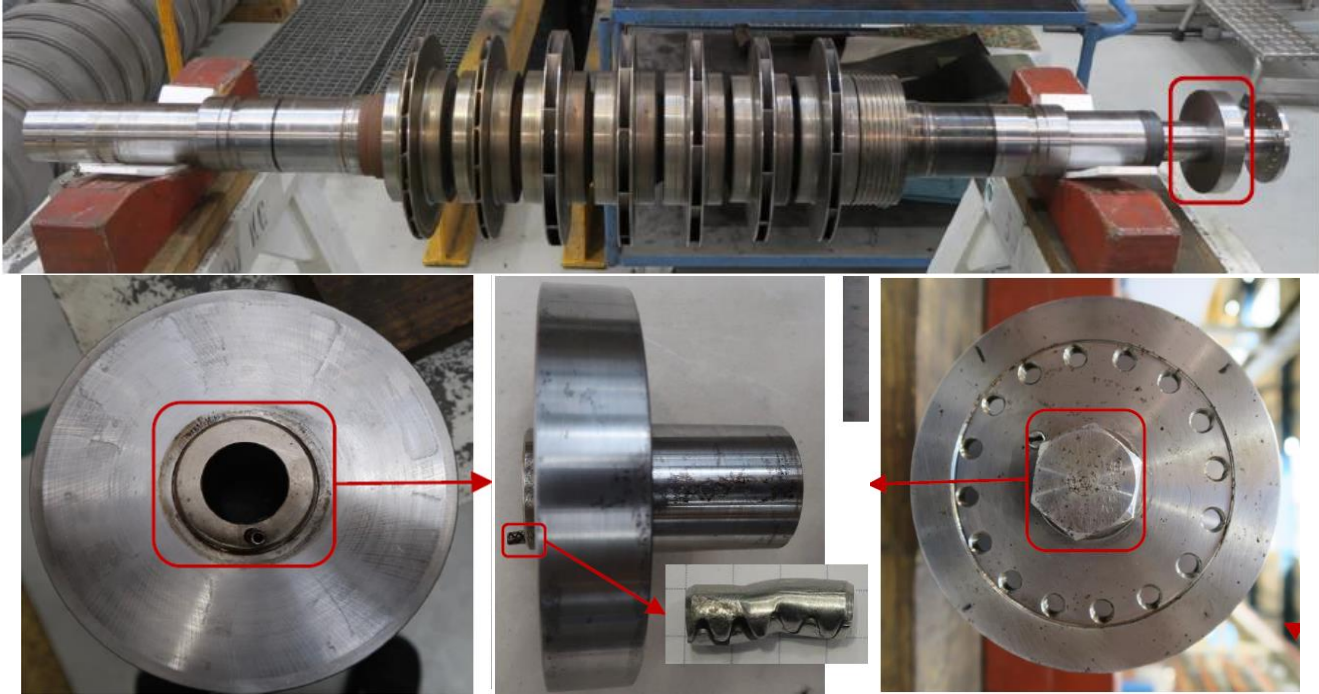
Figure 17: Compressor rotor and thrust collar assembly

- Rotor to thrust collar interface fit was found to be worn and antirotating pin bent (Figure 17).
- The heavy-duty spring pin was deformed/bent/squashed (Figure 17, 18)
- The fitting diameter and the axial contact surface to the shaft was worn
- Thrust collar had become eccentric (radial run out measured) causing a mass unbalance on the rotor.
- High speed balancing test with various thrust collar eccentricities proved this was the cause of the vibration increases.
- The tension on the end screw was correct.

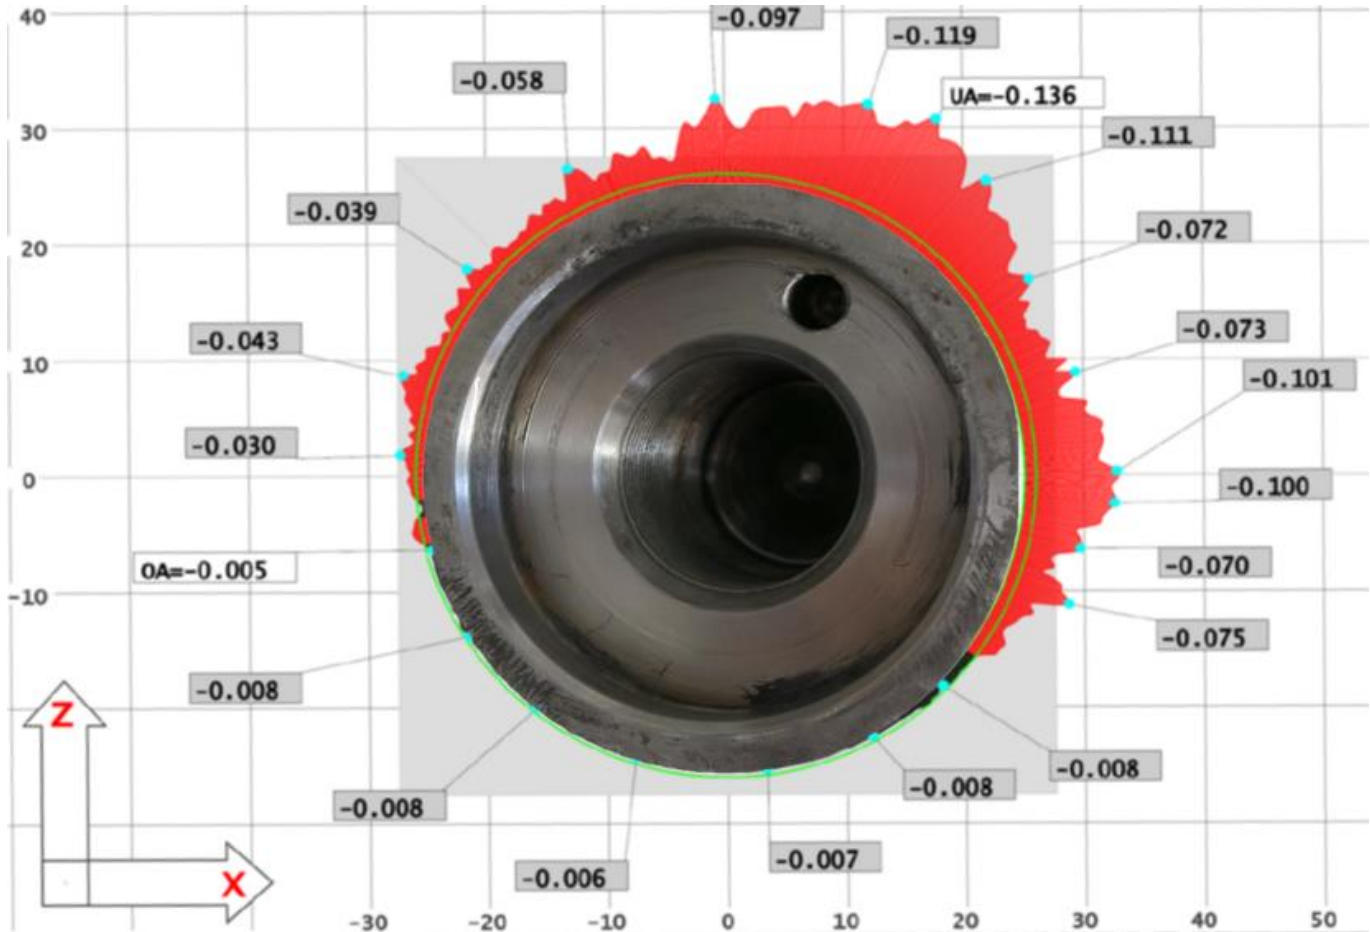
- The thrust collar fitting diameter was unevenly worn
- The radial run out on the fitting diameter was out of centre due to the wear pattern
- The biggest wear (read color) was in the direction of Heavy split pin (antirotating pin)
- The sector on the bottom of the thrust collar fitting (green color) was in acceptable condition
- The axial contact surface to the thrust collar was worn
- The location hole for the anti-rotation pin was out of position and slightly too big
- The heavy-duty spring pin was deformed/bent/squashed

Figure 19: Compressor rotor thrust collar fitting, with worn runout pattern
