ASIA TURBOMACHINERY & PUMP SYMPOSIUM

SYMPOSIA: 24 – 26 MAY 2022

MECHANICAL DAMAGE TO PUMP IMPELLERS CAUSED BY LOW FLOW OPERATION

Flowserve Corporation

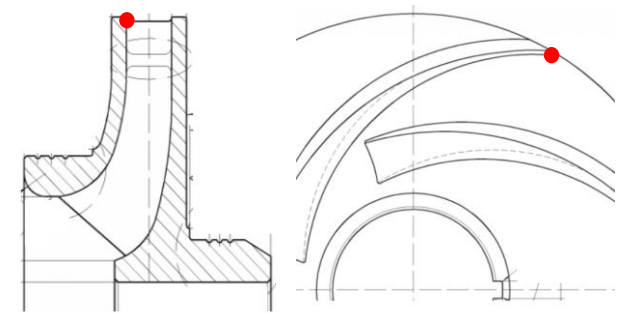
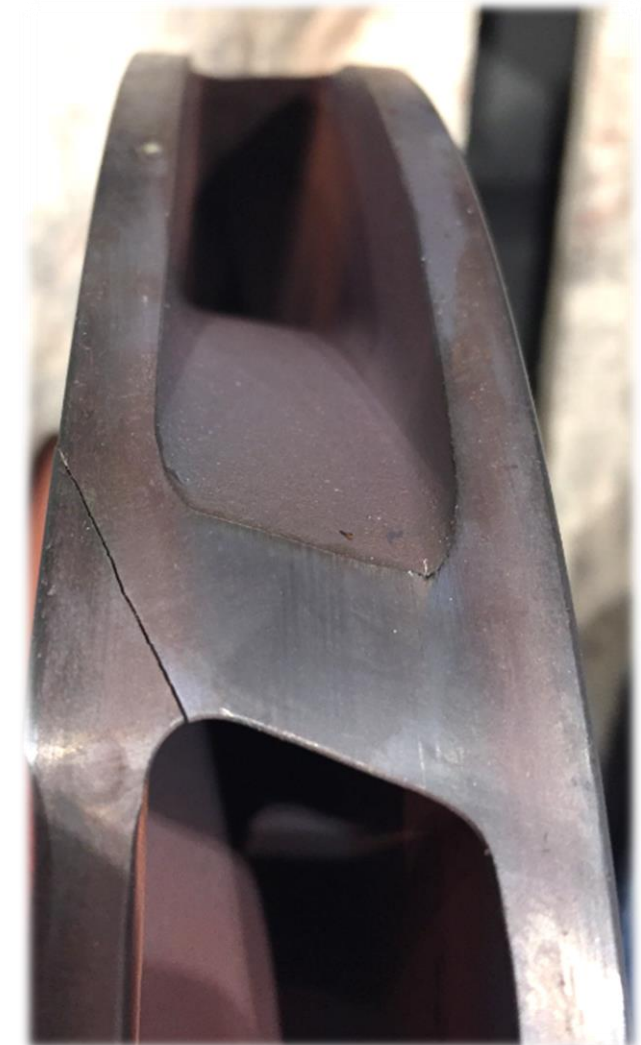
A boiler feedwater pump servicing a combined cycle power plant began operating beyond acceptable vibration levels and was pulled for inspection.

- Problem was traced to 1st stage impeller where a section of the shroud wall had broken off.
- The incident led to more frequent inspections which found cracks in the 1st stage impeller were appearing regularly.

Cracks were found only in the 1st stage impellers.

- Appear between 3 months and 1 year of operation.
- Same location: shroud side trailing edge fillet.

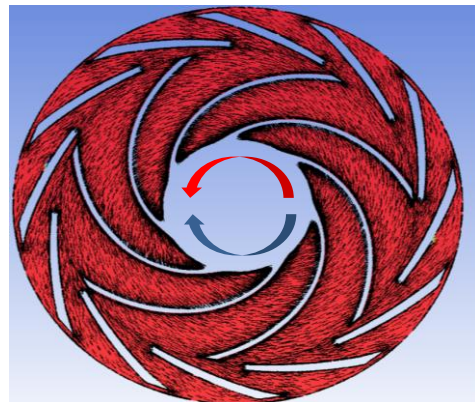
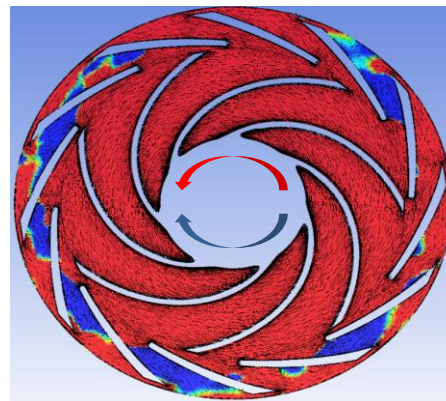
Centerline Plane plots of Tangential velocity at 100% BEP flowrate (LEFT) and 10% BEP flowrate (RIGHT).

Velocity plots showing where flow is moving radially inward (right) or in the opposite direction of impeller rotation (left).

The *Bad Flow* is colored **Blue**.

At 100% BEP, nearly all the flow is moving in the proper directions.

At 9% BEP, 9 out of 12 diffusor passages are fully stalled.

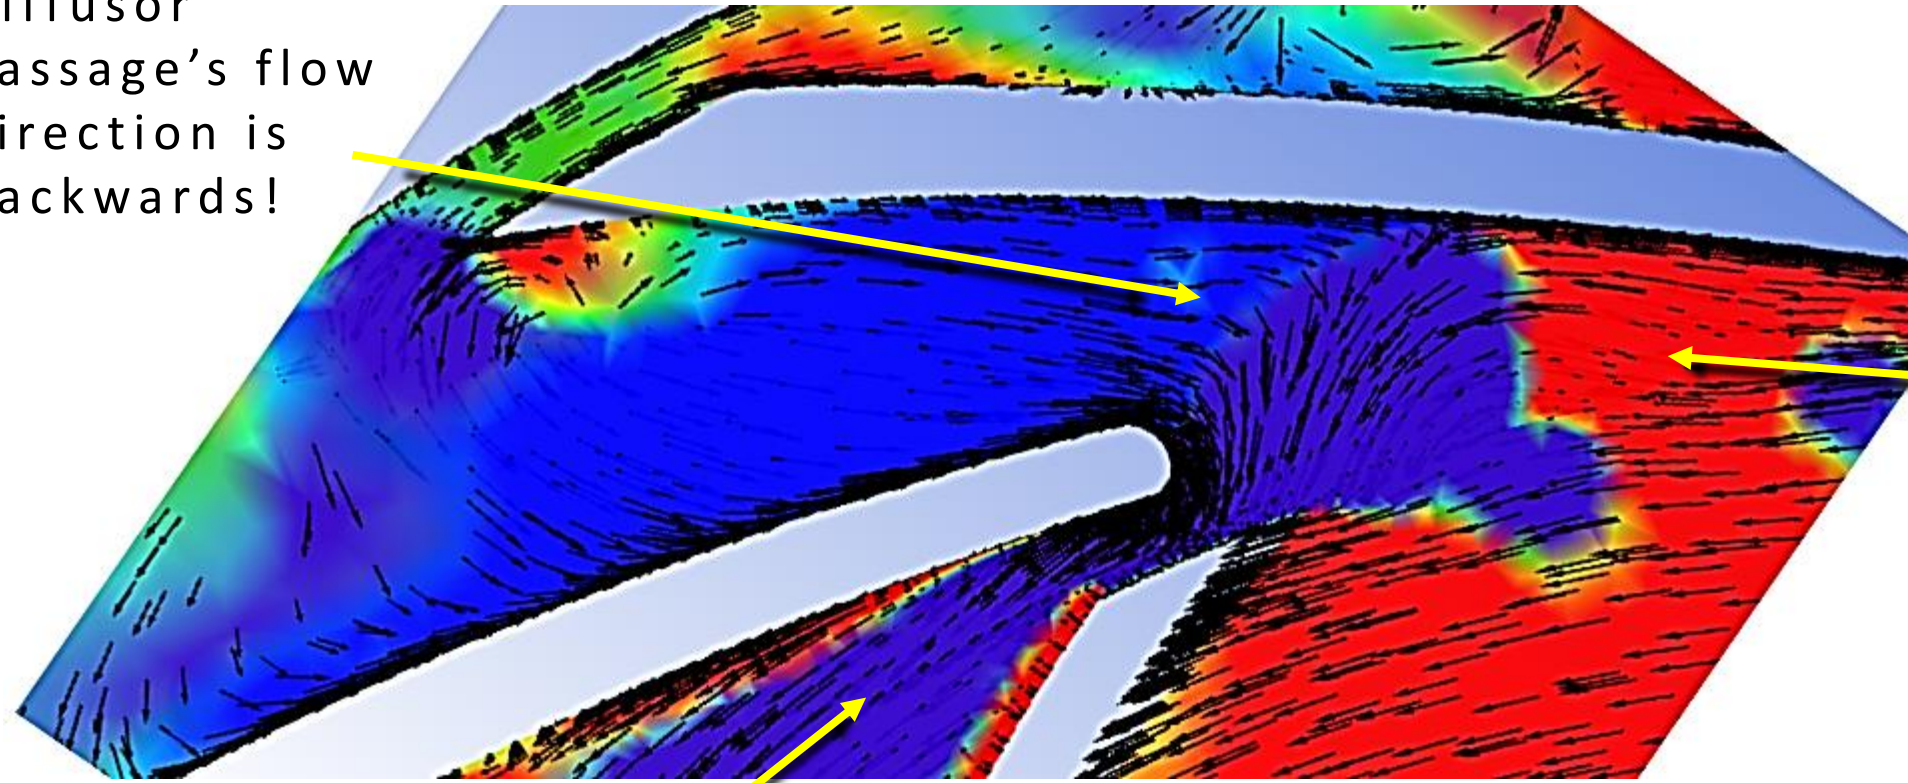
Diffusor passage's flow direction is backwards!

Flow coming off the impeller cannot enter the diffuser and is forced back into the outlet of the impeller.

Flow entering the impeller's outlet

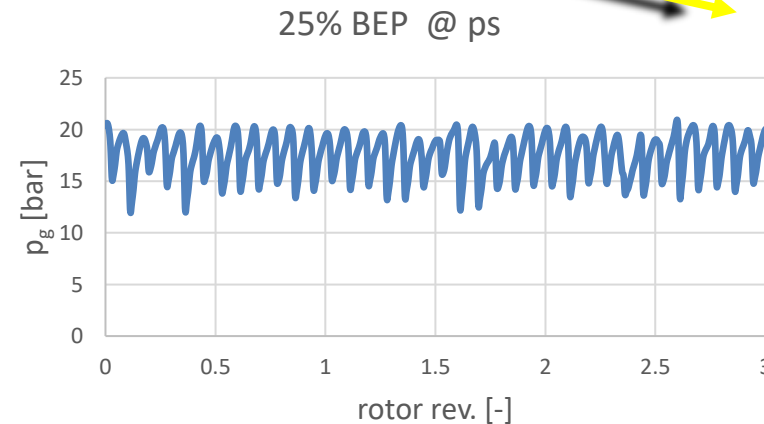
A Monitor Point in the CFD analysis was used to understand the variability of the instantaneous pressure.

The periodic pressure signal become more erratic as the flowrate decreased.

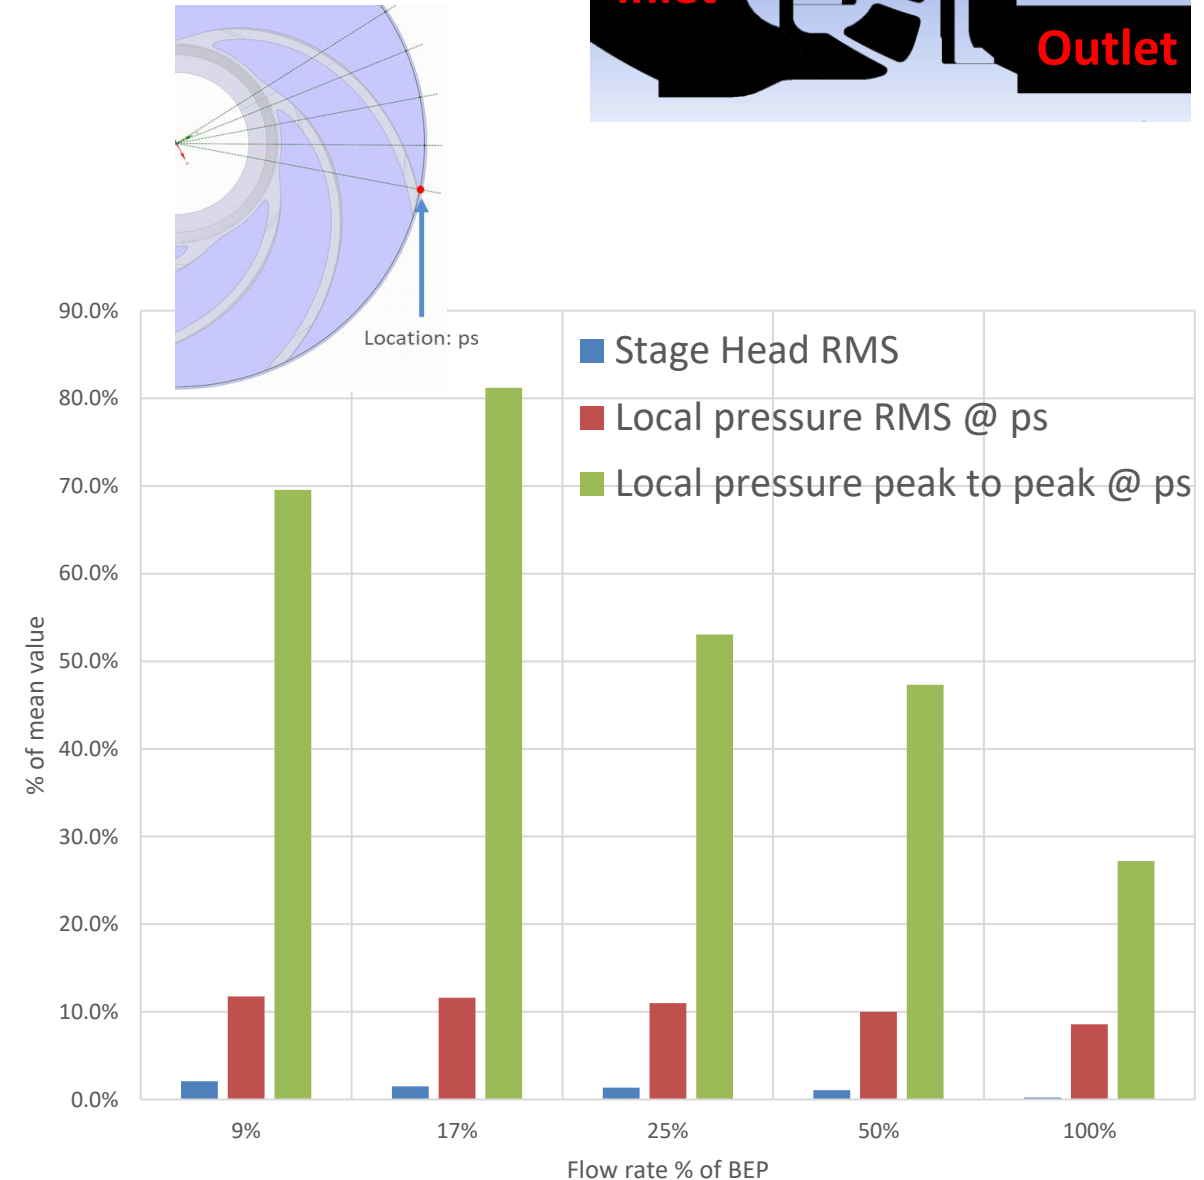
The total differential head across this stage (inlet to outlet) does not produce large fluctuations ($< 3\%$), even at low flowrates.

The variability of the RMS pressure at the *Monitor Point* is generally low as well ($< 12\%$), even at low flows.

The variability of the instantaneous pressure at the Monitor Point, measured peak-to-peak is quite high ($>80\%$).

- This occurrence would not be able to be monitored or detected by typical pump instrumentation.

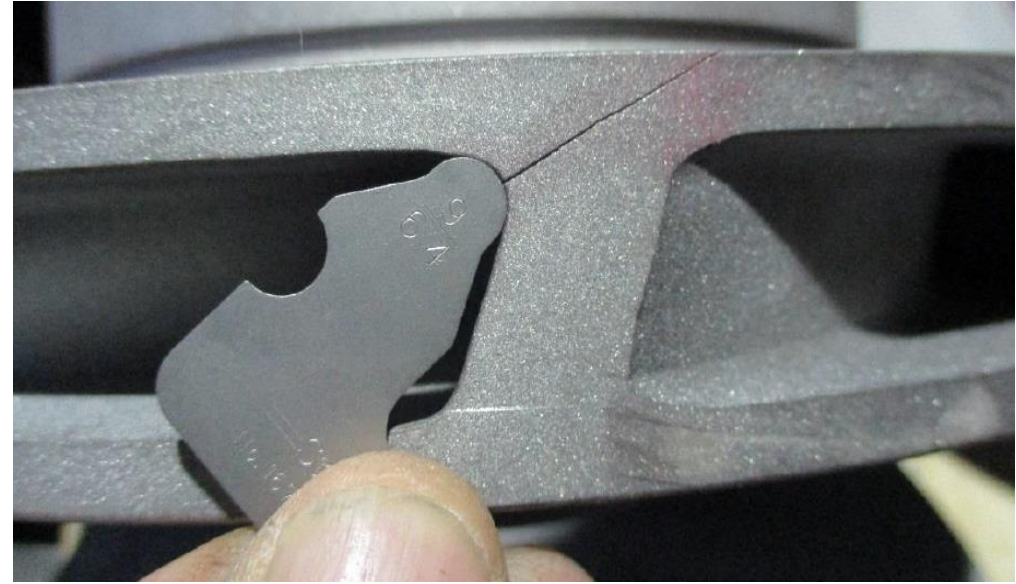
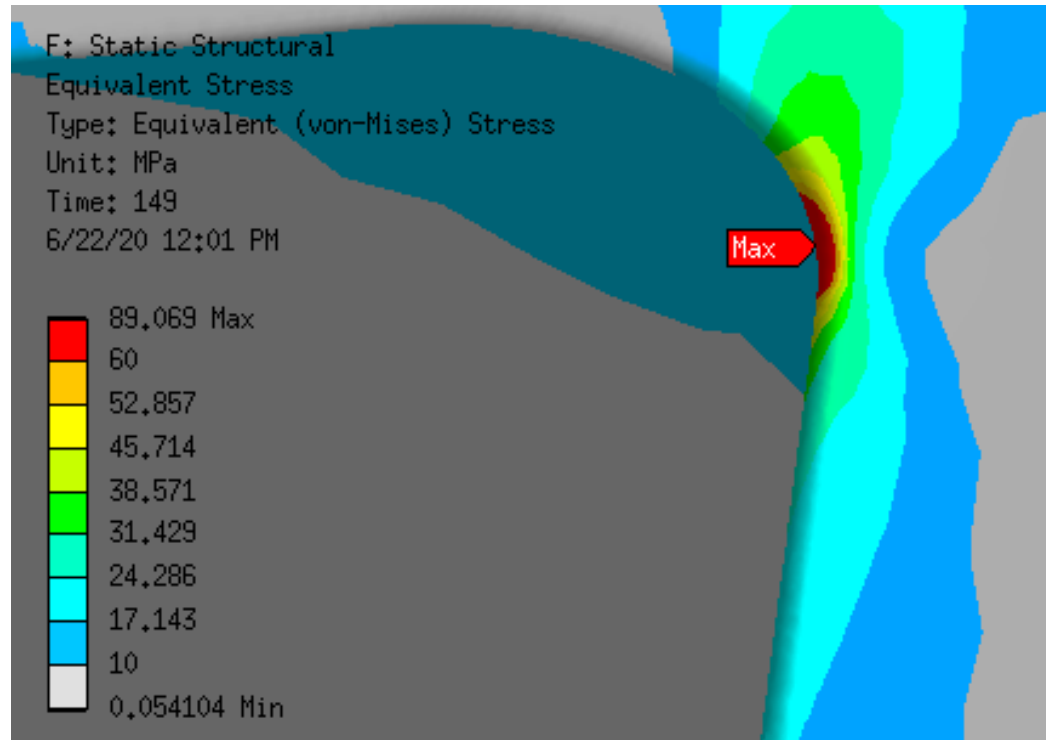
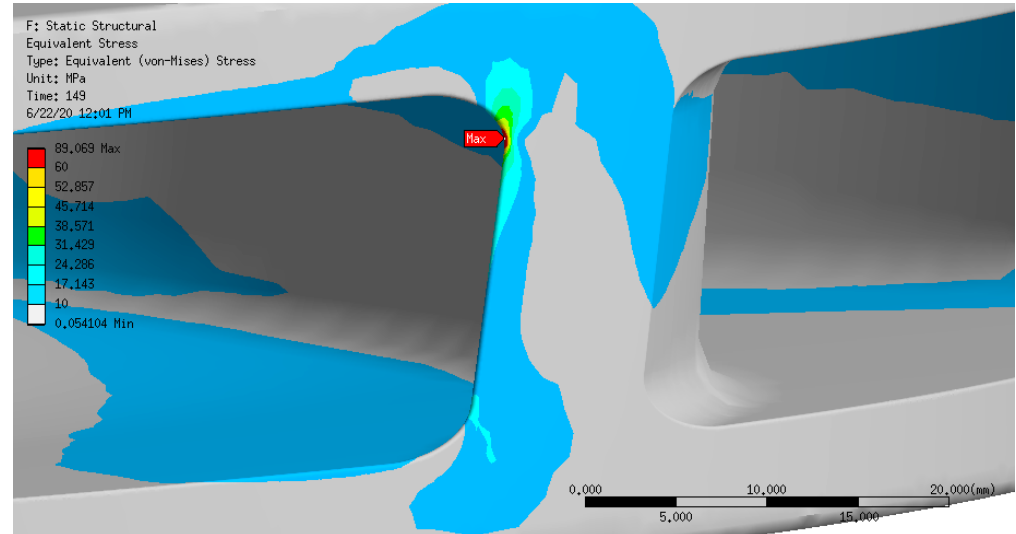
Mapping the transient pressure and adding a centrifugal load to the structural FEA revealed a peak stress location which coincides with the likely area of crack initiation.

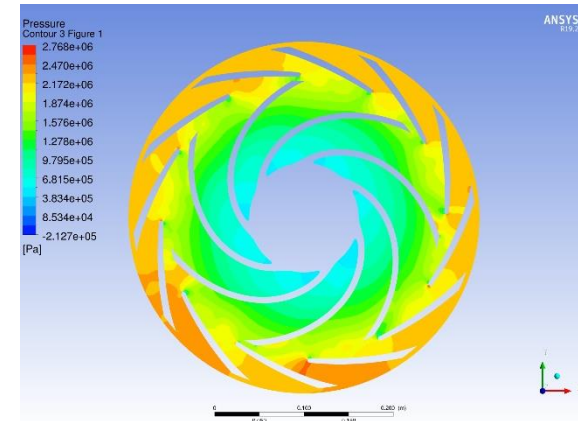
The peak stress for the critical fillet location was plotted at each of the 7 blades for various flowrates.

The periodic nature of the stress is a result of an increase in local pressure as the impeller blade rotates past the diffuser vane.

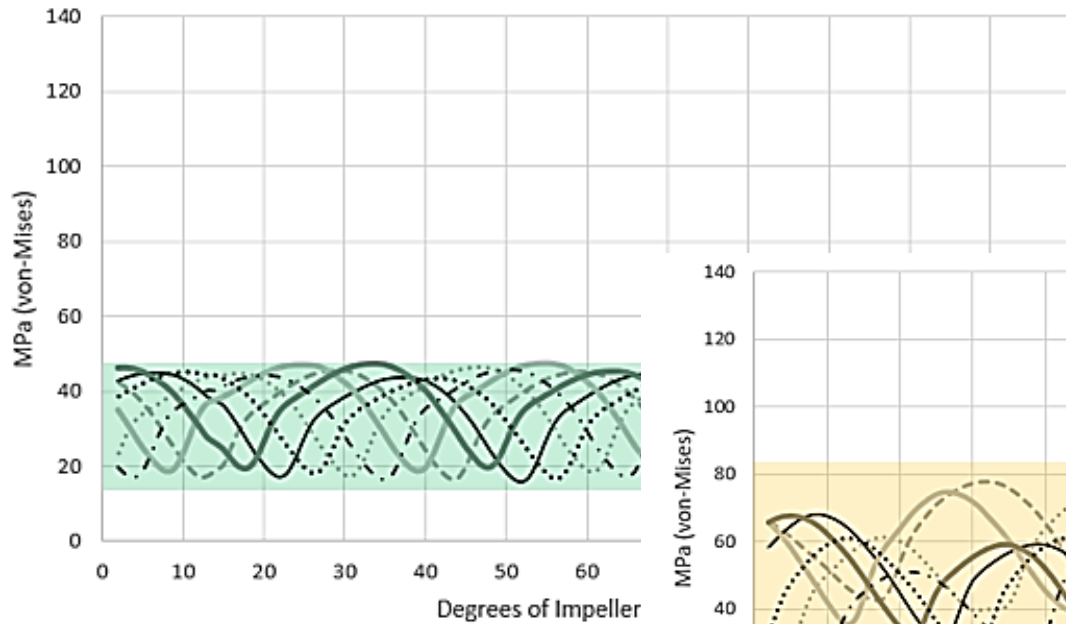
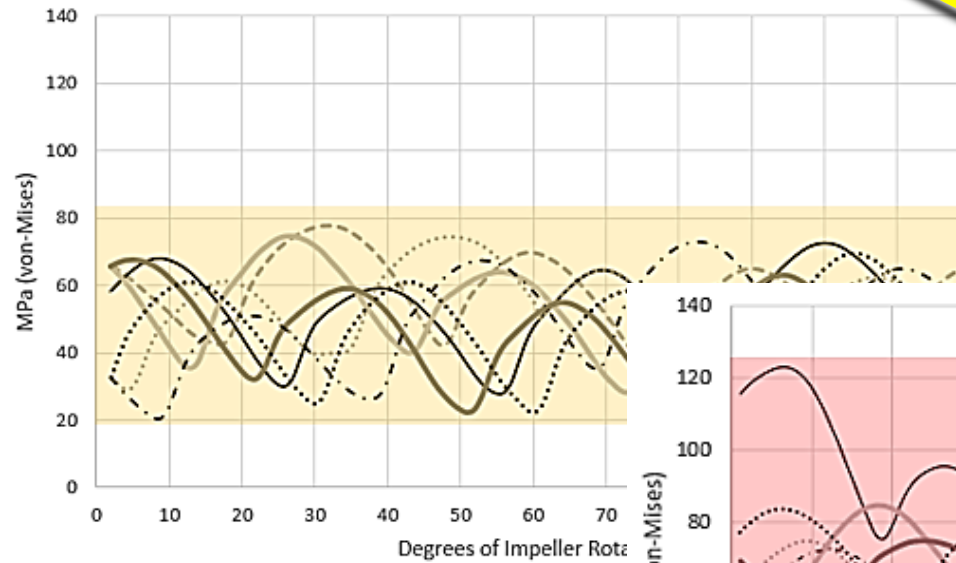
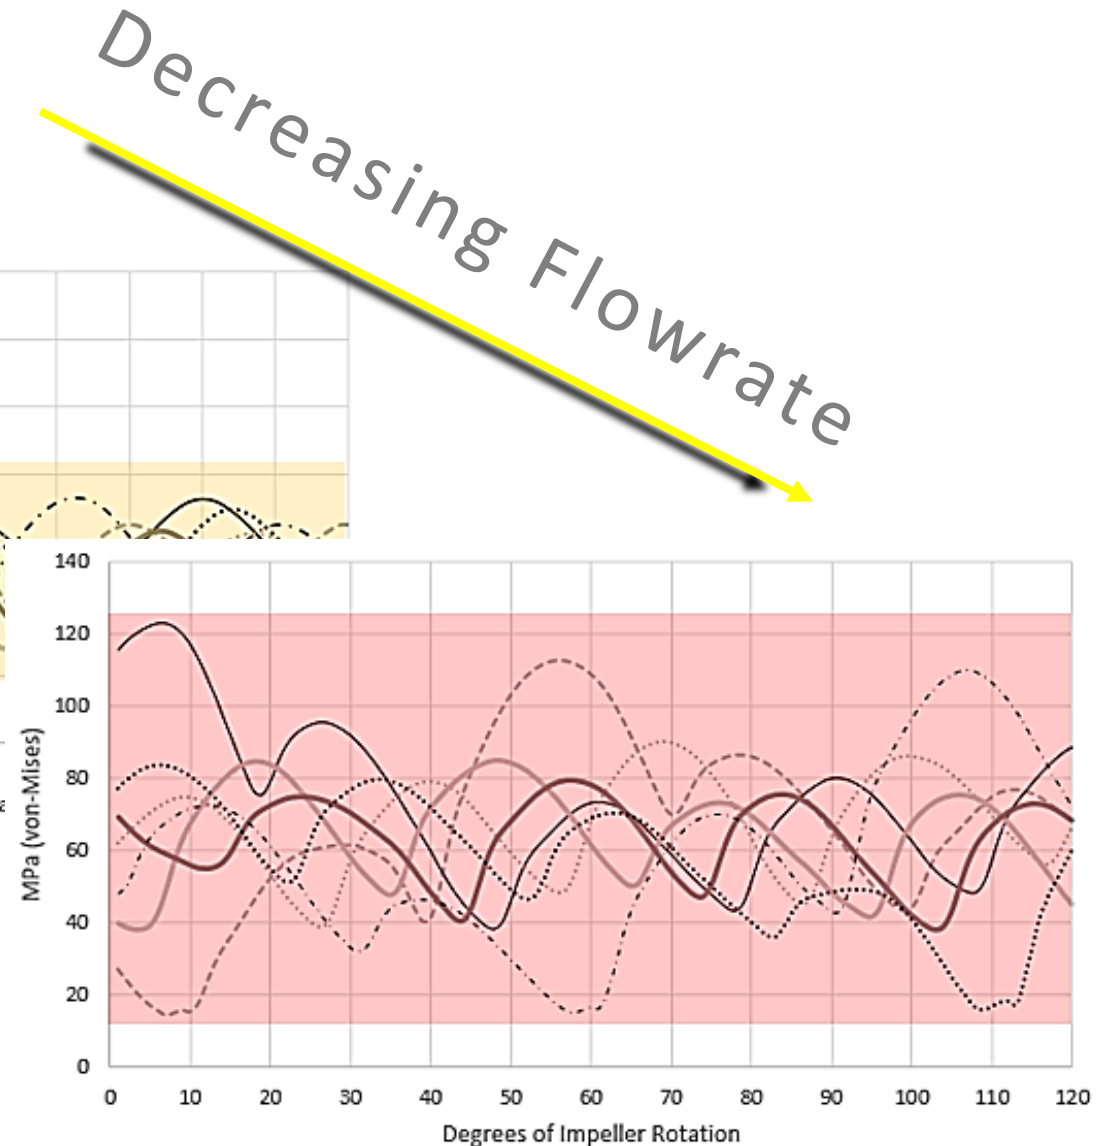
As flowrate decreases, the stress range increases significantly.

- 4x at 18% BEP vs. 100% BEP!

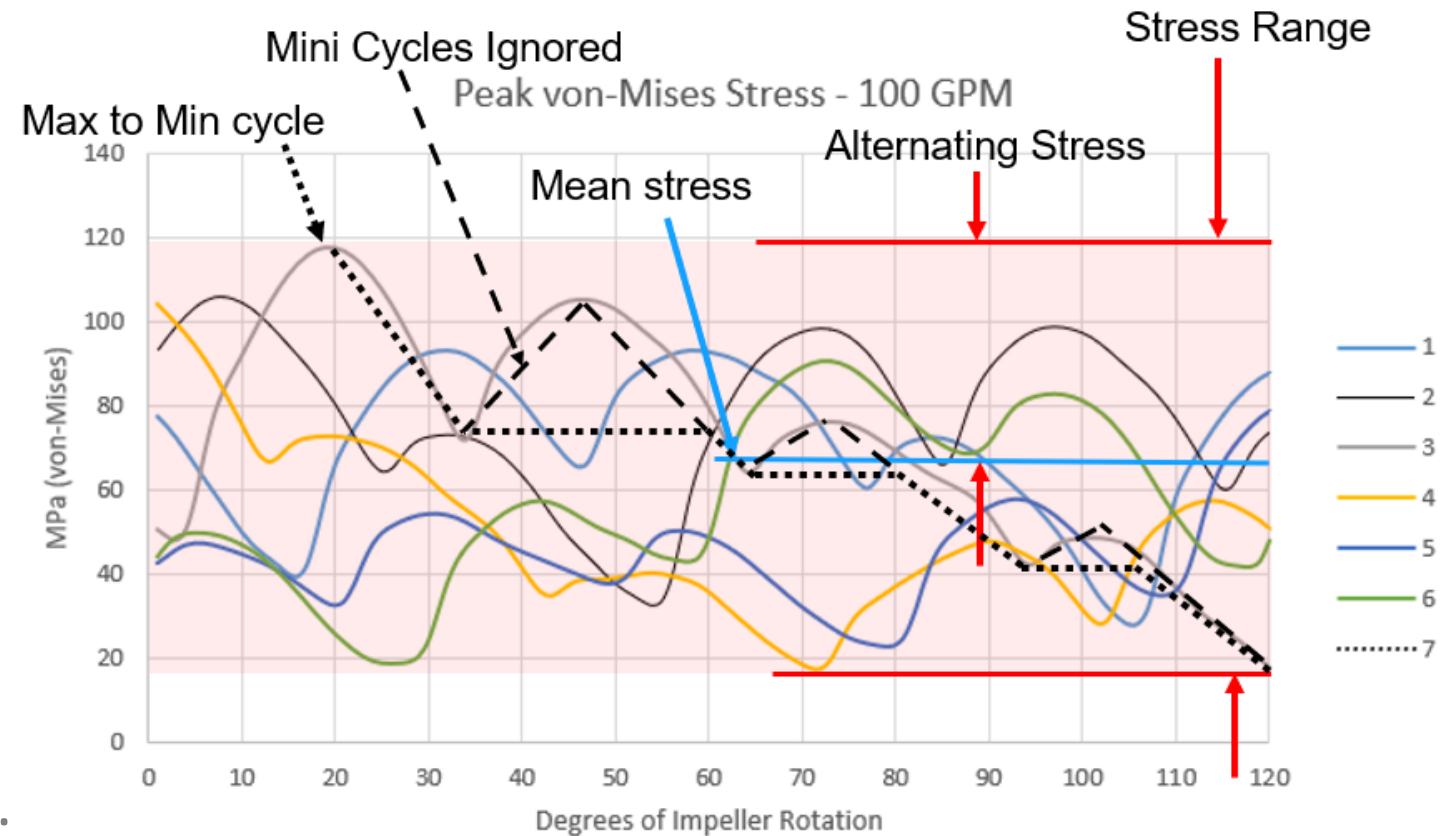
Cyclic stresses were extracted from these plots for the purpose of fatigue analysis.

Note: only 120 degrees of rotation was considered due to computational constraints. It is quite possible that higher peak stresses were not captured.

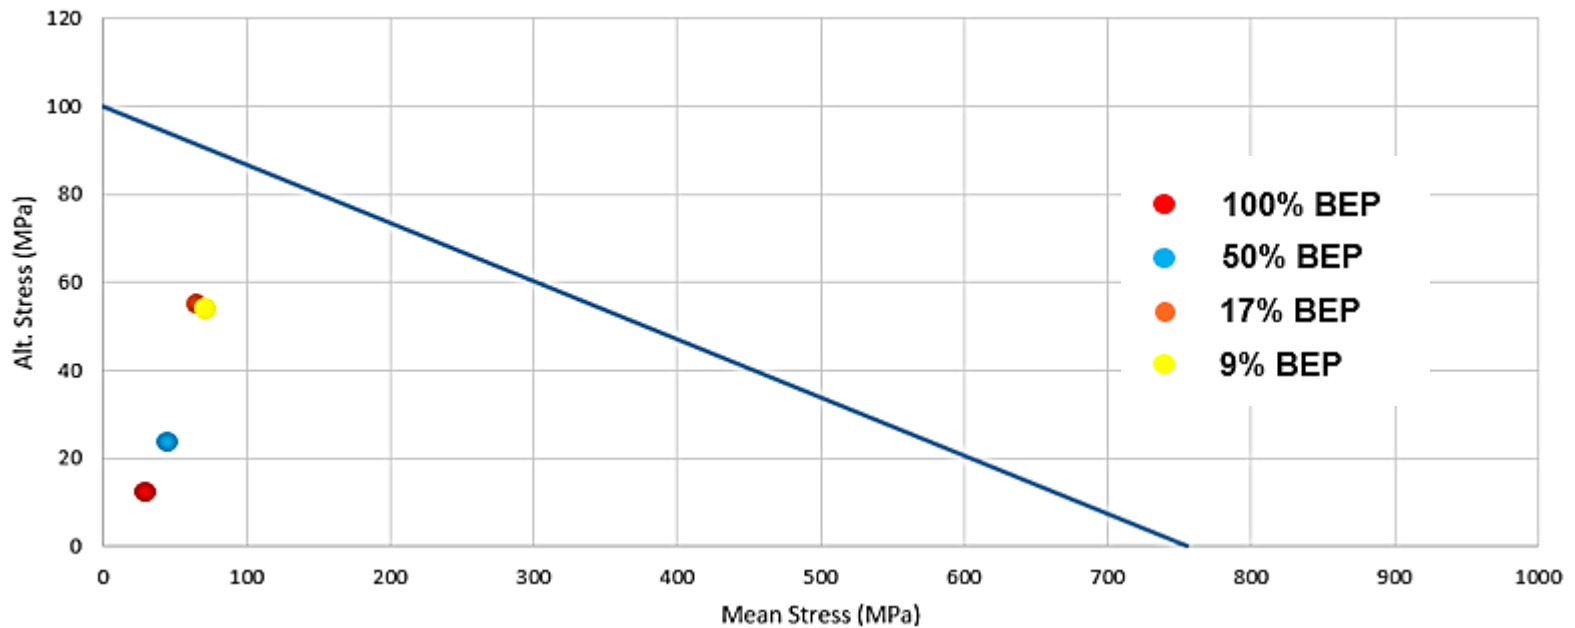
Fatigue Diagram with Modified Goodman Line

Cyclic stresses were extracted from these plots for the purpose of fatigue analysis.

Large reduction in factor of safety with respect to *Infinite Life* with decreasing flow.

Material is CA6NM

Although Modified Goodman fatigue analysis technically indicated “infinite fatigue life” for the impeller at low flows, the variability of the many important of inputs means we are not surprised by the result of numerous but not all the seven impeller blade fillets experiencing crack initiation and growth.

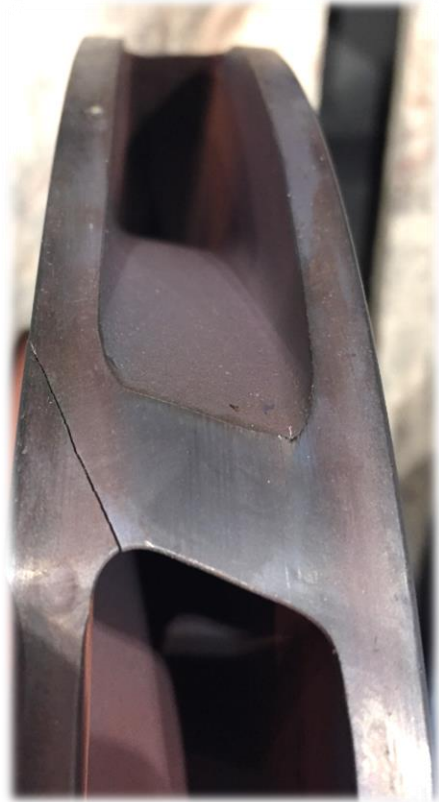
The cracks on the impeller were highly likely to have been caused by the increasing stresses at the critical area when flow was reduced below 20% of the BEP flowrate.

Fatigue life calculations have a high level of uncertainty due to the variability of many of the inputs.

- CFD may not have captured the highest pressure-pulsation the impeller experiences due to the complex nature of simulating chaotic flow.
- The actual geometry of the impeller at the critical location comes from a hand grinding operation and cast surface.

- The typical reasons for avoiding operation at low flow are generally limited to thermal, vibrational, and cavitation concerns, as well as poor efficiency and difficulties arising from operation on a very flat section of the performance curve.
- This study shows cyclic fatigue damage can be a concern with respect to OEMs specifying a minimum flowrate.
- Mitigation efforts with respect to impeller design include:
 - Reducing the outer diameter of the impeller in order to increase the gap between the impeller OD and the diffuser ID will reduce the magnitude of the pressure pulsations.
 - Increase the trailing edge fillet radius
 - Improve surface finish in critical area
- Mitigation efforts with respect to pump operation include:
 - Do not operate below minimum flow (~ 30% BEP)
 - Reduce motor speed (utilize VFD) to reduce flow.
 - Add an automatic recirculation valve.
