## ASIA TURBOMACHINERY & PUMP SYMPOSIUM

# Steam Turbine High Axial Displacement due to Governor Actuator Filter Clog

KER PIN JUN – EXXONMOBIL  
NG WEI SING - EXXONMOBIL

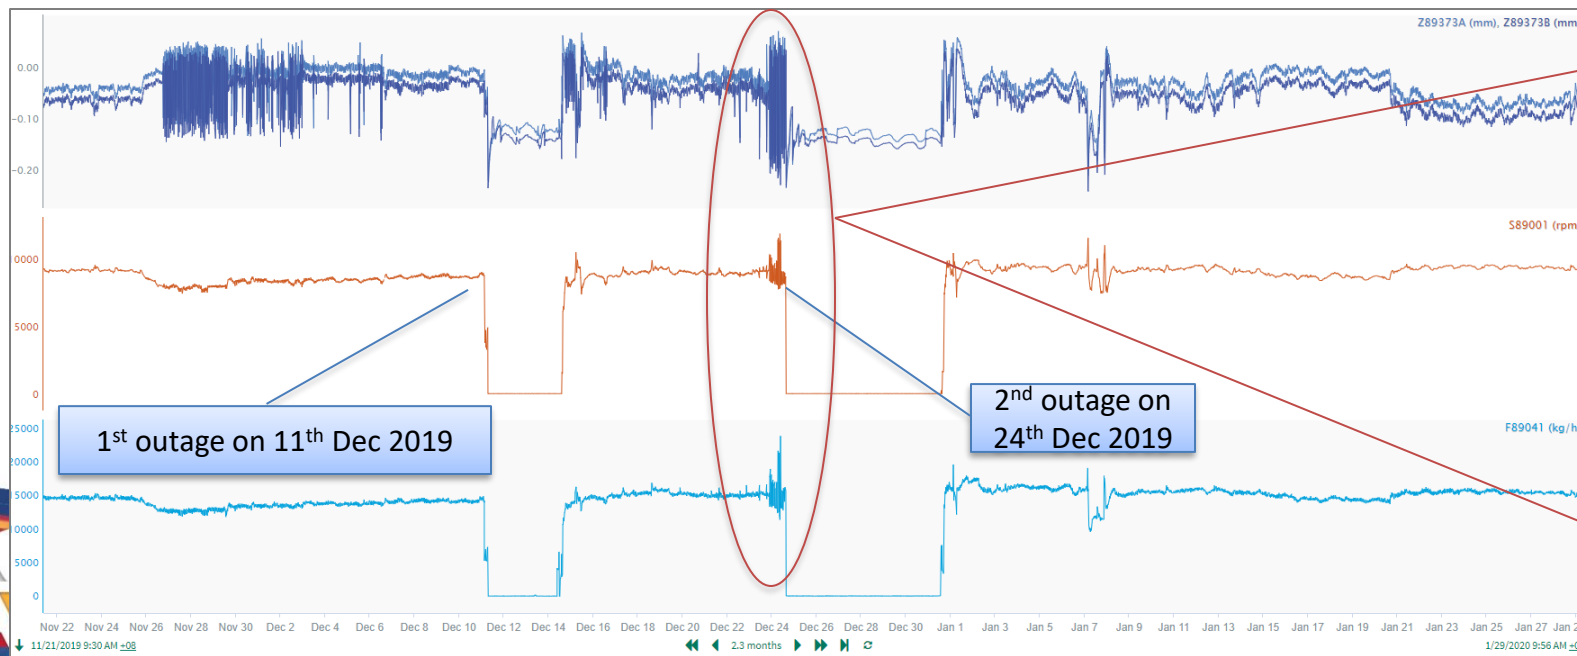
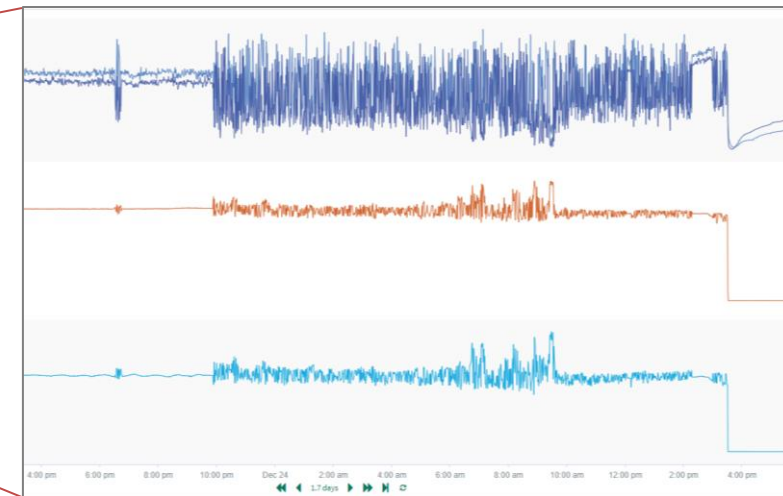
- The steam turbine governor valve actuator had failed twice in the space of two weeks.
- First failure on 11<sup>th</sup> Dec 2019 (5 days outage):
  - Turbine sudden loss of speed from 8,800 RPM to 3,800 RPM. Speed gradually picked-up to close to 1<sup>st</sup> critical speed of 5,000 RPM due to compressor load reduction.
  - Speed was considerably stable prior to the loss of control, but rapid fluctuation in axial displacement was observed 1 – 2 weeks prior to the incident
- Second failure on 24<sup>th</sup> Dec 2019 (7 days outage):
  - Turbine speed started to fluctuate wildly between 8,800 RPM and 11,500 RPM (max. continuous speed)
  - Axial vibration swing violently between -0.15mm to +0.10mm. Abnormal sound can be heard at site
- In both events, turbine was manually shut down to prevent any secondary mechanical damage (which can be very costly to repair with long outage)

Speed and axial displacement rapid fluctuation prior to shutdown

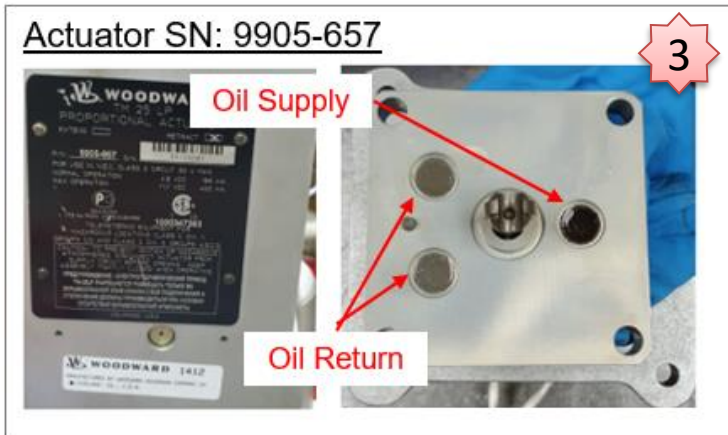
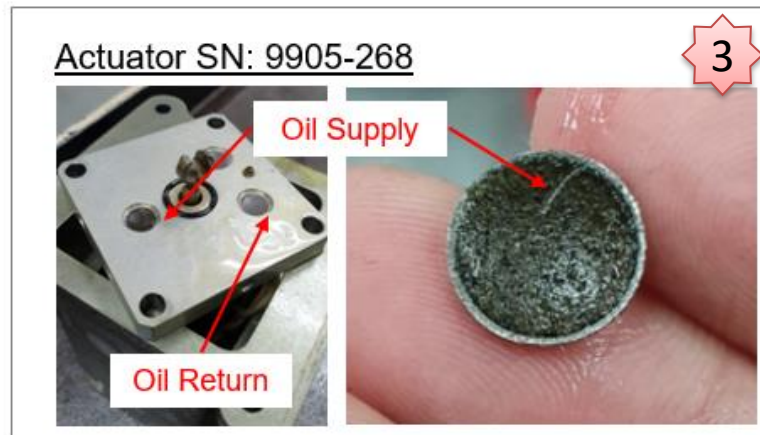
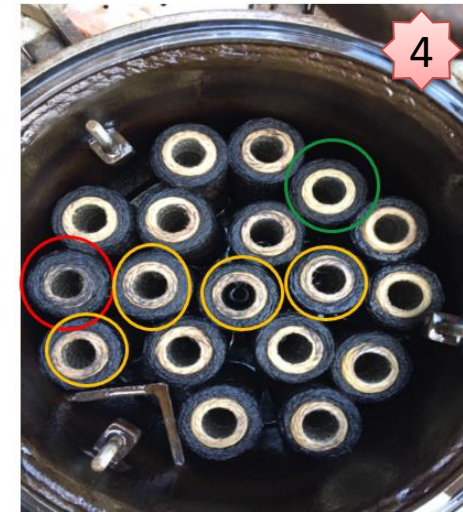
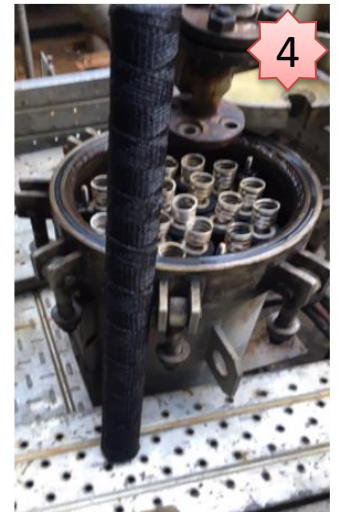
1. Turbine was just overhauled in April 2019, approximately 8 months prior to the failure.
2. As part of overhaul, governor valve actuator was replaced with new. Oil flushing was performed and lube oil and oil filters were replaced.
3. Actuator internal coil filters were inspected and found to be badly clogged with blackish substance.
4. Lube oil filter elements were inspected and found to be badly coated with similar blackish substance.
5. Draining of degassing tank found similar layer of blackish substance which float on oil when left to settle.
6. EDX analysis shows blackish substance was mainly carbon.
7. Degassing tank bottom draining found water and tested to be slightly acidic (suspect carbonic acid)

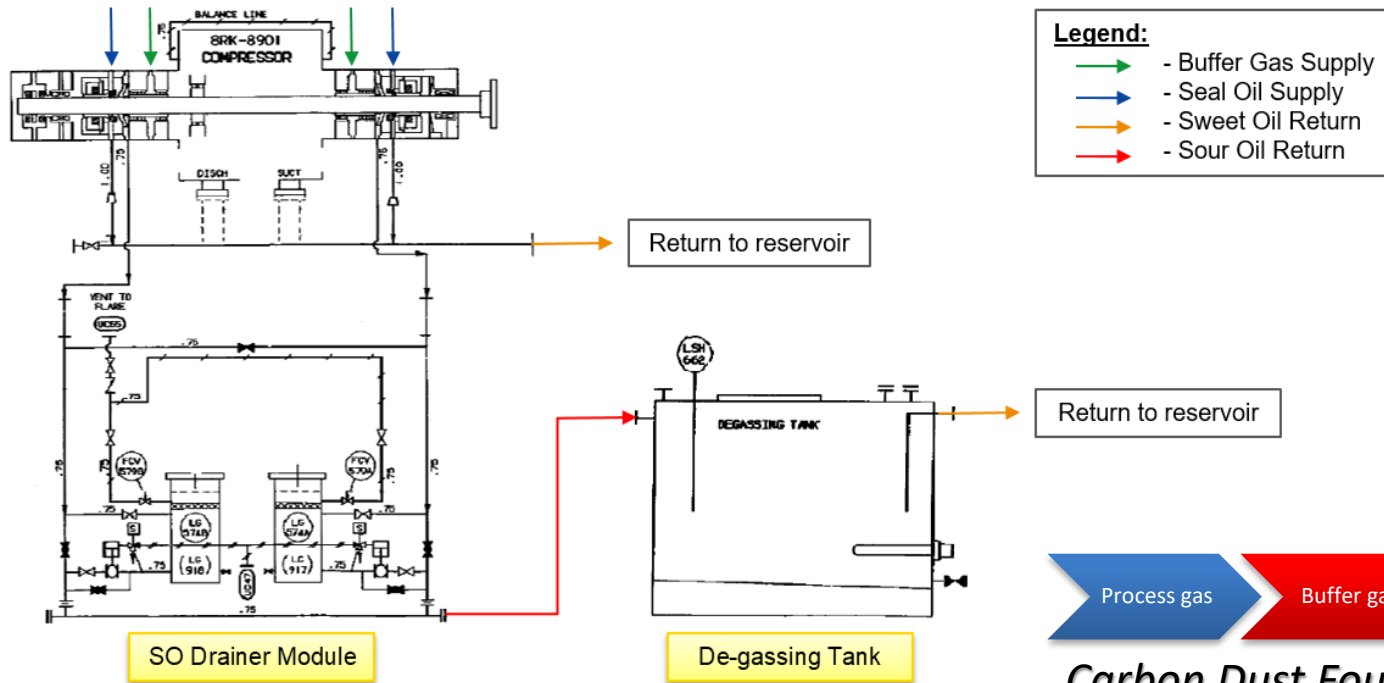
1. Prior to shutting down the turbine for overhaul, the compressor was used for "Coke Burn" operation to avoid catalyst poisoning.
2. By product of "Coke Burn" are soot (fine carbon dust), carbon dioxide and water.
3. During "Coke Burn" process (unit shutting down), the Nitrogen at buffer gas header was only maintained at 700kpag vs. design 1,375kpag for effective operation of buffer gas system.
4. During "Coke Burn", the compressor suction pressure was 600kpag. Taking into account the pressure drop from battery limit to compressor, the buffer gas pressure will not be adequate to prevent "Coke Burn" process gas to come in contact with the seal oil.

*Carbon Dust Foulant path into oil system*
