# ELECTROSTATIC DISCHARGE- STG COMPRESSOR

Bopanna P Ponnanna – Bently Nevada  
John J. Yu ,PhD – Bently Nevada  
Nicolas Péton, PhD – Bently Nevada

## ASIA TURBOMACHINERY & PUMP SYMPOSIUM

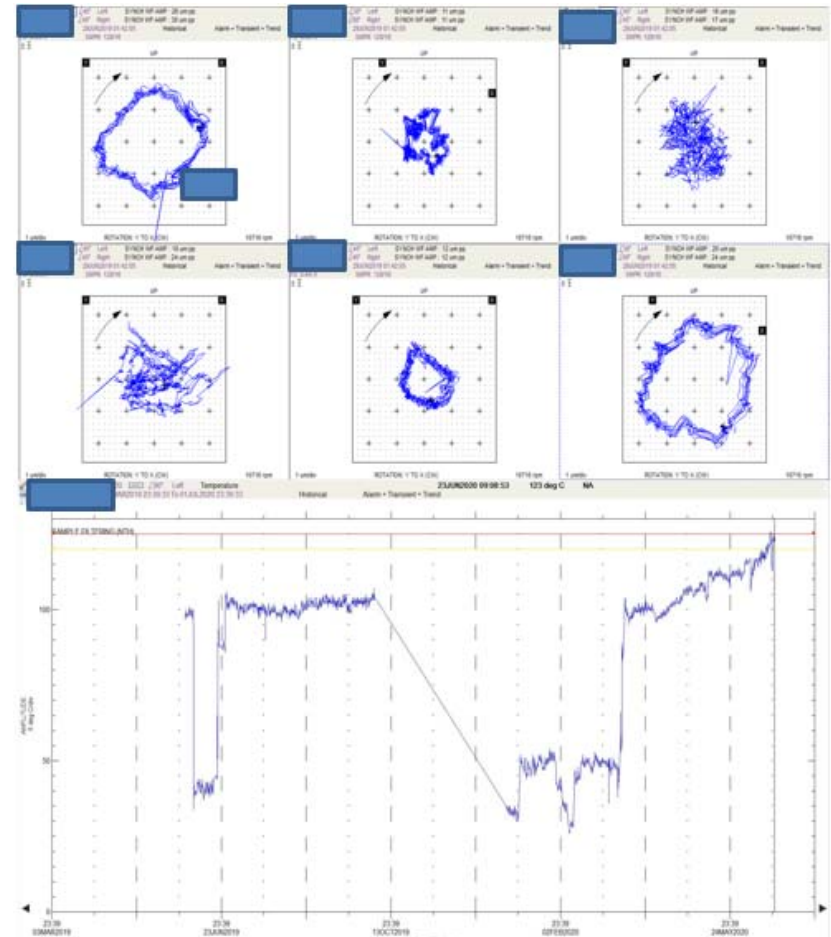
- High intense spiking pattern noticed in orbit plots for all the bearings in 2019.
- ESD was diagnosed, with recommendations to check/replace brushes and to monitor DC gap trends.
- After one year in 2020, there was noticeable increases in bearing metal temperature at turbine LP side from 100 deg C to 120 deg C

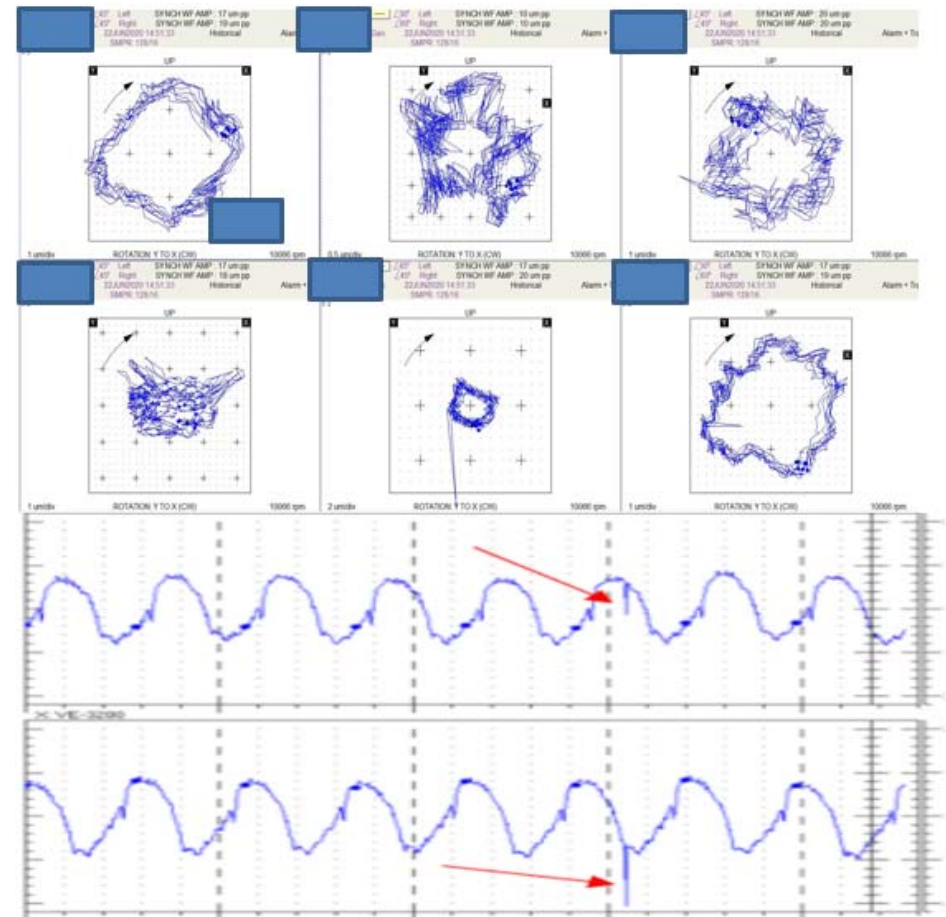
- High intense spiking pattern was still noticed in orbit plots at some bearings even after change of brushes. But it was not as intense as it was in 2019.
- Time waveform plots also showed the corresponding spiks at X and Y probe at the same time.

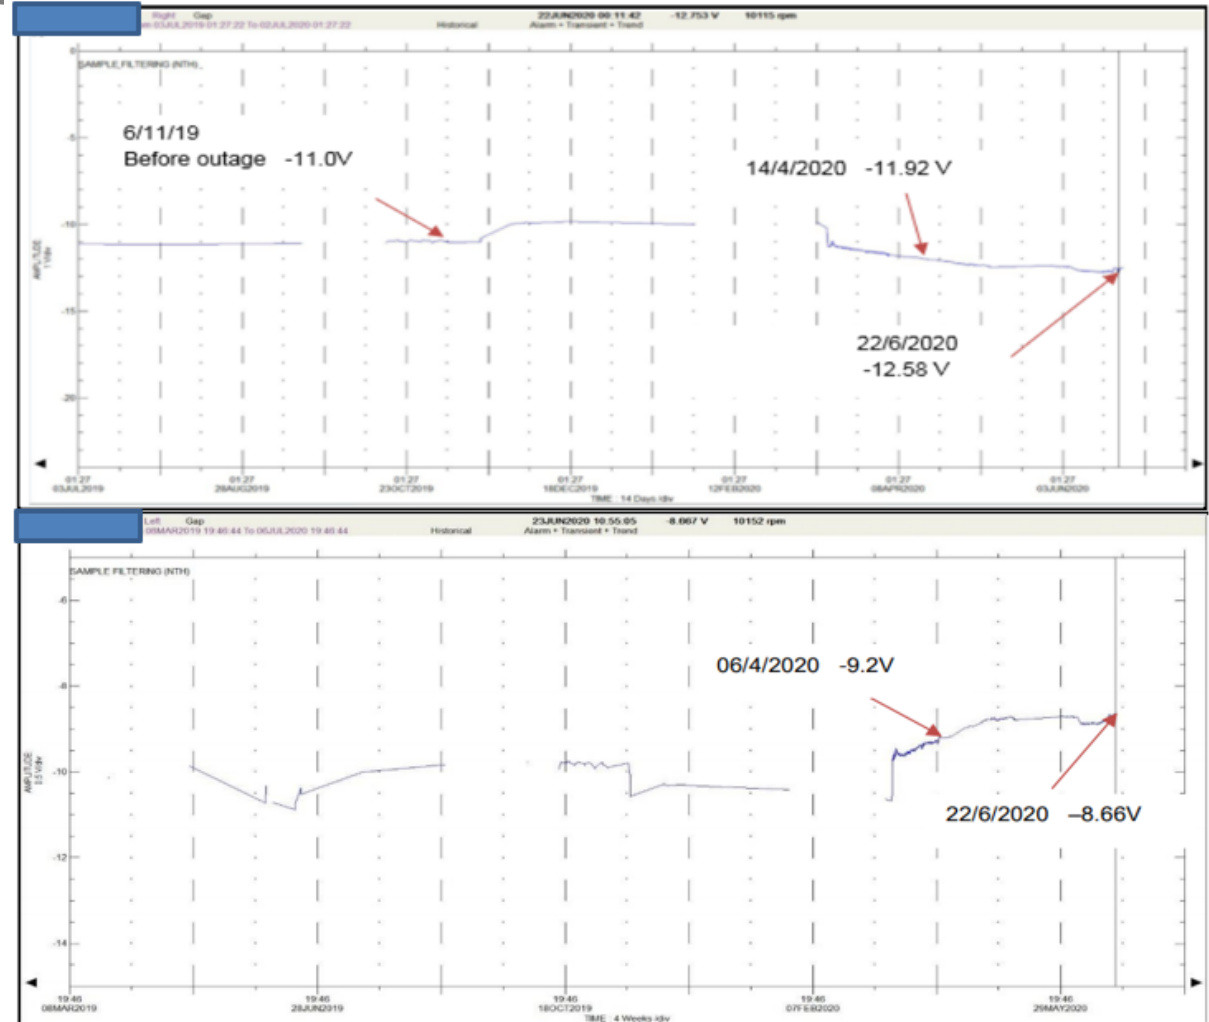
- DC gap trend appeared to shift at turbine LP side over two-month period.
- Deviation was around 1.5 volts which is around 190 microns (200mv/mil) shift, which is substantial.

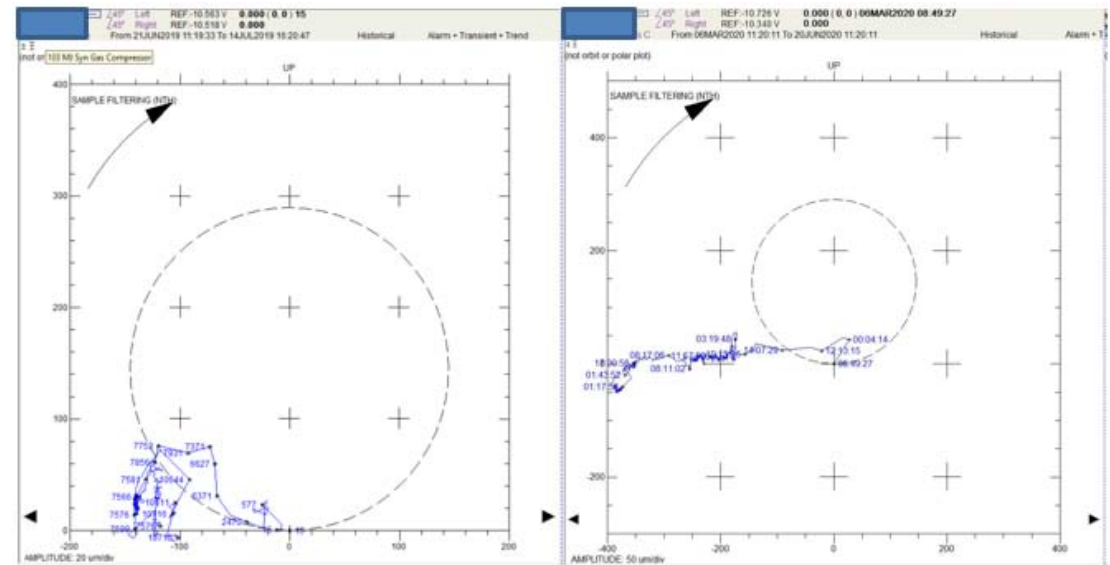
Shaft centerline (SCL) plots also showed substantial shift in position when compared with data from 2019 and 2020. It is also important to remember that SCL plots would also be influenced by thermal growth of the sensors and the bearings.

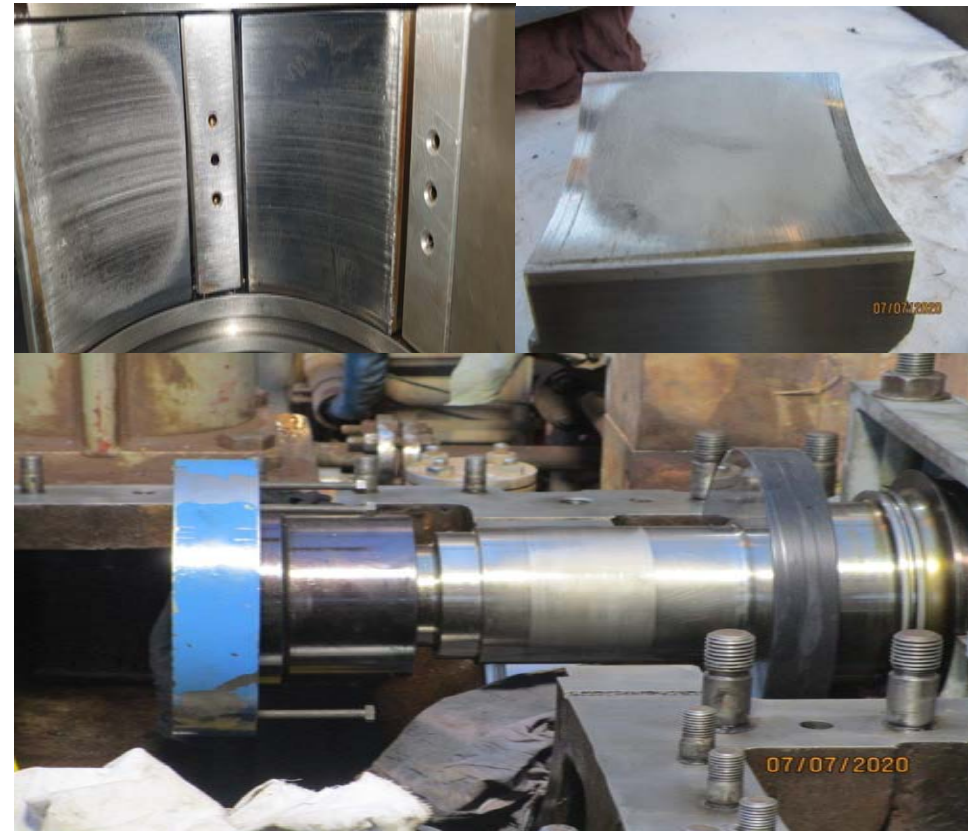
- Frosting effect was noticed in the shaft journal area which is typical on ESD affected machines.
- Similar effect was also noticed on bearings.
- Brush spring mechanism was found to have failed causing ineffective contact.
- Post replacement of brush mechanism and demagnetizing bearing surrounding, ESD issue was resolved

- Bearing inspection to be carried out immediately.
- Check grounding brushes and to replace if found damaged
- Conduct oil analysis.
- Inspect all other bearings at next available opportunity

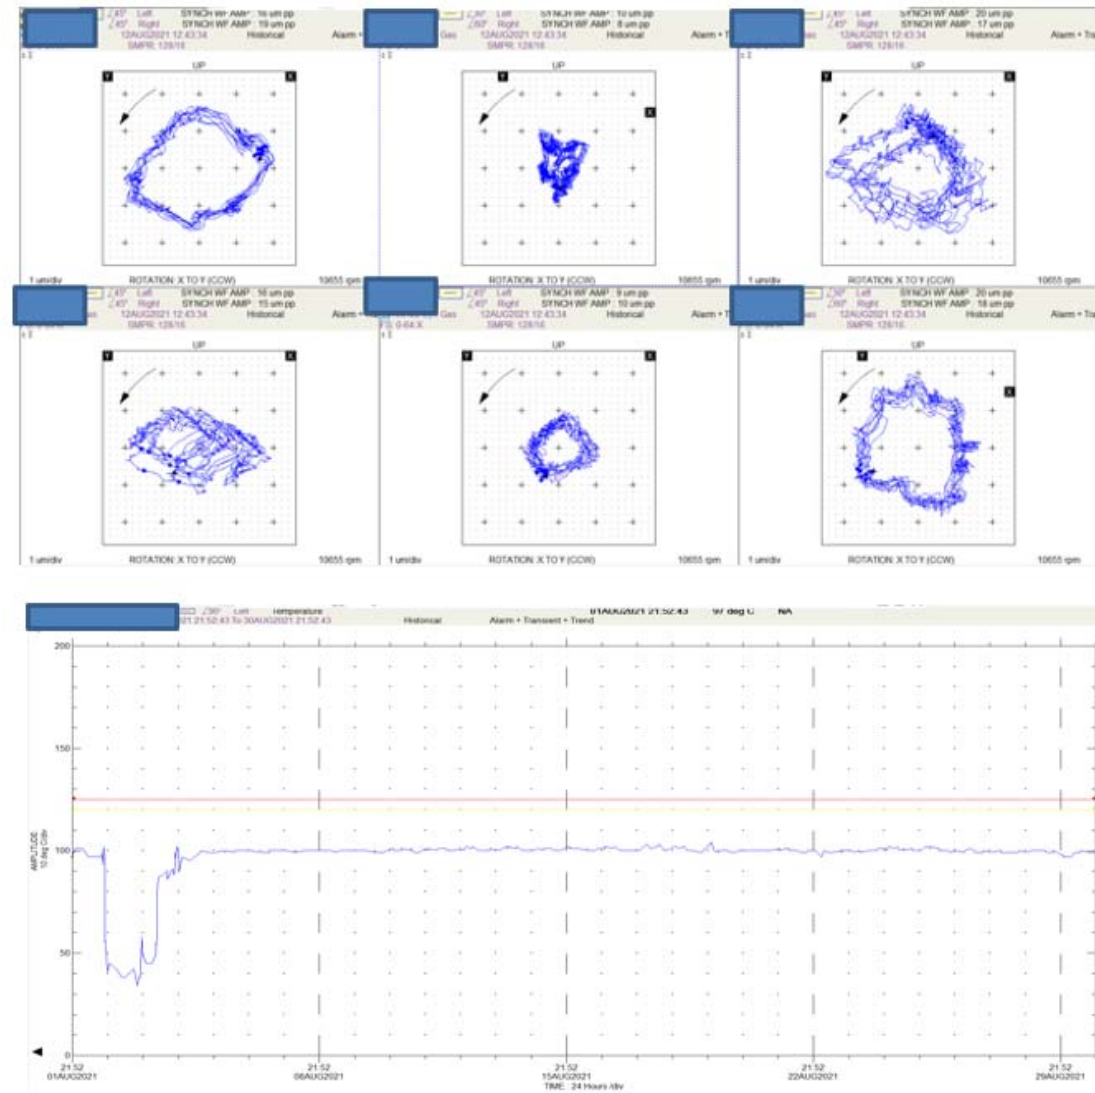
- Post repair ESD spikes were not evident in any of the bearings
- Temperature levels also came back to the normal operating levels
