ASIA **TURBOMACHINERY** & **PUMP** SYMPOSIUM  
APRIL 2020 | KUALA LUMPUR CONVENTION CENTRE

# Identification and Mitigation of H<sub>2</sub> Recycle Gas Compressor Blade Pass Resonance

Machinery Engineer  
ExxonMobil, Singapore

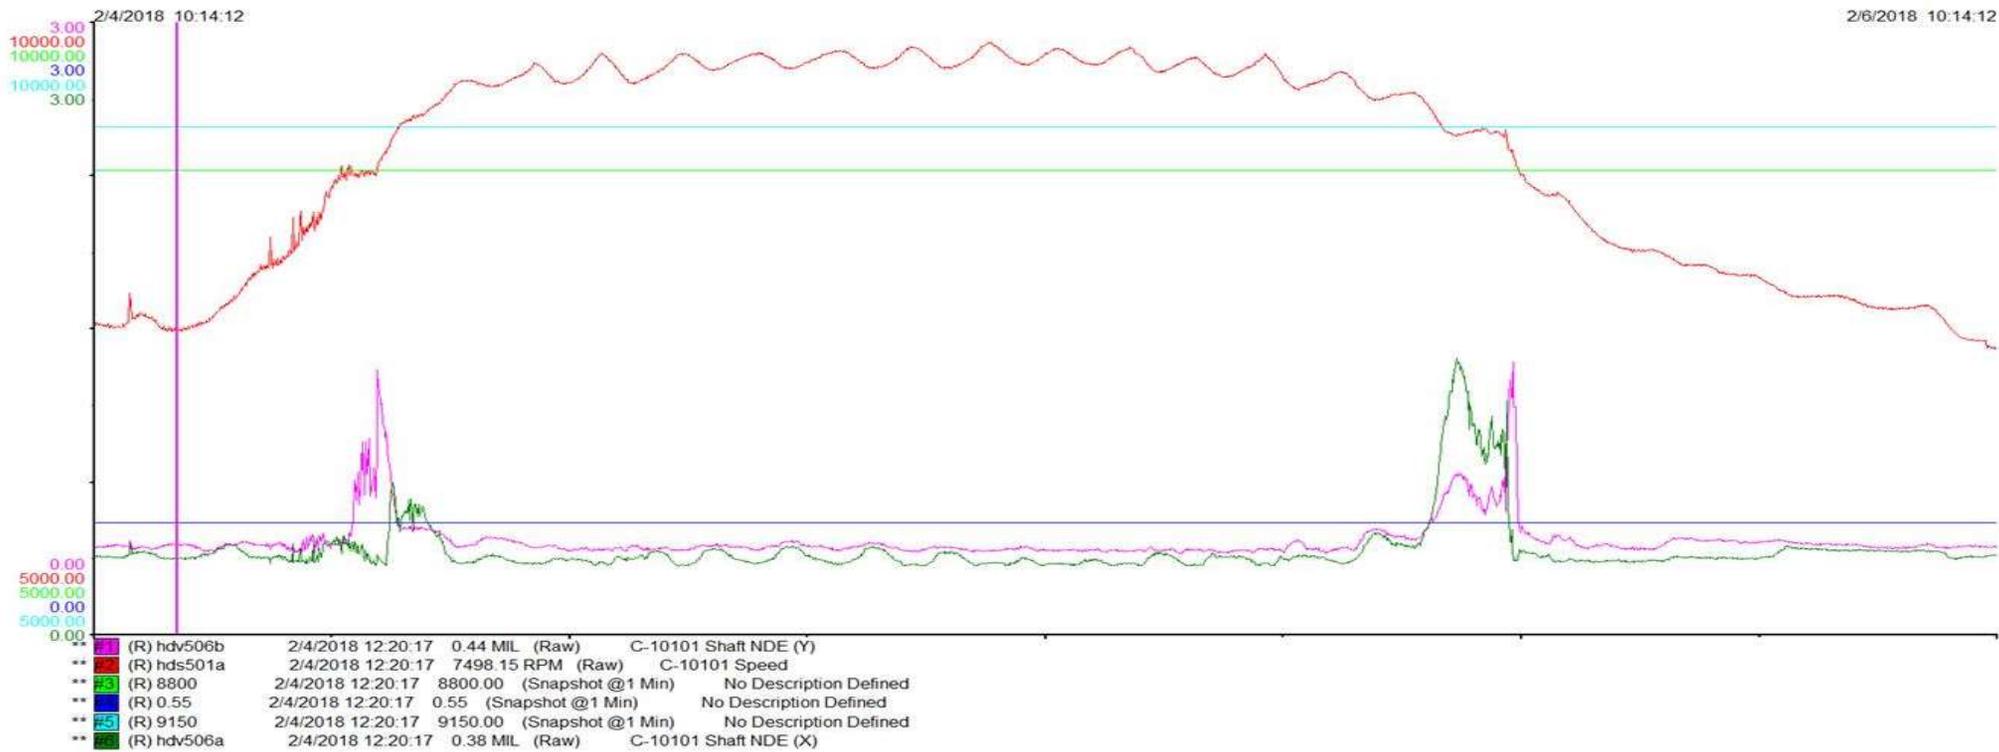
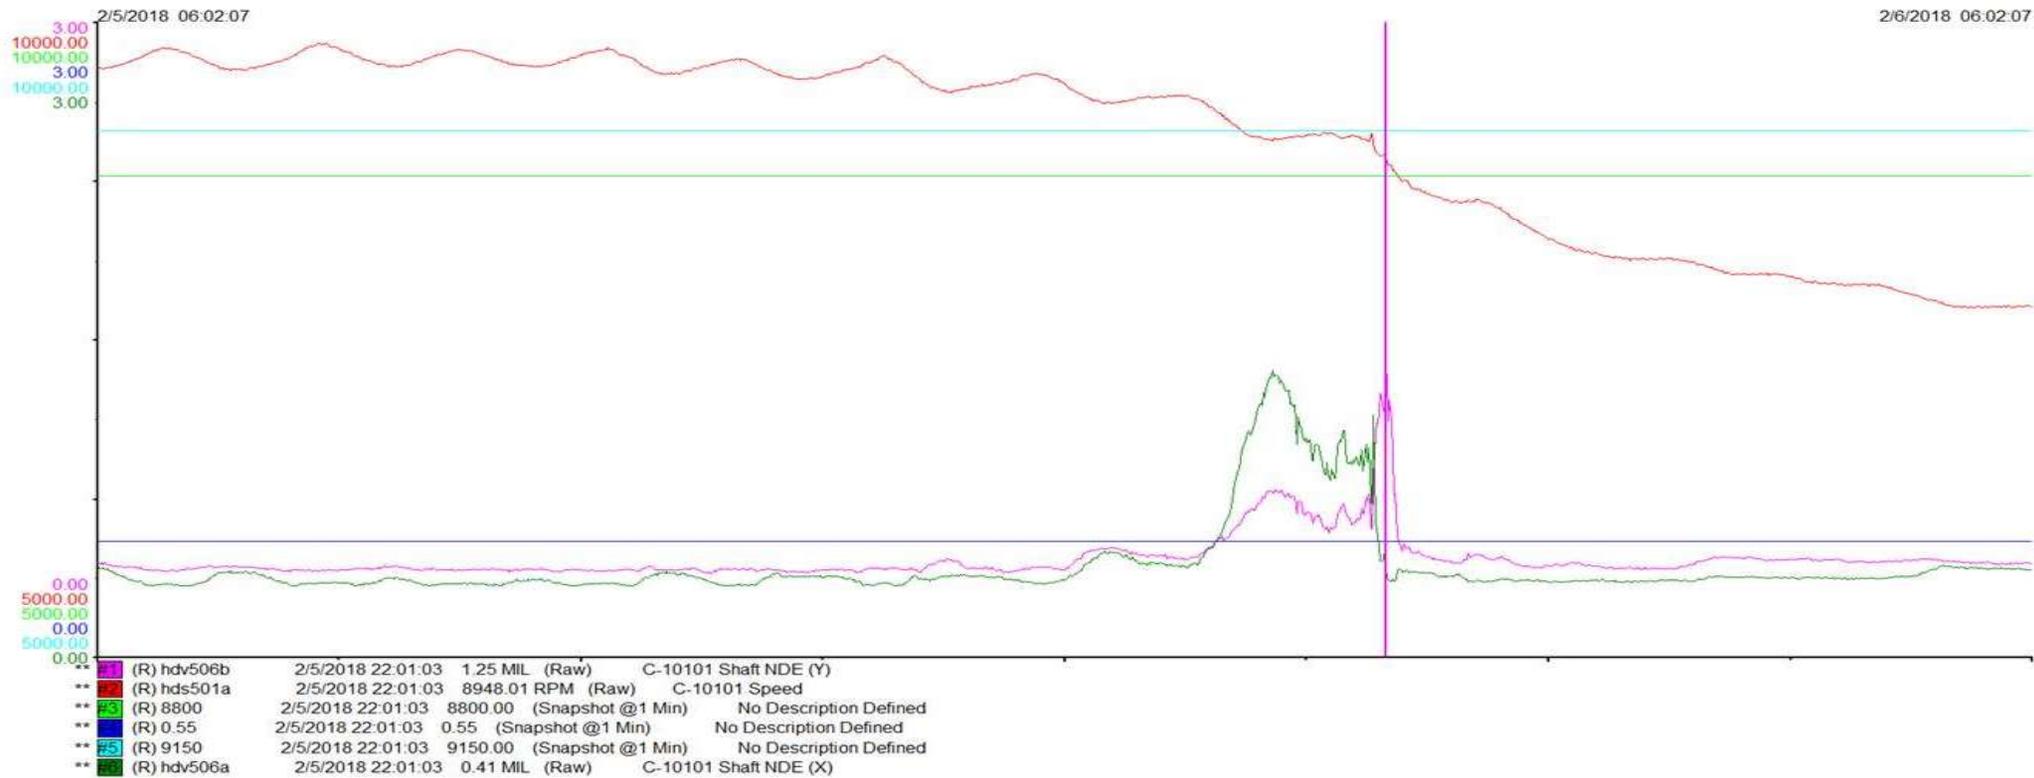
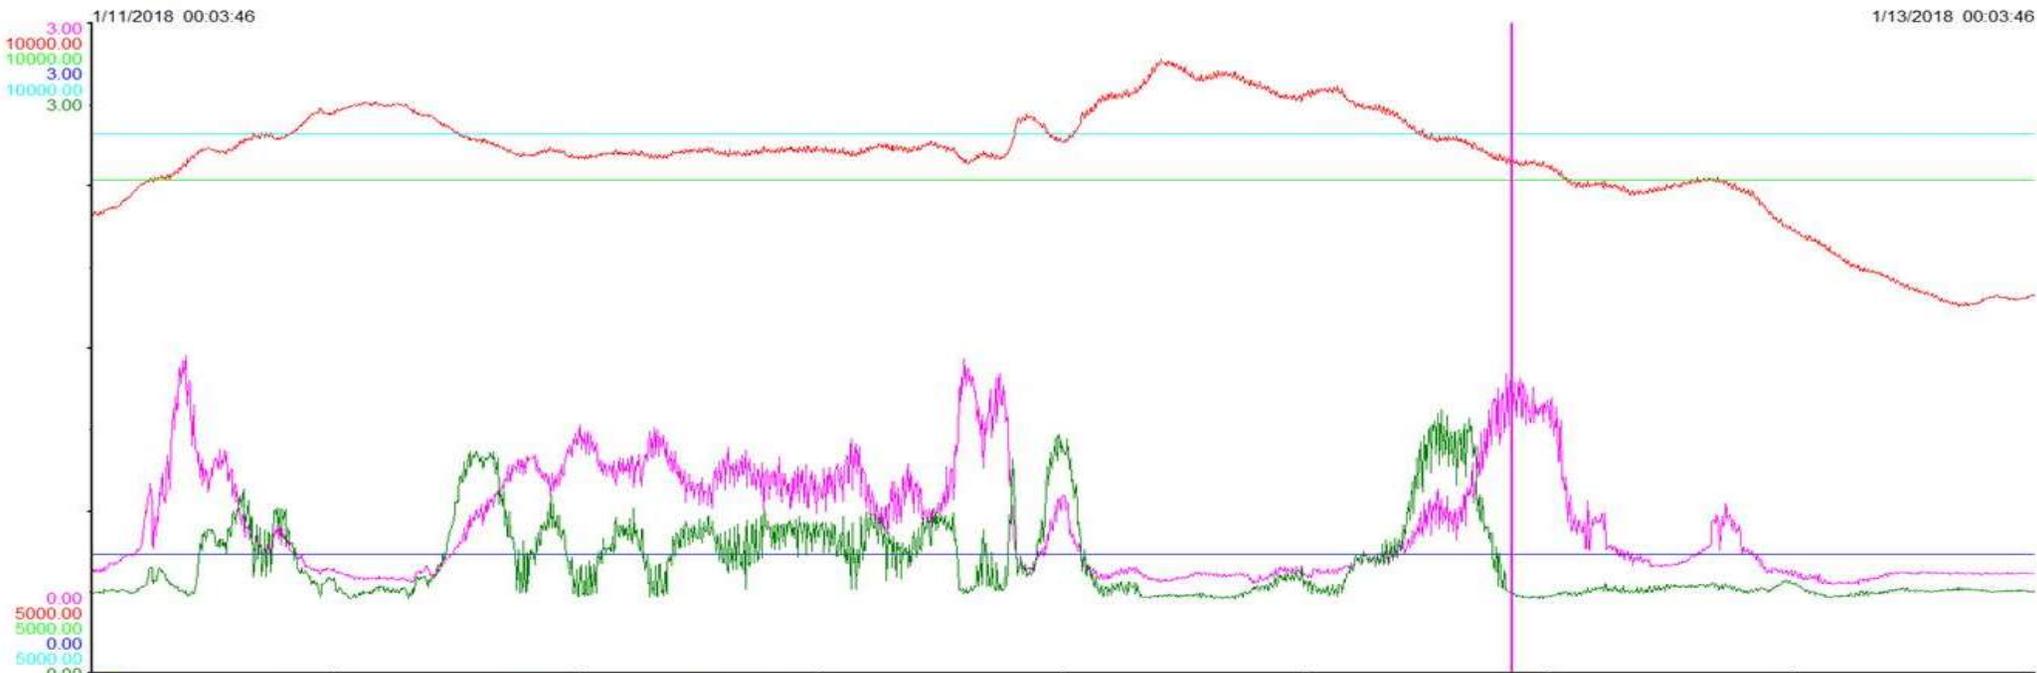
- Vibration spikes were independently studied with speed of the compressor.
- Direct & precise correlation of vibration spikes with speed found in range of 8800 rpm to 9150 rpm.
- It was ascertained that resonance was occurring in the specified speed range.
- Resonance occurring at  $11 \times 9000 \text{ rpm} = 99000 \text{ cpm} = 1650 \text{ Hz}$ .

**	(R) hdv506b	1/12/2018 11:08:45	1.27 MIL (Raw)	C-10101 Shaft NDE (Y)
**	(R) hds501a	1/12/2018 11:08:45	8930.93 RPM (Raw)	C-10101 Speed
**	(R) 8800	1/12/2018 11:08:45	8800.00 (Snapshot @1 Min)	No Description Defined
**	(R) 0.55	1/12/2018 11:08:45	0.55 (Snapshot @1 Min)	No Description Defined
**	(R) 9150	1/12/2018 11:08:45	9150.00 (Snapshot @1 Min)	No Description Defined
**	(R) hdv506a	1/12/2018 11:08:45	0.37 MIL (Raw)	C-10101 Shaft NDE (X)

- **Low cost / minimalistic solution**
  - It is recommended to **avoid operating** in the speed range (8800 rpm to 9150 rpm) that causes the resonance issue till compressor overhaul is performed.
  - Avoiding the specified speed range helps avoid vibration spikes and any concerns of damage of impeller.
  - Operations advised on the same. Logic to avoid specific speed range being explored.

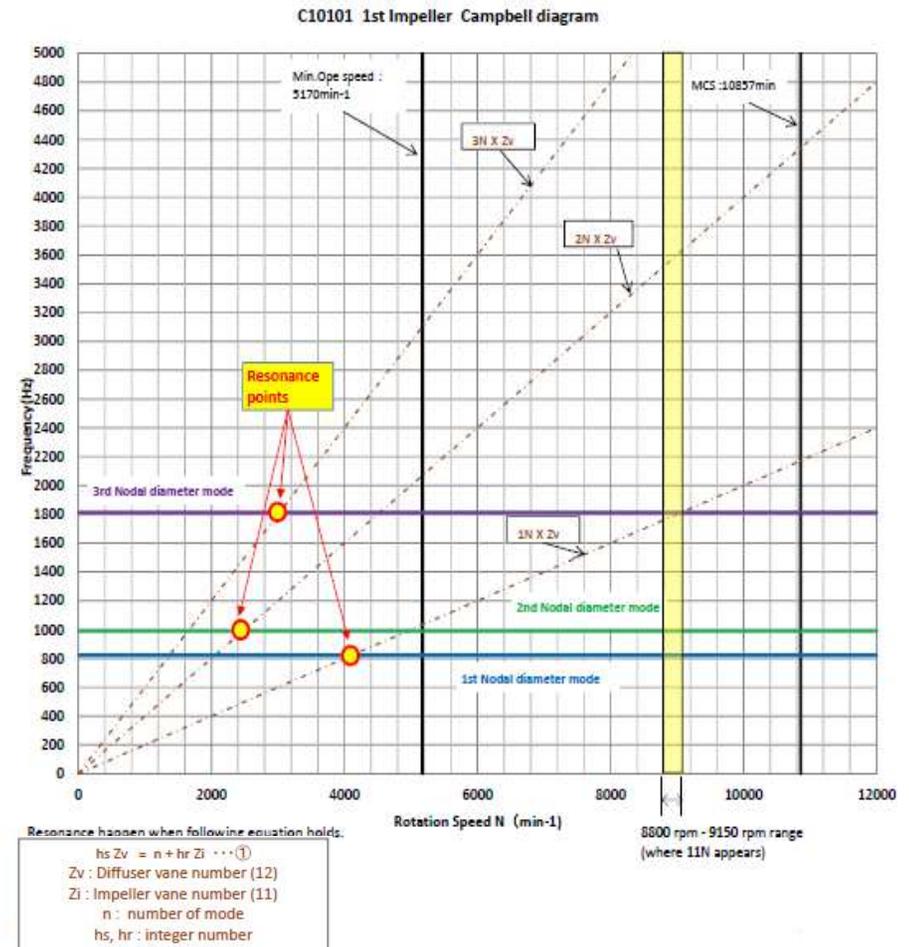
- No resonance nodes in the operating range of the machine.
- Impeller nodal diameter modes also checked for interference.
- No interference found.

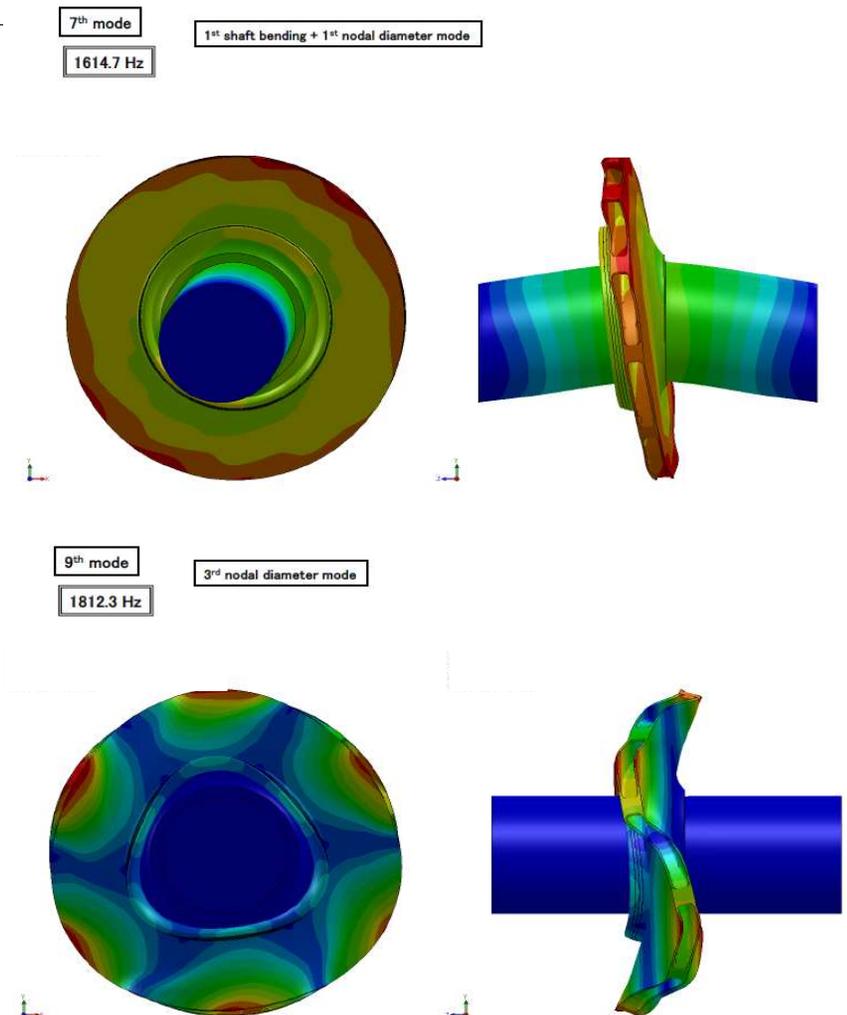
- Impeller nodal diameter modes checked.
- Impeller nodal diameter modes not coinciding with resonant frequency.
- Risk of impeller damage due to impeller resonance ruled out.

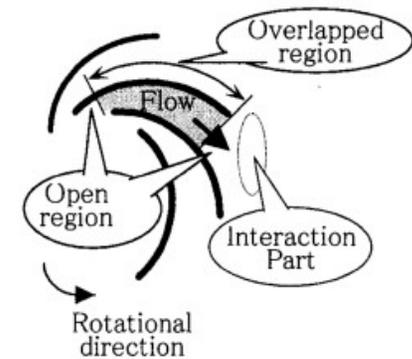
- Acoustic resonance occurring between impeller blade passages.
- Based on gas velocity and blade length and sound velocity, acoustic resonance natural frequency ascertained to be 1742 Hz, in operating speed range of 8800 to 9150 rpm.

$$f_r = \frac{a}{\lambda} = \frac{a}{4l} = \frac{1066}{4 \times 0.153} = 1742 \text{ Hz}$$

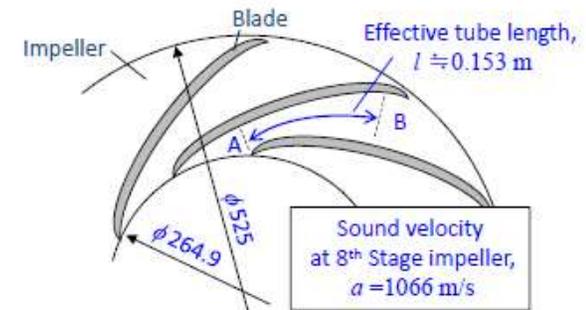
Fig. 2 Acoustic tube model for 8<sup>th</sup> Impeller of C-10101

- Sound velocity for the gas, and the effective length in gap between the blades produces the open ended acoustic wave.
- The frequency of the acoustic wave coincides with the 19<sup>th</sup> eigenvalue of the rotor causing vibration.

Fig. 1 Result of acoustic modal analysis for the impeller of compressor experienced "11N" vibration

- Mitigation of 11x acoustic resonance would require removal of the diffuser vanes OR
- Increase in clearance between the impeller blade tip and diffuser vanes.
- Both would require major modification in machine, especially diffusers.
- Primarily because, it is not possible to determine, the stage in which resonance is occurring. All stages would need to be modified.

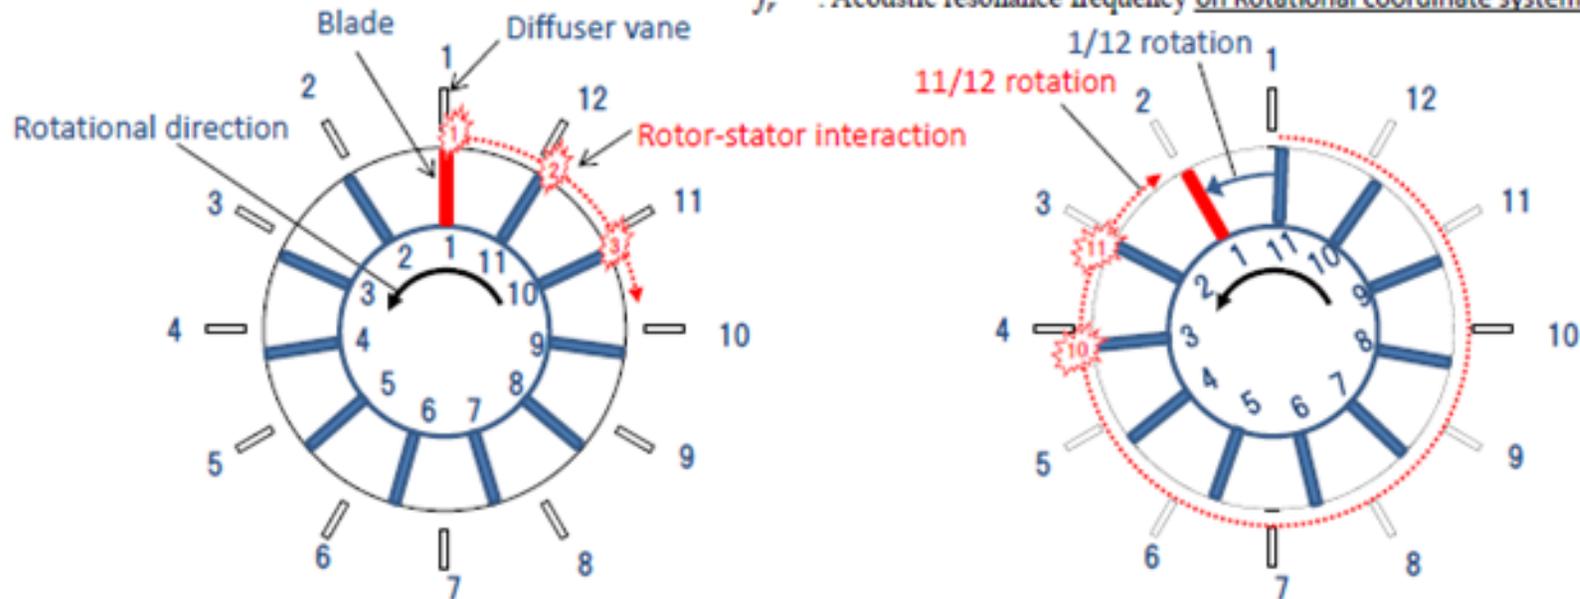
Fig. 3 Rotor-stator interaction for Impeller of C-10101

- Why 11x is answered in the graphic below:

$$f_s = 11f_N = 11 \times \frac{f_r}{12} = 11 \times \frac{1742}{12} = 1597 \text{ Hz}$$
