ASIA **TURBOMACHINERY** & **PUMP** SYMPOSIUM
APRIL 2020 | KUALA LUMPUR CONVENTION CENTRE

Resolution of Steam Turbine High Vibration Due to Rotor Rub

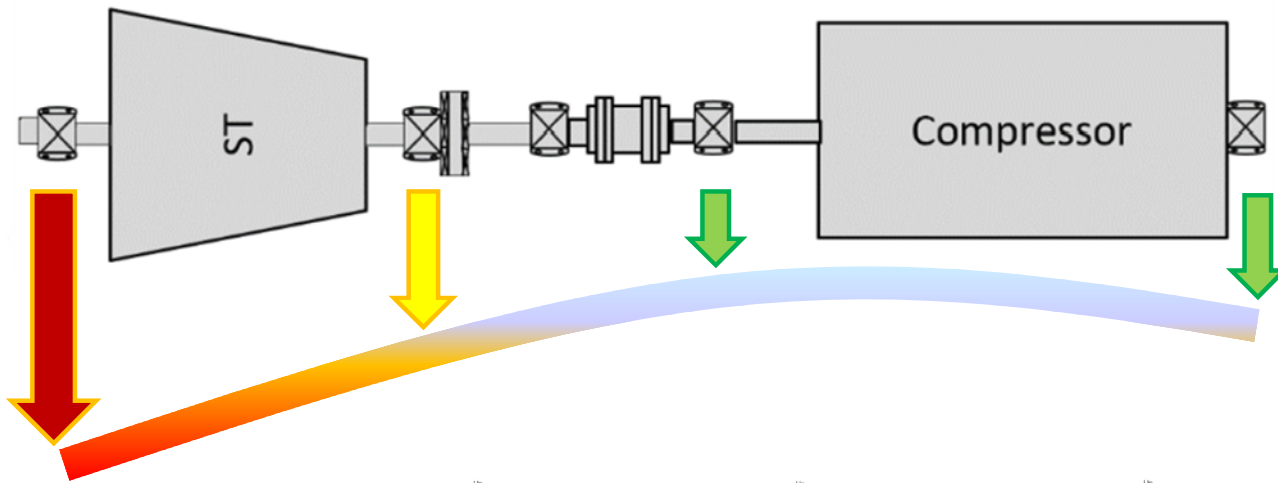
Y: 91.6 μm pp
X: 84.2 μm pp

Y: 77.7 μm pp
X: 63.6 μm pp

Y: 5.12 μm pp
X: 5.61 μm pp

Y: 7.42 μm pp
X: 11.07 μm pp

- High vibration occurred at steam turbine, especially Bearing-1.
- All frequency spectrum indicates sign of dominant 1x vibration.
- Initial suspect: tight internal clearance between labyrinth seals and rotor.

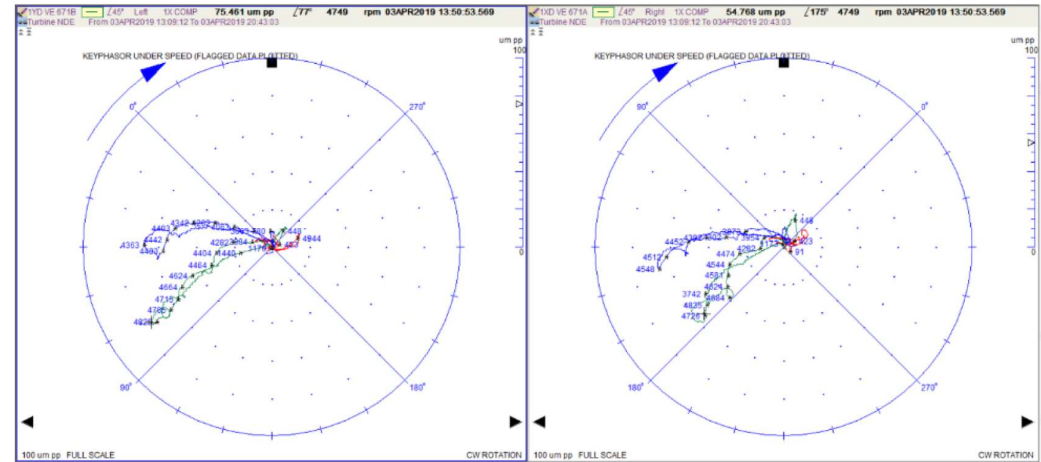
Polar plot for Bearing-1 at 4th run

1. Vibration plots in the first 4 startup were collected from System-1 to study the cause of tripping.
2. Polar Plots:
 - Continuous drastic change of 1X phase within a narrow speed range (4500~4700 rpm) in every startup.
3. Turbine shaft center line (SCL – Bearing-1) plots showed symptom of insufficient lift when the turbine was cruising toward critical speed.

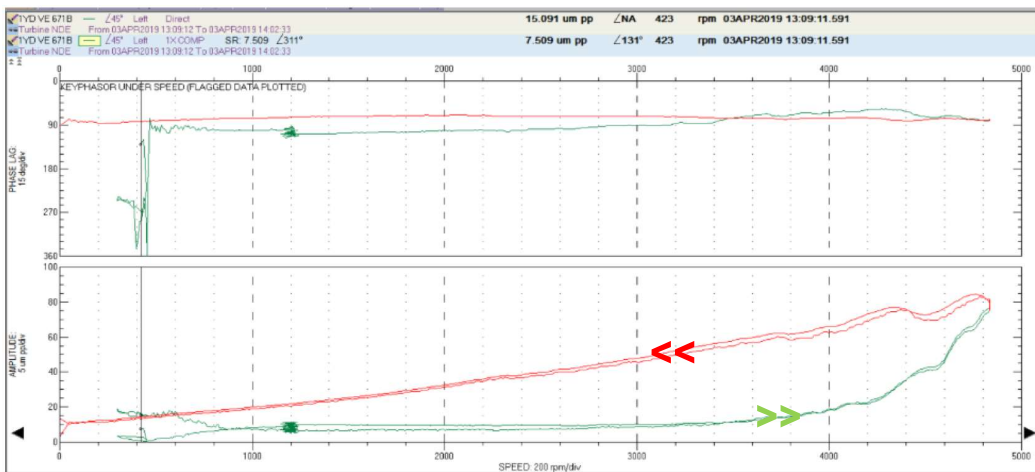
Bode plot for Bearing-1 in 1st run.

1. Bode plots for (cold) startup and shutdown were different in 1st and 4th run.
2. Phase lag of the system was found “interrupted” before critical speed.
3. Direct cause of vibration was suspected due to “uneven “ interference in every startup. Preliminary assessment pointed at potential of internal rub.
 - Rotor lift was restricted when turbine speed increased.
 - Internal rub could have induce spring stiffness during startup and relieve after coast down.
 - Rub causes thermal bow of rotor and modified heavy spot location in every startup.
4. The vibration response from a light rub due to thermal bow of rotor is usually a pure 1X response without any harmonics, which explain the trends picked up in frequency spectrum.

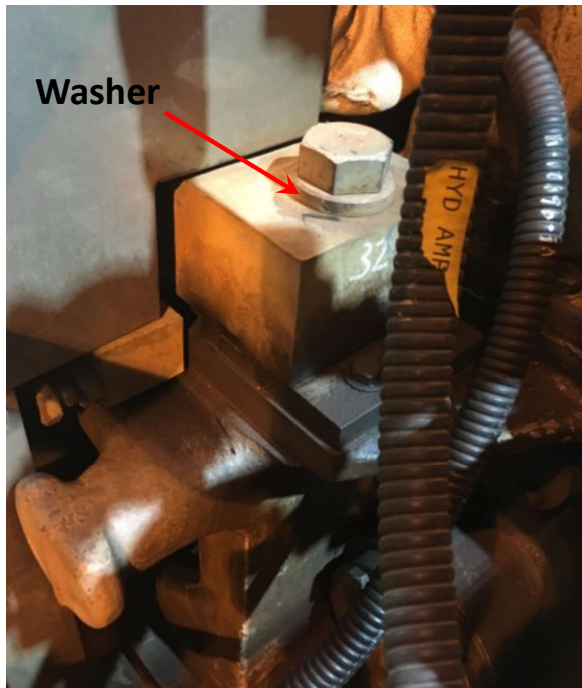
Four (4) hold down bolts are installed in the turbine top casing. Each bolt is mounted to the casing foot via a washer ring.

All washer ring have approximately 0.1 mm clearance and free to move under cold condition.

When the turbine is in operation, the clearance will be closed up by casing thermal expansion.

Without this clearance, casing expansion will be restricted and lead to rotor rubbing against the internals.

During turbine overhaul, the top casing was lifted to extract the rotor assembly for inspection. Most probably the as-found clearance was not checked by OEM rep prior to removal.

One of the hold down bolts at the turbine NDE was found tight.

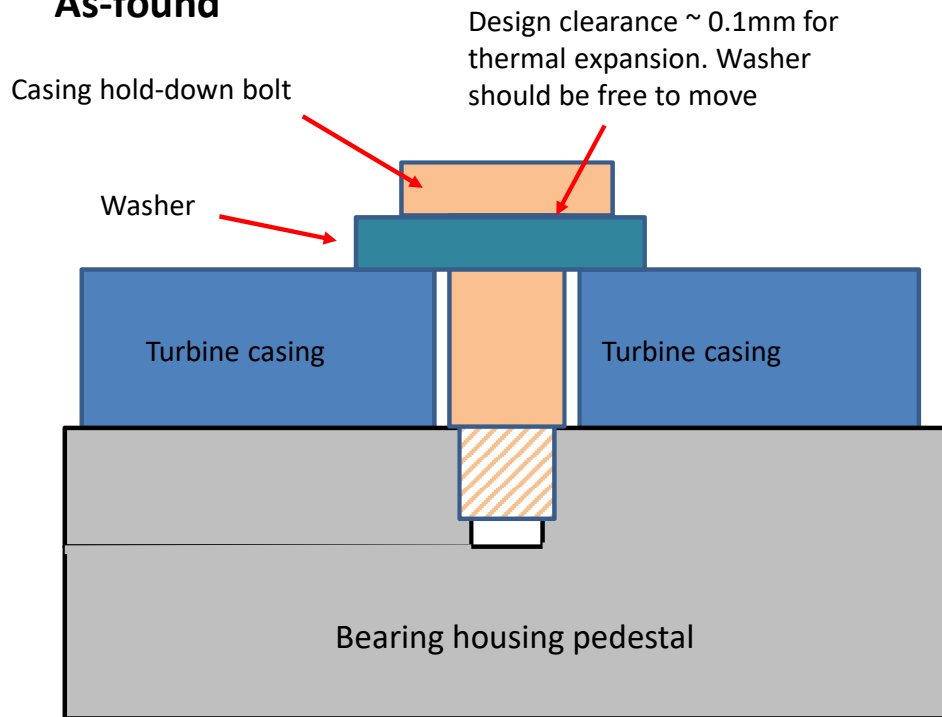
As-found

During detailed troubleshooting, a hold-down bolt on the turbine Drive-end casing was found to be excessively tight. This restrained the normal thermal growth of the casing which caused a minor distortion as more steam was being introduced into the turbine. The distortion resulted in a rub which thermally bowed the shaft and resulted in the high 1X vibration

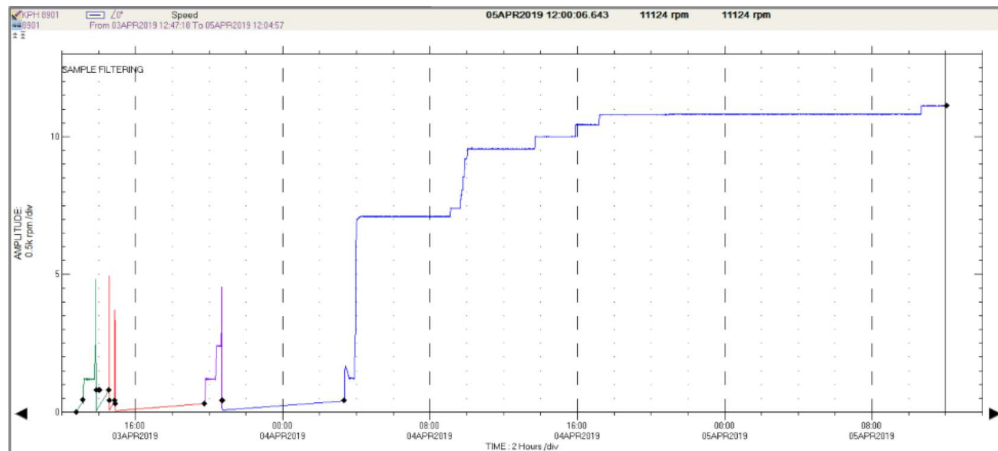
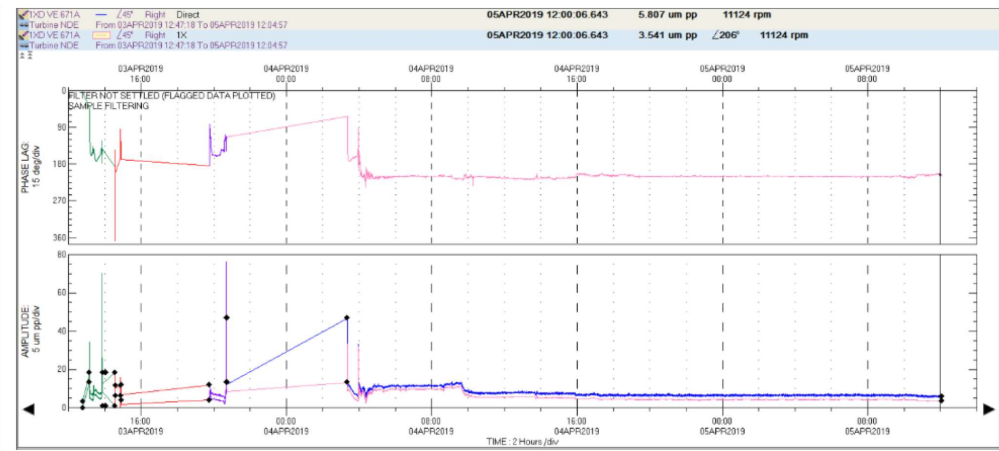
- The compressor train was restarted up successfully after addition of shim.
- Vibration through critical speed was lower than 25 μ m pp.
- Ramp up of speed was smooth and vibration on deck could no longer be felt
- The compressor have been running stably for 6 months since then.
