ASIA **TURBOMACHINERY** & **PUMP** SYMPOSIUM
22-26 FEBRUARY 2021 | NOW VIRTUAL!

Resolution Of Vibration Step Changes On A Steam Turbine Generator

Bently Nevada, Baker Hughes

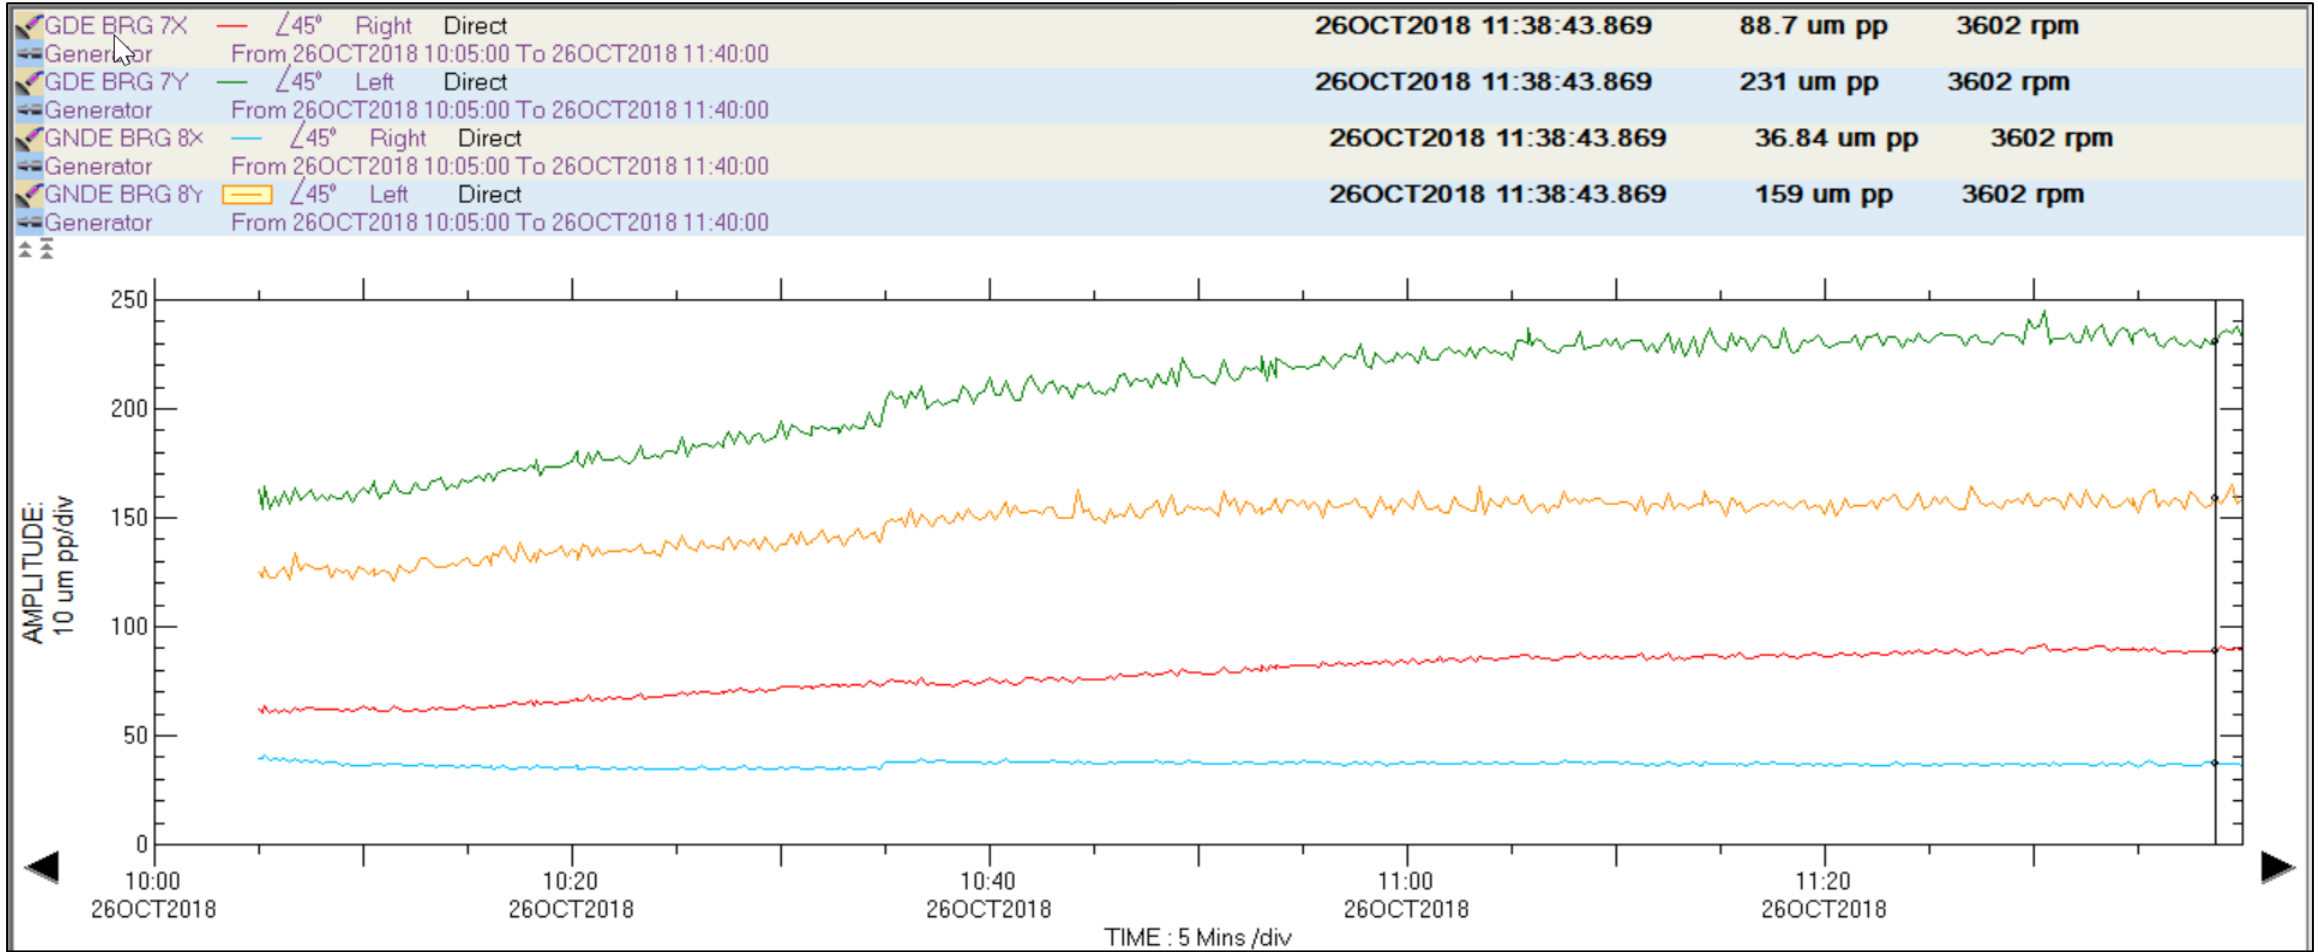
Overall Vibration on Generator DE Bearing#7 reached close to the Danger set point of 231 μm pk-pk

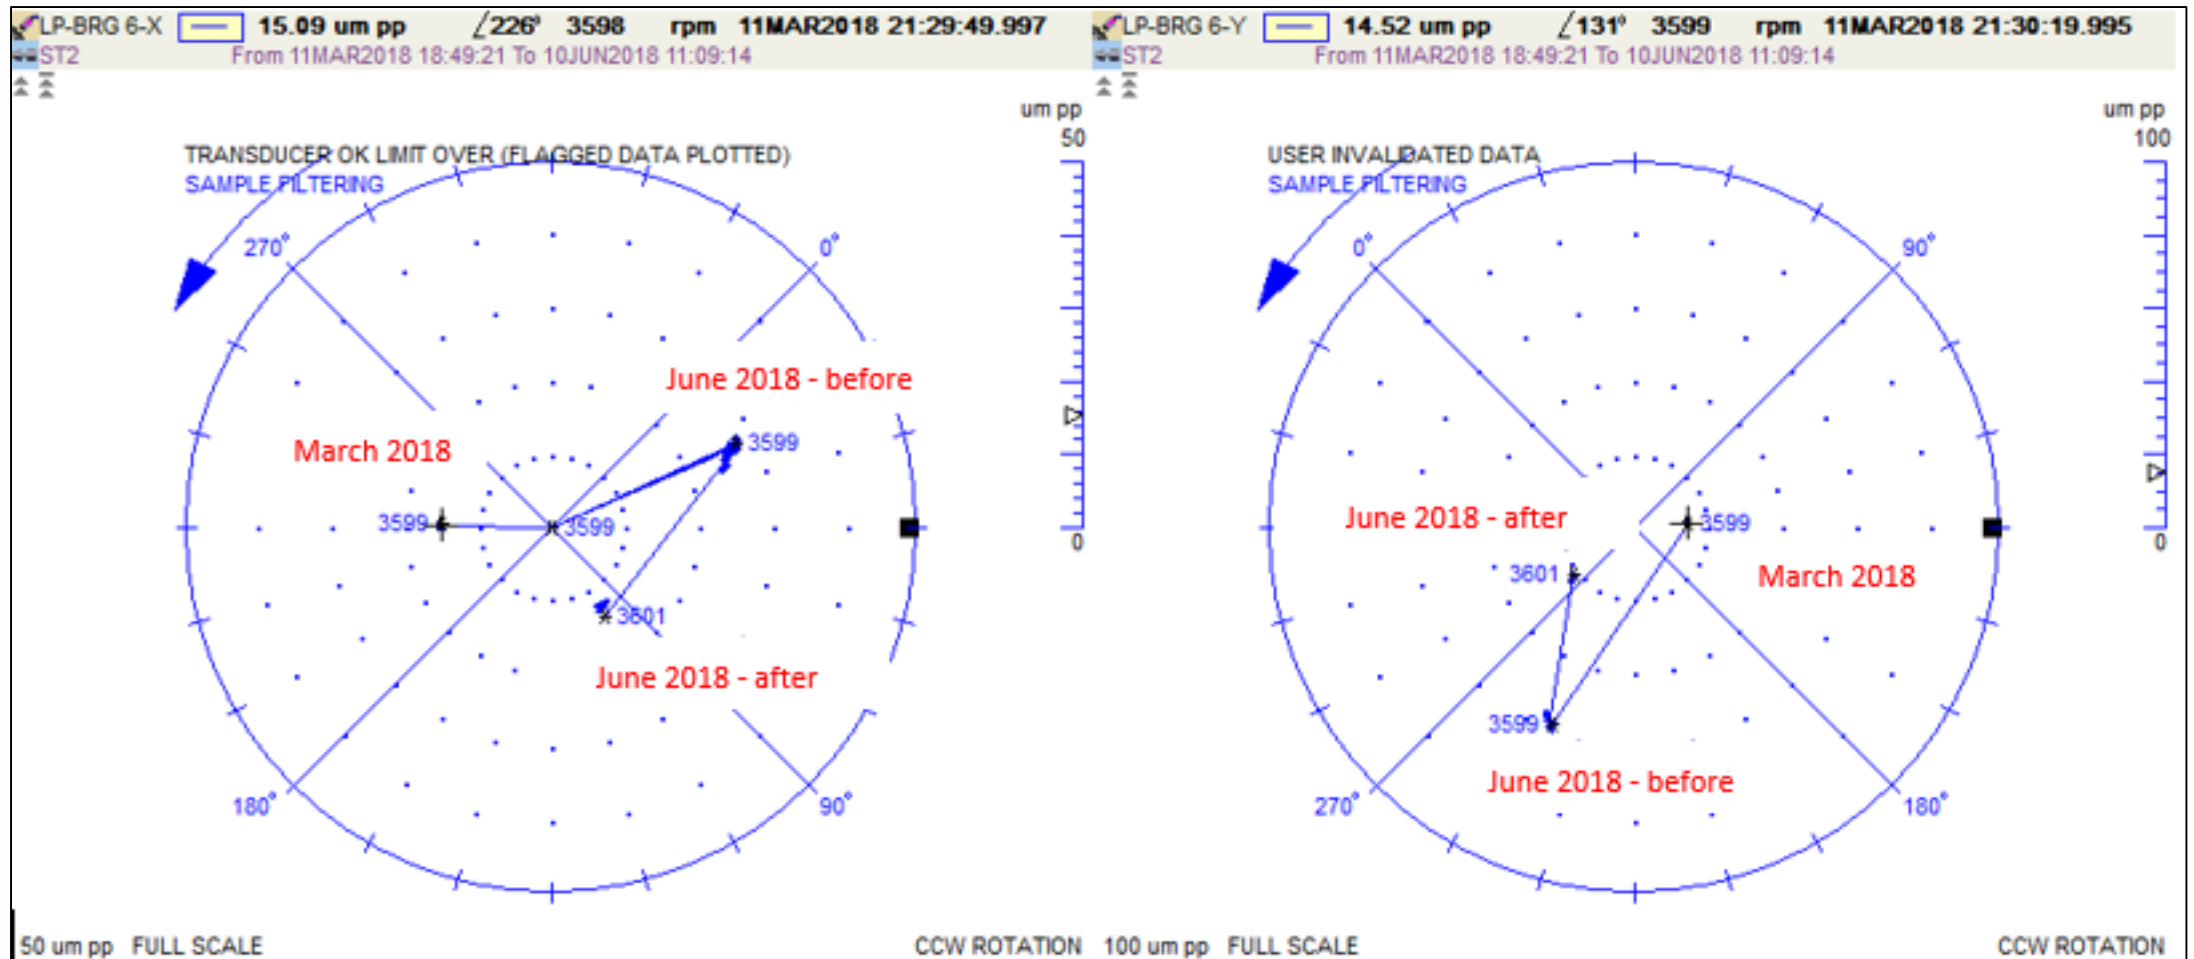
1X vibration/phase random step changes on BRG #6 (March, June)

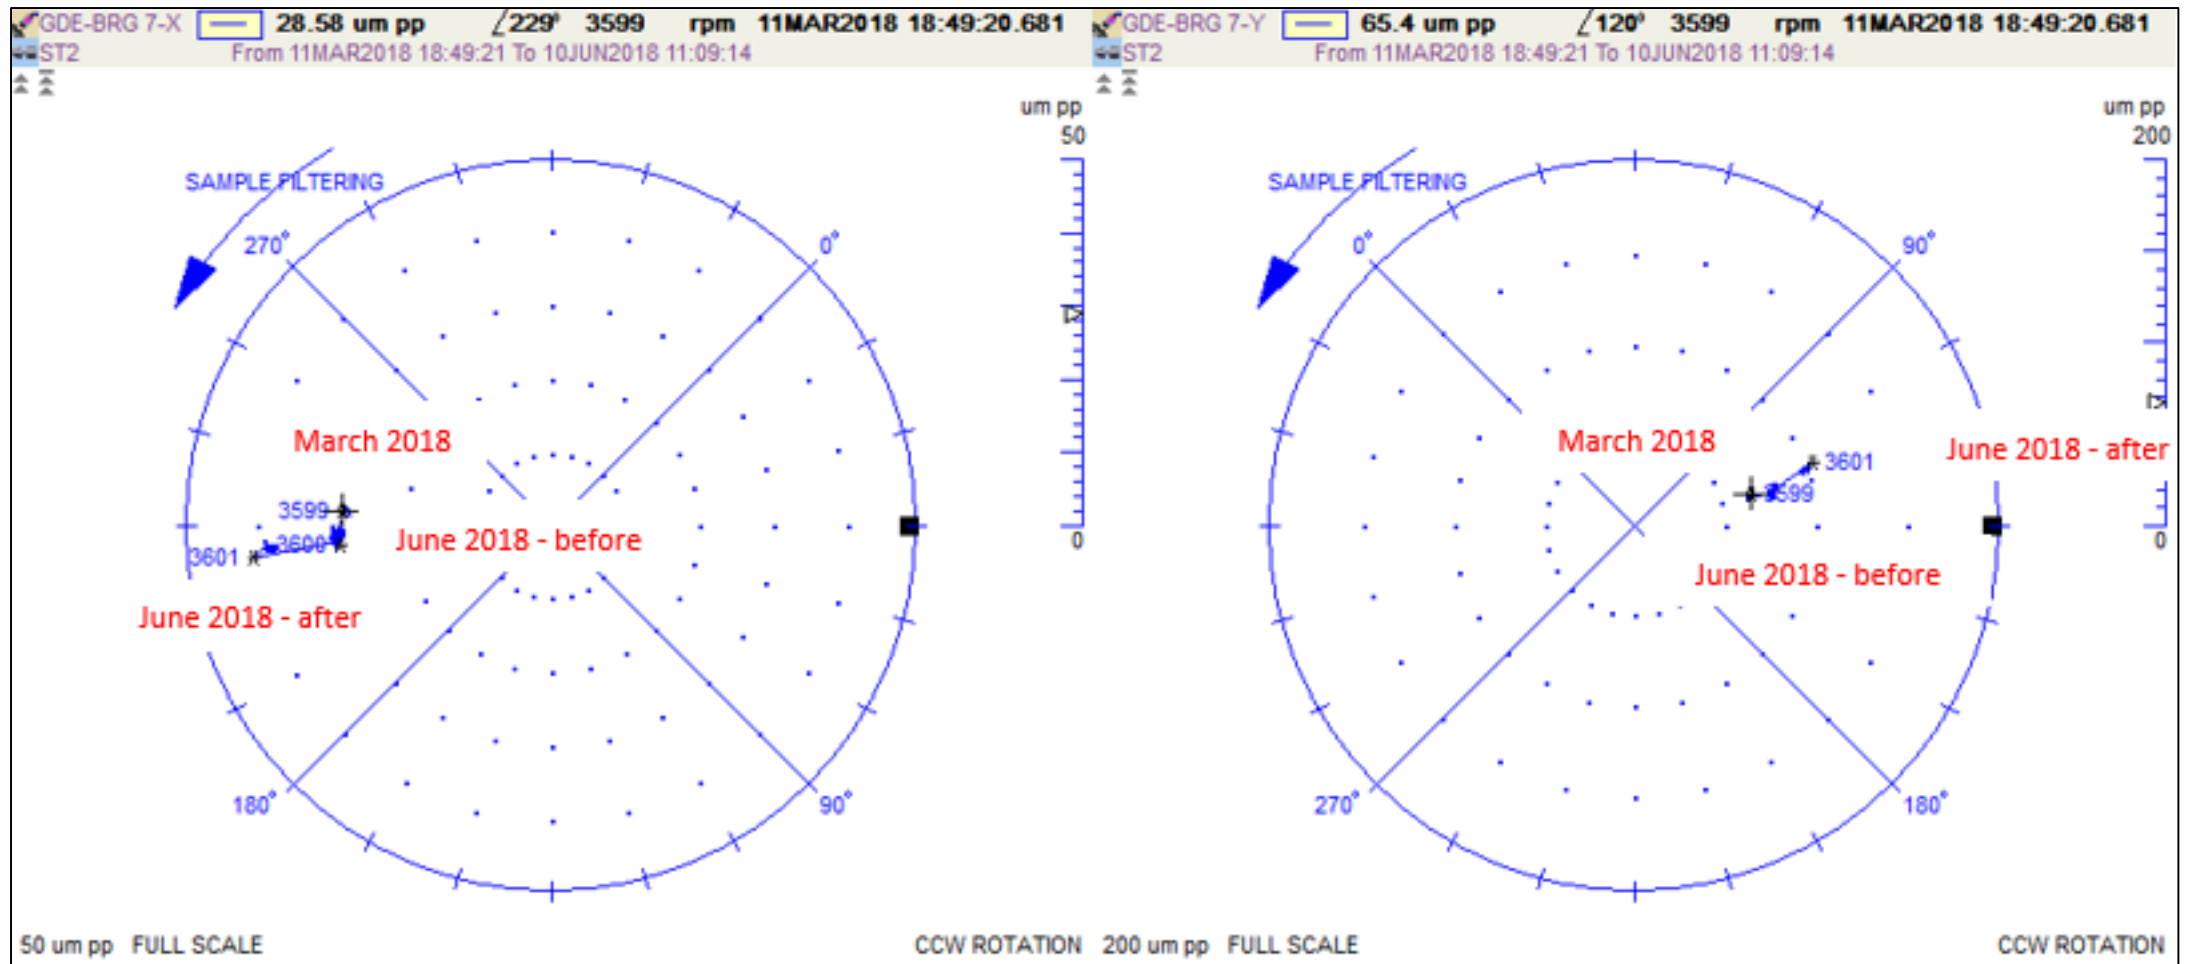
1X vibration/phase random step changes on BRG #7 (March, June)

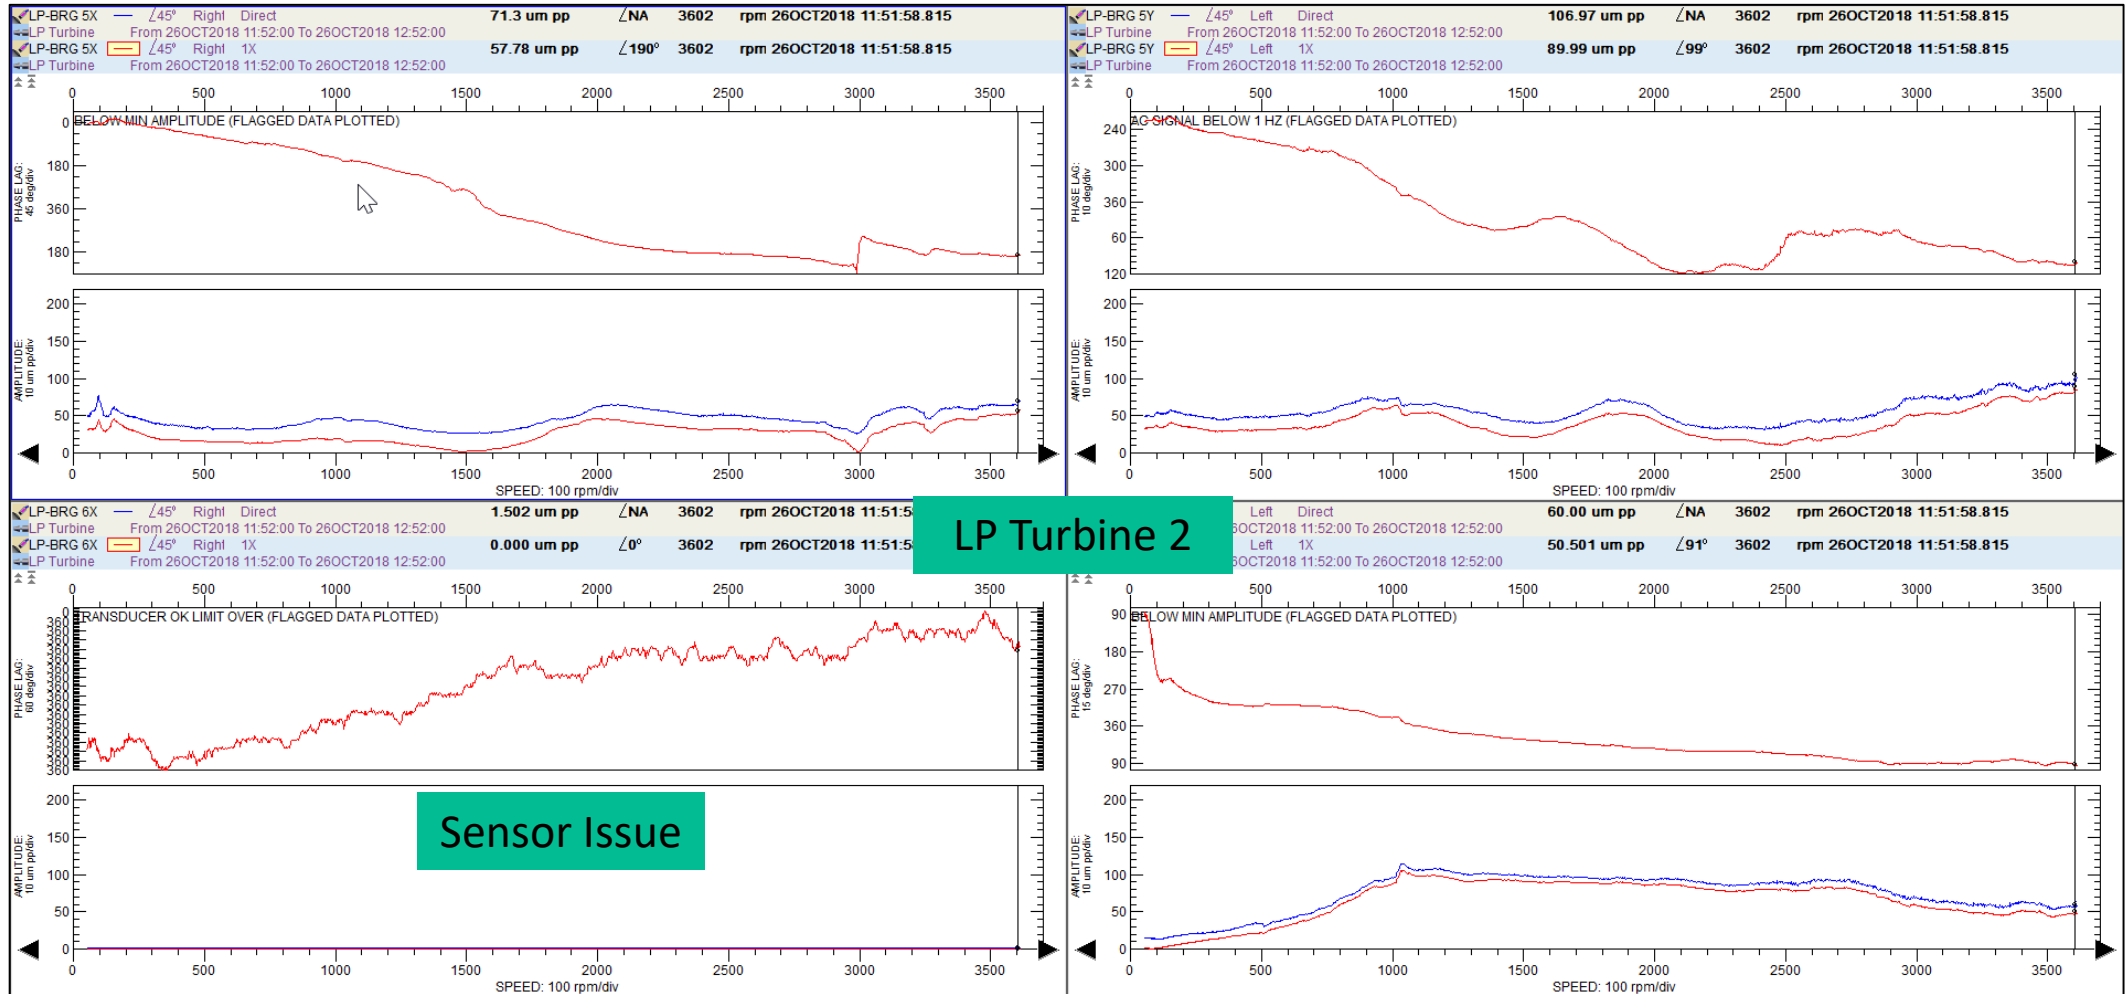
No evidence of elevated critical speed amplitude due to unbalance on the LP Rotor

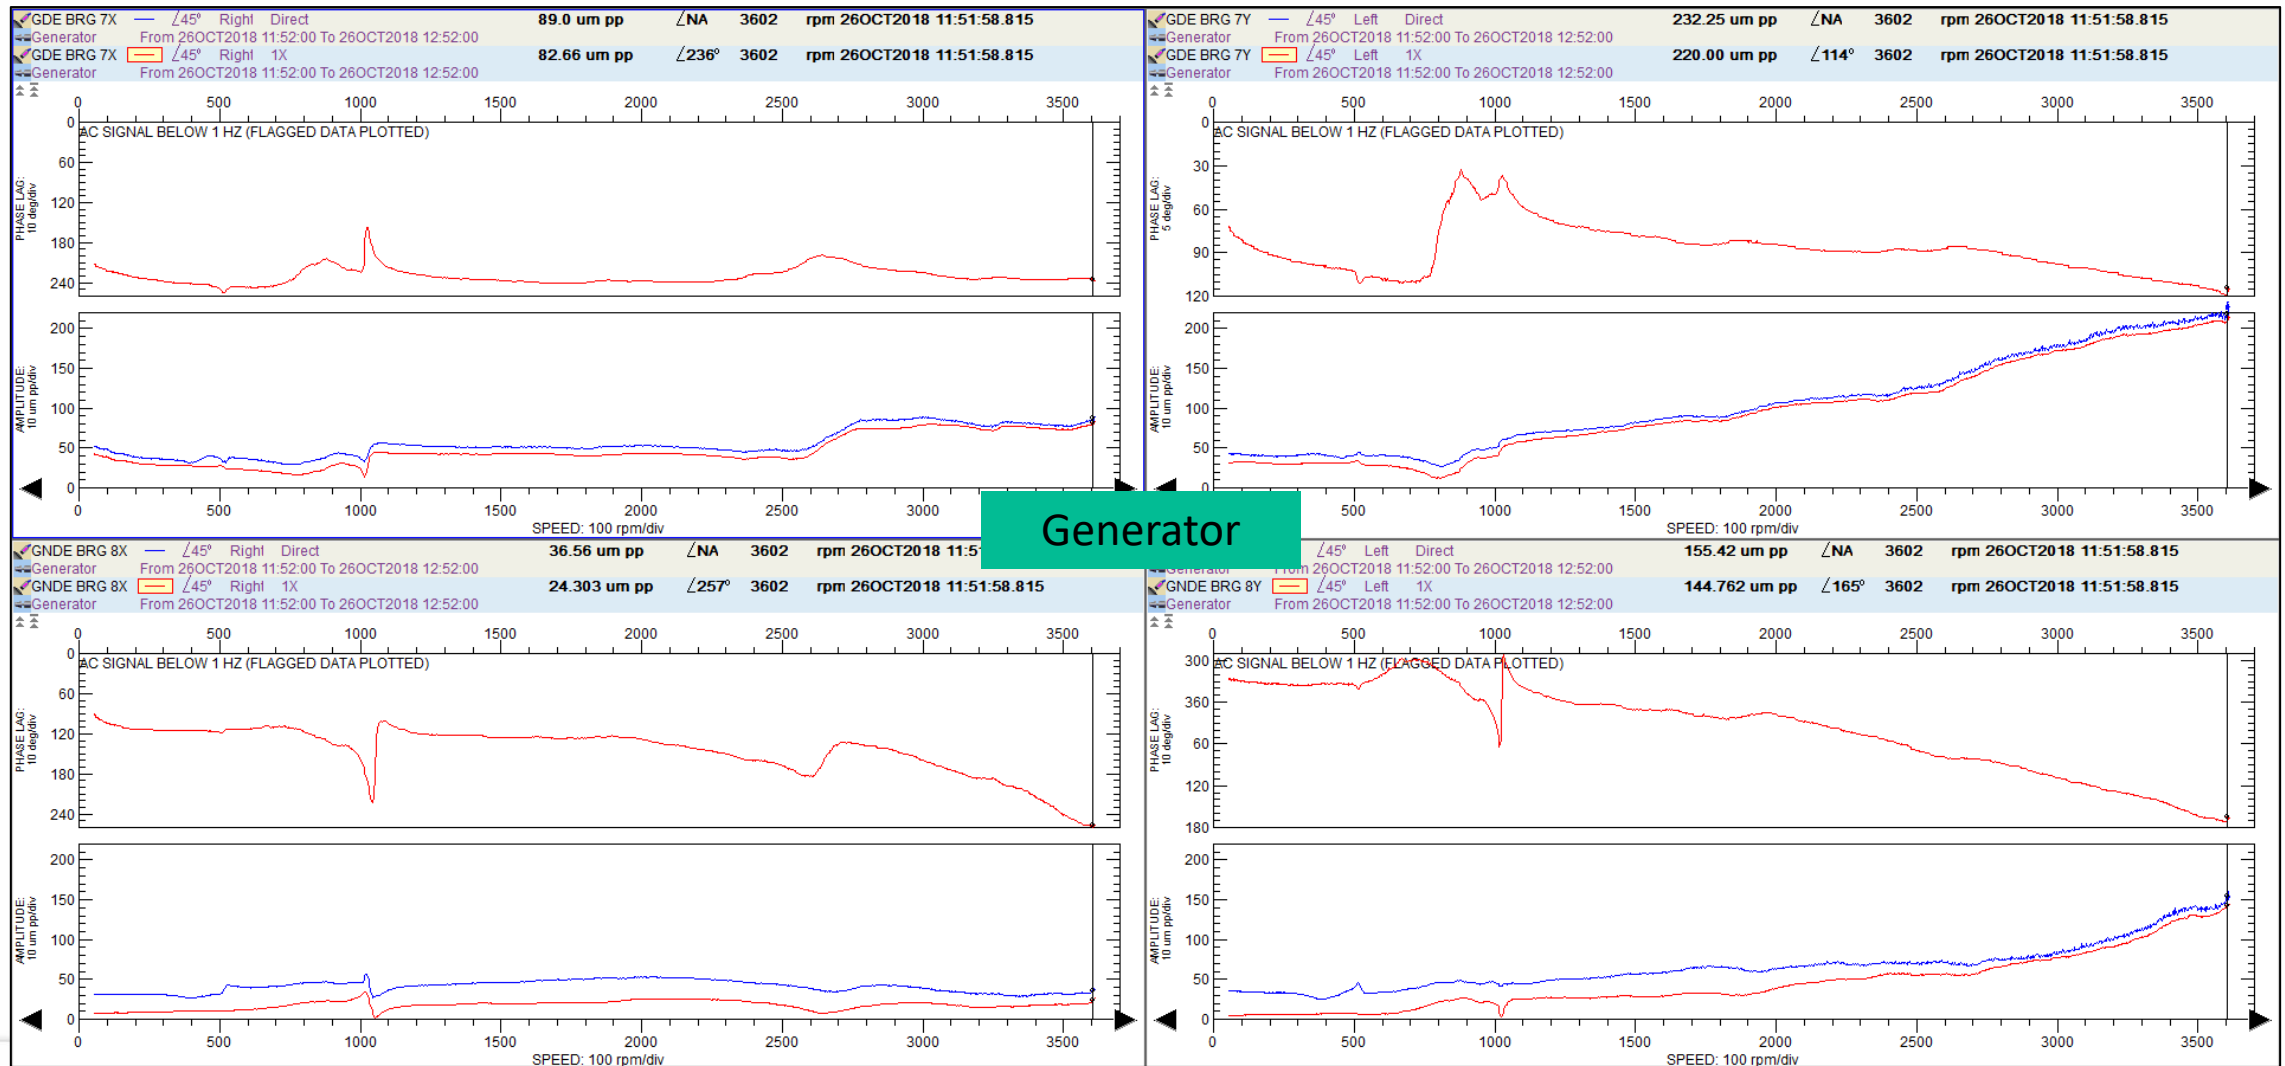
No evidence of unbalance, but symptom of rotor running close to the second critical speed

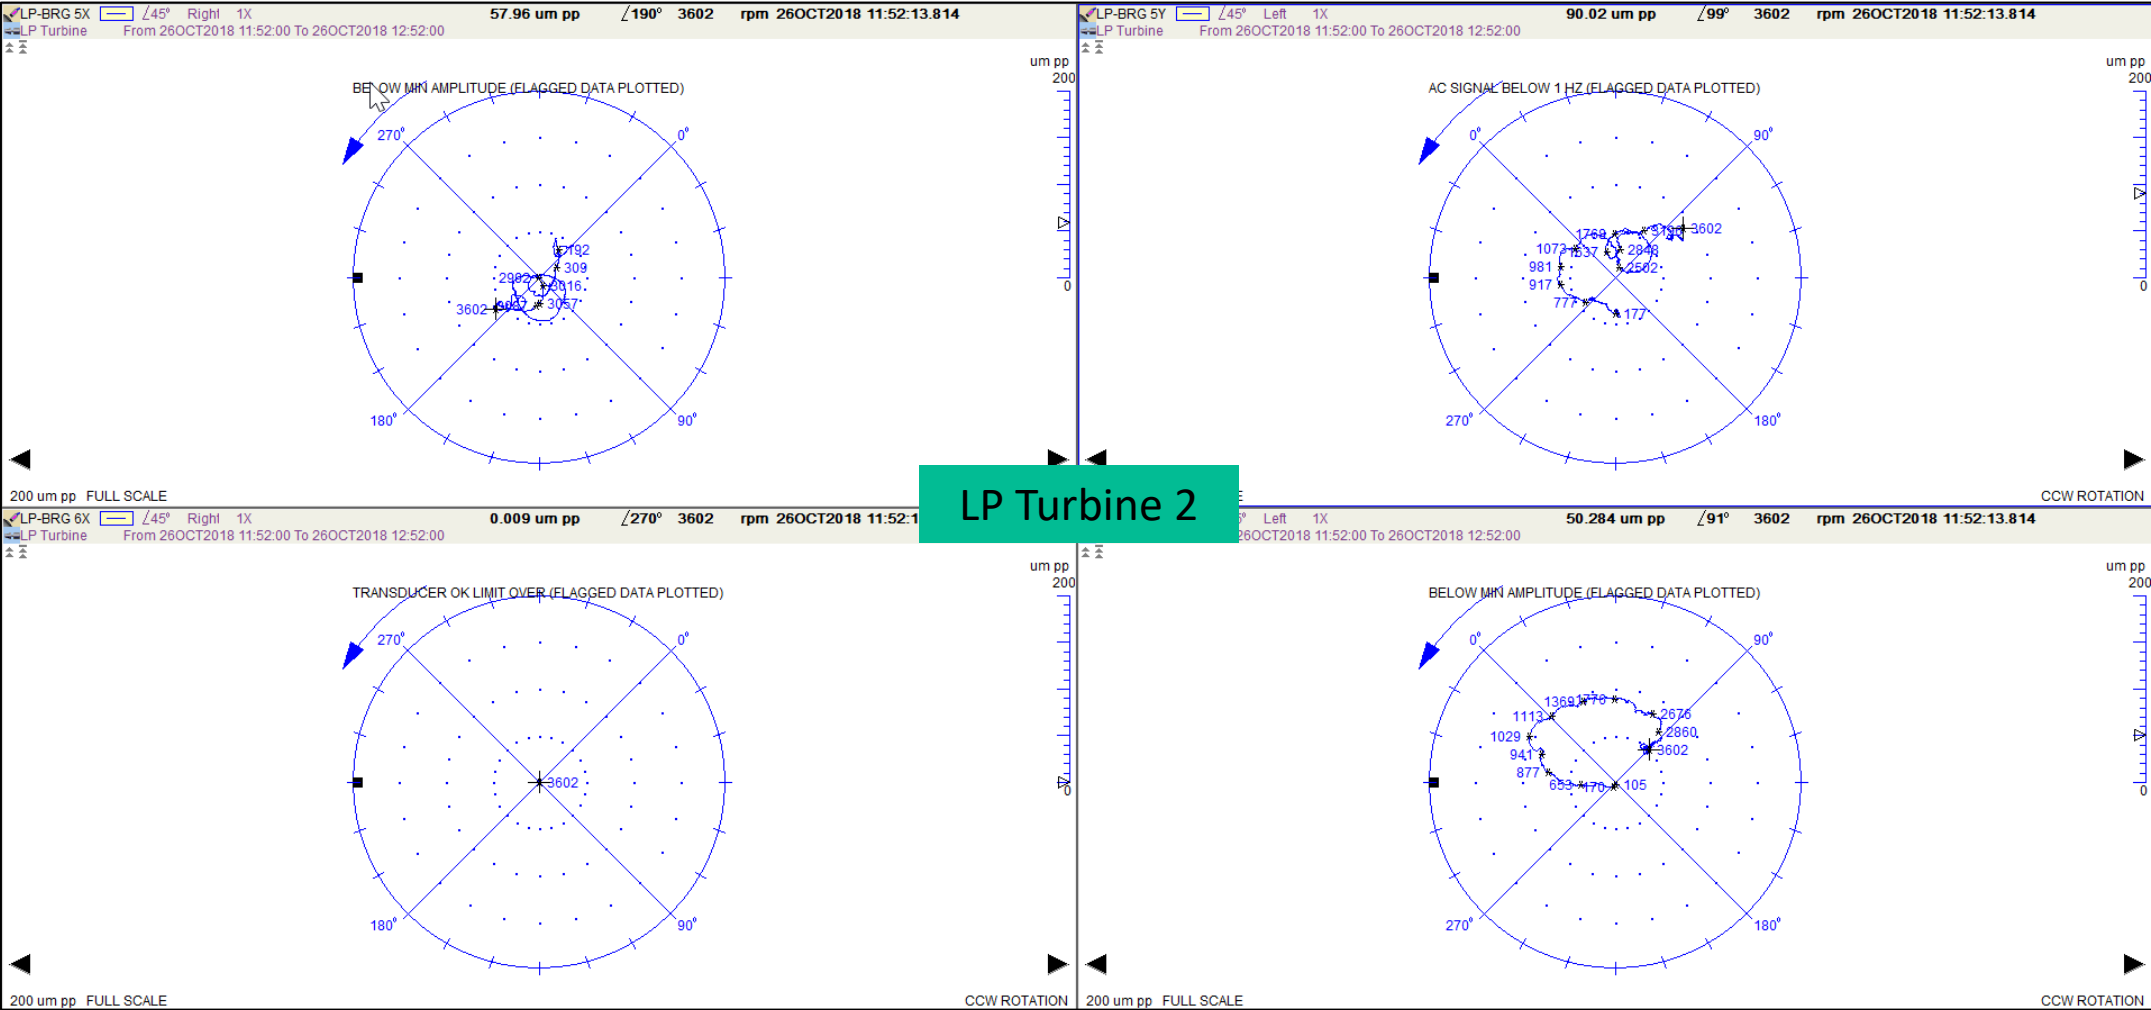
No evidence of elevated critical speed amplitude due to unbalance on the LP Rotor

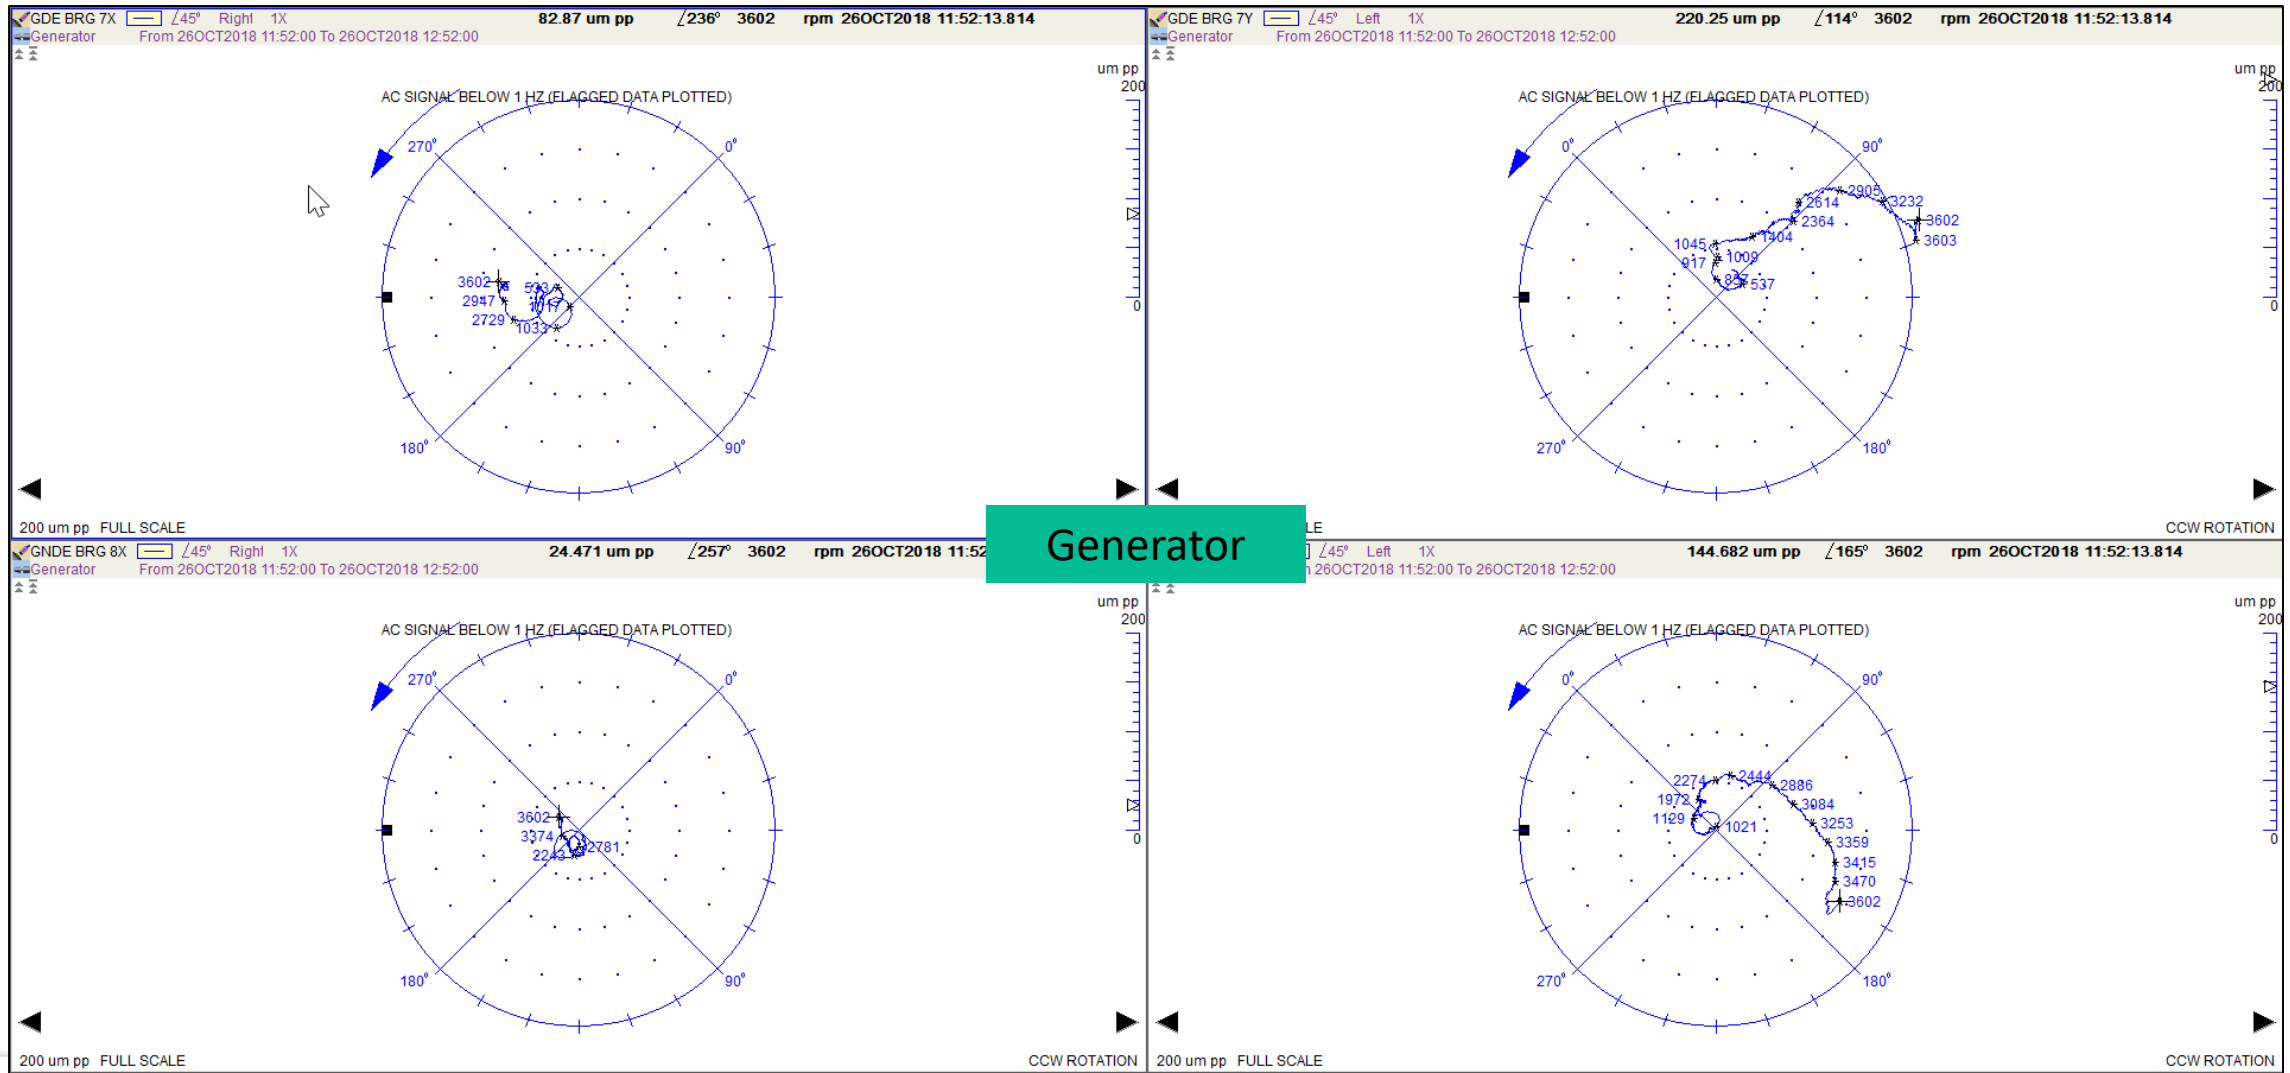
No evidence of unbalance, but symptom of rotor running close to the second critical speed

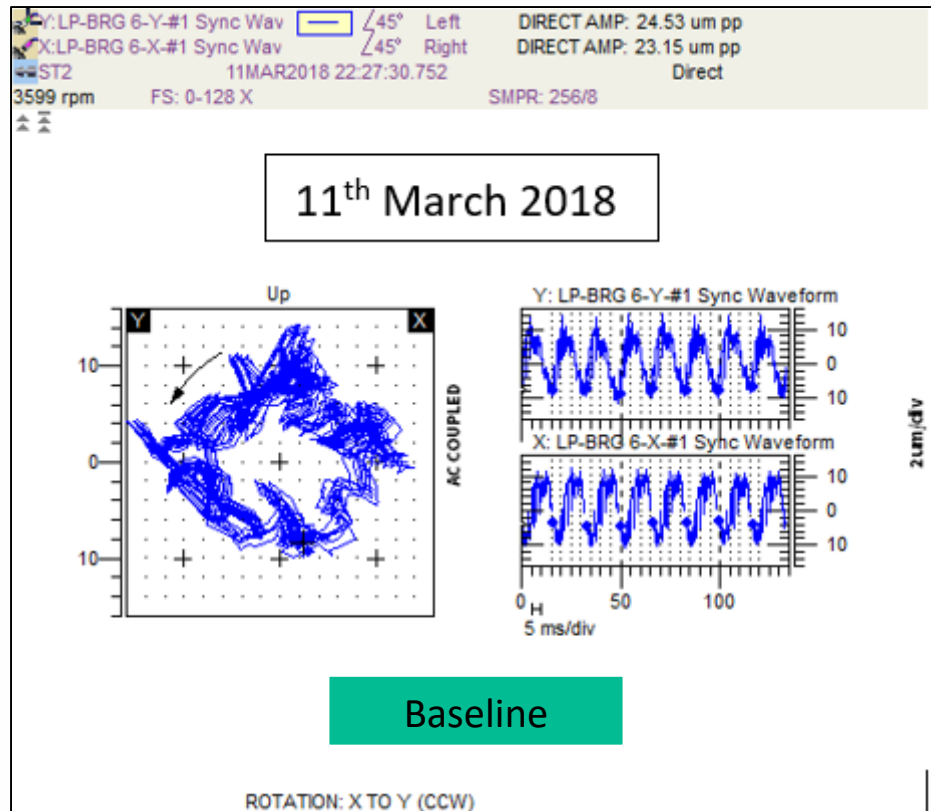
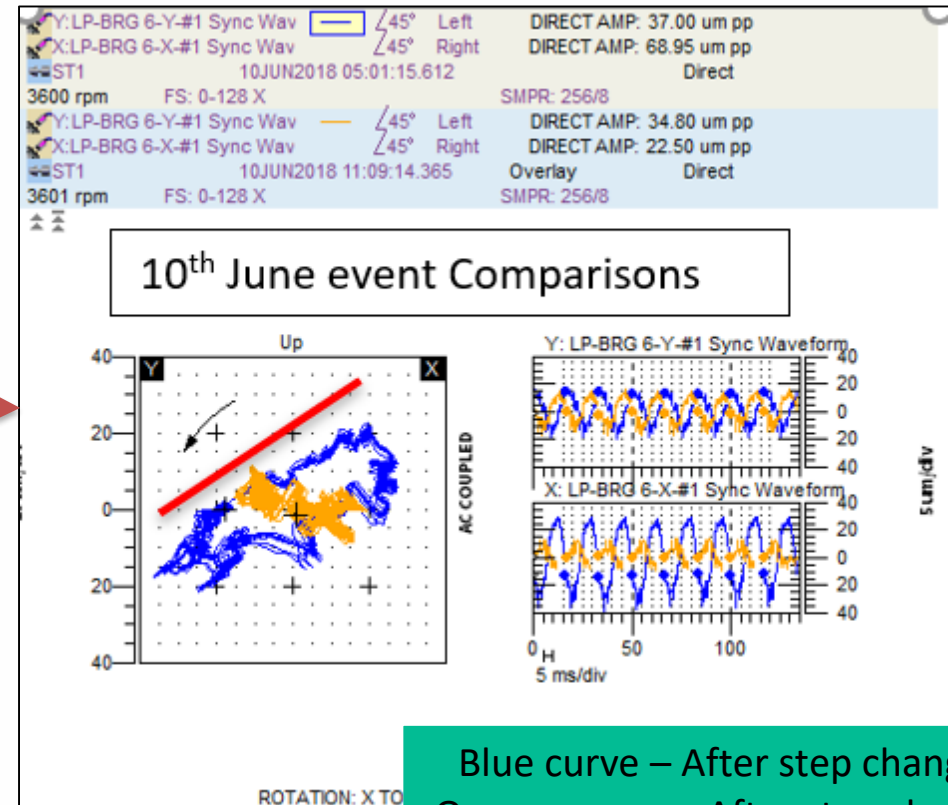
Comparison of Direct Orbits at Bearing 6 for different periods step changes

Orbit shape changed - highly elliptical on Brg#6

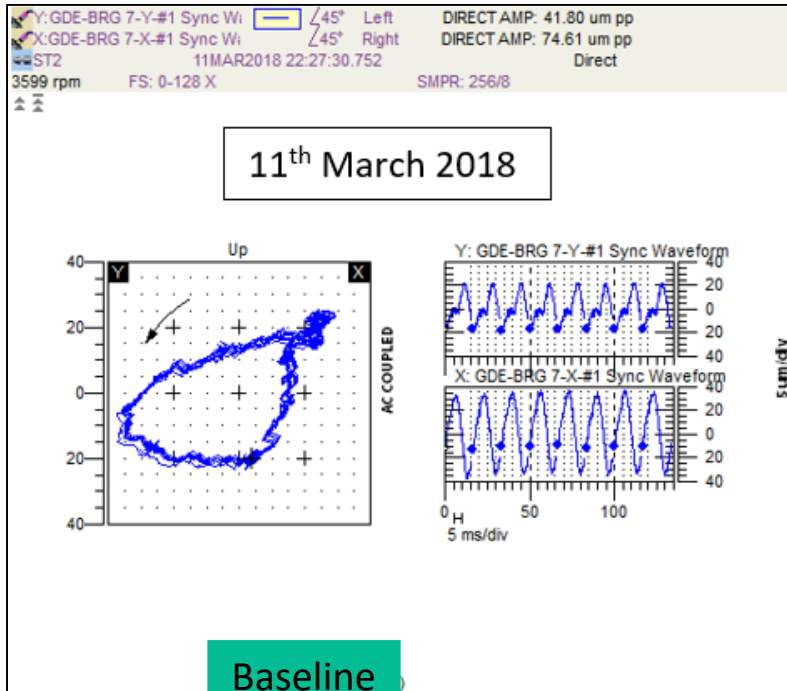
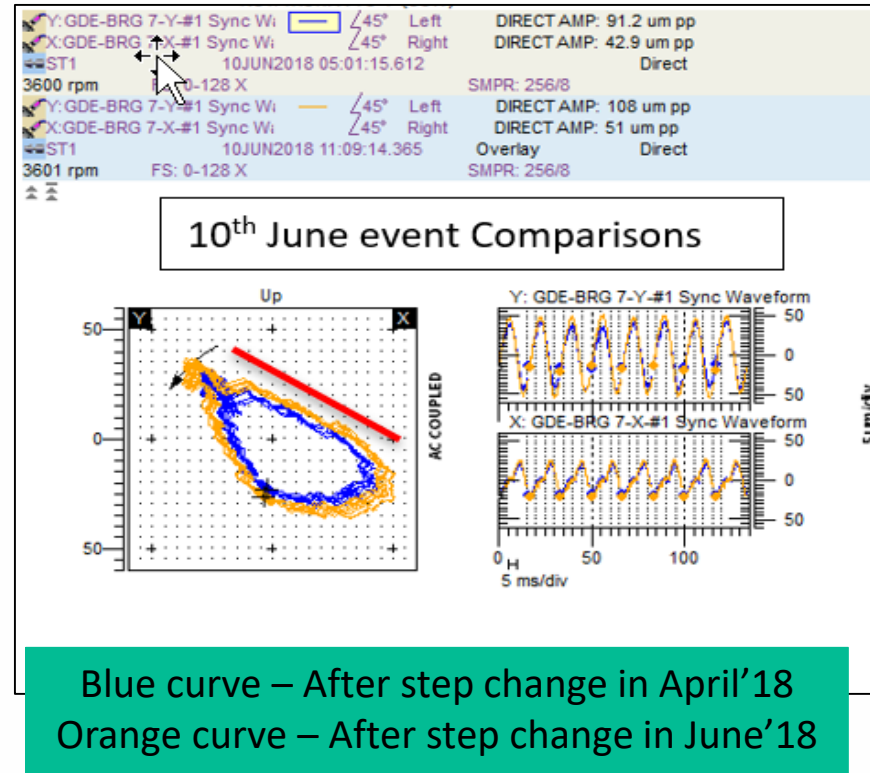
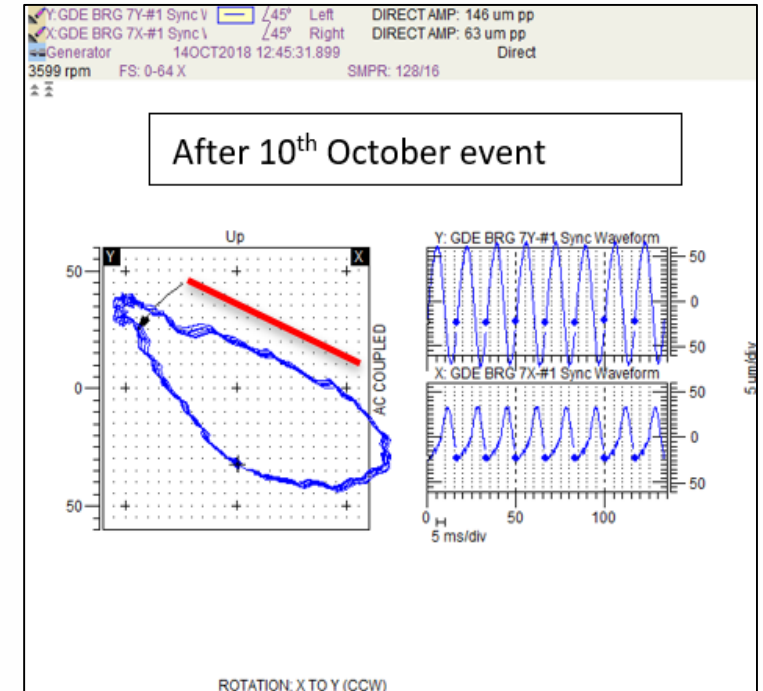
Comparison of Direct Orbits at Bearing#7 for different periods/ step changes

Preload condition changing every step change on Brg#7, also vibration amplified on 10th October event with the same shape

- Vibration step changes occurred on the machine train is suspected to be due to Stiffness changes.
- This stiffness change is highly affecting all vibration levels specially the LP2 bearings (5 & 6) and Generator bearings (7 & 8).
- Preload forces are changing every step change specially on both sides of the coupling between the LP2 and Generator.

1. Inspect the coupling bolts for the design Torque tightness values.
2. Overall inspection for all Machine train supports structure including the foundation, baseplates, soleplates, bearing pedestals, grout condition, etc.
3. Verify that all support leg bolts, base to pedestal bolts, anchor bolts and pedestal hold down bolts are torqued properly.

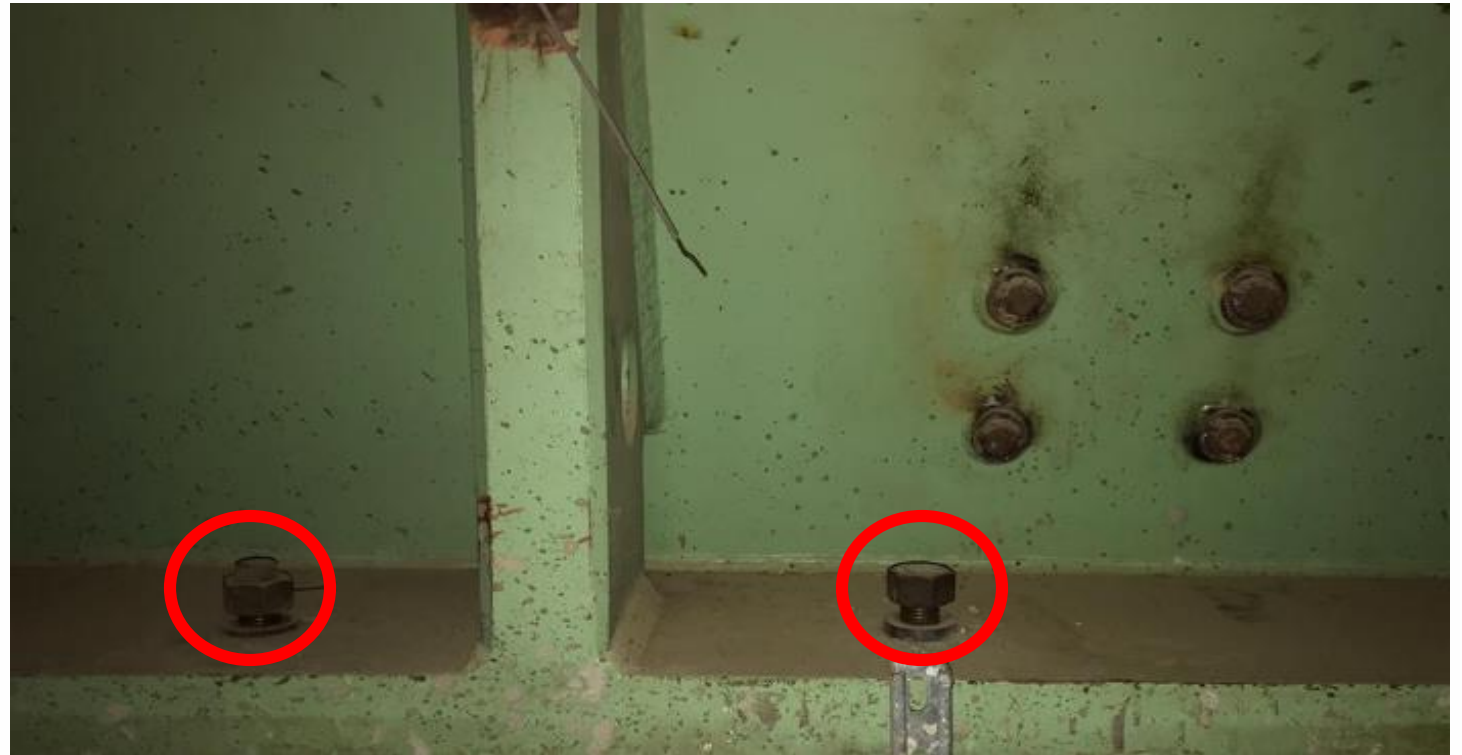
- Inspection of coupling bolts torque/tightness showed no change from the previous outage reading.
- Inspection of the foundation bolts on LP1 and LP2 revealed looseness on all the foundation bolts without tack welds. The bolts were tightened and welded with 0.1 mm clearance as per design specification.
- During the inspection, LP Turbines bearings pedestal bolts found loose without tack welds, so retightening applied according to the OEM recommendations.

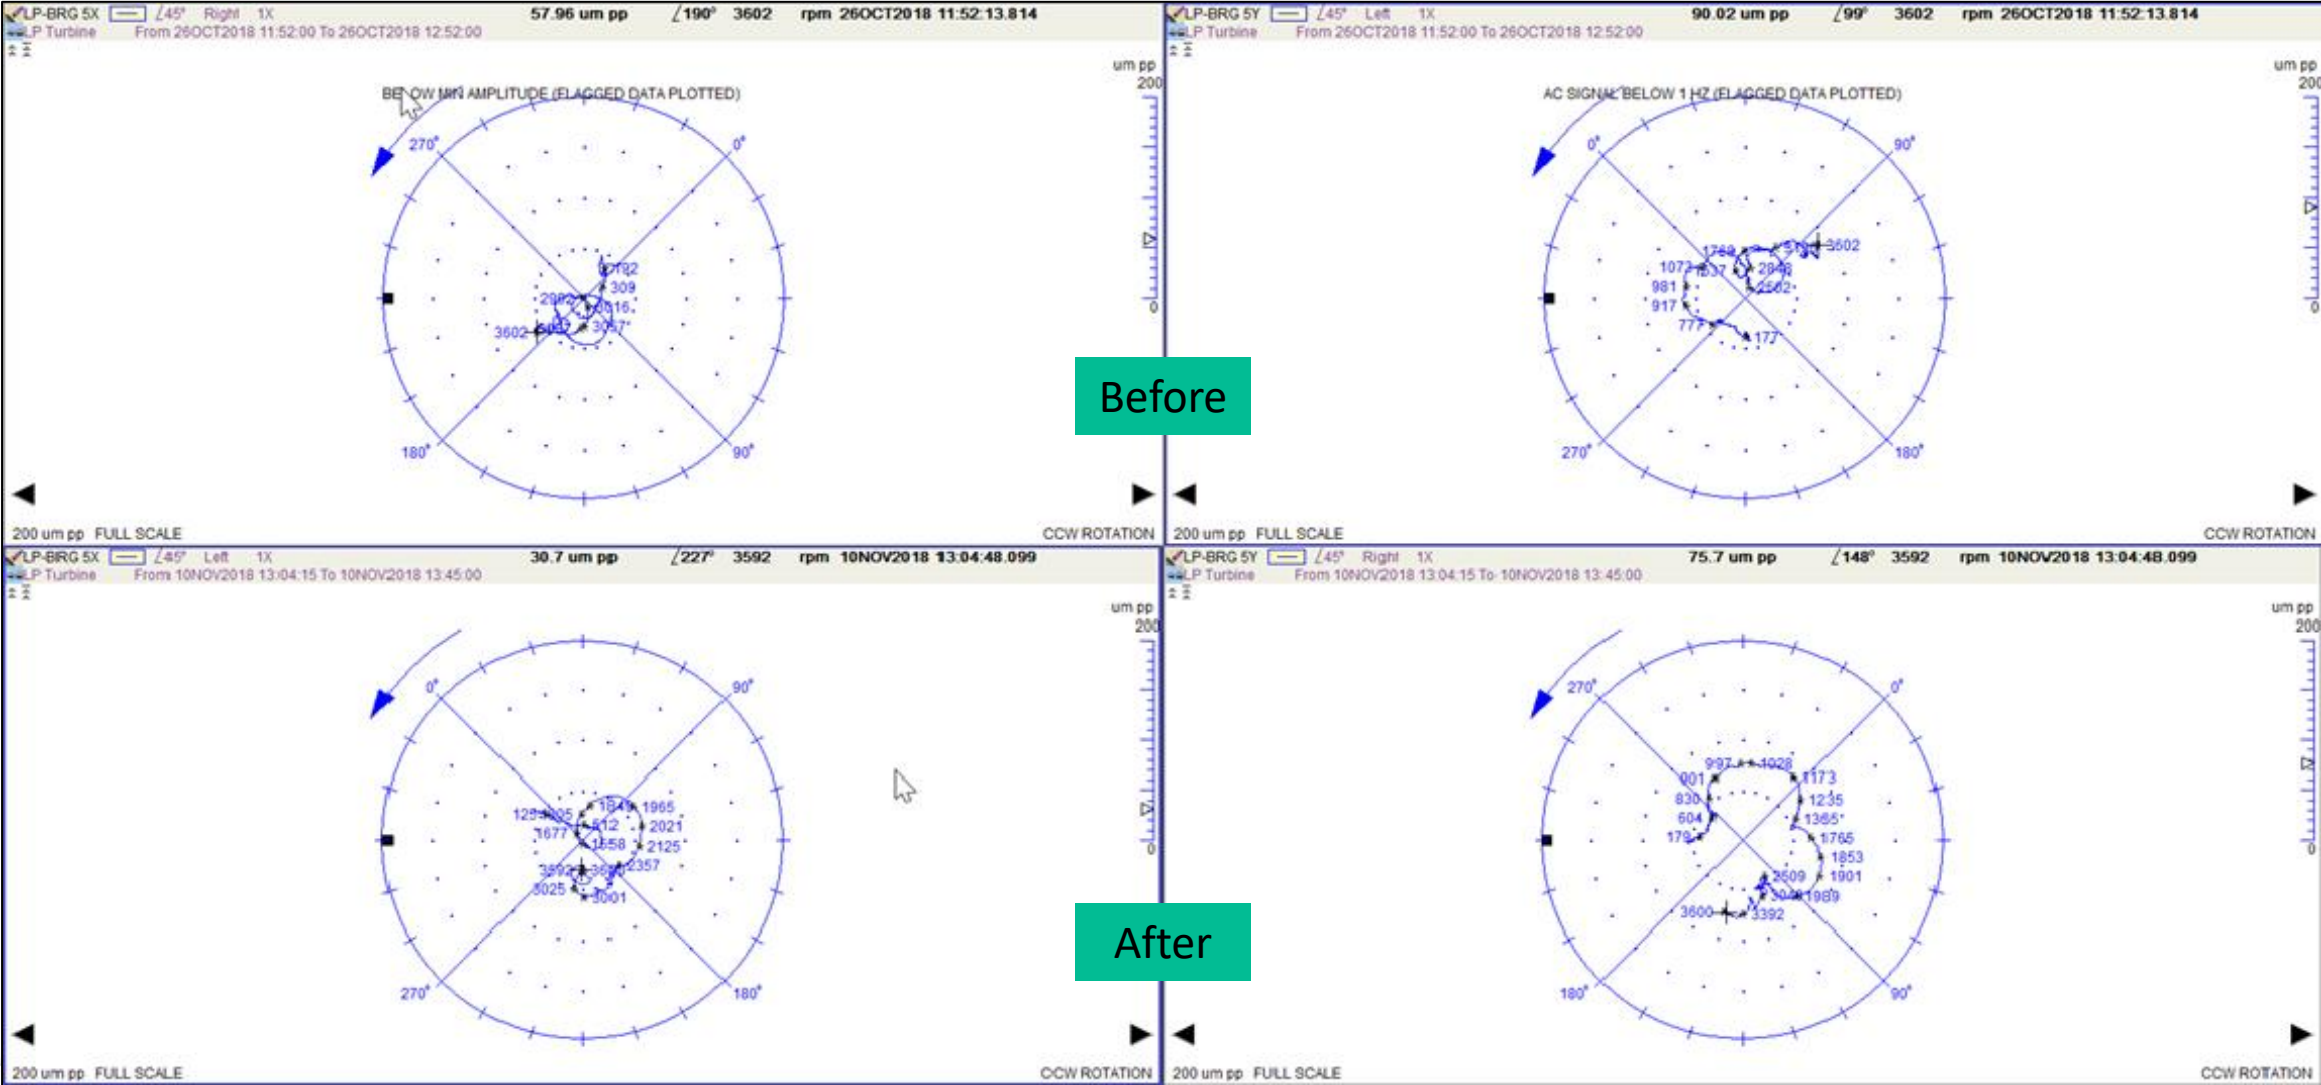
Bearing#5 Polar Plots During Shutdown Mode (Before and After Maintenance)
