ASIA **TURBOMACHINERY** & **PUMP** SYMPOSIUM
22-26 FEBRUARY 2021 | NOW VIRTUAL!

Resolution Of Vibration Step Changes On A Steam Turbine Generator

Bently Nevada, Baker Hughes

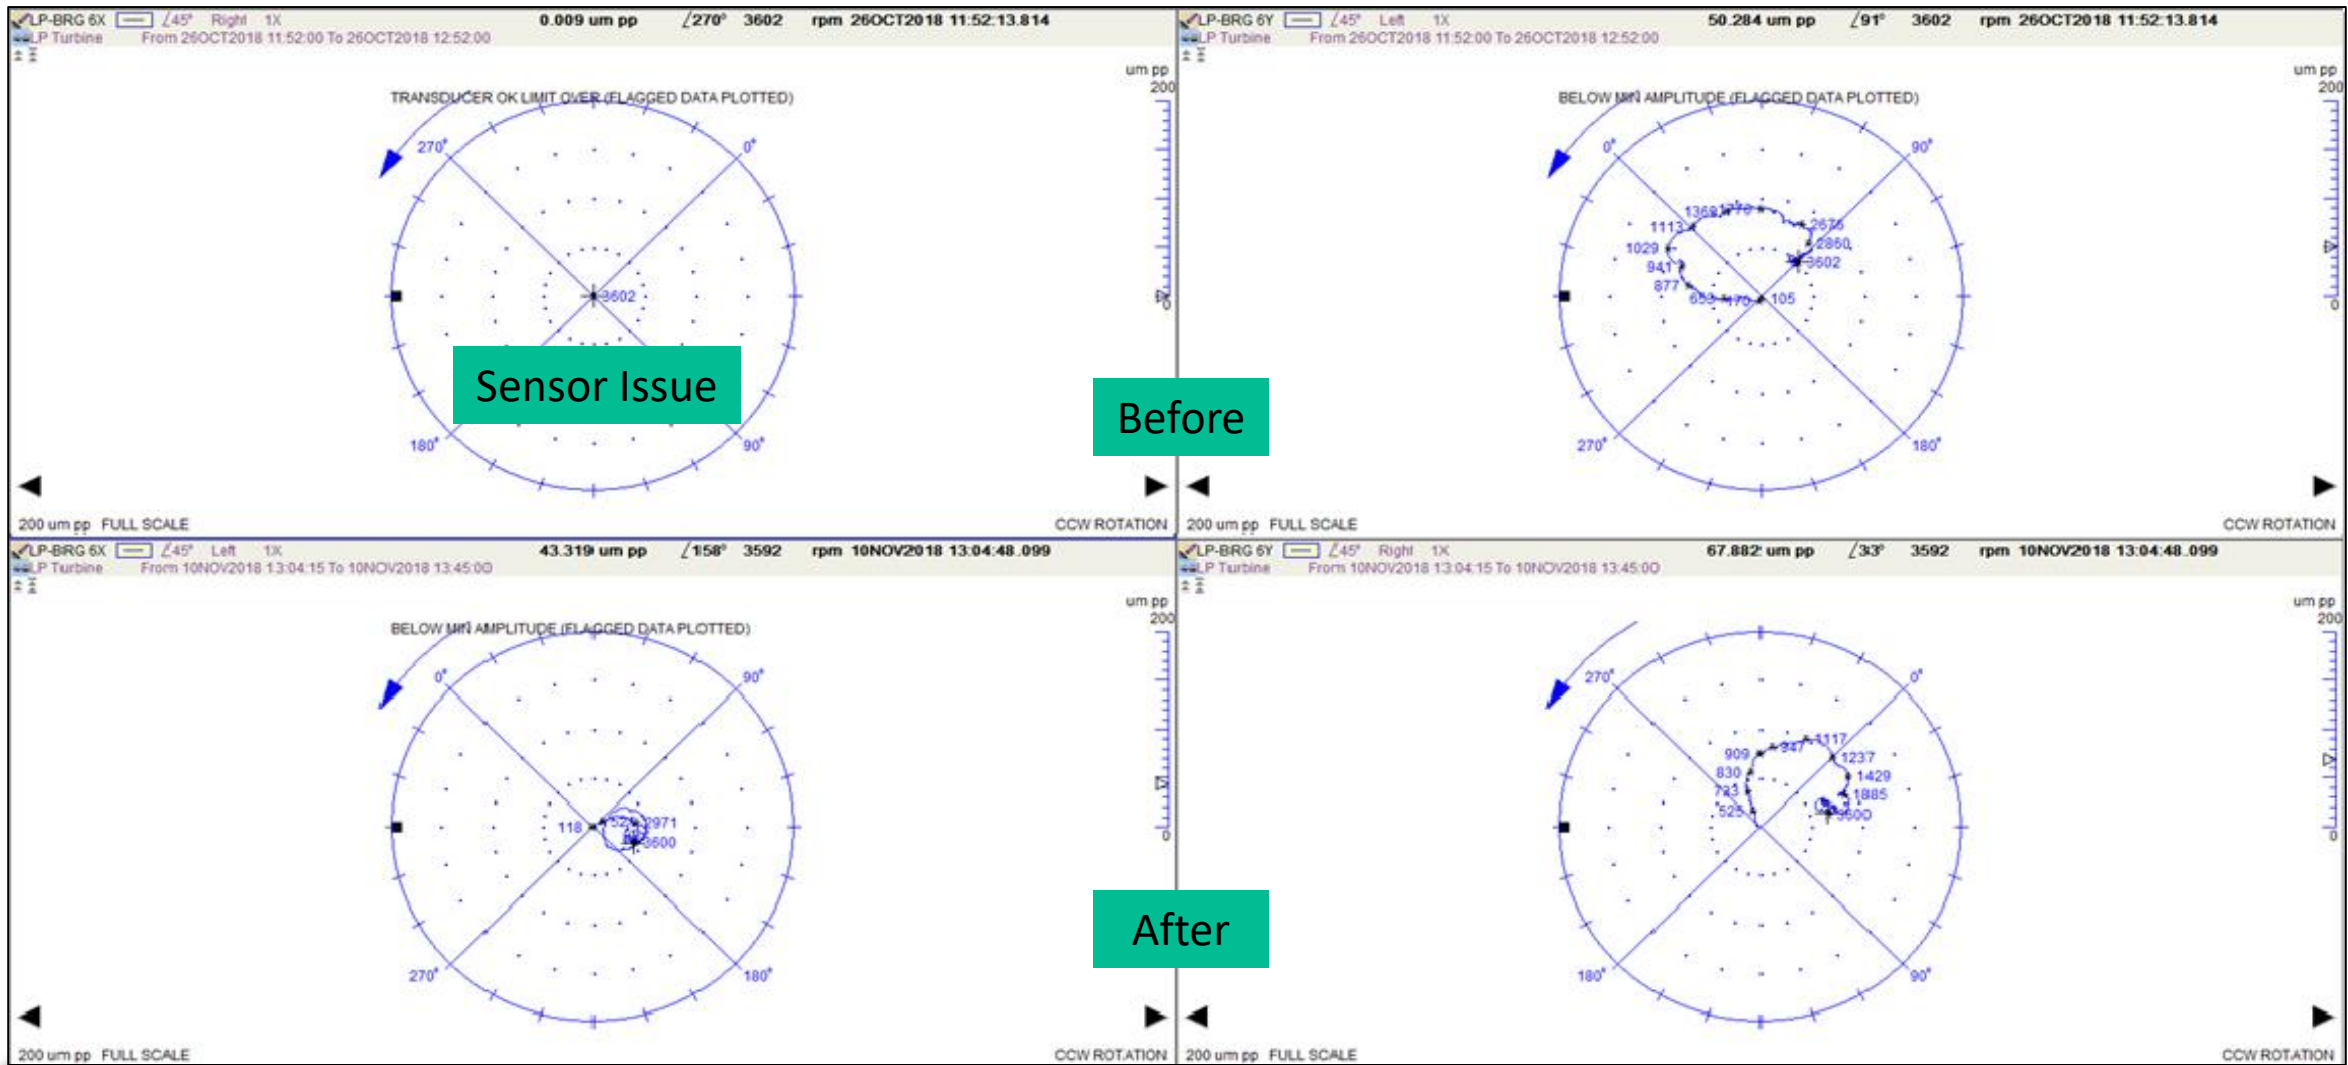
Bearing#6 Polar Plots during Shutdown Mode (Before and After Maintenance)

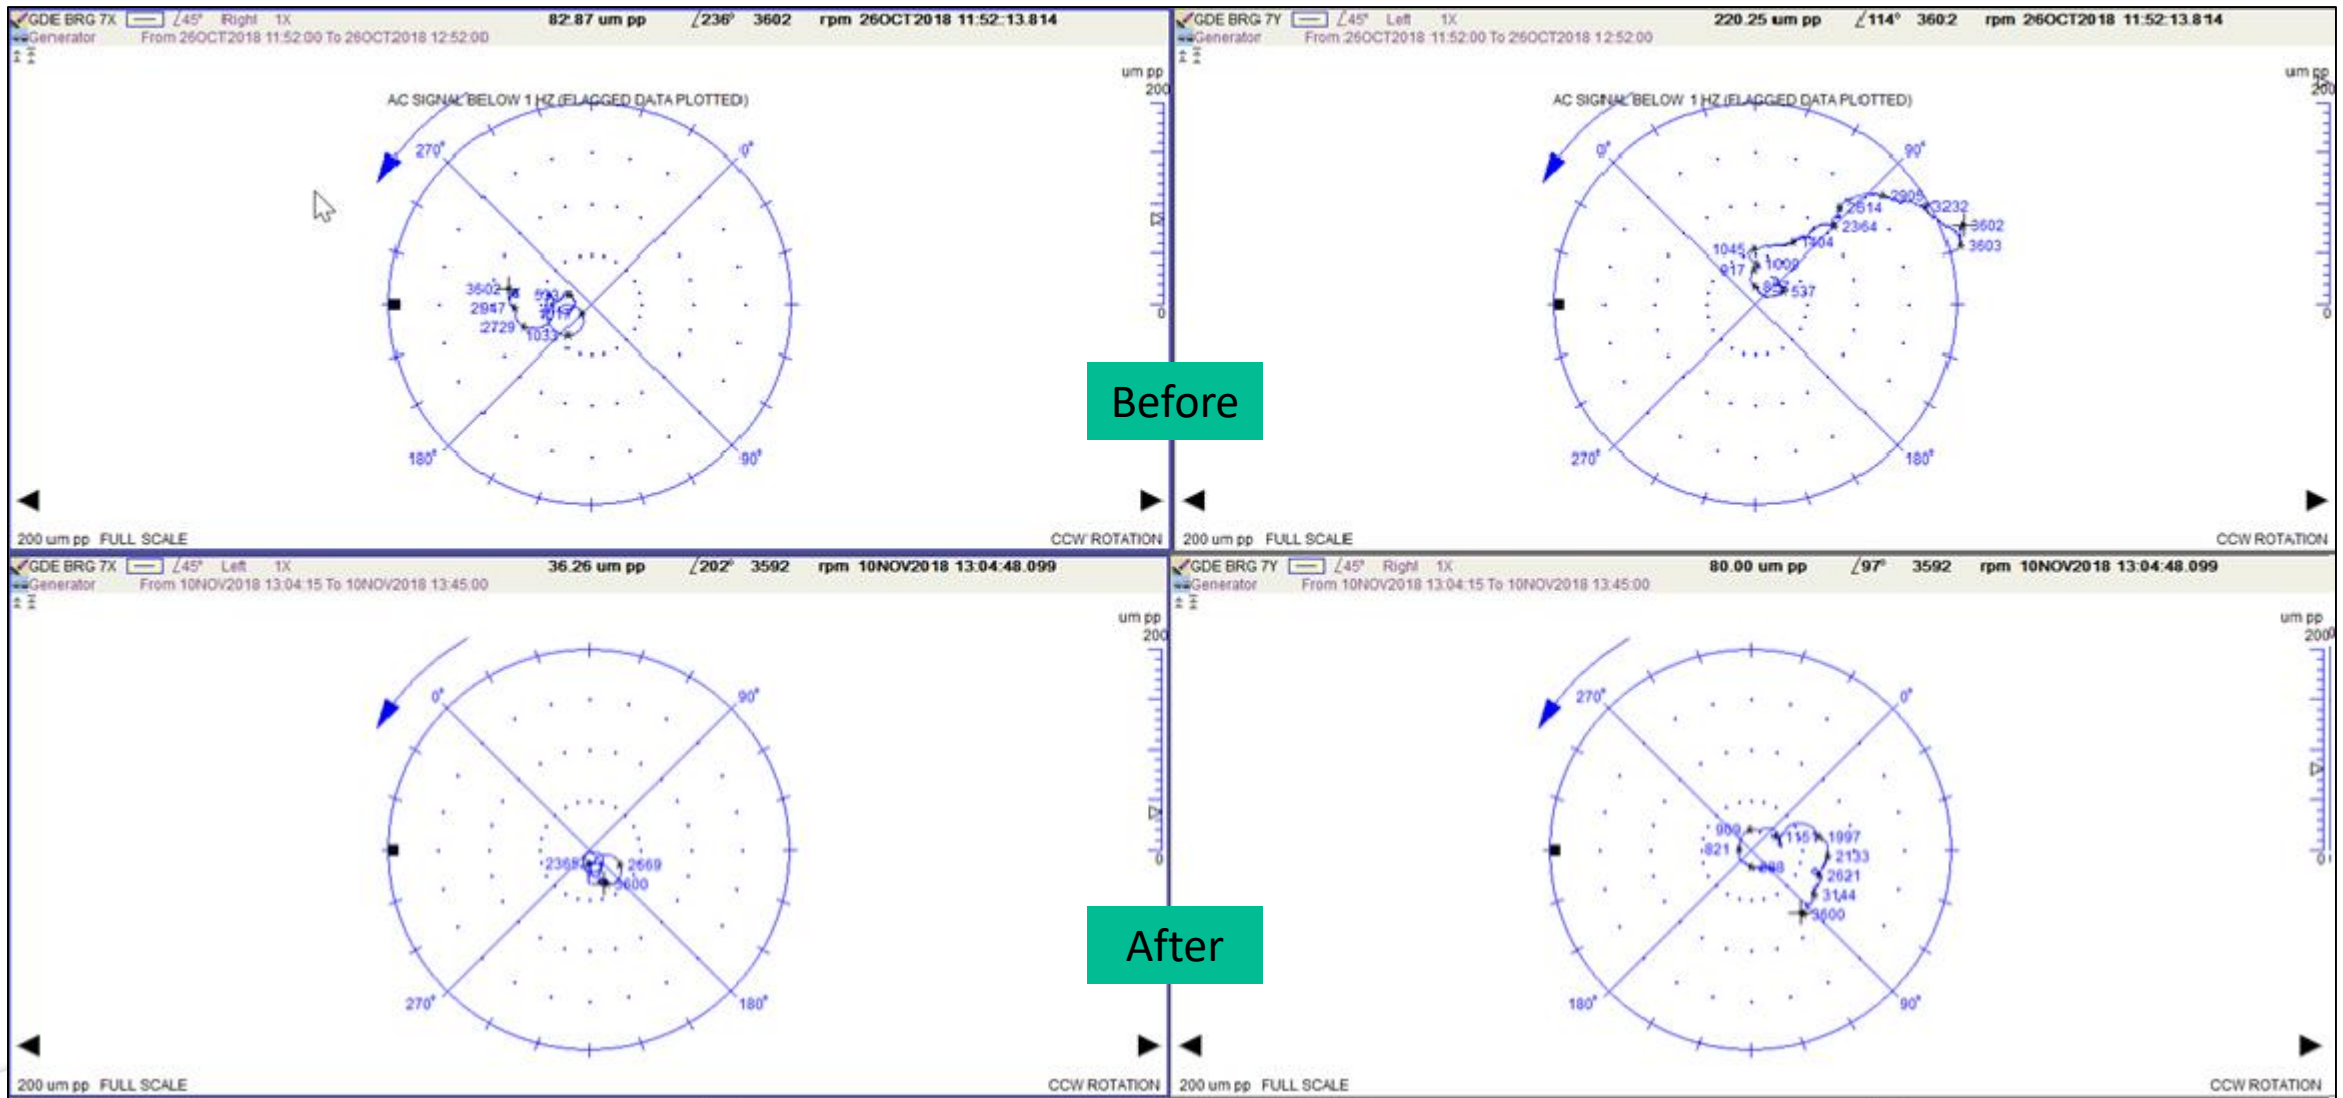
Bearing#7 Polar Plots during Shutdown (Before and After Maintenance)

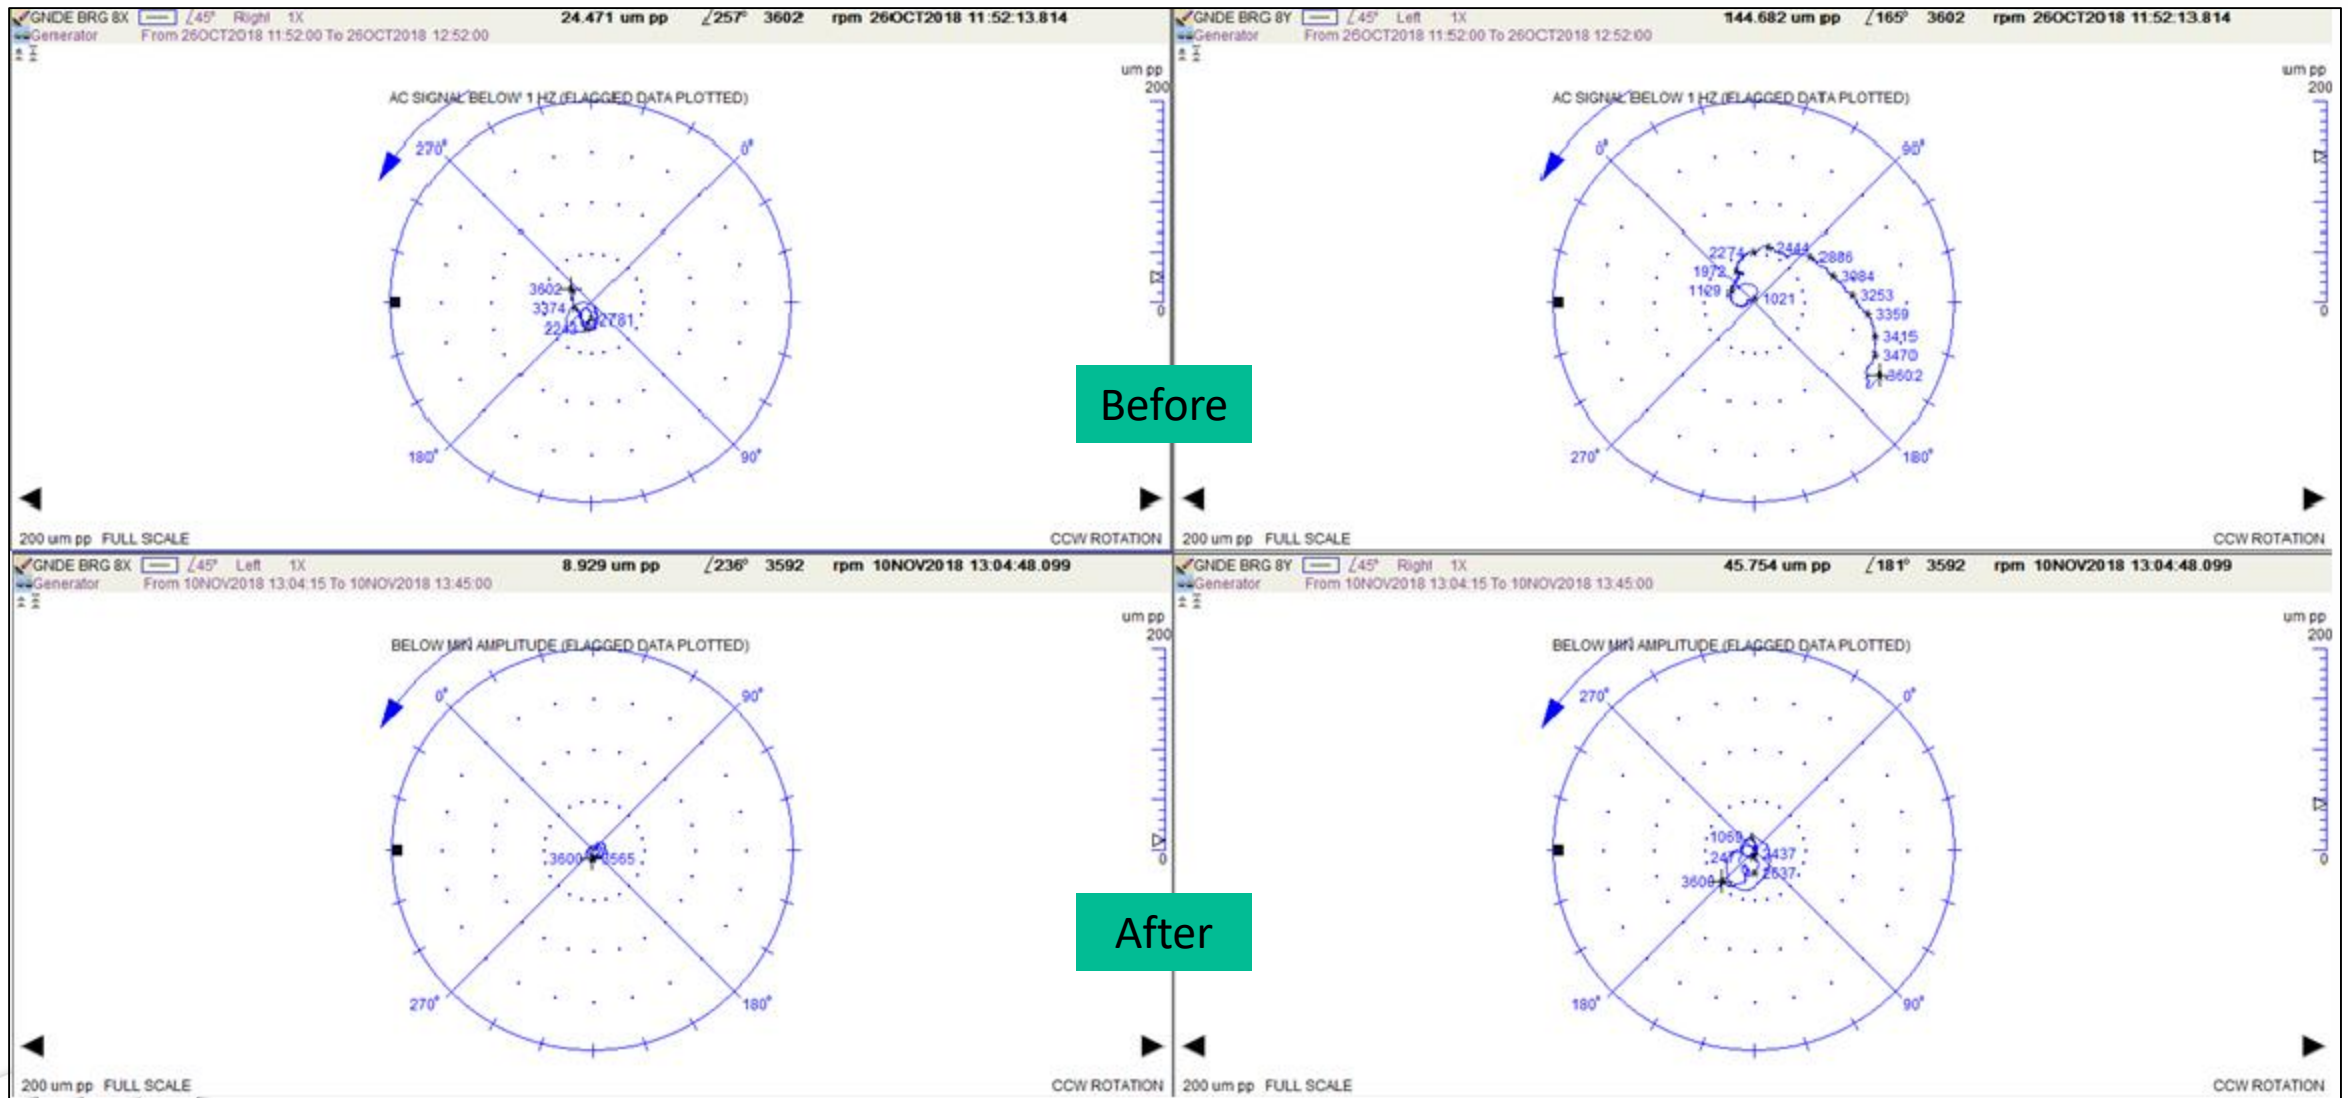
Bearing#8 Polar Plots during Shutdown (Before and After Maintenance)

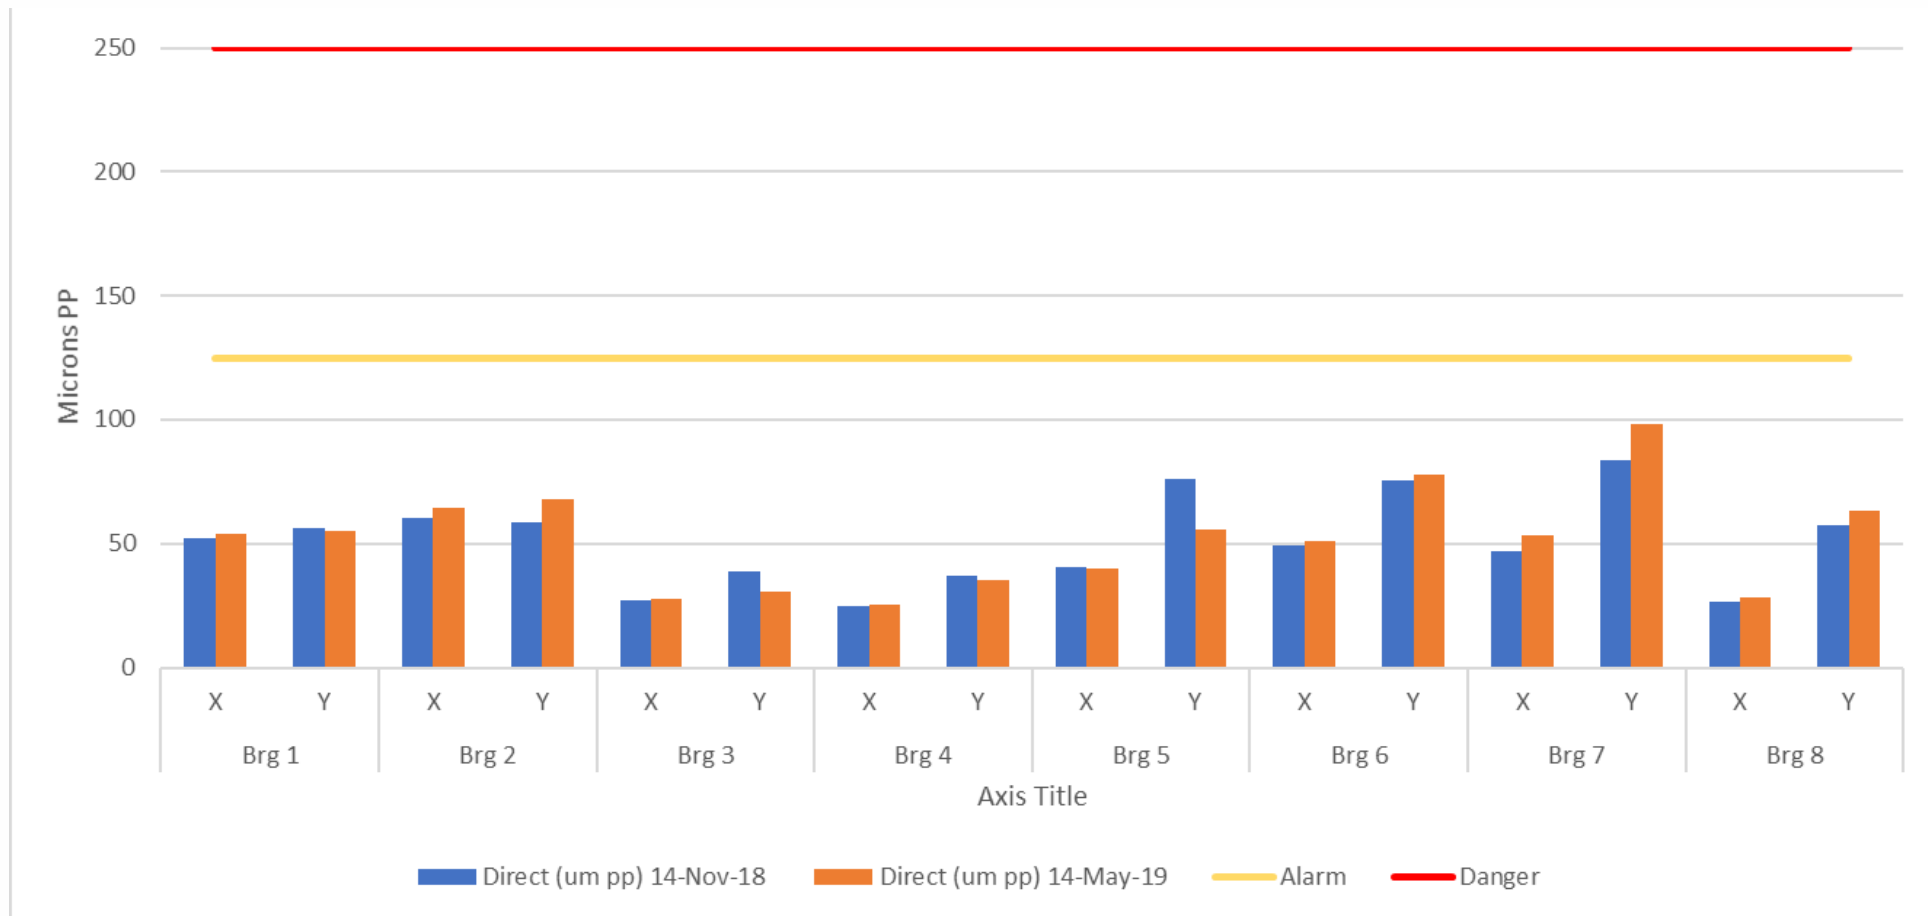
Later on, after 6 months of continuous operation, vibration data recorded showed comparable readings (no change).

Direct Vibration Levels Comparison at Base Load Condition

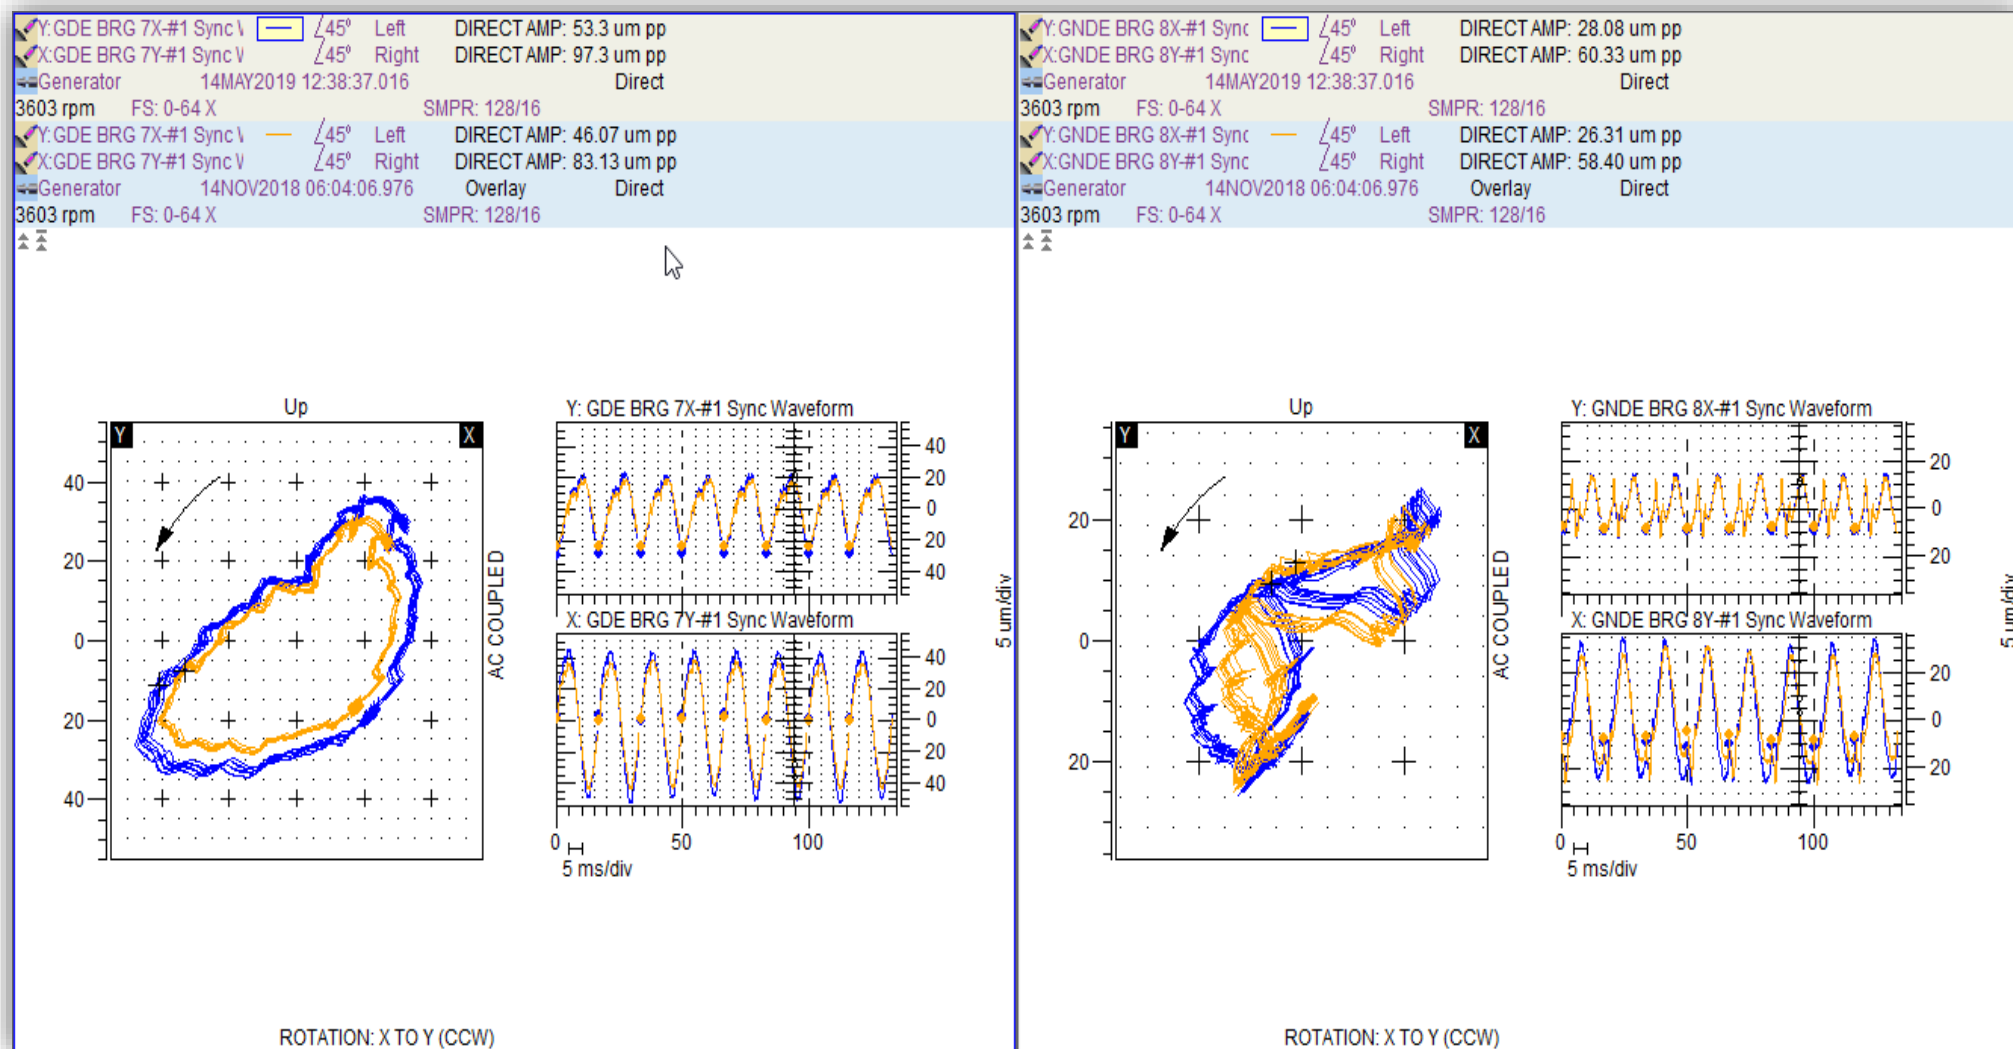
Generator Orbit Plot Comparison between November 2018 (Orange) & May 2019 (Blue)

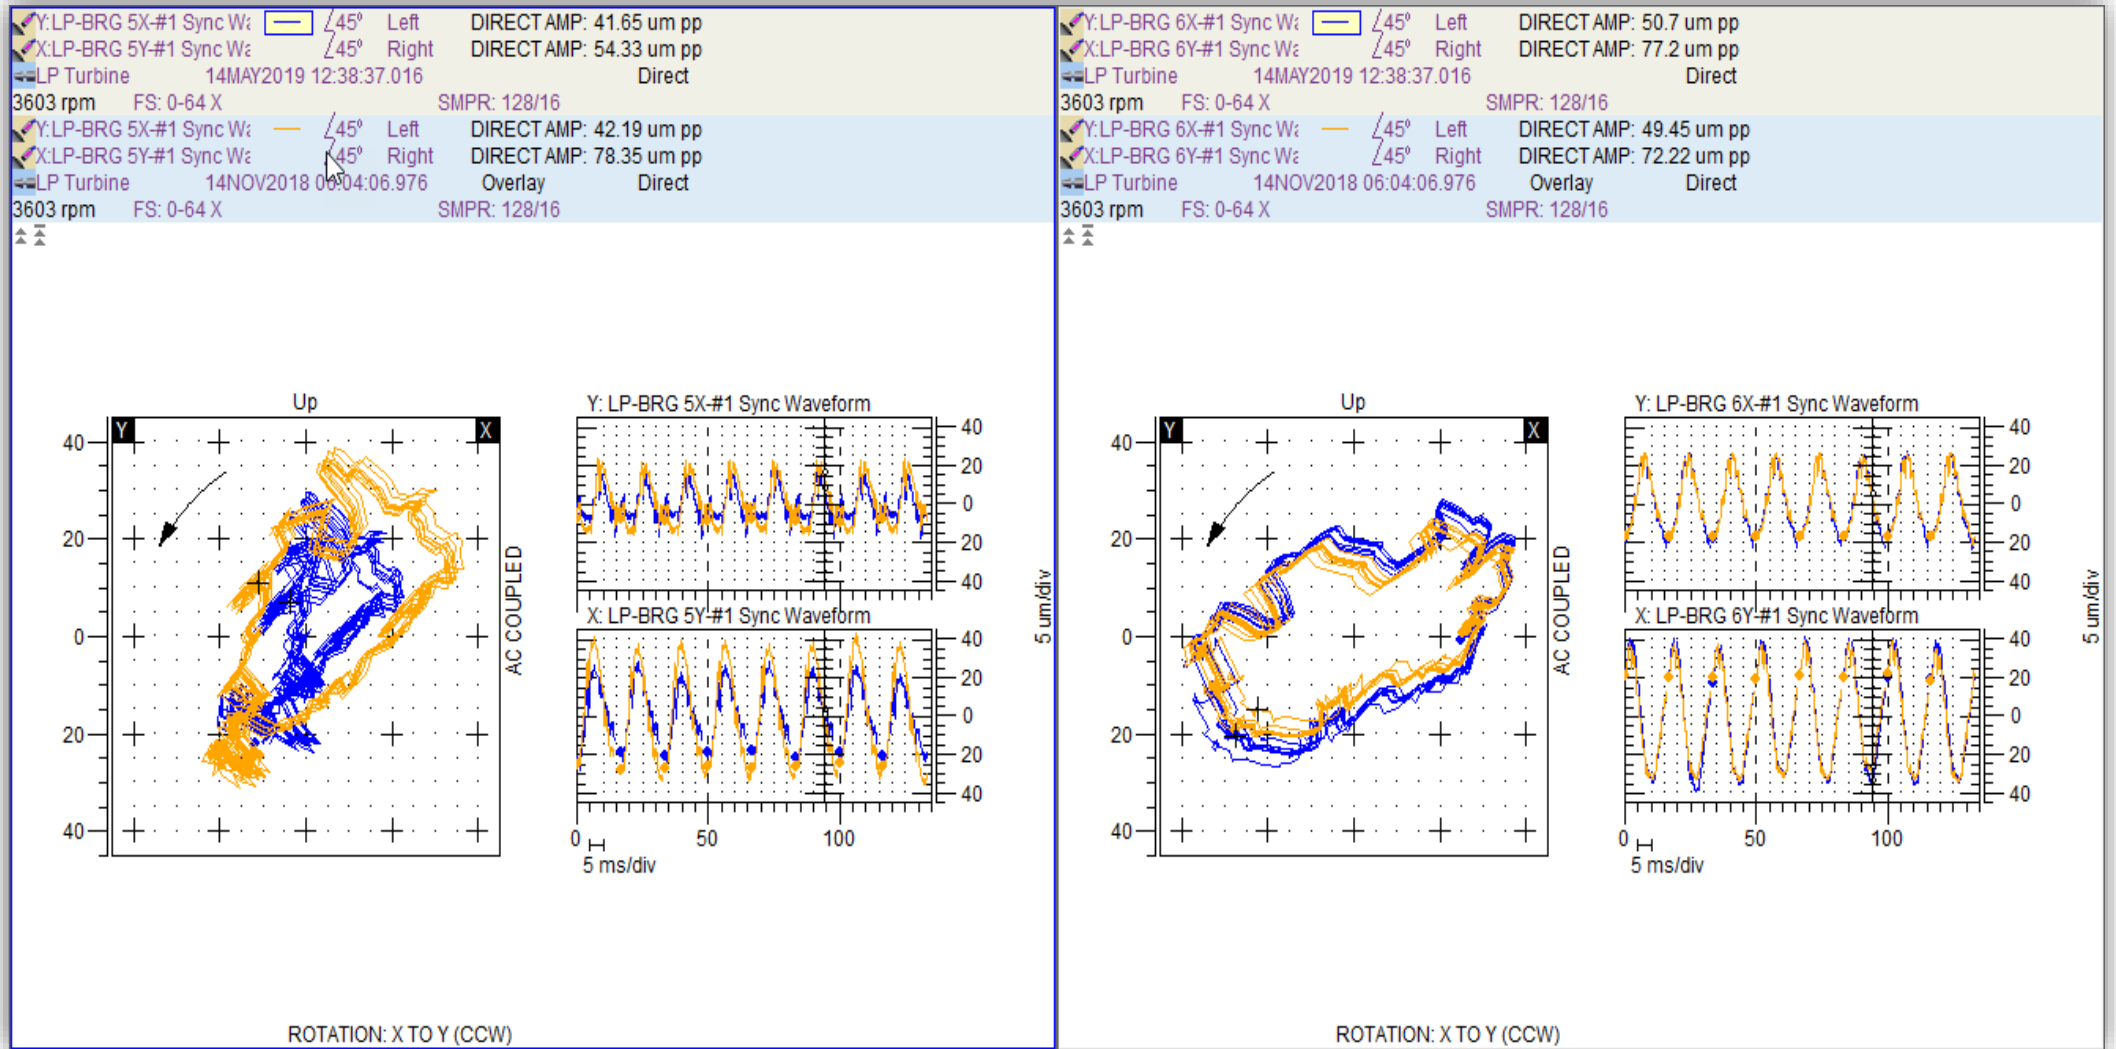
LPB Turbine Orbit Plot Comparison between November 2018 (Orange) & May 2019 (Blue)
