ASIA **TURBOMACHINERY** & **PUMP** SYMPOSIUM
APRIL 2020 | KUALA LUMPUR CONVENTION CENTRE

Online Mitigation of Gearbox Bearing High Temperature due to Oil Varnishing

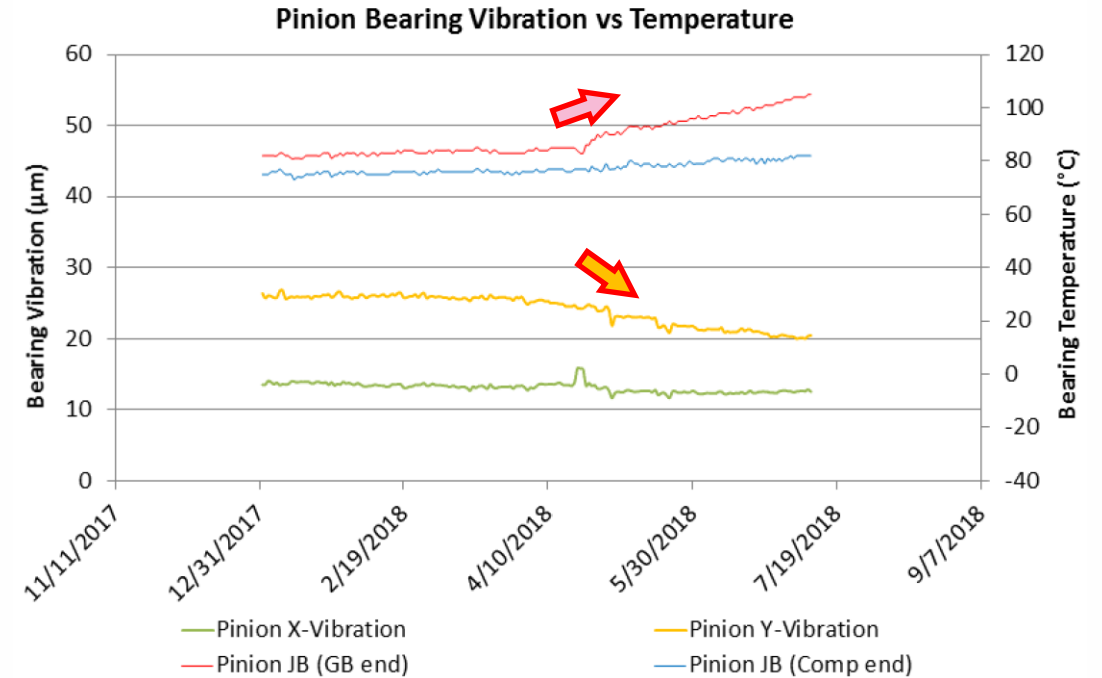
Two occasions of one pinion bearing temperature excursion beyond 100°C.

Pinion bearing temperature from 80°C to 105°C over 3 months.

However the vibration of the pinion bearing in X-direction decreased

Other bearing vibration and temperature in motor and compressor remain unchanged.

Presence of oil varnish in the past compressor overhaul report in 2007

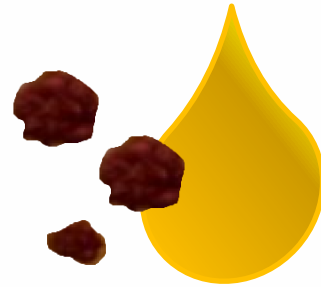
High MPC >40
(Critical)

Deplete of
ZDDP & Phenols

>290,000 particles
(5 to 15 μ m)

Soft contaminants
agglomeration
0.08 μ m

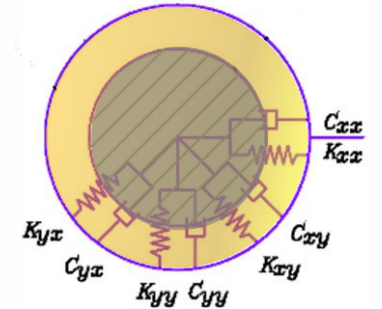
Reduce bearing
clearance

Increase
bearing stiffness

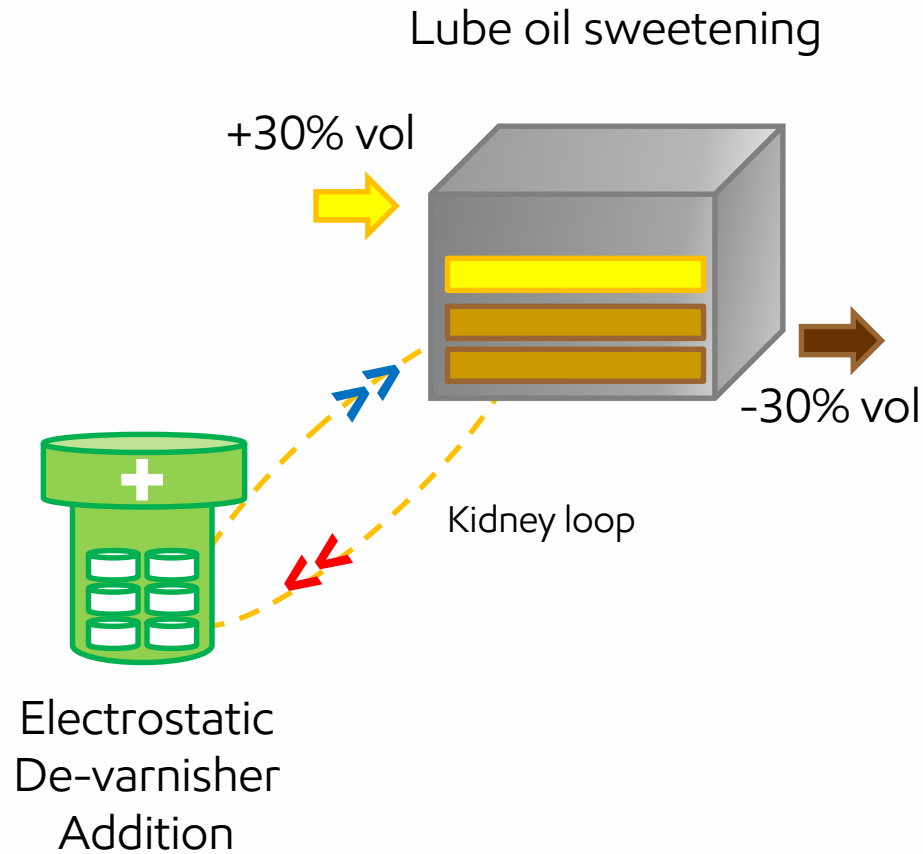
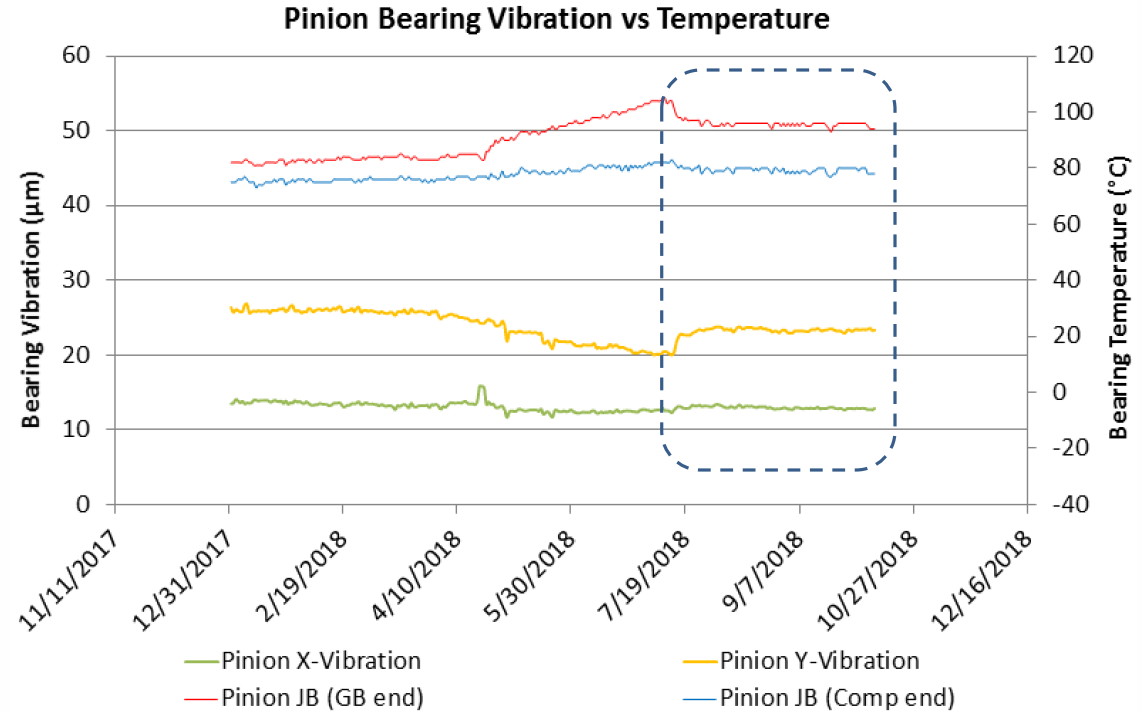
Temporary Mitigation

Effect of implementing temporary mitigation

- Recovering of pinion bearing vibration close to normal level
- Reduced in pinion bearing temperature to 92°C
- Particle counts (5 to $15\mu\text{m}$) reduced by $\sim 60\%$
- MPC remained high >40

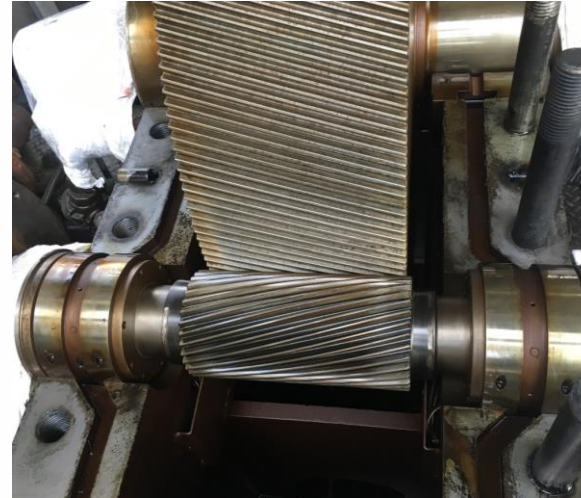
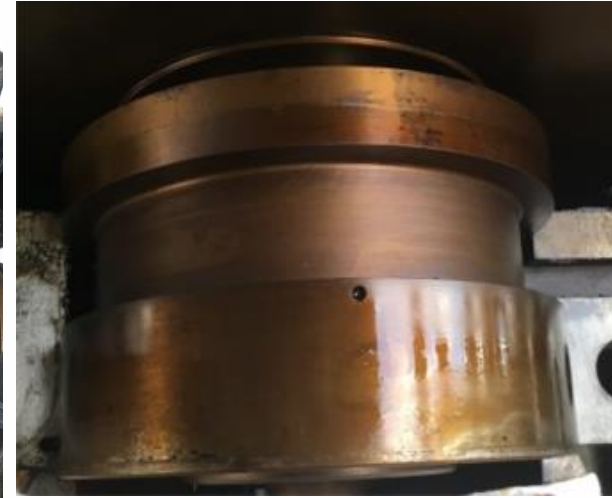
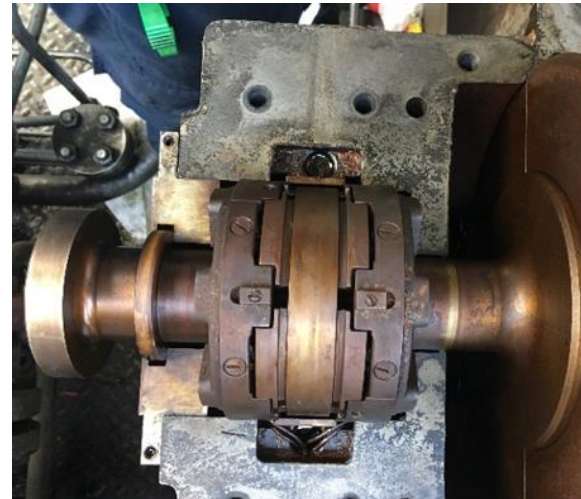
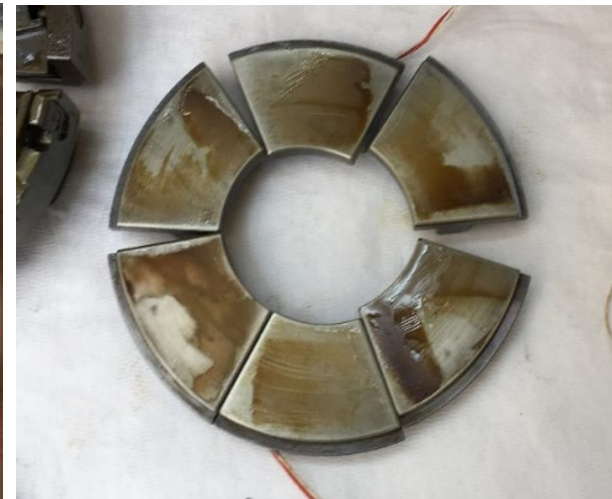
Visually all the gear bearings were heavily coated with lube oil varnish and buttons on the tilting pad bearings were excessively worn out.

Bearings were found difficult to be removed during disassembly.

A thorough lube oil flushing plan was executed during the overhaul to flush the entire lube oil system before topping up with new lube oil.

The gearbox bearings have been running with stable vibration and temperature for five months after overhaul. Lube oil MPC index <10.
