Test set-up contribution into a Generator Mounted Epicyclic Gear mechanical running test performance

Authors: Nick Glover, Gaspare Maragioglio

Scope of this Case Study: Highlight the importance of system integration analysis

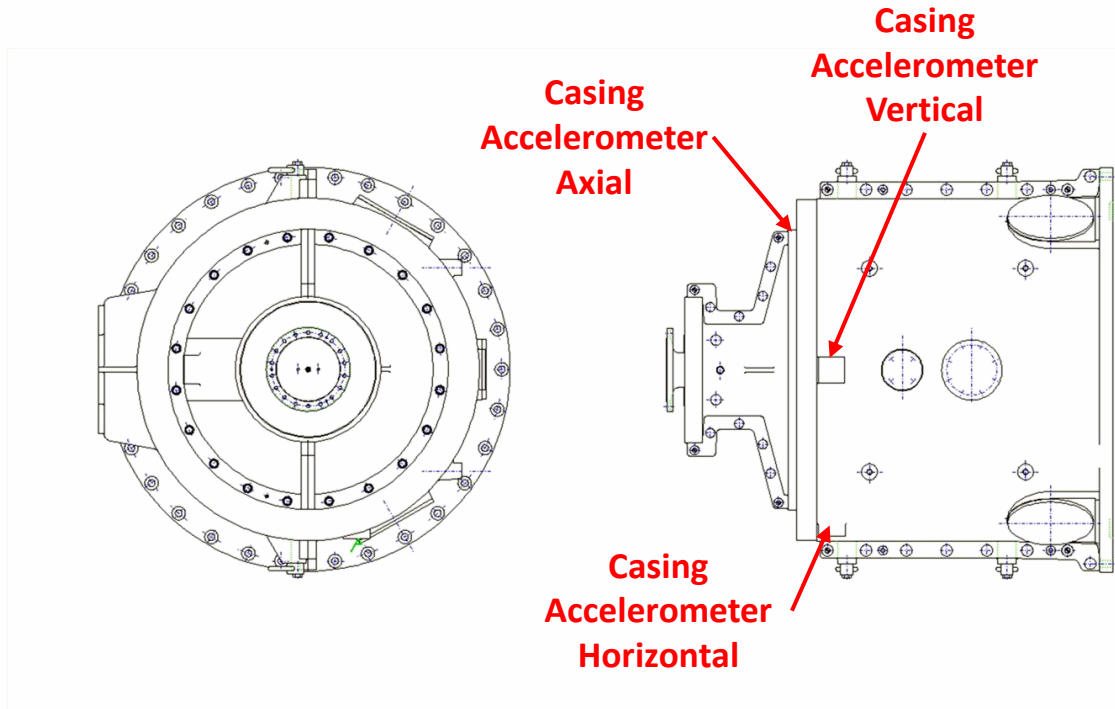
Gear casing vibrations over MRT acceptance criteria defined by test procedure

Casing Vibration Acceleration (g Peak)		Casing Vibration Velocity (mm/sec rms)	
	Measured 95% speed	Acceptance criteria	Measured 95% speed	Acceptance criteria
HS V	1.4	2.5	3.9	1.8
HS A	1.2	2.5	2.8	1.8
HS H	1.0	2.5	11.1	1.8

Three accelerometers are installed on the gear casing to measure the casing vibrations in Axial, Vertical and Horizontal direction

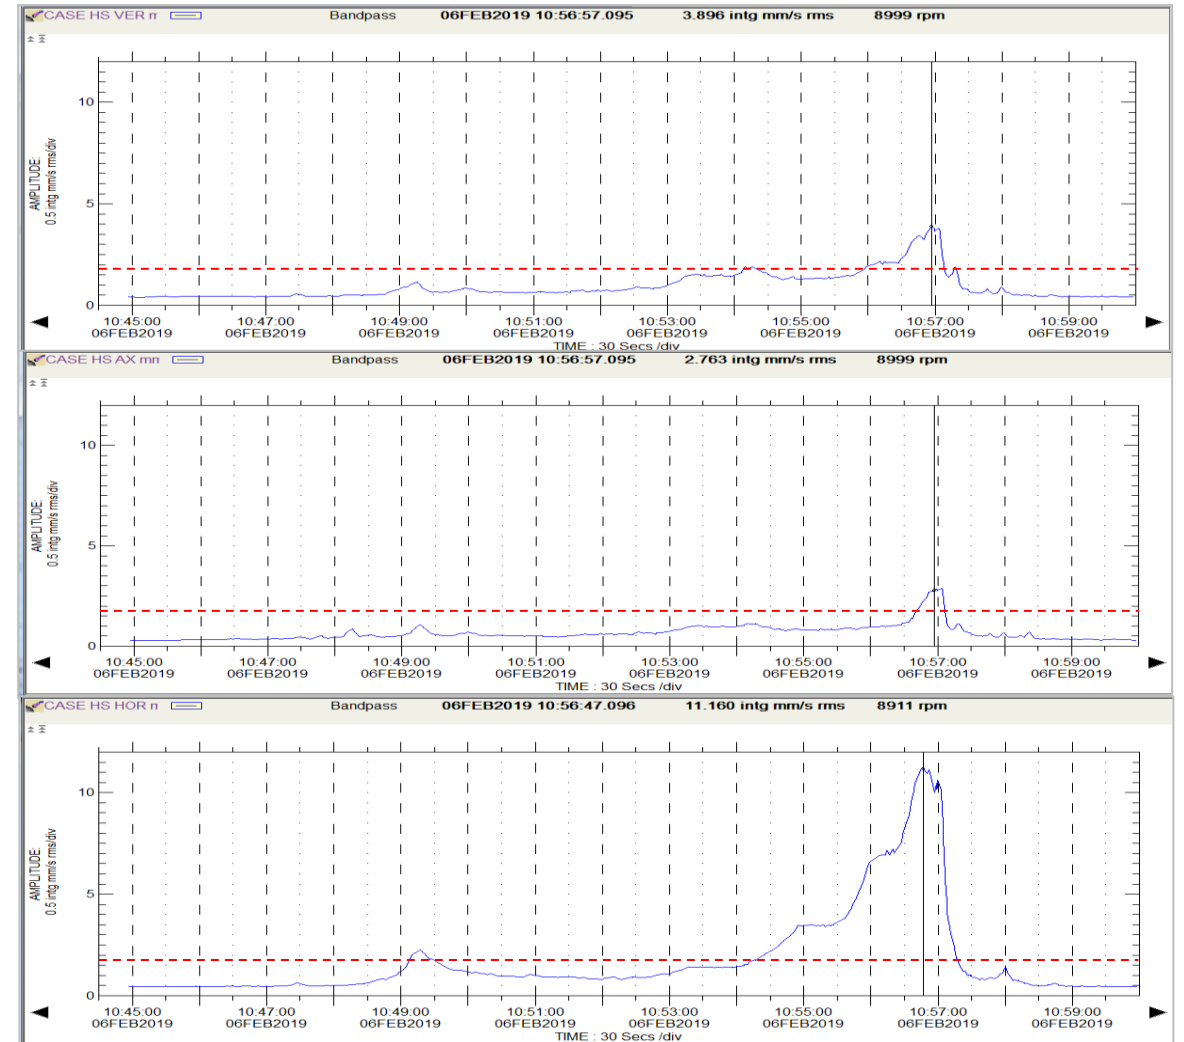
During first internal mechanical running test, gear casing vibrations observed over the acceptance criteria @ 95% speed:

HS V → 3.89 mm/sec rms

HS A → 2.76 mm/sec rms

HS H → 11.1 mm/sec rms

High vibrations prevented to reach the nominal speed. The frequency analysis shows the LSS 1x Rev as main component.

Casing vibration trends – from top to bottom: Vertical – Axial - Horizontal

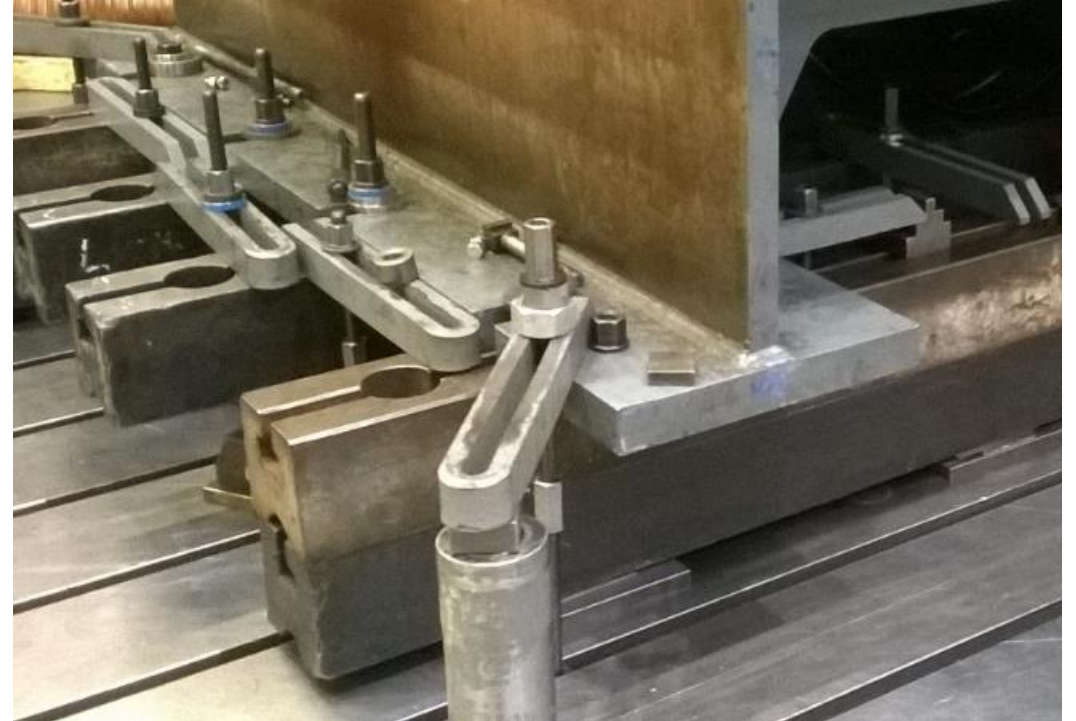
Due to the test equipment arrangement on the test bench, like the electric drive motor and the step-up gearbox, their shaft-line height was higher than the pedestal shaft-line height.

To align the Gear to be tested, and the test bench equipment, the test bench operators decided to install the pedestal on a package of still beams and shims.

This arrangement can heavily affect the support stiffness, being the equivalent stiffness

The observed vibration form and frequency contents were consistent with a lack of stiffness in the structural chain. The pedestal clamping configuration was found defiantly prone to impact the support stiffness (greater flexibility → lower natural frequency, which fell within the operating speed range, therefore prone to be excited by the LSS 1x Rev).

The electric drive motor and the step-up gearbox were moved on new supports to match their shaft-line height with the pedestal shaft-line height.

In this new test equipment arrangement, the gear pedestal was installed directly onto the test bench floor, removing in this way the bad contribution of still beams and shims package.

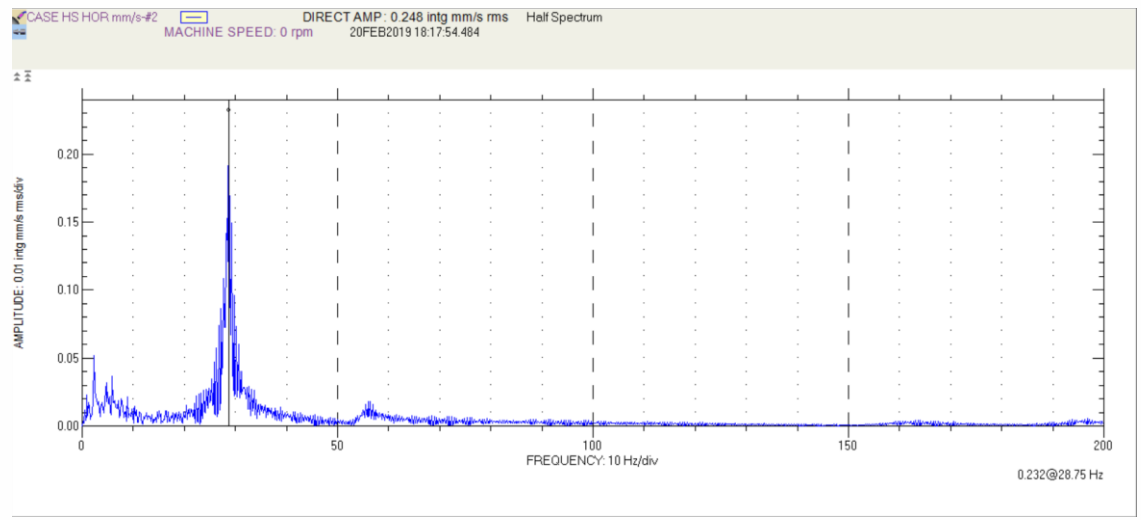
Bump-test response showed a NF @28.75Hz → LSS 1xRev @ 95% speed

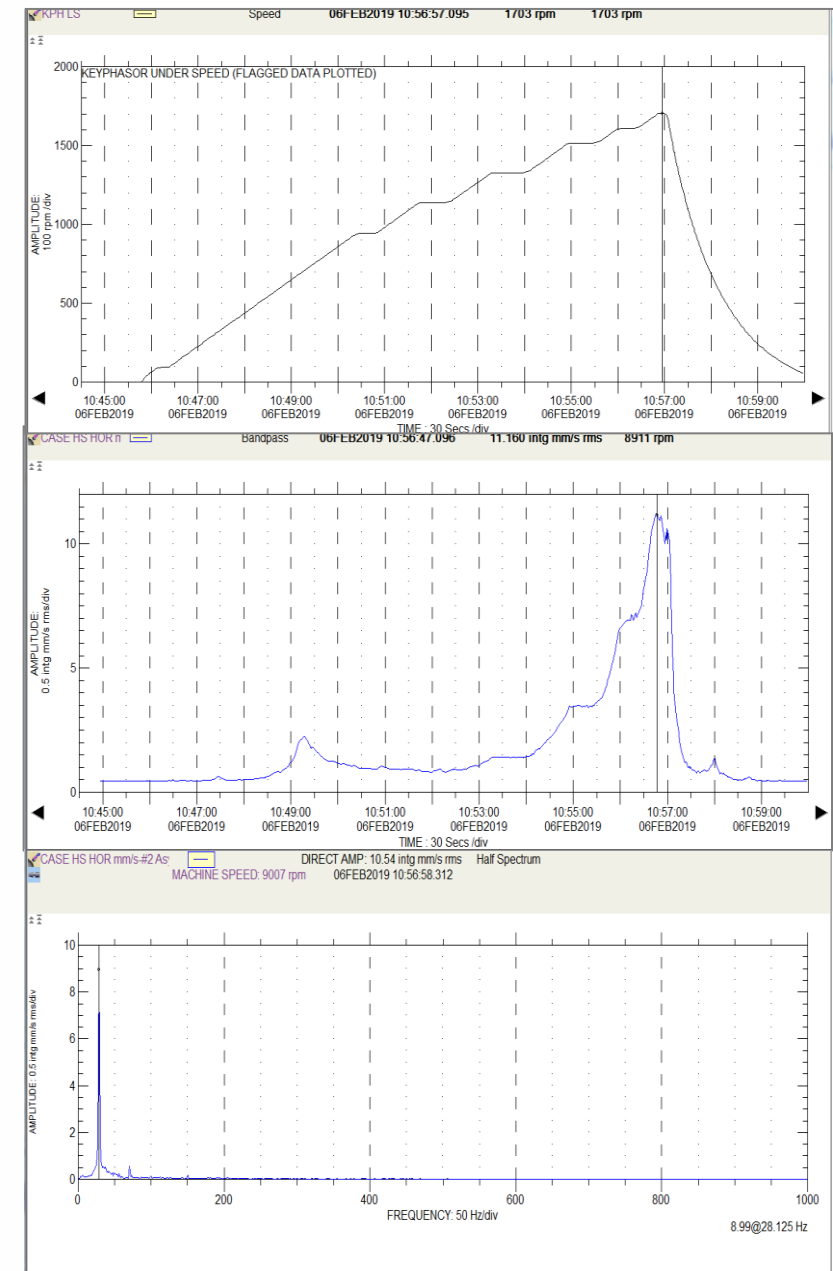
Speed and horizontal vibs trend plus vibs spectrum

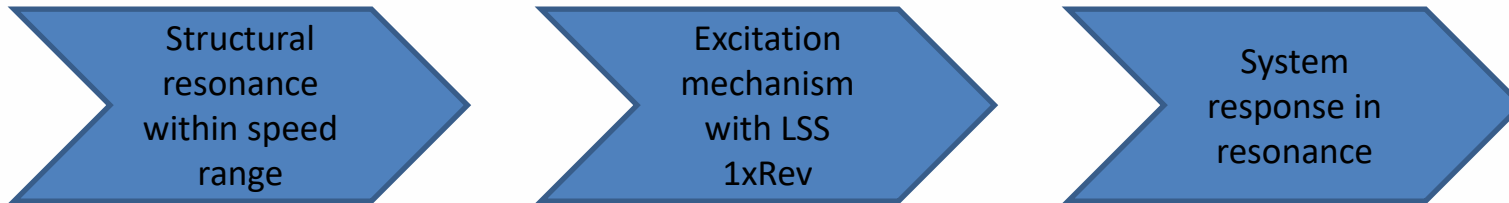
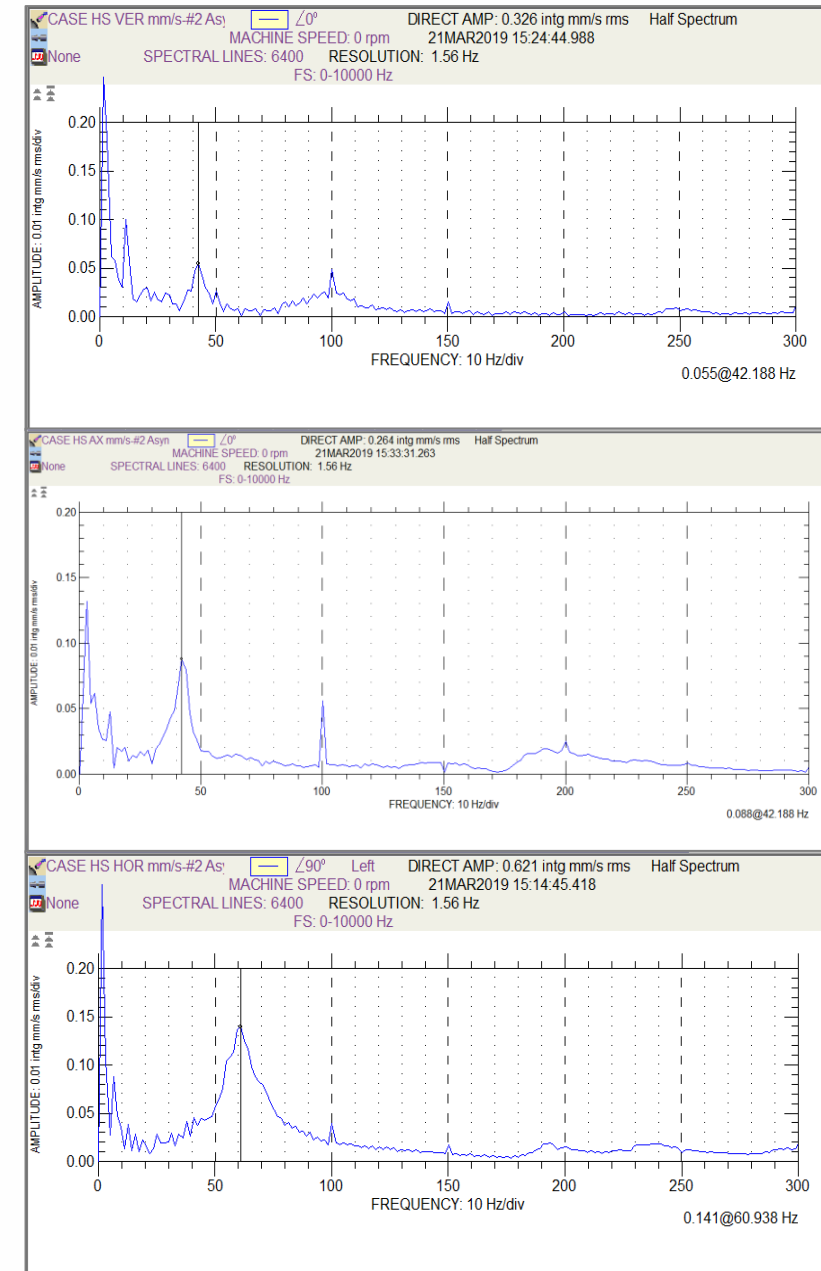
The improved test set-up, now in line to the best practices, allowed to move the pedestal system structural natural frequencies to:

- 42.2Hz (V)
- 42.2Hz (A)
- 60.9Hz (H)

Measurements carried out through bump-test.

Bump-test response in Ver. – Ax. – Hor. direction

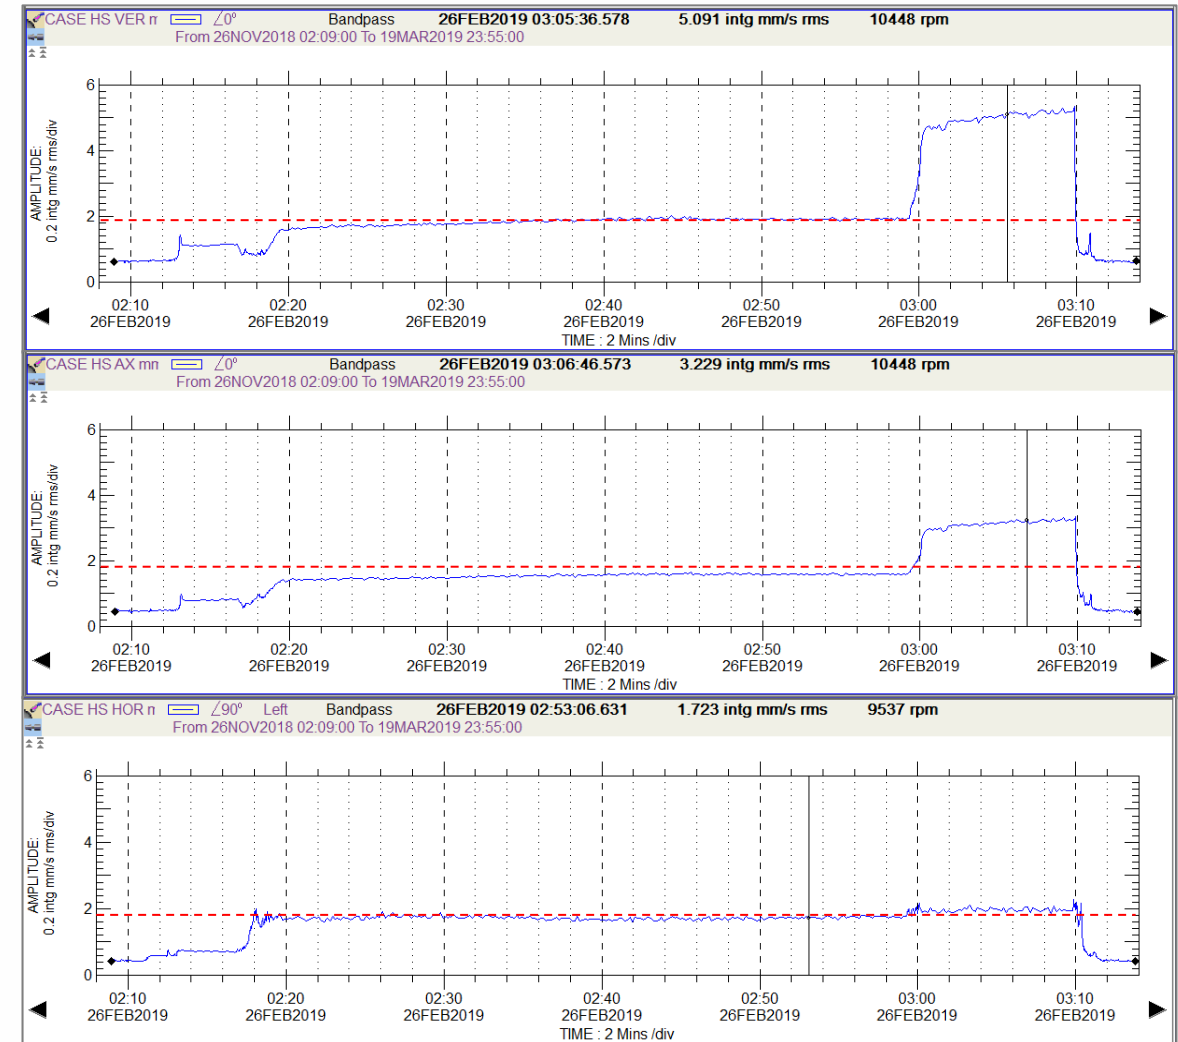
The gearbox vibration level was much improved.

Vertical, axial and horizontal vibrations @100% speed are now right on test acceptance limits.

Casing Vibration Acceleration (g Peak)		Casing Vibration Velocity (mm/sec rms)	
	Measured 100% speed	Acceptance criteria	Measured 100% speed	Acceptance criteria
HS V	1.8	2.5	1.8	1.8
HS A	1.6	2.5	1.6	1.8
HS H	2.1	2.5	1.8	1.8

Casing vibration trends – from top to bottom: Vertical – Axial - Horizontal

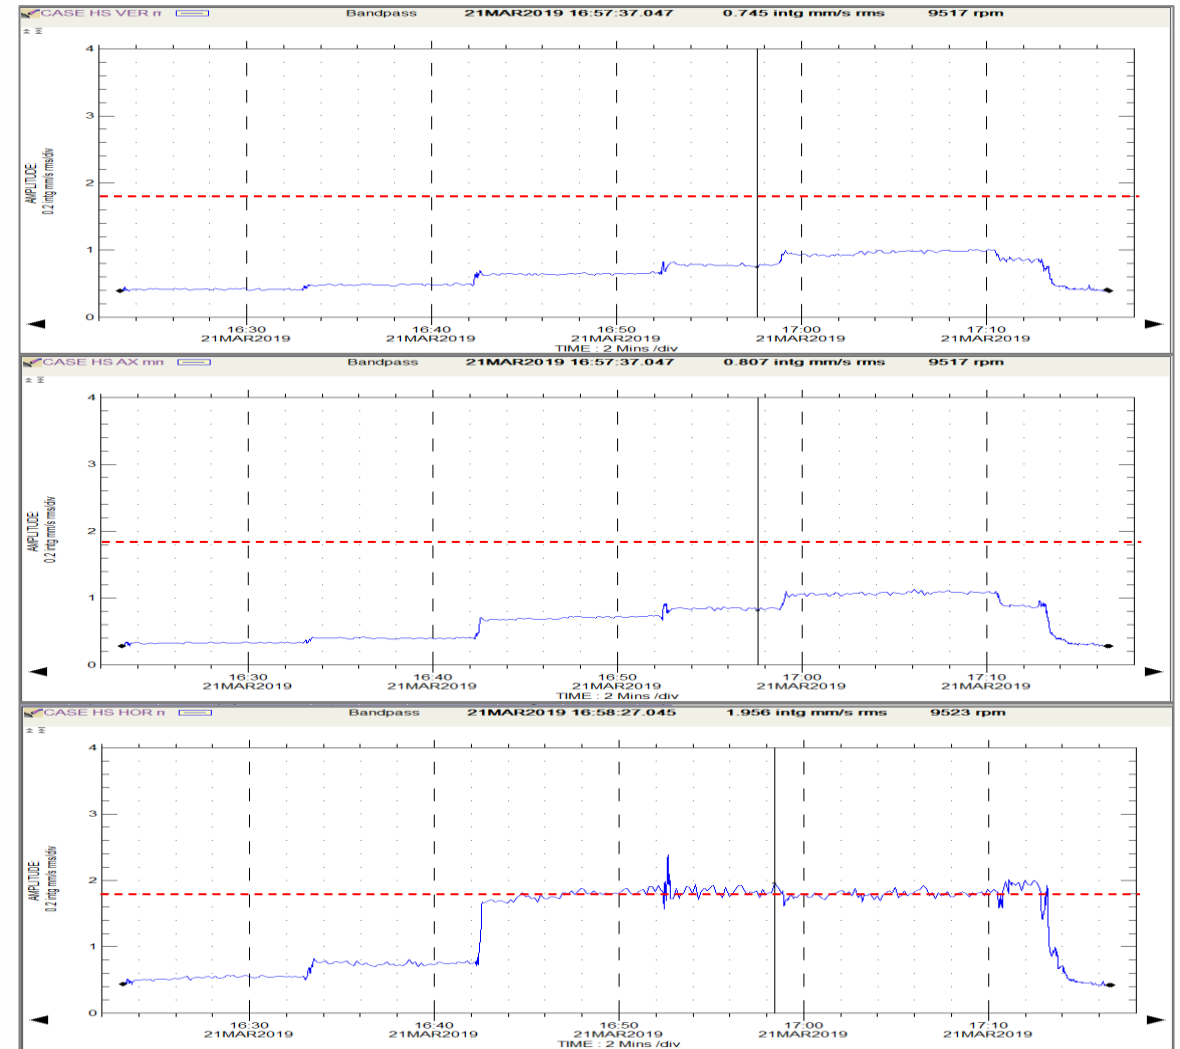
Casing Vibration Acceleration (g Peak)		Casing Vibration Velocity (mm/sec rms)	
	Measured 110% speed	Acceptance criteria	Measured 110% speed	Acceptance criteria
HS V	1.4	2.5	0.8	1.8
HS A	1.4	2.5	0.9	1.8
HS H	1.9	2.5	1.8	1.8

Casing vibration trends – from top to bottom: Vertical – Axial - Horizontal

In order to improved the vibration at overspeed, the LS rotating parts balance has been further improved. Vertical and axial vibrations are now well inside test limits, horizontal right on limit.
