ASIA **TURBOMACHINERY** & **PUMP** SYMPOSIUM

Steam Turbine Oil Seal Rub

Sheekar, Air Products and Chemicals

Patrick Smith, Air Products and
Chemicals

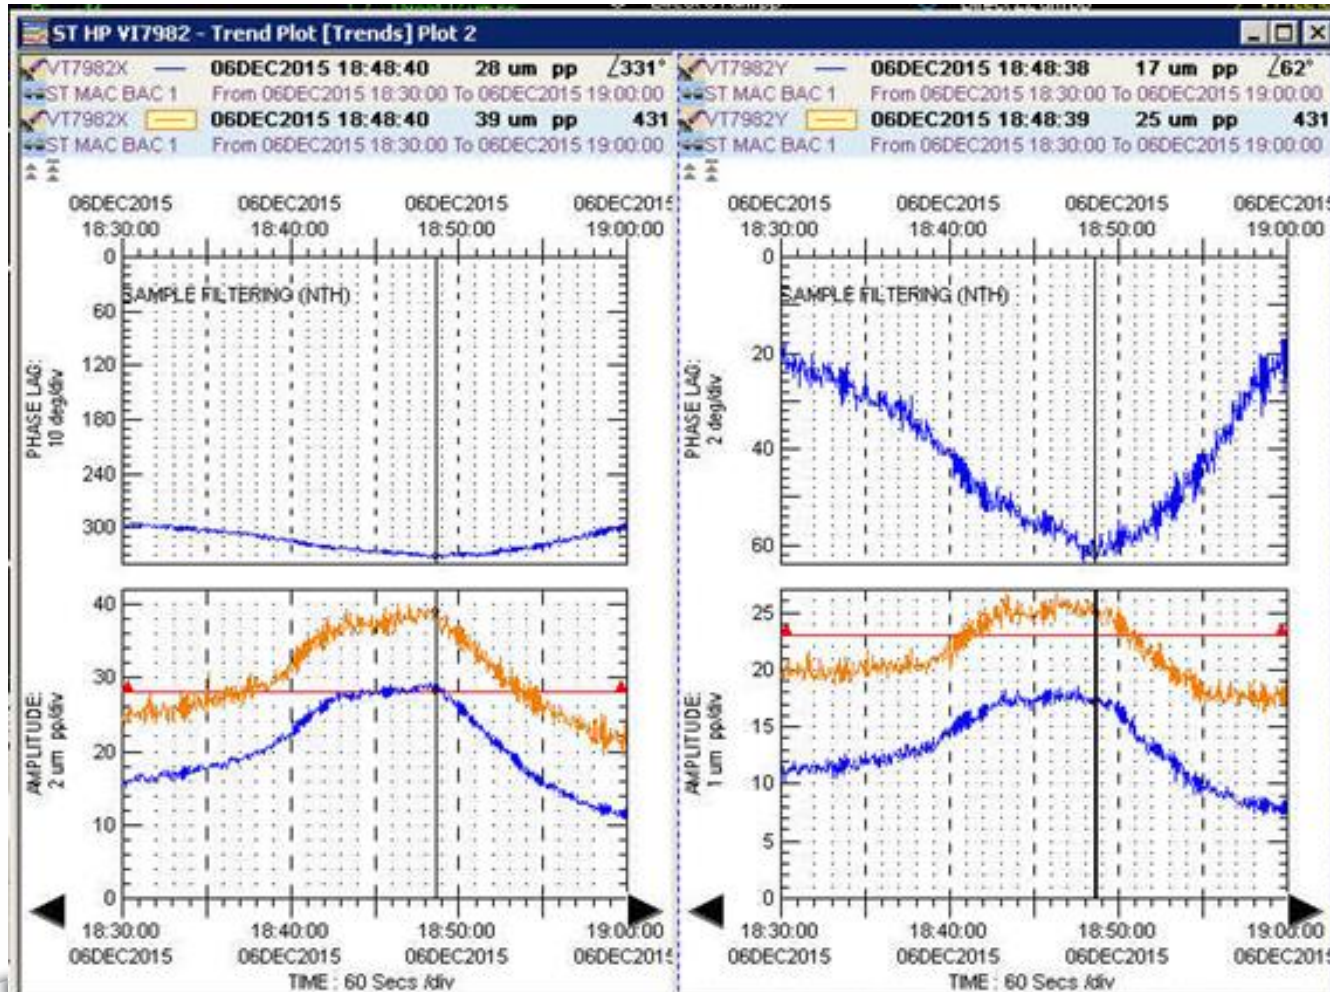
Typical Vibration Excursion

- During the vibration excursions:
 - The “x” vibration would increase to 40+ microns and the “y” vibration would increase to 30+ microns.
 - This was due to an increase in the one times running speed component. The phase angle also changed by approximately 30° to 40°.
- There were no process changes at the time of the vibration excursions.

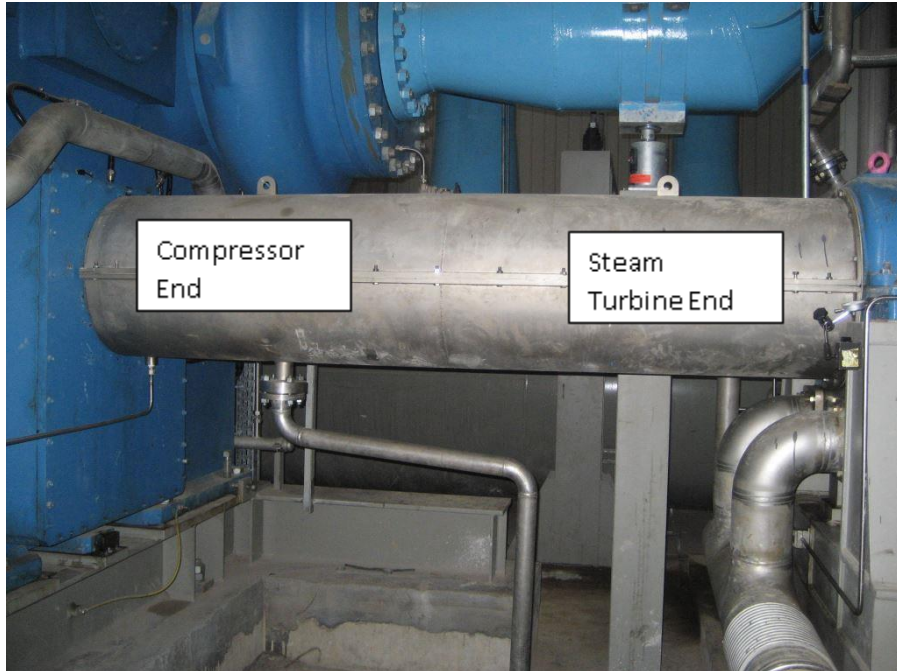
Steam turbine to integrally geared compressor coupling

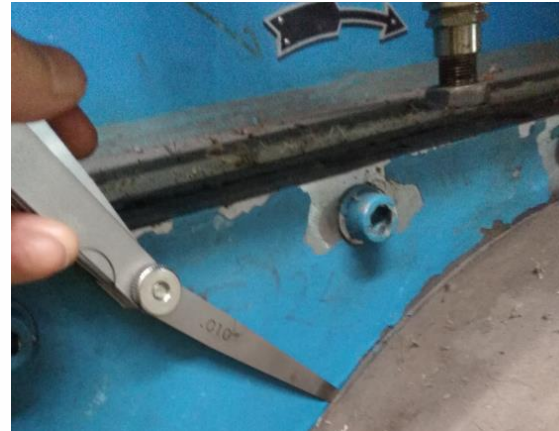
Guard appeared to be pushing against compressor

- The shaft alignment was checked and found to be within design tolerances.
- The coupling guard appeared to be pushing against the compressor was cut to increase the cold gap clearance for turbine thermal growth.
- Dial gauges were installed around the turbine to look for signs of distortion or stuck sliding surfaces – nothing was found
- The process trends were scrutinized and the vibration excursions were not a result of any change in the process
- Steam quality trends were reviewed and there were no issues
- Rotordynamics and bearing design were reviewed – nothing was found
- The carbon brushes were inspected and were fine. But, the brushes were replaced anyway

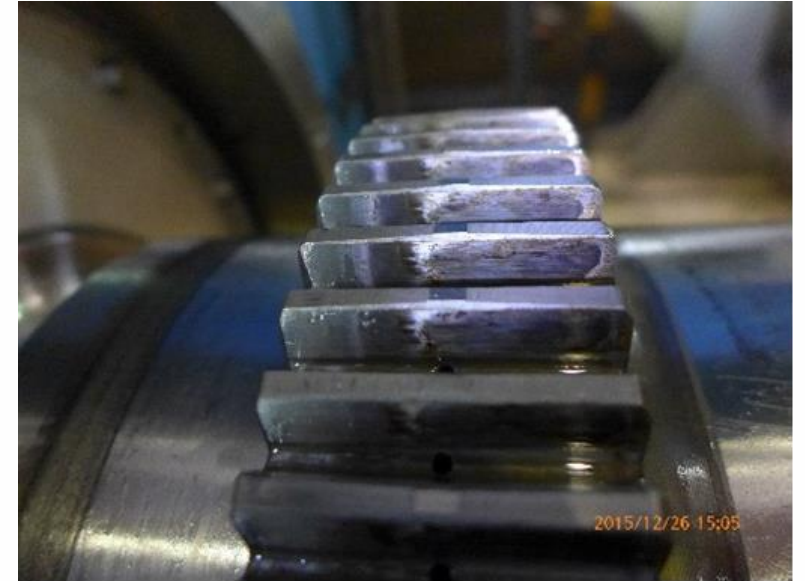
Strange markings on the steam turbine end coupling gear teeth

- Based on the discoloring of the gear teeth on coupling, occasional coupling gear teeth “lock-up” was identified as a possible cause. This could possibly be due to insufficient backlash.
- Backlash could not easily be checked with the installed coupling.
- Oil spray nozzles did not appear to be positioned properly and this was identified as a possible cause of the vibration excursions
- The steam turbine train was restarted, and the random vibration issues continued
- Based on these results, it was decided to replace the coupling with a spare and correct the oil spray nozzle orientation.
- Unfortunately, after replacing the gear-coupling and modifying of oil-spray nozzles, the random vibration spikes persisted.

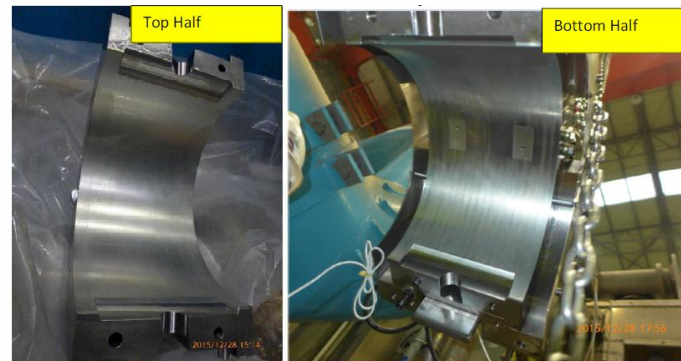
Steam turbine HP end Journal bearing – no issues

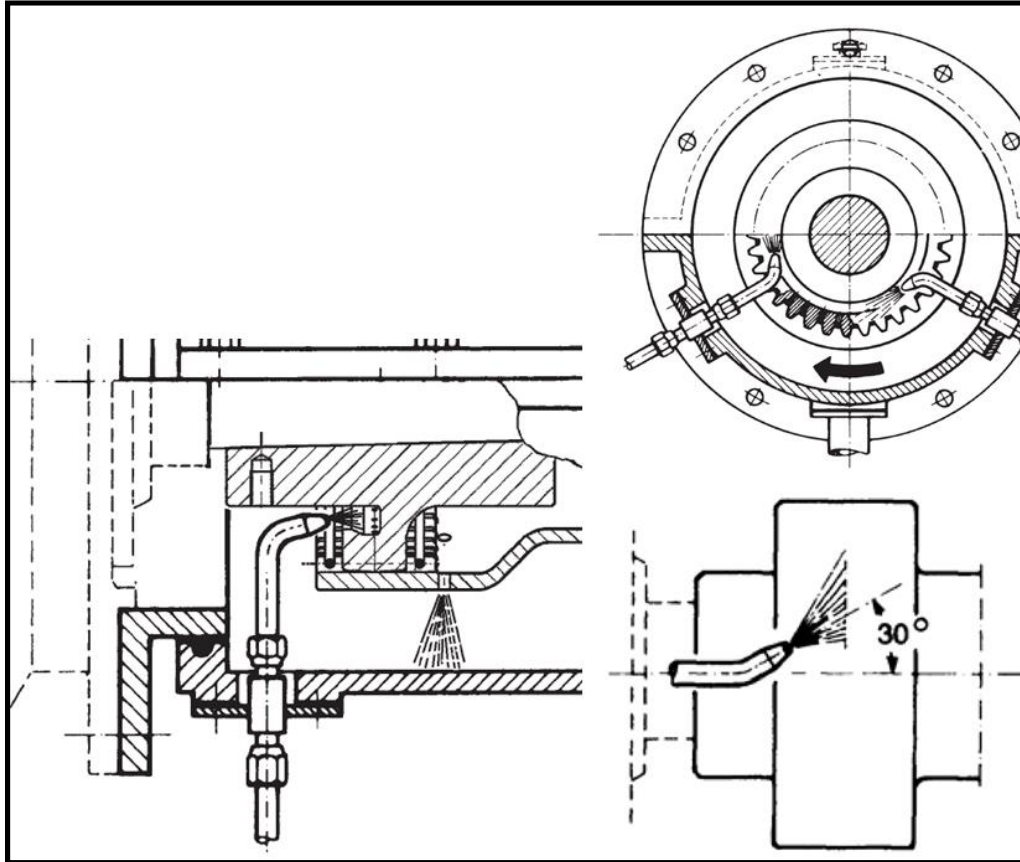
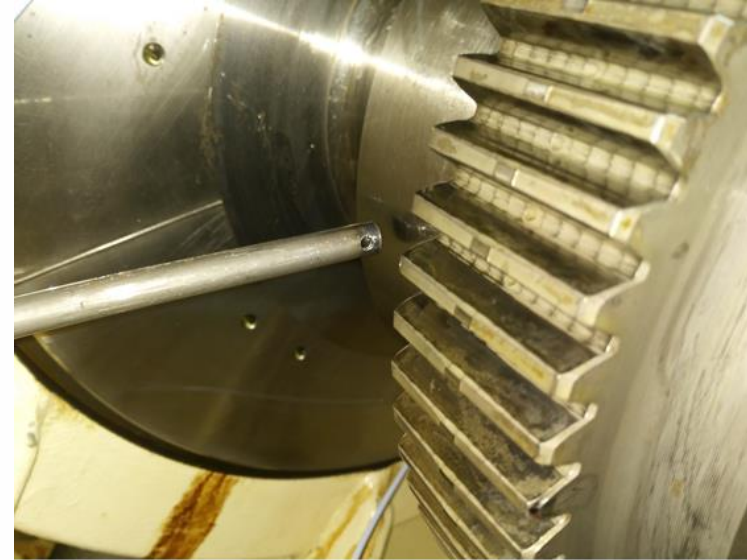
Coupling Lubrication Nozzles and Drain Holes

- Drain holes were inspected and not plugged
- Oil spray nozzles were not positioned properly

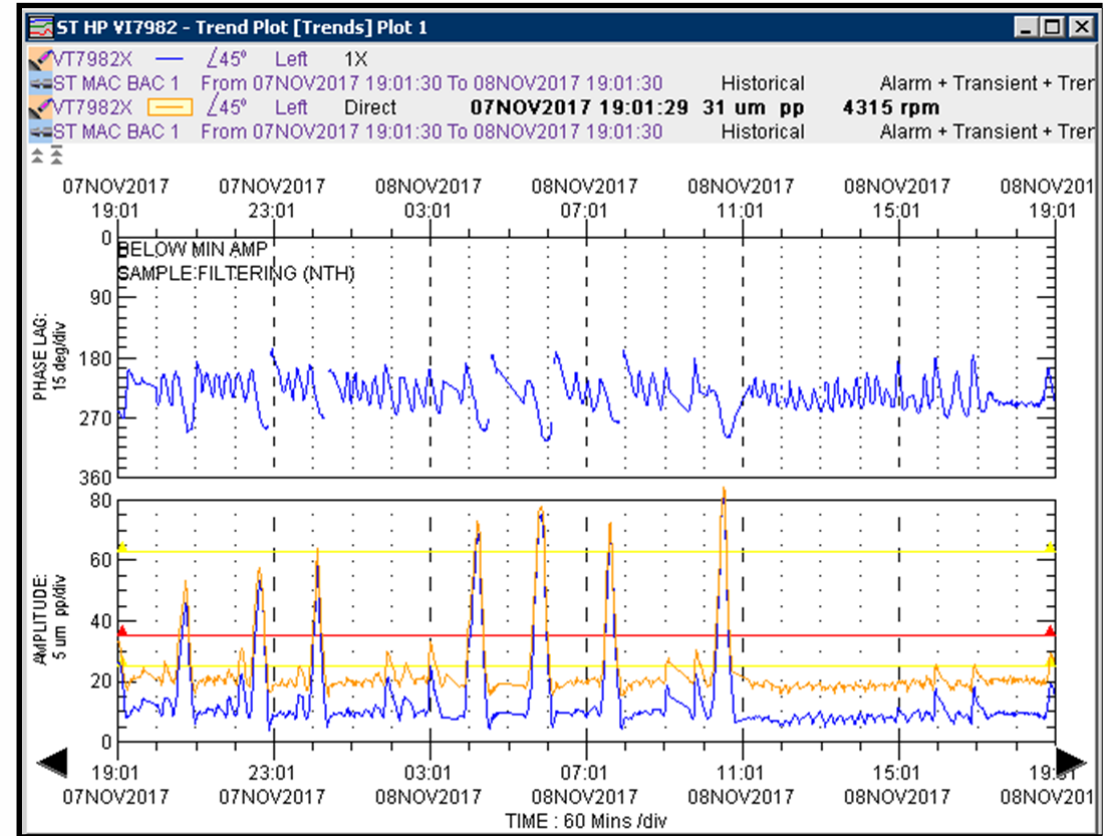
- About six months after the coupling replacement, there was a step change in the frequency and magnitude of the vibration excursions.
- The vibration levels were fast approaching the trip set point.
- Then, a significant steam turbine inlet end bearing leak developed and it was decided to shut down the train to fix the leak and inspect the bearing.

Note spikes in vibration amplitude

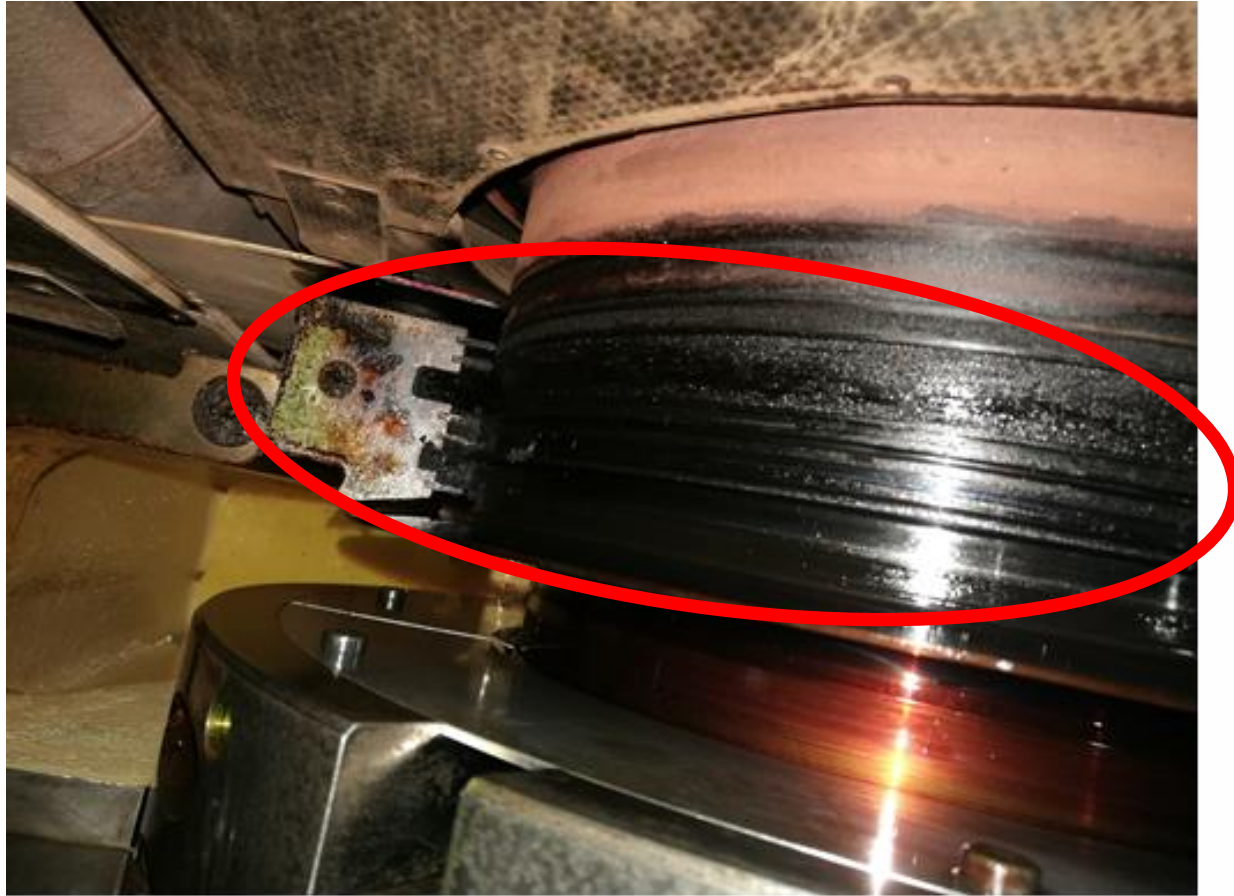
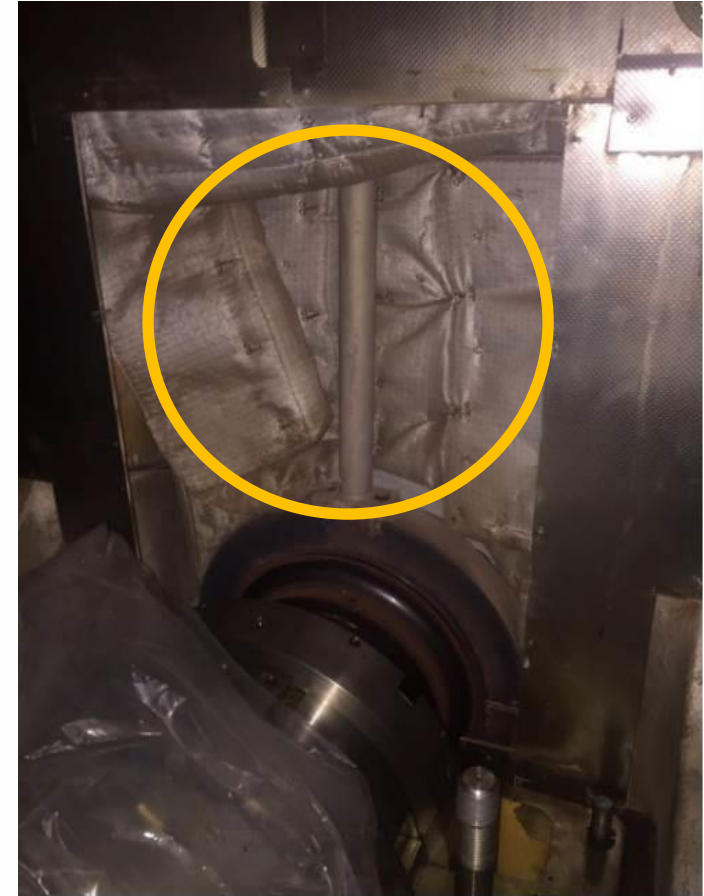
Coking in Bearing Housing Oil Seal

Some insulation pads found missing around the sealing steam pipe

- Oil coking at labyrinth oil seal resulted in rotor rubs. Once the rub occurred, the coking debris dropped and the rubbing stopped. This resulted in the random vibration.
- Oil coking at labyrinth oil seal was due to poor insulation at turbine section close to inlet end bearing

- The bearing housing oil seal was cleaned and insulation pads were added near the inlet end bearing.
- In addition, an air-purge was installed on the oil-seal labyrinth seal (provision already provided by OEM).
- Since making these changes, there have been no vibration excursions.
- It was concluded that the cause of the vibration excursions was due to light rubs caused by a build-up of deposits (oil coking) in the steam turbine inlet end bearing housing oil seal.
- The cause of the oil coking was excessive heat in the oil seal area due to missing insulation pads around the sealing steam pipe.
