# Mitigation of perennial seizure of boiler feed water pumps during commissioning of refinery unit

Mantosh Bhattacharya

## **Problem statement –**

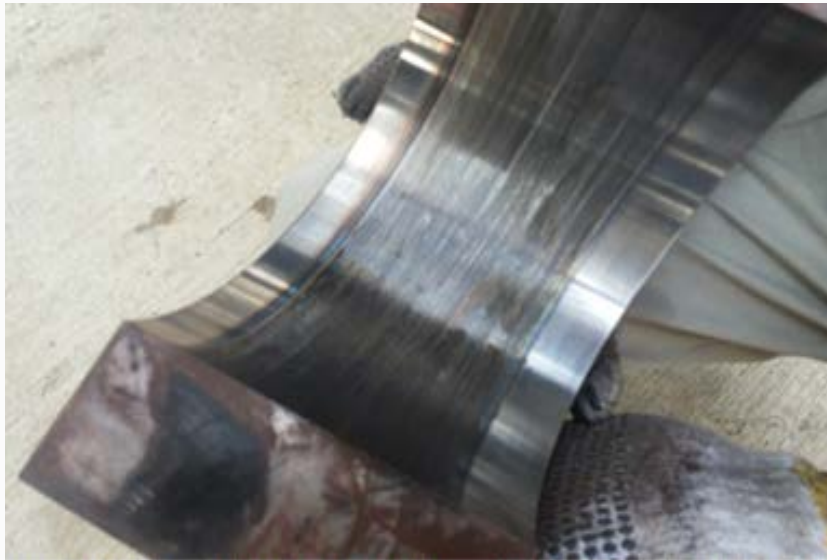
The changes made above could not prevent pumps rotors from seizing .Failures after increasing clearance concluded that sand loading is not the actual reason of rotor stator rub in pumps.

Stator area rub

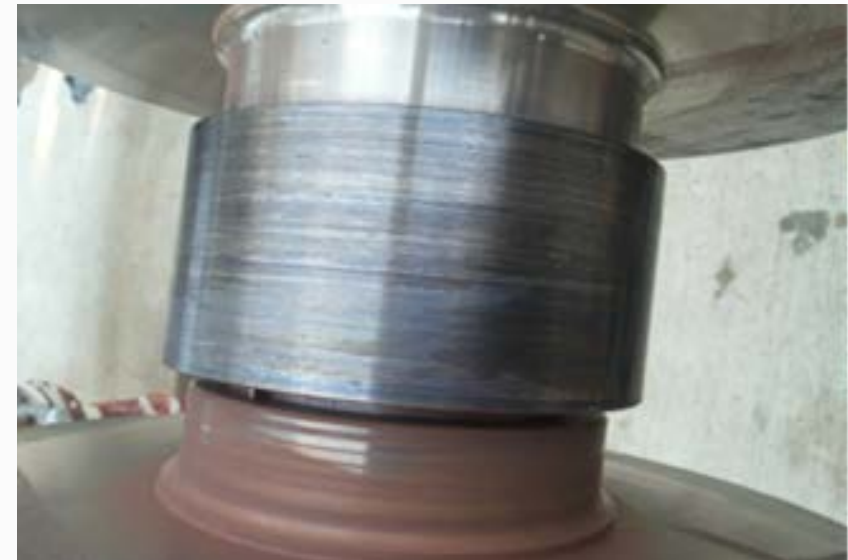
Throttle bush rub

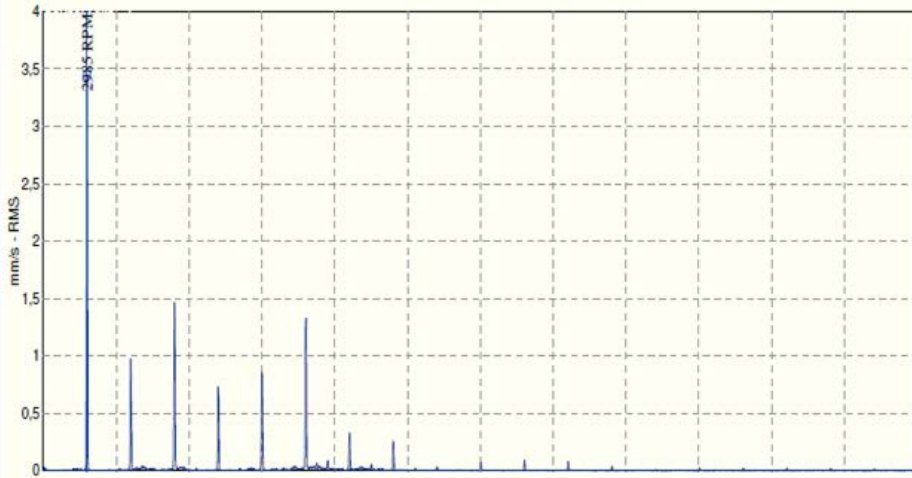
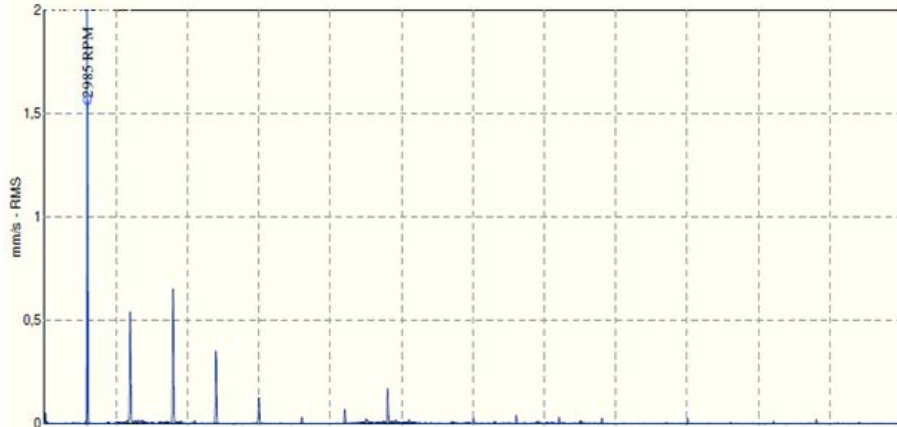
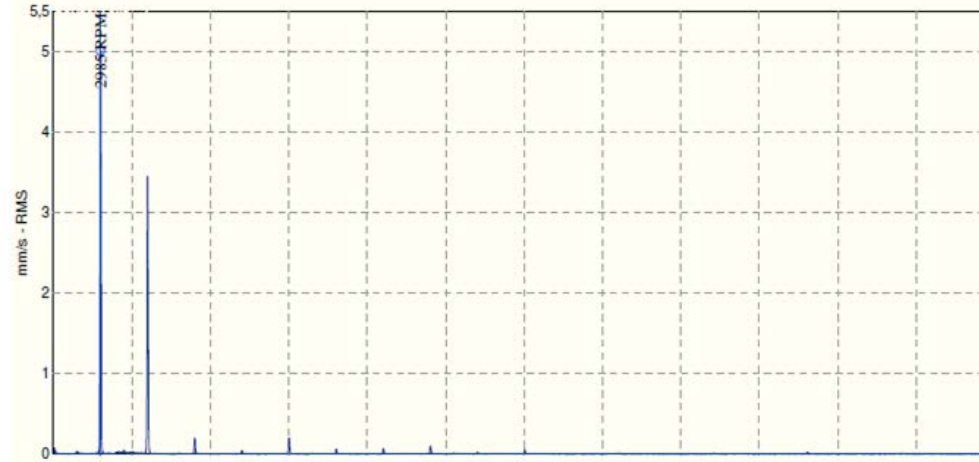
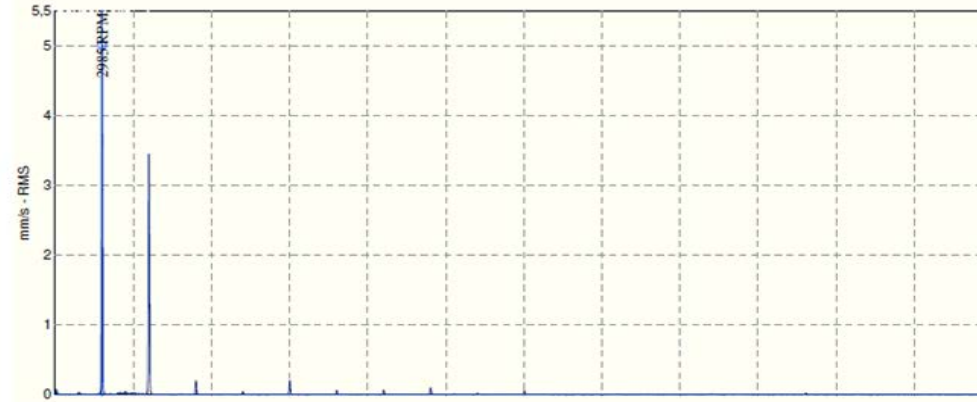
# Driver Motor solo run test at site after pump seizure – DE and NDE vibrations

04-PM-7502A \ m1h., 25.09.2013 12:19:09, Channel X, Trend Overall: 6,197 mm/s  
Amp: 5,01, Freq: 3000, Order: 1,01, ---

Multiple spectral lines showing possible looseness , High 1x shows a possibility of high unbalance

Damaged bearings and shaft as well as imbalance in the rotor found.

Several start-up attempts made against a partially jammed pump unit, led to extensive overheating of the rotor, caused mechanical stress in the rotor . This caused lamination damage that resulted in a significant unbalance with the bearing damage.

Repair attempt: refurbishment of shaft and modification of bearing shells,

Rebalancing of the rotor (residual unbalance 5.10 g / 8.38 g) much higher than ISO 1940 limit

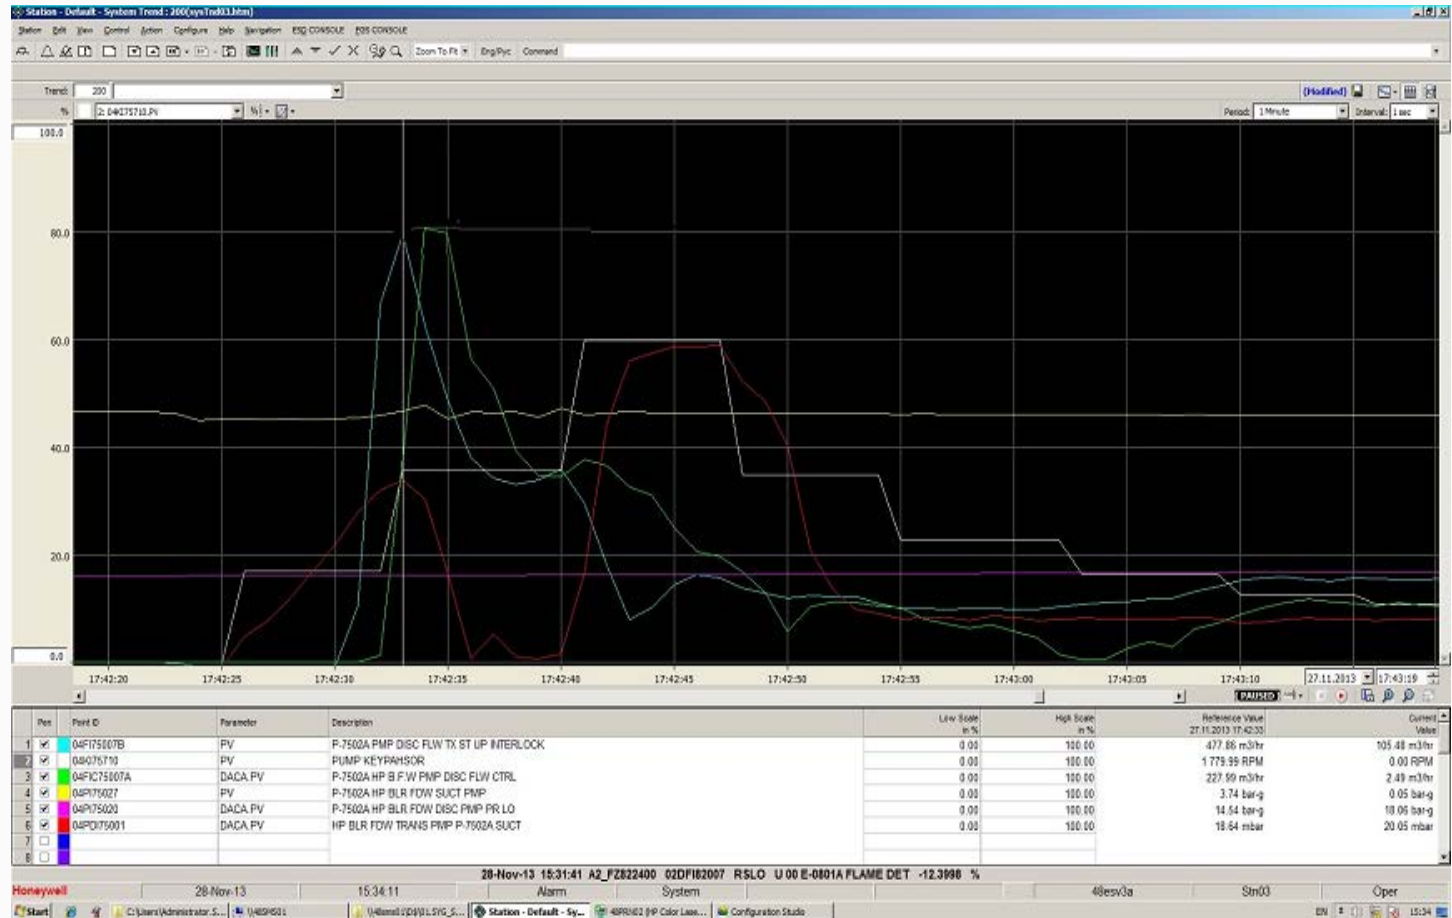
DCS trend of parameters →

7G.Lack of lubrication at close clearance parts leading to encroachment of clearance parts during start up – It was observed by careful analyzing the trend plots that before pump started to pick up full speed , flow fell down and downfall of flow was continuous and never recovered causing a situation of no flow.

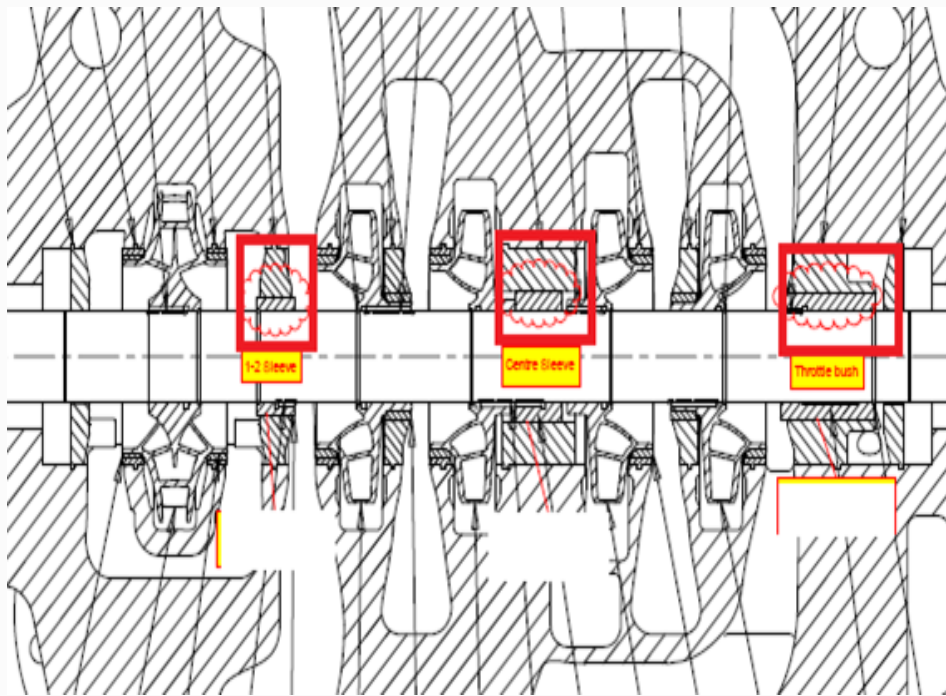
Inter-stage location where clearances were increased

1. **Increased inter-stage clearance** – Throttle bush, center bush and stage bush to avoid rubs .  
Action based on Lateral analysis report of pump – Campbell diagram – extract below –Right
