ASIA **TURBOMACHINERY** & **PUMP** SYMPOSIUM
22-26 FEBRUARY 2021 | NOW VIRTUAL!

Inappropriate Operation During Mechanical Running Test of a High-Pressure Compressor Equipped With an Hole Pattern Seal

Yves Bidaut , MAN Energy Solutions Schweiz AG

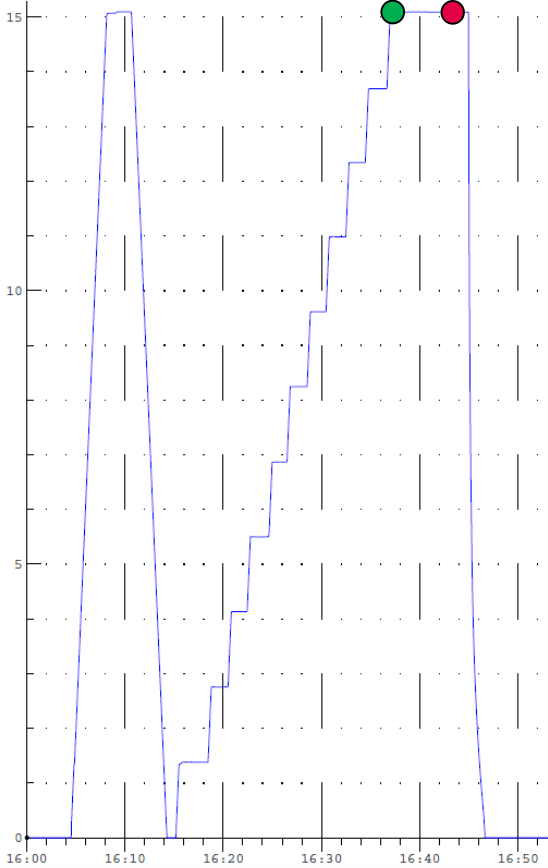
Speed

→ Sudden increase of vibrations at DE (20 μm) and NDE ($> 100 \mu\text{m}$)

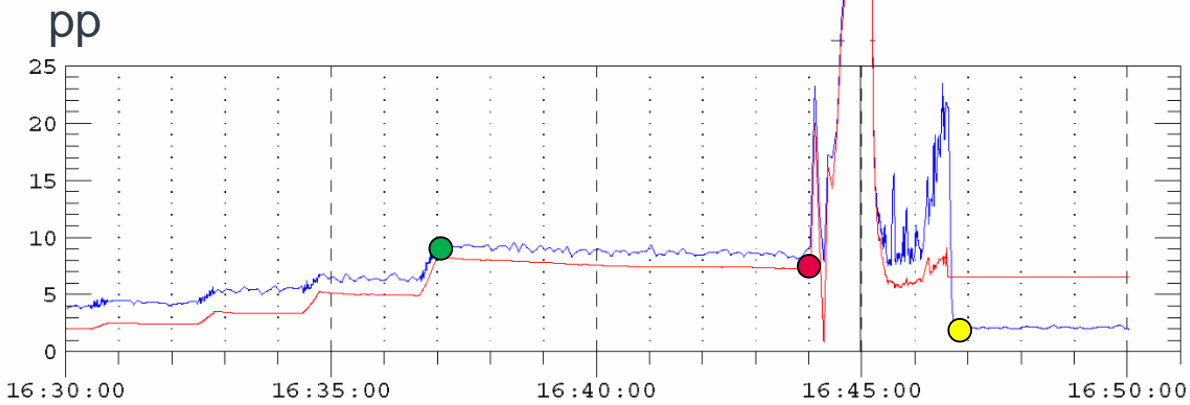
Vibrations

→ Synchronous vibration

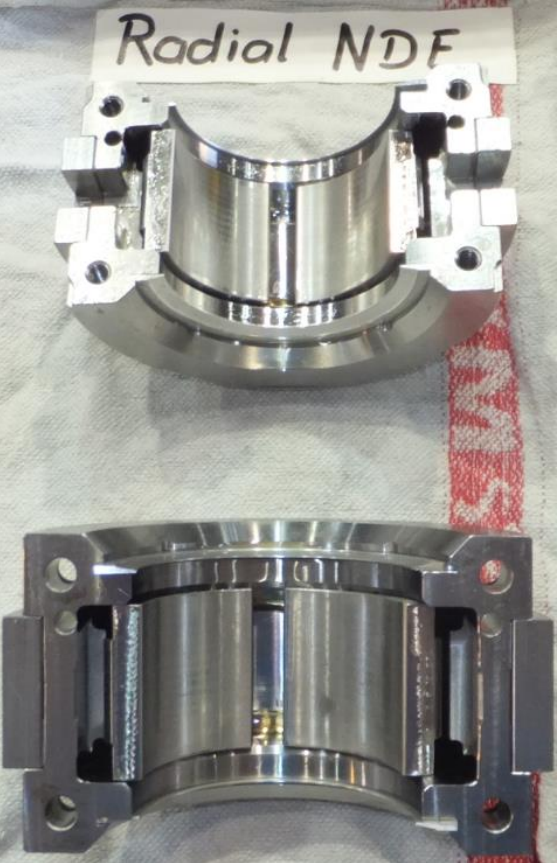
Bearings

No abnormality, no mark

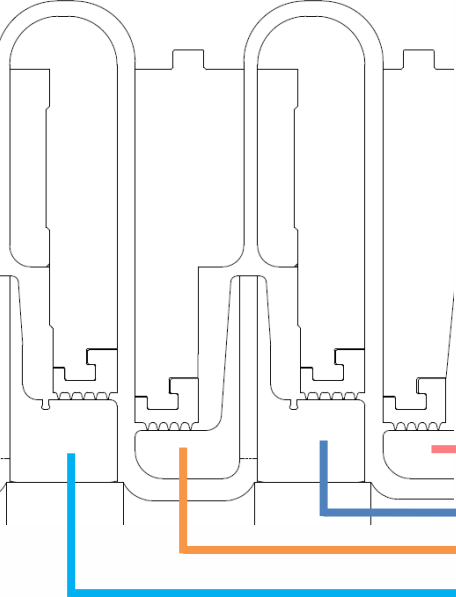
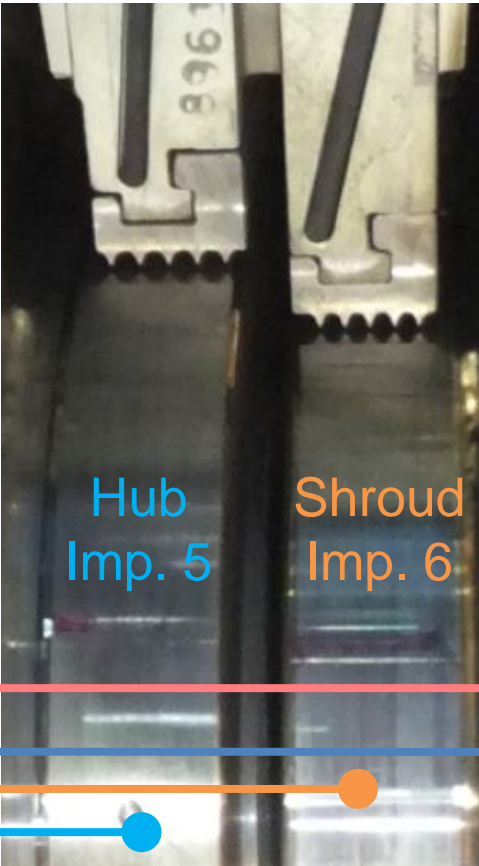
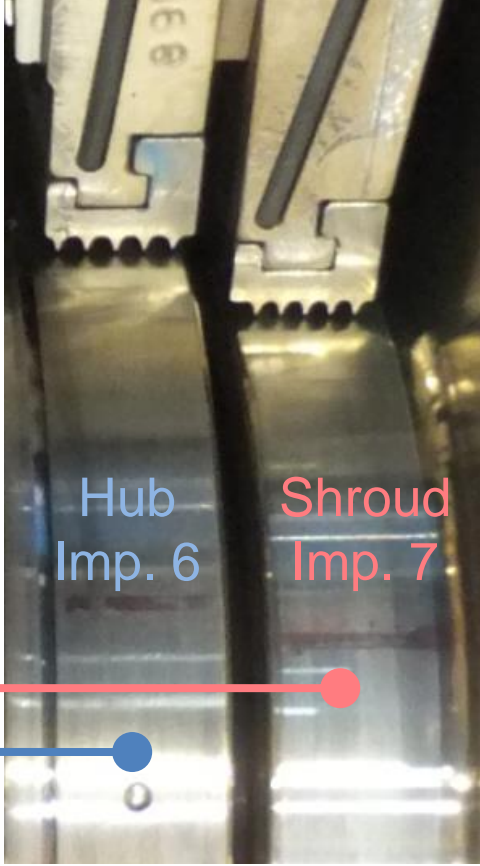
Labyrinth Seals

No abnormality, no mark

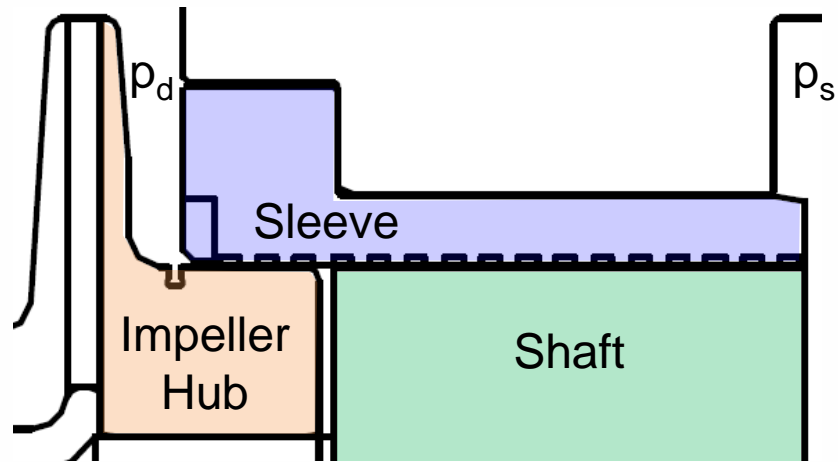
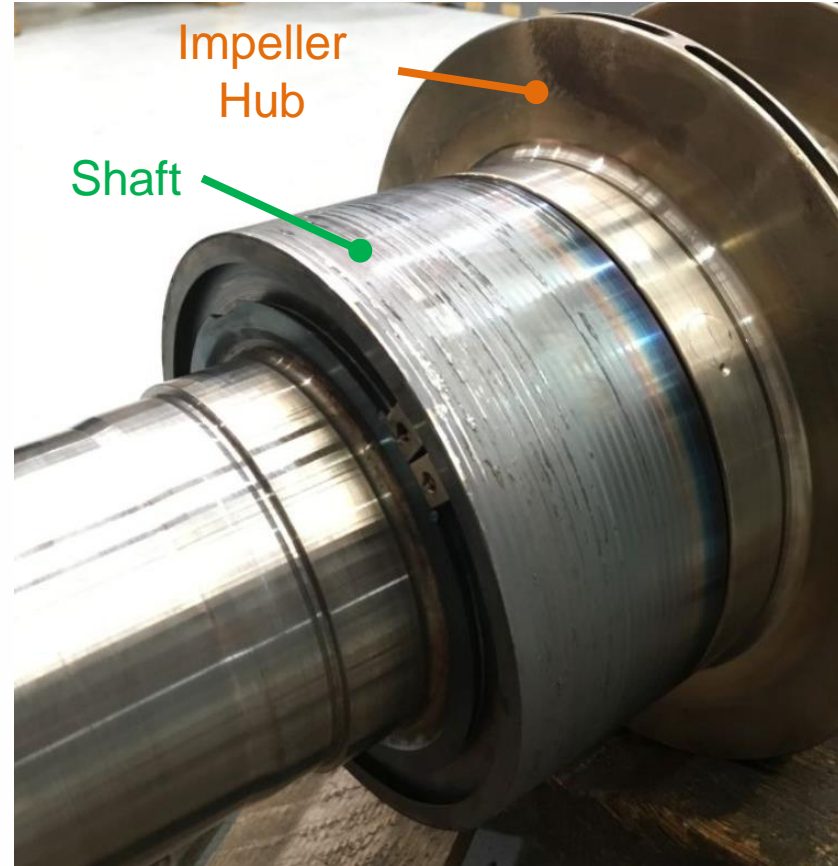
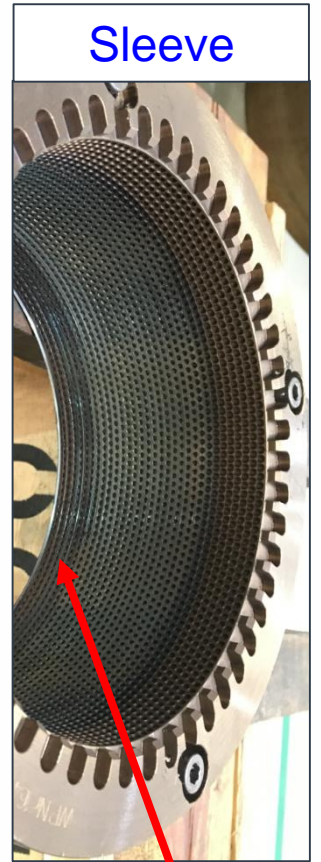
Balance Piston (Hole Pattern Seal)

- Sleeve removed from shaft (possible only after heating)
- Traces of rubbing at suction pressure end

- Due to the reciprocal action «reduction seal clearance» and «increased flow temperature», the gap between sleeve and shaft decreases till rubbing

1. Gas composition modified
→ Decrease of discharge temperature
Original: 70% N₂ + 30% He
Modified: 50% N₂ + 50% He
2. Start-Up conditions modified : duration of start-up increased
→ gradient of increased pressure and temperature reduced
→ uniform temperature distribution in casing
3. Replacement of Hole Pattern sleeve with a new manufactured with slightly increased clearances

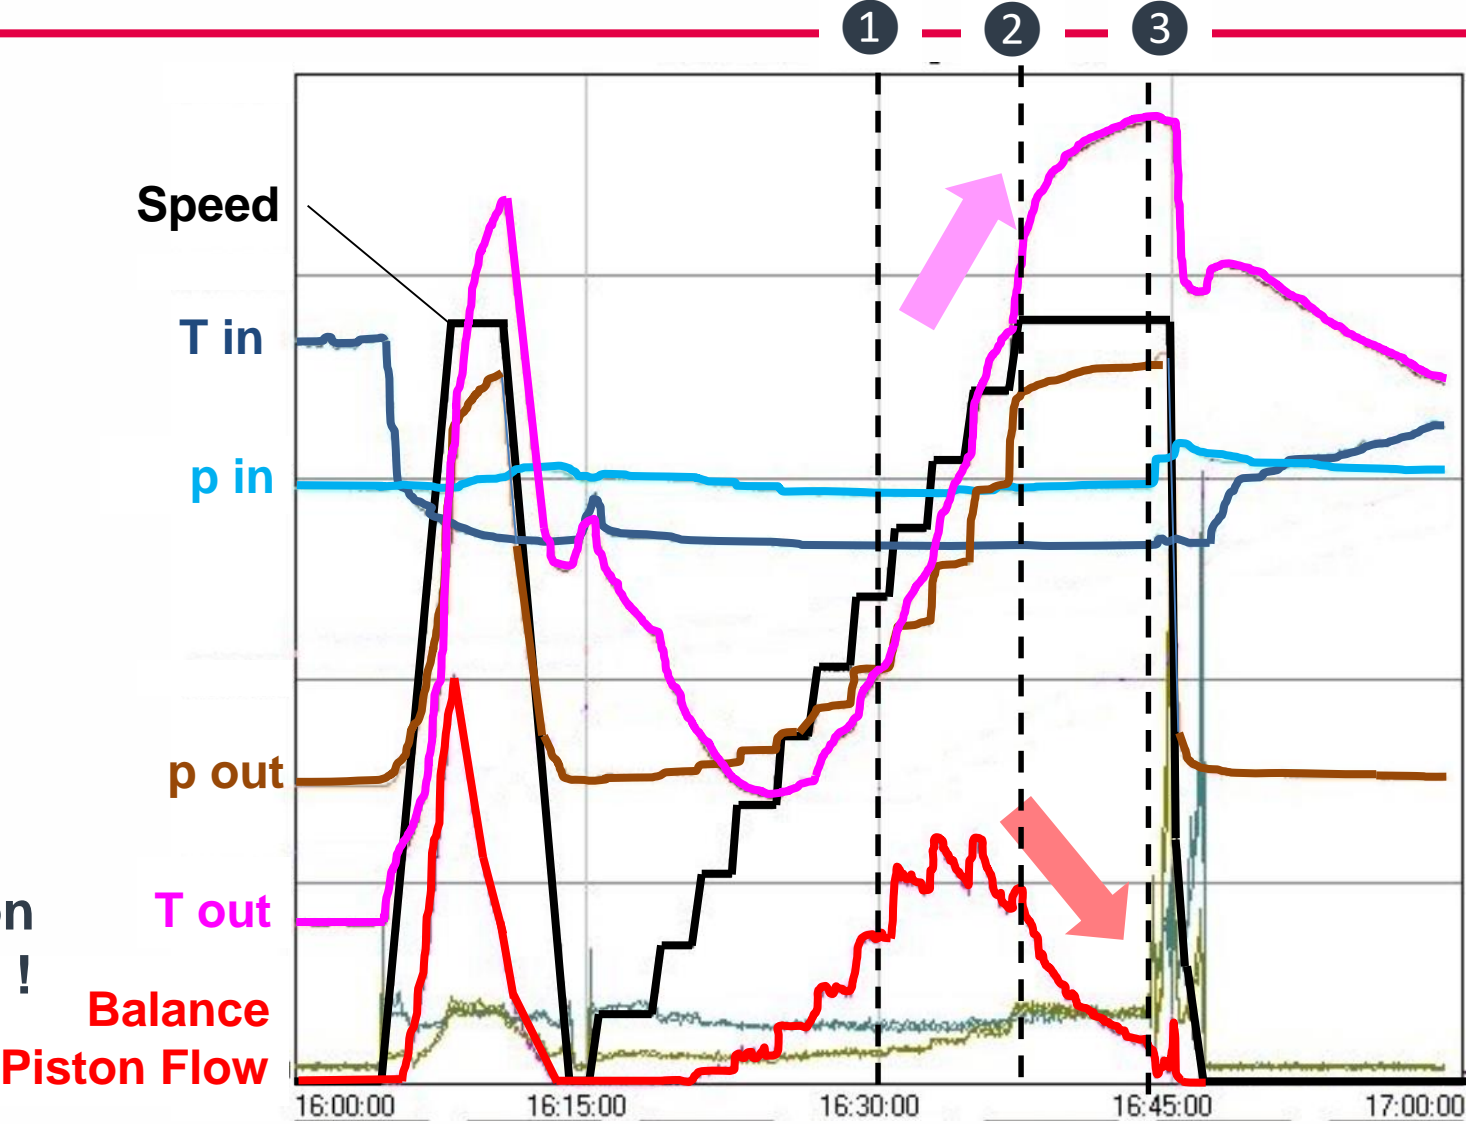
- Trip Speed (at 15'090 rpm)
- Constant inlet conditions (p_{in} , T_{in})
- Increase of p_{out} , T_{out}
- **Continuous decrease of balance piston leakage flow until 0 kg/s !**

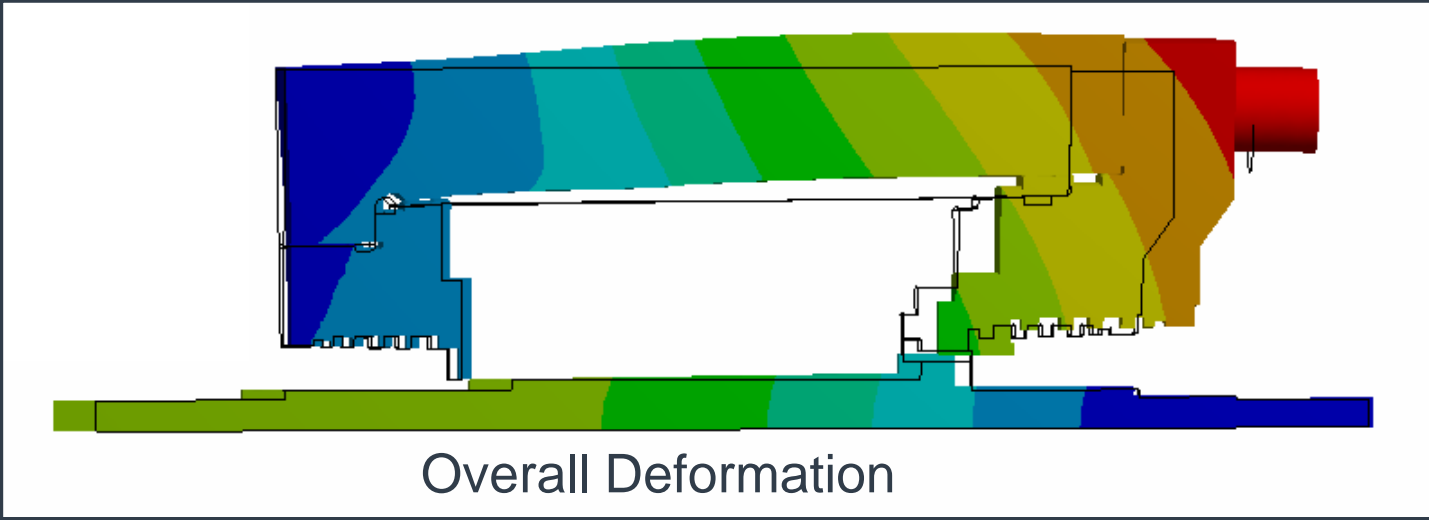
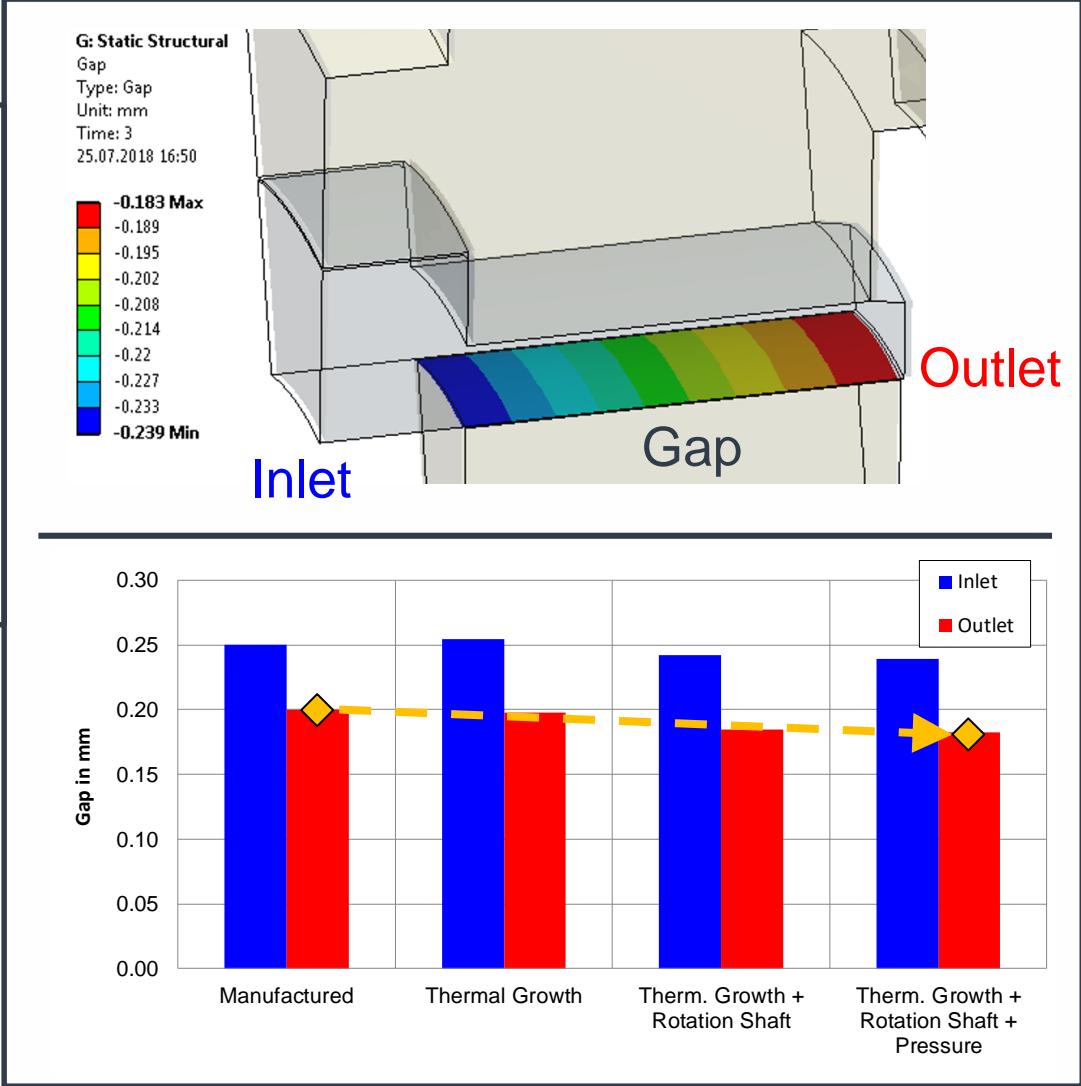
- Reduction of min. clearance from 0.20 mm (manufactured) down to 0.18 mm (operation)
- Clearance still high enough

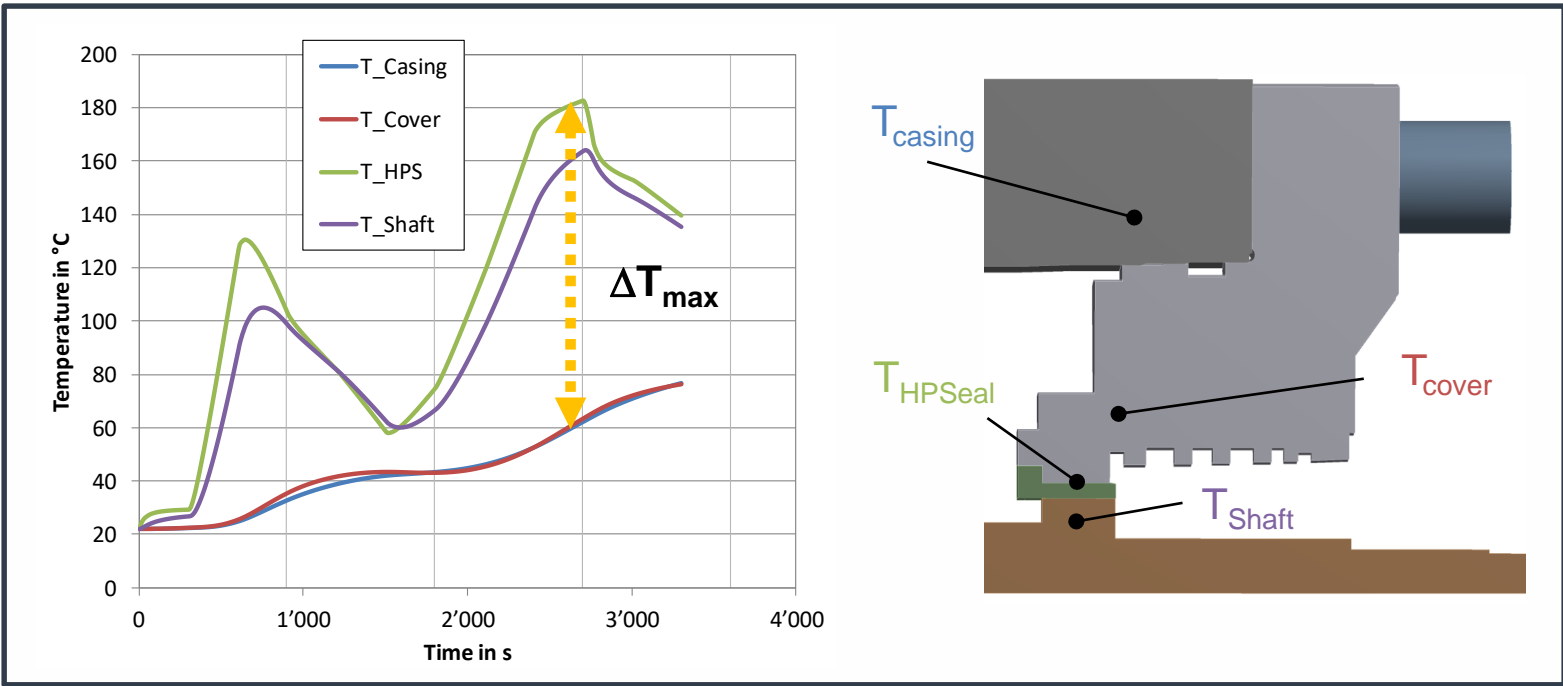
FEA Results

- Hole Pattern Seal and Shaft warm up much quicker than Casing and Cover → High Temperature Difference !

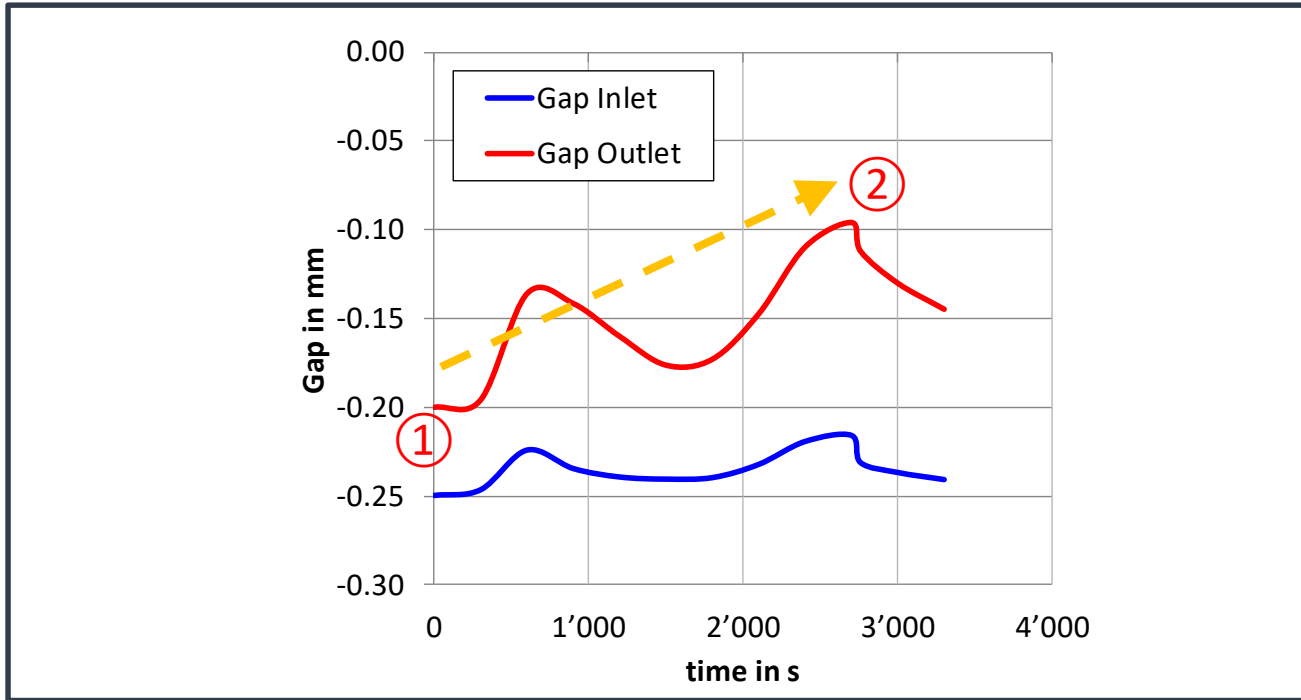
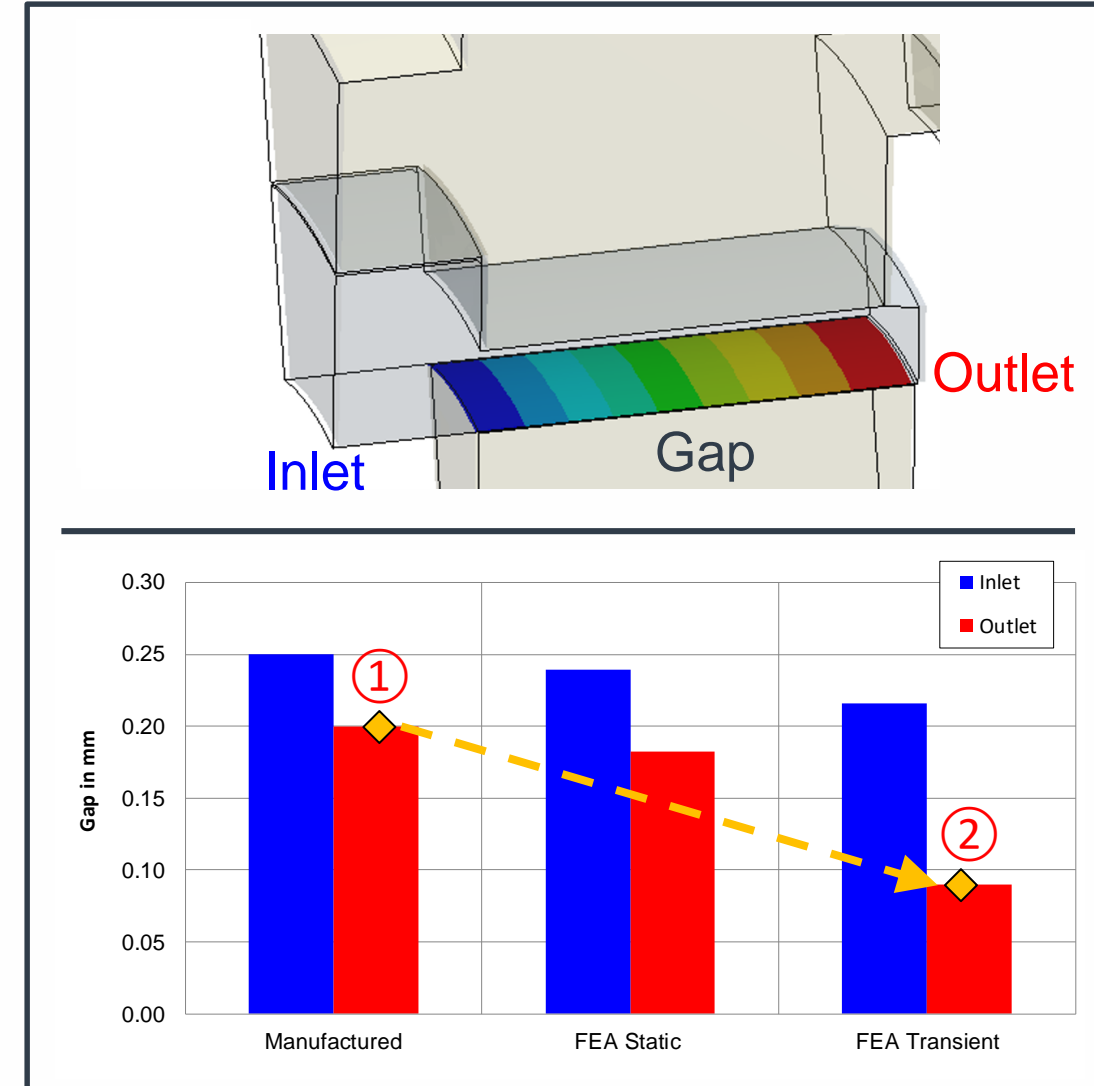
- Due to High Temperature difference between Sleeve/Shaft and Cover/Casing
→ Significant reduction of clearance at outlet !

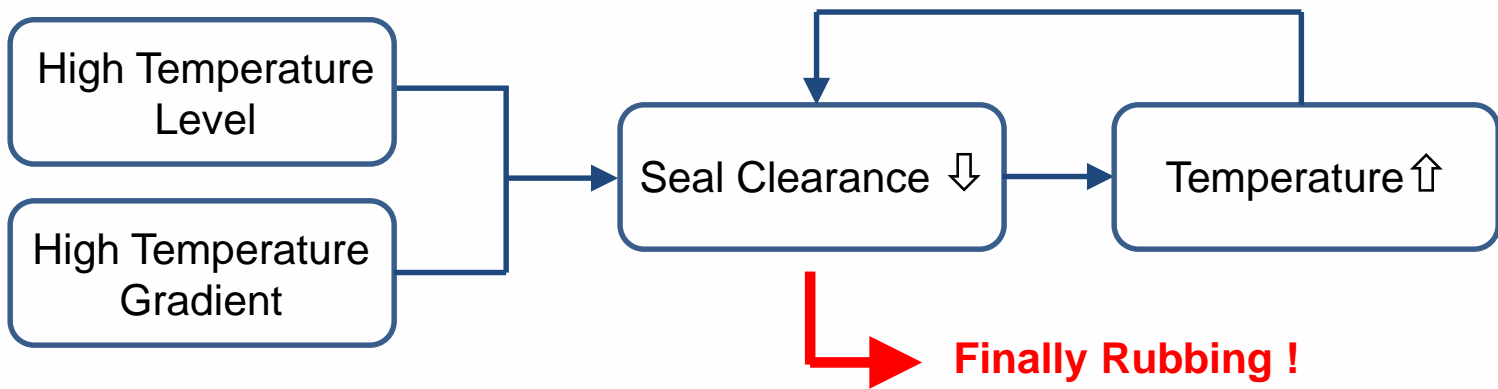
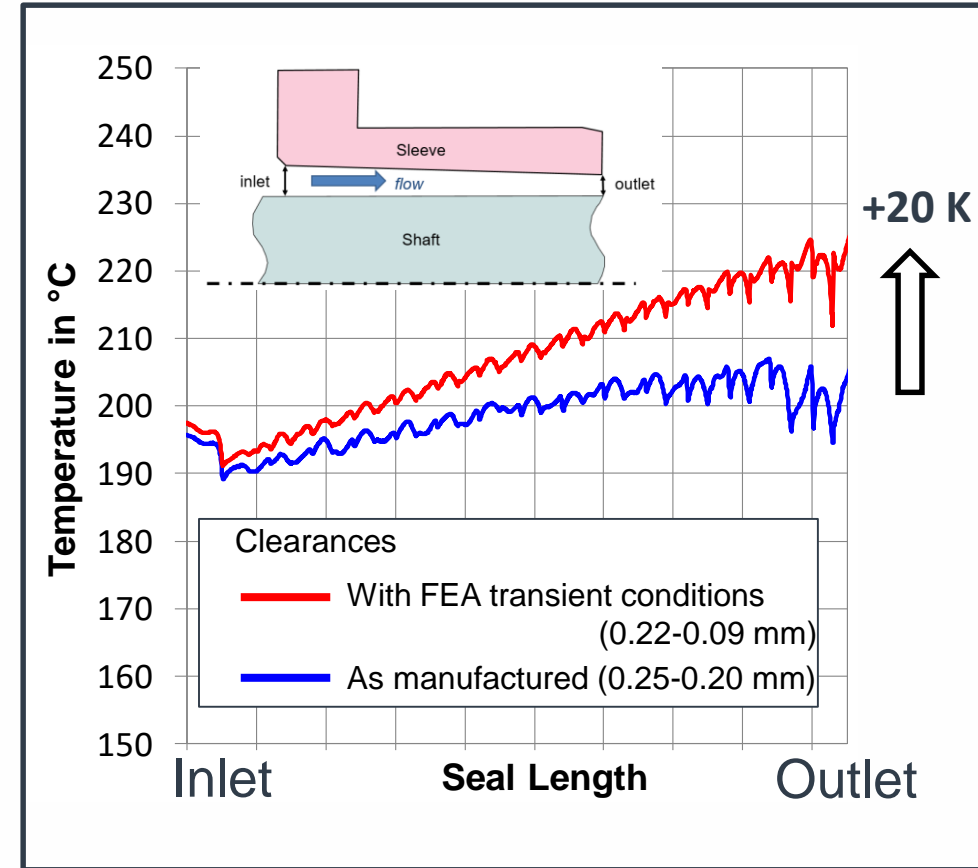
- High temperature and high gradient temperature increase
→ Reduction of clearance
- Reduction of clearance
→ Increase of Leakage Flow Temperature

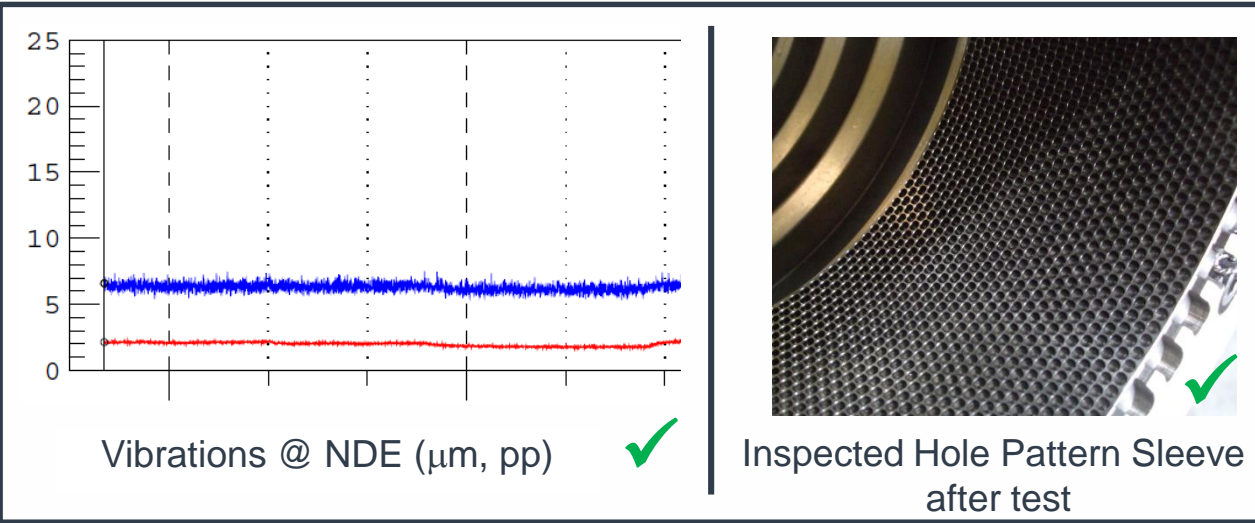
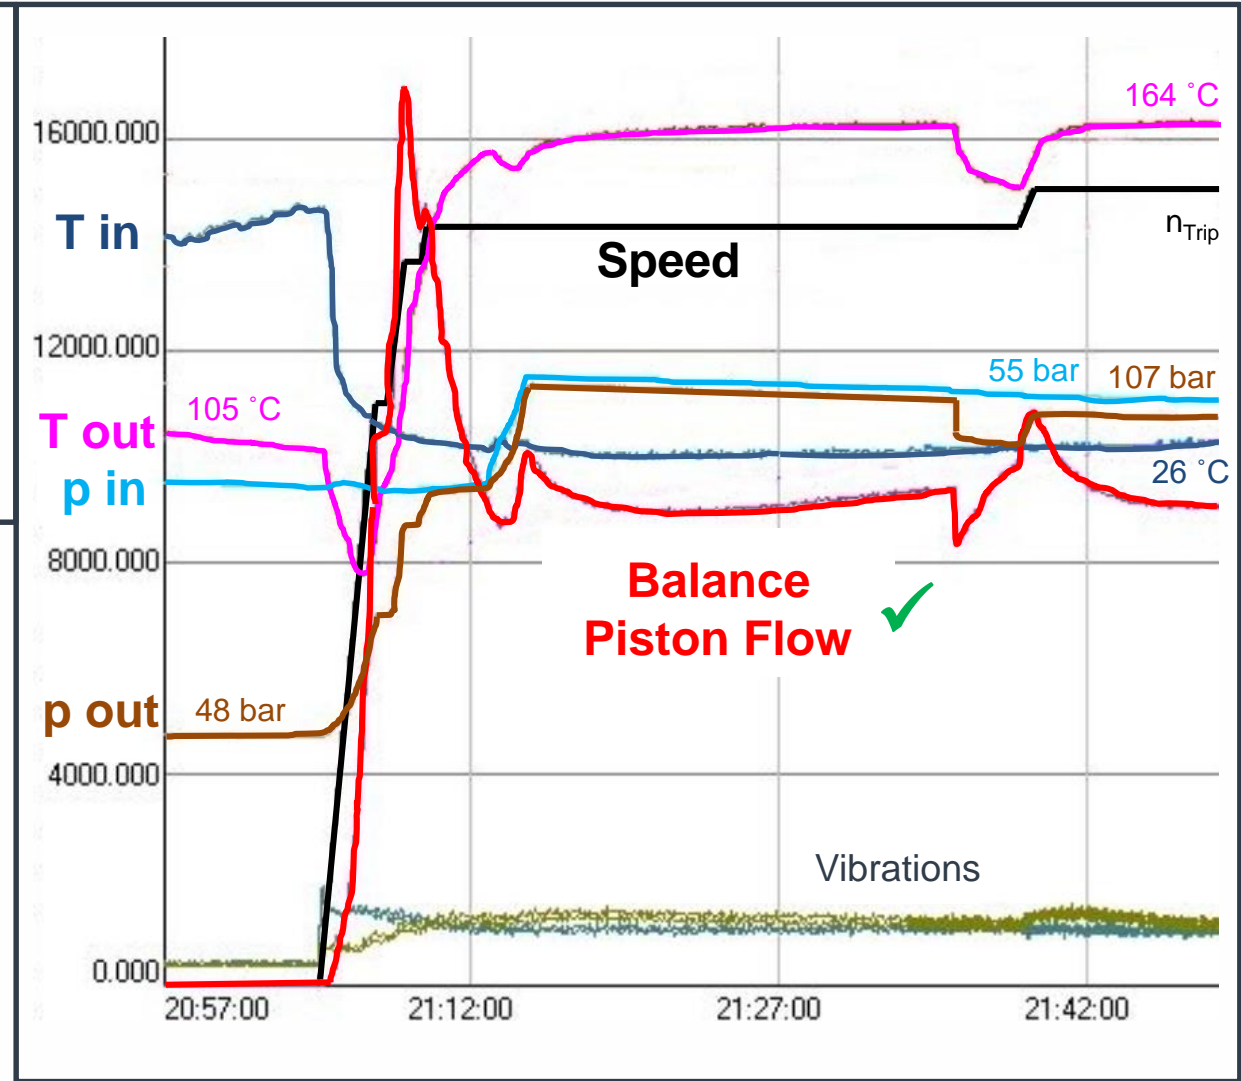
- Leakage flow stable
- All vibrations low and stable
- Mechanical Test successful
- No rubbing at Hole Pattern Seal
