51ST TURBOMACHINERY & 38TH PUMP SYMPOSIA

Case Study on Coupling Crack on a Centrifugal Pump

Train consists of 5000KW/60HZ (3588 RPM) induction electric motor driving a centrifugal pump through a flexible shim-pack coupling.

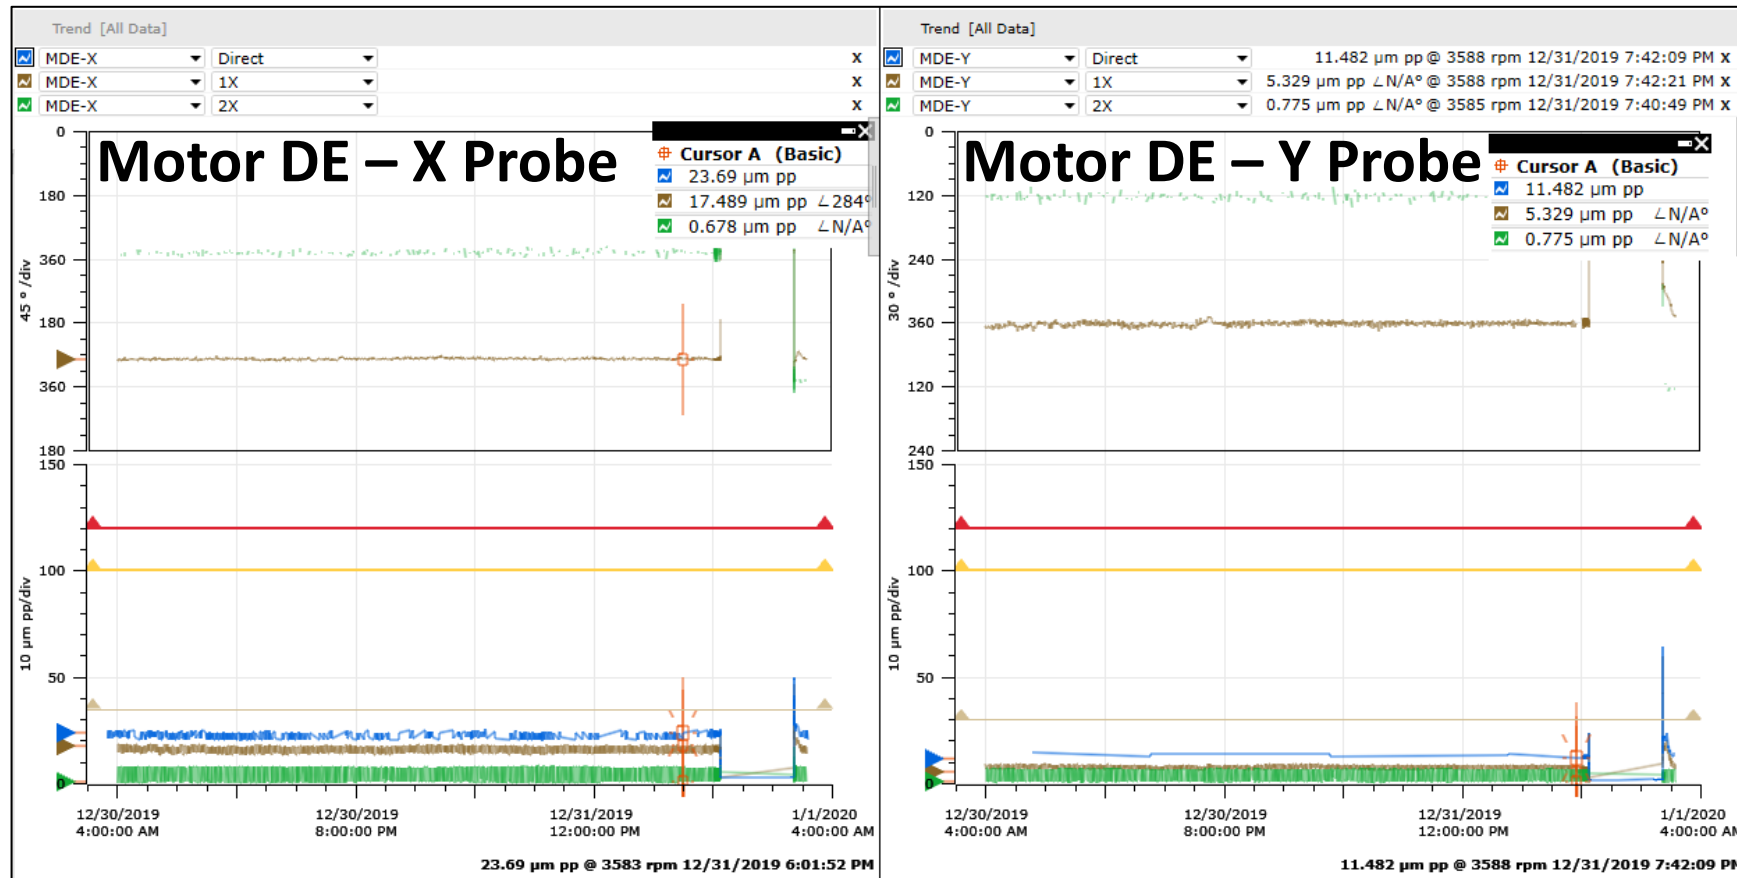
- Motor DE vibration probes shows acceptable vibration levels before the high vibration event.
- Unfortunately, no vibration data were available for approximately 4 months before the high vibration event.

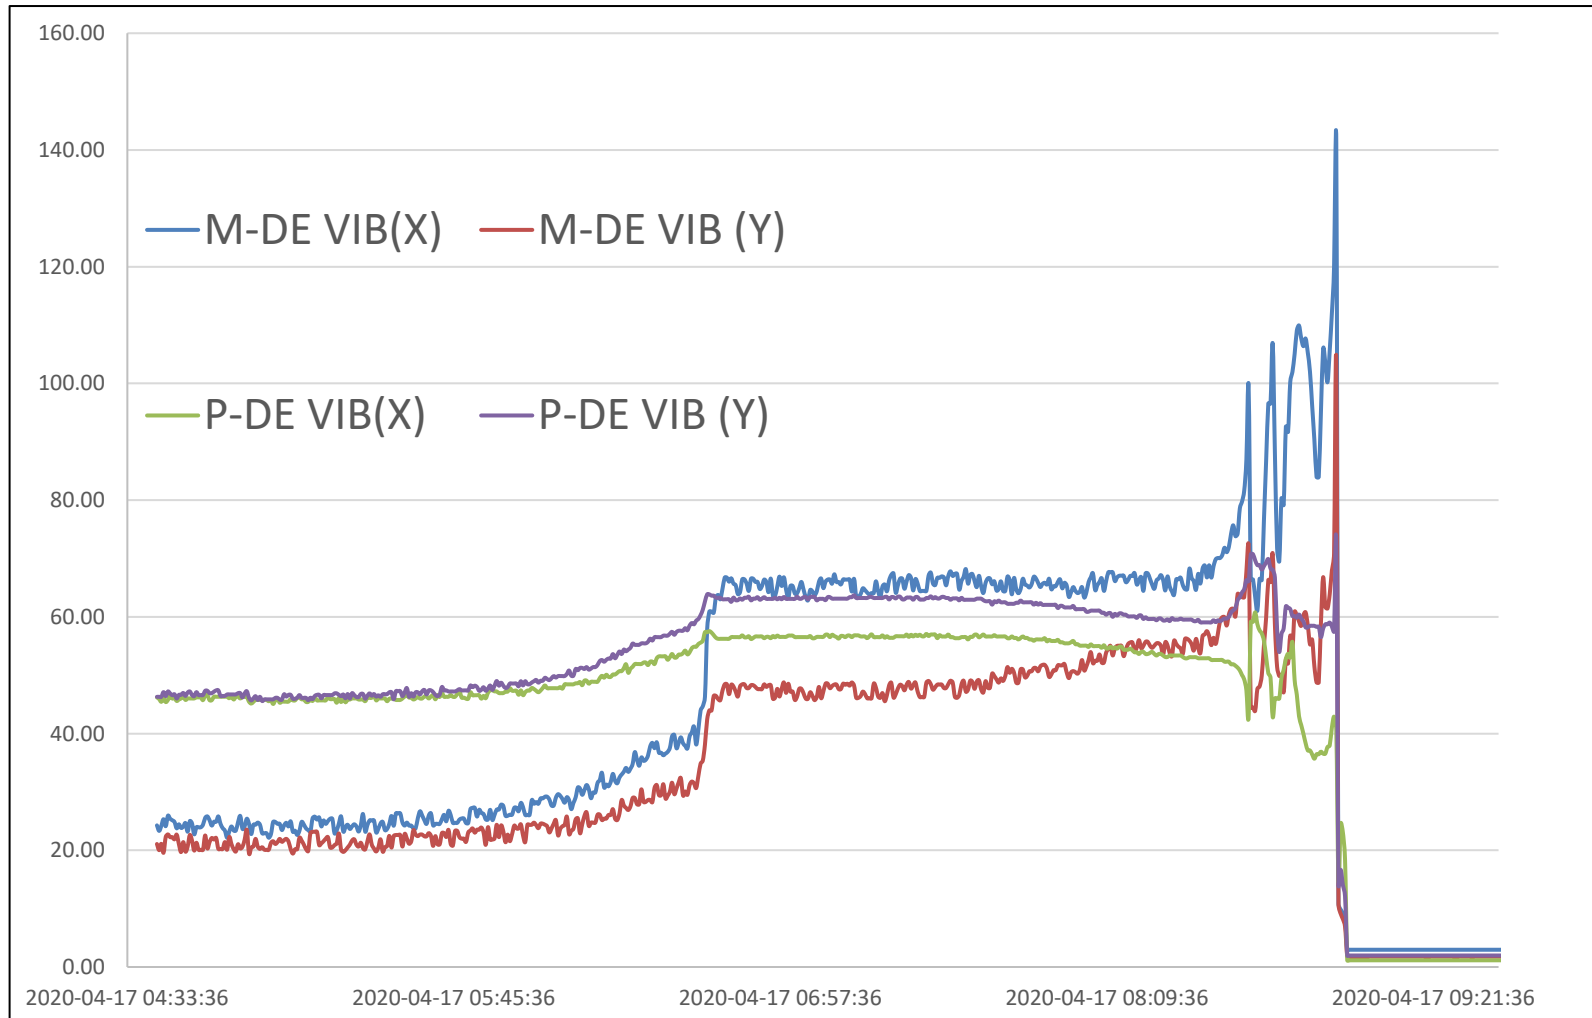
DCS vibration trend during steady State at the vibration trip event

- DCS vibration trend show the gradual increase in vibration levels until tripping the unit on motor DE.
- This trip event had no records on the online monitoring server due to communication loss between the software and the pump monitoring system.

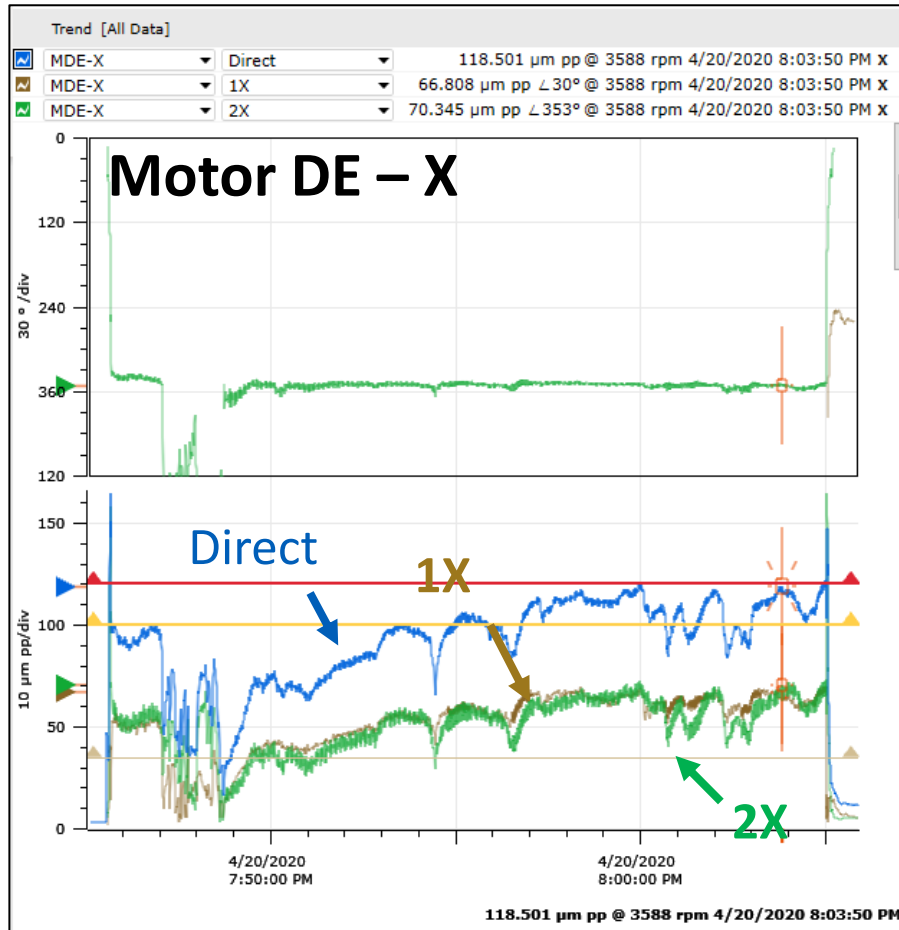
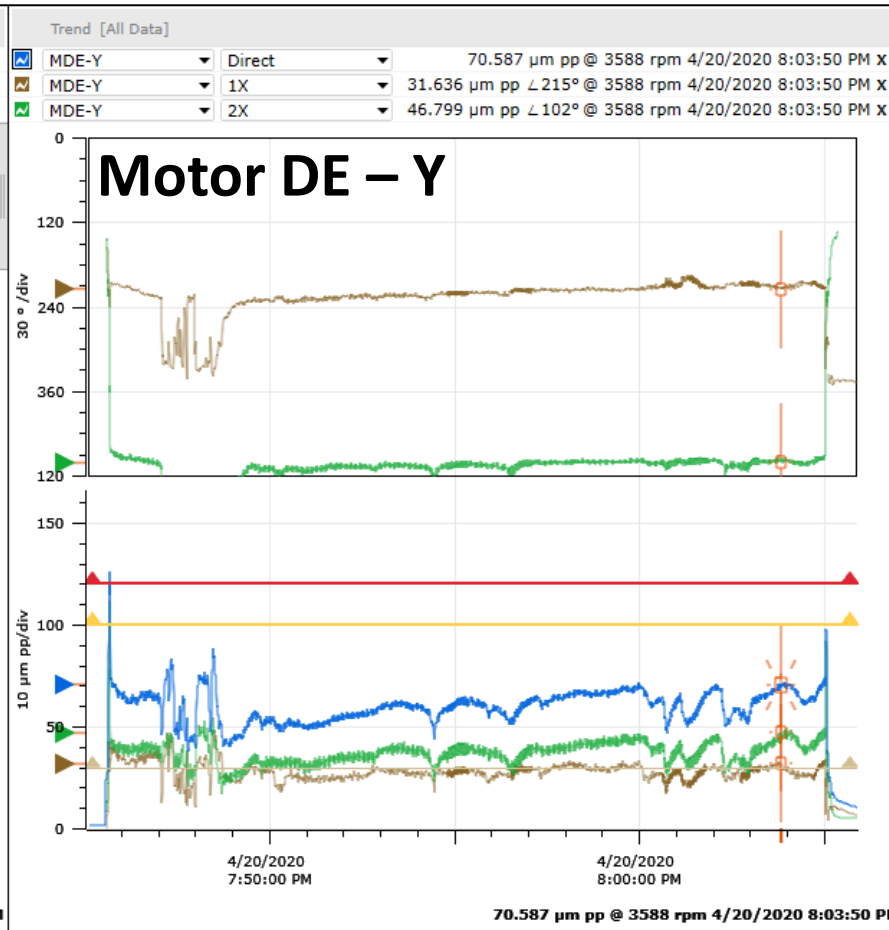
Motor Drive-End Trends after resolving the communication issue

- Motor DE bearing X & Y probes vibration trends recorded on the following startup shows the dominant 1X & 2X filtered peaks raising the overall value. Also, it reveals a rapid fluctuation behavior until tripping the unit again.

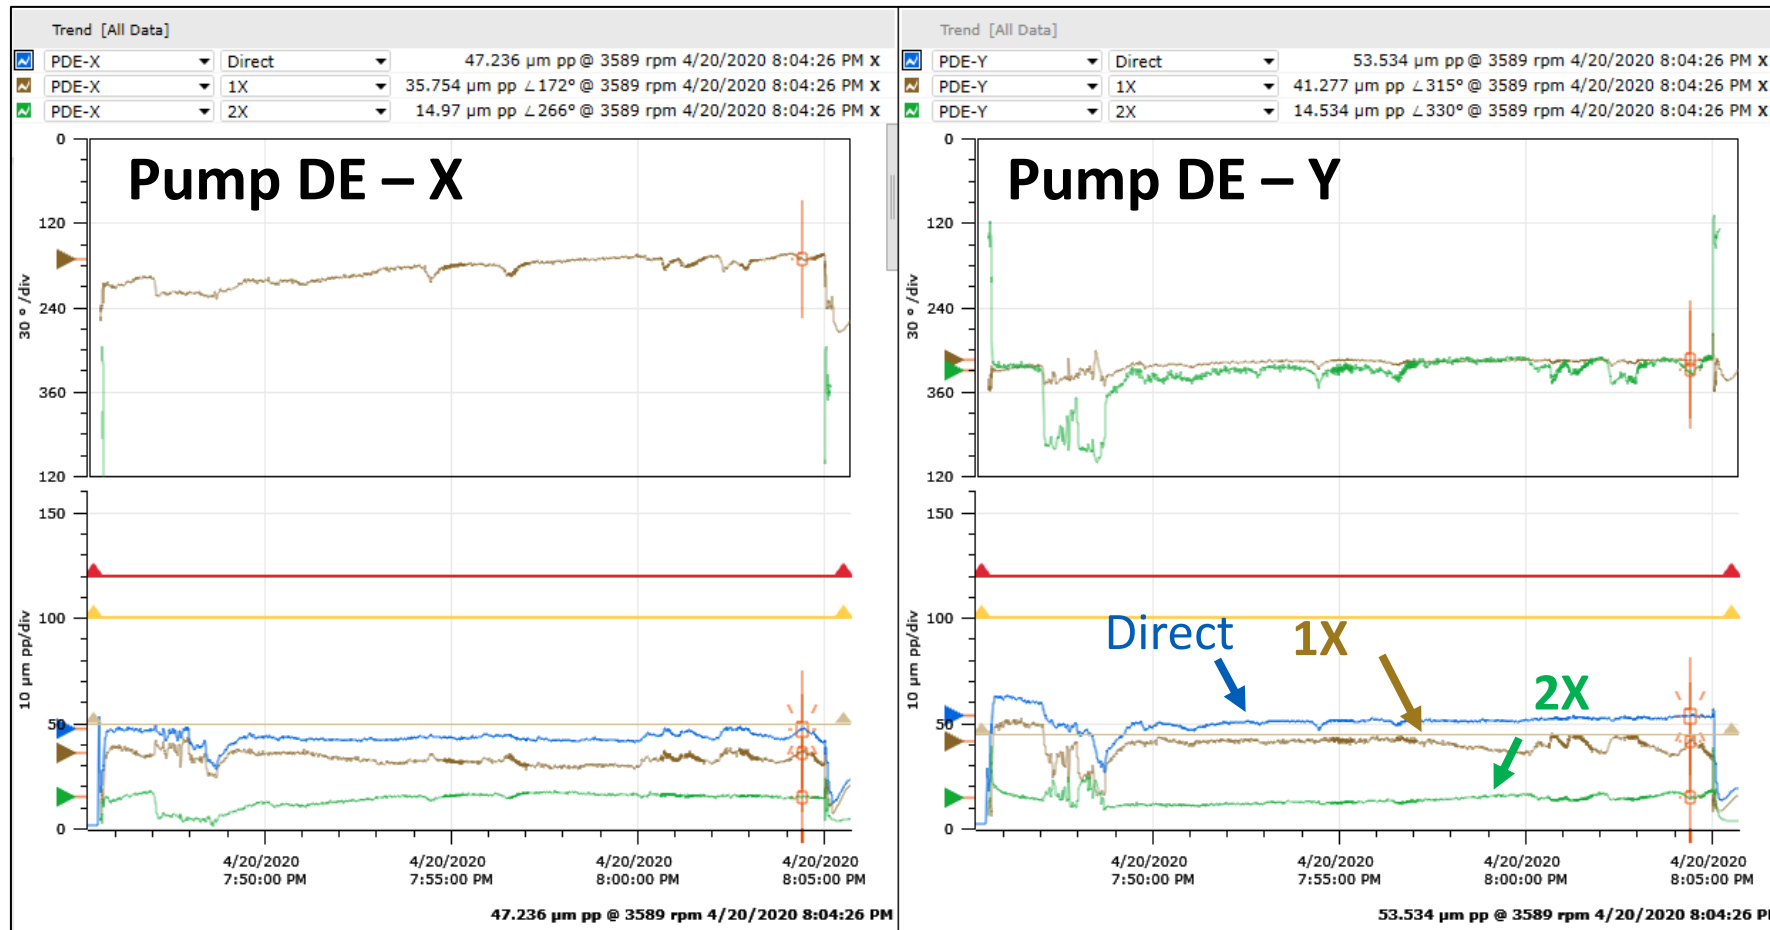
Pump Drive-End Trends after resolving the communication issue

- Pump DE bearing side reveals the dominated 2X peak and the fluctuation behavior, however, the overall values were low.

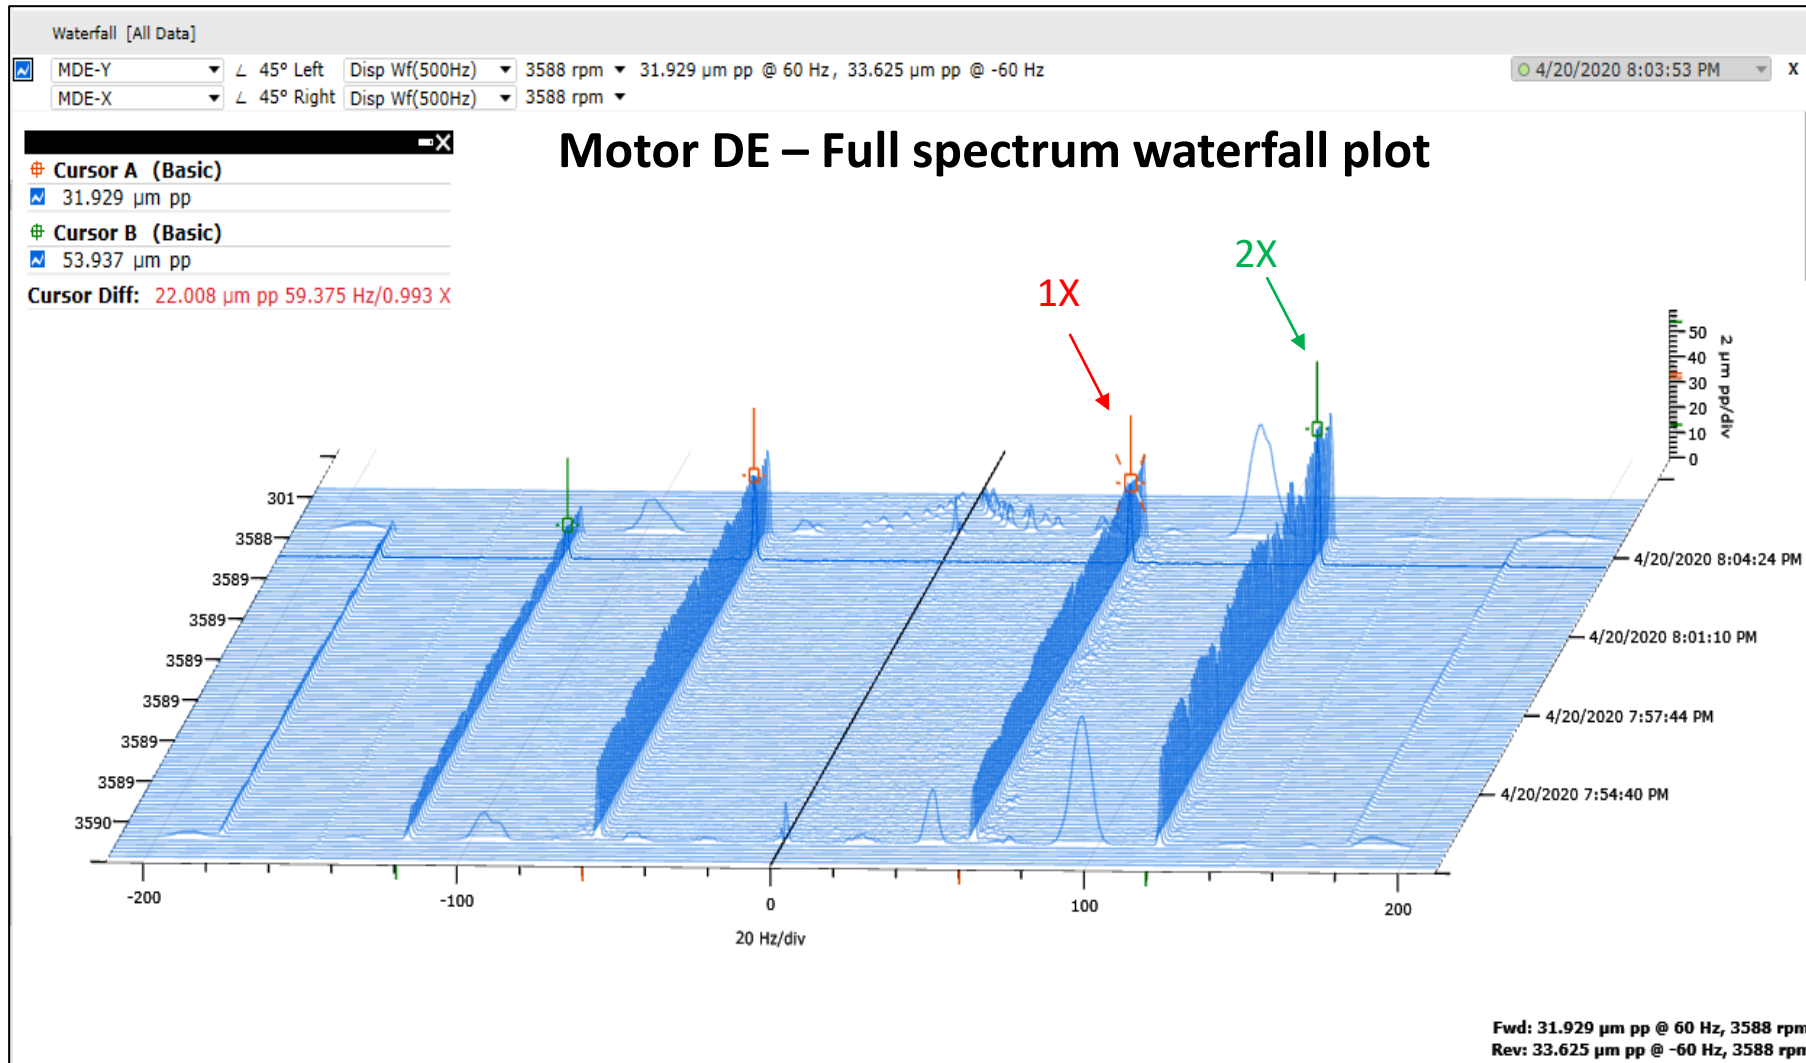
Motor Drive-End Spectrum Analysis

- Motor DE bearing Full-Spectrum waterfall plot during steady-state reveals the dominated 1X & 2X peaks.

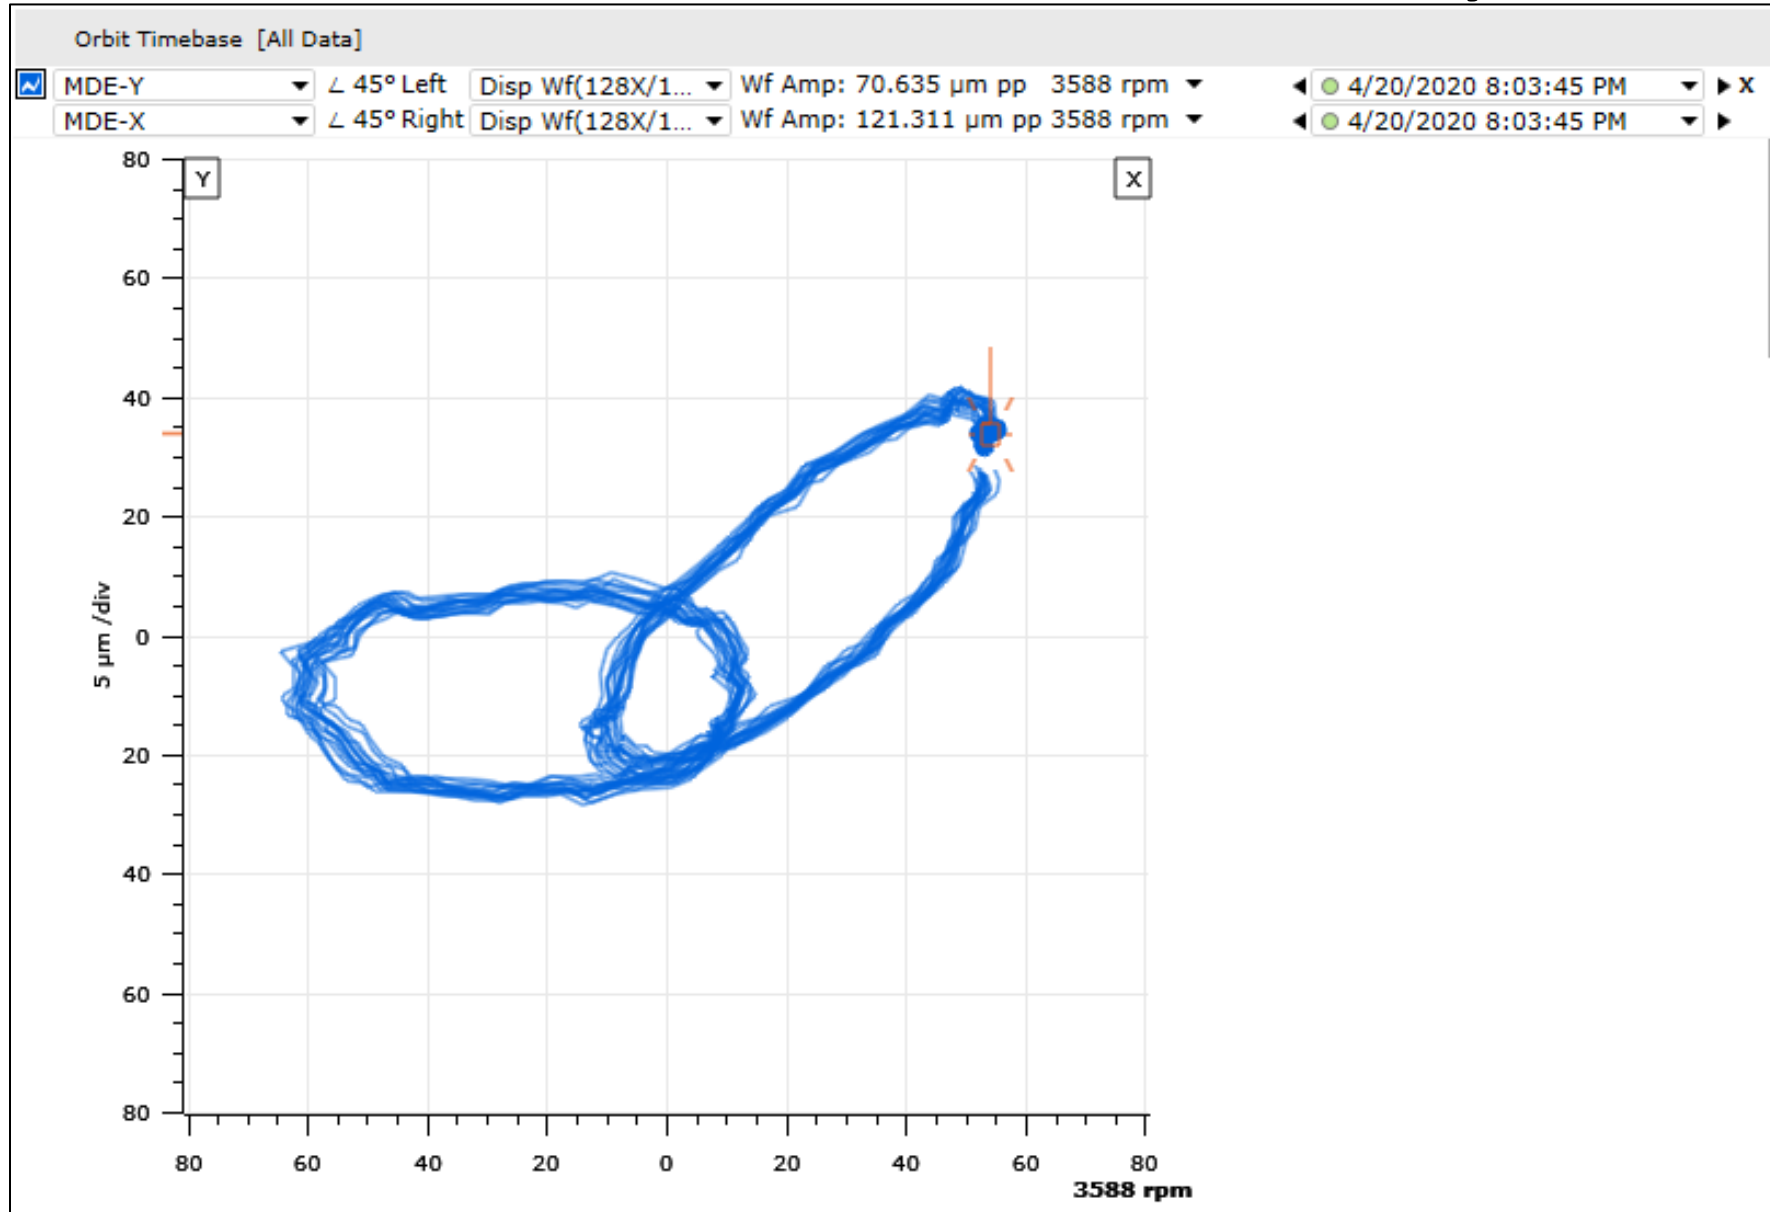
Motor Drive-End Orbit Analysis

- Motor DE bearing orbit plot during steady-state reveals the dominated 1X & 2X peaks.

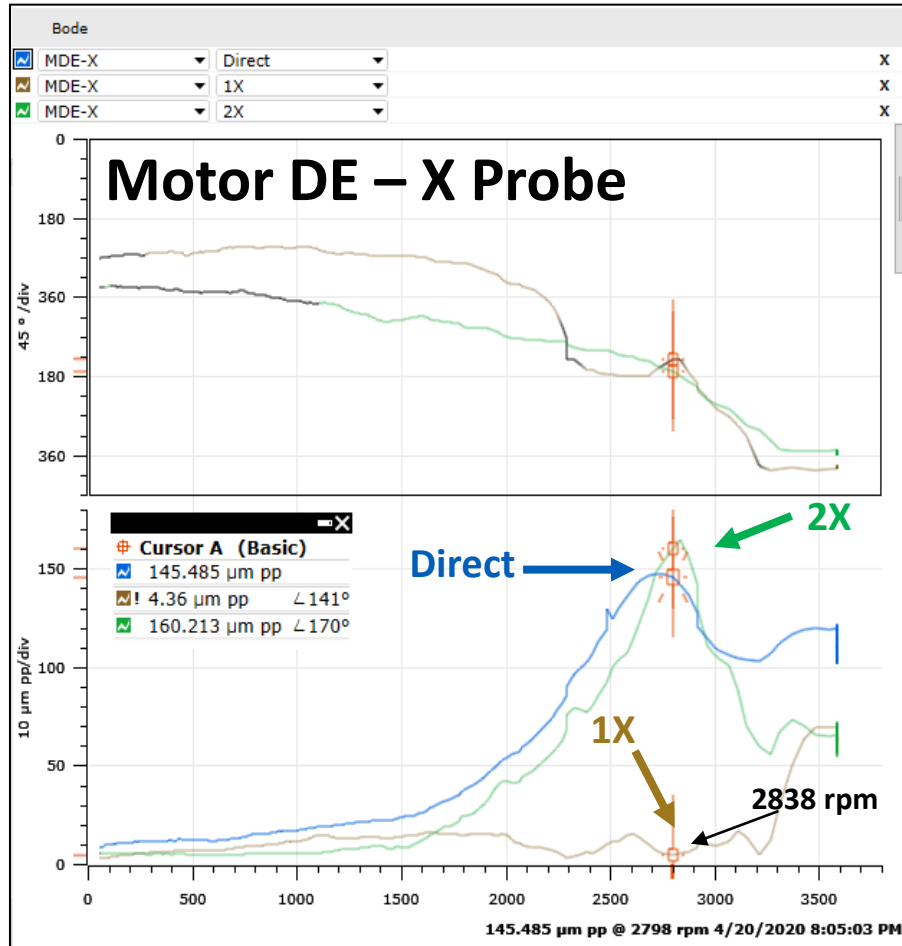
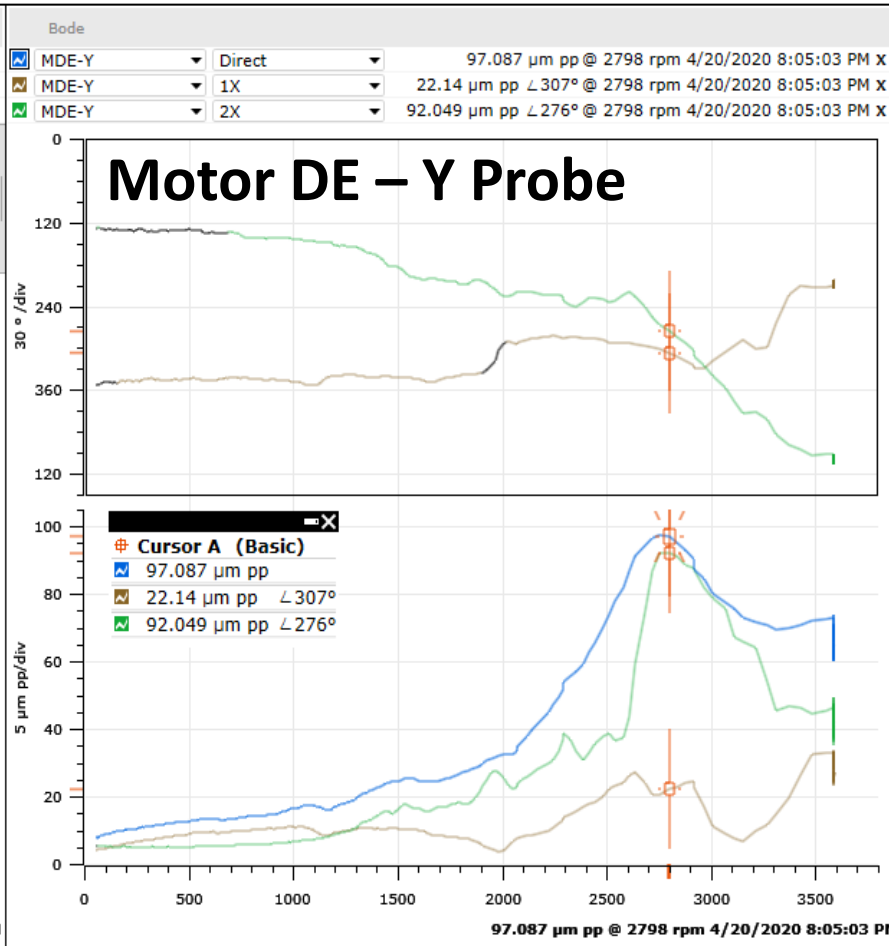
Transient Data Analysis – Motor DE Bode Plot

Motor DE bearing transient data analysis throughout Bode plot show the 2X peak excitation of second critical frequency while passing half of 2nd critical speed at 2800 RPM. While 1st critical speed continues to perform normally during coasting down.

- Transient data analysis throughout Bode, Polar & Full spectrum Cascade plots revealed that the 2X component exhibited abnormal behavior. While the rotor was coasting down and before passing the 1st critical speed (which is ~2300 RPM as per Motor datasheet and previously recorded data), the 2X component was excited, reaching $160 \mu\text{m}$ PP at 2800 RPM. It appears that this 2X vibration at 2800 rpm is half of the second natural frequency of 5600 CPM as evidenced from the shutdown 2X polar plot. Thus, it is believed that the observed 2X peak belongs to excitation of the 2nd critical speed. Note that this unusual behavior was not found on previous runs.
- This phenomena represents a rotor running at a speed close to half of resonant frequency with presence of asymmetric stiffness with a radial force.

- It was concluded that the rotor is experiencing crack symptoms; hence it was recommended to:
 - Inspect the coupling between motor and pump for any sign of coupling shims damage or shaft crack.

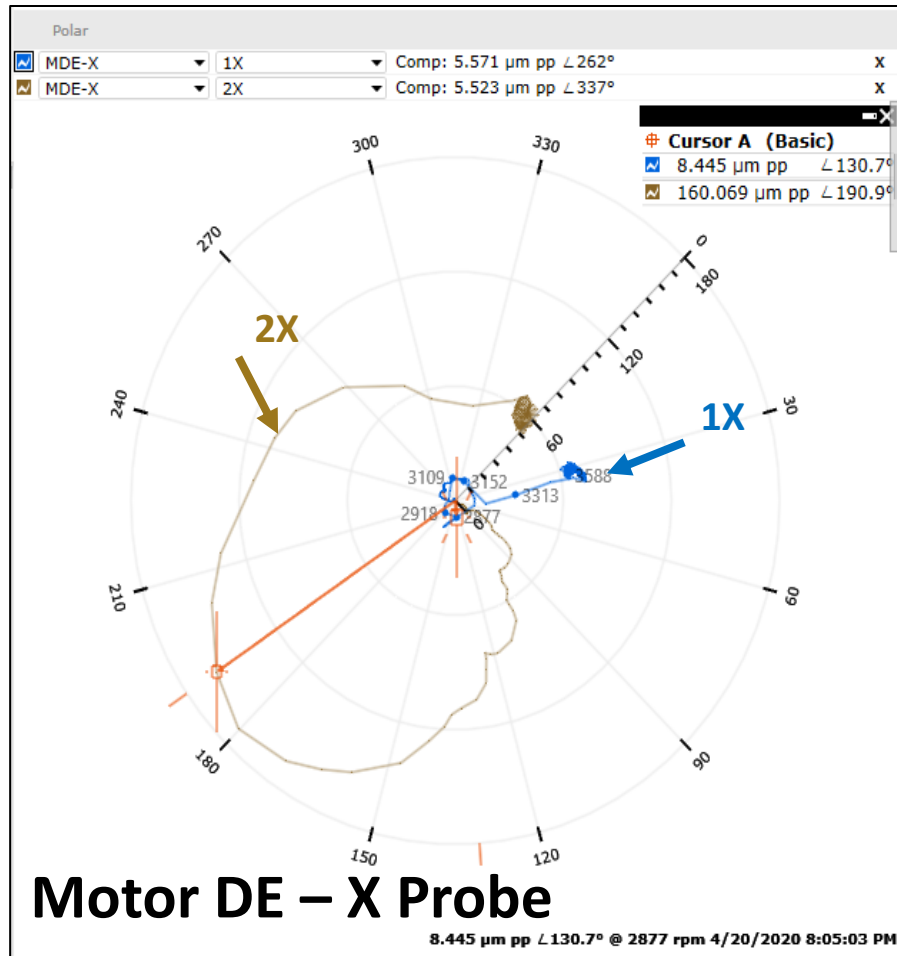
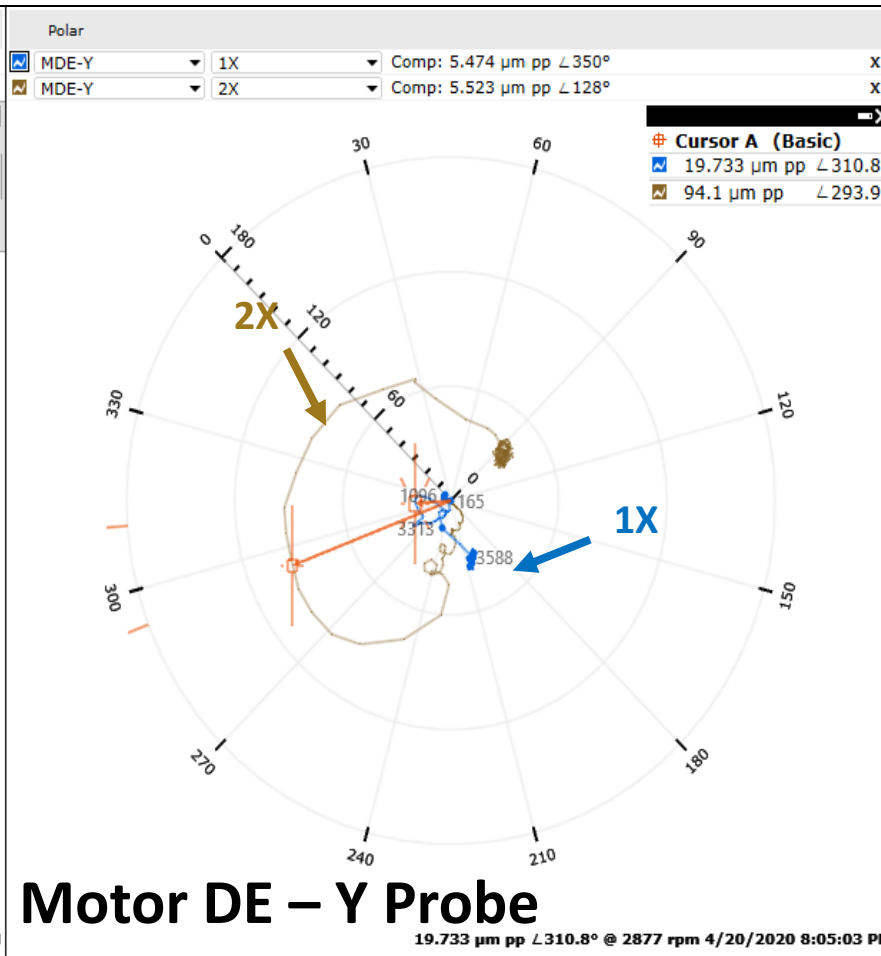
Transient Data Analysis – Motor DE Polar Plot

- Motor DE bearing Polar plot shows the 2X peak excitation of second critical frequency while passing half of 2nd critical speed at 2800 RPM. While the 1st critical speed continues to perform normally during coasting down.

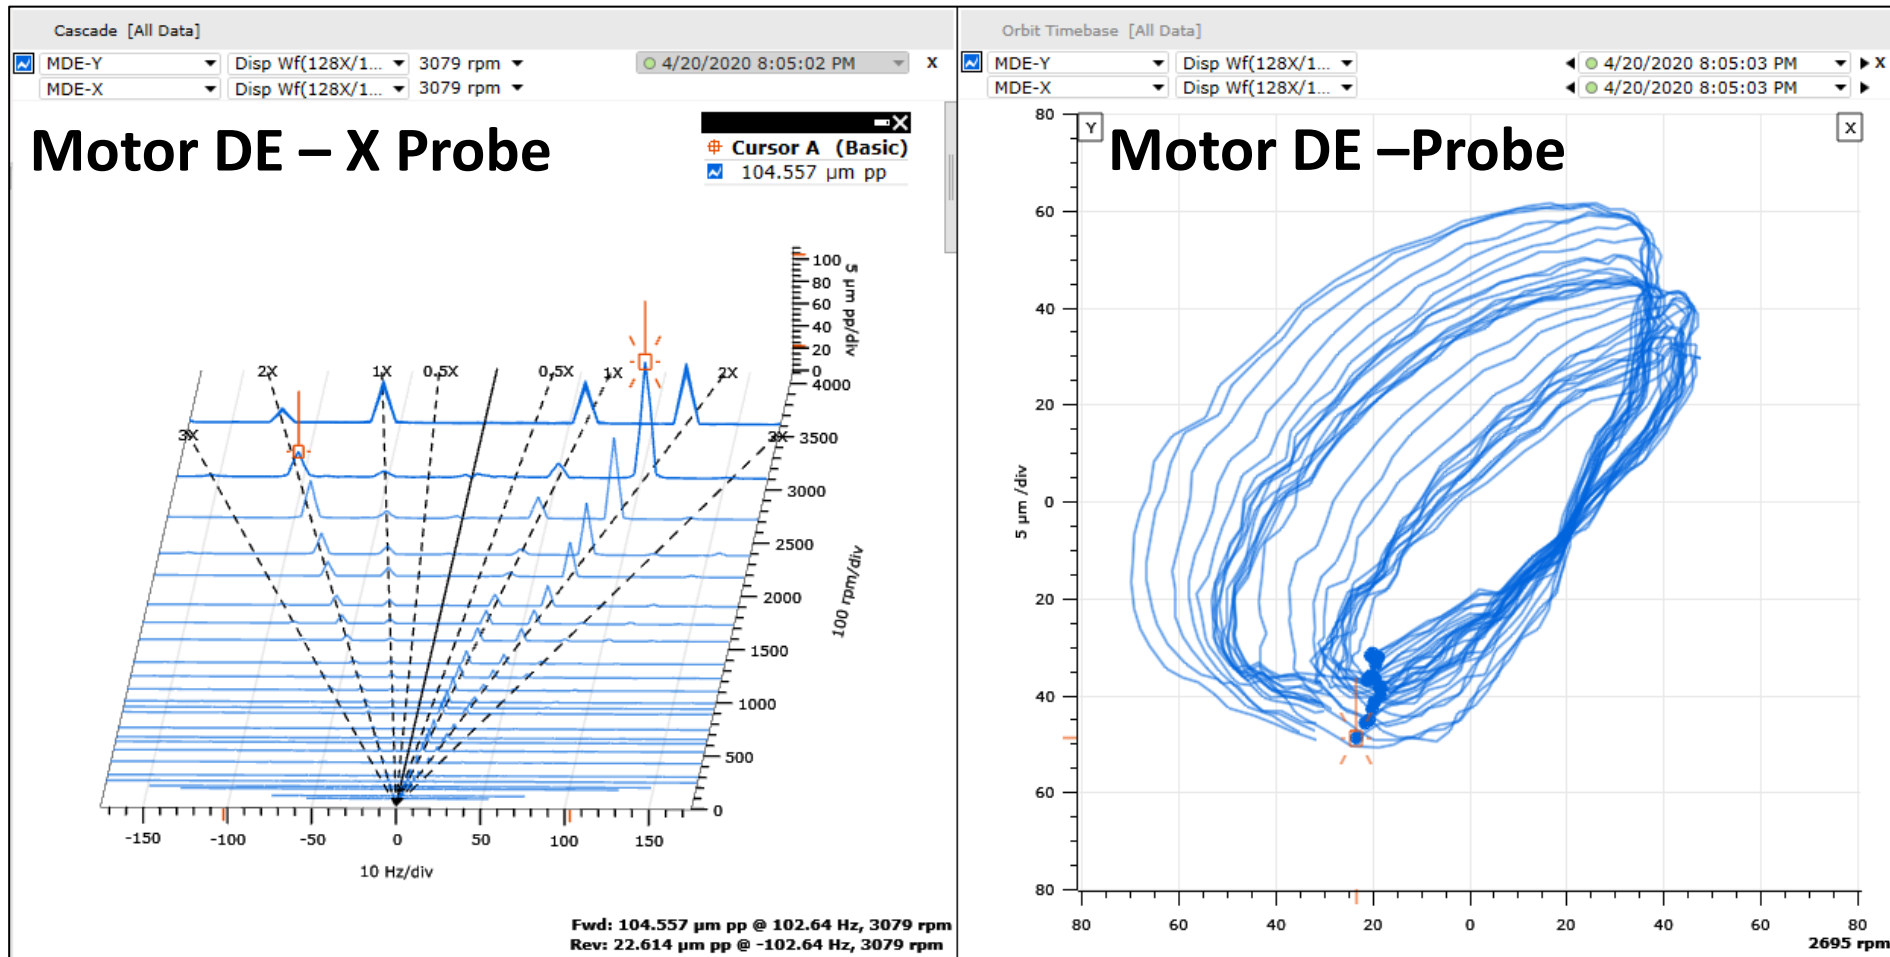
Transient Data Analysis – Motor DE Cascade and Orbit Plot

-Motor DE bearing synchronous Direct Orbit & Full Cascade plot while coasting down at 3231 RPM

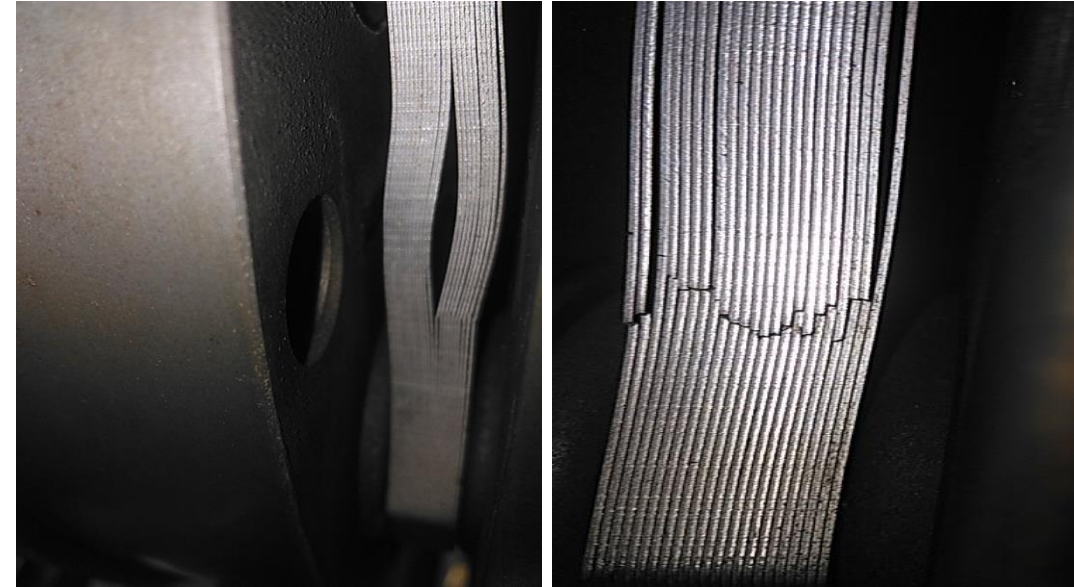
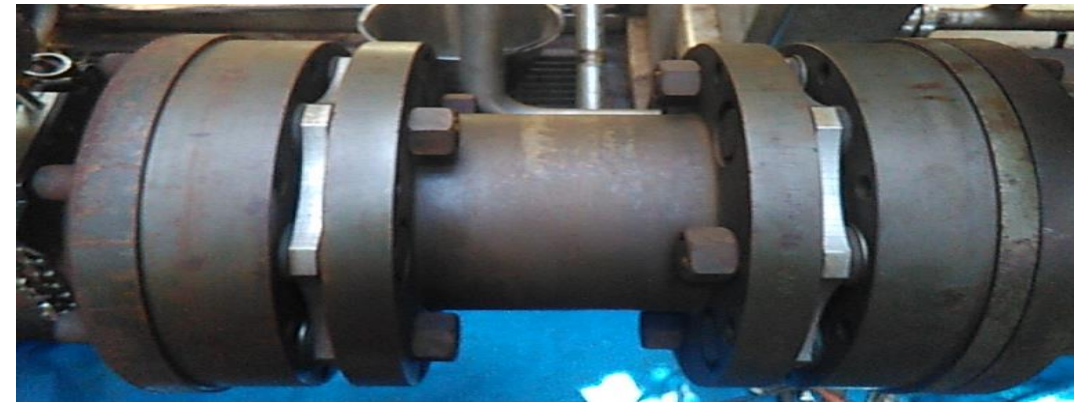
Findings

- ✓ Upon our recommendation, the site team inspected the coupling and found the shims (membrane) are bent and broken, as shown in the photos and inline with what was recommended.

- Historically these units are found in a highly corrosive environment in addition to corrosive foundations (another case from other sister machine) which could lead to this damage.
- The high dynamic forces coming from the motor each startup and frequently due to multiple process upsets could also contribute to experiencing this type of failure. This has been observed historically which also led to multiple pump trip events during startup.
- Minimum flow setpoint for one or two pump operation was found set incorrectly and rectified accordingly.
- Based of the findings above, asset team is working through the list of causes and eliminating them.

- Coupling was replaced and the unit started again with acceptable and normal vibration levels.
