51ST TURBOMACHINERY & 38TH PUMP SYMPOSIA

Repair and Protection of Pump Foundation

Ahren N. Lehner, P.E. & Ken Gerdes, NACE CIP Level III

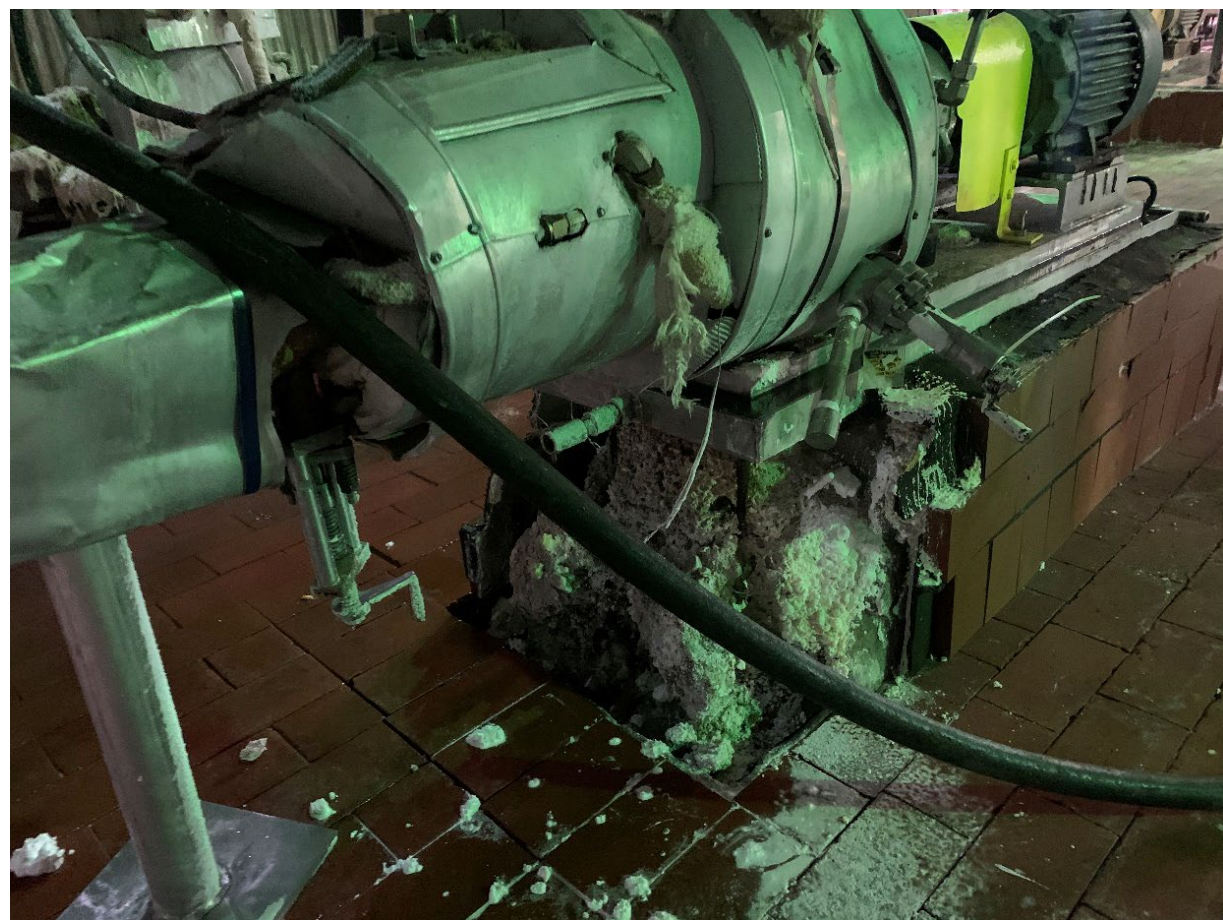
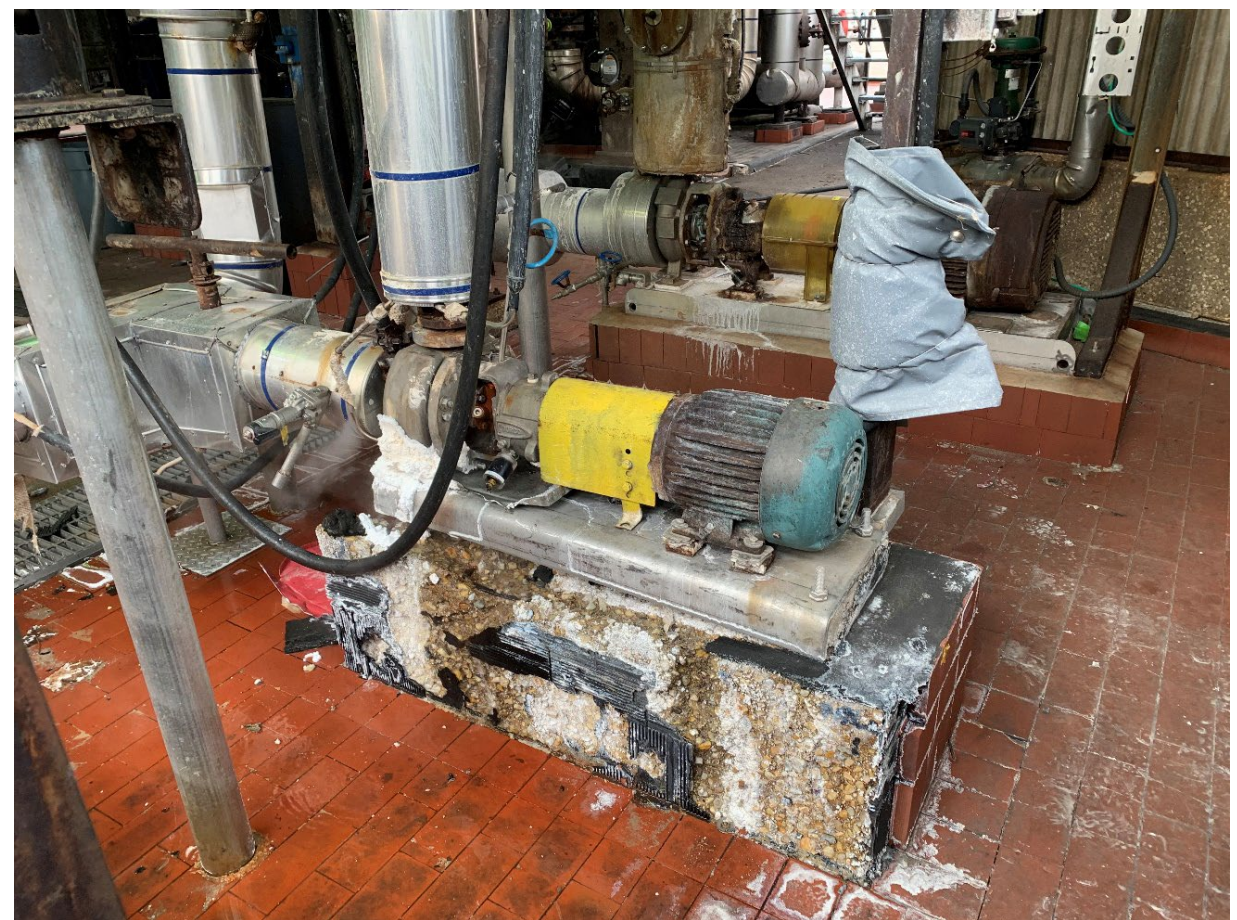
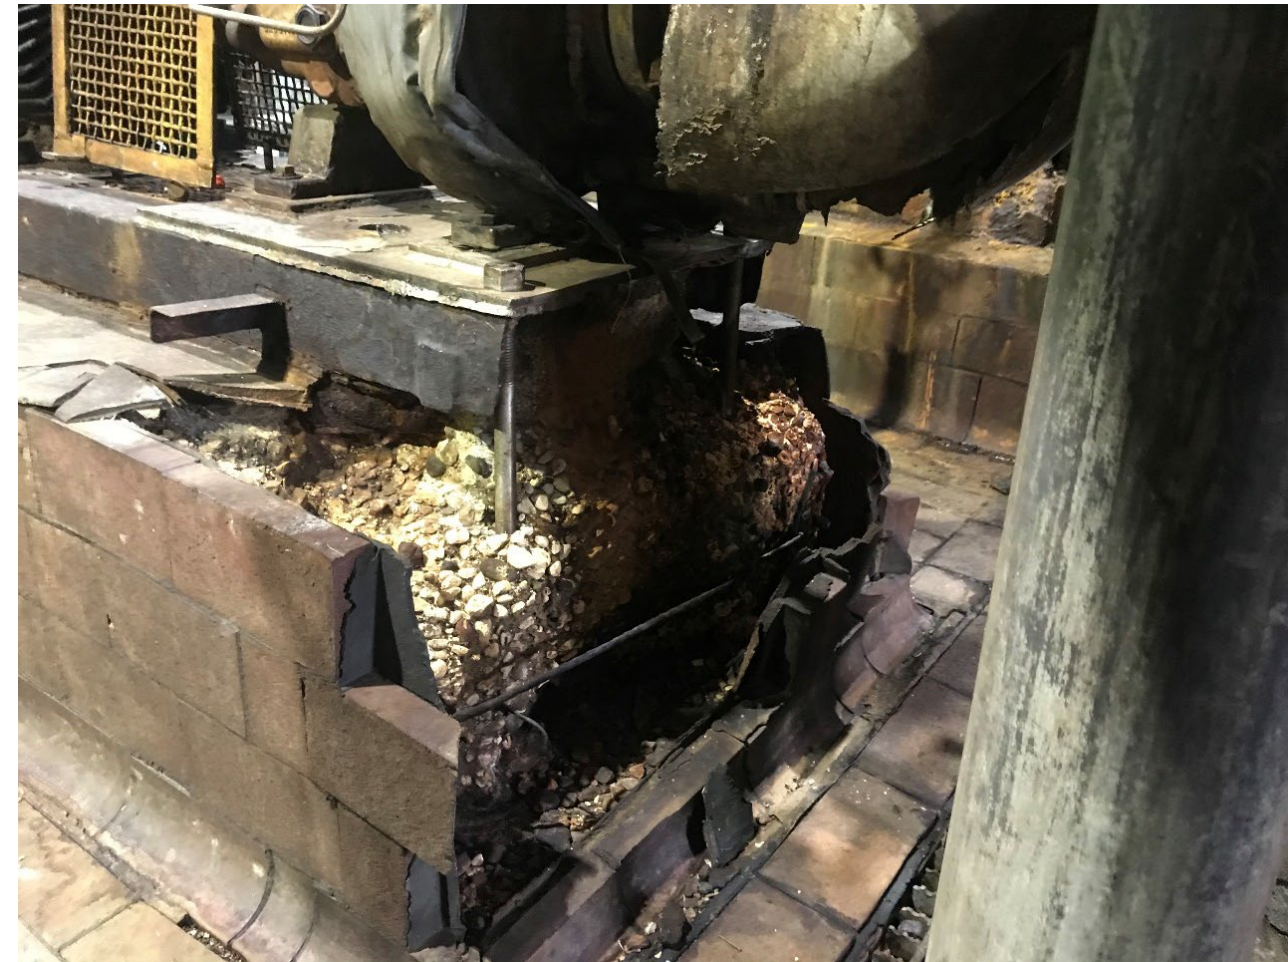
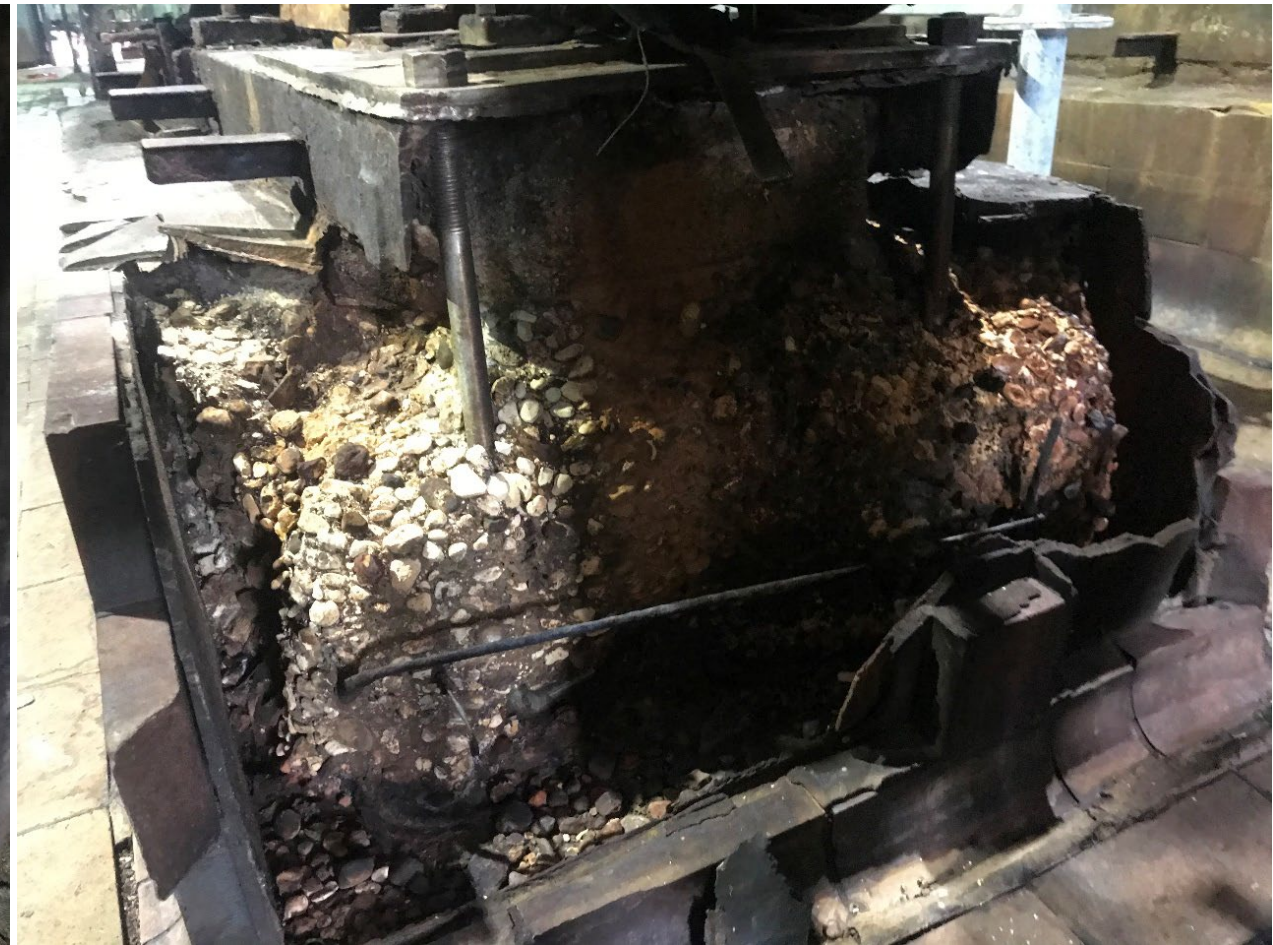
- While we go to great efforts to properly set rotating equipment, often consideration is not made to protect the base, and foundation system from erosion or corrosion. In this case study severe erosion of the foundation took place as the pump seals failed. This allowed for the acid to soak into the foundation causing it to deteriorate. We will go through the process of restoring the foundation and protecting it from further chemical attack.

Deteriorating foundations:
