51ST TURBOMACHINERY & 38TH PUMP SYMPOSIA

Power Turbine Field and Shop Balance Experience

A power turbine (PT) experienced a high 1X vibration issue. Balancing was attempted at two accessible planes on the shaft section. However, the unit could only operate with vibration below the alarm level in steady-state condition while experiencing over 10 mil pp and 1 in/sec pk in transient condition, which is not acceptable. A decision was made to remove the PT section for workshop balance. Indeed, excessive unbalance was measured on it at workshop and then reduced by 97%. Vibration level became very low afterwards at both conditions. From the current case, weight sensitivity or influence data was obtained with respect to the PT section plane. This makes it possible in the future to add correct weights at the PT section on-site without having to ship it for workshop balance. The lesson learned here is that obtaining balance influence data from available balance planes at all different running conditions is very important to see if it is feasible to reduce vibration to an acceptable level at all these conditions by using the available balance planes. If not, an alternative must be found, in

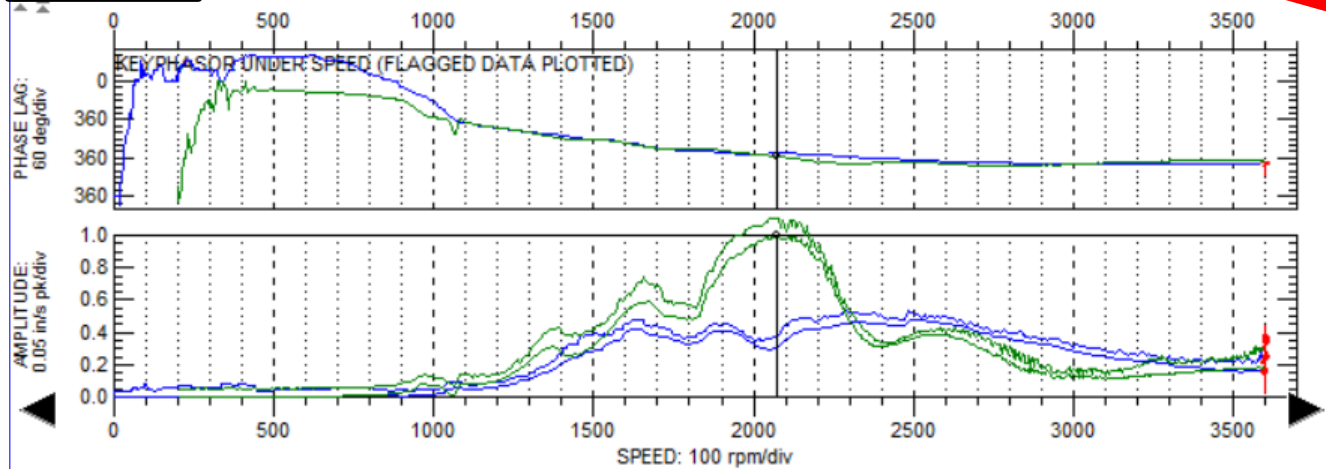
3JD

— $\angle 0^\circ$	Direct	1.104 in/s pk	$\angle NA$	2071 rpm	01FEB2021 19:08:15.955
From 01FEB2021 15:52:28 To 01FEB2021 19:18:05					
— $\angle 0^\circ$	1X	0.995 in/s pk	$\angle 349^\circ$	2071 rpm	01FEB2021 19:08:15.955
From 01FEB2021 15:52:28 To 01FEB2021 19:18:05

~ 2000 rpm during coastdown:
3J \approx 1.0 in/s pk

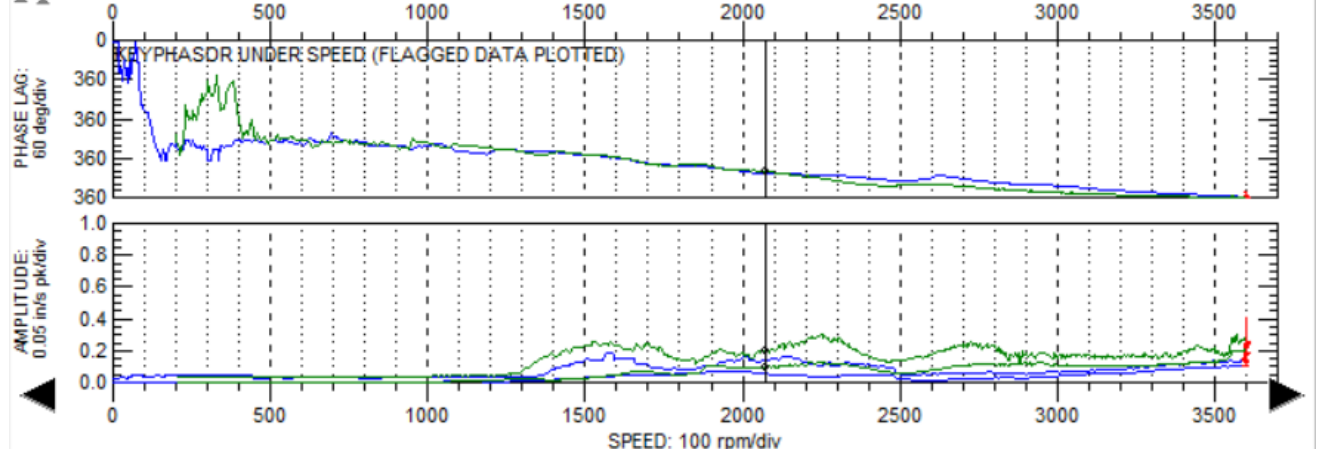
4JA

— $\angle 0^\circ$	Direct	0.197 in/s pk	$\angle NA$	2071 rpm	01FEB2021 19:08:15.955
From 01FEB2021 15:52:28 To 01FEB2021 19:18:05					
— $\angle 0^\circ$	1X	0.098 in/s pk	$\angle 109^\circ$	2071 rpm	01FEB2021 19:08:15.955
From 01FEB2021 15:52:28 To 01FEB2021 19:18:05

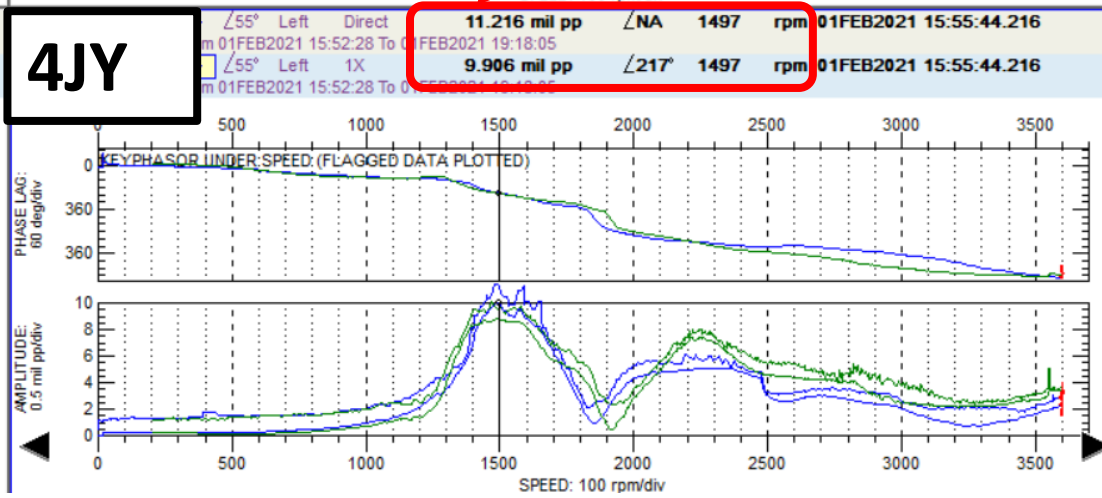
4JY

~ 1500 rpm during coastdown: **4JY ≈ 10 mil pp**

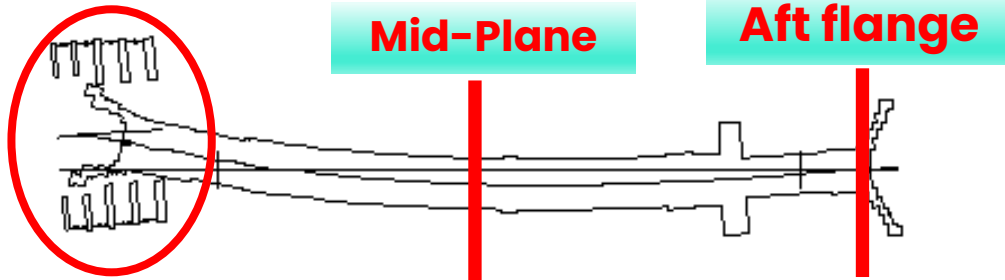
Mode 1 = 32.8 Hz (related to 1500 - 2000 rpm critical speed)

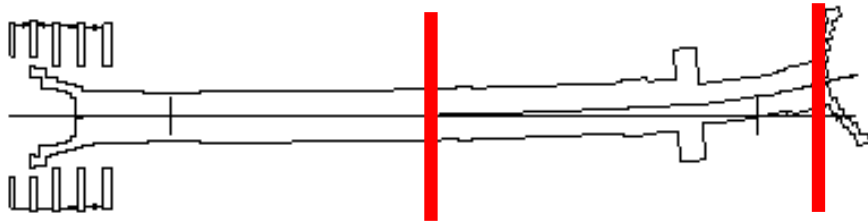
Mode 2 = 56.8 Hz (related to rated speed 3600 rpm vibration)

- Attempts at placing correction weights at mid-span and aft flange did not produce acceptable results.
- A reduction in vibration at either the 1st critical or operating speed was possible but not both.

- Prior to access power turbine balance planes, weight placement at the available two planes should be such so that low vibration maintains in steady-state condition, and the unit should be run for a longer duration.
- Arrange for power turbine shop balance.

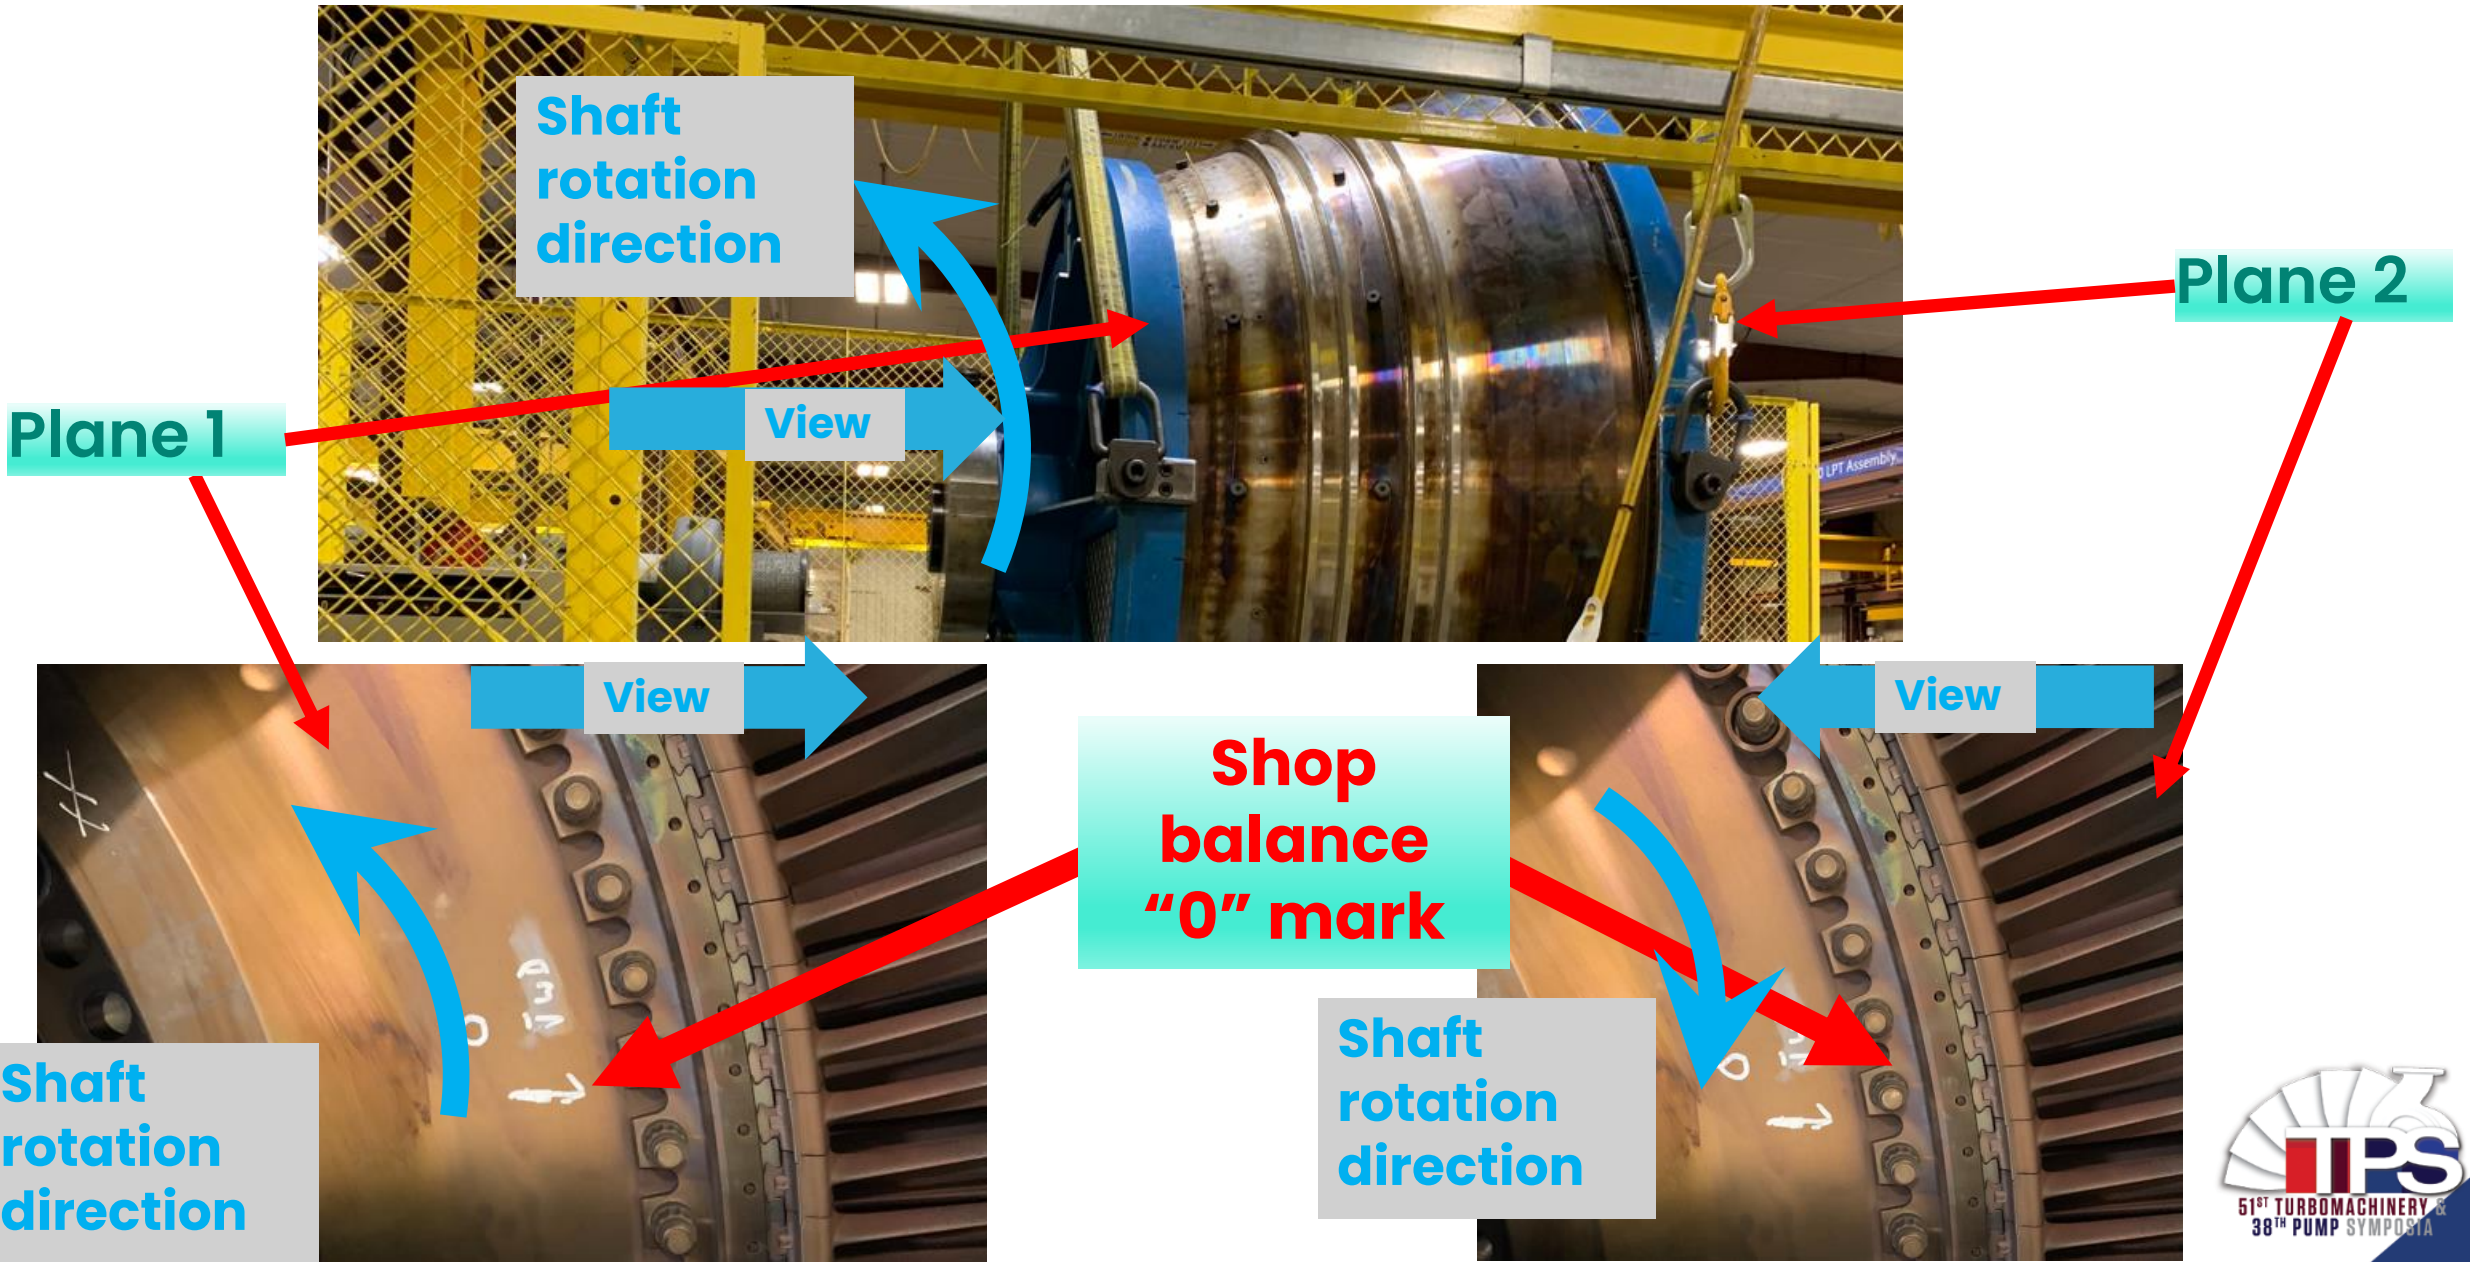
Excessive unbalance

Unbalance:

3357 g.in @306° 4011 g.in @306°

Unbalance reduced by 97%

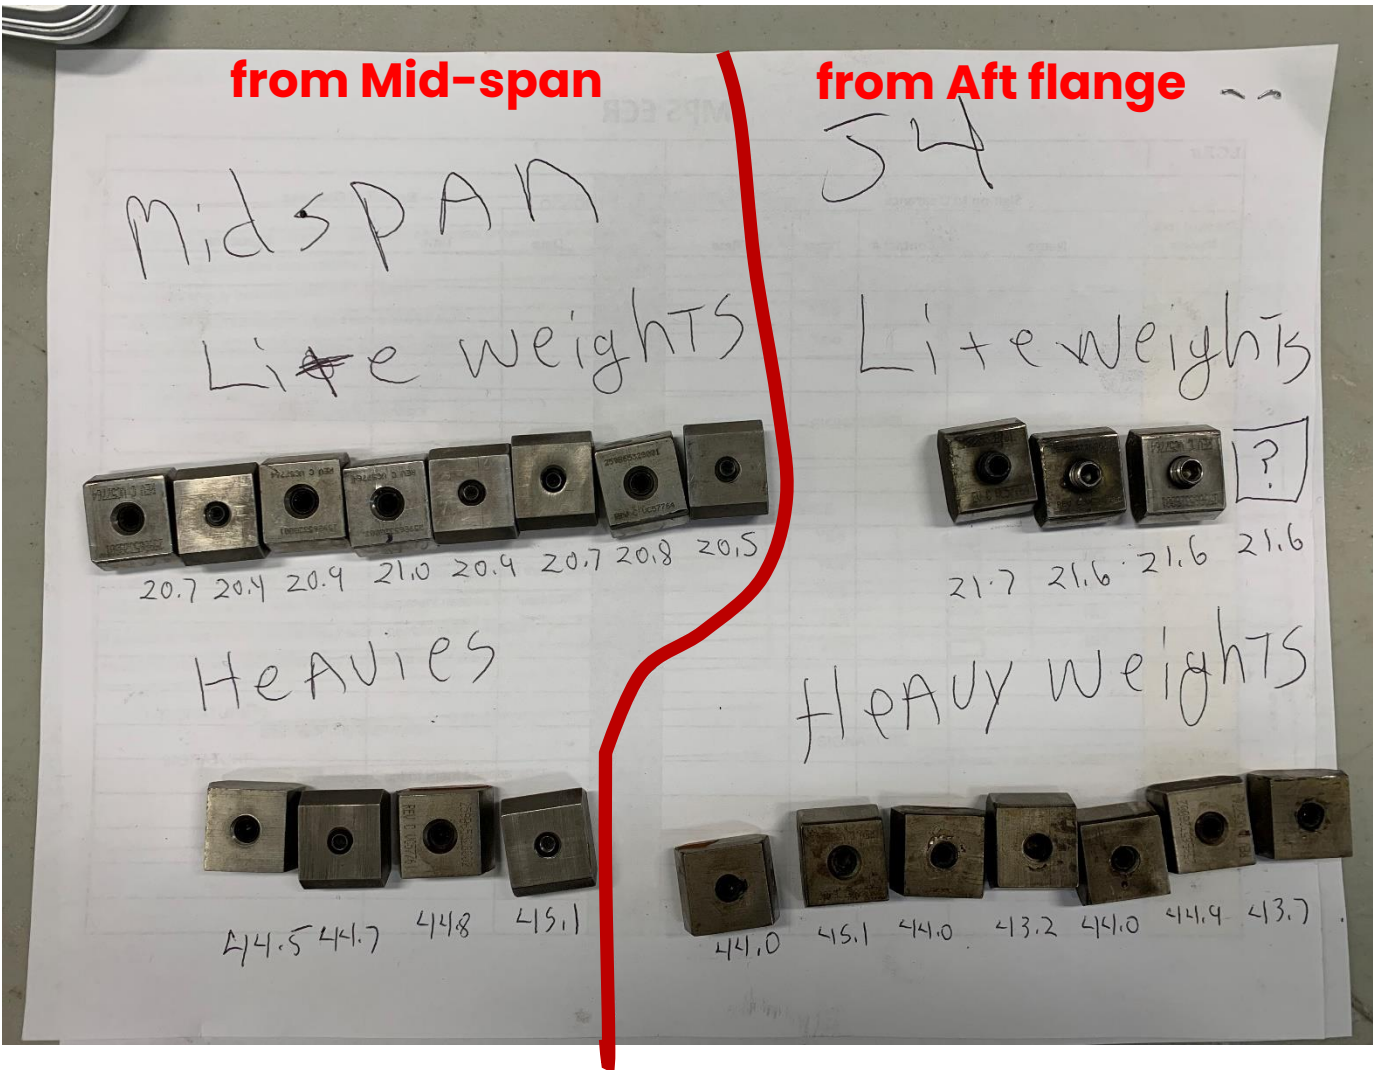
All the previous balance weights removed

- Run on Oct 30th was made with existing field balance weights at the mid-span and aft flange. Field balance weights were previously added to offset power turbine unbalance.
- With the shop balance of the power turbine, it was recognized that these were no longer needed.
- Power turbine was restarted with all weights removed from these locations.
