51ST TURBOMACHINERY & 38TH PUMP SYMPOSIA

Reciprocating Compressor Motor Vibration During Initial Start-up

Robert C. Eisenmann, Jr – bp Rotating Systems Advisor
Yasser Nasef – bp Rotating Equipment Engineer – North Africa

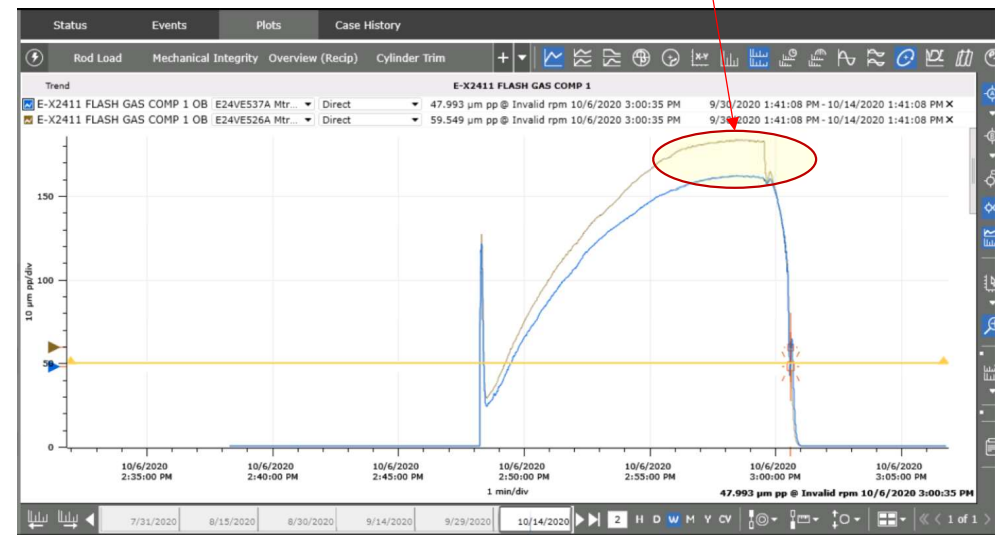
- October 2019
 - Train 1 and 2 commissioning nitrogen runs.
 - Compressors preserved
- October 4th, 2020 – Train 2
 - Commissioning reconvened with 2nd nitrogen runs
 - No significant issues
- October 6th, 2020 – Train 1
 - Alarm on motor vibration after 1 minute 15 seconds
 - Noise from the area of the motor bearing, motor fan and barring device
 - Vibration continued to climb
 - Shutdown after vibration reached 180 microns pp
 - Total run time 12 minutes

Vibration appears to have leveled and started to reduce

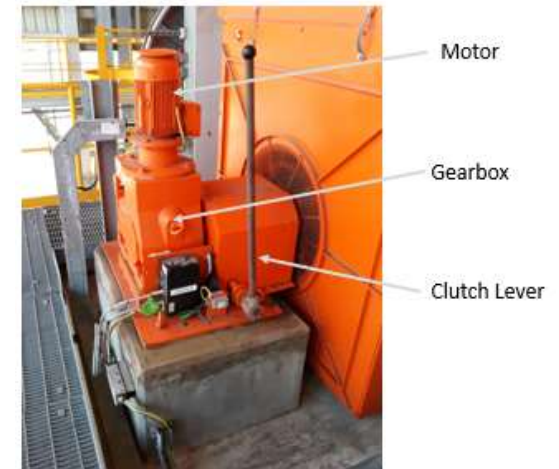
- Alignment
 - Single bearing motor and slight vibration response on compressor frame
 - Not supported by historical data
- Bearing Fault
 - No significant gap movement and no abnormal temperature increase
 - Gap did not return to post run position immediately following shutdown
 - Not supported by historical data
- Motor/Shaft Fault
 - Sinusoidal waveform where amplitude varies over time
 - Not supported by historical data
- Barring Device
 - Area of concern due to noise in area

Motor driven barring device with reduction gearbox and clutch

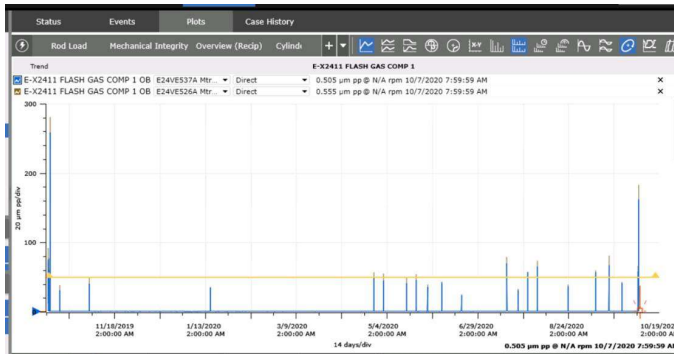
- Barring during 1 year of preservation, runout up to ~75 microns at times, higher than expected

Barring and runs in October 2019 with very high displacement during barring but semi acceptable runs with the exception of the run on October 9th

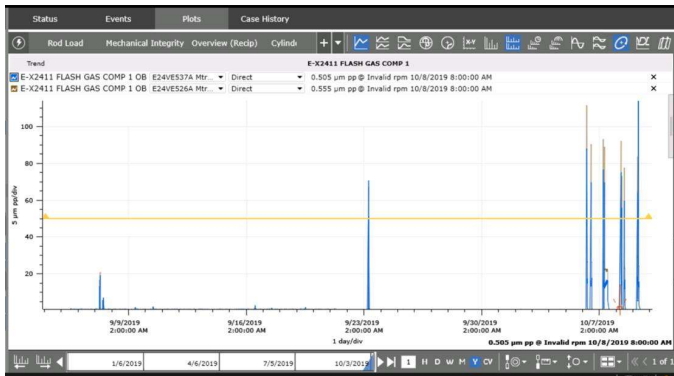
- Very high readings from October 2019

October 9th, 2019 run test. Running state with ~260 microns that dropped to ~20 to 30 microns after 20 minutes.

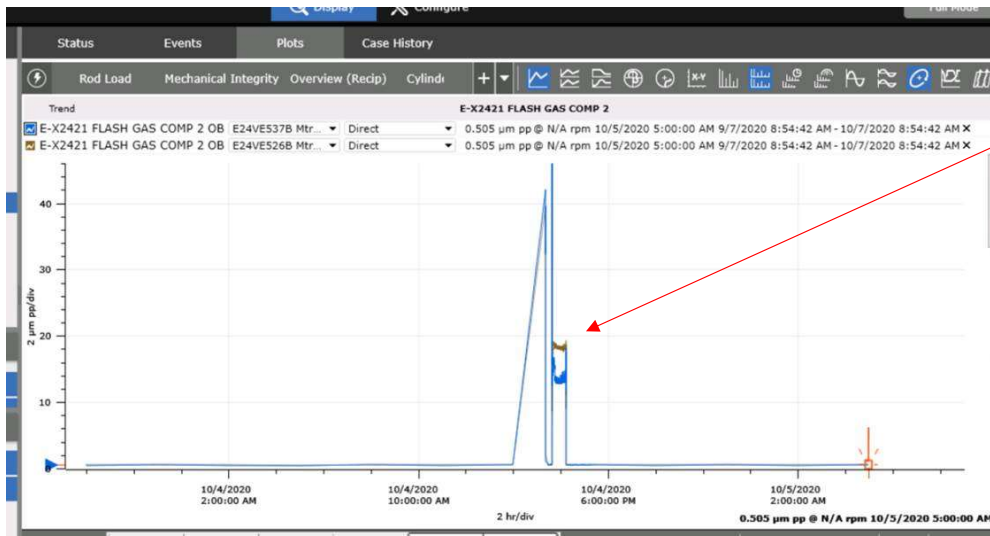
- Run on October 6th, 2020, where the barring and run are at acceptable levels of about 45 microns during barring and less than 20 microns during the run.

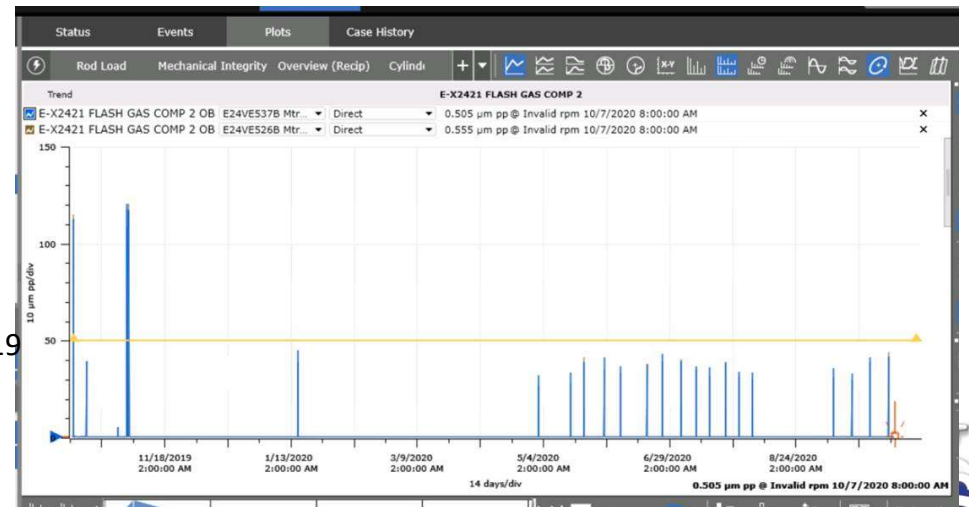
- Barring events in 2020. All are at acceptable levels, but 2019 shows very high levels during barring. This indicates some influence from the barring device.

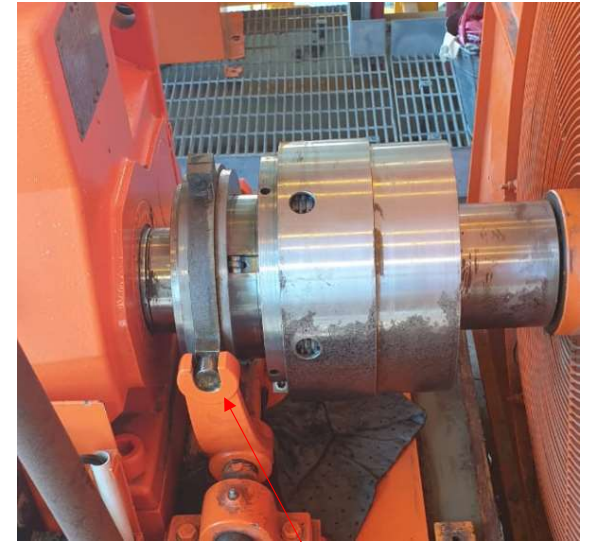
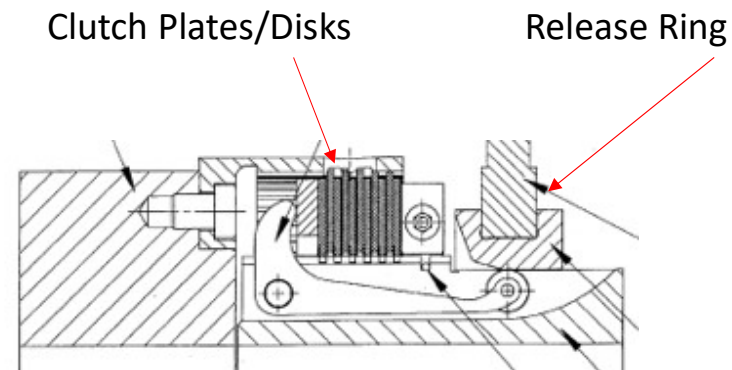
- History indicates clutch was adjusted due to slipping
- Significantly harder to engage clutch on Train 1 verse Train 2
- History shows that vibration decreases after some run time
- Elevated response during barring
- Vertical, horizontal and angular misalignment identified
- Clutch plate wear

- Attempted to resolve the vibration issue by:
 - Adjusting the clutch
 - Aligning the clutch
 - Then removing the clutch completely
- All resulted in no significant changes in response
- Re-evaluated the options and decided to inspect motor shaft, bearing and alignment

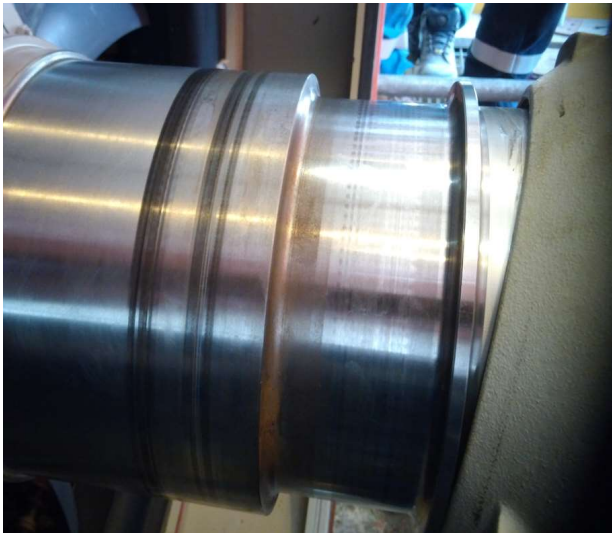
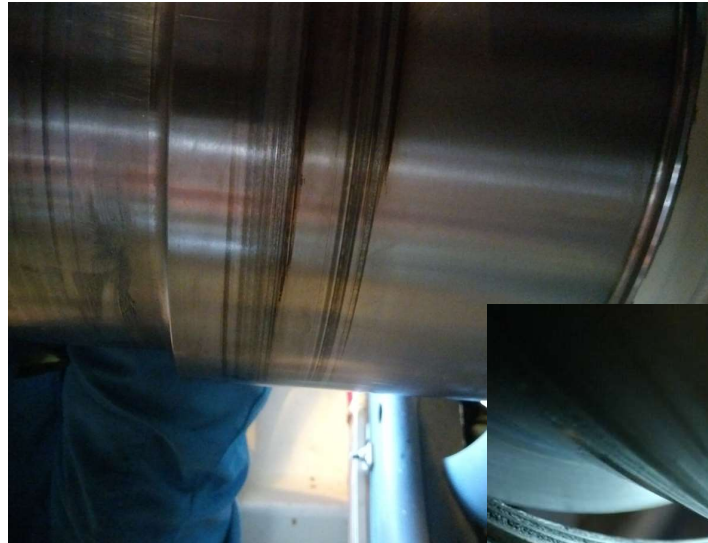
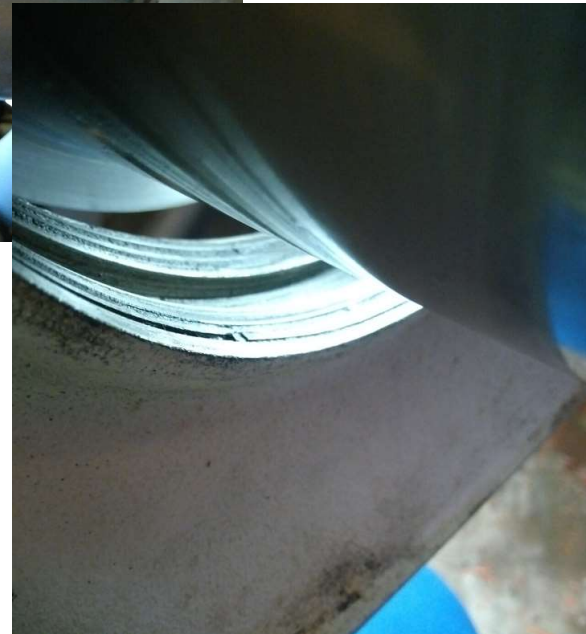
Inner Air Seal

- The motor data supplied was only an outline drawing showing external details
- Bearing was a 3rd party supplied bearing assembly
- During bearing inspection, inner seal was identified
 - Motor OEM identified inner PTFE air seal.
- Inconsistencies on motor stator alignment/movement data

- PTFE seal “rub tolerant”
 - Heavy rub
 - Material pulled from grooves and balled up

- After PTFE material was removed from the inner air seal and alignment was verified, there was a successful start-up.
