### THREE CASE STUDIES: MOISTURE CONTROL IN A HOT, HUMID CLIMATE

Warren R. French, P.E., RRC, CCS, President  
French Engineering, Inc., Houston, Texas

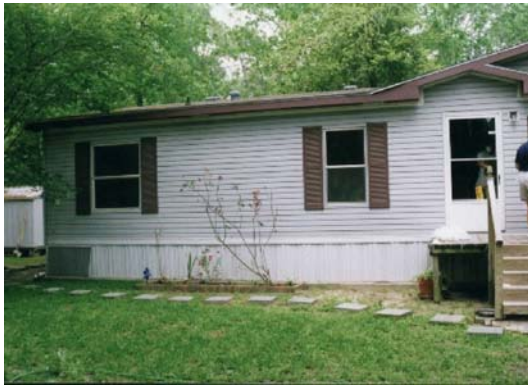
**Figure 1**

This project was a small pre-manufactured home located in the pine woods of East Texas. See Figure 1.

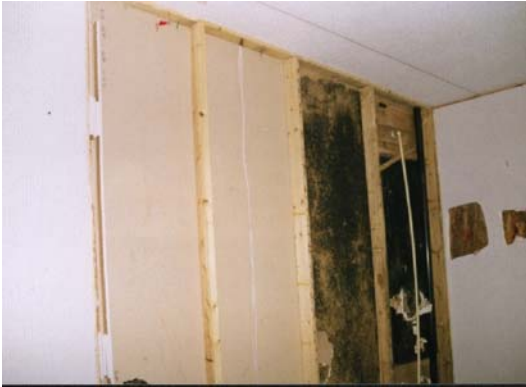
**Figure 2**

Our investigation at this project consisted of thorough visual examination of the existing construction, as well as observation of typical construction assemblies at several locations where selective demolition was performed. We observed that there appeared to be a strong correlation between the occurrence of significant mold growth in certain wall, floor, and ceiling cavities and the presence of unsealed openings that allowed significant and unhindered moist air infiltration. See Figure 2.

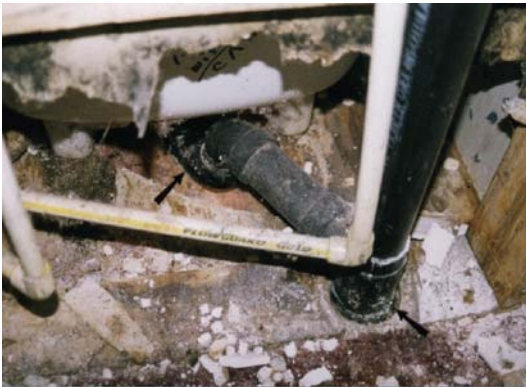
**Figure 3**

These unsealed cavities consisted of deliberate openings at plumbing penetrations, as well as inadvertent openings occurring within the cladding between siding installations and trim pieces. See Figure 3.

It was noted that many of these inadvertent openings were caused by inadequate design and careless or poor workmanship. These anomalies appeared to be widespread and prevalent throughout the cladding of this pre-manufactured residence. The correlation between un-sealed

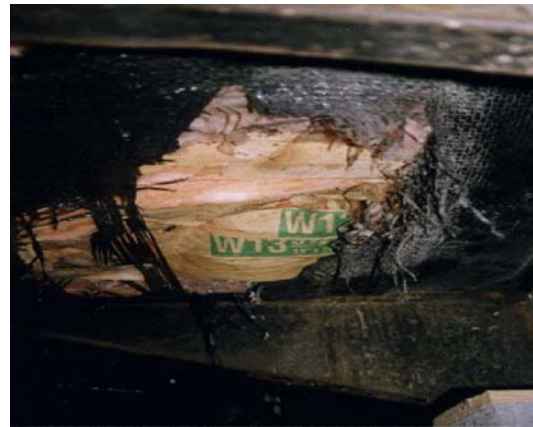
**Figure 4**

We observed that the interior vinyl wall covering, most likely utilized in an attempt to reduce maintenance, represents a low permeance wall covering on the “wrong” side of the wall. In addition, the heavy sheet vinyl floor covering also represents a low permeance floor material. Based on information provided, each of these conditions were most likely exacerbated by excessively low interior temperatures within the living space during the summer cooling season. In the Kitchen and Breakfast Room, we observed that the manifestation of moisture accumulation and mold within the floor system occurred primarily along the joint lines of the OSB floor deck, where vapor drive would find the least resistance.

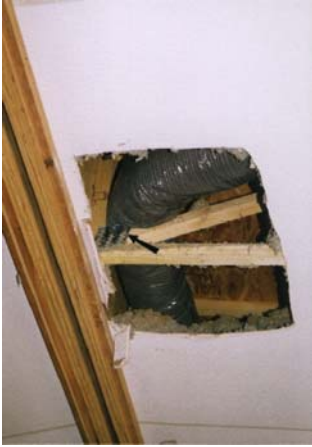
**Figure 5**

Other locations observed to be exhibiting suspected moisture accumulation and mold growth were along the ceiling in several different areas. One location in the ceiling corner of the Master Bathroom was believed to be associated with openings in the vinyl siding and related trim occurring within the exterior cladding due to poor workmanship. Selective demolition in another location in the ceiling of Bedroom No. 2 was found to be immediately below the location of an air conditioning flexible duct. This same situation was also observed in the Living Room ceiling, where selective demolition revealed that the minimally insulated flexible duct was wedged into a joint of the wood roof truss immediately adjacent to, and in contact with, a perforated metal gang-nail plate. Since the roof

truss space has vents that allow direct infiltration of outside warm, moist air, it is suspected that the immediate contact of the duct with the metal gang-nail plate has “super-cooled” the gang-nail plate to a temperature below the exterior dewpoint, causing continual condensation, moisture accumulation, and potential mold growth. See Figure 5.

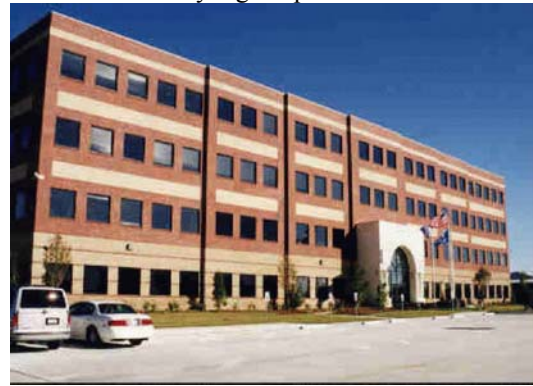
**Figure 6**

The third project was a four-story office building recently completed on the lake front shore near New Orleans, Louisiana. See Figure 6. We were retained by the general contractor to assist in determining the cause for mold and mildew growth, as well as to diagnose the cause for several specific chronic leak locations. See Figure 7. Our investigation included a review of the original construction documents, visual

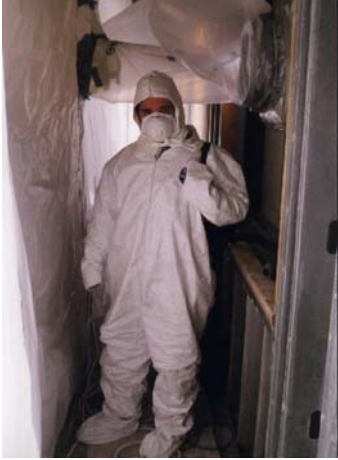
**Figure 7**

inspections, selective demolition, field leak testing, and a thermal and vapor flow analysis of the typical wall assembly. See Figure 7.

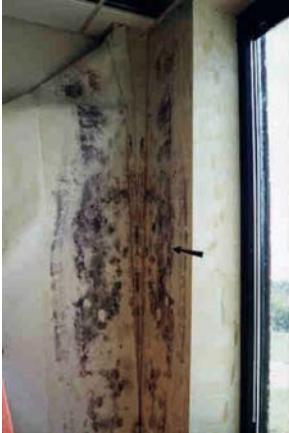
**Figure 8**

Finally, we used appropriate pressure taps through the building envelope at window perimeters to determine that the building interior was being maintained at a negative pressure with respect to the outside conditions. Based on information provided, it was further determined that the building tenant had added a large exhaust fan that had not been accounted for within the original balance and adjustment of the HVAC system. This addition, as well as other tampering with the dampers controlling outside air, contributed to the negative pressure conditions within this building. These conditions would combine to significantly increase the pressure difference between the interior and exterior, with the exterior being relatively higher virtually all of the time. Other problems included direct water leakage at a flashing located above the garage that allowed water infiltration when weather systems originated from the North. In addition, a portion of the first floor of this building was composed of split-face concrete masonry units (CMU) that had been subject to chronic water infiltration during periods of inclement weather.

A number of different recommendations were implemented in order to correct each of these issues. We recommended removal of the vinyl wall covering and replacement using acrylic paint or high permeance (low vapor resistance) wall coverings. In addition, we recommended balancing and adjusting the supply air and exhaust air comprising the HVAC system, as well as establishment and implementation of an effective and proficient control system for the interior temperature and humidity. We further recommended that the HVAC supply air registers be moved further away from the exterior walls so that impingement of cold air is minimized at these surfaces. As a final adjustment, we recommended that the gaps and cracks within the brick masonry be sealed and that consideration be given in the future to applying a clear masonry sealer to the exposed brick surfaces. Other recommendations implemented at this project included comprehensive renovation of the garage flashing that had been previously leaking, as well as application of an elastomeric coating at the split-faced CMU.
