## ACHIEVING AIRTIGHT DUCTS IN MANUFACTURED HOUSING

Neil Moyer  
Principal  
Research Engineer  
Florida Solar Energy Center  
Cocoa, Florida

### ABSTRACT

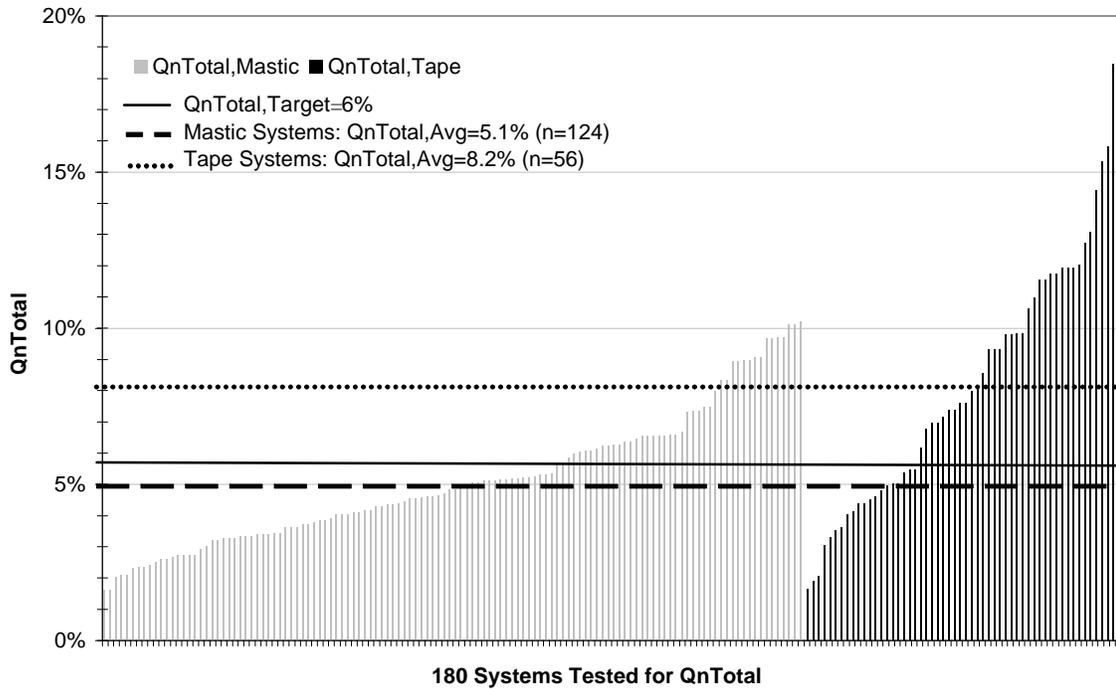
For taped systems (n=58), average  $Q_{n_{TOTAL}}=8.2\%$  (n=56) with 19 systems reaching the  $Q_{n_{TOTAL}} = 6\%$  target (Fig. 2). Average  $Q_{n_{OUT}}=5.7\%$  (n=30), more than double the mastic average, with 5 systems reaching the  $Q_{n_{OUT}} = 3\%$  goal (Fig. 3).

**Figure 0** All 180  $Q_{nTOTAL}$  data points.  $Q_{nTOTAL,Avg}$  for taped systems (dotted line) was 8.2, well above the  $Q_{nTOTAL}=6\%$  target (solid line) whereas for mastic systems  $Q_{nTOTAL,Avg}=5.1\%$ . Mastic data points exceeding the target are listed in Tables 7 and 8.

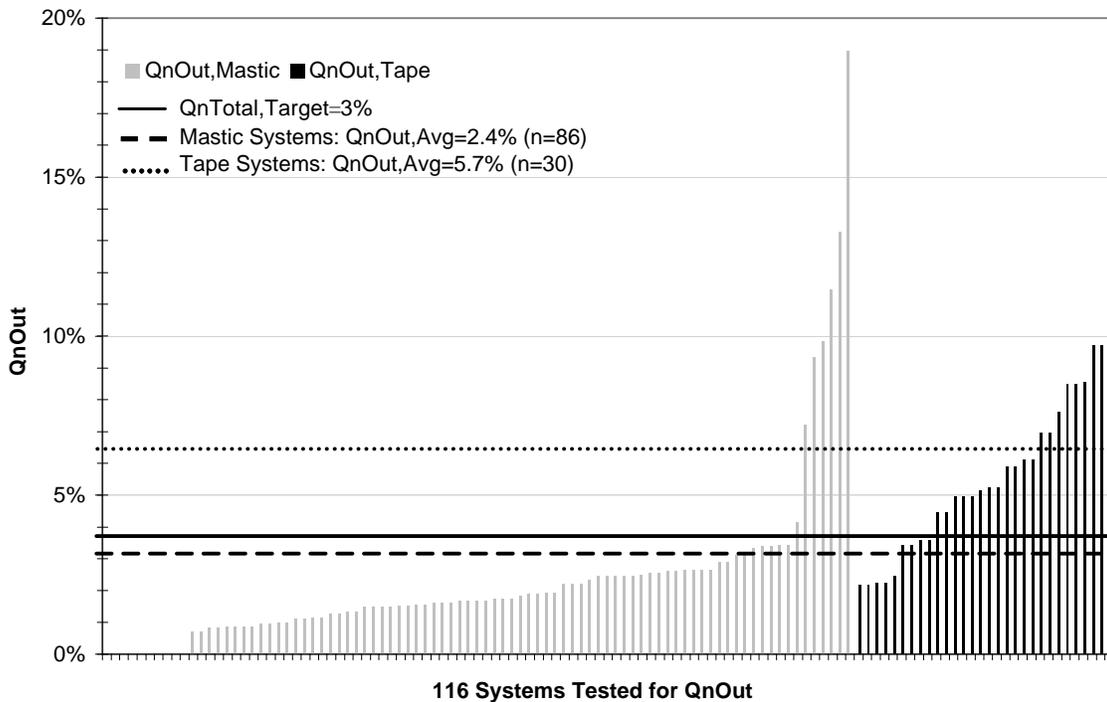
**Figure 2** All 116  $Q_{nOUT}$  data points. Five taped systems met the 3%  $Q_{nOUT}$  goal (solid line); however the  $Q_{nOUT,Avg} = 5.7\%$ , significantly exceeding the target. For mastic systems, the  $Q_{nOUT,Avg} = 2.4\%$ . Mastic systems exceeding the 3%  $Q_{nOUT}$  target are listed in Tables 8 and 9. Twelve mastic systems had  $CFM25_{OUT}$  measurements below the threshold of instrument accuracy. (Energy Conservatory, '96.) These are reported as  $Q_{nOUT} \sim 0\%$  and do not register on this scale (note blank area on the far left portion of the X axis.)
