School Conditions Will Continue to Earn Failing Grades

ABSTRACT

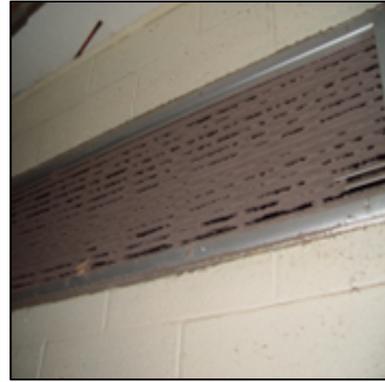
Significant audit observations included low classroom temperatures, high relative humidity levels and operations and maintenance problems (see Figure 6). Room temperatures as low as 64°F were measured during the audit visit, with the average temperature of 13 rooms measured being 68.4°F. Monitored temperature and relative humidity data from 7 classrooms during the week after the audit also showed a number of rooms with low temperatures and high RH levels. Of these, over a two day period with outdoor high temperatures of 86°F and an average dew point temperature of 68°F, temperatures in three classrooms, the cafeteria and library averaged at or below 70°F, and RH levels in one classroom, the cafeteria and library averaged above 65%. Dew point temperatures in Florida are commonly well above 70°F, so maintaining rooms at these low temperatures can create opportunity for condensation in exterior wall cavities, especially if the building operates at negative pressure.

Figure 6.
Main
Return
Grilles
Behind
Stage of

Cafetorium Blocked b/c Maintenance Staff Unaware of Their Locations

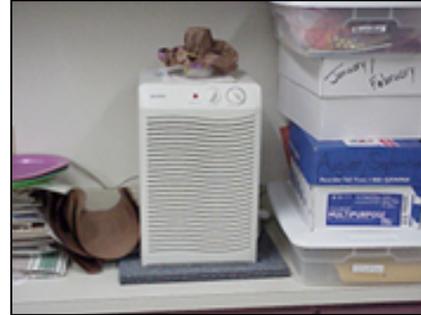
Significant audit observations include high RH levels (60-70%), leaky building envelopes and several instances of low classroom temperatures. At the time of the audit, portable dehumidifier “band aids” were commonly in use in the classrooms to help control RH levels (see Figure 7).

Figure 7. A Portable Dehumidifier Used to Reduce Classroom Humidity Levels

- Tighten the buildings by sealing the eave vents. This will make it easier to get the buildings to operate at positive pressure, reduce the natural infiltration rate, and allow indoor humidity levels to remain below 60% for extended periods (even several days at a time) with the conditioning systems off.

- Reduce the air handler flow rates to improve their dehumidification performance.
- Adjust the outdoor air intakes to 15 cfm per person based on average occupancy. It is expected that once the buildings are tightened, the outdoor ventilation air will be sufficient to produce pressures in excess of a +2 pascal target.

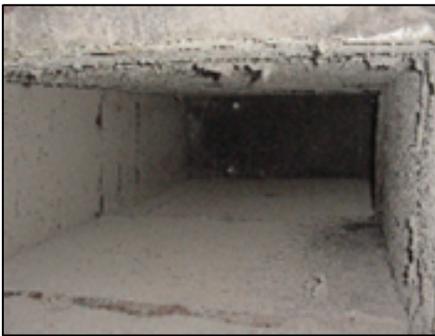
Significant audit observations include dust accumulation, negative pressure in part of the building, low ventilation rates and musty odors (see Figure 8). A visual inspection showed dust accumulation throughout the building, especially in the ceiling space, likely due to inadequate filtration of outdoor air or outdoor air bypassing the filters. Blower door tests showed that both main buildings are very airtight (south wing ACH50 = 1.0 and north wing ACH50 = 1.5). Pressure mapping found that with all operational HVAC equipment running, the main area of the south building was operating under significant negative pressure (-8 Pa) and the north building was operating under somewhat positive pressure (+2.3 Pa).

Figure 8. Dust in Return Duct after Outside Air Intake

- Get exhaust systems operating per original design parameters.
- Install exhaust air on the janitor's closet.
- Repair bathroom fans and make sure bathrooms operate at negative pressure with respect to all adjacent spaces including the bathroom ceiling spaces. Also eliminate cases where the bathrooms are being depressurized by the adjacent mechanical rooms (which are acting as return plenums).

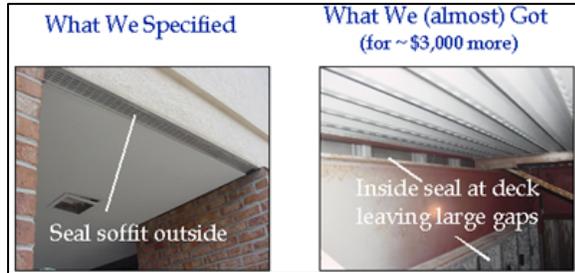
Although outside soffit sealing was specified, the contractor was planning on attempting to seal off an opening inside the space above the eave. This plan still would have left significant areas unsealed at a cost of approximately \$3,000 more than what was

specified finally budgeted. Figure 12 below shows the differences in the specified and planned sealing solutions.

Figure 12. Specified vs. Contractor-planned Soffit Sealing Solutions

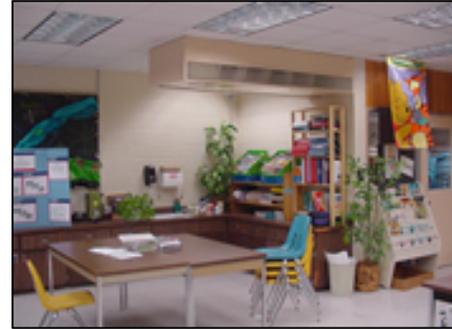
At the second Florida elementary school, issues identified from the conditions audit included low classroom temperatures, high relative humidity levels and operations and maintenance problems. Room temperatures as low as 64°F were measured during the audit visit, with the average temperature of 13 rooms measured being 68.4°F. Monitored temperature and relative humidity data from 7 classrooms during the week after the audit also showed a number of rooms with low temperatures and high RH levels. Dew point temperatures in Florida are commonly well above 70°F, so maintaining rooms at these low temperatures can provide surfaces on which water can condense. Recommended retrofits included:

Figure 13. Air Handler in One of the Florida Elementary School #2 Classrooms

- A dedicated outdoor air ventilation system
- Tightening building envelope / evaluate fan coil

leak openings.
