Case Studies of Commissioning HVAC Systems

B. K. Browning, PE Principal Engineer KWR Services Austin, Texas

ABSTRACT

This paper discusses problems found during third party commissioning of projects where humidity control was an indicator of significant problems.

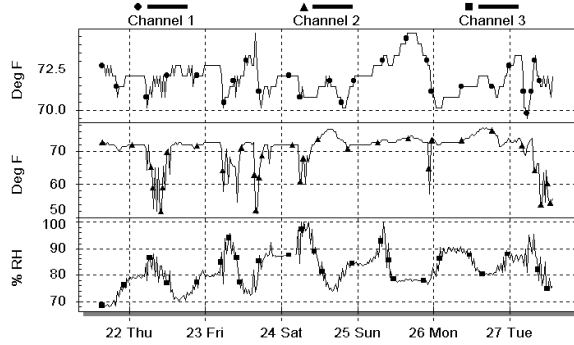
Figure 1 - Space temp (Ch 1), Supply temp (Ch 2), & RH for Zone 4 of Project 1

Comfort control problems were reported shortly after the building was occupied and the weather turned humid in April. The operator reported hot complaints even when the zone set point temperature was 72° F. Figure 1 shows the space temperature (Channel 1), supply temperature, (Channel 2), and relative humidity (Channel 3) for the zone where the complaints were occurring.

The relative humidity shown in Figure 1 was very high at all times but especially during the early morning hours. The supply temperature indicated the A/C would remove moisture from the air (supply temperature below 55° F) when the A/C was running. The space temperature indicated there were significant interactions with other A/C in the large open area.

Blower door and pressure measurements indicated the building was relatively tight for a small commercial building³, with an air change per hour at 50 Pascal (ACH50) of 8.3. However, it was found that the air conditioners were introducing over 2600 CFM of outdoor air even when the OA intake was blocked. This indicated significant air leakage on the return side of the duct system. The source of the leakage was found to be installation details where the air barrier (sheathing) was cut out at structural elements. One example is shown in Figure 2 where the sheathing was cut out to clear structural members. Not only was the center of the channel left open, the sheathing was cut out several inches on each side of the channel. The result was roughly a square foot of open area to the outside every four feet along the perimeter of the building. This leakage path was a direct connection of the above ceiling return plenum to outdoors.

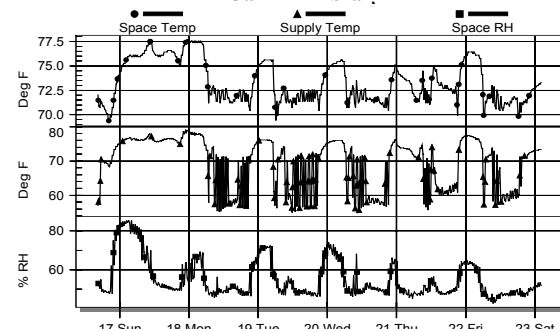
Figure 3 - Temperature & Relative Humidity After Return Plenum Corrections

Once the return plenum leakage was corrected, the humidity problem was reduced and changed in character, but not eliminated. As shown by Figure 3, the space relative humidity was still very high, but now the problem was primarily during unoccupied periods.

The high humidity during unoccupied periods was traced to the restroom exhaust fan running 24 hours per day. The drawings indicated the exhaust fan was to be interlocked with one of the furnace blowers, but the interlock was never installed. Once the exhaust fan was interlocked with the HVAC control system the humidity during unoccupied hours improved significantly.

Figure 1 and Figure 3 both indicate poor temperature control. Overcooling of the space is indicated, frequently at times when the supply temperature shows that unit is not running.

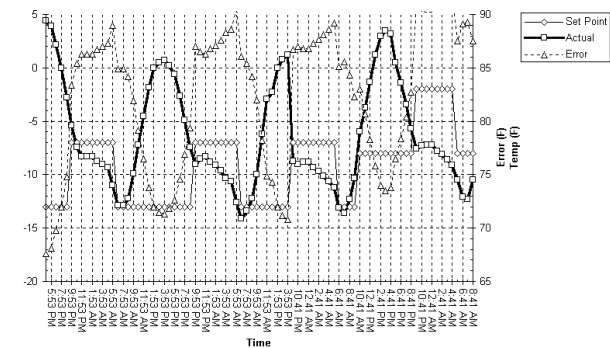
Figure 4 - Trend Log Temperature Data

Figure 4 is a trend log taken from the DDC control system. The heavy line is the actual temperature detected by the controls for the zone adjacent to the zone shown in Figure 1 and 3. The “square wave” line is the set point temperature for this zone. The control system was properly controlling the air conditioner based on its temperature readings.

Unfortunately, this temperature sensor (the one ‘lost’ after startup) had been relocated to halfway up a skylight well. The adjacent zone was cooling until the skylight reached the set point, frequently overcooling the adjacent zones. The sensor was reported to be mounted in the skylight well because that was the “only location in the zone that was accessible to the technician”. Once the cause of the problem was identified, other locations in the zone became accessible.

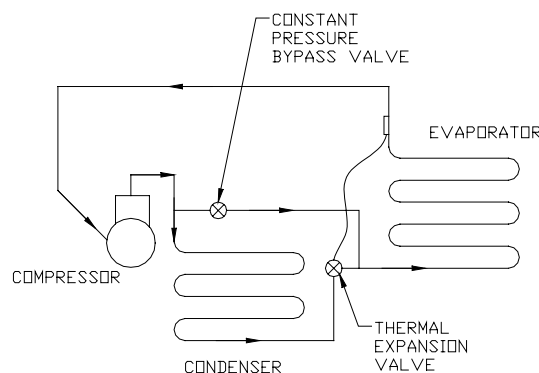
Figure 5 - OA Preconditioning System Refrigerant Circuit

bypass system was scheduled for this system to allow for capacity control at lower load conditions. The contract documents specified the size of the condenser, evaporator, and blower, control and safety devices, and that the hot gas was to bypass to the evaporator distributor. The contractor was allowed all other design decisions. Figure 5 shows a schematic of the OA preconditioning unit refrigeration circuit as installed.

Note that the hot gas was bypassed to the evaporator inlet near the distributor. This configuration is shown in the 1998 ASHRAE Refrigeration Handbook as “the most satisfactory hot-gas bypass arrangement” with respect to full (100%) unloading. However, this installation was using the hot gas bypass for partial unloading under conditions where the evaporator should be kept cold. When this configuration is installed on an OA preconditioning unit, the moisture removal capacity is greatly reduced anytime the bypass regulator opens. The hot gas warms the evaporator and greatly reduces the latent (and sensible) capacity of the system.

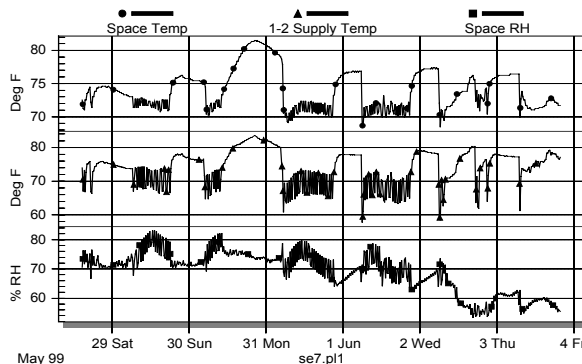
Figure 6 - Space Temp, Supply Temp, & Relative Humidity in Meeting Room

Figure 6 shows the temperature and relative humidity in the space after the unit was started and reported to

be operating properly. At the end of May, the latent load was clearly out of control.

On June 2, the contractor was met on site to identify the source of the humidity control problem. The OA preconditioning unit was found to have a leaving dry bulb temperature of 64° F. Since the leaving dew point temperature could be no lower than the leaving dry bulb temperature, the OA preconditioning unit was not able to remove enough moisture from the outdoor air to maintain the space humidity. (Note - the leaving dew point temperature will be the lowest possible space dew point in moisture generating spaces located in humid climates. Moisture generating spaces includes latent load from occupants.)

The high leaving temperature was initially thought to be an undercharge of refrigerant because the condenser sub-cooling was only 3° F. When the charge was increased, the bypass regulator would open and actually increase the leaving temperature to the high 60s. The hot gas bypass regulator was reset to remain closed under design conditions and only open when the system was unloaded.

After the hot gas bypass was set to open only under extreme conditions, the relative humidity was maintained below 60% during occupied periods.

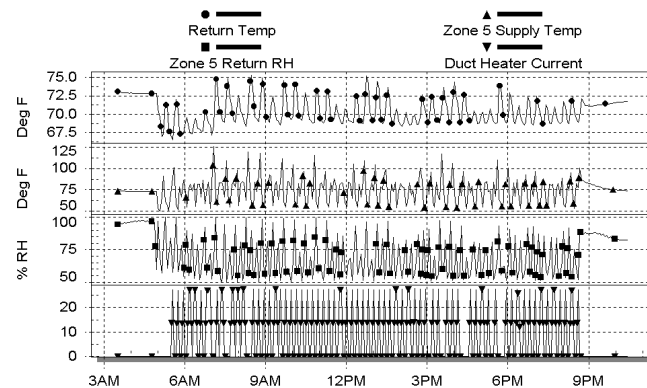
Figure 7 - Return Temp, Supply Temp, Return RH, & Duct Heater Current

Figure 7 shows the space temperature, supply temperature, dew point, and duct heater current for the space collected during cooling conditions for one day in October 2000. The space temperature indicates the space is being overcooled in an attempt to control the humidity. The relative humidity varies from 50% to near 100%. The reheat is coming on to control the overcooling. However, the gas furnace is also coming on as indicated by the supply temperature over 100° F.

Note that the space temperature and relative humidity are represented by the return temperature and relative humidity. The sensor had to be located in the return duct near the duct heater in order for the duct heater current to be monitored by the same data logger. Comparison of these data with data from a logger located in the space indicated the return duct location was very similar to space conditions EXCEPT when the blower was off during unoccupied periods. The relative humidity near 100% before 6:00AM and after 9:00PM should be disregarded as a measurement anomaly.

Clearly there is a problem from a large source of moisture driven into the space. Initial indications were that the moisture was due to space depressurization and/or envelope problems. After those problems were corrected, the temperature and humidity variations were still very similar to Figure 7. This moisture was due to ventilation air brought into the space through the air conditioner. When the space temperature cools to the thermostat set point, the air conditioner cycle off and the OA is brought into the space unconditioned. The zone was scheduled for a constant 130 cfm of OA on a 1300 cfm air flow. Other zones of this project are not experiencing the humidity problem because all other zones have two-stage air conditioners. With two-stage air conditioning, at least one of the units is removing moisture from the space a larger portion of the occupied hours. Doty⁴ and Henderson⁵, et al, discuss evaluation of such problems when using DX systems on mechanically ventilated spaces.

Other problems indicated by Figure 7 include the large temperature swings as the system cycles into and out of the dehumidification operation. The space temperature is shown in Figure 7 varying from approximately 67° F to 75° F. The supply temperature indicates the HVAC controls are operating and trying to maintain the space within the normal comfort range. The air conditioner supply temperature is low enough to dehumidify the air while the air is cooled. The duct heater is operating providing reheat for additional moisture control.

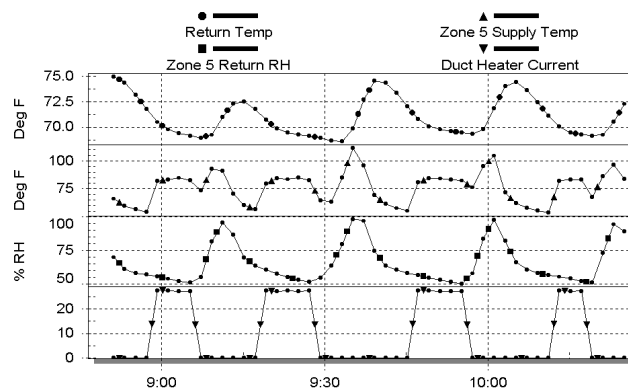
Figure 8 - Expanded Time Scale of Figure 7

Figure 8 is an expanded time scale during the morning shown in Figure 7. Note that before 9:00, the air conditioner was on in response to high humidity. The air conditioner supply temperature is in the 50s and the space is drying out. When the space temperature reached roughly 70° F, the duct heater came on as indicated by the duct heater current and the increase in supply temperature. At about 9:10, the humidistat was satisfied and the system came out of humidity control mode. Once

back in 'normal' mode (not humidity control mode), the controls sensed the space was below the heating set point and turned on the gas furnace. The furnace quickly brought the space temperature above the 70° F heating setpoint. However, by the time the space temperature was up to 72° F, the relative humidity was high again and the system went back into humidity control mode with the air conditioner locked on.

The cycle repeated again with a peak space temperature of 75° F at 9:40. At some point during a summer day, the sensible load should become high enough the space temperature would exceed the cooling setpoint before the humidity exceeds the humidity set point. When this occurs, the control system heating-to-cooling switchover will happen before the cooling would come on in response to high relative humidity. The switchover has a deadband (temperature or time) to prevent the system from quickly switching from heating to cooling or cooling to heating. It appears this cycle has the larger temperature swing characteristic of passing through the deadband. A close inspection of the data log indicates that no cooling or heating was on between roughly 9:35 and 9:39. At around 9:39 AM the system had gone back into humidity control mode.

Instrumentations and data interpretation are areas that need very careful review. Figure 8 shows the duct heater increased the supply temperature to a little over 75° F. At the same time, the duct heater is operating; space temperature is shown to drop below 70° F. It would seem that a source of heat removal other than the supply air would be required for this to occur. However, a check of the average temperature of a three-ton air supply (1200 cfm) at 55° F reheated by a 5.6kW (27A at 208V) duct heater would be 70° F. By this calculation the space temperature is verified and the supply temperature needs to be investigated. The supply temperature sensor location

was found to be near a wall of the supply duct in an area that was warmer than the average temperature of the entire supply airflow.
