Improving Permeability and Salt Leaching in Irrigated Sports Fields: Exploratory Testing

S. Miyamoto, Ignacio Martinez, Francisco Luna, and David Tirre
Texas AgriLife Agricultural Research and Extension Center at El Paso
El Paso City Parks and Recreation Department
and
El Paso Water Utilities

February 2008

TWRI Technical Report 310

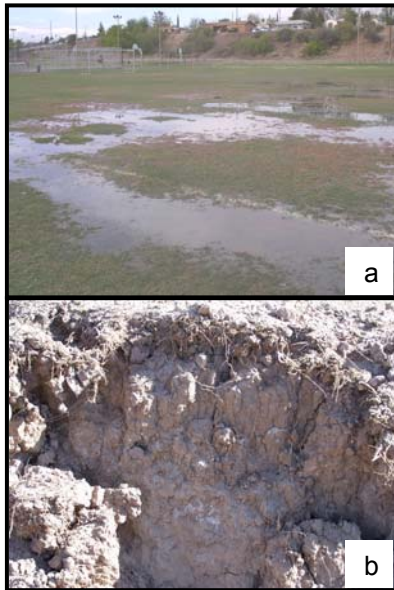
Fig. 1 Water ponding caused by poorly permeable clay (1a) and salt accumulation in the clay layer (1b).

Rainfall usually can not infiltrate once clayey soil is salinized, because sodium (Na) ions cause aggregate breakdown. If one attempts to leach salts by applying a large quantity of water, it can stand for days. Bermudagrass usually continues to grow, as it responds favorably to ample amounts of water and nitrogen application. However, the clayey ground can become a muddy area (Fig. 2a). When dried, the soils become hard. These are not ideal features for athletic activities.

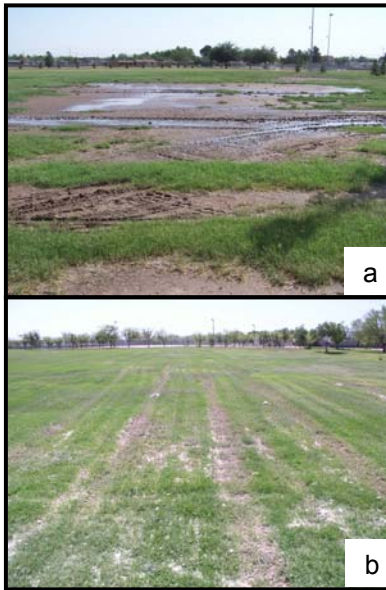
Fig. 2 Poor water infiltration into sports fields developed on clayey soils.

A conventional method of dealing with this type of soils is to reseed and apply gypsum (Fig. 2b). Gypsum application to disked and pulverized clay can help improve water infiltration into the pulverized soils (e.g., Miyamoto and Enriquez, 1990). However, if subsurface drainage is impaired, usually the case in deep clay, gypsum application has limited or no impacts on salt leaching.

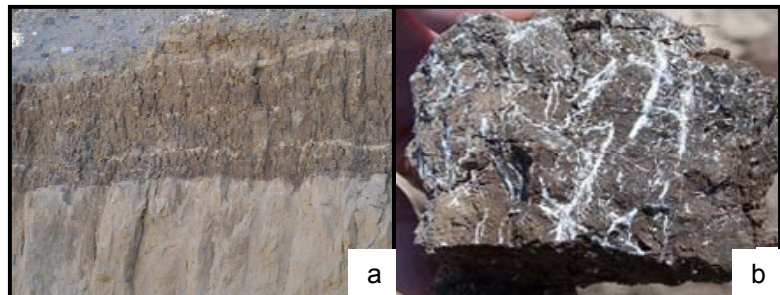
Fig. 3 Soil profile of stratified soils (3a), and salt accumulation in old root channel in the top layer (3b).

In sports fields irrigated with sprinklers, no drainage is likely to result beyond the boundary between the two horizons, unless deliberate leaching irrigation is practiced. This leads to salinization of the clay layer as exemplified in Fig. 1b as well as Fig. 3b. Salt leaching from stratified soils is possible only when the clayey soil has sufficient permeability. Silty clay and clay usually do not fall into this category.

Since the movement of soil water ceases at the boundary, plant roots are rarely found in the sand layer. This observation led to a false notion that the sand is not good for plants. Actually, this sand layer is better suited for growing turfgrass. Mixing or inverting two layers can create better soil for grass growth.

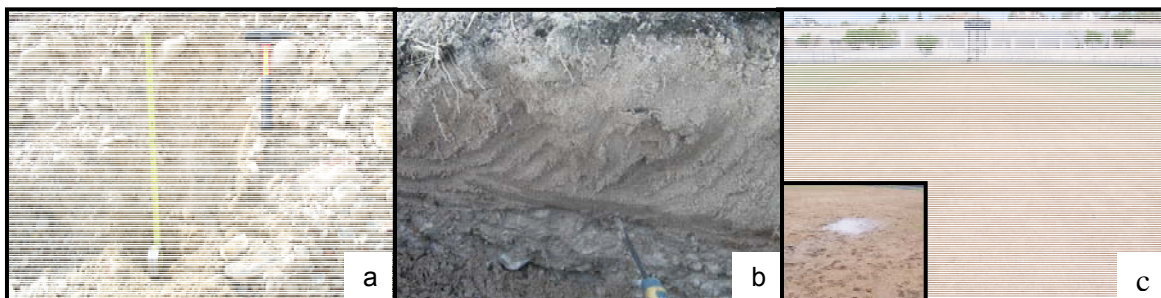
Fig. 4 Examples of stony sediments in the Canutillo soil series, and poor drainage upon topdressing.

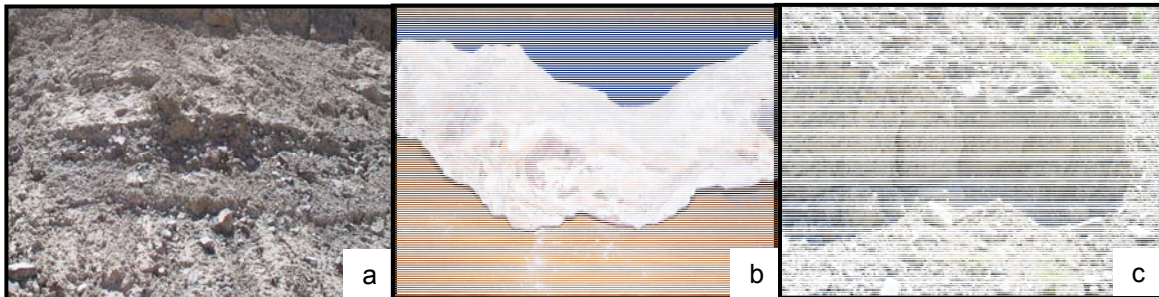
Fig. 5 Example of the Delnorte soil series containing the calcic horizon.

The slope of the caliche layer affects drainage. When the surface of the caliche layer has an appreciable slope, and the calcic horizon has cracks, there would be natural drainage as the percolating water travels along the surface of caliche layer until finding a crack (Fig. 5c). The drainage problem appears when the calcic layer is graded to a minimum slope, and the calcic horizon has no cracks or is sealed during construction. Even when topdressed (typically to a depth of 6 to 8 inches), salinization can occur when the subsoil (calcic layer) does not have sufficient permeability. The subgrade slope needed for appropriate drainage has not yet been determined, and would vary depending on the hydraulic conductivity of the topsoil, the distance to the crack, as well as irrigation management.

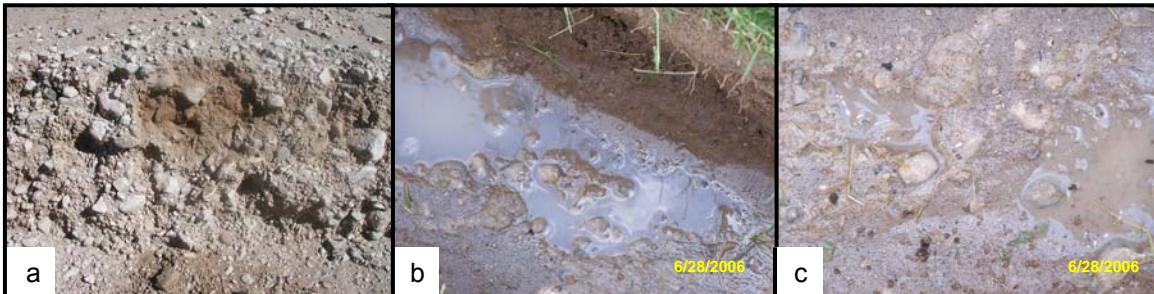
The area, which consists of stony sediments, extends from the foothill to the transition to the valley floor of the Upper Valley (Attachment I). One site was selected, Galatazan Park developed on Canutillo gravelly loam. The site soil is referred to as sediment because the top soil was removed during grading, and there seem to be no clear indication of soil development in the remaining material, except for slight calcium carbonate coating in the soil material (Fig. 6a). In some areas, the indurated layer seems to be a thin layer of a petrogenic calcic horizon. The prevailing condition was water ponding over the subgrade, which seemed to be sealed (Fig. 6b and 6c). This park had been maintained successfully with potable water. When the source of irrigation was converted to reclaimed water with salinity around 1,150 mg/L, soil salinity increased to nearly 10 dS m⁻¹, and turf (hybride Bermuda) became thin. This field had a slope of 2 to 3%.

Fig. 6 A typical Canutillo gravelly loam and water ponding over the subgrade.

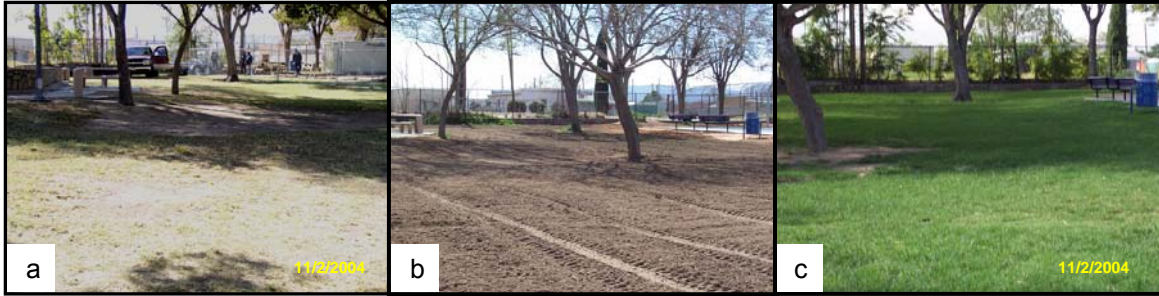
Fig. 8 Estrella-Rivera Park (Gila sandy loam) before and after salt leaching treatments.

Estrella - Rivera Park: In the spring of 2005, the entire park was rotor-tilled by the park maintenance and irrigated daily for a week. Soil samples were collected five each from the sloped area, and five each from the flat area to a depth of 0 to 8 inches and 8 to 16 inches, prior to and after the treatment. Soil salinity decreased from 9.6 to 2.0 dS m⁻¹ in the top 8 inches, and from 10.5 to 2.7 dS m⁻¹ in the depth of 8 to 16 inches (Table 4). Since no control section was left, it is difficult to assess if rotor-tilling helped salt leaching. The park maintenance personnel believed based on their experience that irrigation water would have run off if not tilled. In any case, this example indicates that salt leaching is not difficult in sandy soils through a simple method of tilling and ample irrigation. By the summer (June of 2005), common bermudagrass covered most areas (Fig. 8c). The park maintenance was considering to topdress the sloped area with sand.

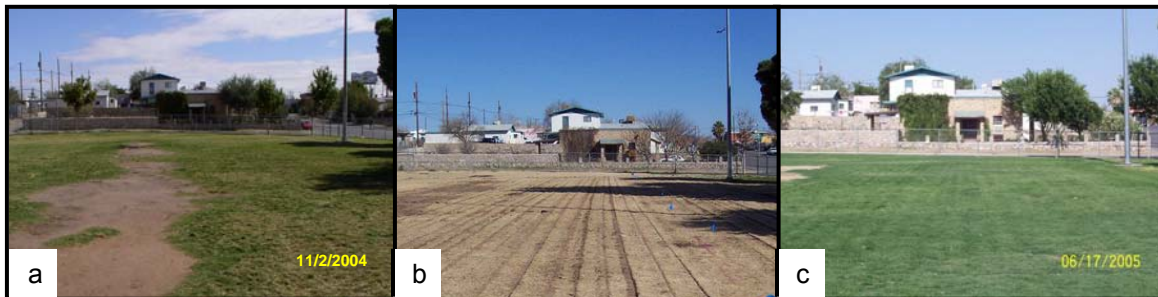
Fig. 9 Mary Webb Park (Harkey silt loam) before and after shallow chiseling treatments.

The use of the minimum-till ripper improved salt leaching in the high traffic area, but not in the low traffic area (Table 5). In the low traffic area, soil salinity in the treated area was slightly higher than the untreated area, although the difference between them was not statistically significant. The reason is unclear, but it is possible that separation of the chiseled layer (discussed later in Fig. 15) may have limited water penetration and salt leaching. A new roller and weight bars were attached to the unit (Fig. 10) in order to press down the chiseling lips and the sod layer lifted by the action of the chisels. Also note that soil salinity of the control section has increased, especially in the high traffic area where turf cover was poor. This is probably related to the conversion of irrigation water from potable (0.9 dS m^{-1}) to reclaimed water with higher salinity (1.3 dS m^{-1}). In any case, soil salinity

Mary Webb Park: Mary Webb Park consists of Harkey silt loam, and had good stands of hybrid bermudagrass, except in the middle section of a football field and a path leading to the field (Fig. 9). Soil samples were collected from two areas; high traffic area (which includes the football field and the walking path), and low traffic area (the open park area). Soil test results indicate initial soil salinity was 3.2 dS m^{-1} in the top 8 inches in the compacted area and 1.4 dS m^{-1} in the noncompacted area. In February of 2005, the shallow chisel shown in Fig. 7c was pulled by a 100 Hp four-wheel drive tractor. The shanks, spaced 11 inches apart penetrated 6 to 7 inches. The entire test area was broadcast with loamy sand to a depth of about $\frac{1}{2}$ inch.

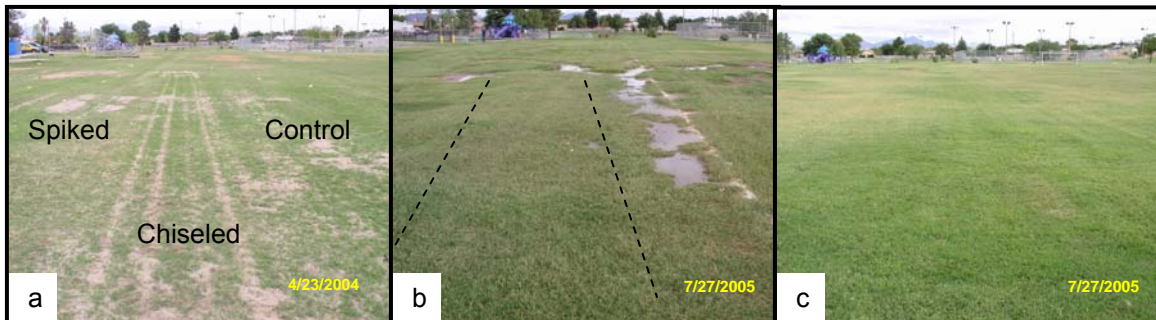
Fig. 11 Lomaland Park (Harkey silty clay loam) before and after the shallow chiseling treatments.

Approximately one month after the treatments, the strip which was chiseled has shown a visible response (Fig. 11b). However, there was no significant effect of the treatments on soil salinity when measured four months after the treatments (Table 6). The soil samples were collected from 0 to 6, and 6 to 12 inches at twelve locations (four sites per treatment).

The condition of grass may have improved in the chiseled section, probably because of improved aerification. The chiseling operation lifted the ground by ½ inch or so, and prevented water from standing (Fig. 11b), while the check plot as well as the strip treated with the vibratory spike often had standing water and yellowing turf. Harkey silty clay loam does not shrink or swell, and permeability is very low, once it is compacted. The visual improvement in turf condition in the chiseled strip lasted throughout the summer, but disappeared in the fall (Fig. 11c).

Lomaland Park: Lomaland Park, consisting of Harkey silty clay loam, has had a chronic problem of standing water, as shown earlier in Fig. 1a. This park has been used extensively, and turf has been always worn out. The vibratory spikes and the minimum-till shallow chisel were tested with a control plot in the mid-April of 2004 (Fig. 11). Unfortunately, there was nearly one inch rain two days prior to the test. The soil moisture condition was too high for the optimum performance of the vibratory spikes or the chisel. The minimum-till chisel did not fracture the soil as much as it does when the soil is dry or moist. Upon these treatments, the entire area was topdressed with loamy sand to a thickness of about ¾ inch.

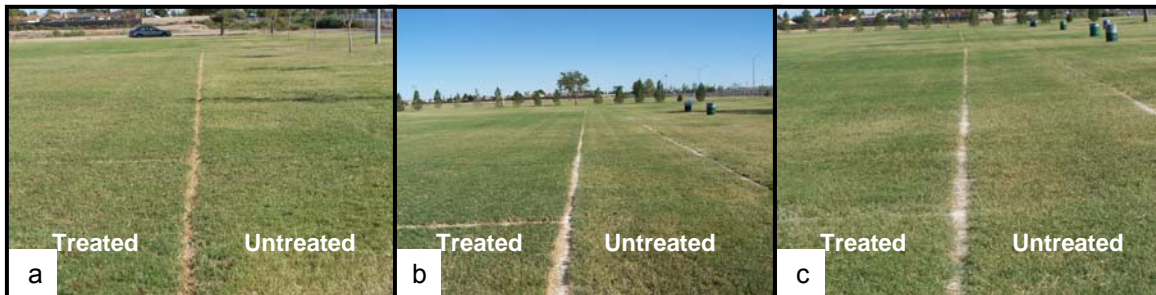
Fig. 12 Effects of aerification Harkey silt loam (a), Anapra silty clay loam (b) and Saneli silty clay (c) at Shawver Park.

Results (Table 7) indicate that soil salinity has decreased, but there was no difference between the aerified area versus the untreated area with one exception in the area where the untreated area has a slope and extensive foot traffic. However, the treated area was flat, as it was leveled. There was no visible response of turf to the treatment (Fig. 12). This set of results should be interpreted by considering the fact that these fields, especially the one on Saneli silty clay have not been used extensively for athletic activities, and previous aerification activities are unknown.

In the spring of 2006, a vibratory spike (Fig. 7b) was used in the soccer fields consisting of Harkey silt loam, Anapra silty clay loam, and a turf shaper (Fig. 7g) was used in the area consisting of Saneli silty clay loam. The fields consisting of Saneli silty clay have been rarely used for athletic activities. We could not ascertain what was implemented prior to 2006. After aerification, all fields were said to be irrigated heavily. This activated growth of bermudagrass. In July and August, the area received heavy rainfall (3.2 inches in July, 6.8 inches in August, and 5.0 inches in September). Soil samples were collected in May of 2007 from the treated area and the untreated area, eight samples each or sixteen sites per test area.

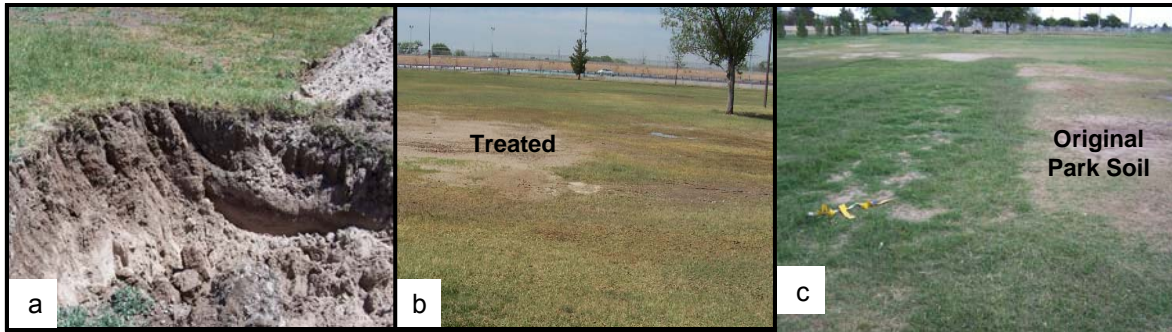
Fig. 13 Effects of profile modification of Sanlei silty clay at Shawver Park, West: Stratified profile (a), after inverting (b), and by May of 2007.

Soil salinity measured in the winter has shown a good deal of salt leaching (Table 7), and bermudagrass in the treated area has shown excellent growth as compared to the growth in untreated areas (Fig. 13).

Soil profile modification tests began in 2006 in the west end of this park consisting of Saneli silty clay. The silty clay extended 23 inches, which was first removed with a large front-end loader. The loamy sand layer was also removed in the same manner to a depth of an additional two feet. The silty clay layer dug was then pushed back into the trench, and was covered by the loamy sand. This operation essentially inverted the soil profile. The area was seeded in August of 2006. Soil samples were collected in December of 2006 and were analyzed for salinity.

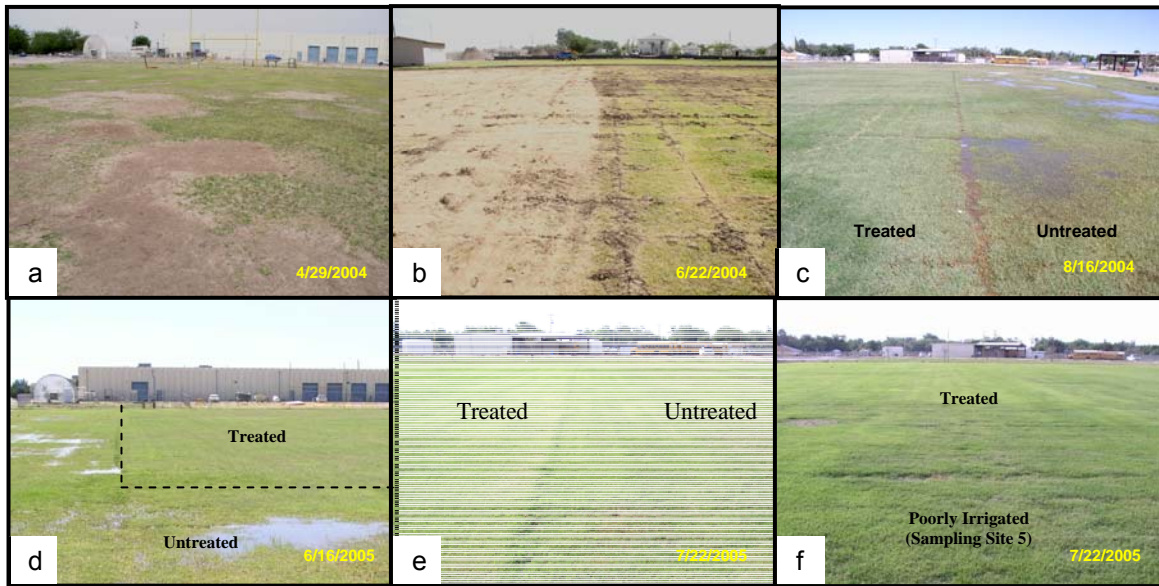
Fig. 14 The transformation of the Clint Practice Field (Glendale silty clay loam) following subsoiling and topdressing.

The progression of the practice field is shown in Fig. 14. Initially, turf conditions towards the tail end of the field (soil sampling locations 5 and 6) were in bad shape (Fig. 14a). Soil salinity in the area exceeded 10 dS m^{-1} in the first 8 inch layer (Table 8). The situation became worse after chiseling, as the topdressing operation extended for several weeks due to manpower shortage. A visible difference in growth of turf appeared in a year. More importantly, a major difference between the chiseled and non-chiseled areas appeared in standing water (Fig. 14c and 14d). In the chiseled area, water from rainfall or flood irrigation disappeared in less than a day or two, whereas in non-chiseled area, it stood for a week. By the end of July of 2005, the chiseled area had attained a good cover of turf, except in the area designated by soil sampling sites 5 and 6 (Fig. 14f).

Soil salinity readings initially ranged widely 4.2 to 11.8 dS m^{-1} . Low salinity readings seemed to be associated with soils with the low saturation water content as well as with the distance from the irrigation ditch. Soil sampling locations were numbered with the increasing order from the ditch. When measured fourteen months after the treatment (June 6, 2005), there was good salt leaching in the area covered by the three sampling sites (1, 2 and 3), which was towards the irrigation ditch. When soil salinity was checked again in February 27, 2007, salts were leached from sampling site 5, but not completely near site 6. The weak portion shown in the last photo of Fig. 14f has also disappeared.

Upon chiseling, the area was topdressed with Hueco fine sand to a depth of 1 ¾ inches by the Clint school maintenance (Fig. 14b). The test site was flooded 5 to 6 times a year, according to the maintenance personnel. Soil samples were taken on April 20, 2004 prior to the treatment, and June 6, 2005, 14 months after the treatment. The treated area was sampled again in February of 2007 at six locations. No seed was planted, and no Gypsum was applied to this site. Nitrogen fertilization was made at a rate of 50 lb-N/acre three times in 2005. Soil samples were analyzed for the field soil moisture content, the saturation water content, and the soil salinity by the method mentioned earlier.

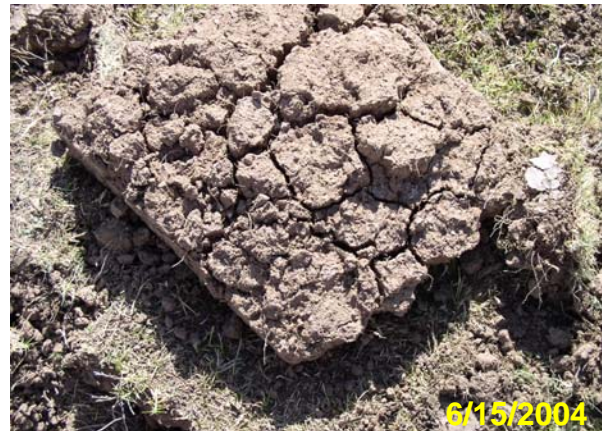
Fig. 15 A block of top layer flipped over when the surface chisel cross over the subsoiling path.

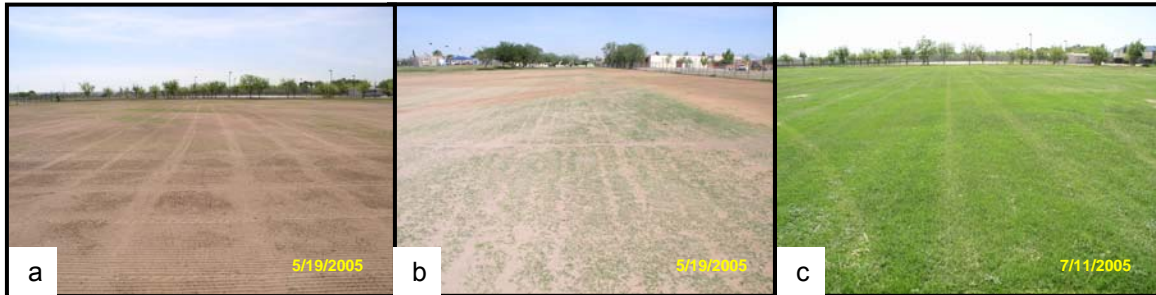
Fig. 16 Pavo Real, North: Initial condition (a), after shallow chiseling (b), and by the mid-summer (c).

Results (Table 10) have shown that neither shallow chiseling nor excavation followed by sandy soil placement had caused significant effects on salinity, except for the initial decrease in soil salinity in the chiseled section. Chiseling also increased the soil moisture content initially. It is most likely that low permeability of the soil below the surface impaired drainage and salt leaching.

Pavo Real Park, North: This section of the park consists of Tigua silty clay. Water infiltration in high use soccer field was slow, and good turf covers have long vanished. Shallow chiseling (7" deep x 11" spacing) was implemented in April 2005 in dry fields, mainly to break out the ground for reseeding. Once the

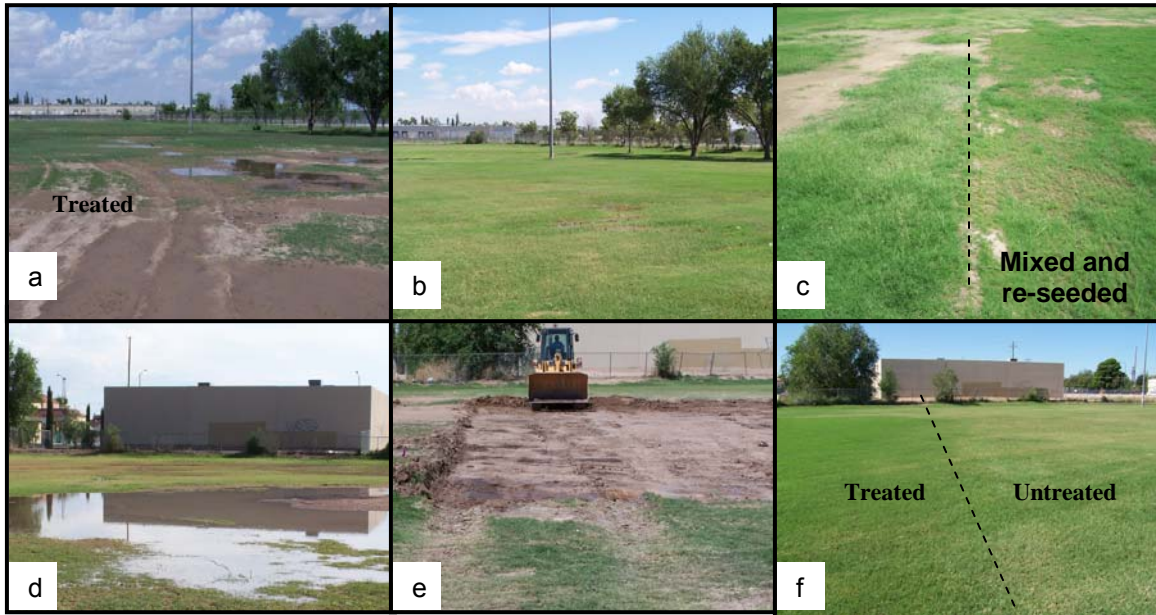
Fig. 17 Pavo Real, South: After subsoiling (a), at the end of the season (b), profile mixing plot after seeding (c), water ponding in the untreated area (d), excavation of clay (e), and turf at the end of the season (f).

The first treatment, subsoiling, provided visible improvements in water infiltration (Fig. 17a and 17b). However, the difference in infiltration became less visible after a month or two. At the end of the growing season, subsoiled strip was not recognizable (Fig. 17b). Nonetheless, soil salinity in the subsoiled strip was lower than untreated strip by 27% (Table 11).

The second treatment, profile mixing, improved water infiltration and provided good establishment of new turf (Fig. 17c). By the end of the season, new turf had completely covered the ground. Soil salinity in the mixed area was lower than the native area by 36%

(Table 11). The texture changes from silty clay to clay loam. No water was ponding in the treated area, while standing water was frequently observed in non-treated areas.

The third treatment, excavation, initially experienced difficulties of establishment, as the irrigation scheduling was set for established grass. However, as soon as this problem was corrected, bermudagrass grew, and covered the entire ground in a season. Poor water infiltration has been a chronic problem at this site (17d). After excavation, water infiltration was improved, and no standing water was present in the excavated area. Soil salinity measured at the end of the season was slightly elevated, and was greatly lower than salinity of the native soil (Table 11). This result is in sharp contrast to the results shown in Table 10 where the excavation which did not provide drainage resulted in no salt leaching.

Pavo Real Park, South: This section of the park consists of Saneli and Glendale silty clay. Three test plots were established on Saneli silty clay which has a layer of silty clay or clay from 0 to 24 inches. The first treatment was subsoiling with the same shank placed at the boundary between the clay and the sand layers. However, no topdressing with sand was made after subsoiling. The second treatment involved a mixing of the clay layer and the sand layer below, using a backhoe at a target mixing ratio of one part of clay with one part of loamy sand by volume. The third treatment involved excavation on the clay layer to a depth of 6 inches at one end and 11 inches at the center over the distance of 20 ft. At the center line, a trench was dug to the sand layer. The excavated clay was hauled away, and was replaced by loamy sand. The entire test area was topdressed with a mixture of loamy

sand and sandy loam, leveled, and seeded with common bermuda on April 26, 2007. All of the test areas were adequately irrigated with sprinklers, using 45 inches per year.

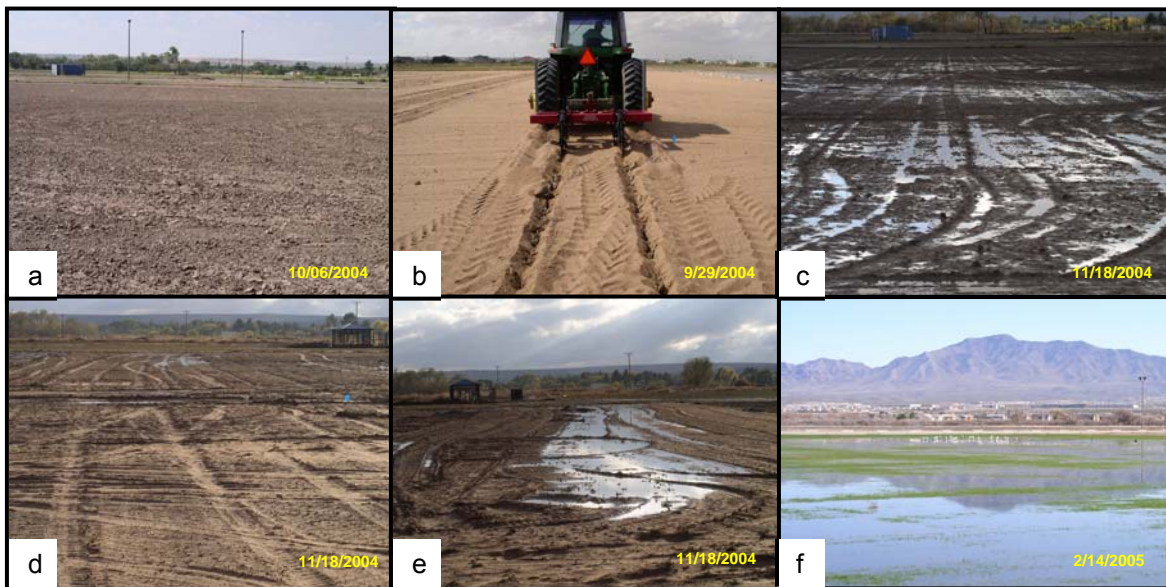
Fig. 18 Soil preparation at Valley Creek Park: Initial ripping (a), deep subsoiling (b), puddling after the first rain (c & e), and standing water after a rain storm (f).

On November 16, 2004, rainfall (3/4 inches) created water puddling in the area not toppedressed (Fig. 18c), as well as the area which was toppedressed, but was not chiseled (Fig. 18e). There was, however, no water ponding in the area toppedressed and subsoiled (Fig. 18d). The entire area was sodded in December of 2004 through January of 2005 using

Valley Creek Park: Valley Creek Park was planned to have two full-sized soccer fields. The first field consisted of four soil types: Harkey loam, Harkey silty clay loam, and Saneli silty clay loam, and Saneli silty clay, and the second field, Saneli silty clay loam, and Saneli silty clay. Both fields had been ripped to 16 inches by a contractor, except at a strip along the sideline where laterals were connected to control boxes. Both fields were disked and leveled (Fig. 18a). At this point, soil samples were collected at three locations per soil type per field to a depth of 12 inches. They were analyzed for the saturation water content and salinity of the saturation extract. On September 20, 2004, the second field consisting of Saneli series was toppedressed with Hueco fine sandy loam to an average depth of 1.5 inches. This was followed by subsoiling at a 40-inch shank space to a depth of 28 inches to draw the fine sand into the chiseling cracks (Fig. 18b). A subsoiler was not used along the sideline with sprinkler boxes. The topsoil was smoothed with a land leveler.

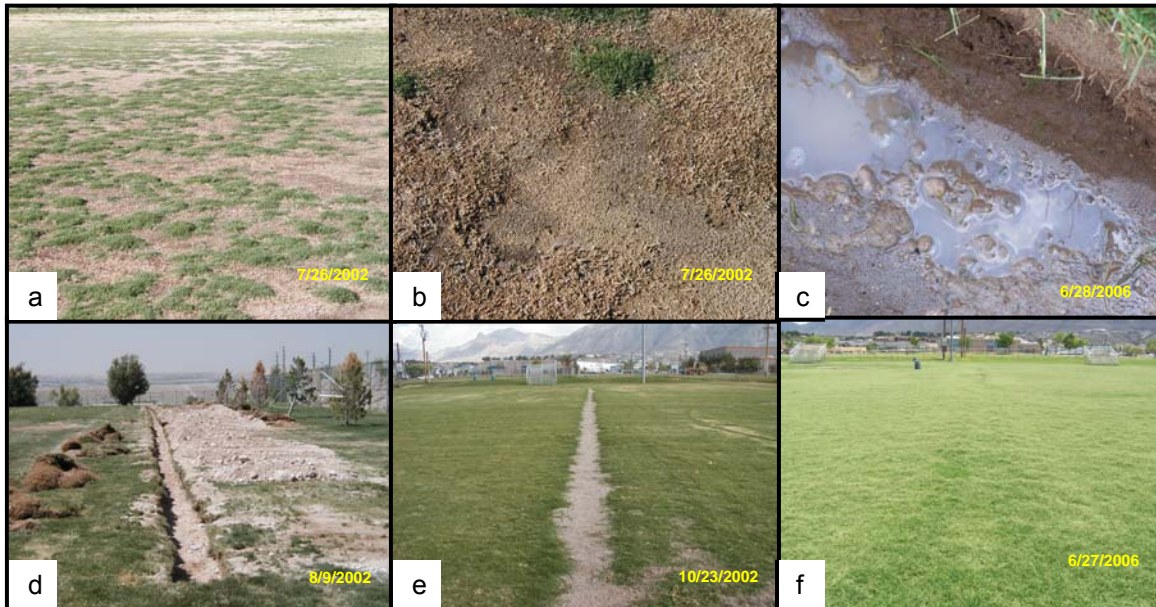
Fig. 20 Galatazan Park; salinized in June and July 2002 (20a & 20b), trenched in August of 2002 (Fig. 20d) and leached (Fig. 20e).

Trenching is a simple operation, yet this system is not efficient in terms of salt leaching efficiency, unless placed much closer. A vibratory chisel was subsequently used on June 29, 2004 to provide cracks in the subgrade at 36 inch spacing to a depth of 30 inches. This piece of equipment does not disturb turf, but did push up a few pieces of stone, 10 inches in diameter towards the surface, thus causing bulging. This test run was then discontinued. Subsequent observations show that there was no water puddling in the chiseled area, while the surrounding area did show ponding. However, we had difficulties of finding chiseling cracks in subgrade. It is possible that the sediment may have settled, causing the chiseling cracks to close.

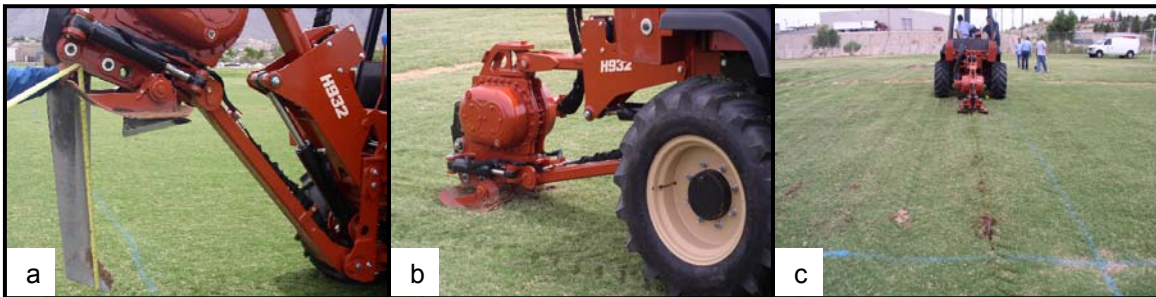
Fig. 21 A vibratory chisel used at the Galatazan Park.

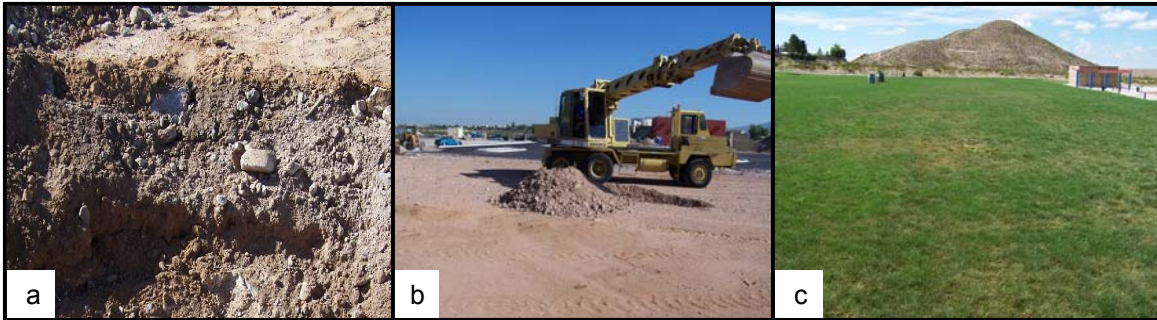
A troublesome observation was that the area consisting of sandy subsoil without caliche was generally water-stressed, while the caliche area was generally wet. This problem of uneven water retention is likely to persist. As mentioned earlier, sprinkler laterals are placed across several soil boundaries, covering from the poorly permeable calcic horizon to coarse sand.

Fig. 22 Three Hills Park; the calcic horizon (22a), a trenching down to 8 ft. deep (22b), and the turf above the caliche area in June, 2007 (22c).

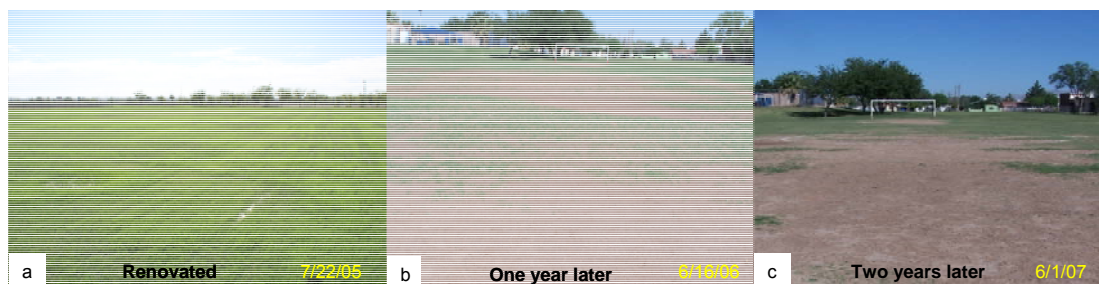
Fig. 26 Degradation of a sports field after renovation: Pavo Real, North.

Renovation Methods: Fields consisting of deep clay are difficult to maintain mainly because of poor drainage. In the past, these fields were taken off from the use schedule for one or two years under a renovation project. Renovation simply means that grass cover is re-established. Since soil conditions remain essentially the same, the re-established grass cover diminishes in a few years (or shorter in some cases), as long as the high soil salinity is present (Fig. 26). The effective renovation must include salt leaching. However, if the salt level is not very high or salt leaching operation can not be implemented for one reason or another, our experience has shown that the use of shallow chisels,
