**Water Loss Test Results:  
West Main Canal  
United Irrigation District of  
Hidalgo County**

**April 6, 2006**

Report Prepared by:  
Eric Leigh and Guy Fipps,<sup>1</sup> P.E.

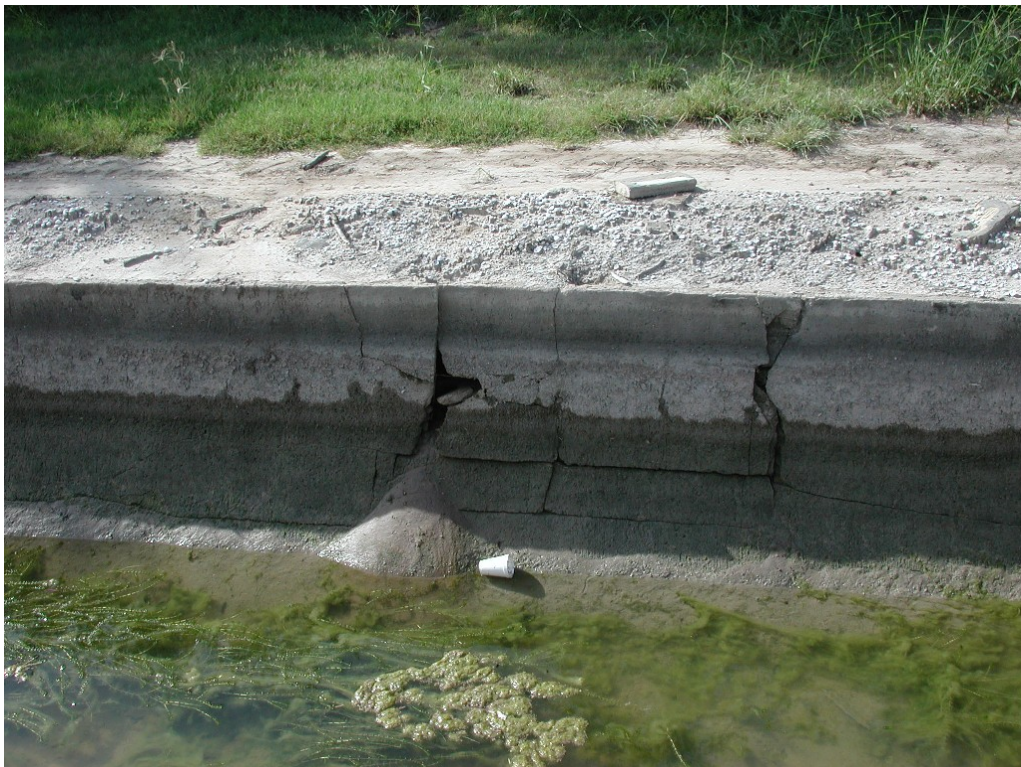
Figure 1. Large cracks and aquatic vegetation shown above contribute to higher total losses of canal segments.

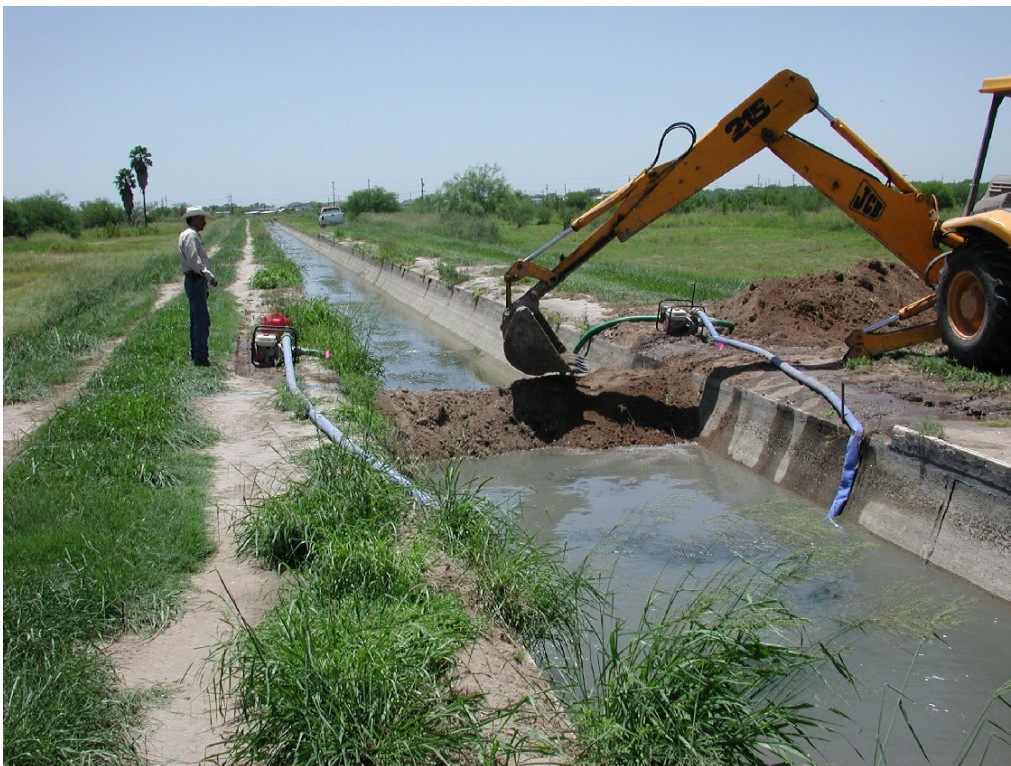
Figure 3. Photo of the earthen dam being built on test segment UN1.

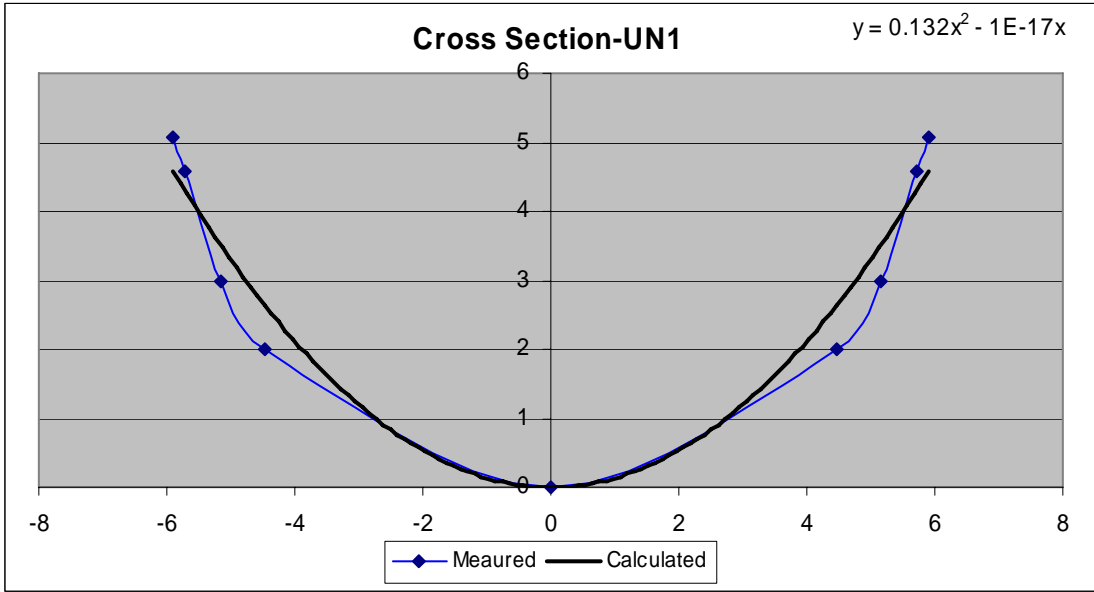
Figure 4. Cross-section for Test Segment UN1.

- The average seepage loss rate measured for Test Segment UN1 was 2.29 gal/ft<sup>2</sup>/day.
- The average seepage loss rate measured for Test Segment UN2 was 2.11 gal/ft<sup>2</sup>/day.
- Test Segment UN3 had two turnout gates (unable to be verified as leaking) that may have contributed to the total loss rate of 2.11 gal/ft<sup>2</sup>/day. Test was performed with water level being only 50% total depth.

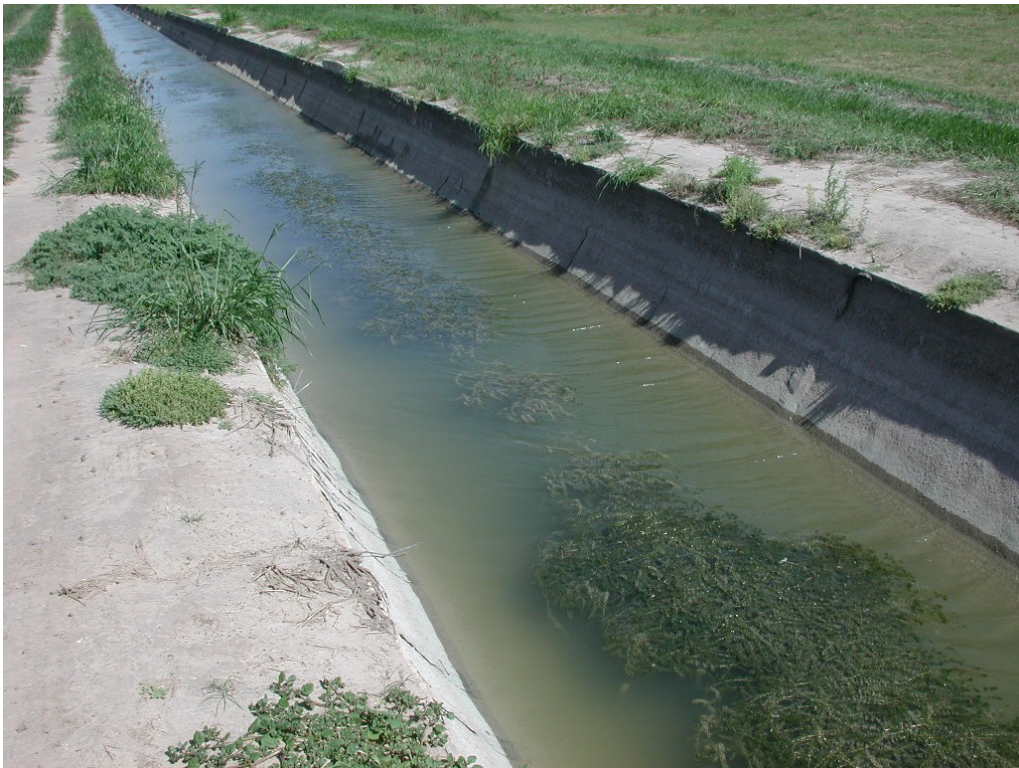
Figure 5. Photo of test segment UN1 showing aquatic vegetation problems.

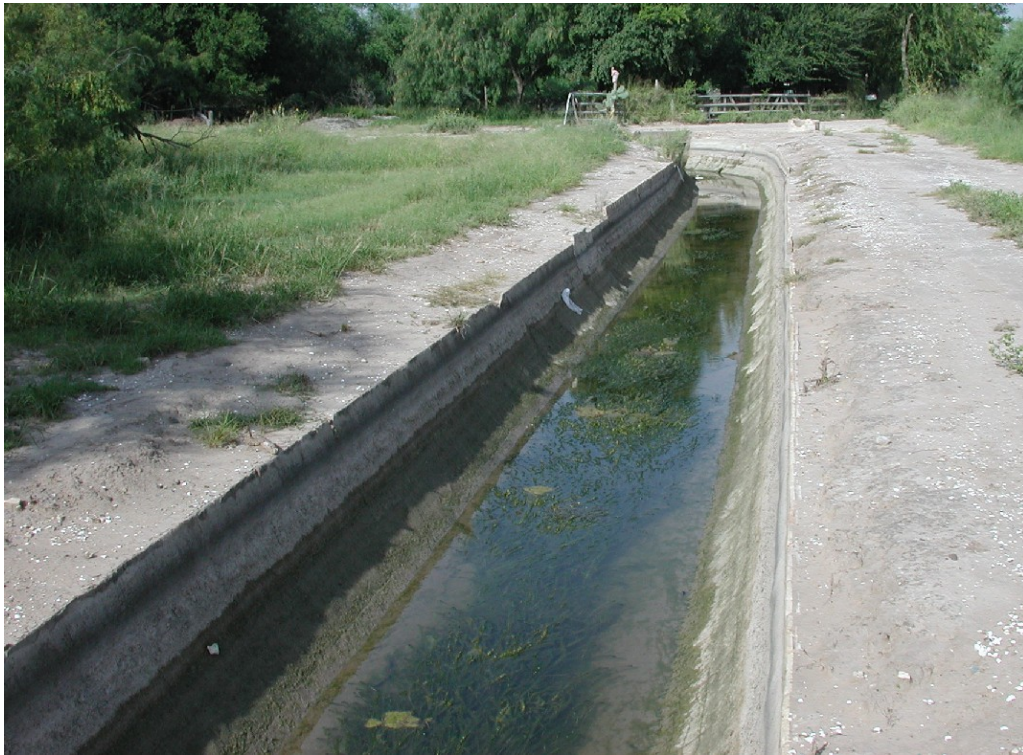
Figure 7. Photo of test segment UN2 showing aquatic vegetation problems.
