Estimation the performance of solar fiber optic lighting system after repairing the glass Fiber Cables in a South Korean Residential Building

Kwang-Seok Cha
 Renewable Team Leader
 Hyundai Engineering and
 Construction, Ltd.
 Seoul, South Korea

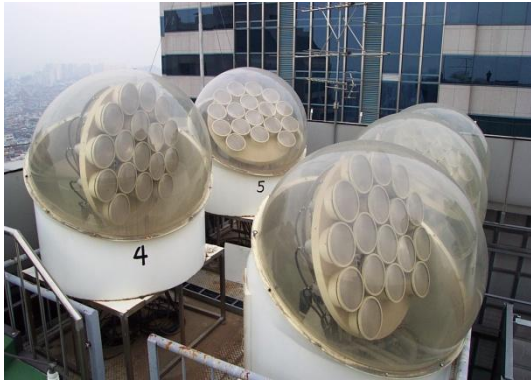
Fig. 2 Dirty of Concentration part

and the dirt covering it. Fig. 3 shows the body's corrosion due to its being constructed from steel. Fig. 4 shows the sensor installation for the sun tracking.

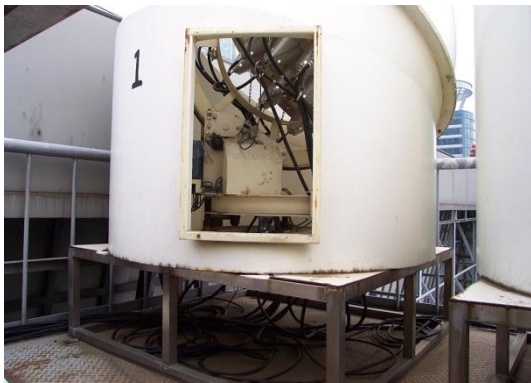
Fig. 3 Corrosion of the body

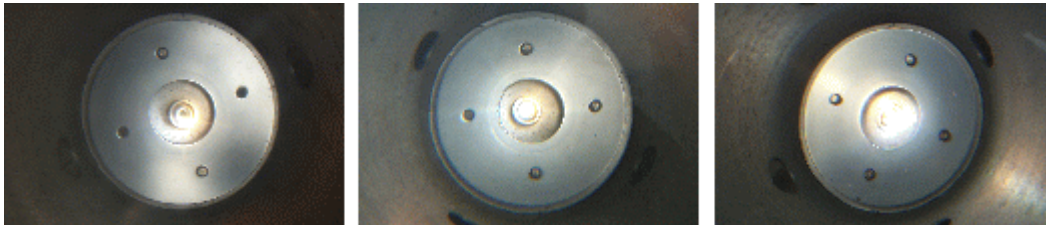
Fig. 6 Sample of focusing shape at the terminal of cables in concentration part

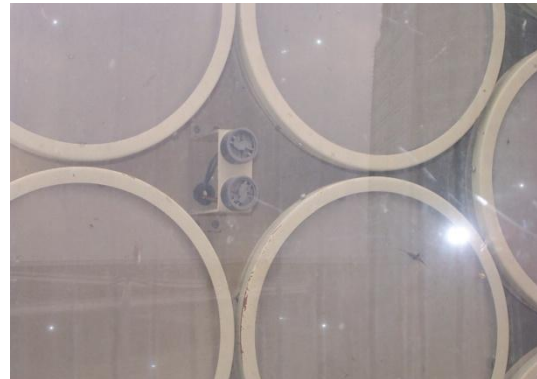
Fig. 4 Exchange of sensors

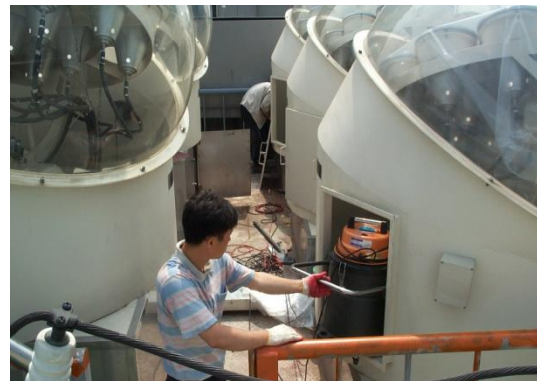
Fig. 5 Cleaning inside

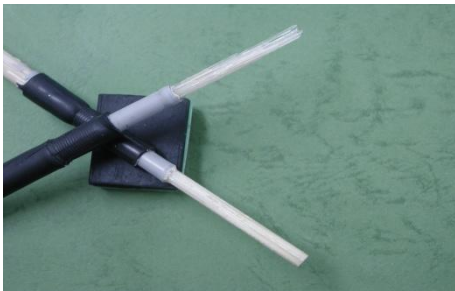
Fig. 9 Comparison of good and damaged cable ends (upper one is damaged)

were repaired. In one cable there are about 42 glass fibers. If at least ten fibers showed signs of damage, the cable was repaired. Repair work can be seen in Figures 9-14. In Figure 14, the worker has ground off the end of the fiber optic cable and is splicing each fiber with a piece of stainless steel.

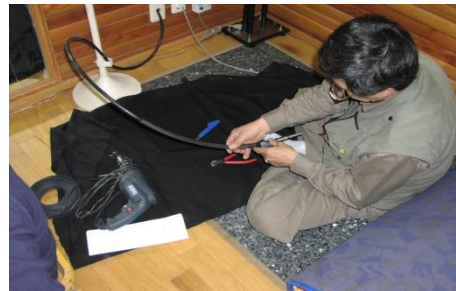
Fig. 11 Inspection of the status before repairing

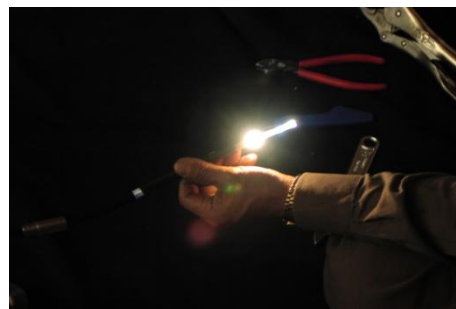
Fig. 12 Checking line status before and after repair

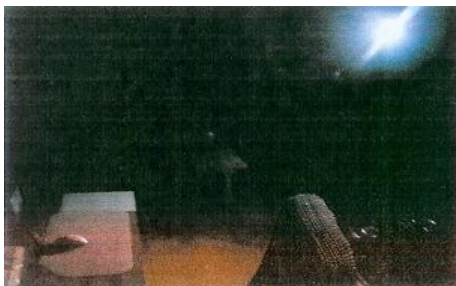
Fig. 20 Lighting environment before repair

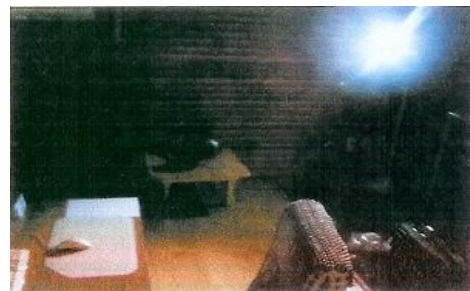
Fig. 21 Lighting environment after repair
