Fast and Ultimate Vibration Field Solution: From Problem Detection to Field Performance Validation

Giancarlo CICATELLI
Flowserve - Italy

Bruno SCHIAVELLO
Flowserve Corporation - USA

First Middle East Turbomachinery Symposium

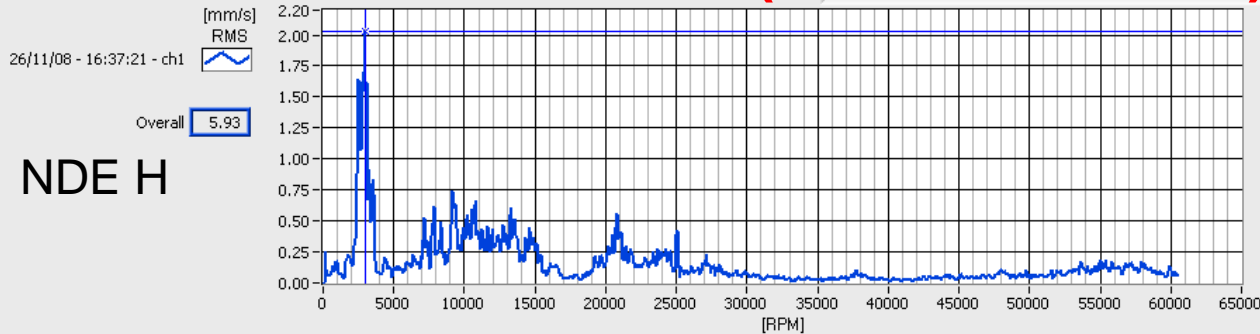
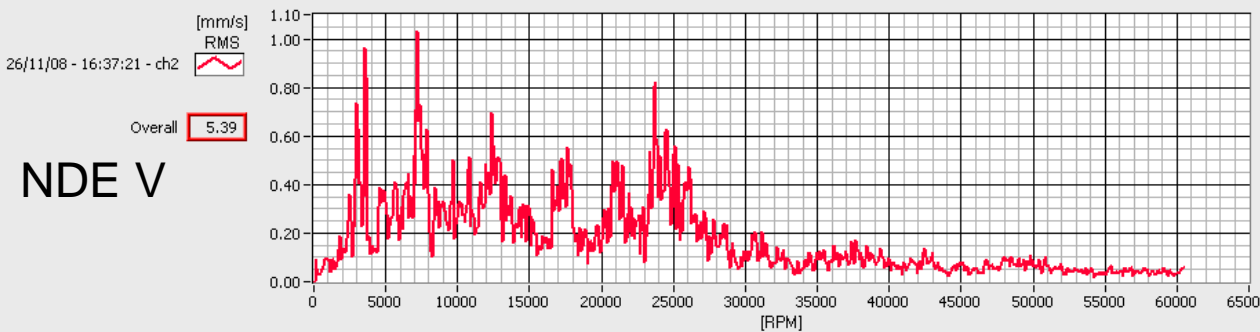
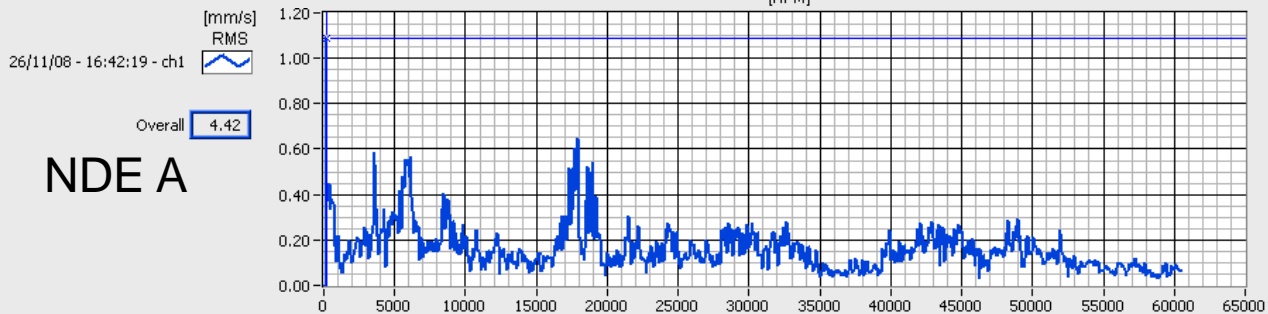
NDE vibration spectra

Remarks:

a) Low amplitude at VPF

(< 1 mm/s = 0.04 ips)

b) High activity mainly

across a range up

500 Hz (30000 rpm)

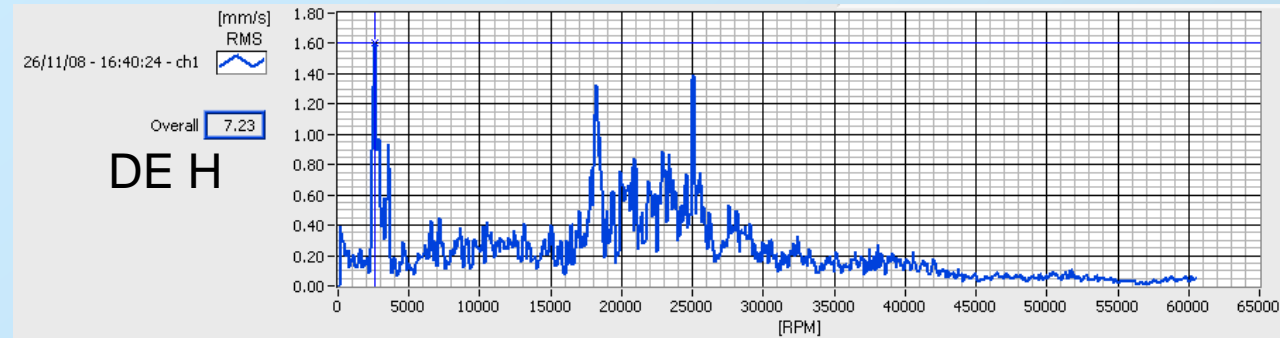
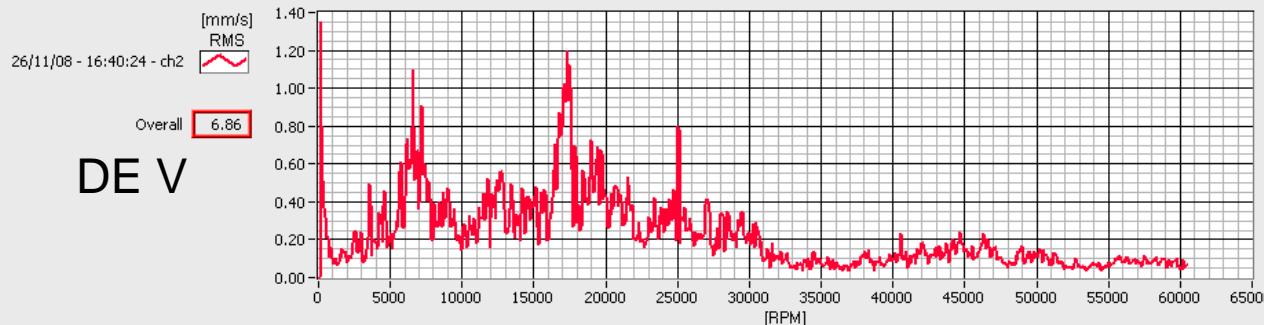
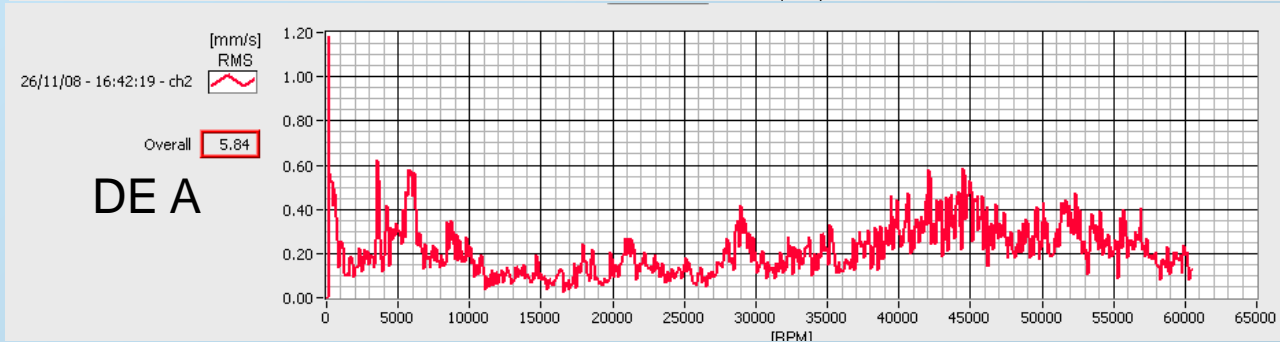
DE vibration spectra

Remarks :

a) Max amplitude at VPF

(1.4 mm/s = 0.06 ips)

b) High activity distributed

and dominant across

a range up 500 Hz

(30000 rpm)

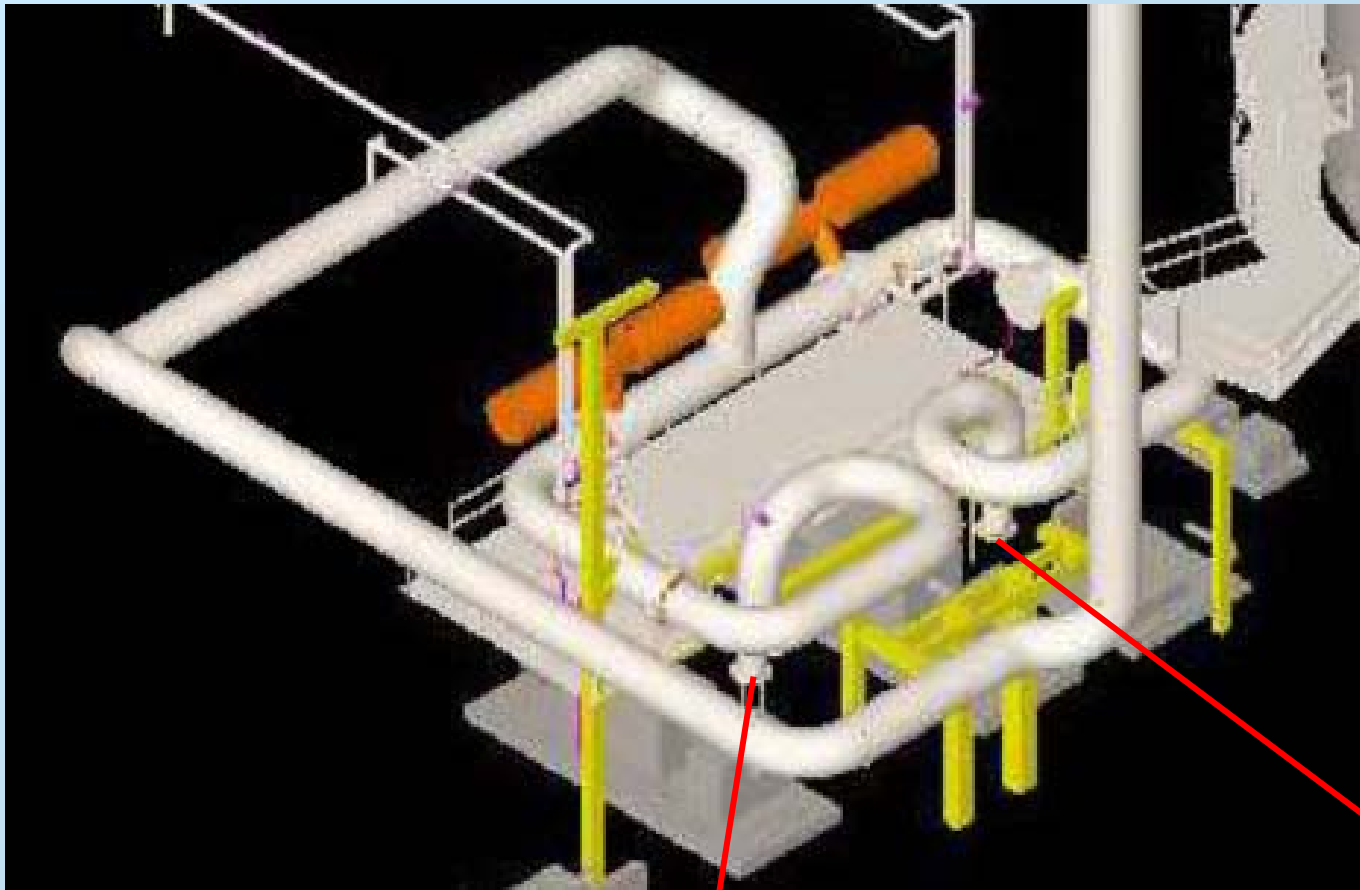
Initial analysis – Suction piping

POSSIBLE CAUSE	Why yes	Why not	Result
Fluid dynamics of the piping	Unsteady and random spectra with a broadband distribution of many peaks of low frequencies are indicative of intense turbulence. Piping was not fully compliant with HI recommendations	Piping designed according to customer best practice	PROBABLE CAUSE
Fluid dynamics of the pump	Unsteady and random spectra with a broadband distribution of many peaks of low frequencies are indicative of intense turbulence. Pump operation at capacity below BEP is potential source of high turbulence	Same type of pump running well in other applications	PROBABLE CAUSE

- ❖ The customer modified the piping layout as to have it compliant to Hydraulic Institute recommendation.
- ❖ The results of the modification showed visible reduction in vibration level, though not within the required acceptance limits.

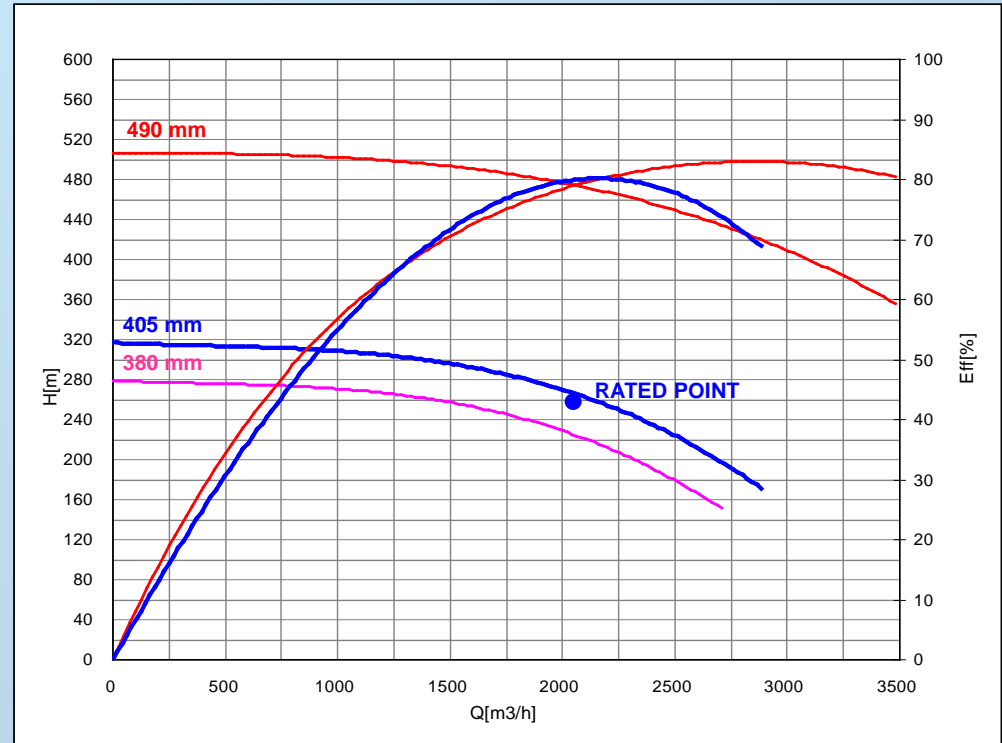
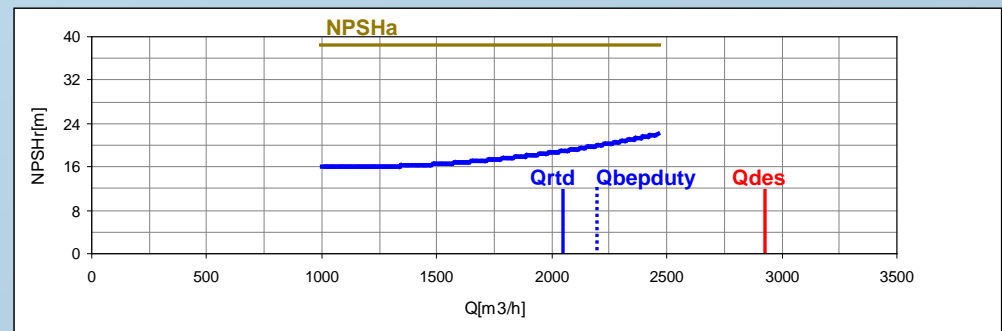
Test Curves

$Q_{rated} / Q_{design} = 0.74$ (Too low)

$Q_{rated} / Q_{sl} = 0.64$ (Too low)

$Q_{rated} / Q_{sr} = 0.98$ (Possibility of
suction recirculation start)

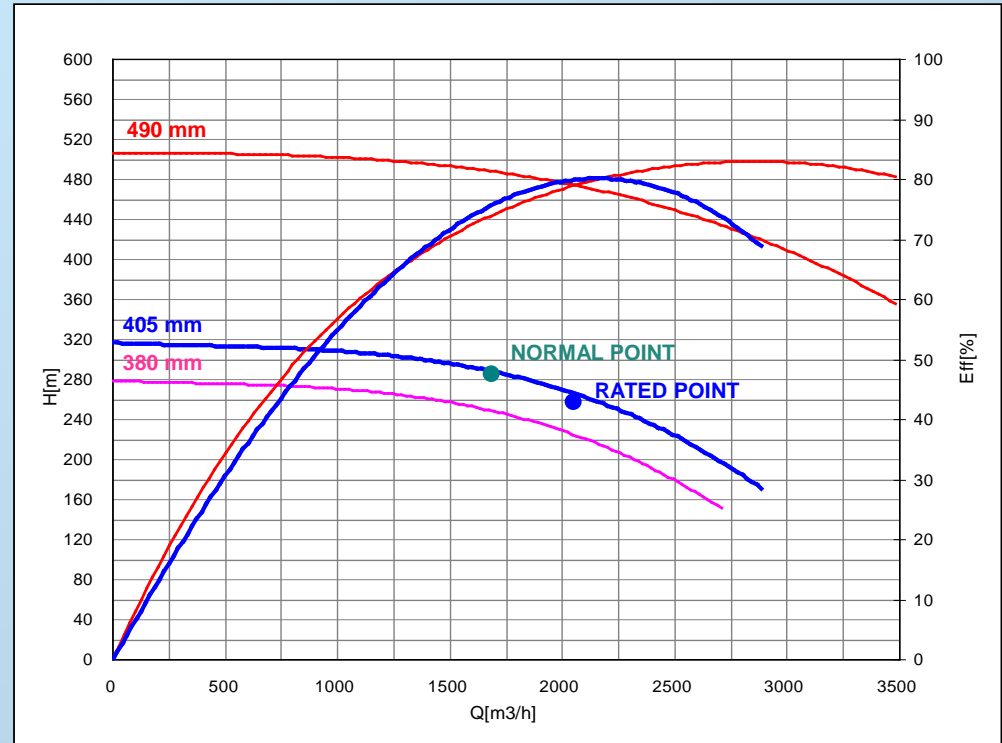
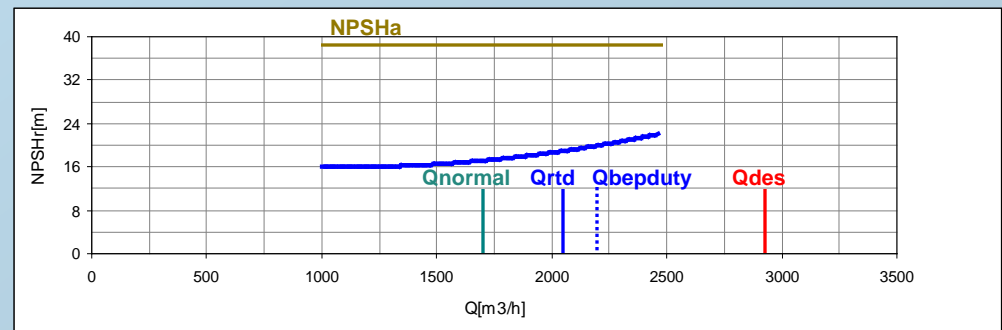
Test Curves

$Q_n = 59\%$ of Q_{des} – RED FLAG

Suction recirculation is root
cause of vibrations

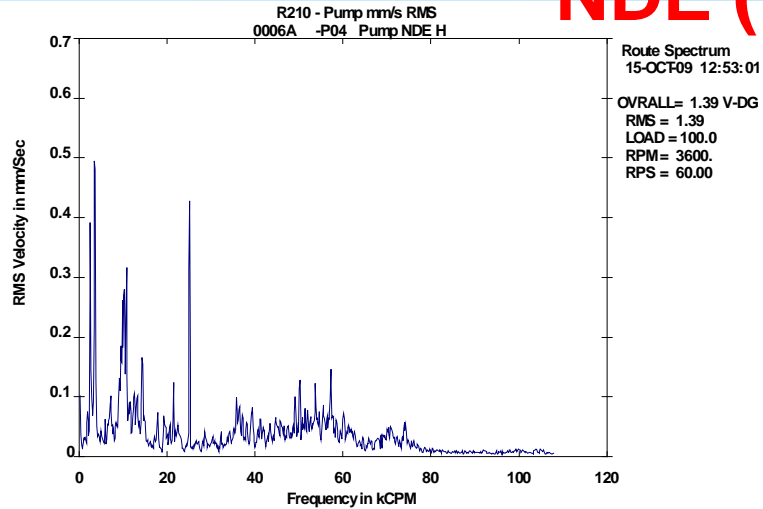
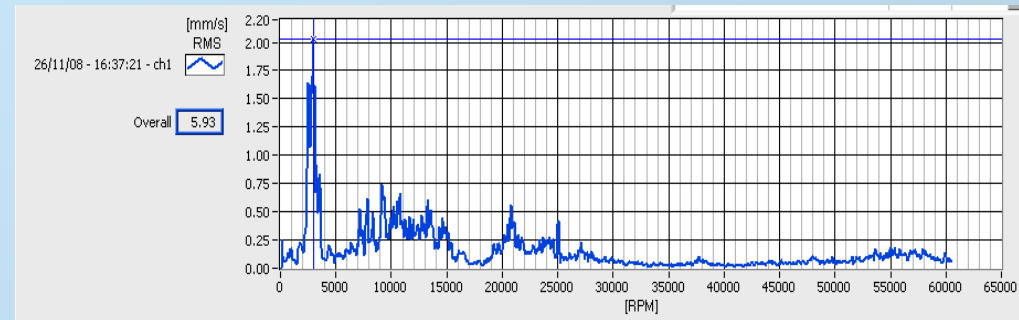
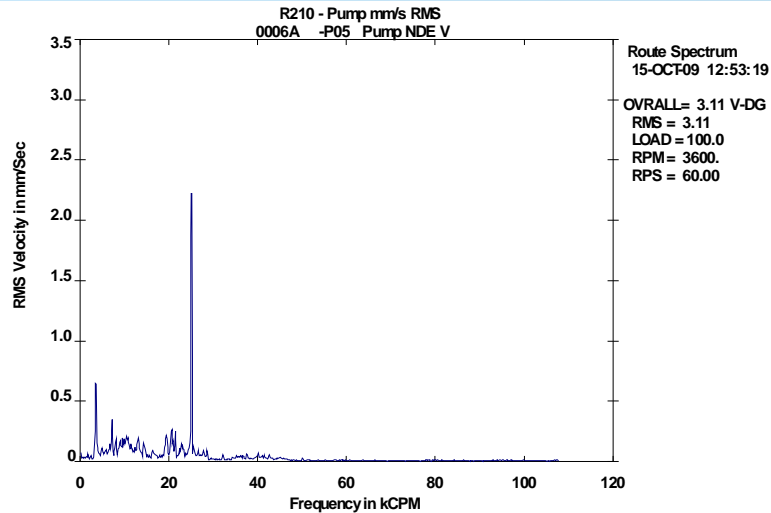
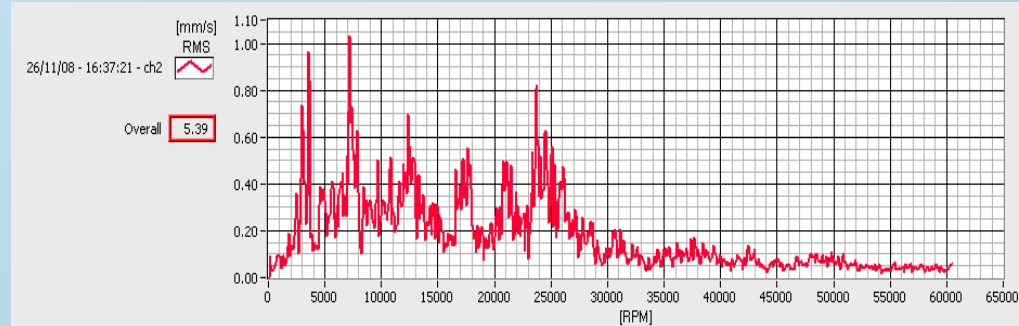
Field data comparison at normal capacity NDE (October 2009)

Old	New
H mm/s(ips)	5.93 (0.23)	1.39 (0.05)
V mm/s(ips)	5.39 (0.21)	3.11 (0.12)

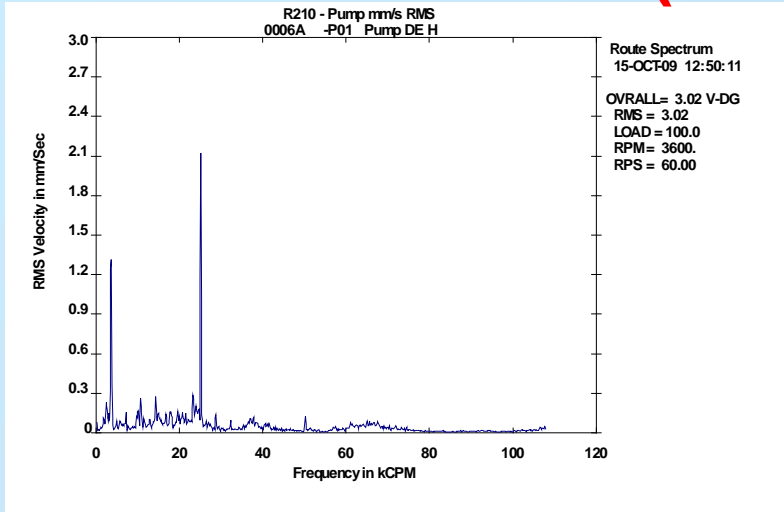
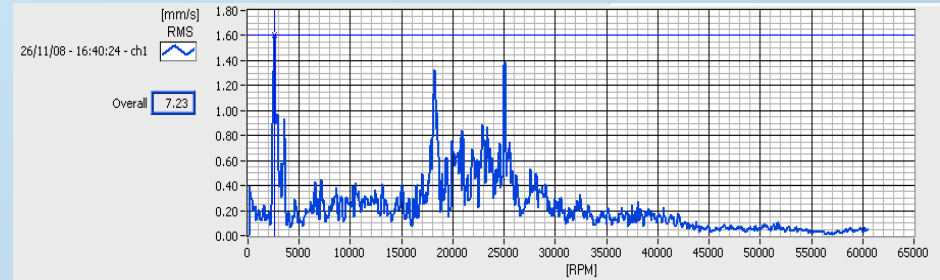
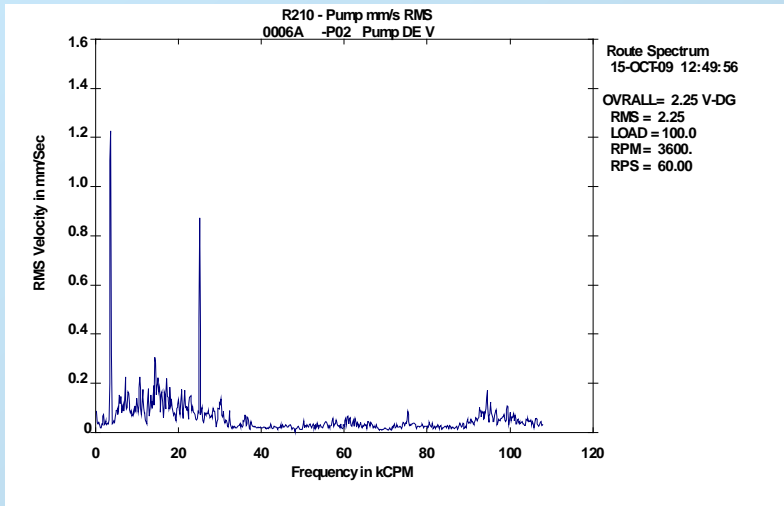
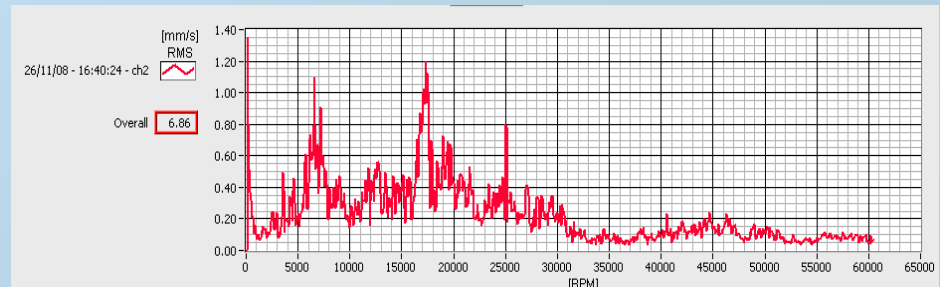
Field data comparison at normal capacity DE (October 2009)

Old	New
H mm/s(ips)	7.23 (0.28)	3.02 (0.12)
V mm/s(ips)	6.86 (0.27)	2.25 (0.09)
