Reverse Rotation of Compressor - Drive Turbine train can cause major damages

(A Case Study of Delayed Coker Unit Wet Gas Compressor Drive turbine Barring Gear damage due to Reverse Rotation: Its Detection, Diagnosis & Correction)

**HPCL-Mittal Energy Limited,
Bathinda Refinery, INDIA**

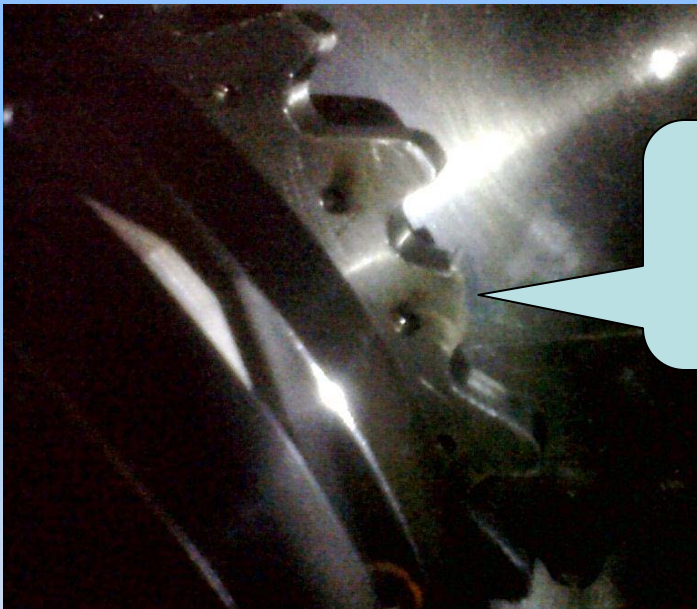
- **Compressor – Steam Turbine train was under barring mode after unit shutdown**
- **After 3 hours into the shutdown, it was reported that the hydraulic barring of turbine rotor had stopped.**
- **During the investigation, it was discovered that one tooth of barring gear wheel on turbine rotor was broken (exhibit # 1 & 2)**

Exhibit # 1: Barring gear wheel on turbine rotor with one tooth broken

- Rotor was replaced with new rotor during planned shutdown of the unit
- Recurrence was avoided with solution, following logic was implemented :
 - ❑ Closure of 1st Suction and Final Discharge motor operated valves (MOV) with coast down after trip / stop, when machine comes to standstill.
 - ❑ Closer of Antisurge valve on trip/stop, when speed reaches below 400 RPM
 - ❑ Drain case pressure only through case diaphragm drains to avoid condensation

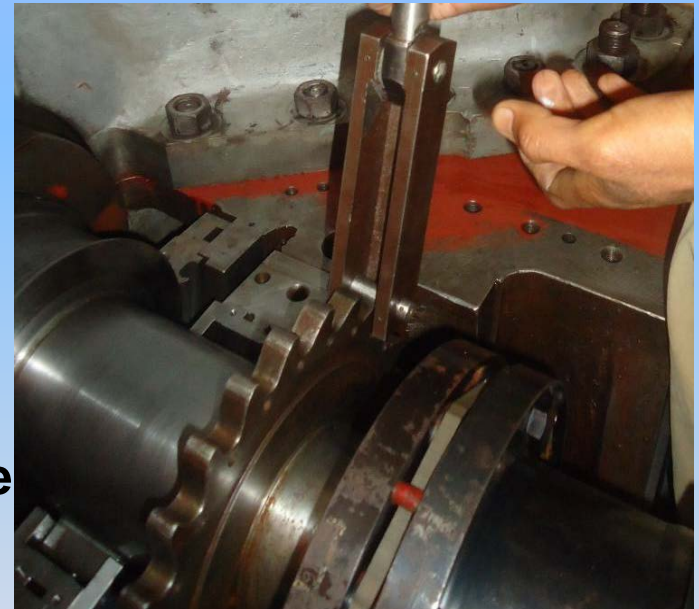
Exhibit # 3: Hydraulic barring latch arrangement (rotor could not rotate due to broken tooth)

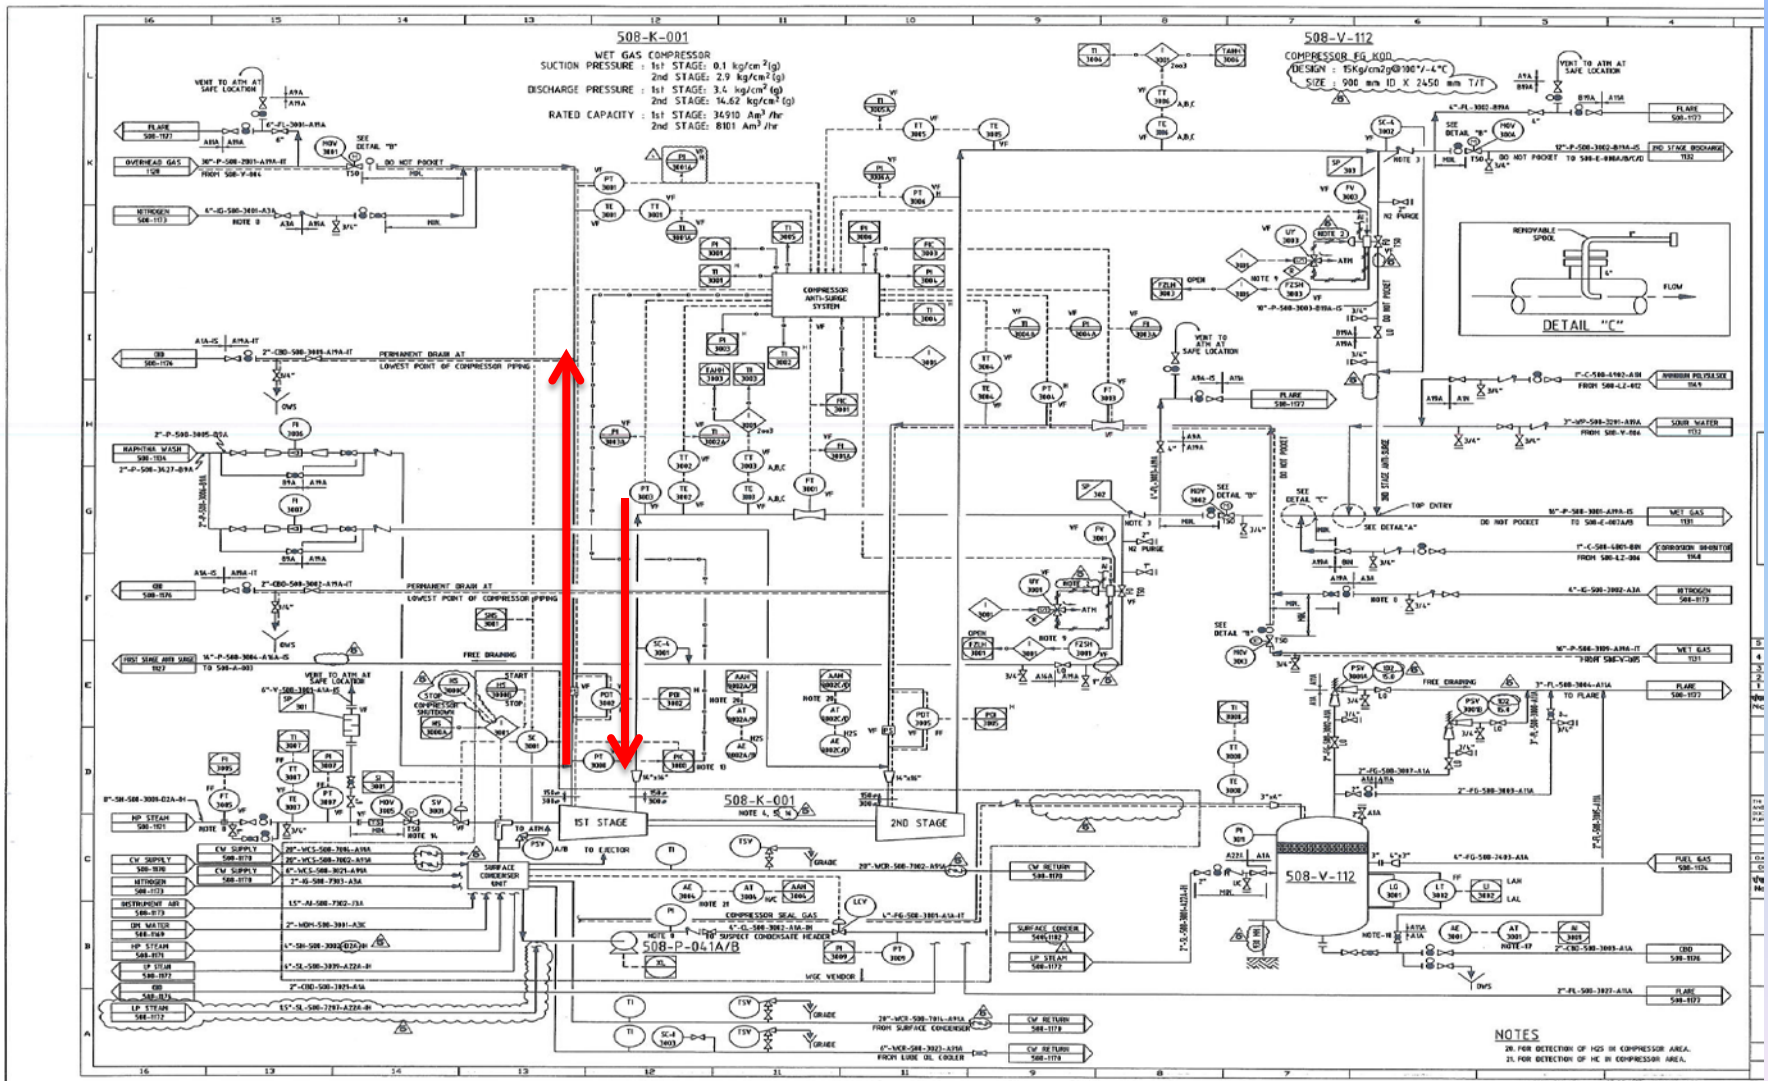
P & ID of compressor showing the direction of gas flow across the casing

- Before the incident, sudden depressurization was done by opening the drain line of 2 inches size, at the 1st Stage compressor suction
- Flow created during depressurization across impeller eye resulted in rotor reverse rotation during barring gear in engaged condition, causing barring gear tooth damage

Gas flow causing reverse rotation marked in Red color

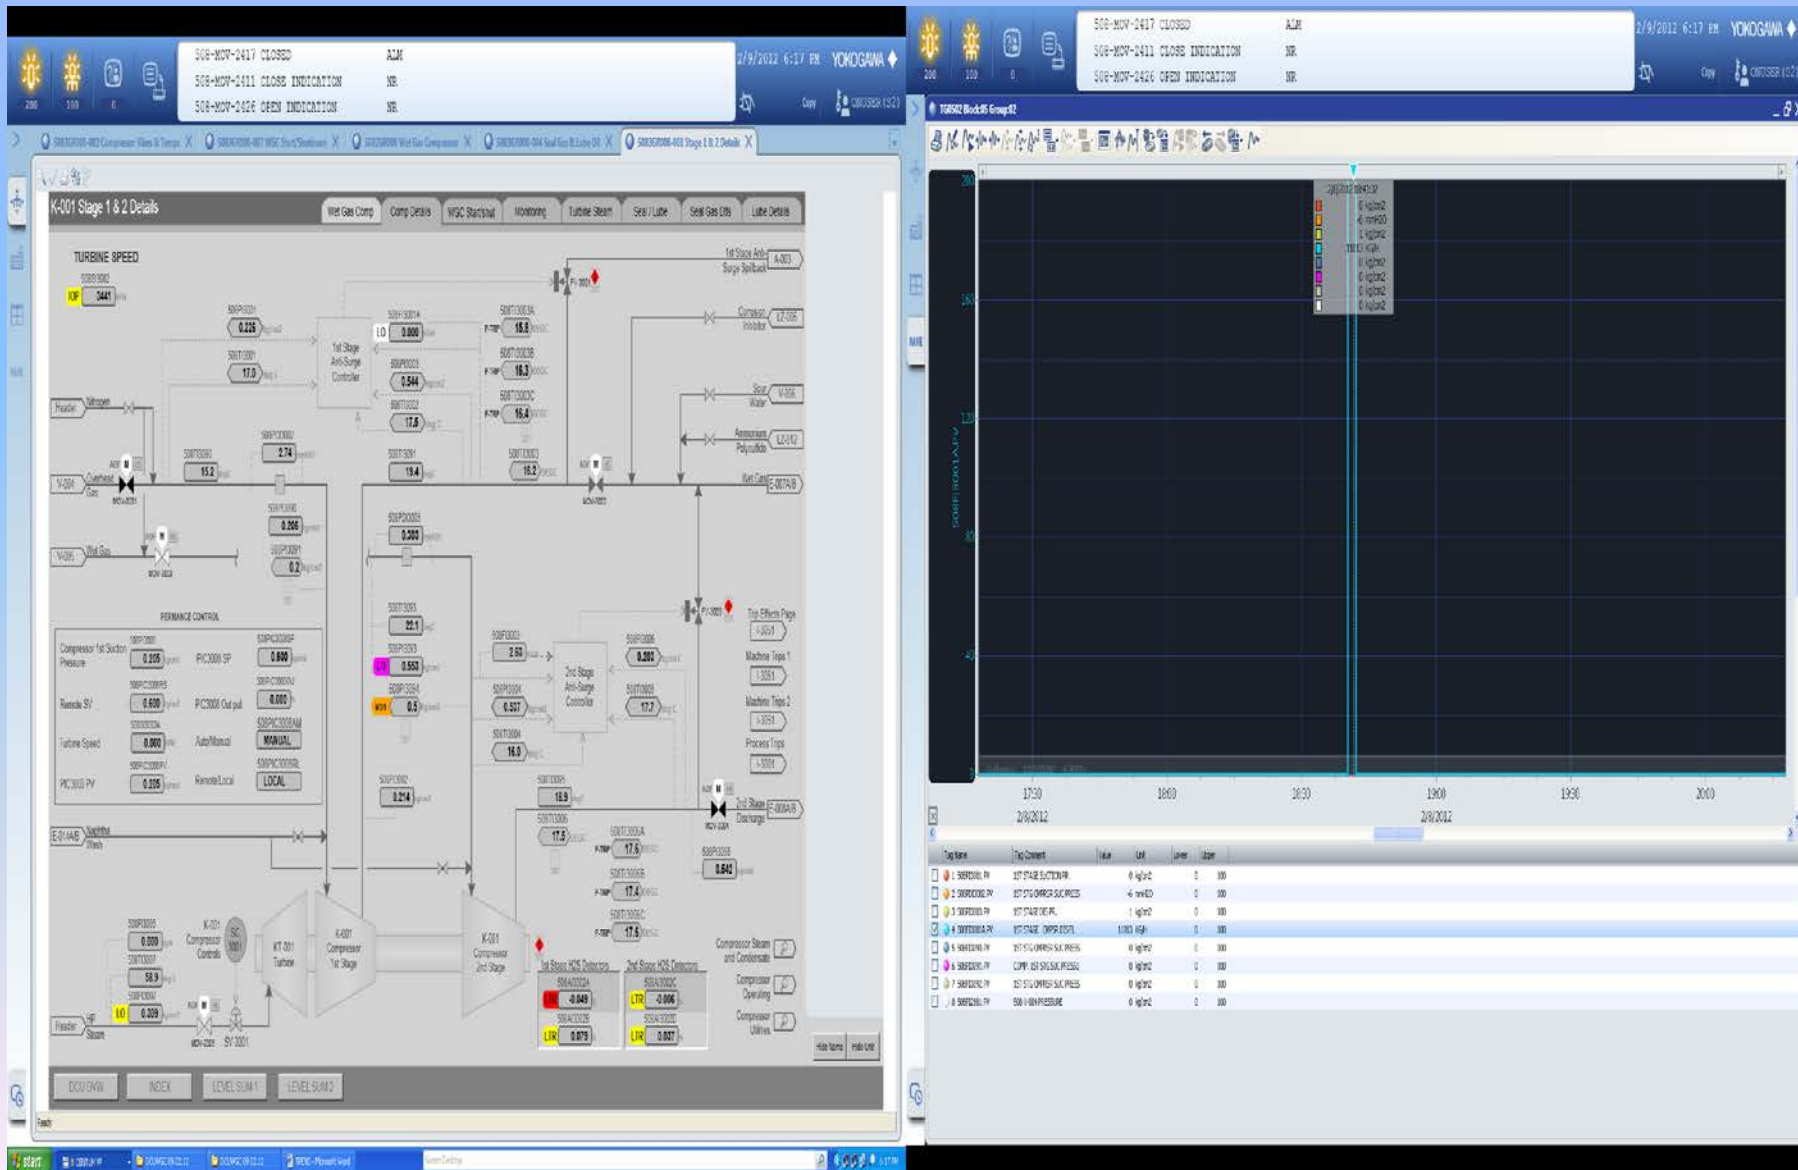
Trend indicating flow from 1st Stage:

- Speed trend indicated that the compressor had rotated at 427 RPM during incident**
 - Flow across the 1st stage casing was measured at 11013 Kg/hr at time of incident**
-
- **Barring gear construction & failure pattern indicated reverse rotation**

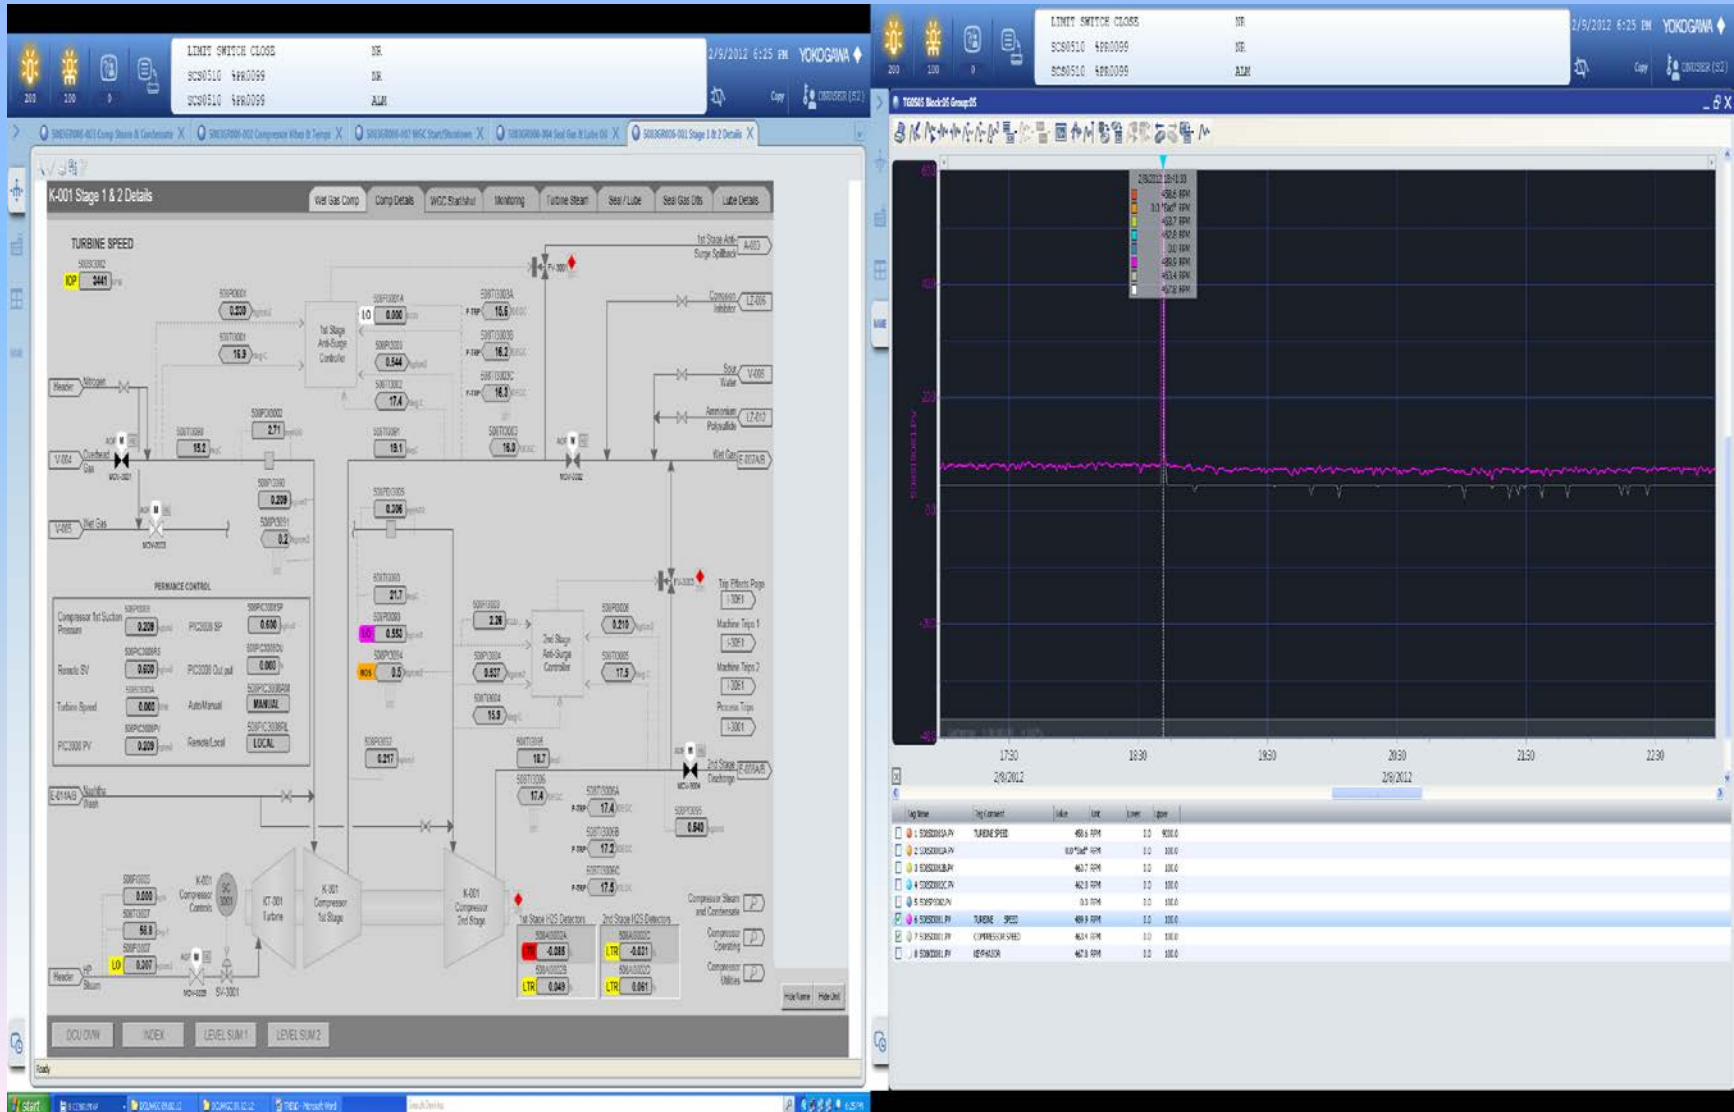
Trend indicating speed pick up during shutdown of unit
(reverse rotation at 427 RPM)

- **Compressor acted as a driver, due to reverse flow of gas and rotated the coupled unit at 427 RPM in the reverse direction**
- **At same time, turbine barring gear wheel was in the engaged position with the hydraulic latch , this led to breaking the tooth of the turbine barring gear wheel**

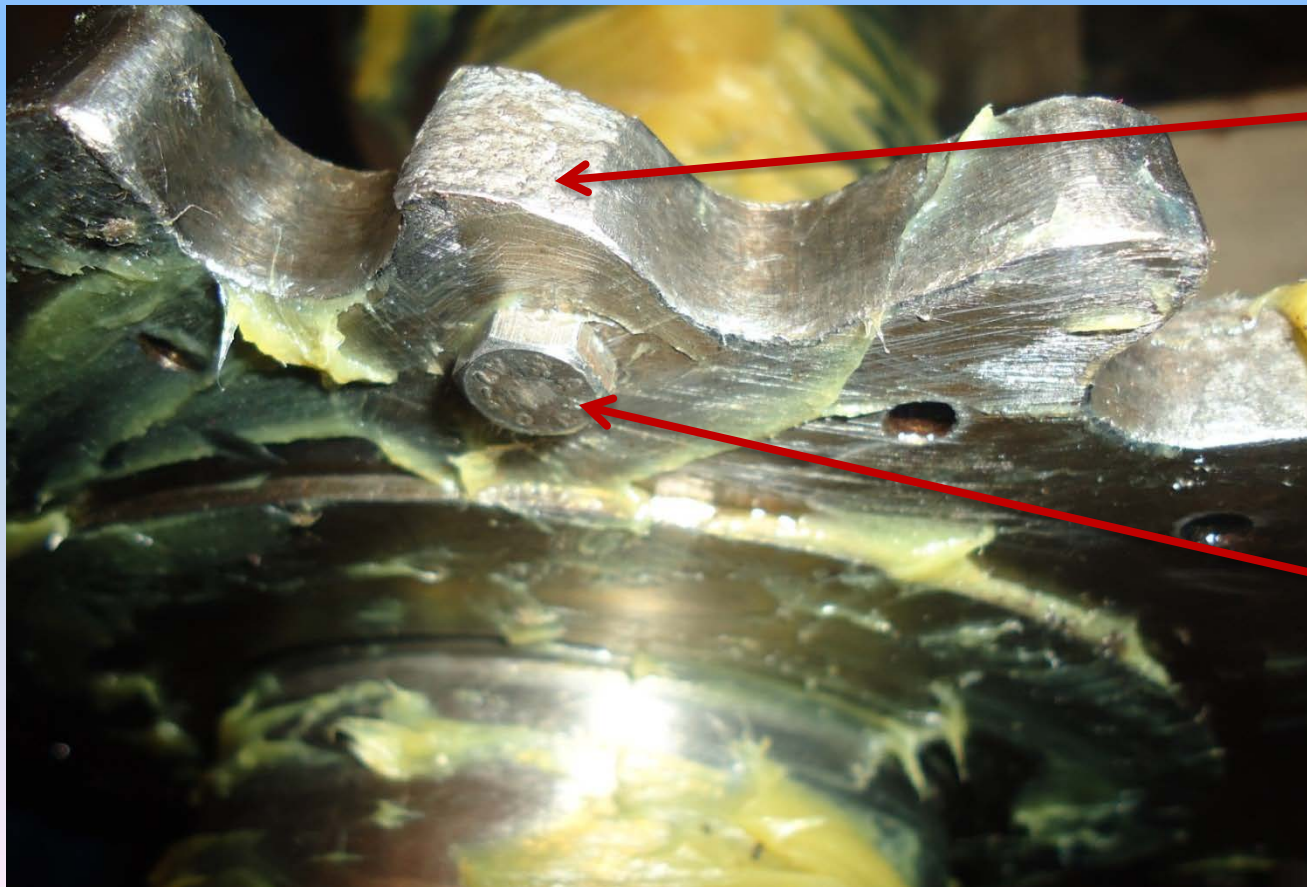
Exhibit # 4

**Broken
tooth**

**Bolt of equivalent
mass**

- Due to the urgency of Unit Start up, temporary solution was thought off & executed :
- The broken piece of gear tooth was weighed and a bolt of equivalent mass was fixed on gear wheel (refer exhibit # 4)

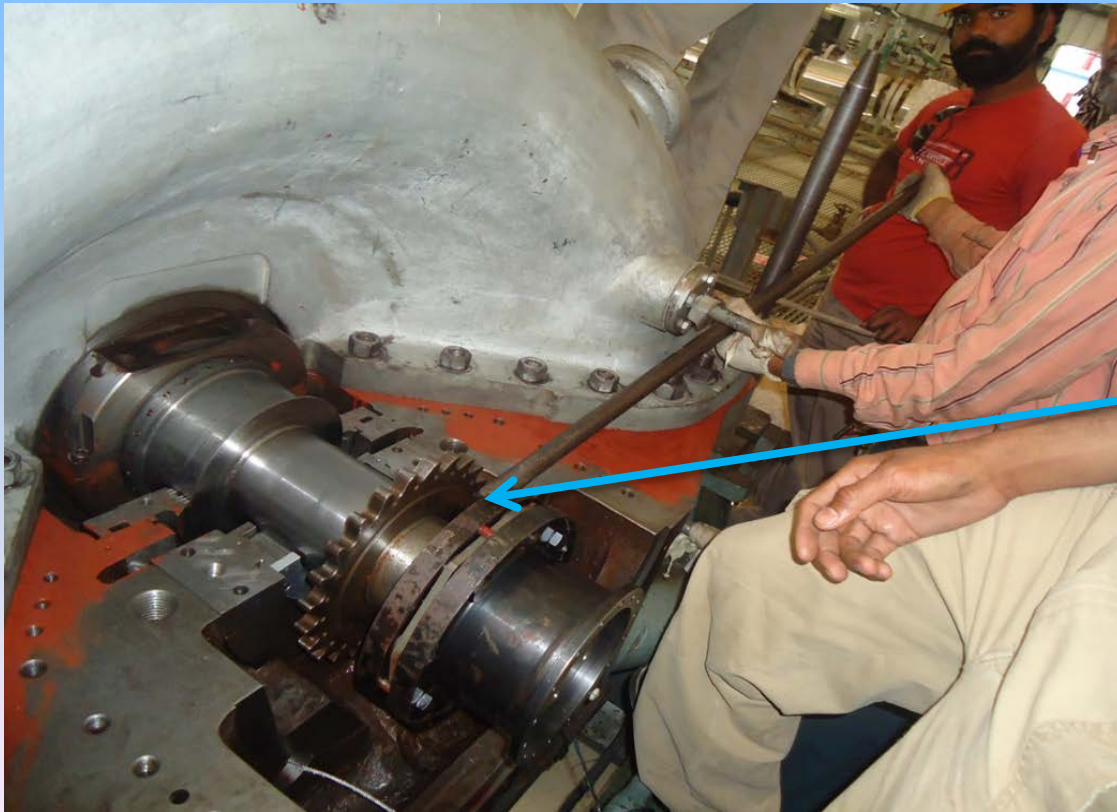
Exhibit # 5

Demonstration of turbine rotor barring done manually

- Manual barring arrangement was made and the machine was commissioned successfully with vibrations within acceptable limits (Refer Exhibit # 5)
- With above temporary solution the delayed coker unit of Refinery had successful start up
