ASIA TURBOMACHINERY & PUMP SYMPOSIUM
SINGAPORE | 22 - 25 FEBRUARY 2016
M A R I N A B A Y S A N D S

2 Case Studies on Unique Machinery Repair Techniques:

- Brush Plating Repair of Eroded Compressor Diaphragm
- Combining 2 Failed Gearboxes into 1 Functional and Reliable Gearbox

ExxonMobil Exploration and Production Malaysia Inc.

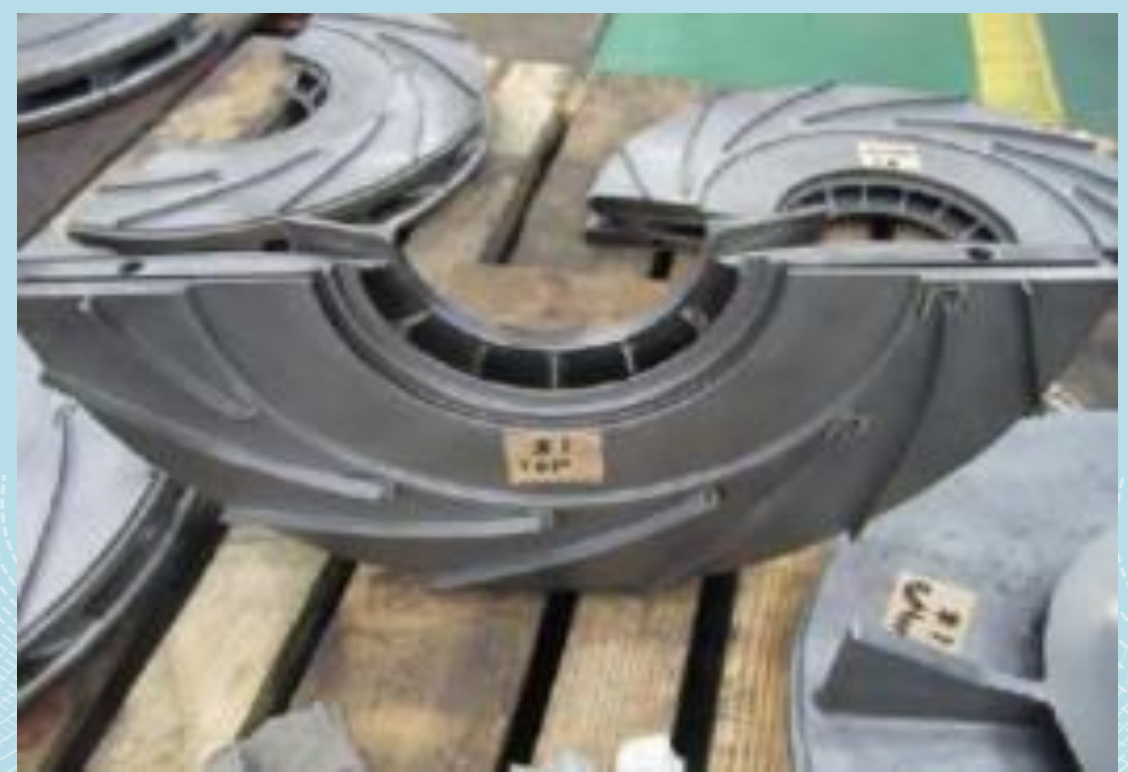
HP Inlet Diaphragm (top)

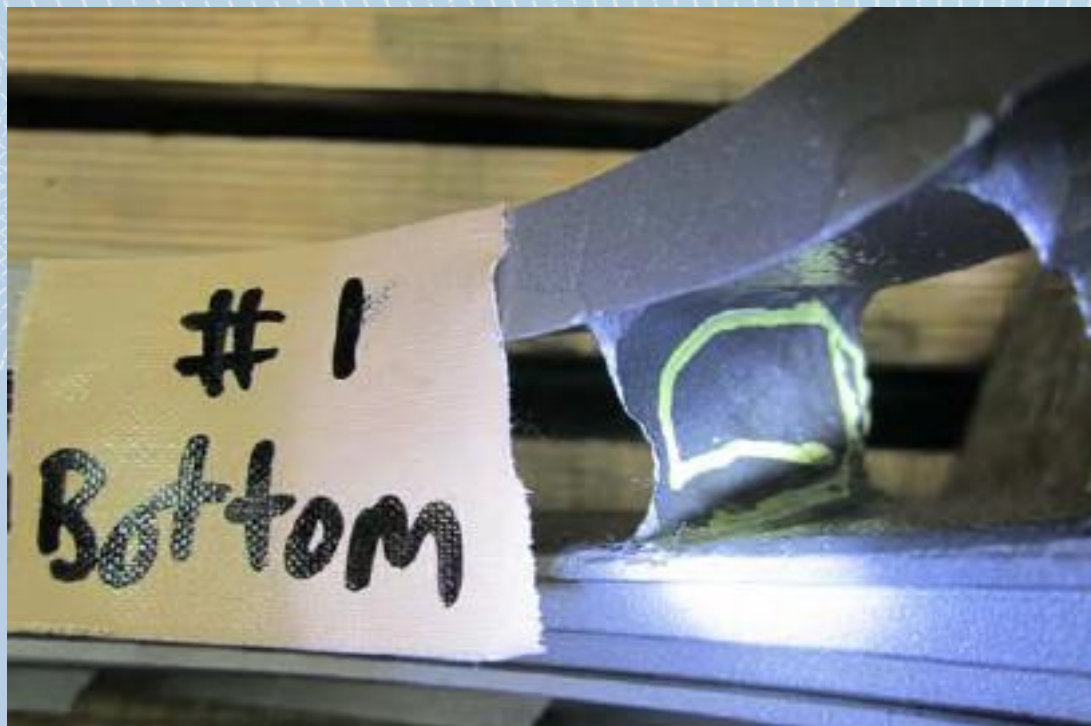
- A compressor train removed for overhaul in June 2011 due to loss of compressor efficiency
- HP inlet diaphragm vanes found eroded (70% material loss) due to liquid carryover
- >6 months of lead delivery time for new diaphragm

Eroded Vanes(bottom half)

- Able to perform electroplating repair at localized damaged areas (eg. diaphragm vanes)
- Faster lead time (repair completed in approximately 6 weeks)
- Repair conducted at regional one-stop comprehensive engineering service provider shop

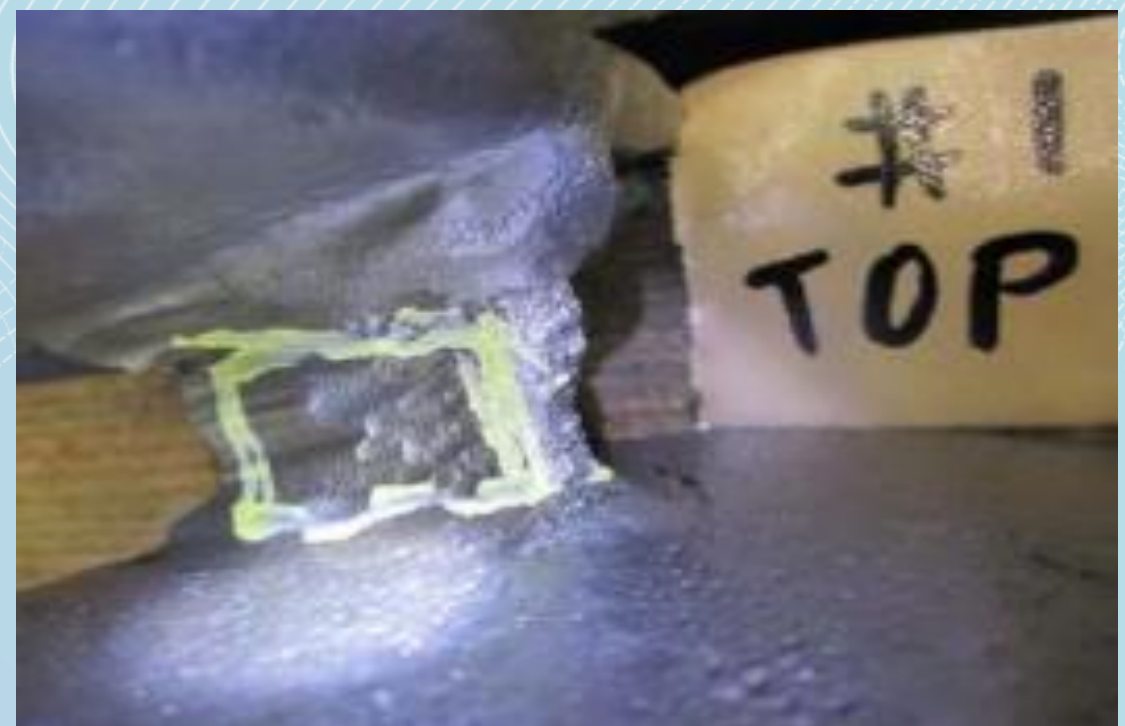
Eroded Vanes(top half)

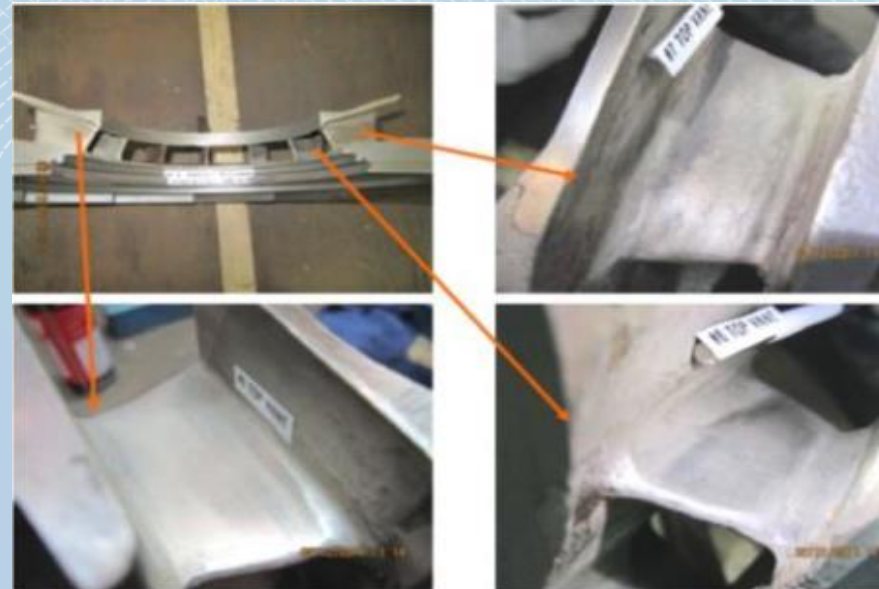
*Repaired Top Half of
Diaphragm*

- Rectifier provides direct current required for plating and anodizing
- One lead connected to plating tool (anode) vs other lead connected to part being plated (cathode)
- Circuit completed when plating tool touches work surface, allowing copper deposit onto surface
- Copper deposit was build up to around 2-3mm thickness while final nickel cap (bonding + hardness/erosion resistance) was plated to 0.5mm thickness

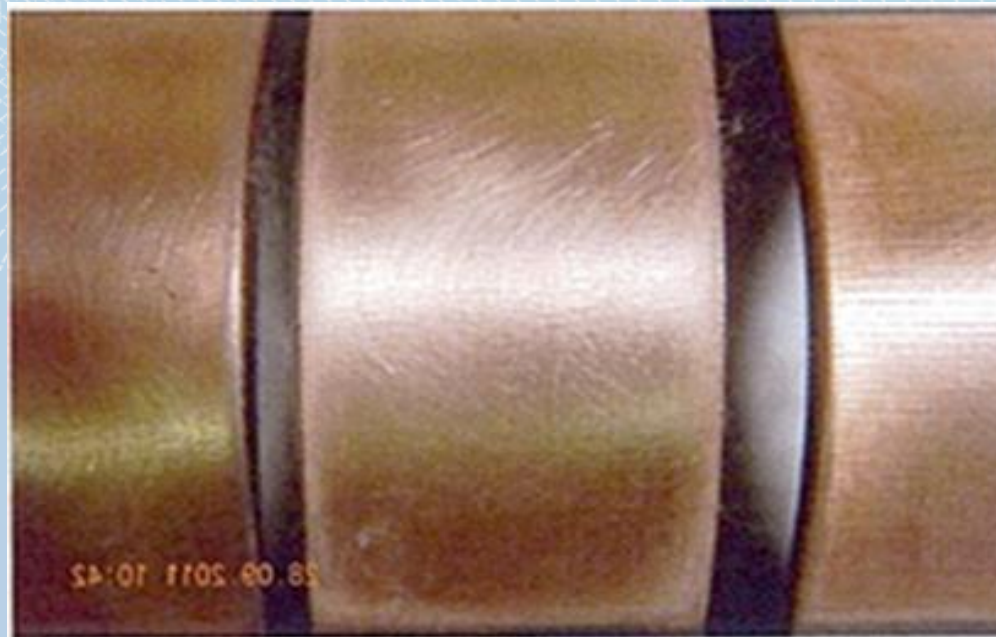
- Trial run conducted to ensure adhesion effectiveness
- 3 cast iron samples were plated with approximately 0.045mm of copper overlaid with 0.002mm to 0.003mm of nickel
- 3 samples were bent to approximately 80 degree on the inner radius
- After bending, all 3 samples were found with only micro cracks and no lifting or delamination of the brush plated copper.

***Bent Cast Iron with Copper
Nickel Plating***

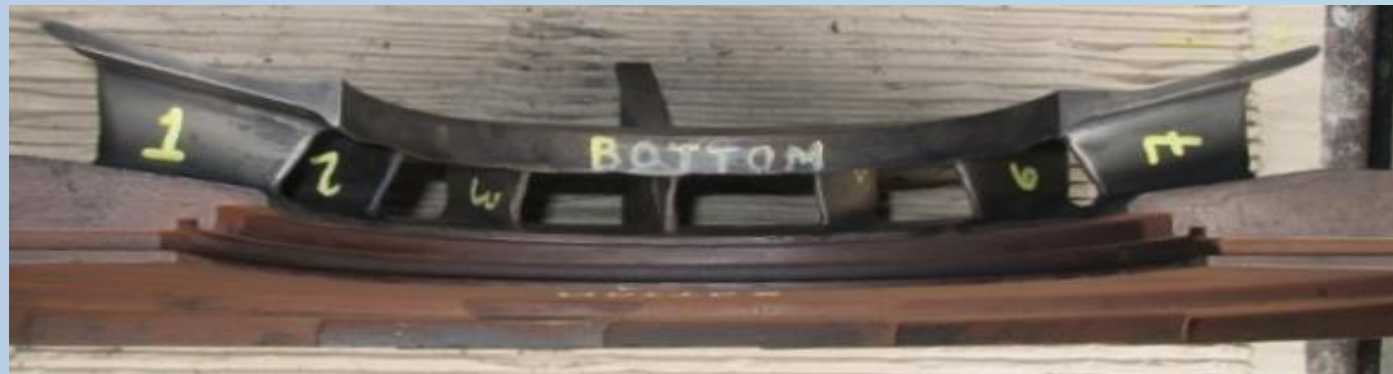
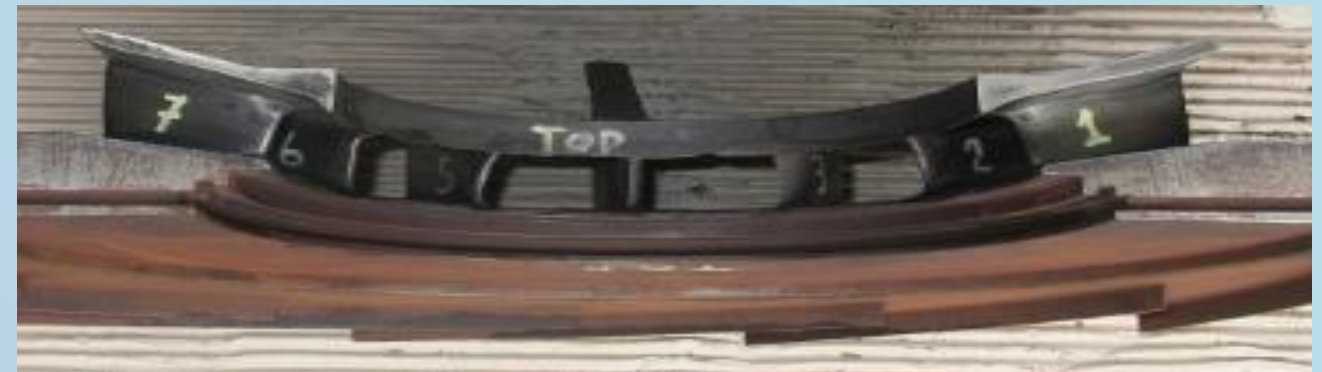
Diaphragm After Plating

Findings Post 12,000 Run Hours

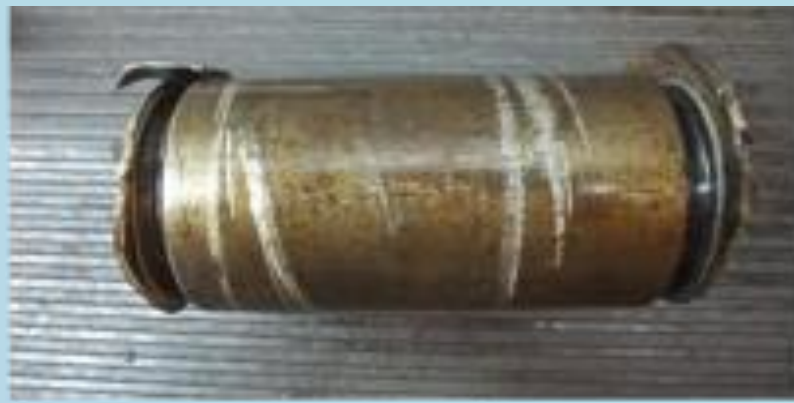
Location of debris

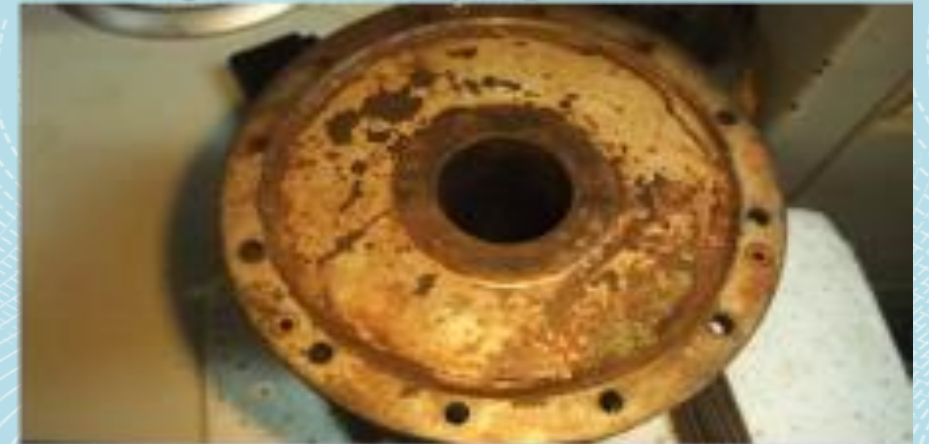
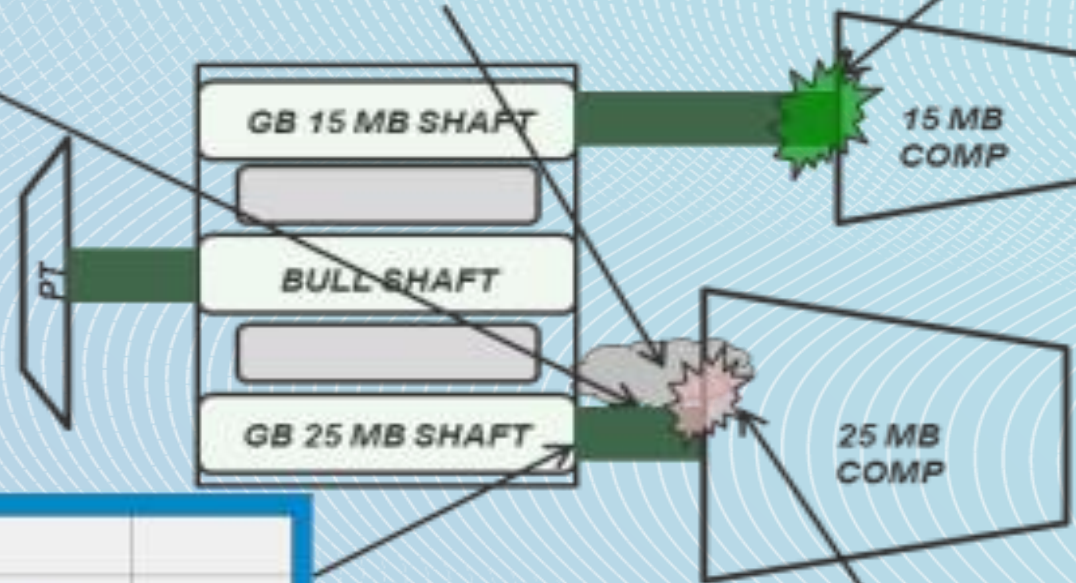
Location of August 15 MB Coupling Failure

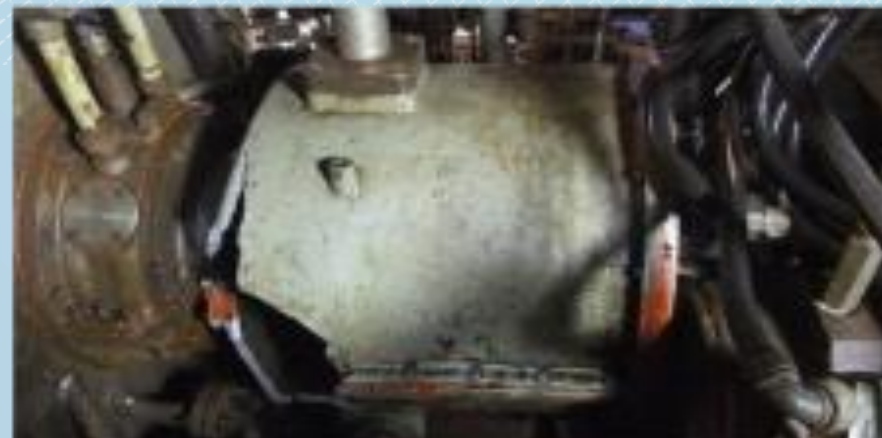
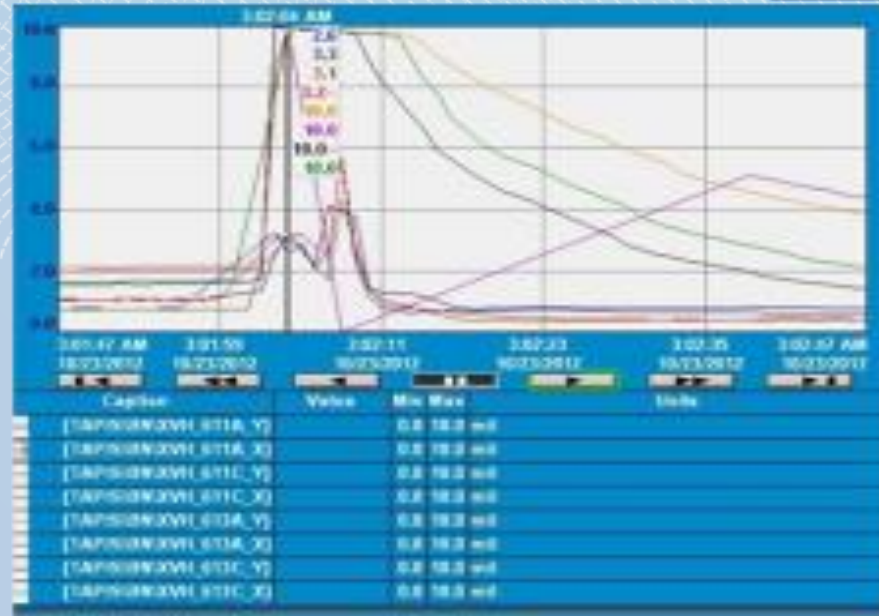
Section of Coupling Cover Broken

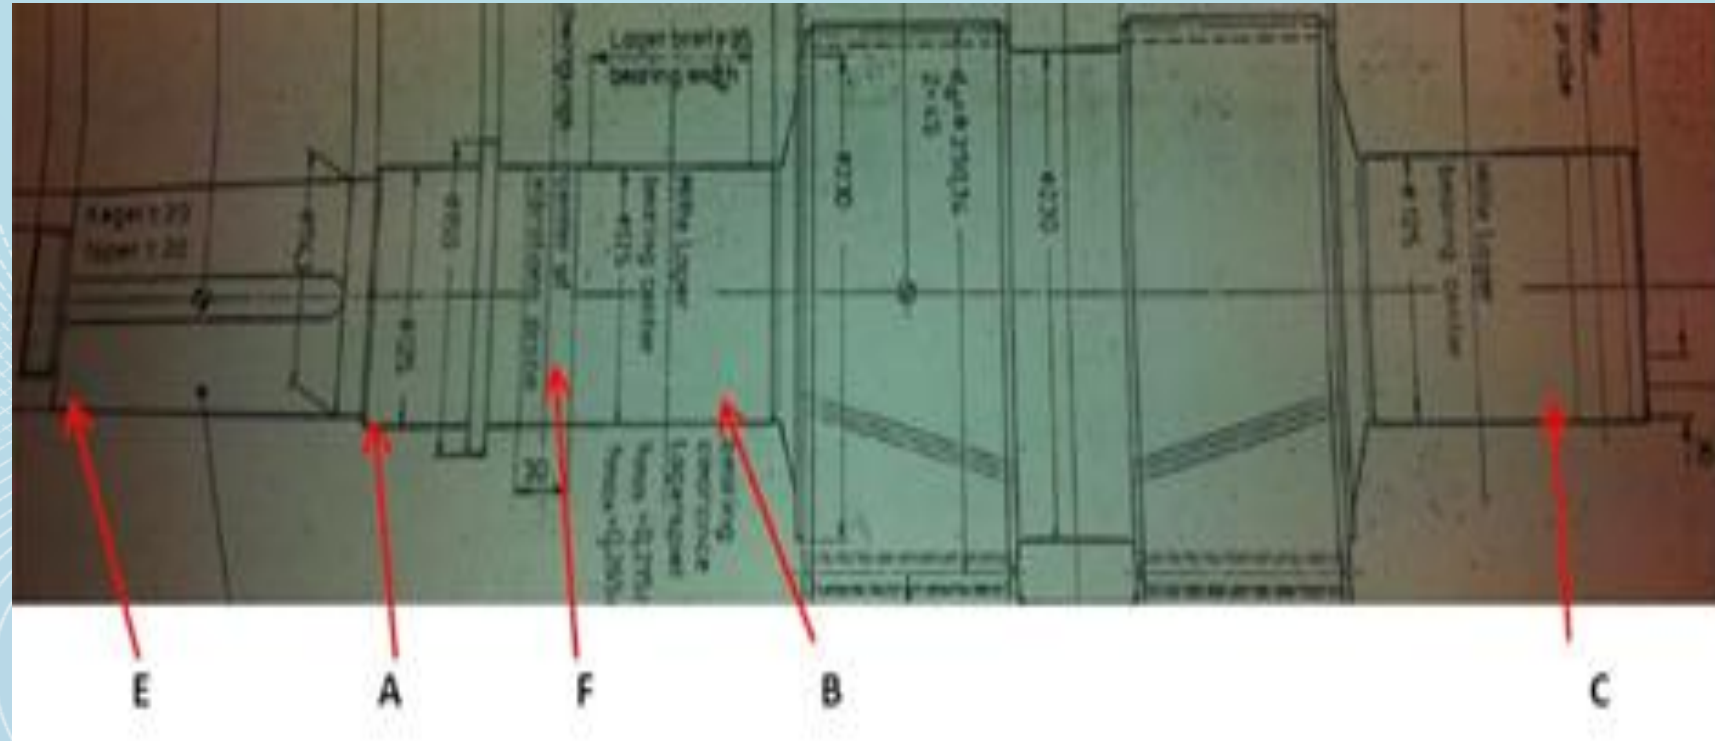
Dial Indicator Run-out Readings
(units in mm)

- First coupling failure (Train A) led to bent output shaft 1 driving Low Pressure Compressor Coupling
- Second coupling failure (Train B) led to bent output shaft 2 driving High Pressure Compressor Coupling

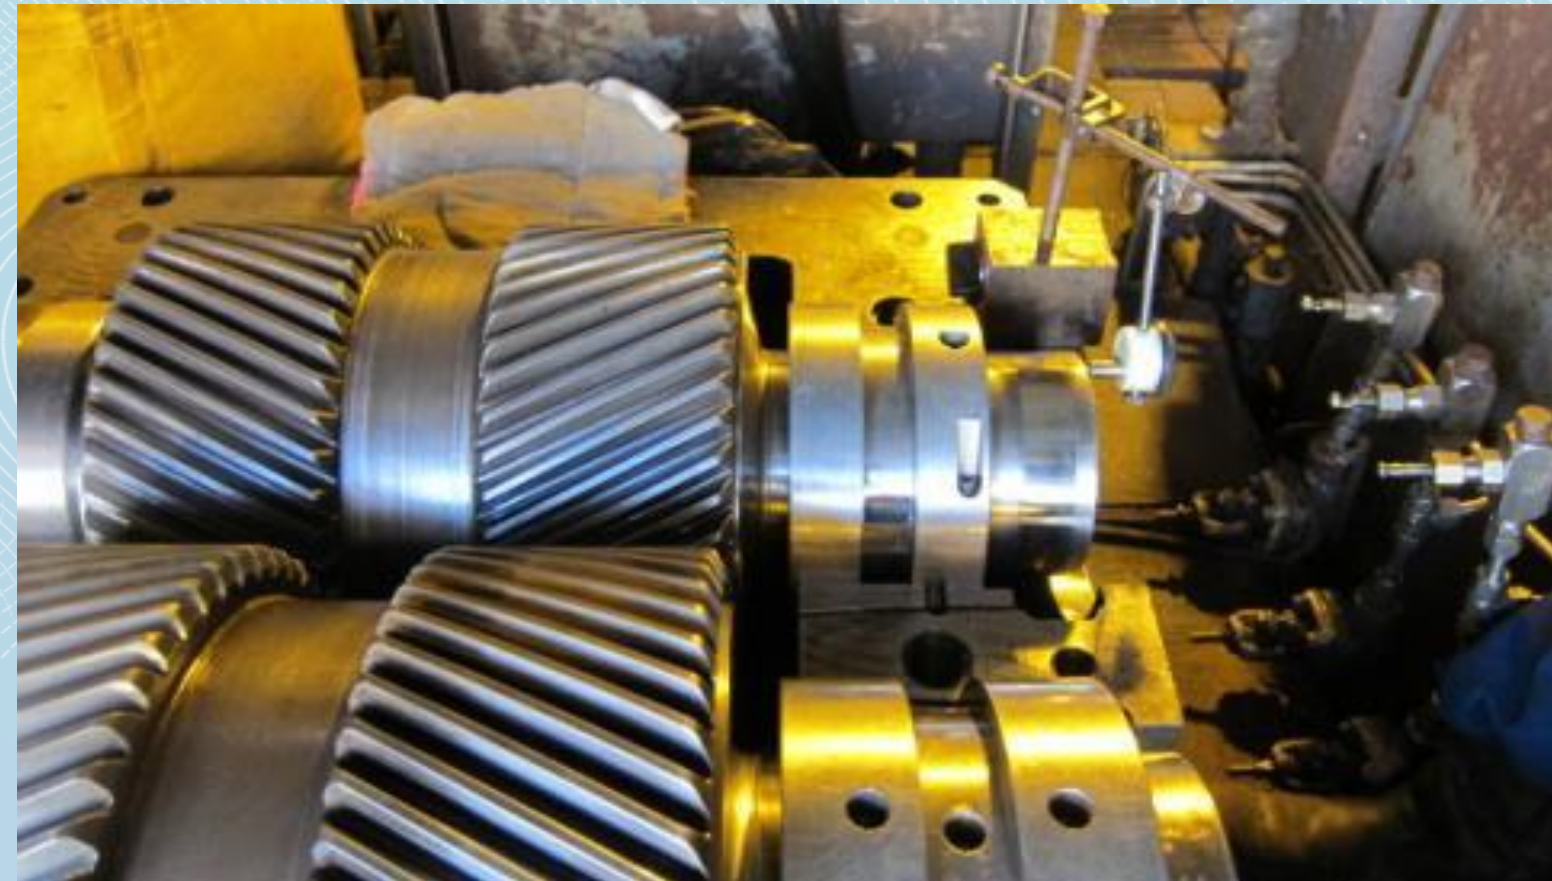
- Carried out tooth contact checks (verified 80% tooth contact area)
- Case-hardened gear tooth surfaces

Assembly and set up for on-site gear tooth contact verification

- Replaced damaged Output Shaft 1 from Train A with 'good' shaft from Train B

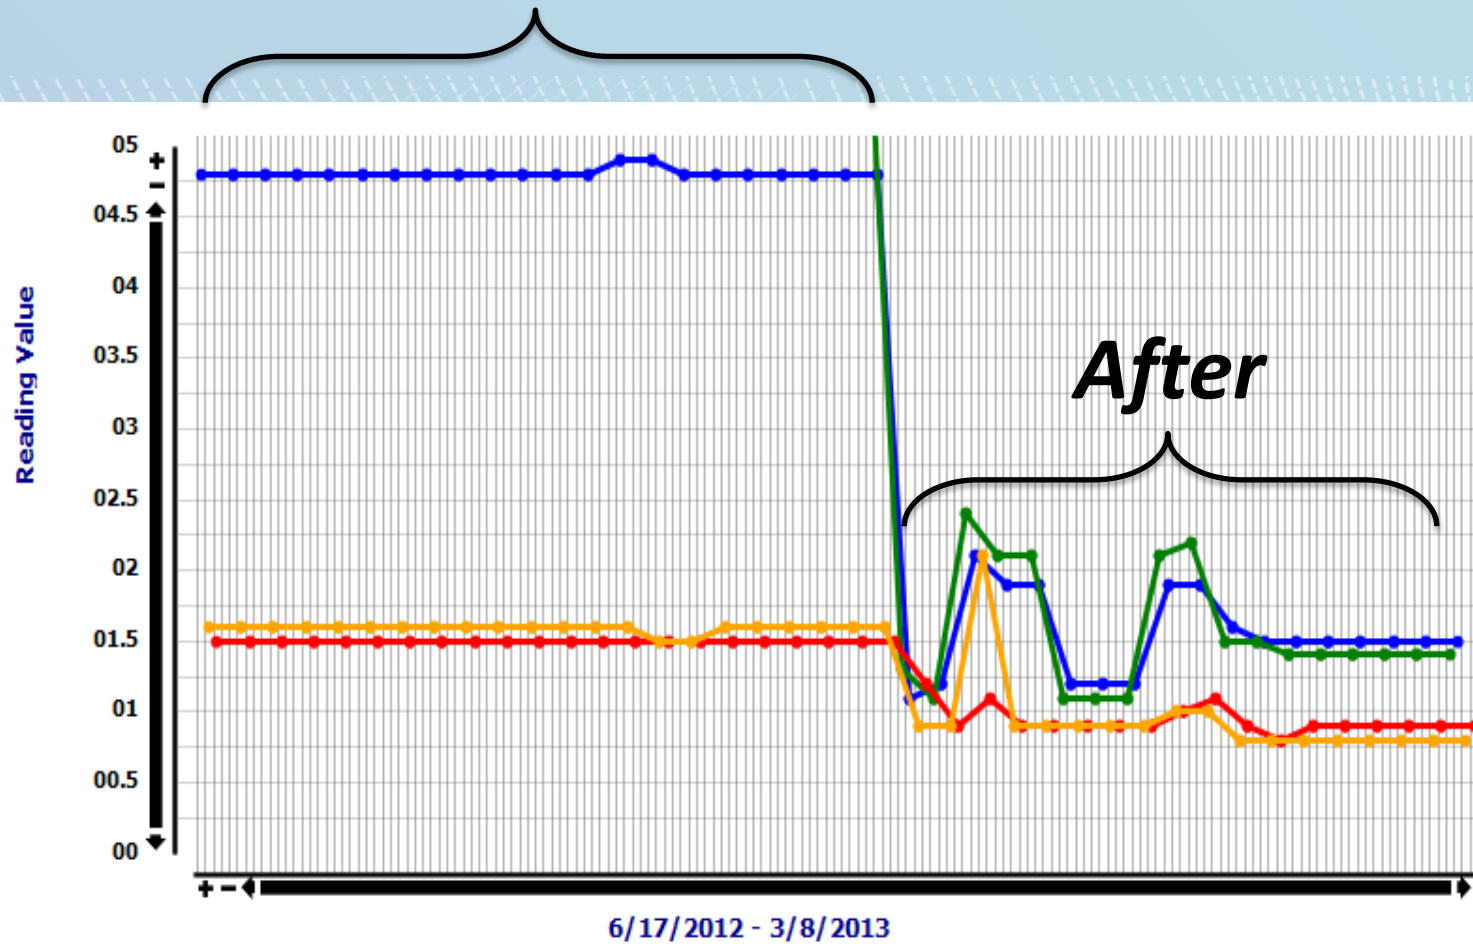
“Before and After” Vibration Readings for GB Unit A

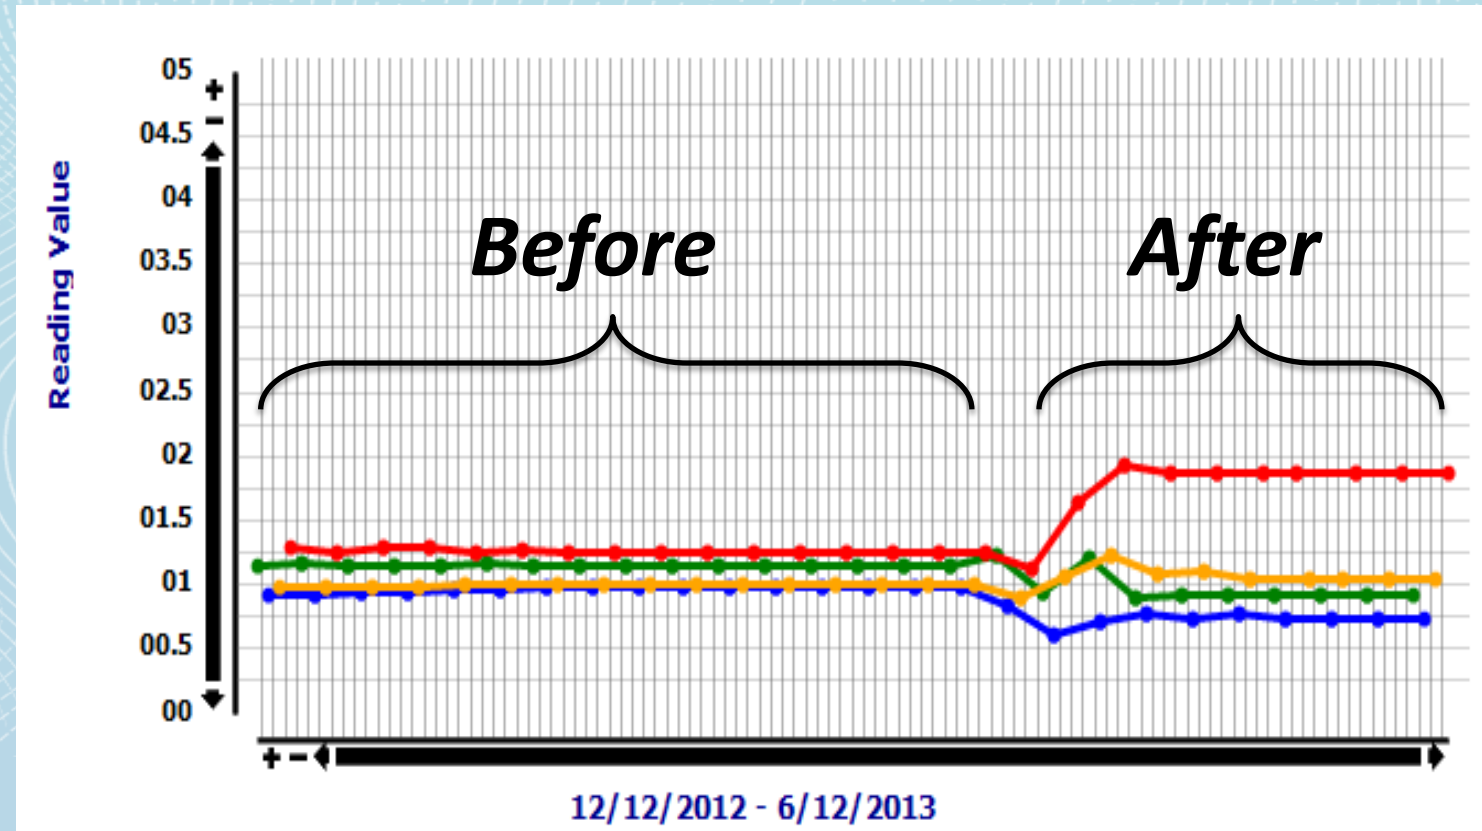
“Before and After” Vibration Readings for GB Unit B

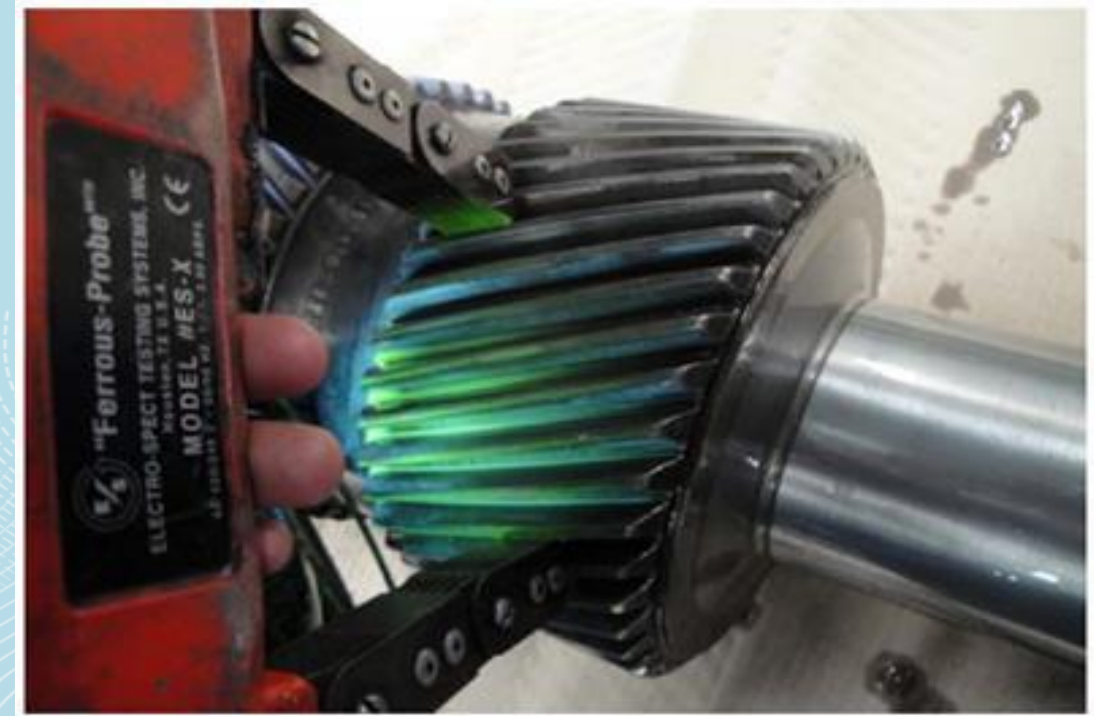
- Workshop run-out readings were almost identical to those at site (TIR approximately 0.2 mm)
- Balancing checks verified tapered shaft eccentricity
- Magnetic Particle Imaging (MPI) and Ultrasonic testing (UT) demonstrated no subsurface cracks or defects
- Rockwell Hardness to confirm material identity and yield stress
- **ASSESSMENT:** Rotor damage was confined to eccentricity thus repair options could be pursued

Above: MPI testing on gear teeth
Below: Hardness test location and results

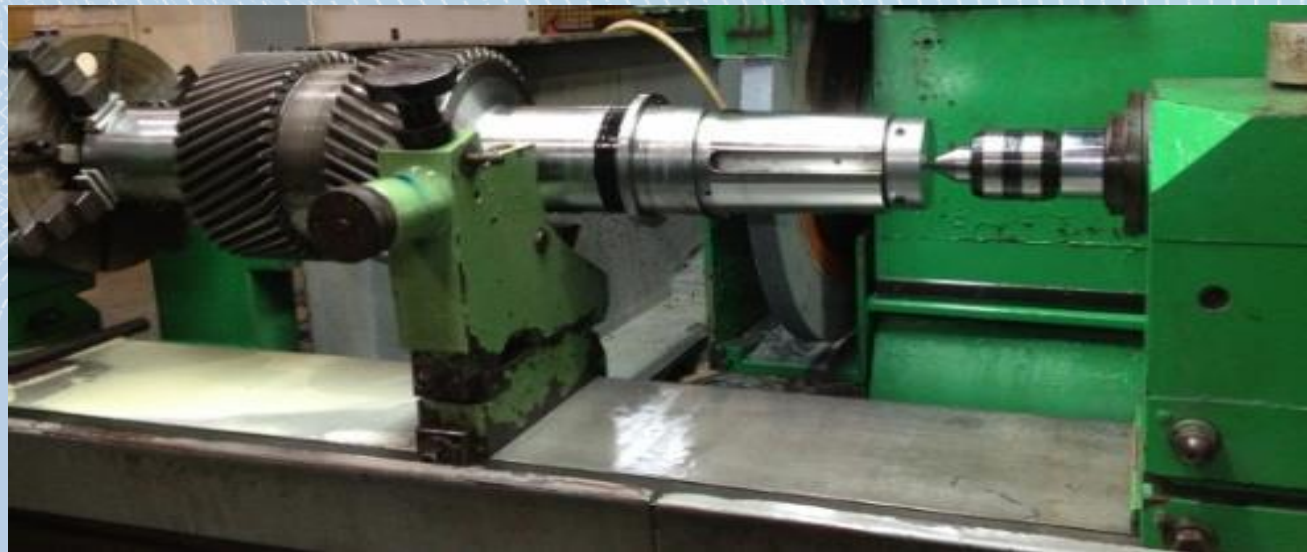
Tapered Surface Grinding

1. Hydraulic press to correct gross eccentricity
2. Surface grinding of shaft taper to restore 1:20 taper profile to coupling hub area
3. Full inspection to confirm no damage sustained in Steps 1 & 2

- Hydraulic press reduced shaft TIR from 0.2 mm to 0.05 mm
- Surface grinding successfully restored TIR to within 0.01 mm (shortened shaft by 1 mm)
- **SAFETY!:** Rotor balancing, MPI, UT and Die-penetrant tests showed rotor to be acceptable

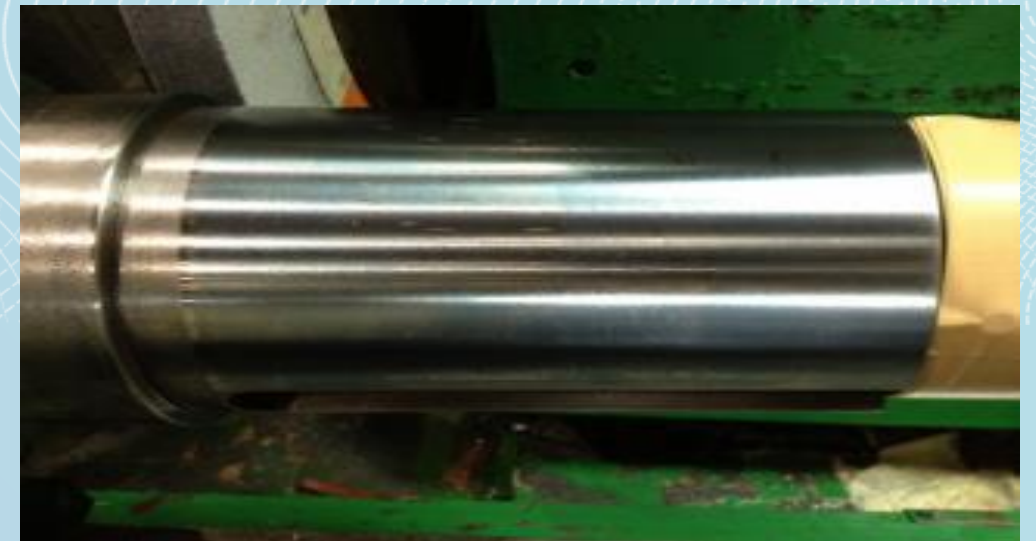
*Completed Surface Finish
(roughness 0.266 micron)*
