Roots of Mold Problems and Humidity Control Measures in Institutional Buildings with Pre-Existing Mold Condition

Texas A&M University, College Station, Texas

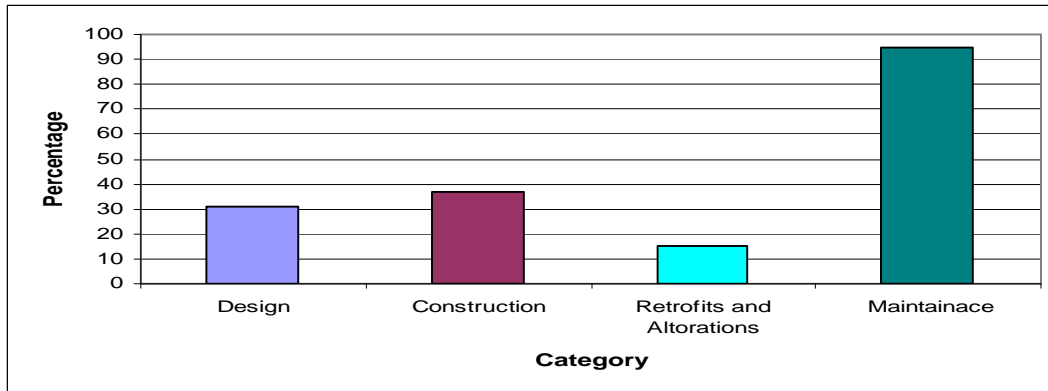
Figure 1: Percentage Category breakdown for Texas A&M University Buildings with Humidity Problem

The first of these categories, the one in which an engineer has the most control over, is HVAC design. A building should be designed properly to provide a comfortable environment so that its occupants will be able to conduct their duties. The building should be provided with the proper type and kind of equipment for it to be properly cooled or heated. It is also crucial for a building to have a positive differential pressure to the outside atmosphere. If the building is negative, the engineer will have no control as to what type of air will be drawn into the building making it impossible to control the humidity level. Figure 1 shows that 31 percent of TAMU buildings with humidity problem were categorized as having a design problem.

Once a building has been in place for several years changes have to be made to it in order to better fulfill its purpose, for example, a conference room has to be changed into four new offices or a classroom has to be converted into a computer or server room. There are also advancements in the technology utilized in the office environment. Offices must now have fast and reliable Ethernet connections. There is also the need for additional telephone lines for fax machines and other office equipment. All this wiring has to be directed and distributed throughout the building. In order for this to be done, electrical conduit has to be run through walls and from floor to floor. Often the breaks made in walls and ceilings are not properly sealed. It is really not an aesthetic problem since most of these holes are made above false ceilings and hidden from public view, however these holes combined with pressure differential are enough to allow for undesired flow through the building. For the TAMU buildings with humidity problems, 15 % were categorized as having been caused by retrofits and alterations (figure 1).
