Experience with Vertical-Turbine Pumps Rebowl Upgrade

18th International Pump Users Symposium March 5-8, 2001. Houston, Texas

REBOWL UPGRADE OF VERTICAL-TURBINE PUMPS PROVEN EFFECTIVE

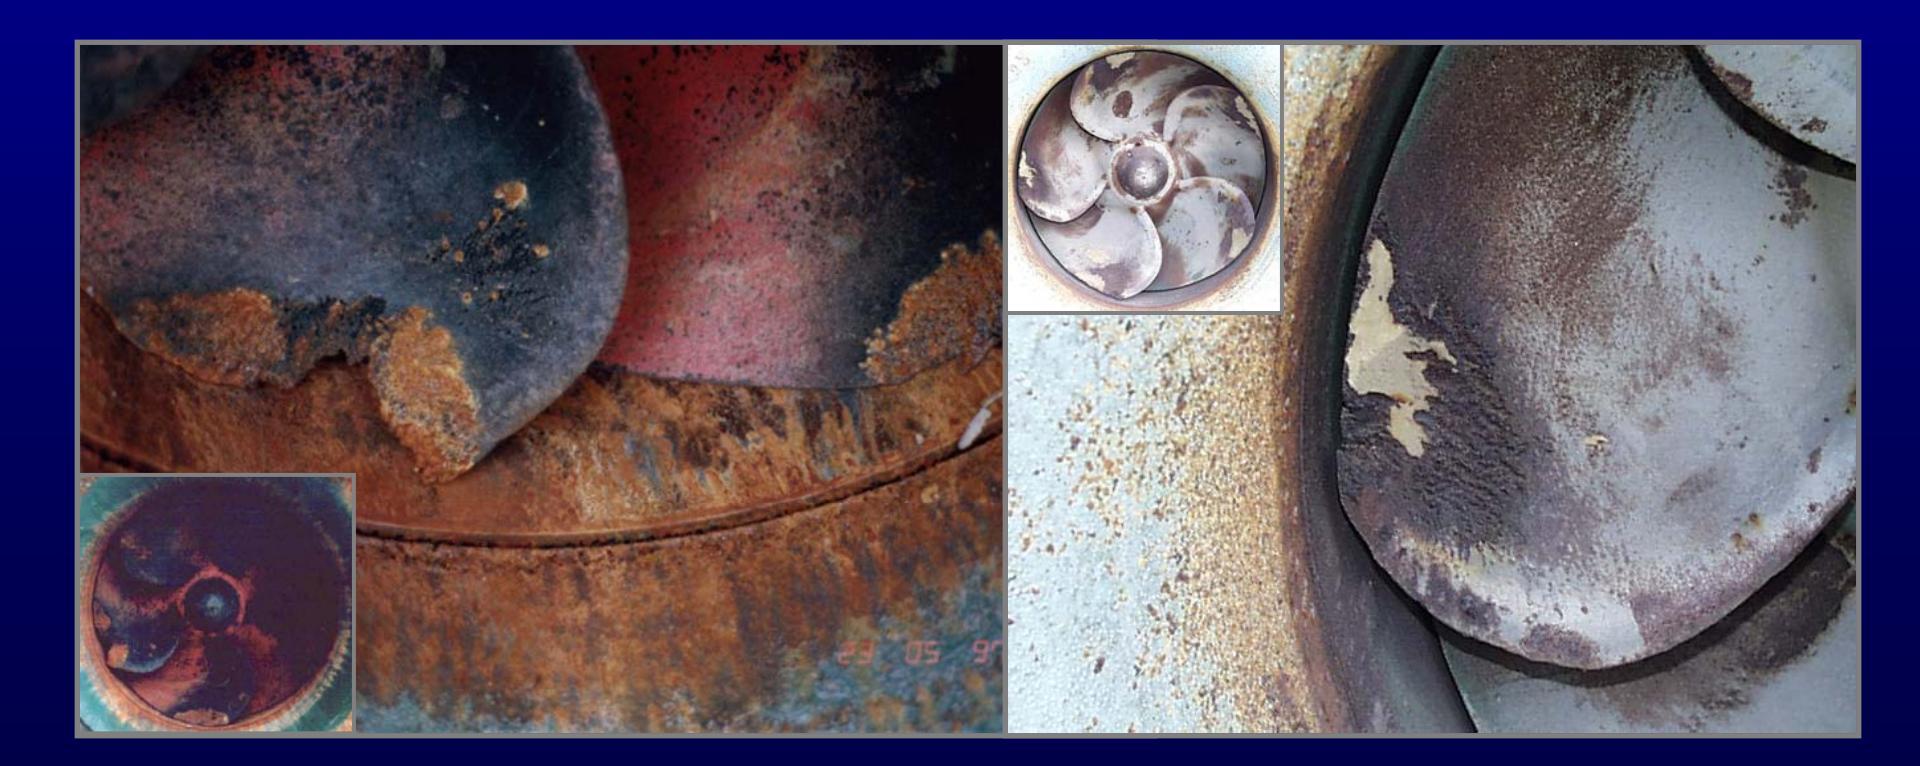
- Pump efficiency progressively reduced due to cavitation / recirculation damage of impellers.
- Yearly overhaul required.

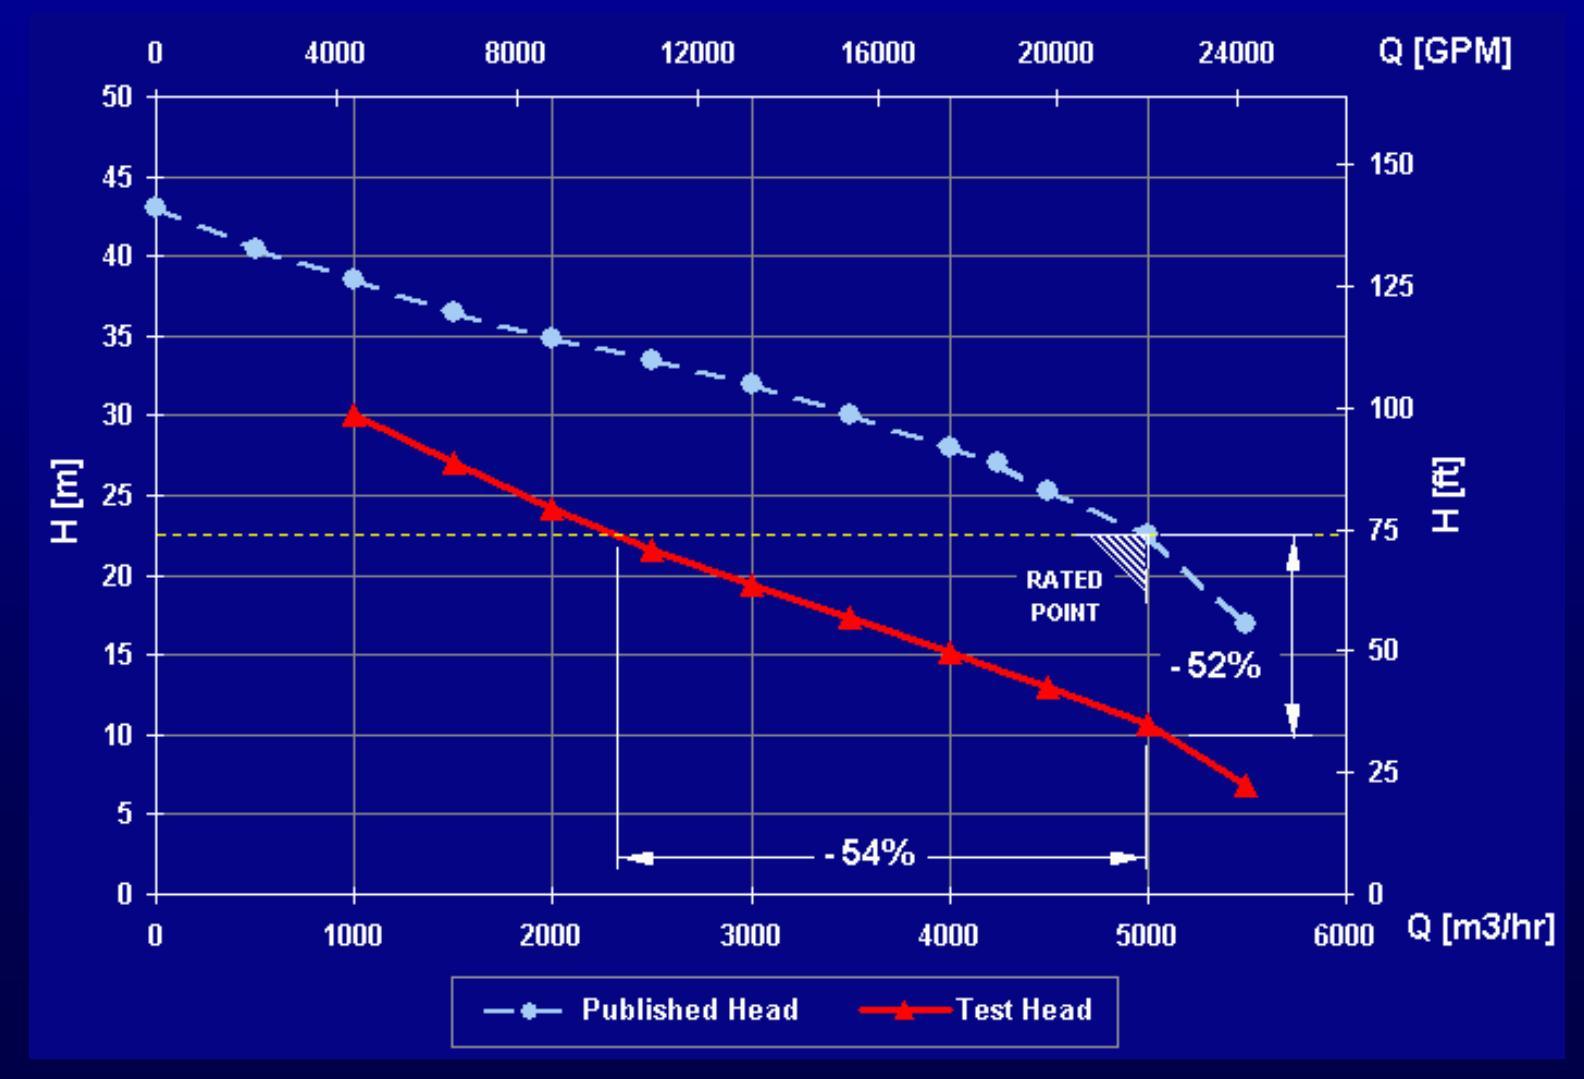
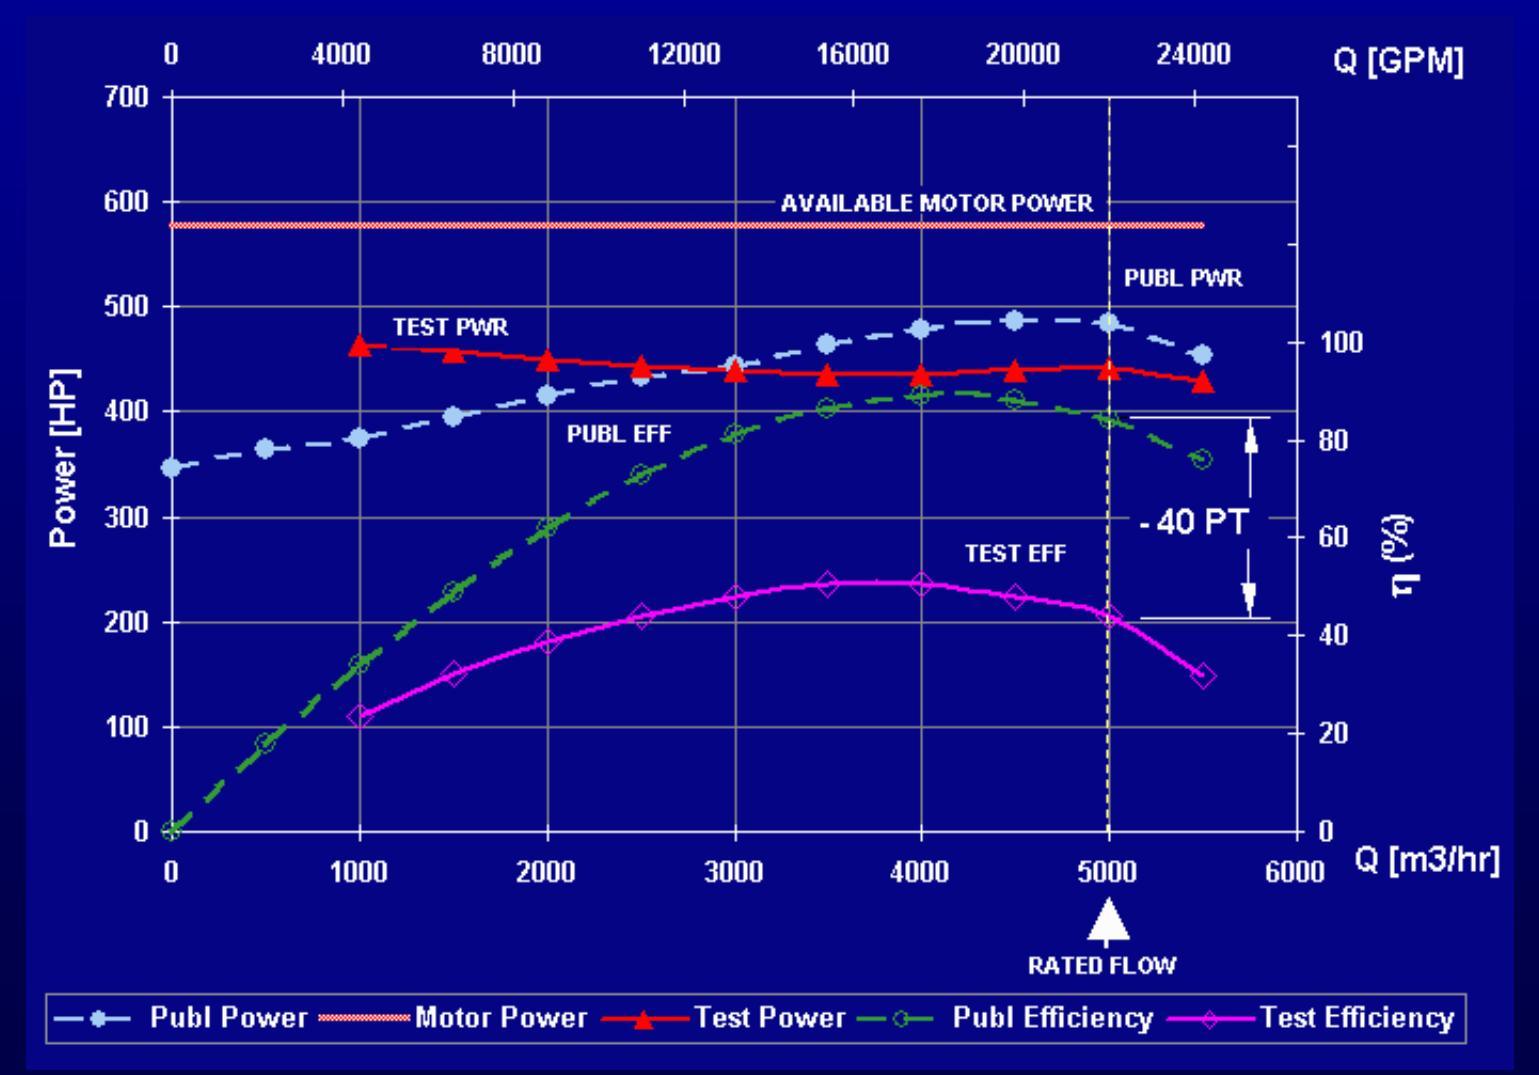
PUBLISHED VS TEST PERFORMANCE ORIGINAL BOWL ASSEMBLY @ 890 RPM

- Considerable performance impairment found.
- Excessive radial clearance between impeller and suction liner is a primary cause for efficiency loss.
- Manufacturing deficiencies cause mismatching between impeller and liner profile.
- Proper adjustment of uniform clearance is difficult and time consuming.
- It is unlikely to reach new operating requirements even if the bowl assembly is fully restored.

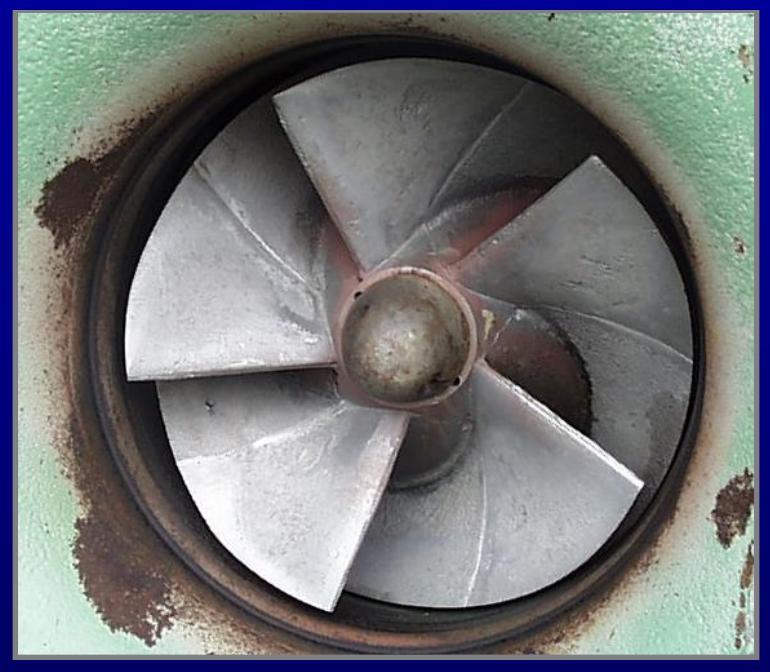
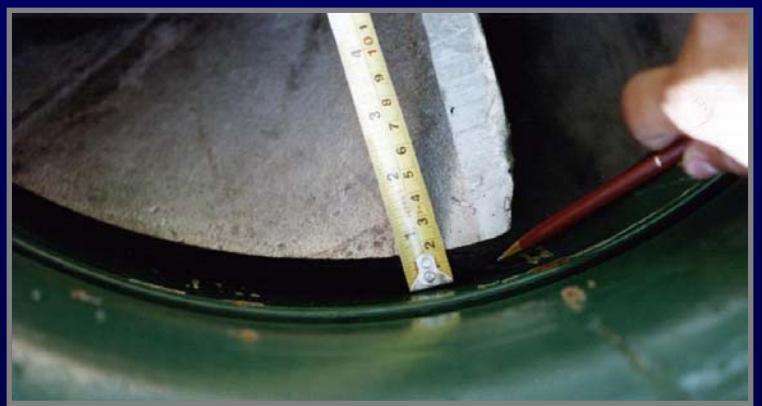
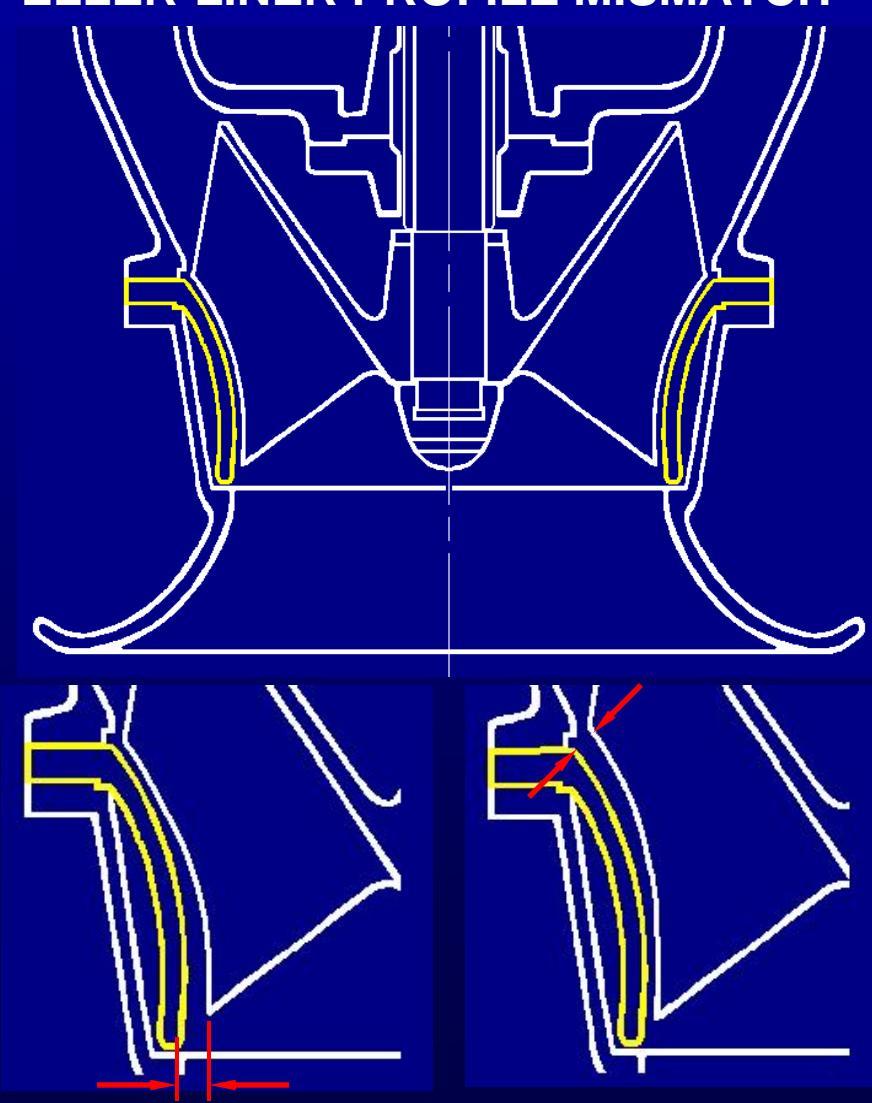
EXISTING BOWL DEFICIENCIES

LARGE RADIAL CLEARANCE / IMPELLER-LINER PROFILE MISMATCH

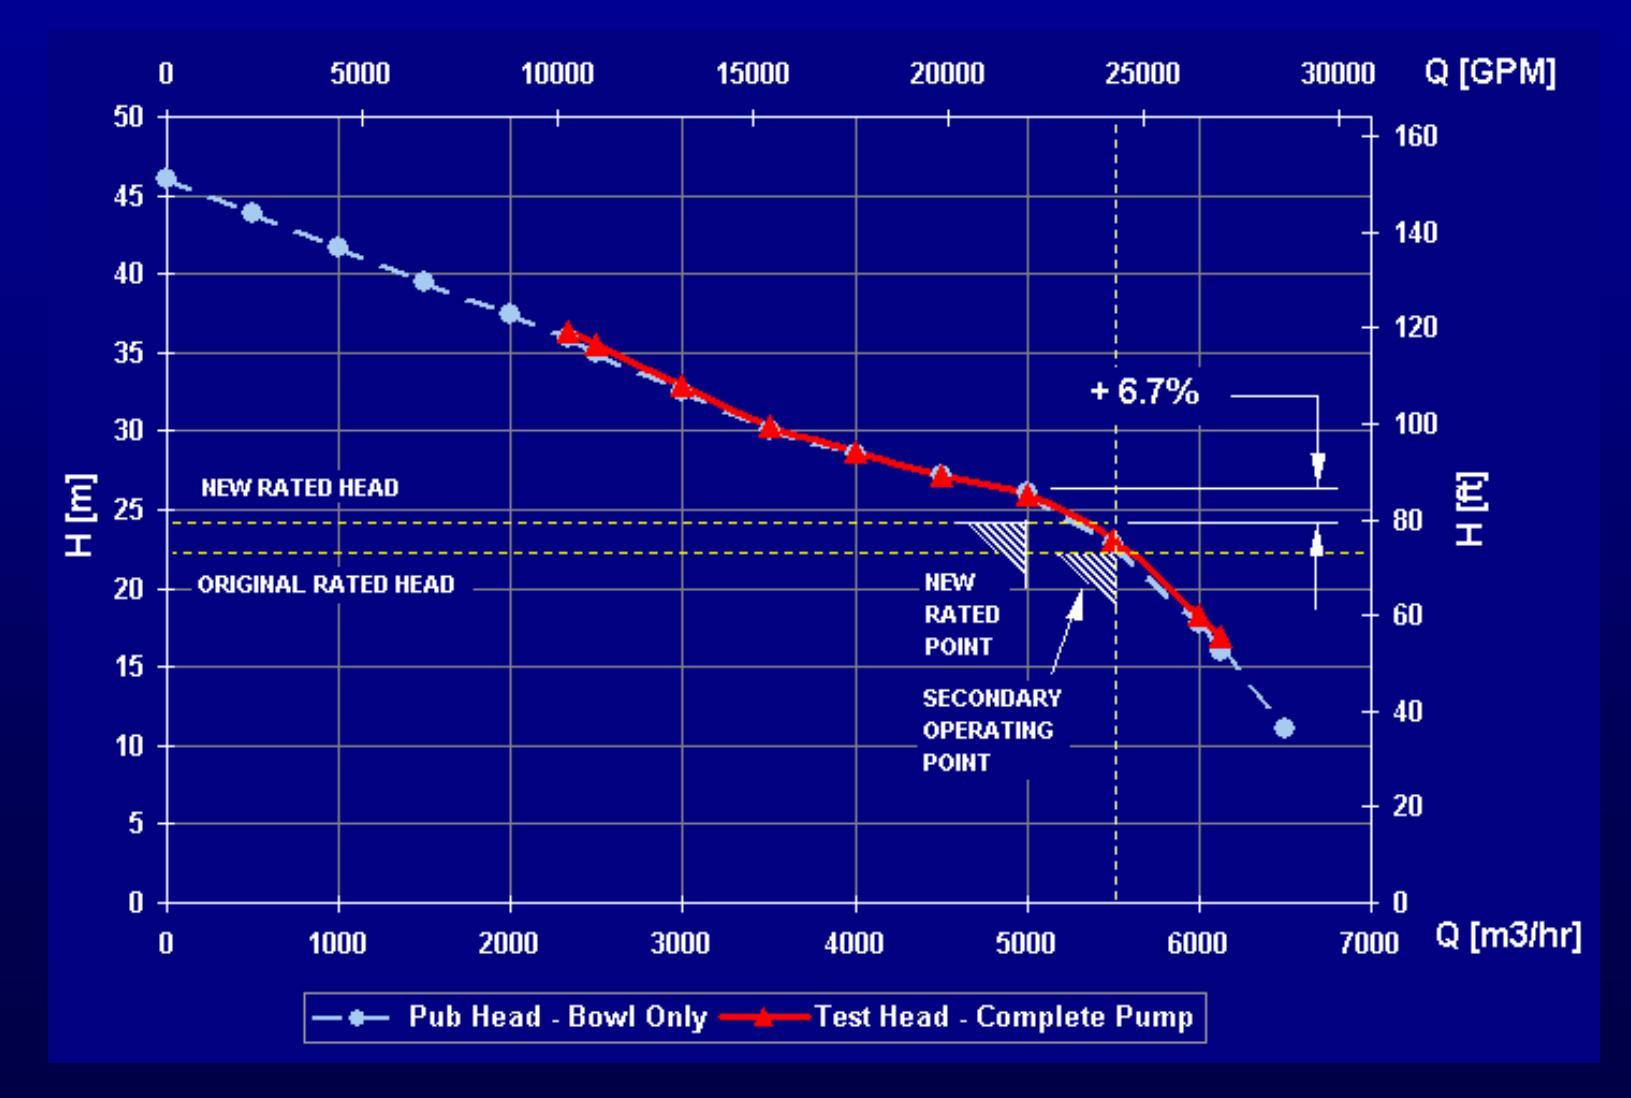
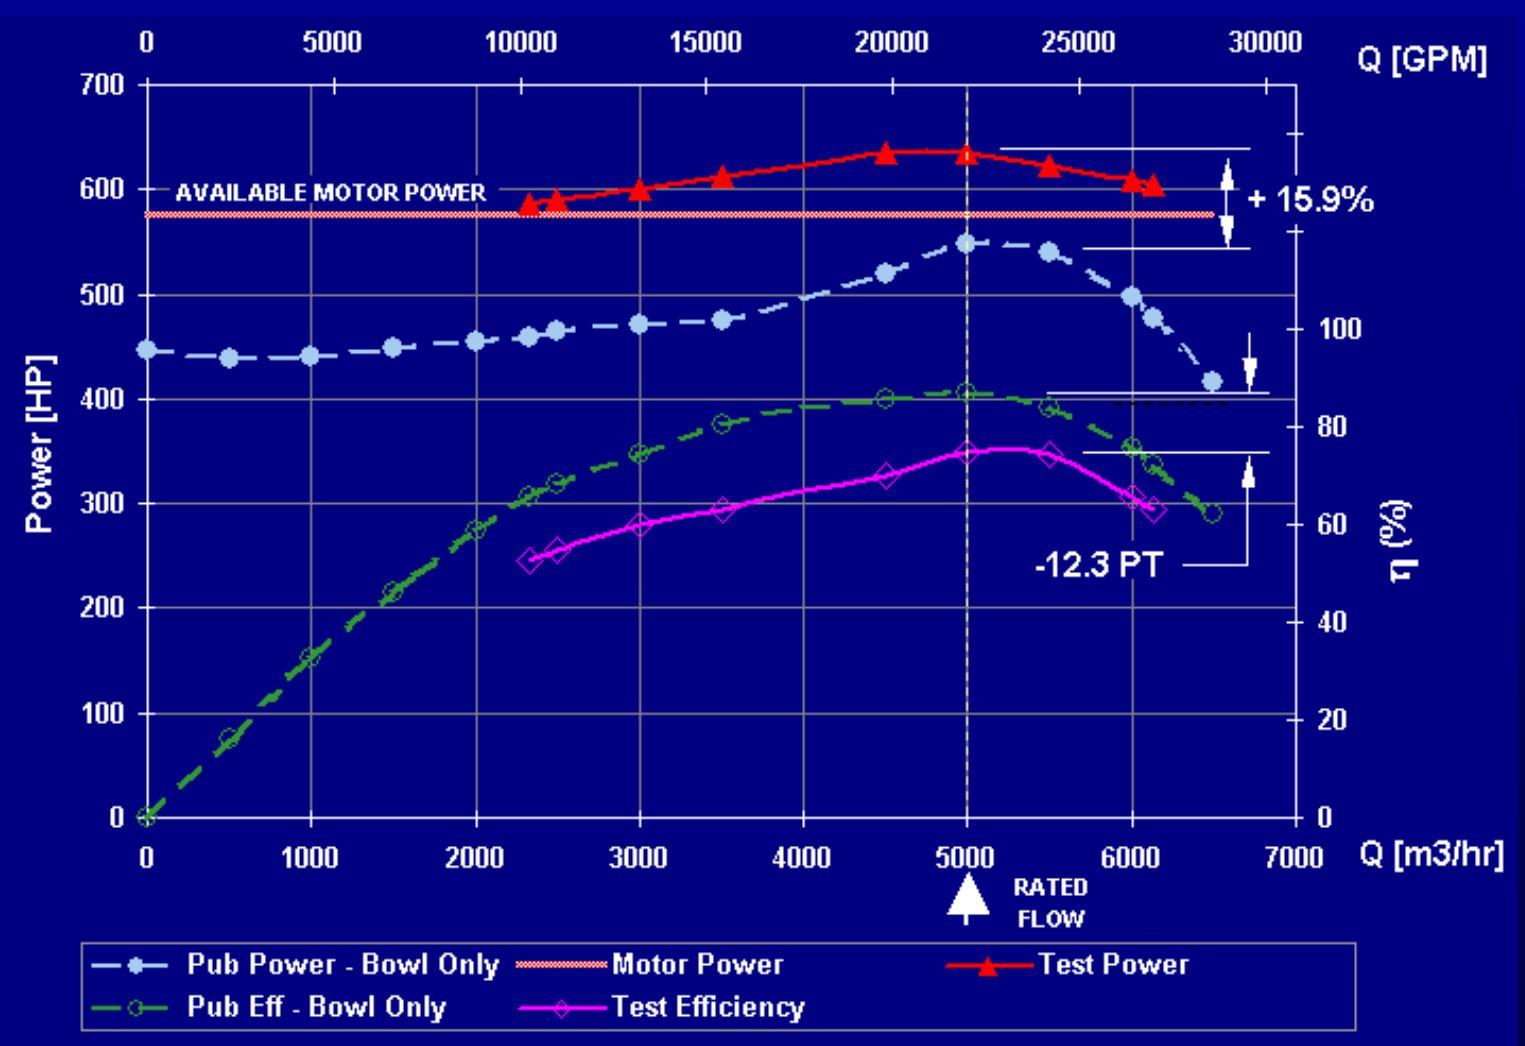
PUBLISHED VS TEST PERFORMANCE IMPELLER Ø 21.25" @ 890 RPM

- Satisfactory head-flow performance.
- Complete pump BHP larger than expected:
 - Bowl published: + 16%
 - Motor rating: + 10%

Impeller rework required to adjust performance.

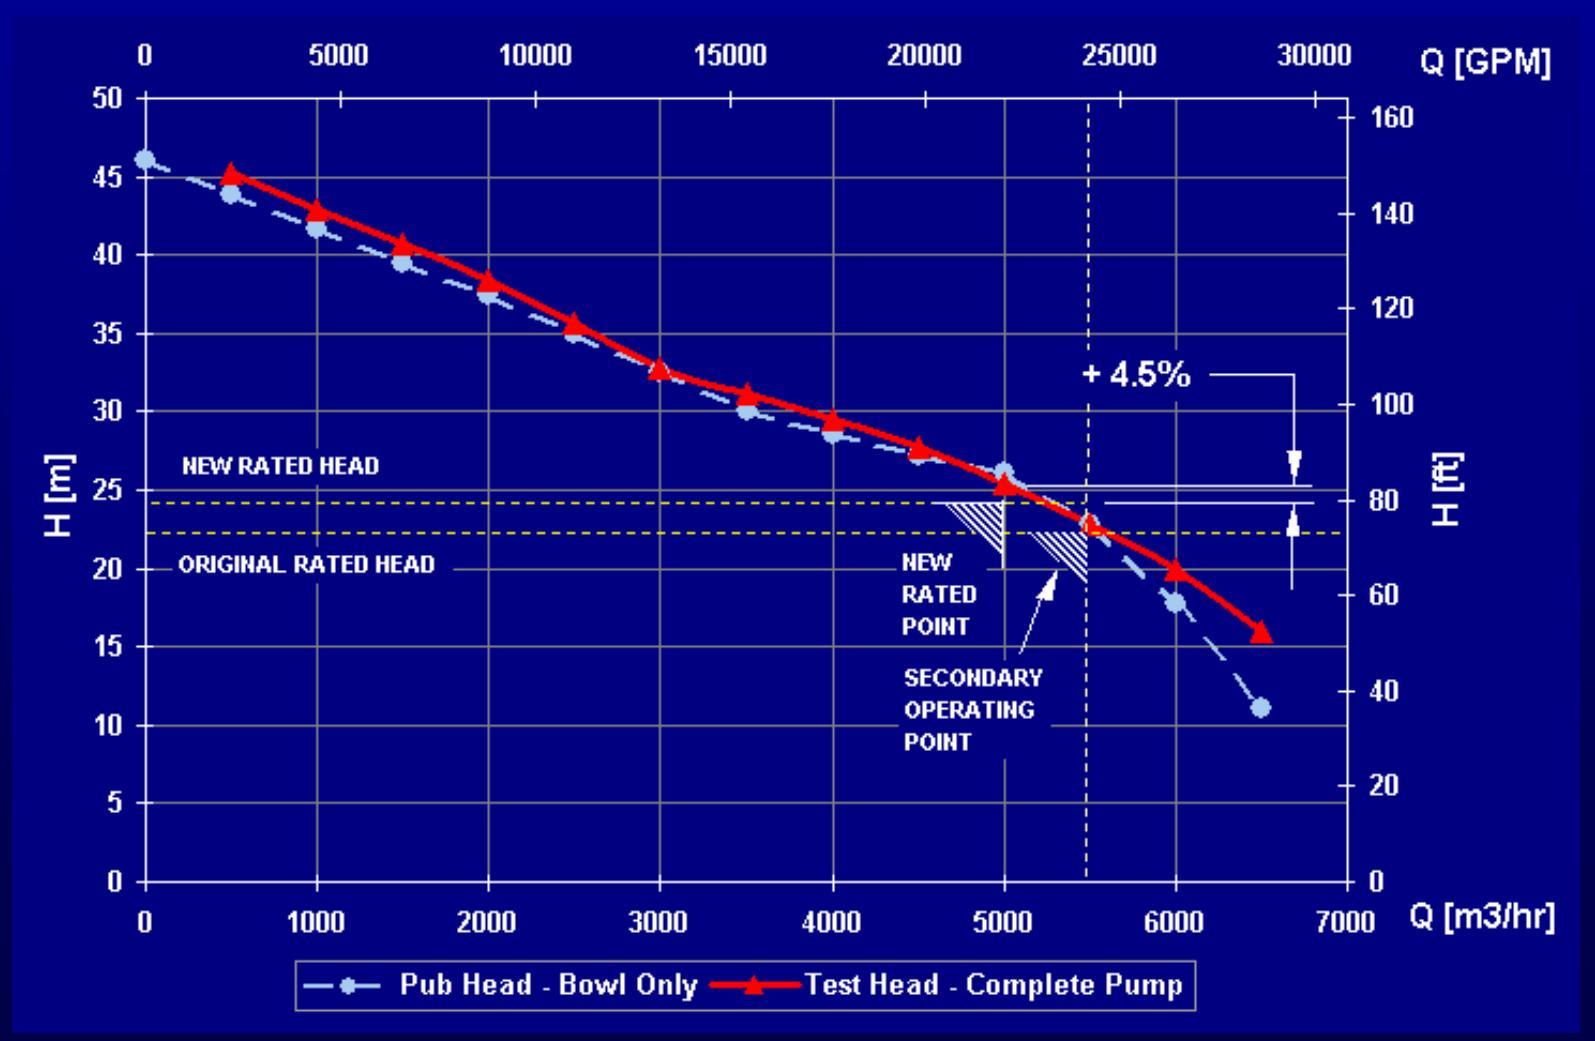
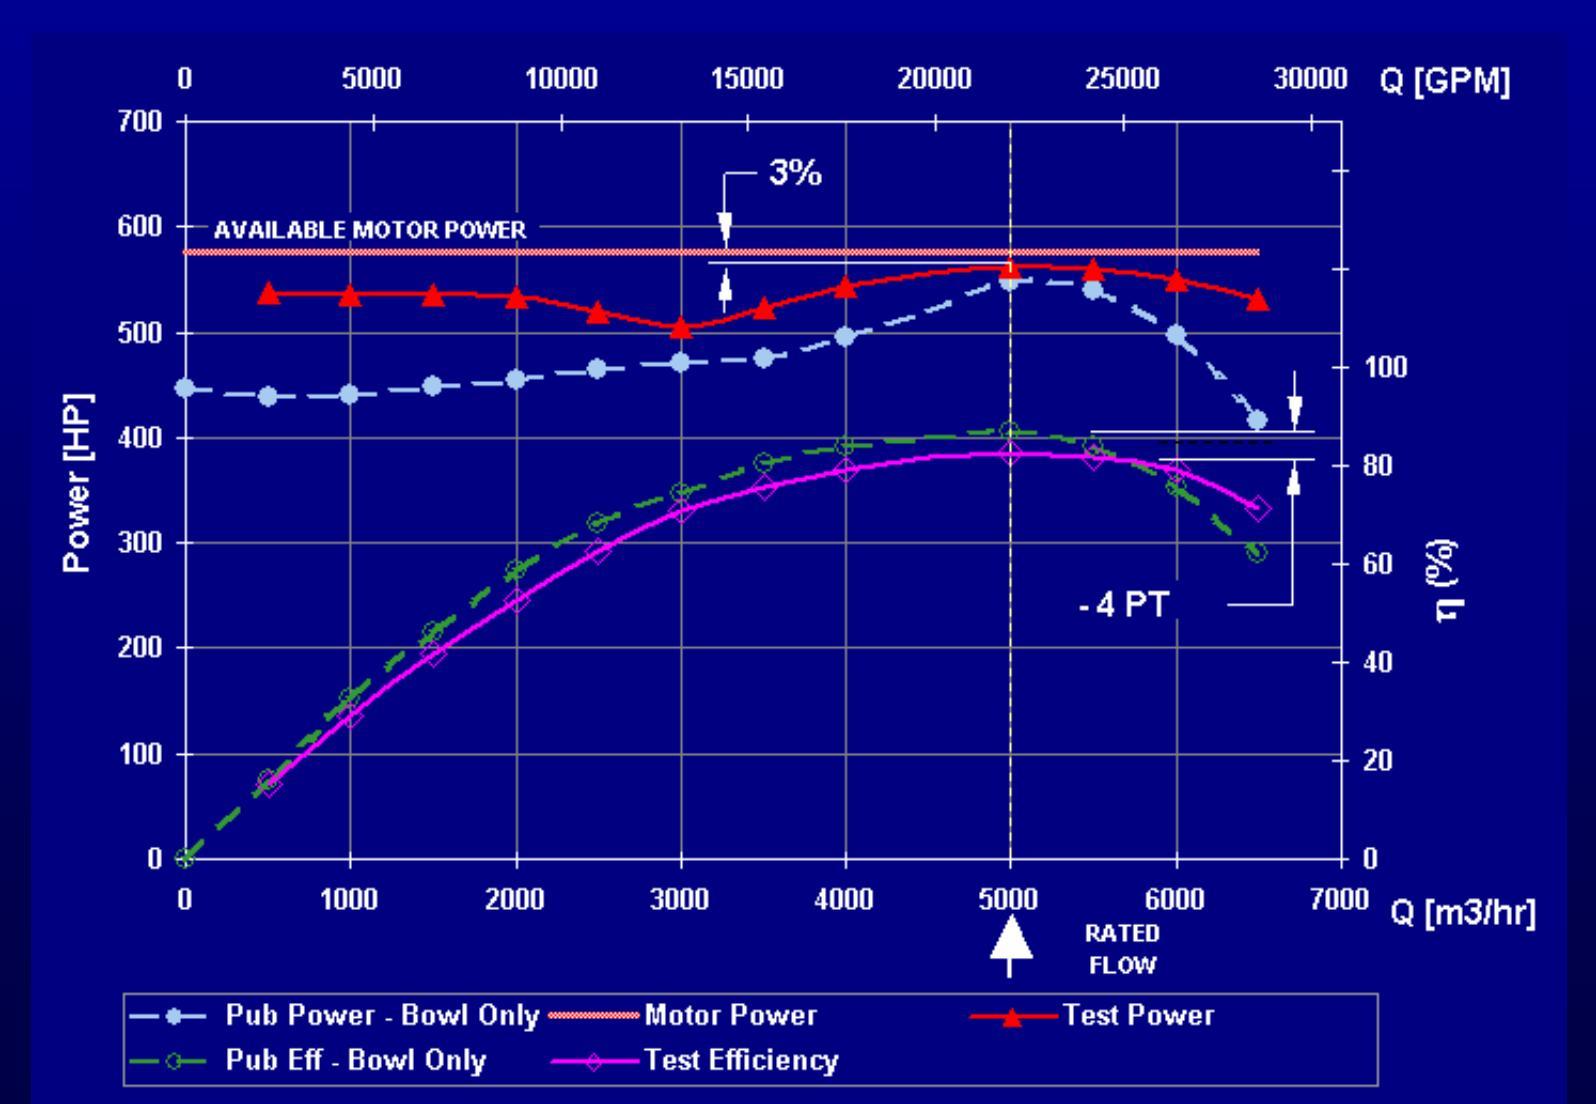
PUBLISHED VS TEST PERFORMANCE IMPELLER Ø 20.75" @ 890 RPM

Specified operating points successfully reached. 80 ft + 5% @ 22,000 GPM Rated: Secondary: 75 ft + 1% @ 24,200 GPM **BEP: Coincident with rated point** Shaft horsepower adjusted to limitations. BHP: 95 – 97% of motor rated Efficiency improved by impeller rework. Final: 83% @ BEP 75% @ BEP Before rework:
