HIGH SPEED PUMP: MECHANICAL SEAL BAD ACTOR RESOLUTION

ABSTRACT

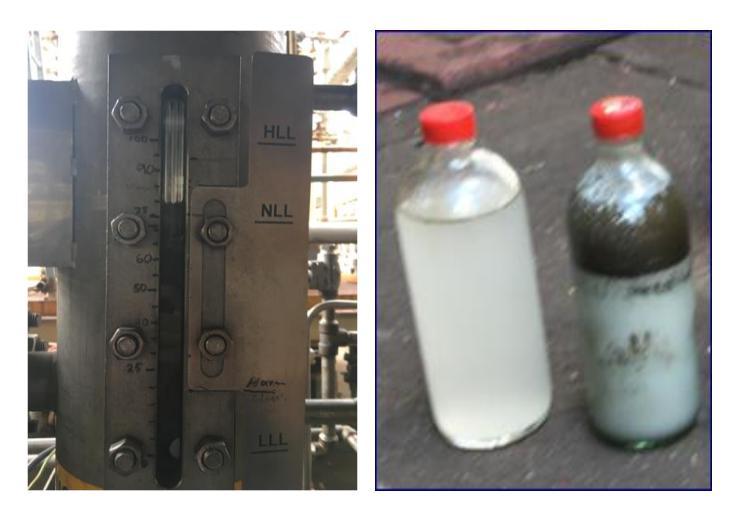
- Average life of 0.5 years
- Commission Plan13 and adjusting N2 pressure (not helping much)
- Product reversal to seal pot

Figure: Sample of liquid in seal pot (flow reversal indication)

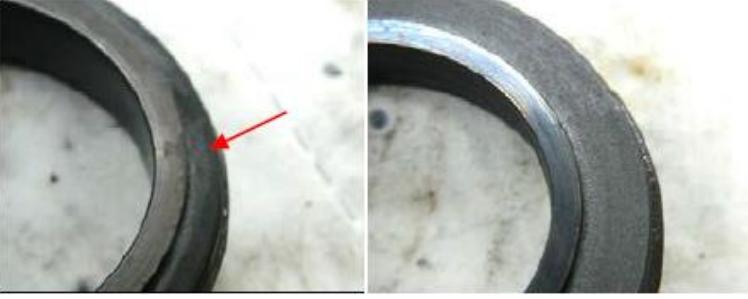
Failed seal: Wear & blistering marks; indication of "dry run"

Figure: Seal face worn out and blistering

- Process Nature:
 - Pumpage (Sour water) contain undissolved H2S in solution
- Operating Condition:
 - Pumpage temperature fluctuates between 40-75 DegC.
 - High operating speed promotes vapor coming out from solution
- Mechanical Design
 - Too many elbows installed during previous design upgrade

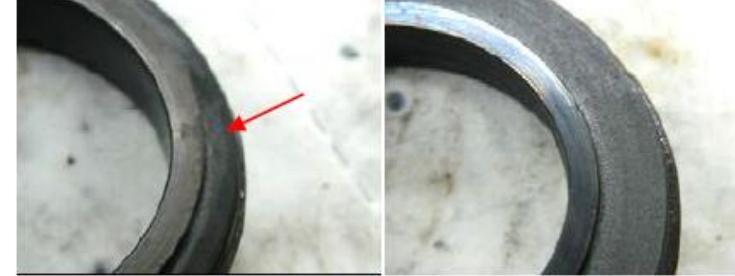
Failed seal: Wear & blistering marks; indication of "dry run"

Figure: Seal face worn out and blistering

Promote more

barrier fluid flow

across seal

(Scallop Design)

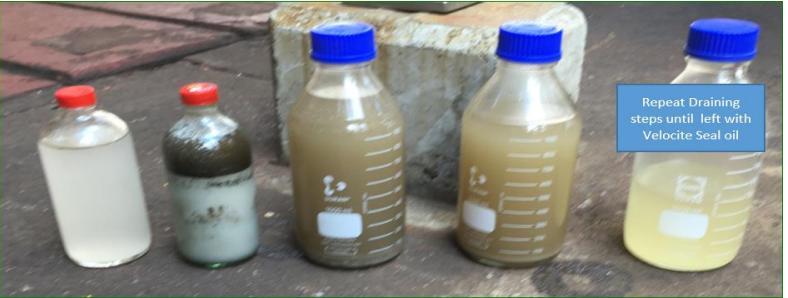
- Challenges during recent upgrade:
 - Level in seal pot gaining gradually;
 - Series of barrier fluid draining performed
 - Adjust N2 pressure for optimum operation (from 10 bar to 12 bar)

Figure: Series of draining performed to remove "milky" solution; after ~1month operation

- Realized that product temperature did increase seal pot level rate
 - Need more cooling!
- Increase Plan32 orifice size (10%) to provide more cooling to seal chamber
