**INSPECTION OF INTERNAL POST-TENSIONED TENDONS USING
NONDESTRUCTIVE TESTING**

A Thesis

VIRGINIA RENE FOSTER

Major Subject: Civil Engineering

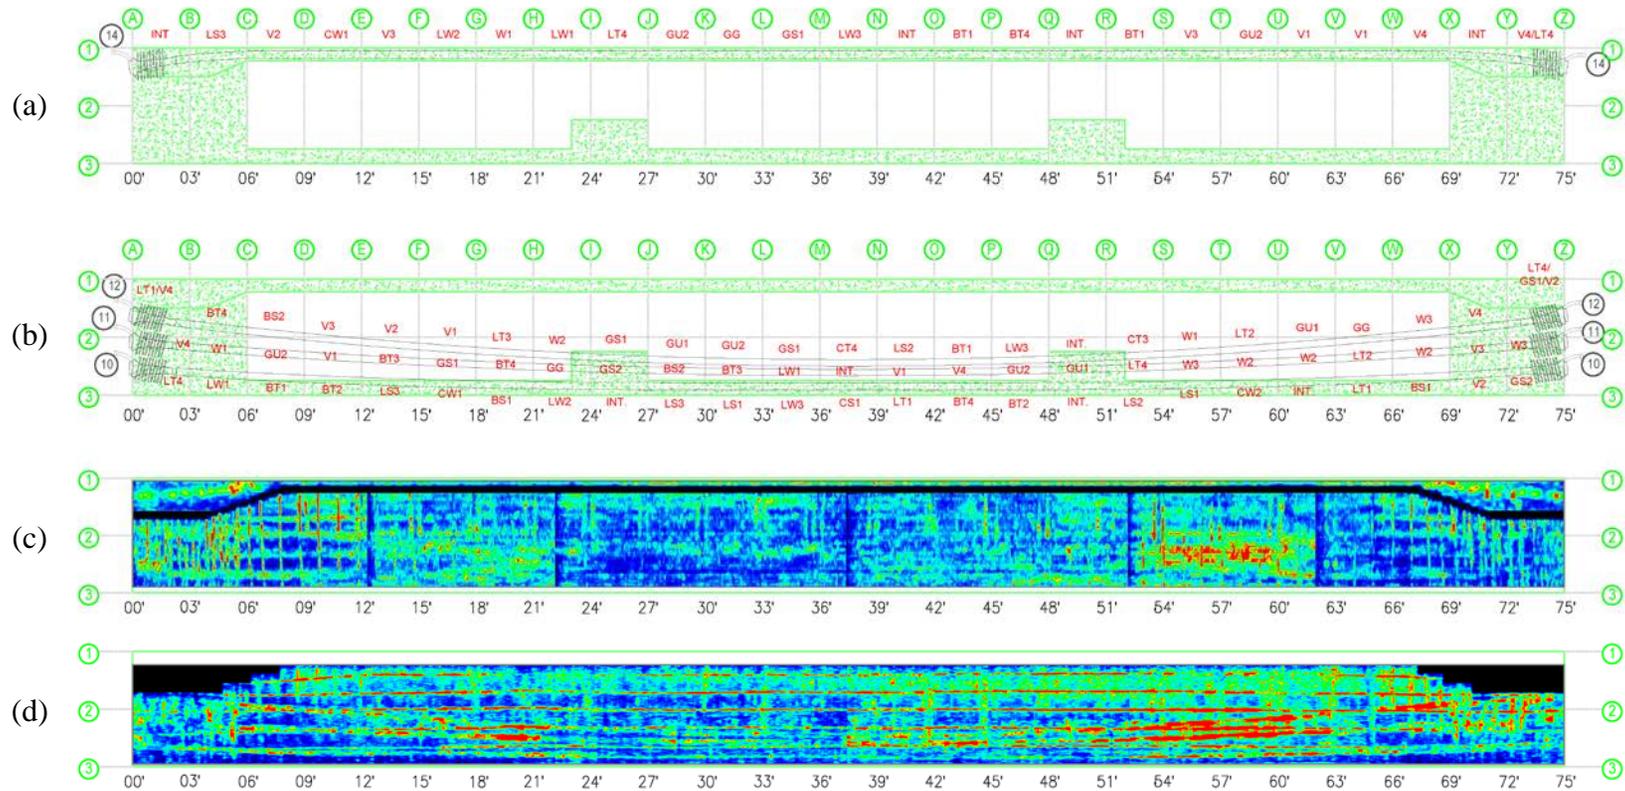
It should be noted that the external walls were scanned using six sections, and the internal walls were scanned using seven sections. In images where the device was oriented parallel to the ducts, such as Figure 4-1c, the division of these sections is clearly

apparent, as they are marked by small vertical blue regions. These regions correspond to areas with less information. With a horizontal step of 5.91 in. (150 mm), each scan overlaps the previous by 8.86 in. (225 mm). These blue regions correspond to the beginning of each new section and consequently to areas where there is no overlap in the data. Even in scans when the device was oriented perpendicular to the ducts, i.e. Figure 4-2d, some of the section divisions are also visible. This could be due to a number of factors, including but not limited to the change in velocity from section to section or possibly inconsistent pressure, as multiple individuals were used to scan the specimen.

Figure 4-1: North Wall Exterior Scans – MIRA: (a) Tendon 14 Defect Key; (b) North Wall Defect Key; (c) MIRA Device Parallel to Ducts (Wall Scan Depth: 2.88 – 9.66 in.; Flange Scan Depth: 6.51 – 9.66 in.); (d) MIRA Device Perpendicular to Ducts (Wall Scan Depth: 2.88 – 9.66 in.)

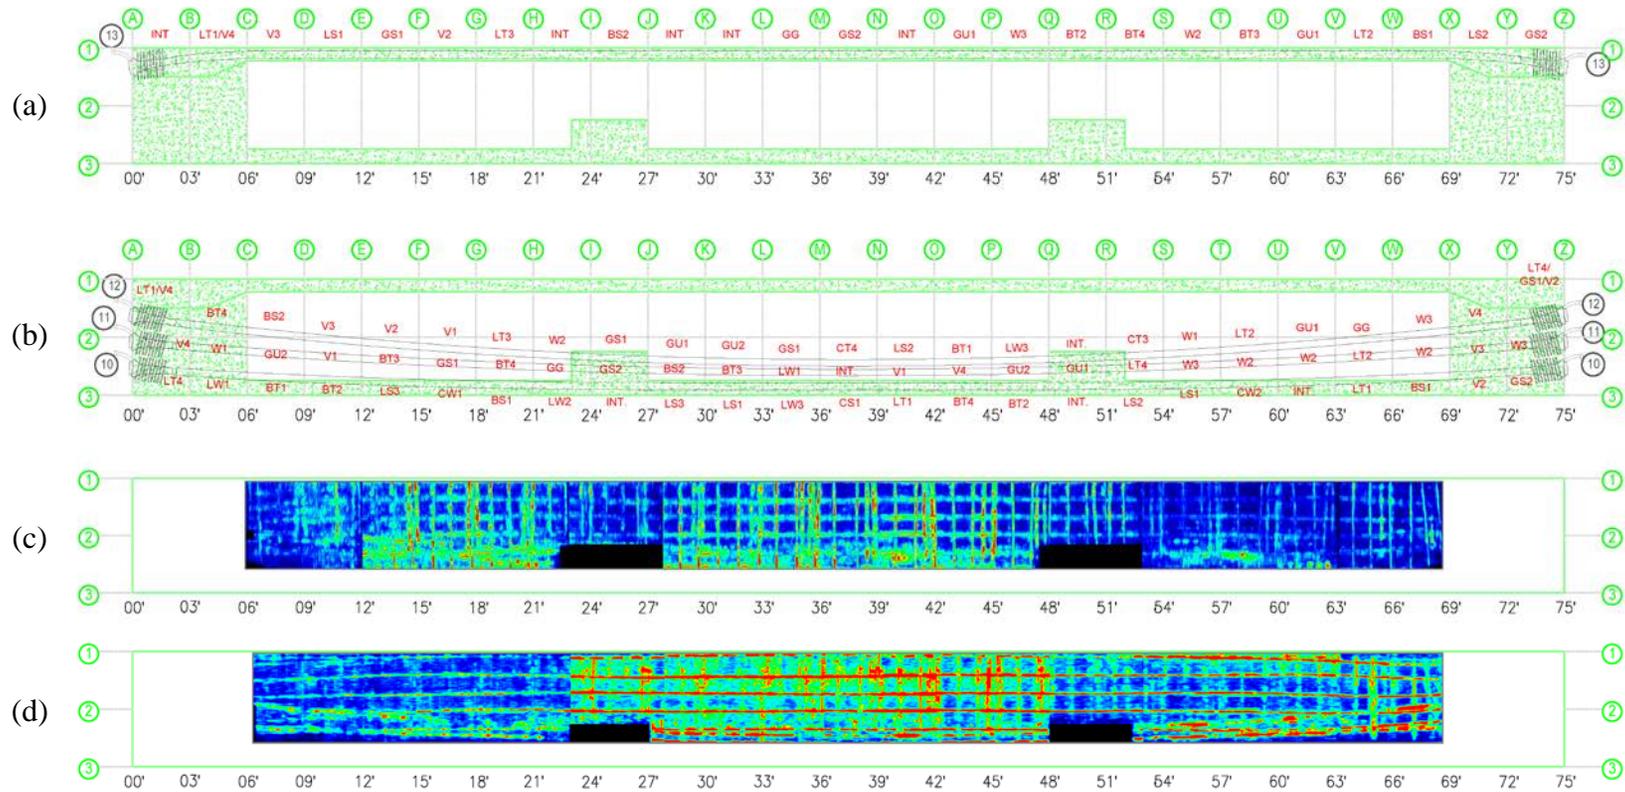
Figure 4-2: North Wall Interior Scans – MIRA: (a) Tendon 13 Defect Key; (b) North Wall Defect Key; (c) MIRA Device Parallel to Ducts (Scan Depth: 2.88 – 9.66 in.); (d) MIRA Device Perpendicular to Ducts (Scan Depth: 2.88 – 9.66 in.)

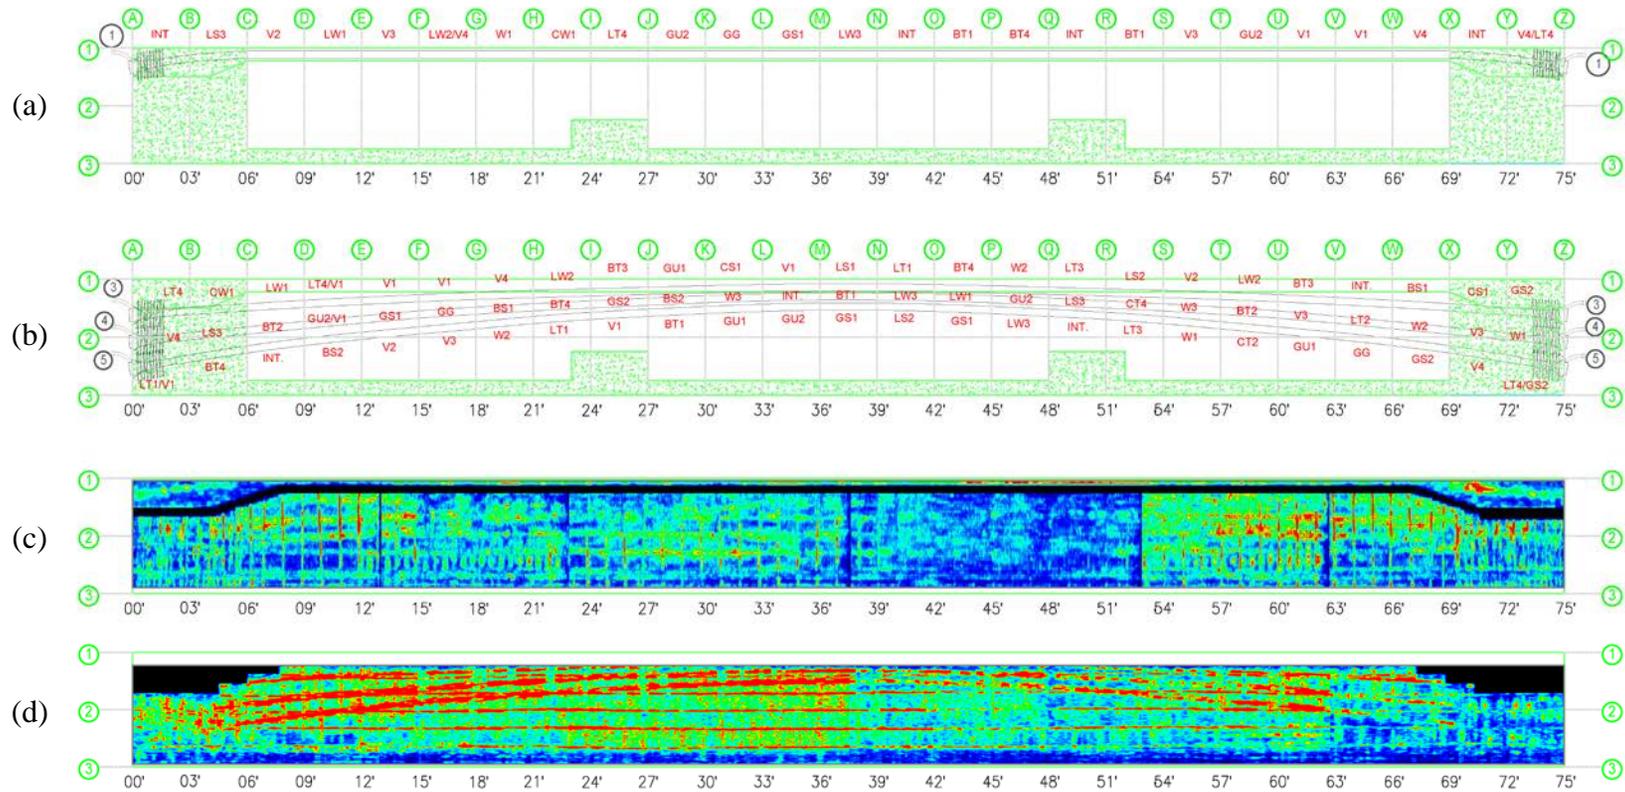
Figure 4-3: South Wall Exterior Scans – MIRA: (a) Tendon 1 Defect Key; (b) South Wall Defect Key; (c) MIRA Device Parallel to Ducts (Wall Scan Depth: 2.88 – 9.66 in.; Flange Scan Depth: 6.51 – 8.77 in.); (d) MIRA Device Perpendicular to Ducts (Wall Scan Depth: 2.88 – 9.66 in.)

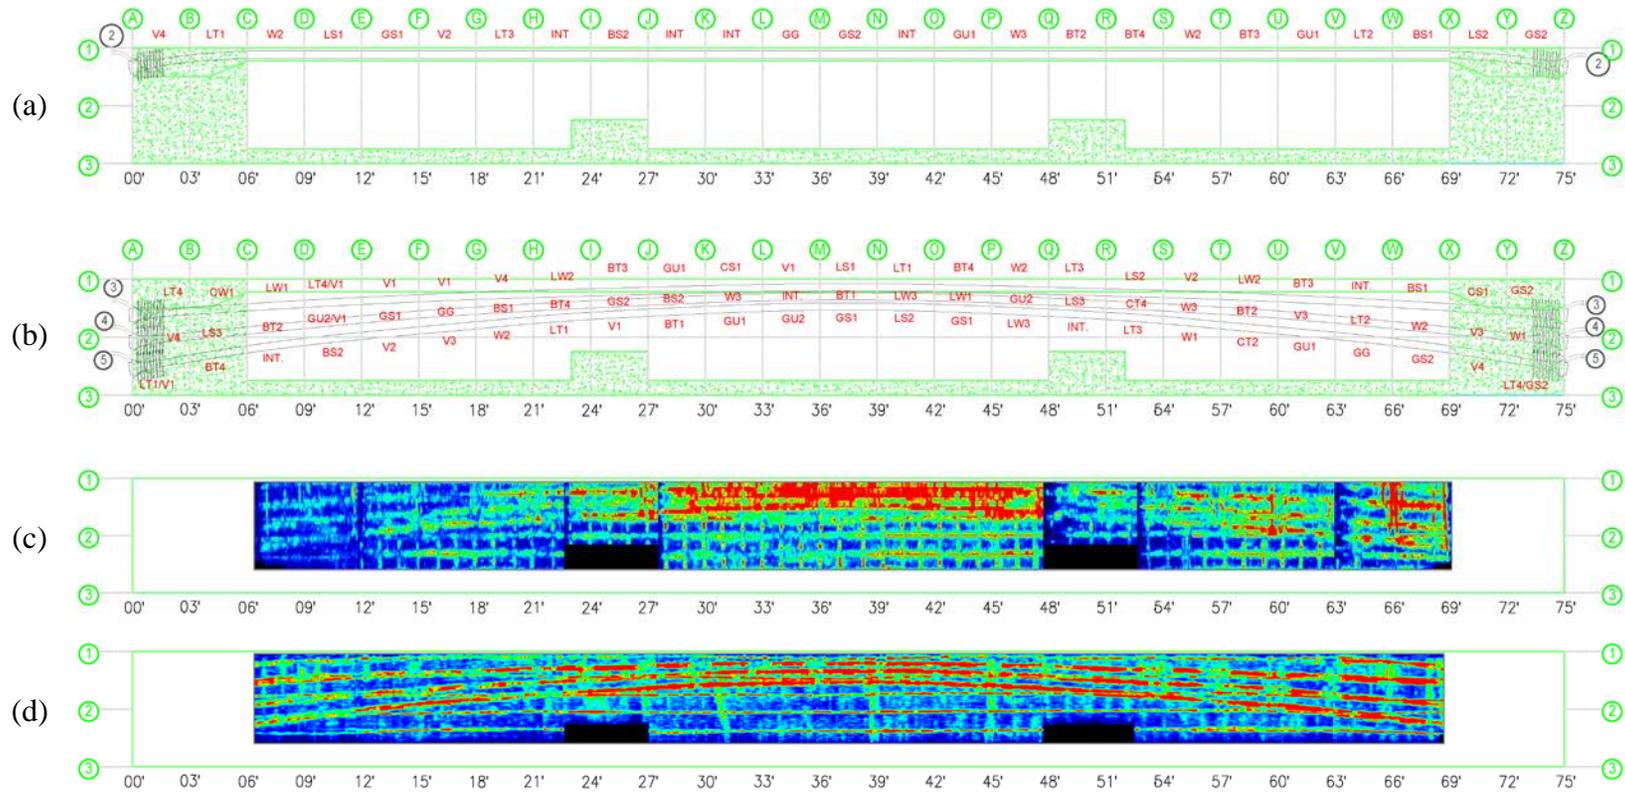
Figure 4-4: South Wall Interior Scans – MIRA: (a) Tendon 2 Defect Key; (b) South Wall Defect Key; (c) MIRA Device Parallel to Ducts (Scan Depth: 4.04 – 9.66 in.); (d) MIRA Device Perpendicular to Ducts (Scan Depth: 2.88 – 9.66 in.)

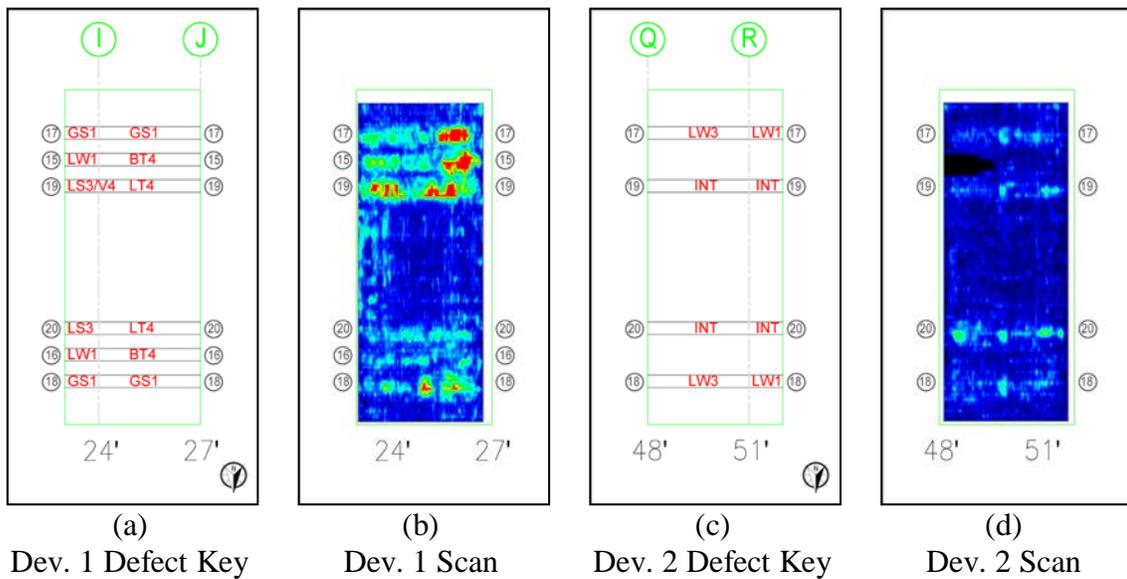
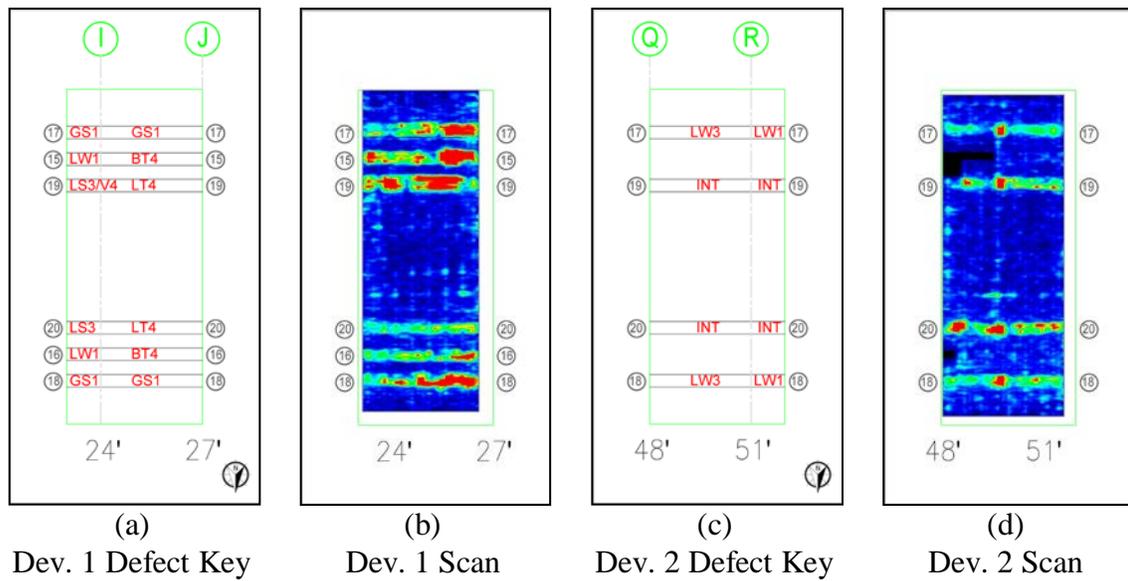
The deviators were also scanned using the A1040 MIRA ultrasonic tomographer. While the ducts are identifiable, again the grout defects are not distinguishable from good grout. The images in Figure 4-6, when the device is oriented perpendicular to the ducts do have better resolution than the images in Figure 4-5, when the device is oriented parallel to the ducts. This is consistent with the results of the wall scans.

Figure 4-5: Deviator Scans – MIRA Device Oriented Parallel to Ducts (Dev 1 Scan Depth: 5.82 – 12.33 in.; Dev 2 Scan Depth: 5.82 – 12.33 in.)

Figure 4-6: Deviator Scans – MIRA Device Oriented Perpendicular to Ducts (Dev 1 Scan Depth: 5.82 – 12.33 in.; Dev 2 Scan Depth: 6.17 – 11.85 in.)

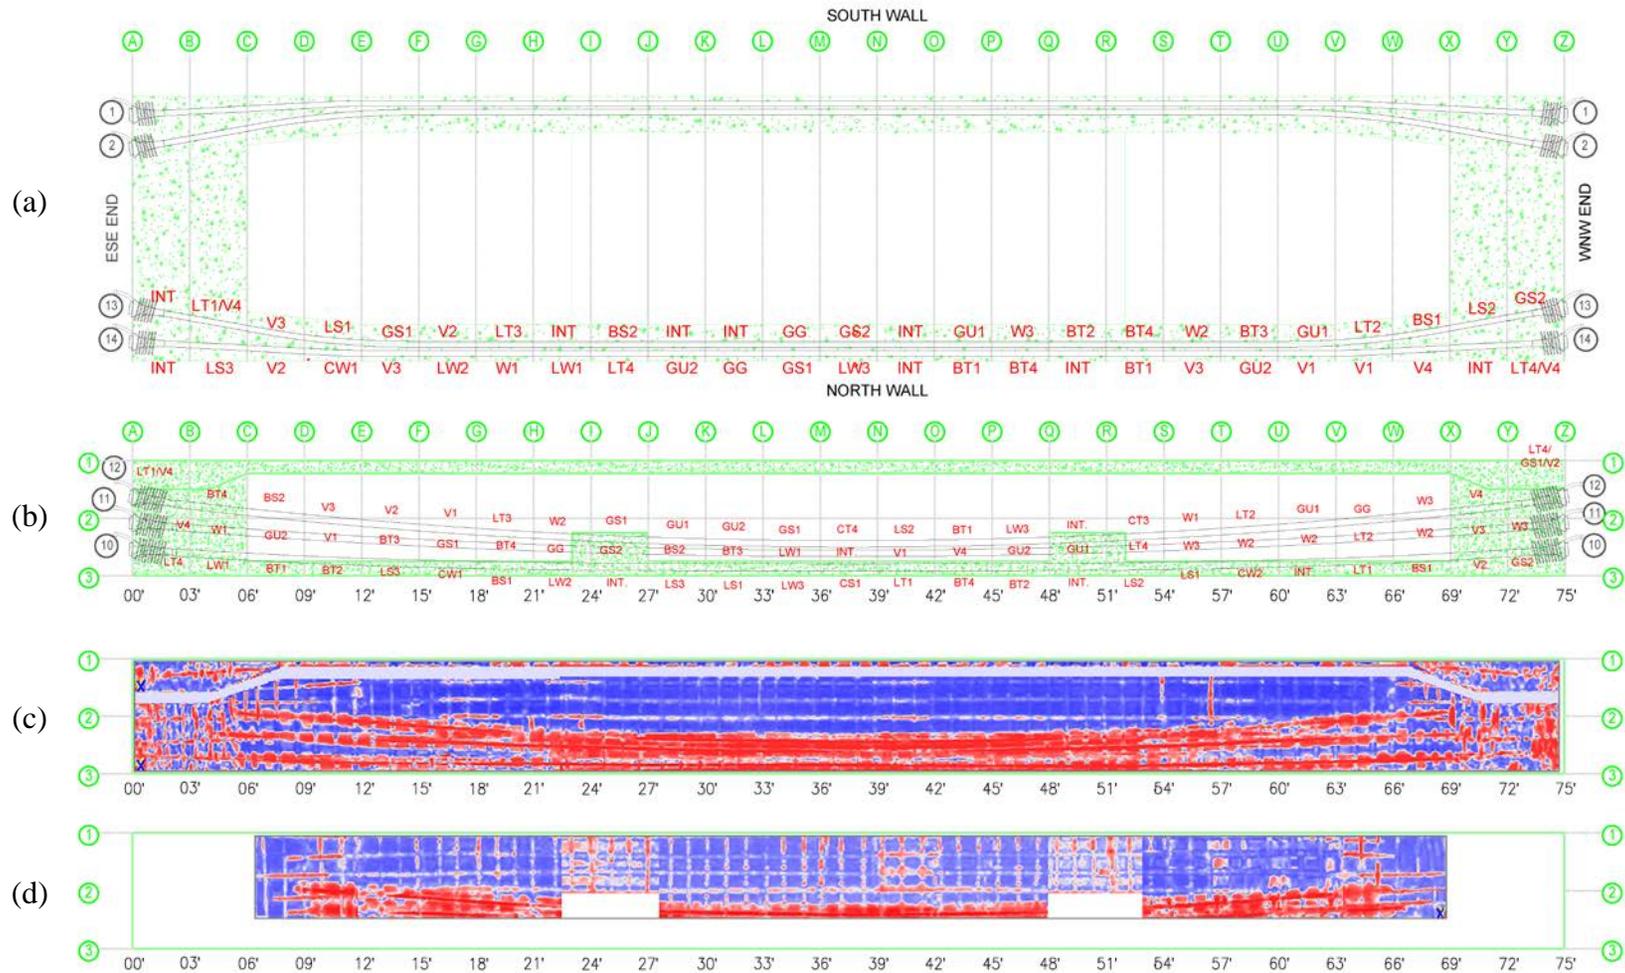
Figure 5-1 presents the GPR results for the North Wall. The metal ducts are clearly identifiable in both the interior and exterior wall scans, as they produce strong reflections. However, these reflections prevent the grout defects from being identified. These results are consistent with those observed by other researchers as detailed in Chapter II.

Figure 5-1: North Wall Scans – GPR: (a) Flange Defect Key (Plan View); (b) North Wall Defect Key; (c) Exterior Wall Scan (Wall Scan Depth: 4.58 in.; Flange Scan Depth: 6.46 in.); (d) Interior Wall Scan (Scan Depth: 5.41 in.)

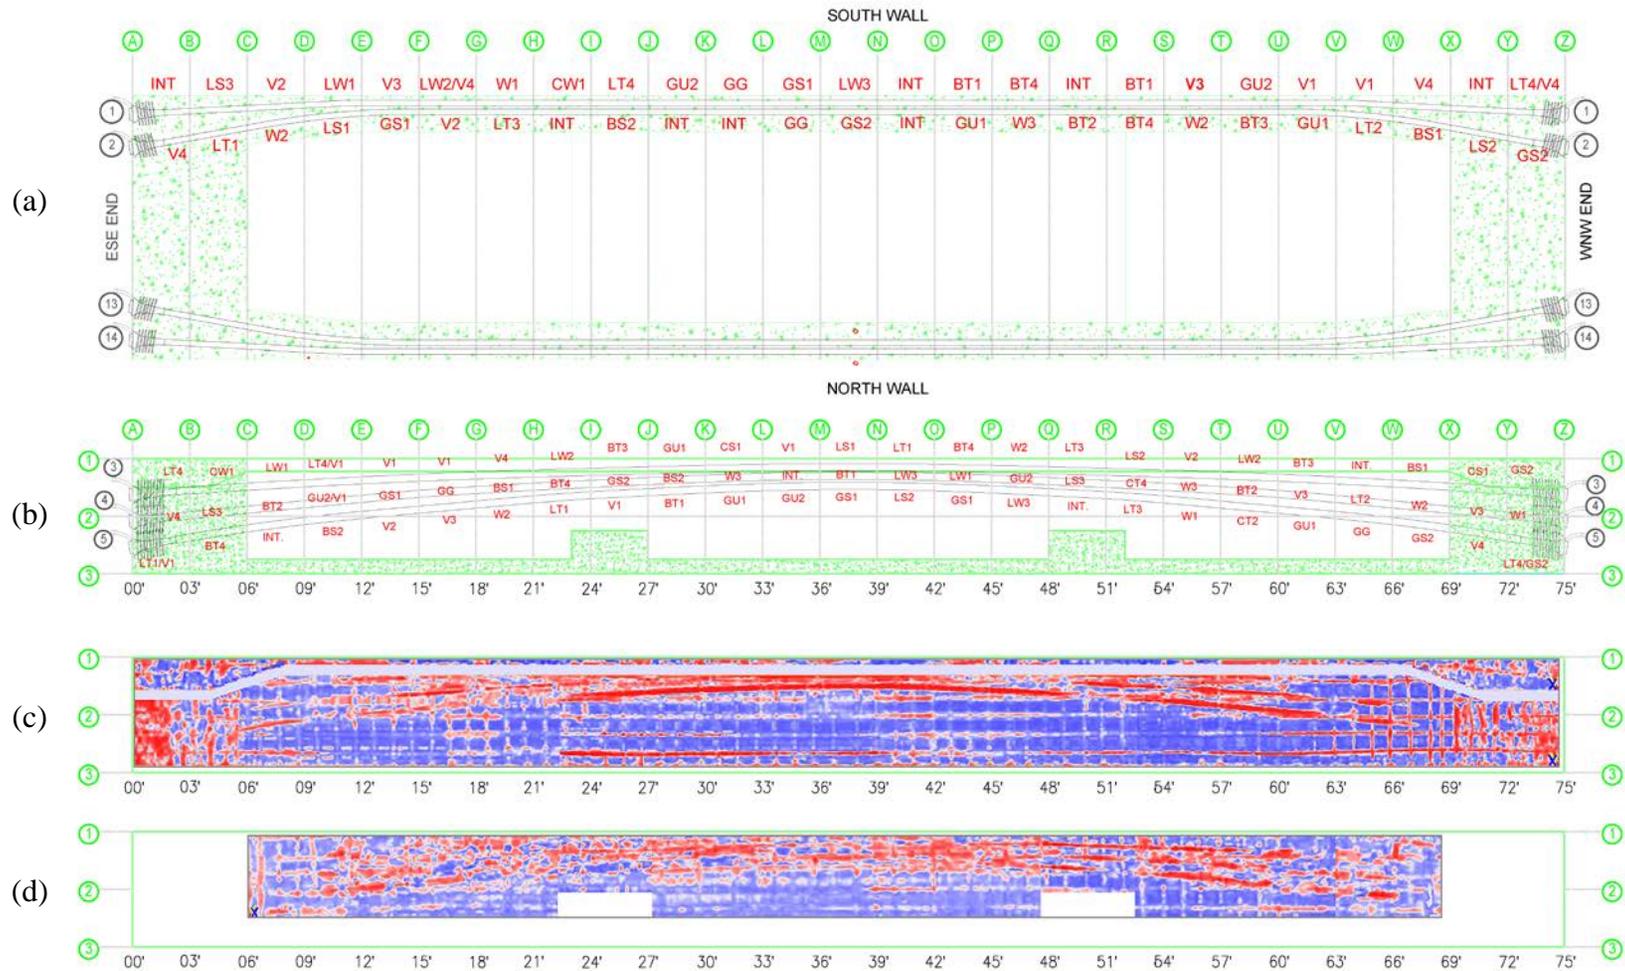
The South Wall results in Figure 5-2. The plastic ducts do not provide as strong reflections, making them more difficult to identify. This is especially true in the interior wall scan. While in theory this would allow for the grout defects to be better observed, they are not discernable in these images. This could partially be attributed to the orientation of the voids as reported by other researchers (Pollock et al., 2008).

Figure 5-2: South Wall Scans – GPR: (a) Flange Defect Key (Plan View); (b) South Wall Defect Key; (c) Exterior Wall Scan (Wall Scan Depth: 4.78 in.; Flange Scan Depth: 6.08 in.); (d) Interior Wall Scan (Wall Scan Depth: 5.36 in.)

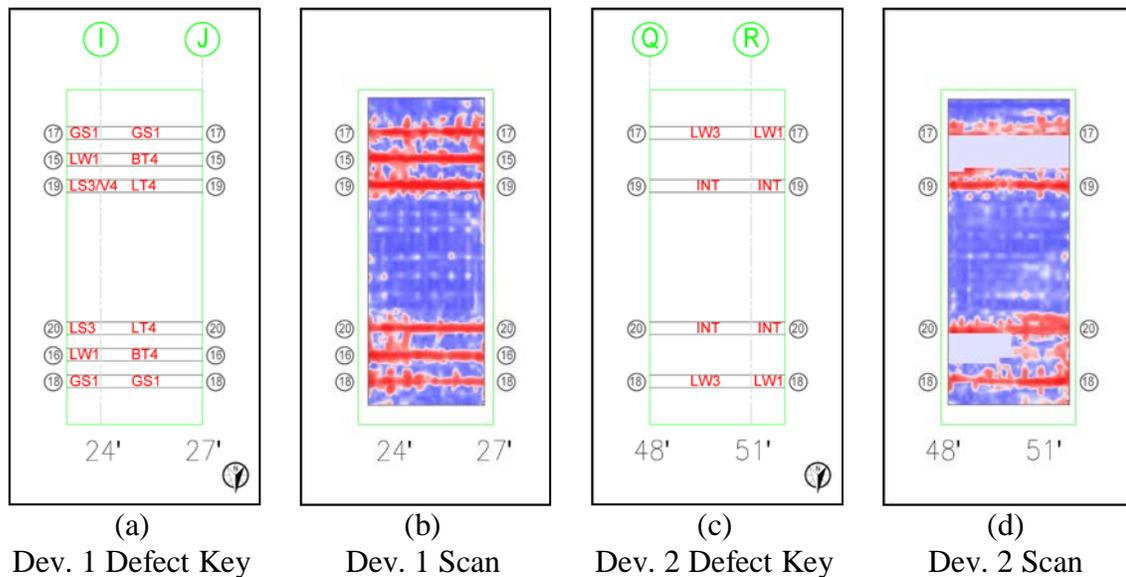
Figure 5-3: Deviator Scans – GPR
(Dev 1 Scan Depth: 4.44 in.; Dev 2 Scan Depth: 4.44 in.)

The deviator results appear in Figure 5-3 and are consistent with the wall data. The metal ducts within the deviators are clearly identifiable, but the defects themselves are not. It should be noted that the deviator scans are 1.77 in. (45 mm) thick and that the gray regions in Figure 5-3d were inaccessible due to the external tendons T15 and T16, which pass over the deviator rather than through it.

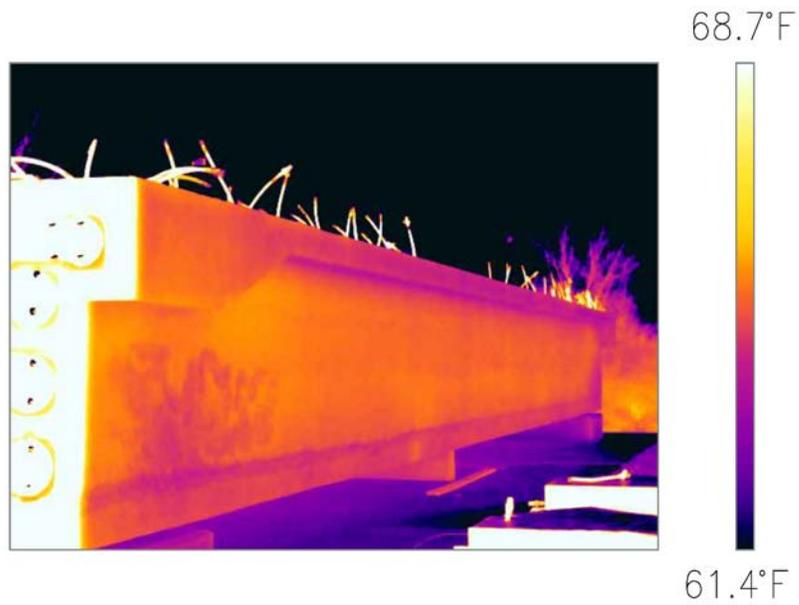
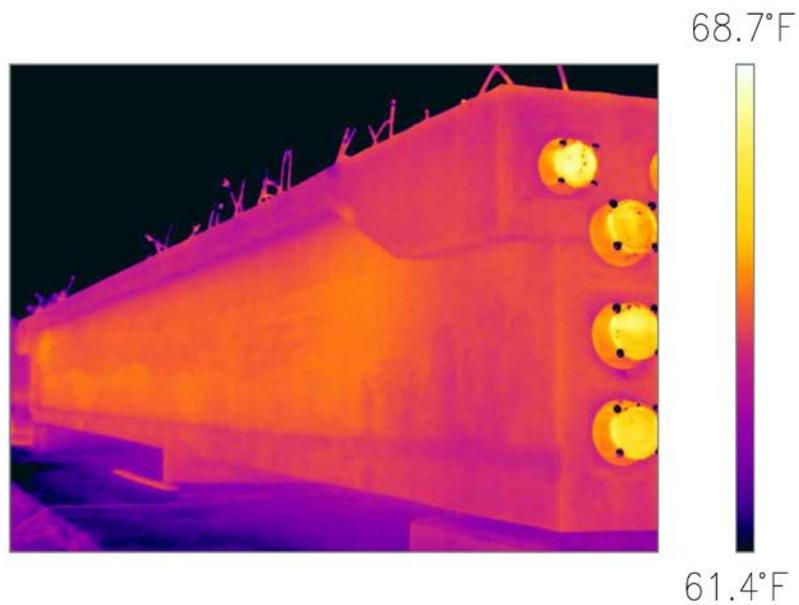
Figure 6-1: North Wall Exterior IRT Image

The angled images of the North Wall in Figure 6-1 do not reveal any information about the ducts or the grout defects. However, from these images the surface condition can be assessed, as the uneven, grinded surfaces near the ends of the specimen and above the bottom slab are visible. These are simply features from the construction process.

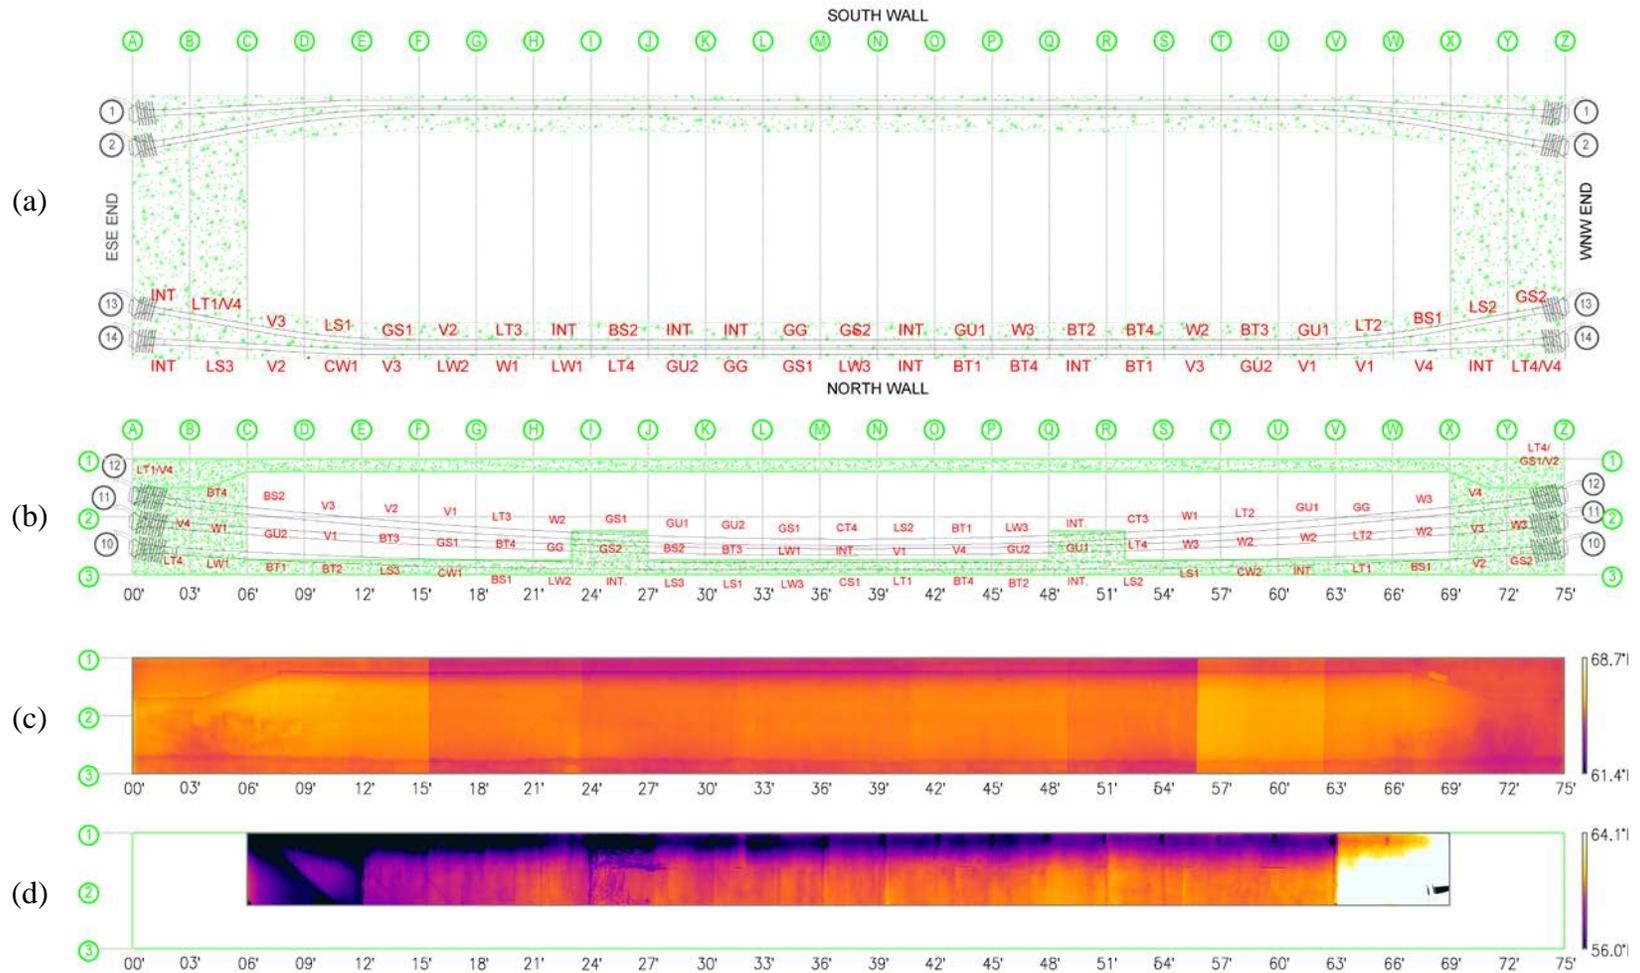
The defect key for the North Wall appears in Figure 6-2, along with images of the interior and exterior. While the rough anchorage zones and slab line are again

visible, the metal ducts are not. In Figure 6-2c, a small warm rectangle appears on the flange near marker X (69 ft). This is actually a 2 in. x 4 in. piece of lumber used in the formwork that remains in the specimen. The piece of wood cools at a different rate than the surrounding concrete and so it is visible in the temperature profile.

It should be noted that Figure 6-2d shows a fairly large temperature differential between the two ends of the wall. In the morning, the interior west side of the North Wall receives direct sunlight while the east side is shaded. While ideally, the entire specimen should be shaded or in direct sunlight, the orientation of the specimen did not provide such an opportunity. This point becomes moot as the technology does not appear to be able to locate the internal ducts or their defects. Please note that an external duct is visible in this image due to its proximity to the internal wall.

Figure 6-2: North Wall Images – IRT: (a) Flange Defect Key (Plan View); (b) North Wall Defect Key; (c) Exterior Wall Image; (d) Interior Wall Image

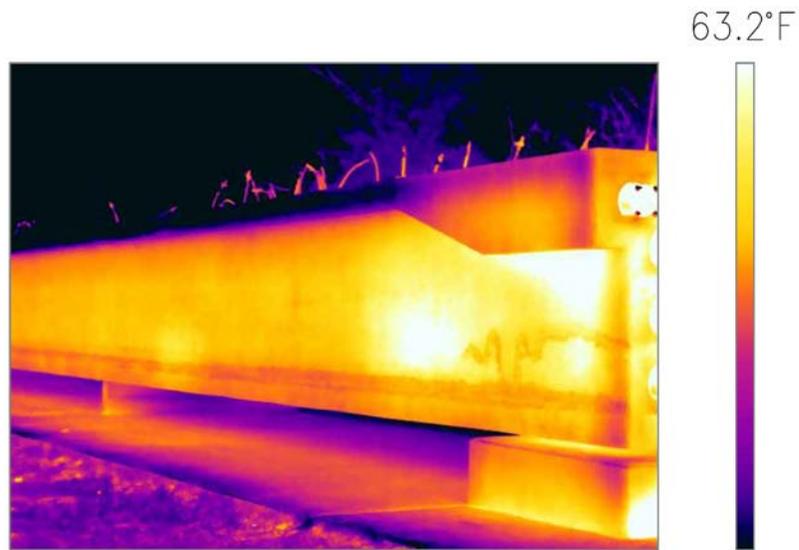
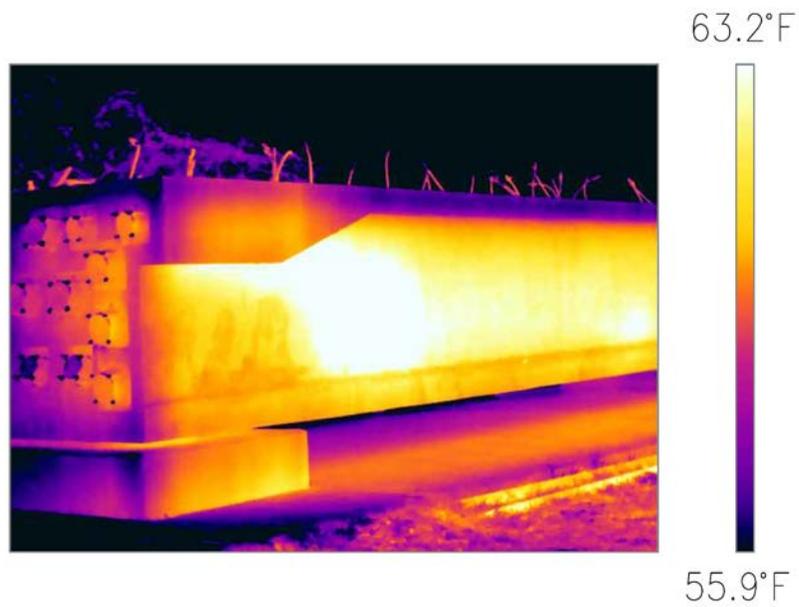
Figure 6-3: South Wall Exterior IRT Image

The HDPE plastic ducts are not visible in the angled images of the South Wall in Figure 6-3. The rough anchorage zones and slab line are visible. There are two anomalies in these images which are quite interesting. The anchorage zones appear to be comparatively warmer than the rest of the specimen. Warmer regions also appear along the wall surface on each side of center. A full length IRT image of the girder wall will likely provide further information and perhaps offer an explanation for these abnormally warm regions.

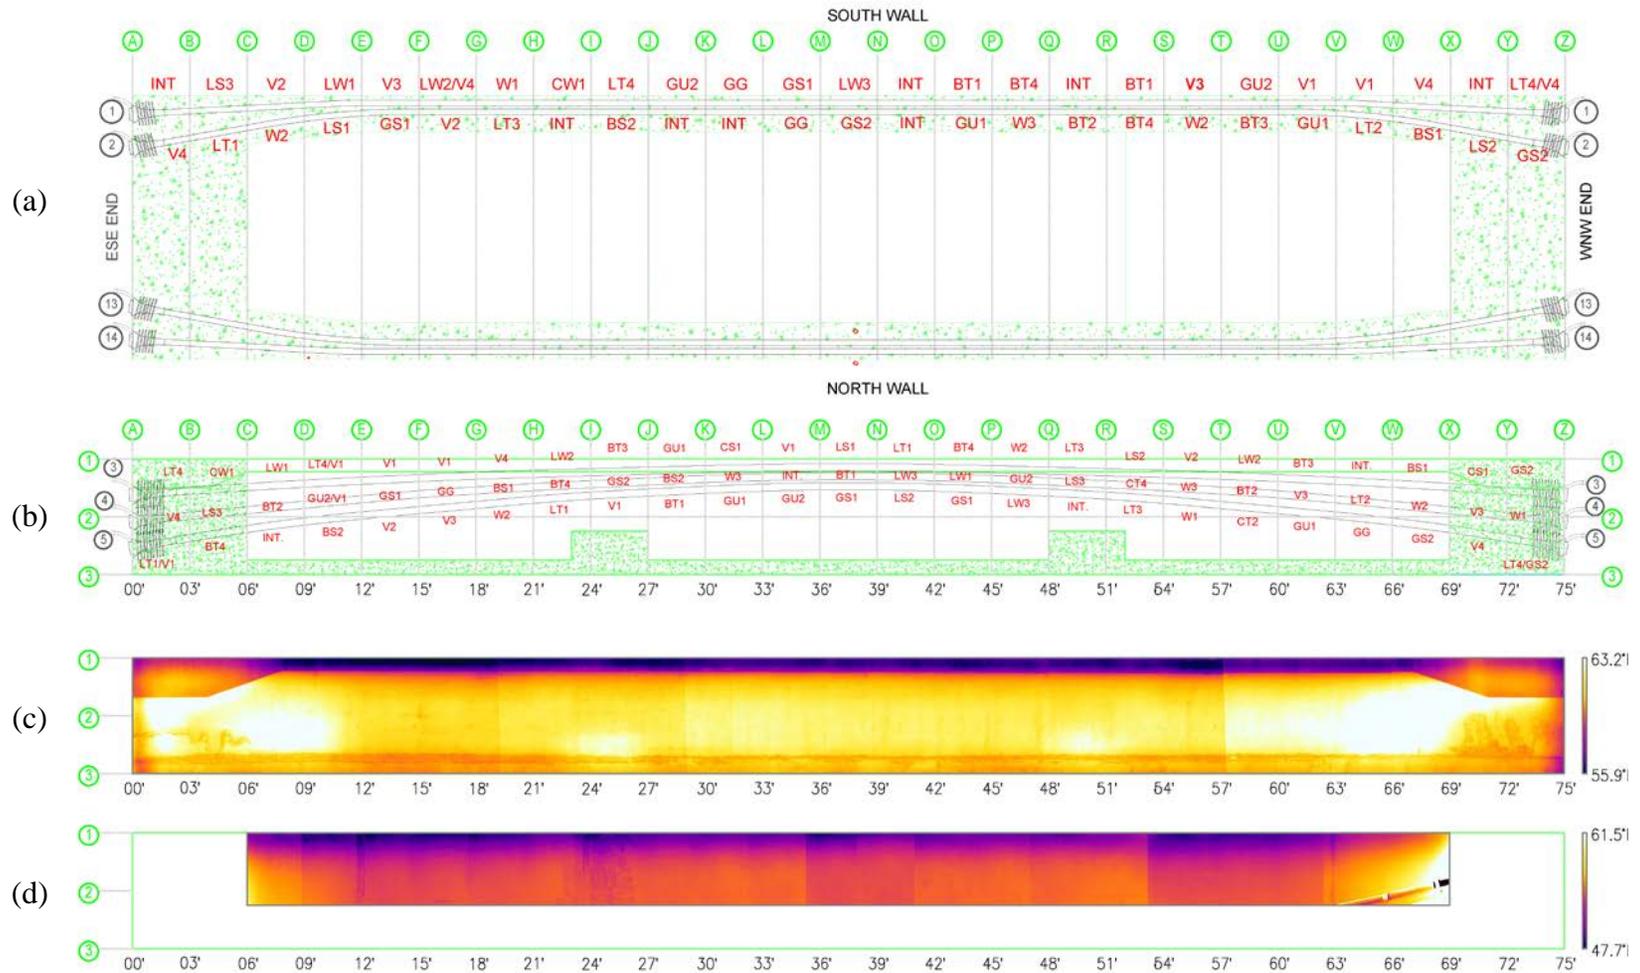
indeed warmer than the surrounding areas. The two warmer spots on either side of center, which were identified in Figure 6-3, are clearly visible and correspond to the deviator regions. It is possible that these regions are warmer due to the additional wall thickness. Due to the proximity of the external ducts to the interior walls, an external tendon is visible in Figure 6-4d. However, no internal ducts or grout defects are visible.

It is likely that the ducts are embedded too far into the wall to be visible using infrared thermography. These results are consistent with previous research. Musgrove (2006) discovered that a temperature gradient of at least 135°F (75°C) is required in order to detect simulated voids with concrete covers of 2 in. (50.8 mm) or less, and Pollock et al. (2008) noted the difficulty in obtaining the necessary temperature gradient in thicker concrete specimens, particularly when the heat can propagate along the length and height of a specimen. An exploration of the end cap regions should provide more promising results.

Figure 6-4: South Wall Images – IRT: (a) Flange Defect Key (Plan View); (b) South Wall Defect Key; (c) Exterior Wall Image; (d) Interior Wall Image

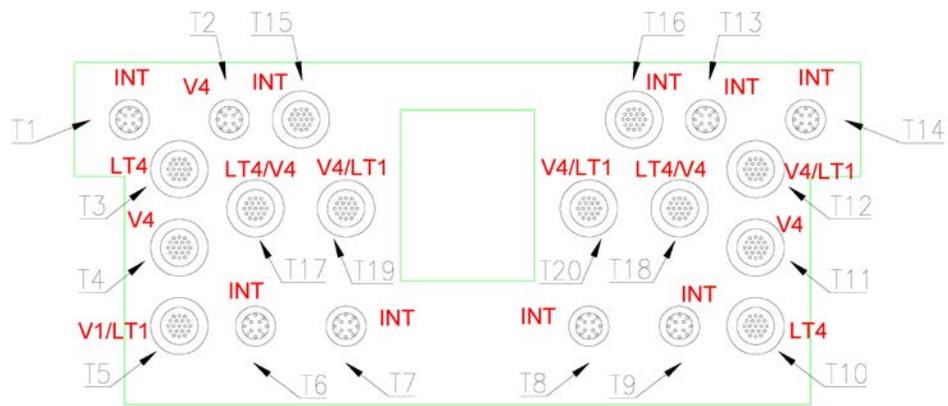
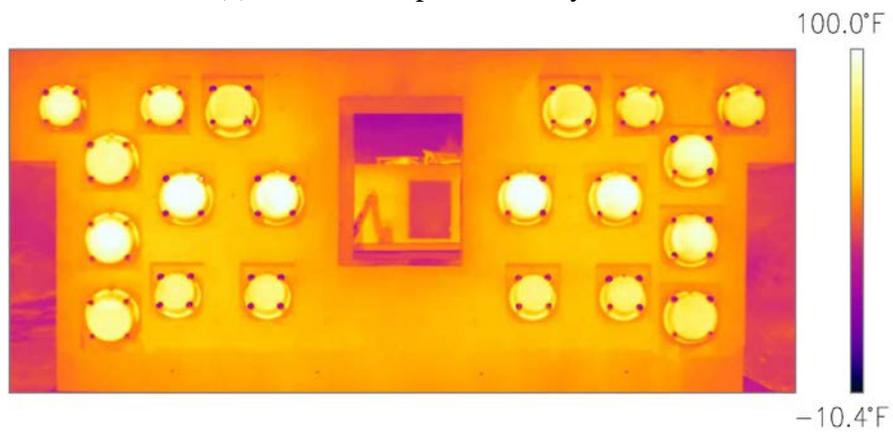
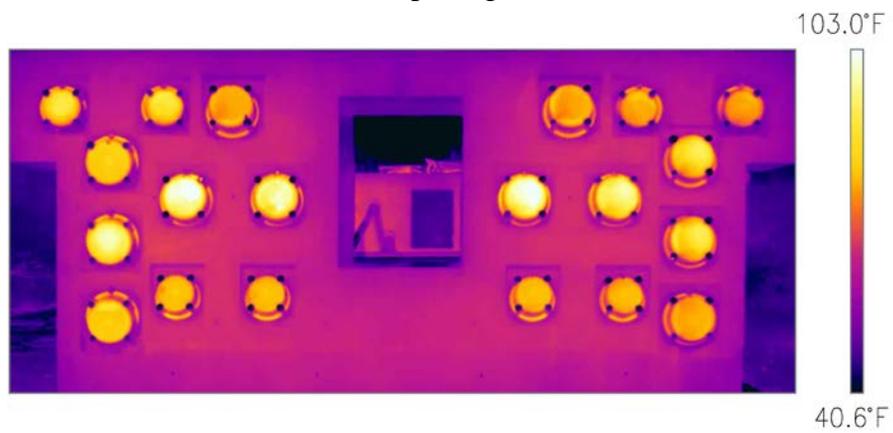
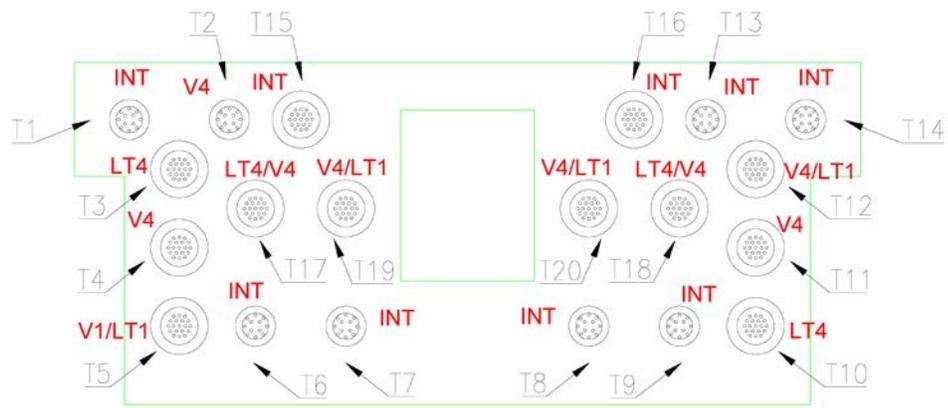
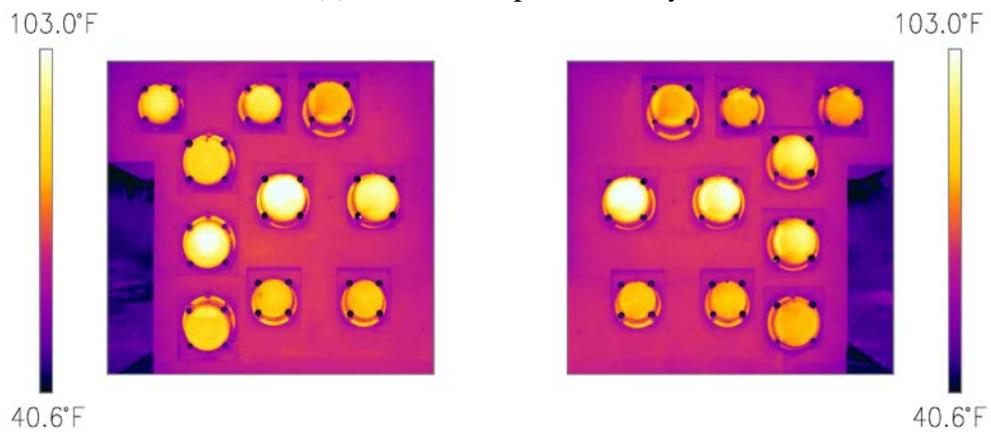
Figure 6-5: East End Cap Images – IRT

After comparing with the defect key, these hypotheses are determined to be correct. However, not visible in these figures is the complete void in tendon T2. The end cap for tendon T2 appears to be pointed down and away from the eastern morning light. Thus, it does not heat up like the other end caps with voids.

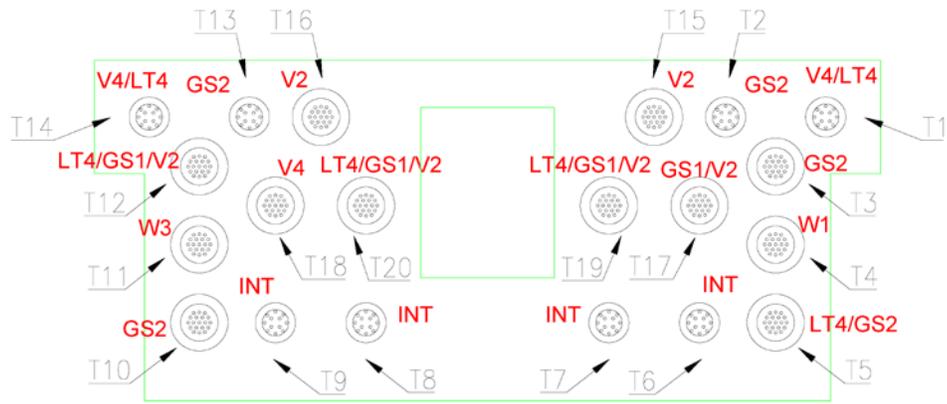
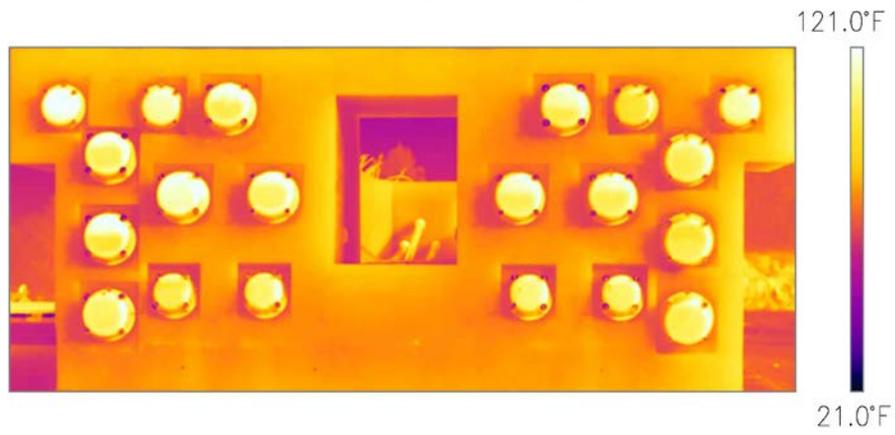
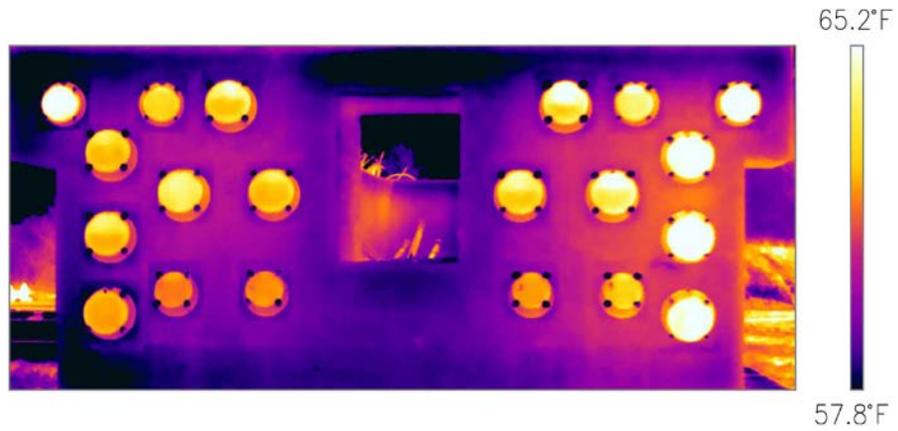
Figure 6-7: West End Cap Images – IRT

From Figure 6-7, it appears as though tendons T1, T14, and T18 are completely ungrouted at the anchorage zone, while tendons T11, T12, T15, T16, T17, T19, and T20 are partially ungrouted. These regions are likely to be voided or contain water-filled cavities. After comparing with the defect key, these hypotheses are deemed to be correct. However, the small water defect in tendon T4 is not identifiable. Additionally, the IRT camera does not appear to be able to distinguish between the water-filled cavities and voids or between “good grout” and soft grout. However, it seems extremely reliable in determining whether a duct’s cross-section is fully grouted or if a water/void defect is present.

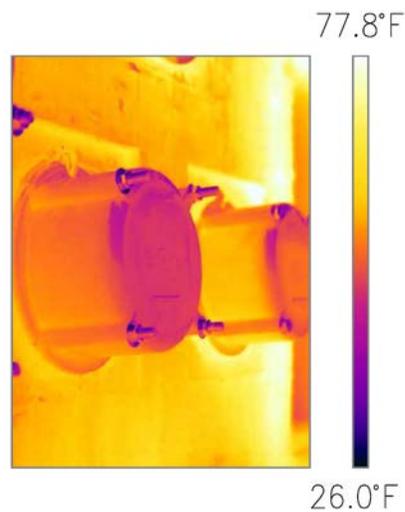
Figure 6-8: Close-up of End Caps T18 and T20

While infrared thermography appears to identify ungrouted regions in the anchorage zones, it requires access to the end caps. In practice, this access is quite limited, and the end caps are generally only visible from the side. Images were thus taken of the end caps with practical access in mind. Figure 6-8 shows the end caps for tendons T18 and T20 from the North side. Tendon T20 is known to be partially ungrouted and Tendon T18 is completely voided. These facts are confirmed by the faces of the end caps in Figure 6-8. However, the sides of the end caps appear to reveal nothing about the condition of the grout. The line on the face of the end cap, which marks the temperature differential between the grout and the void in tendon T20, is not visible on the side of the end cap.
