A REPORT ON THE REFUGEE CAMP AND HOUSING PROGRAMS IN
CHOLOMA, HONDURAS, FOR THE REFUGEES OF HURRICANE FIFI:
DECEMBER 1974

Frederick C. Cuny

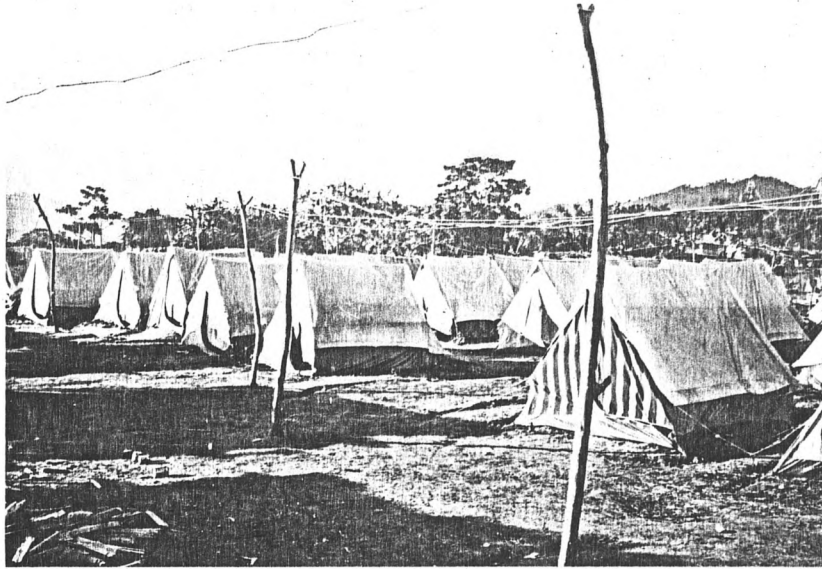
Type A

Initial housing in the camp consisted entirely of tents provided in the early construction phases. At the north end of the site, permanent housing is being built which will house a portion of the residents (this new construction will be discussed subsequently). The tents are of two types, illustrated on page 8, which are designated types A and B for the purpose of this report. Both are designed for camping in a temperate environment, not for long-term occupancy in a refugee camp, and both types show considerable wear and patching (see Figure 5). Major problems include: holes in the ground cloth; tears in the roof and walls; malfunctions of the zippers; deterioration of the guy lines; and breakage of the aluminum ridge poles. Residents have noted that type A is too small for family living and does not allow many personal goods to be stored. They have also remarked that type A is less comfortable than type B. Type B, however, is more susceptible to wind damage and deterioration of the roof.

FIGURE 4:
TENTS USED AT CHOLOMA

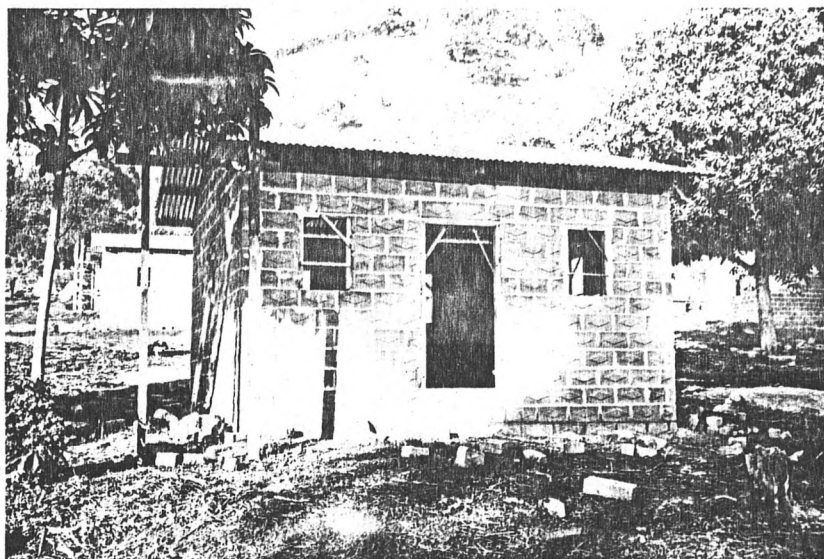
9a
Completed Unit

The units are constructed of concrete blocks which are formed and set off-site, taking approximately 3 days to set. The blocks are then trucked to the site and used to build the units, which are approximately 5 x 5 meters and have a conventional peaked roof (see Figure 9). Again, the unit is only a shell with no interior partitions. Construction time on site is 8 days.

FIGURE 9:
CONCRETE BLOCK HOUSING
