Case Study: From Promise to High Performance

**Achieving a 30%+ Reduction in Natural Gas Consumption
through Existing Building Commissioning**

*International Conference for Enhanced Building Operations
October 18-20, 2011 / New York City*

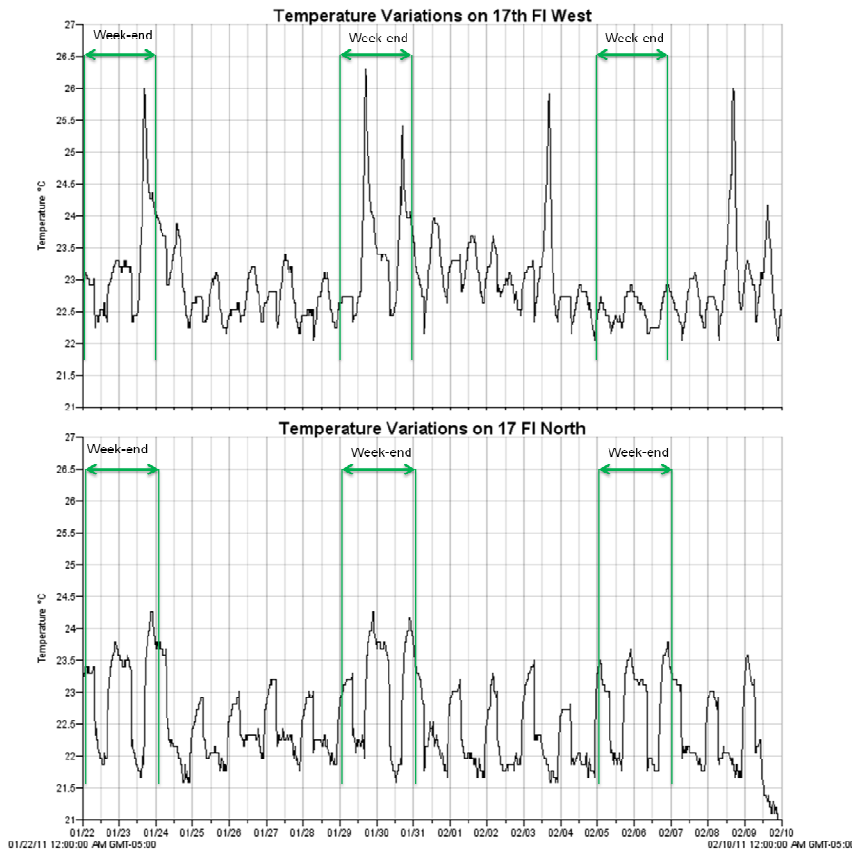
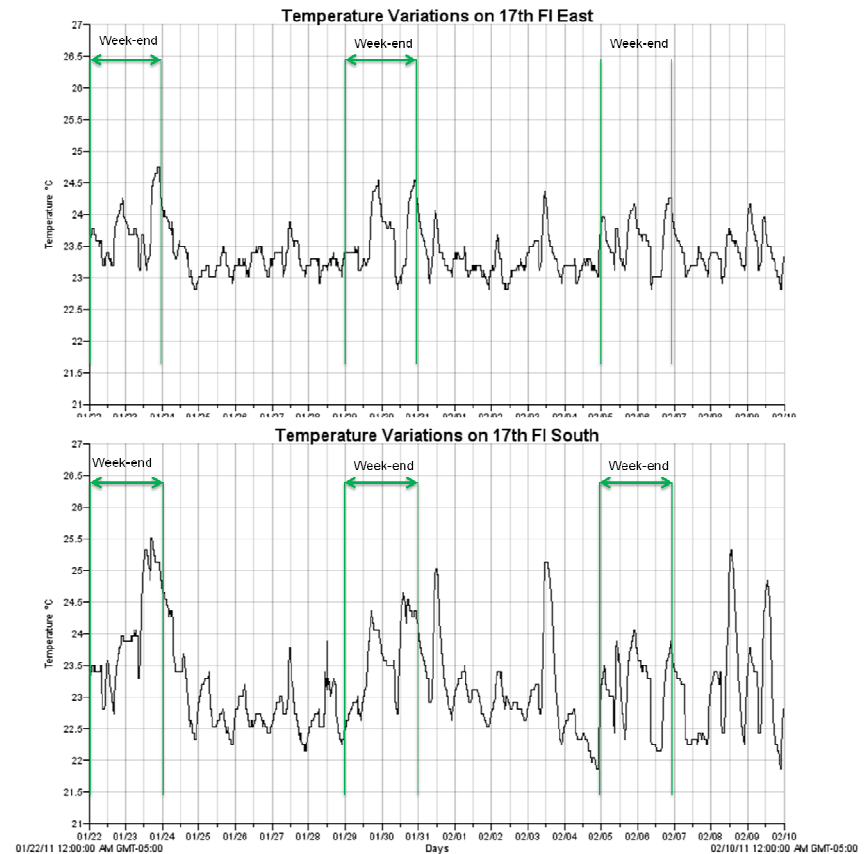
Example: 17th Floor Temp. Energy@Work Inc. © 2011 www.Energy-Efficiency.com

Graphs show temperature variations at the N, S, E and W perimeter locations.

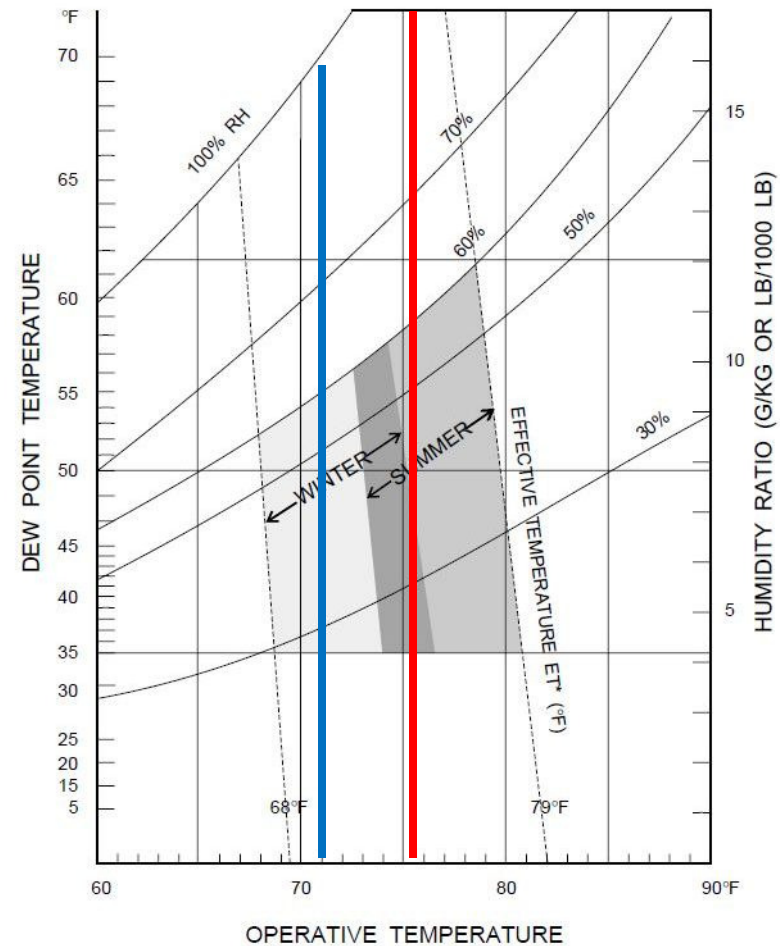
ASHRAE Standard 55

“Thermal Environmental
 Conditions for Human
 Occupancy”

Thermal comfort chart:
 Industry-recognized
 indoor comfort reference.
