AN ENVIRONMENTAL ASSESSMENT OF BERMUDA'S CAVES

A Thesis

Submitted to the Office of Graduate Studies of
Texas A&M University
in partial fulfillment of the requirements for the degree of
MASTER OF SCIENCE

December 2003

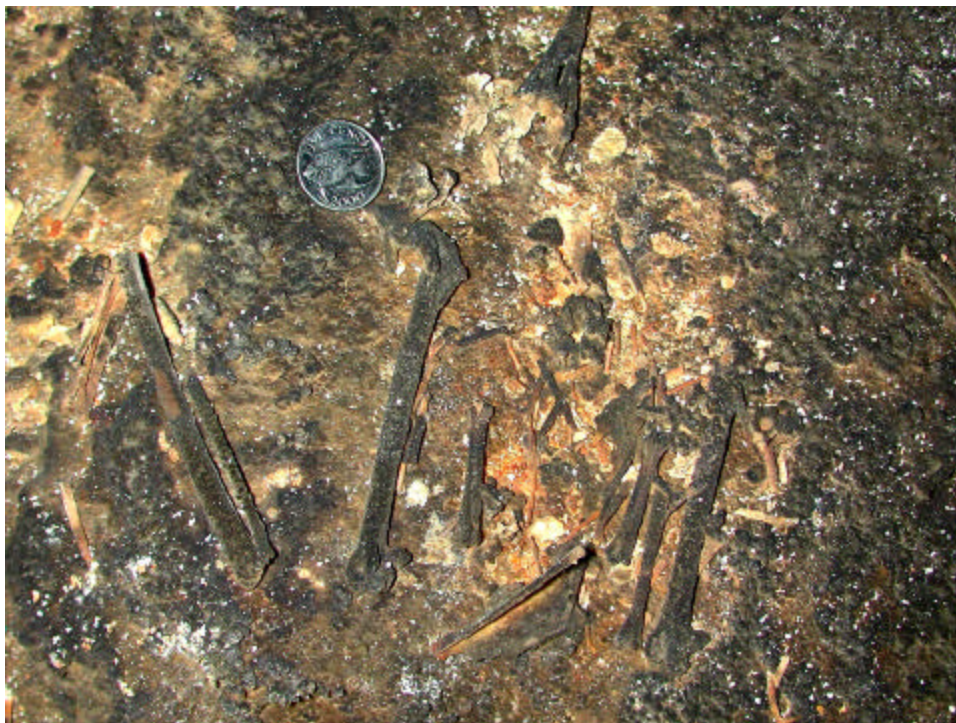
Some caves also contain relicts which evidence events that occurred much earlier in the history of the cave. For example, some caves on the island contain fossilized bird skeletons, some of which are believed to be cahow bird bones, revealing a time in Bermuda’s history when the currently endangered cahow population was much larger (Figure 2).

Figure 2. Fossilized bird bones in Jane's Cave with Bermudian coin for scale.

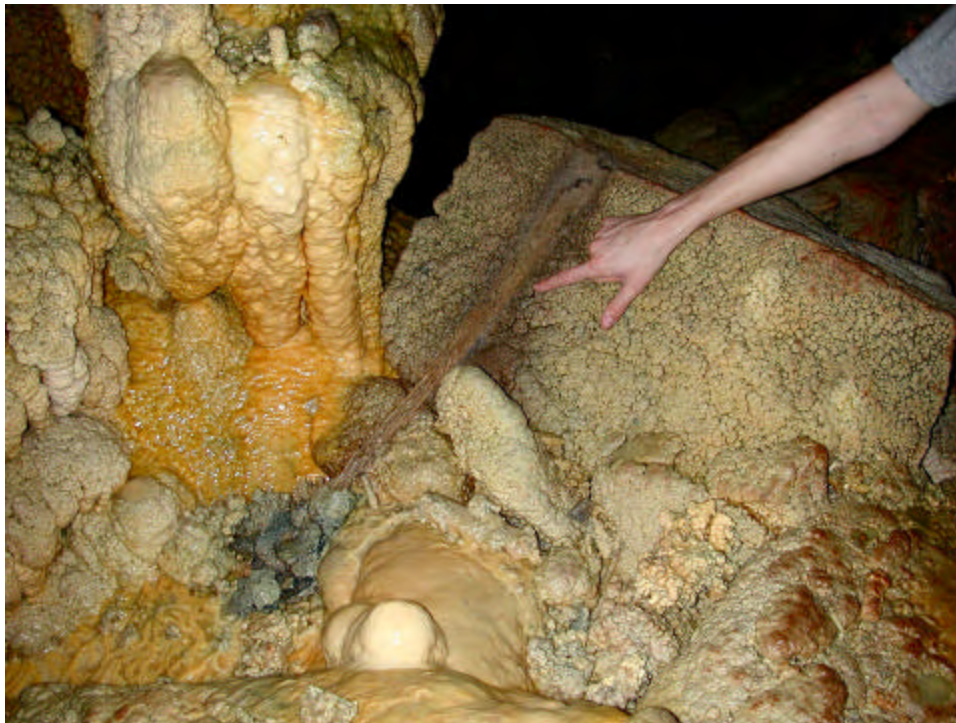
Figure 3. Old wooden torch in Jane's Cave.

Another feature in the caves that shows the presence of earlier explorers includes black soot on the ceilings of some of the caves, which was deposited by either wooden torches or kerosene lamps before the time of batteries and flashlights. In one particular cave, Jane's Cave, located next to a fairway on the Castle Harbour golf course, an extremely old wooden torch was discovered cemented by calcite to a slab of flowstone that was located a considerable distance into the cave (Figure 3). This relict revealed how, prior to the days when more reliable light sources became an essential part of caving, early explorers were not deterred and ventured deep into some of the more complex and physically challenging caves.

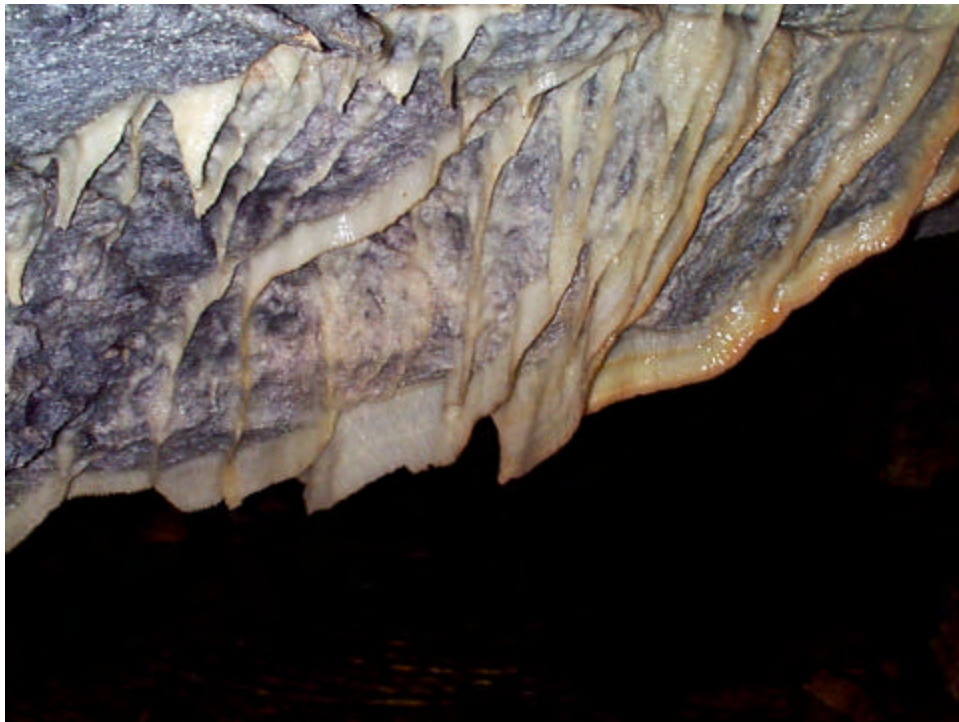
Figure 6. Drapery speleothems in Shop Cave.

Like the caves themselves, the speleothems within the caves also formed slowly over many thousands of years, and thus can be considered nonrenewable resources (Iliffe 1979). Some of the speleothems from the collapse caves in Bermuda have been studied and were found to be at least 200,000 years old (Harmon et al. 1983). Thus, while caves can recover from certain impacts, the effects of vandalism of speleothems or the elimination of caves through quarrying are permanent in terms of the lifetime of our present society. Gamble (1981) asserts that intentional disturbance to the surface or subsurface portion of a cave is normally of a long-term nature and is usually irreversible. Figures 6 and 7 represent speleothem decoration in two separate caves in Bermuda.

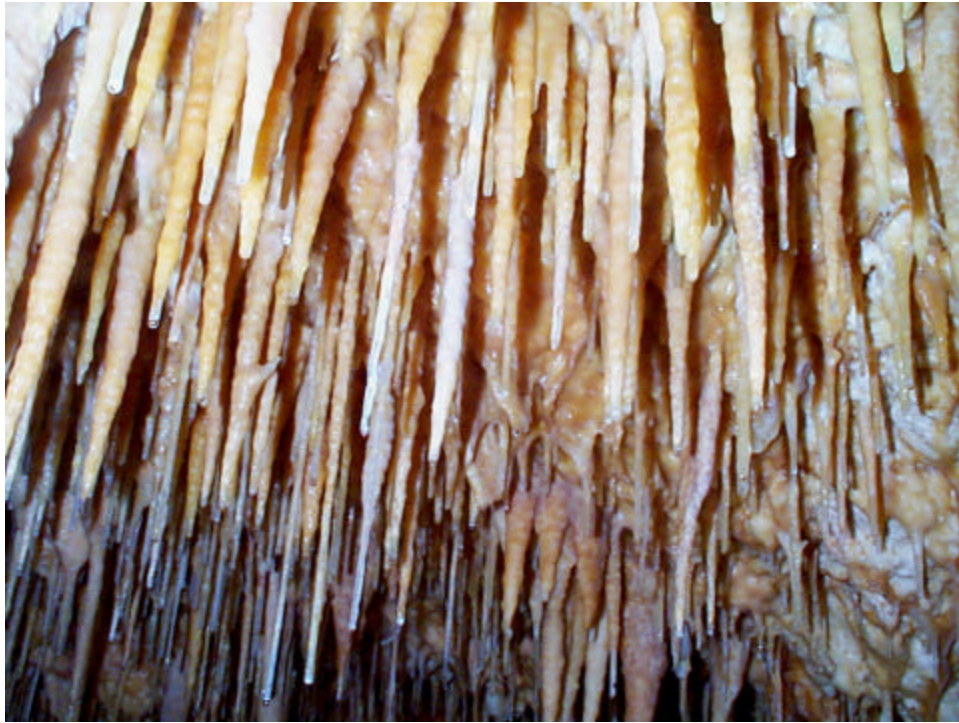
Figure 7. Stalactites in Kitson Cave.

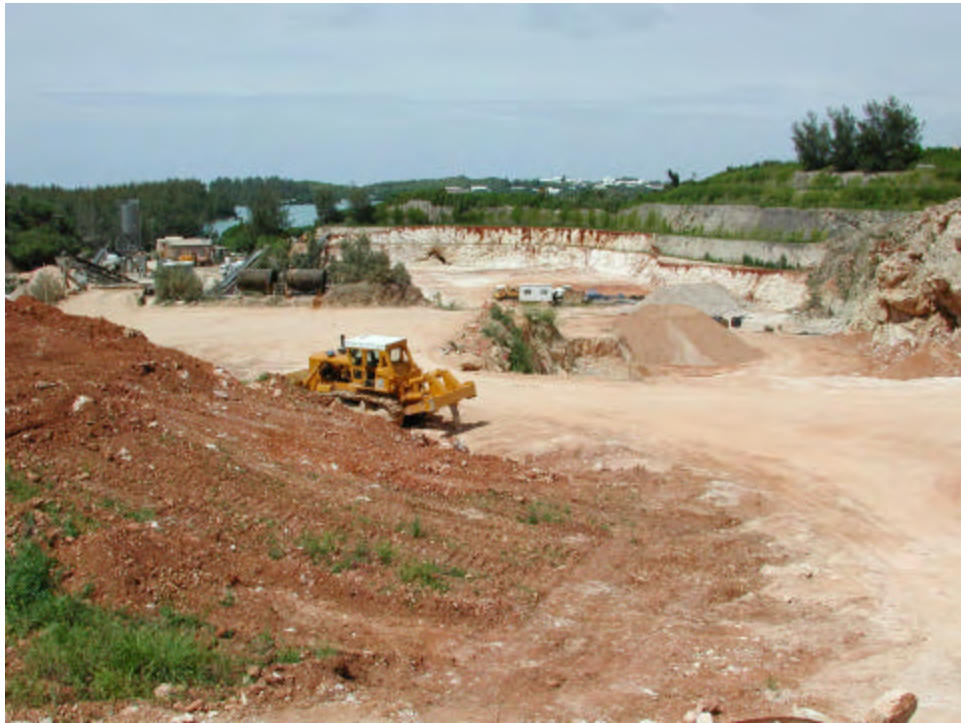
rock formation: the Wilkinson quarry, a privately owned quarry (Figure 8), and the Public Works Department (P.W.D.) Quarry, run by the government. Though the P.W.D. quarry has not been quarrying actively for the past four years and is currently not in operation, there is still considerable rock on the property left to extract (Tankard personal communication). The material removed from these quarries is used to provide hard aggregate for concrete and asphalt (Department of Planning 1988).

Figure 8. Photo of Wilkinson Quarry.

Throughout the course of the respective operations in these quarries, a number of caves have been destroyed, including Government Quarry Cave, one of the largest and most well decorated on the island. Additionally, twelve of the thirteen remaining caves at the P.W.D. quarry that existed in 1983 have been destroyed. As sensitivity towards the cave environment was not truly introduced in any significant way into Bermuda legislation until the 1980s, countless unknown other caves on the two quarry properties were most likely destroyed. As the supply of material from these quarries is finite, it is clear that Bermuda will eventually have to rely on imported materials, as the Planning Department has asserted that there is no alternate location that could provide this particular type of hard aggregate without serious environmental damage. Furthermore, there are few large areas of land that remain undeveloped or environmentally unprotected where large scale quarrying could even be considered (Department of Planning 1988).

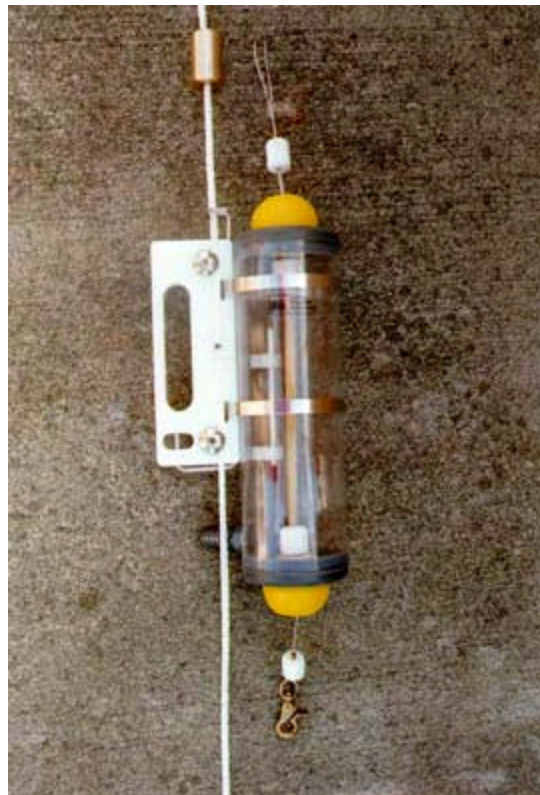
Figure 9. Vertical water sampler (Aquatic research webpage).

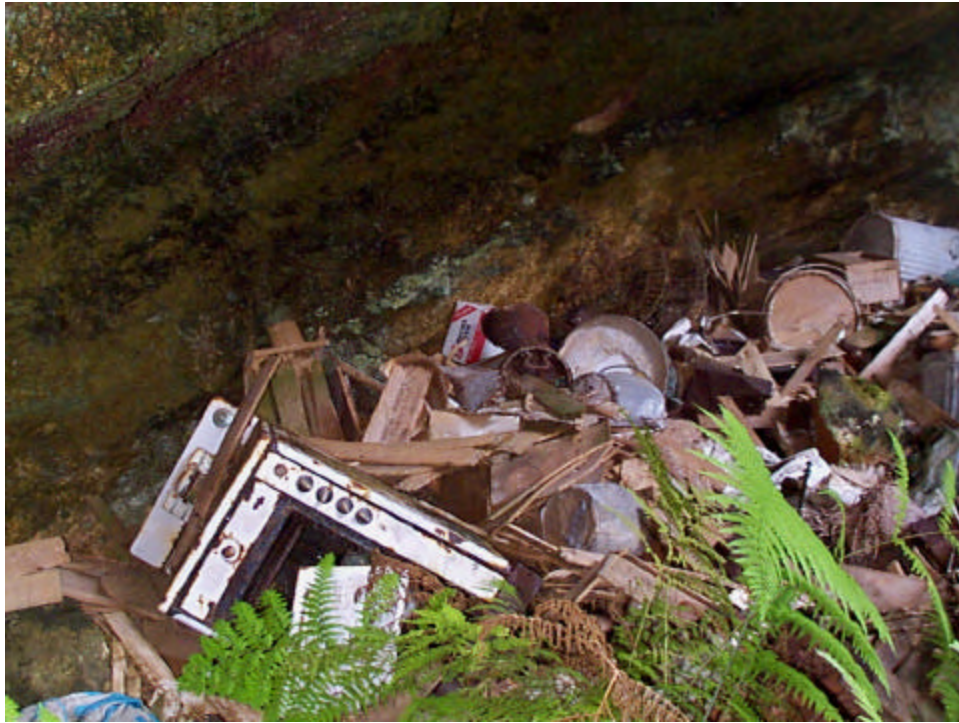
Another cave that has been improved significantly since the original survey is Sear's Cave, a 15 m diameter sinkhole located in Smith's Parish (Figure 15). This cave is rather isolated from the majority of the caves that are located in the Walsingham rock formation in Hamilton Parish. Nevertheless, it is particularly vulnerable and merits protection, as it contains the largest population of the endangered Bermuda cave fern on the island. It is located behind a residential area, and for years it was used as a trash dump. Eventually, huge piles of trash built up in the cave, including cans, bottles, discarded appliances and yard and lawn debris. The cave was considered to be dangerous to residents who lived nearby, as it was such a large and deep pit, that they worried about children accidentally falling into the cave. Currently, the cave has a much better status, as both the cave and surrounding area were purchased by the Audobon Society. The group used large construction machinery to extract large piles of trash.

Figure 15. Trash that still remains under the overhang in Sear's Cave.

While a great deal of the trash was removed, it was difficult to clean it all out because the lip of the cave is undercut on two sides, making it difficult to access that area of the sinkhole. After the majority of the trash was extracted, a tall fence was installed around the entrance to the cave to prevent further dumping and to keep trespassers from entering the cave. Originally, this cave was rated a “4” for dumping and littering and is now rated a “2”. Thus, despite the poor environmental health of this cave in the past, current efforts dramatically improved the status of its habitat.
