ANALYSIS OF THE MECHANICS OF THE OURAY, CO LANDSLIDE

An Undergraduate Research Scholars Thesis

Analysis of the Mechanics of the Ouray, Co Landslide. (May 2013)

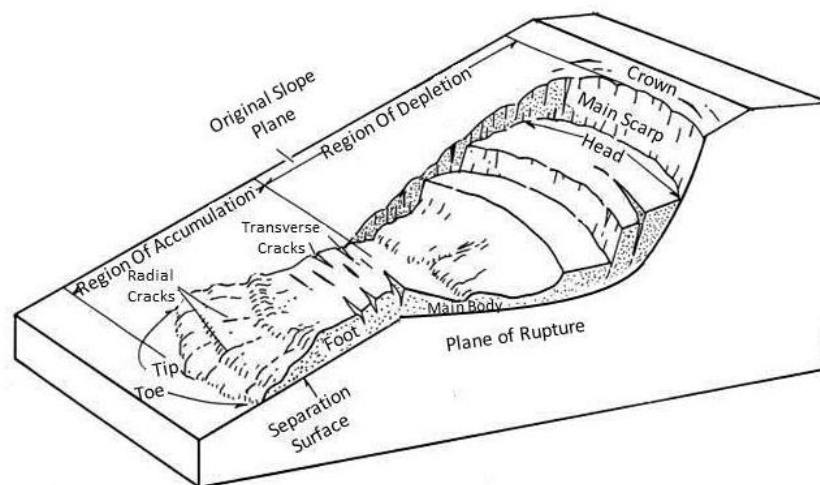
FIGURE 1. IDEALIZED LANDSLIDE DIAGRAM AND FEATURES (Modified from Varnes, 1978)

A 'Landslide' is a term used to describe a wide variety processes that result in the movement of slope forming materials down and outward as driven by gravity (Schuster R. L., 1978). In an assessment into the principles of a landslide, investigations must be made into the following areas: landslide features(Figure 1), landslide dimensions, landslide activity (grouped as: State of Activity, Distribution of Activity, and Style of Activity) (Varnes, 1978), state of activity, distribution of activity, style of activity, rate of movement, water content, materials, types of movement, and landslide processes Understanding the morphological differences of landslide types is essential in understanding the Ouray, Co Amphitheater Landslide.

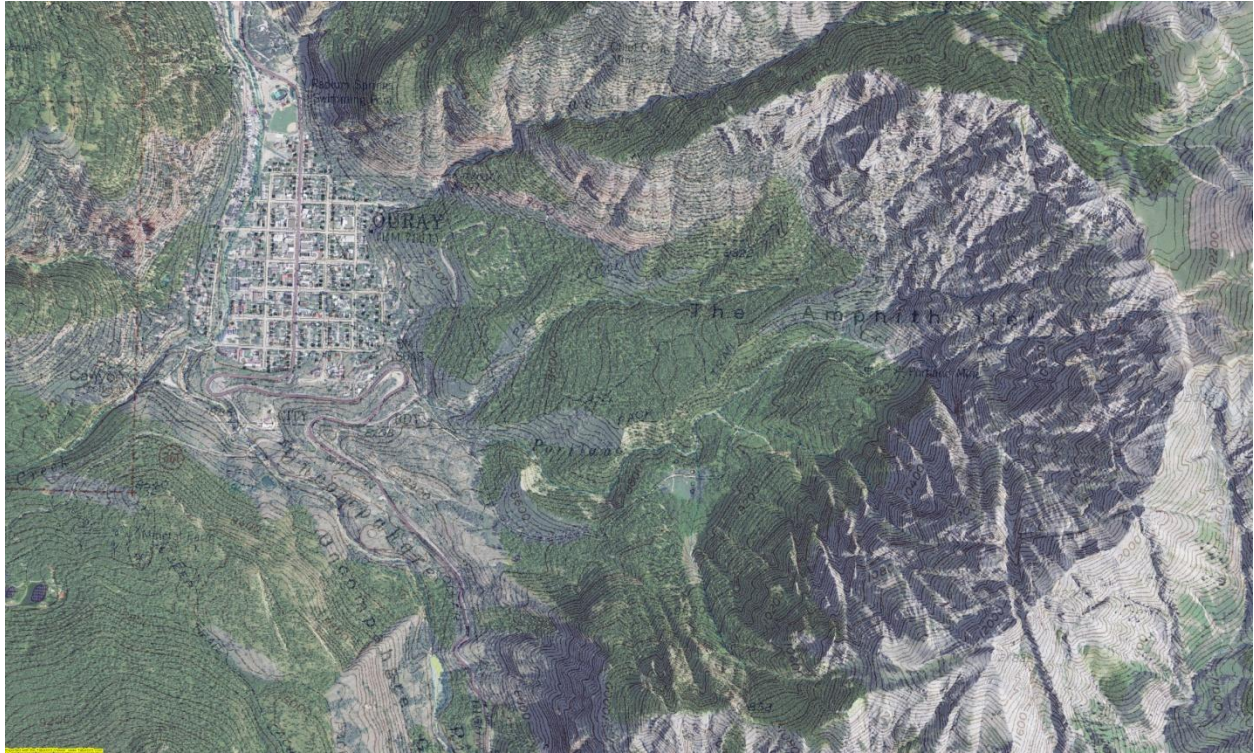
FIGURE 2. AERIAL/TOPOGRAPHIC OVERLAY

possible. The first maps generated were a 36 x 36 high resolution aerial photograph of the landslide, and a 36 x 36 topographic map overlaid over a aerial photo of identical scale 1 : 24000 (Figure 2).

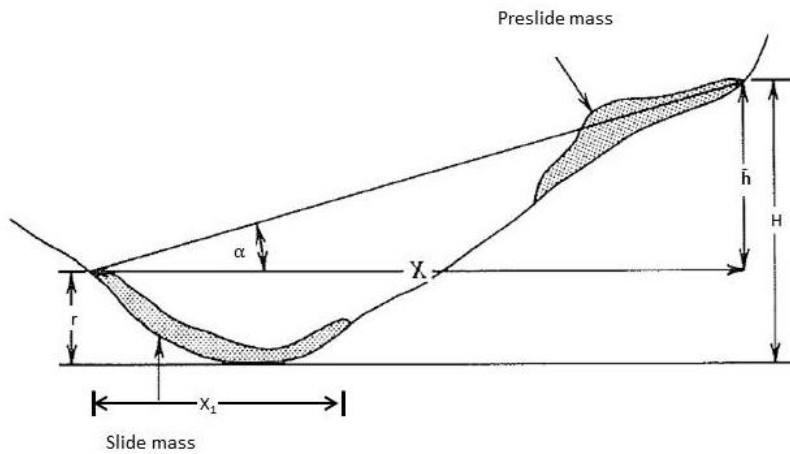
FIGURE 9. GEOMETRY OF LANDSLIDE. (Modified from Costa and Baker, 1981)

An analysis of the topography of the area using remote sensing techniques, created a model of the landslides structure in cross section. This allowed for the identification of the form of slope failure and its geometry (figure 9). The extent of the slide was established by measurements taken for maps. This includes measurement of the total vertical fall (H), the net vertical fall (h), and the horizontal distance of movement (X) which is the run out distance of the slide mass.

Using the Equation: $\mu = \frac{h}{X} = \tan \alpha$, the average coefficient of friction (μ) and the angle of repose which is the threshold at the average slope over which the slide moves (α), are calculated. Also the maximum run up/down distance (r) is calculated by: $H - h = r$. Using the 'r' value, the average velocity (v) that the slide traveled was calculated by $v = \sqrt{2gr}$ where 'g' is the slides acceleration due to gravity.

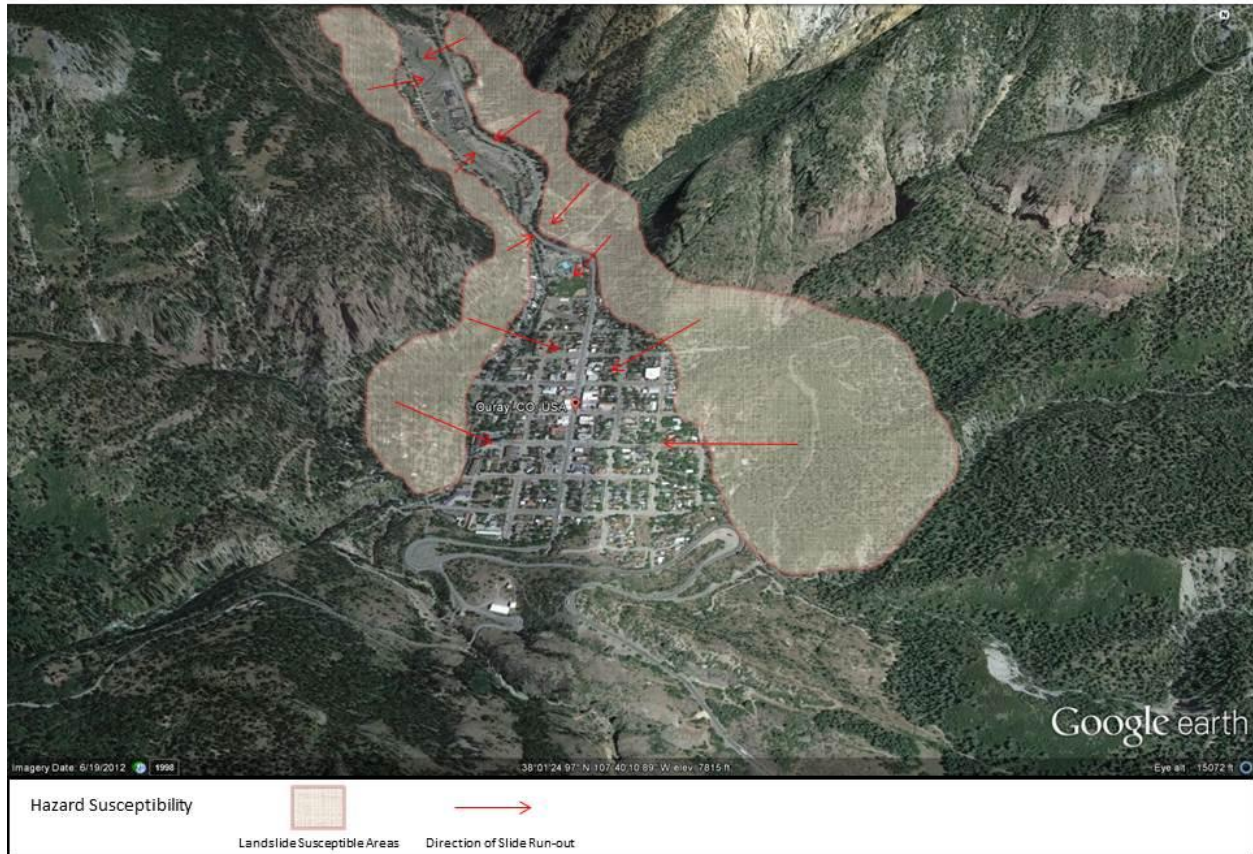
FIGURE 11. HAZARD SUSCEPTIBILITY MAP

From the analysis, the landslide is determined to be a planar slide of 176,994,271.6 ft³, composed of San Juan tuff mixed with glacial deposits. The slide has a horizontal run out distance of 11,289 ft on a threshold angle of 20.9⁰. The slide is a result of an over steepening of the valley walls from glacial erosion during the last interglacial of the Pleistocene age when the exposed Molas shale experienced strain and saturation resulting in decreased shear strength associated with the shale when the support of ice contact was removed. This analysis has led to the identification of similar areas in geologic situations that suggest that they are prone to future failure. Application of the methods used to investigate the Amphitheater landslide are applied to the other areas. The area that poses a threat to the loss of life and property, have been mapped

out in the map of hazards (Figure 11).
