**THE DEVELOPMENT OF A METHOD FOR THE IDENTIFICATION AND  
SELECTION OF PRESERVATION VALUES FOR THE PROTECTION OF  
WWII UNITED STATES ARMY AIRBASES IN TEXAS**

A Dissertation

MICHAEL ANTHONY BUNCH

December 2014

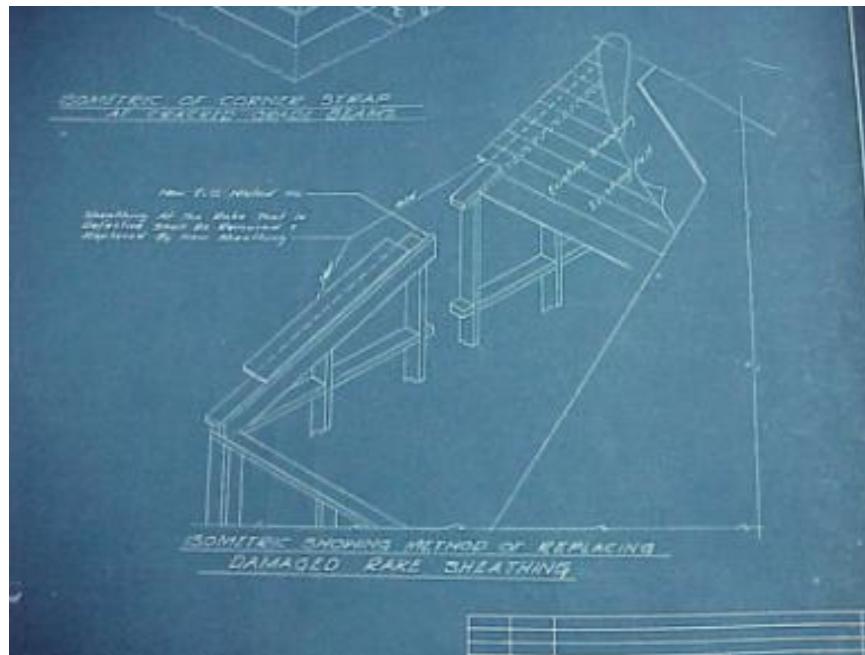
**Figure 21      1942 Isometric Drawing A**

Figures 21 through 36 depict rare blueprint drawings and, for comparison, photos of some of the buildings shown in the drawings. Figures 21 and 22 are typical elevation drawings. Figure 23 is a drawing of the chapel. Figures 24 and 25 show the interior and exterior of the chapel in 1957. Figures 26 and 27 show two views of the chapel as it looked in 2013. Figures 28 through 34 are more blue line drawings. These drawings are especially rare because they dated 1942. Unfortunately, these building no longer exist.

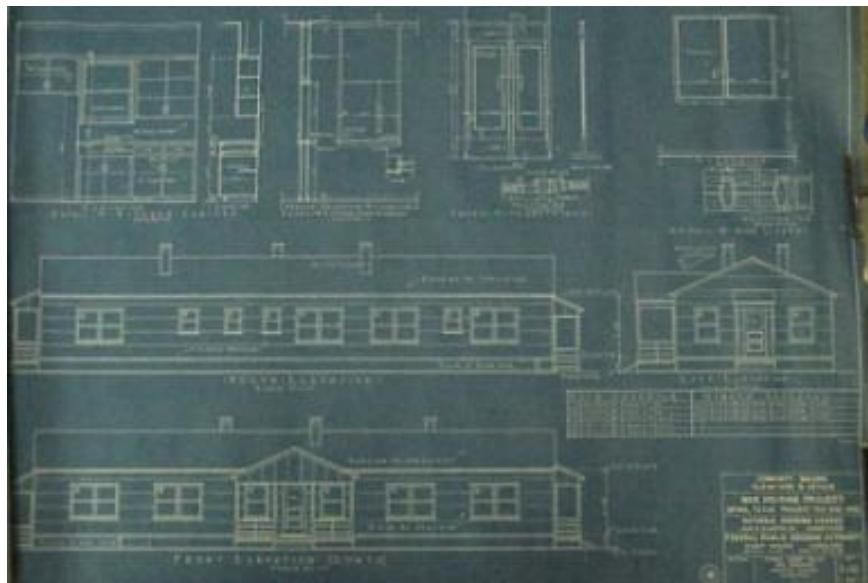
The drawings in Figures 35 through 38 are dated 1943. Of special note are Figures 36, 37, and 38, which are line drawings from the Wherry housing project. Figure 39 depicts a typical Wherry housing duplex in 2013.

**Figure 36**      1943 Wherry Housing Elevations

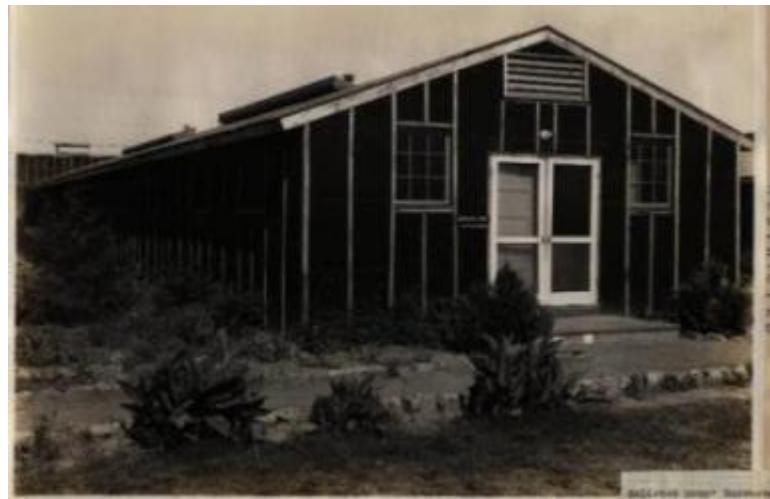
**Figure 40      Enlisted Men's Barracks**

Figures 40 through 44 are photographs of some of the buildings shown in the blue line drawings. However, these photographs are from the 1950s, and in some cases, these buildings had already had some upgrades performed or been adapted for slightly different use.

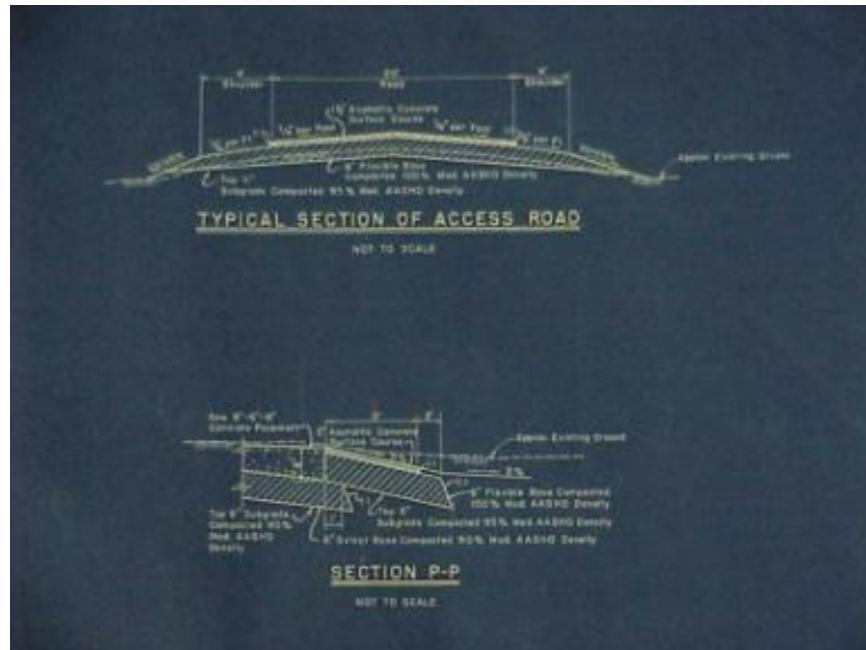
**Figure 52      1954 Runway Resurfacing Drawing A**

Additional blueprint contract drawings were found that depicted the airfield construction details. Several are shown in the next section. The quality of the prints was remarkable and they were likely left undisturbed in the flat files for many years. These drawings should be carefully preserved because they are rare original drawings. Blue line drawings that are more recent can be seen in Figures 52 and 53. Figure 54 is several years older. Figures 55 and 56 are blue line prints on linen paper that show the base configuration. Figures 57 through 61 are photographs of general-purpose buildings at Bryan AAB, as they existed in the mid-1950s. Figure 62 shows one of the remaining general-purpose buildings as it is in 2013.

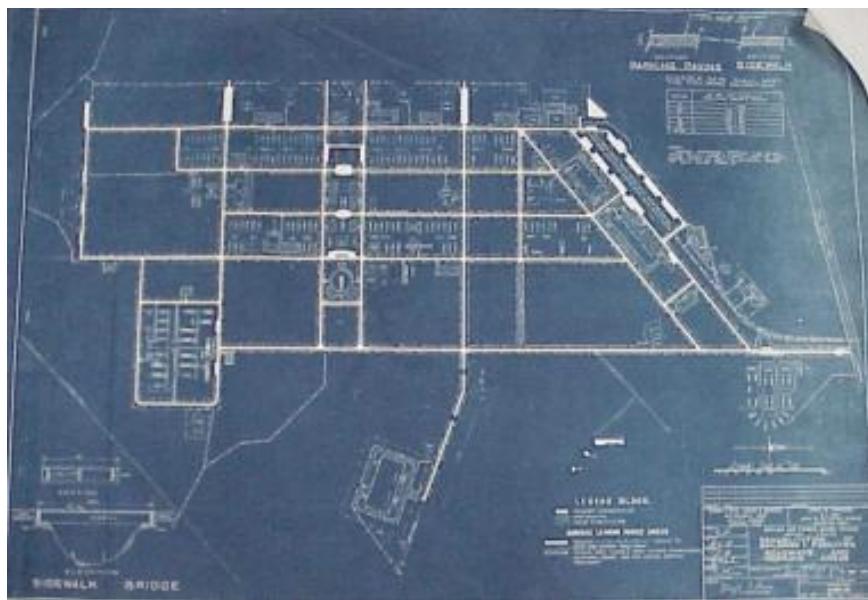
**Figure 54      1952 Road Pavements**

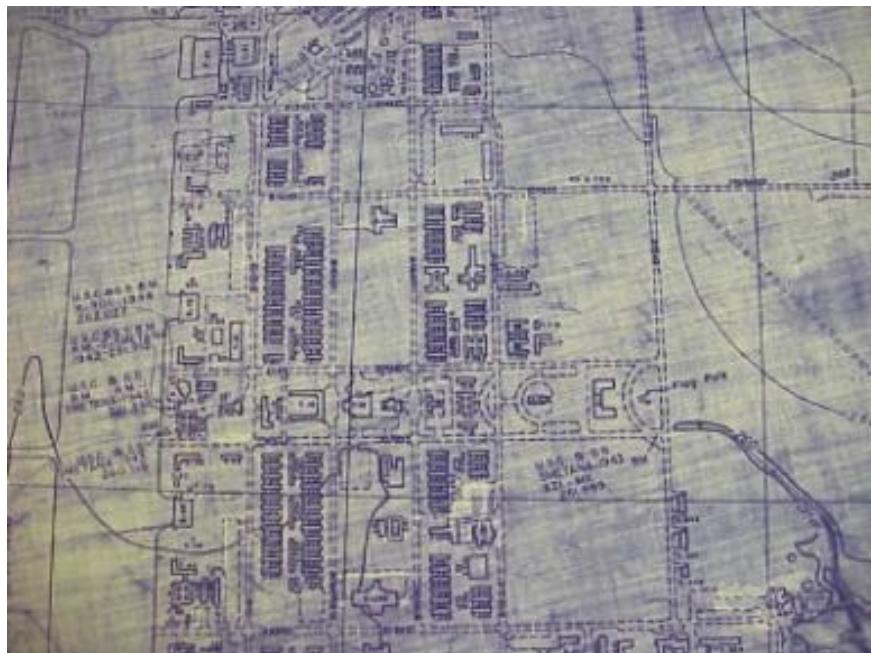
**Figure 55      1955 Master Plan Drawing A**

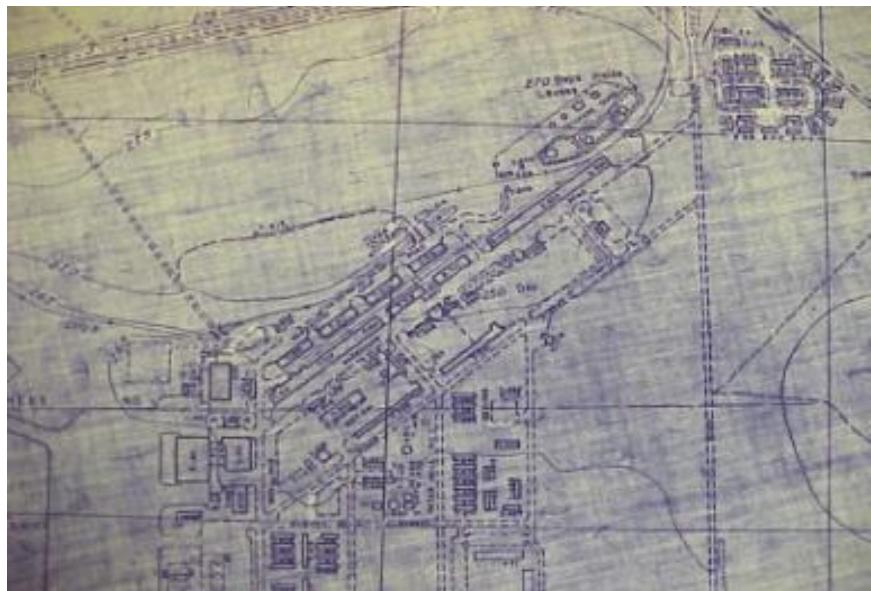
**Figure 56      1955 Master Plan Drawing B**

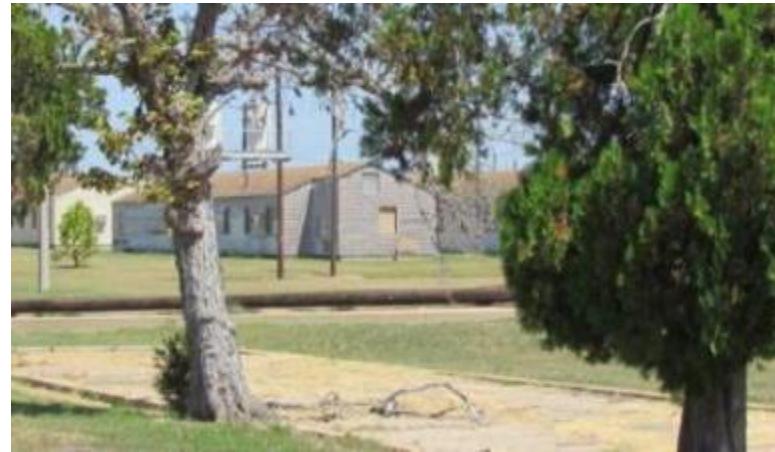
**Figure 62 2013 General Purpose Buildings**

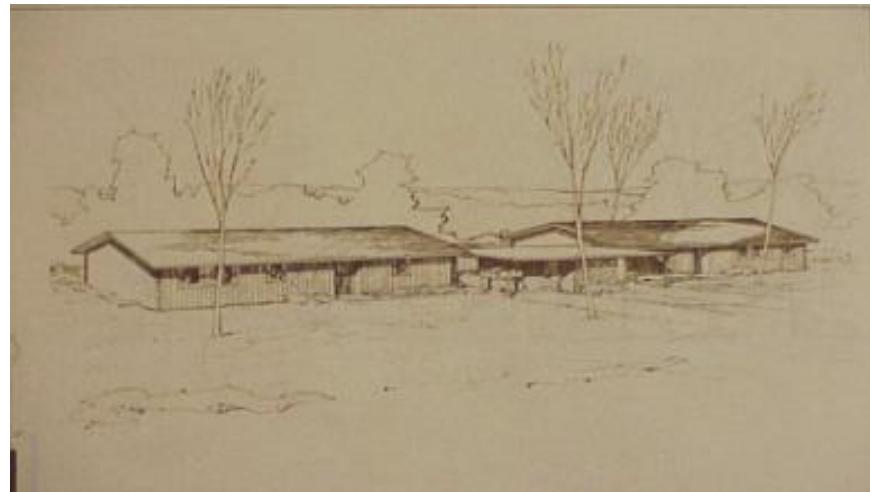
**Figure 63      1953 Duplex**

Lockwood, Andrews, Newman, and Associates made some very interesting drawings for the military housing at Bryan AAB (Figures 63, 64, 66, 67, and 69 - 75). These drawings were generic multi use drawings with the quantity of units and floor plans being selected as appropriate to the specific base requirements at the time of construction. Several of these plans are labeled for use at other bases as well and these types of homes were built at many bases across the state and the country. Figures 65 and 68 are current building photos as of 2013.

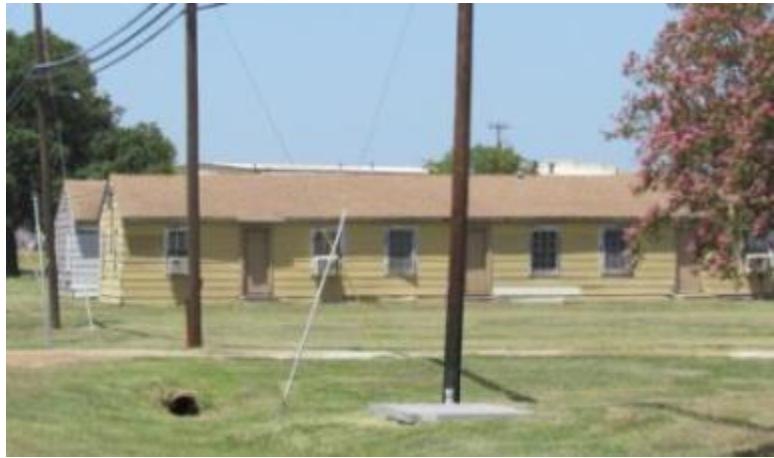
**Figure 76      African-American Barracks in 2013**

The two African-American barracks (Figures 75 and 76) suffered from years of neglect and were in danger of collapsing in 2012. The roofs on both buildings had caved in at the center due to long-term leakage. Professors Woodcock and Warden identified the historical significance of these buildings and successfully campaigned for their preservation to the TAMU facilities department. Although currently the buildings are unused, the roofs have been repaired and the exteriors patched. Without the hard work of Woodcock and Warden, these historic buildings would have been lost.

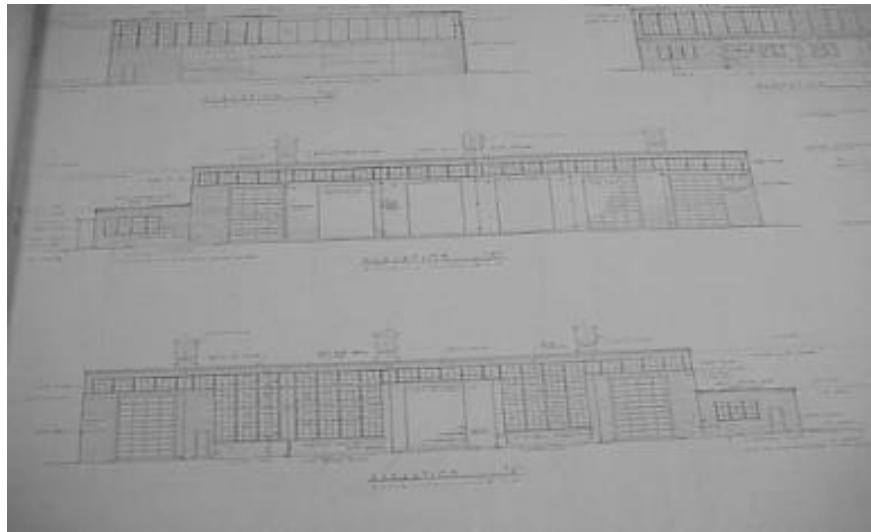
**Figure 77     1954 Hangar Elevation Drawing A**

Figures 77-83 are drawings and photos of major hangers at Bryan AAB that were discovered and cataloged. There are four large hangers still standing at the East Campus of TAMU (Bryan AAB). Two have been sensitively reconfigured by TEC (Figure 80) and TTI (Figure 81) to meet their requirements. Unfortunately, another large hanger was demolished in 2010 because weathering had caused it to become so badly deteriorated that it was no longer safe.

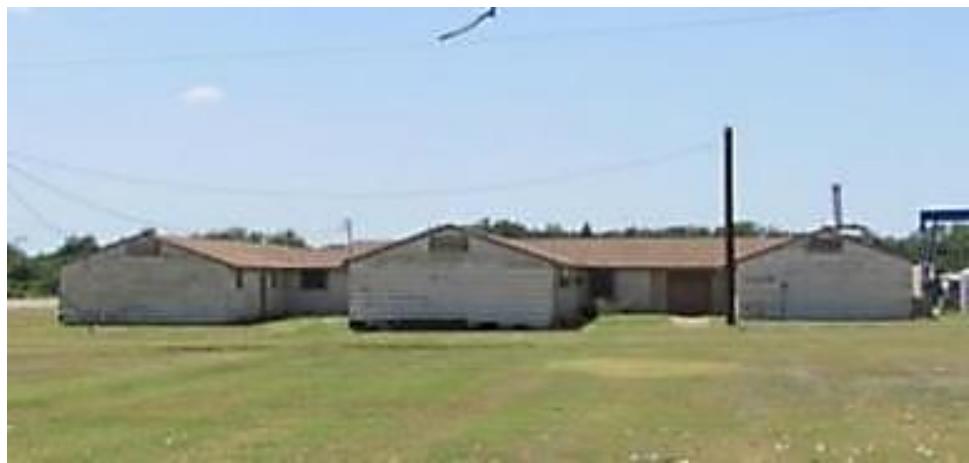
**Figure 93      Squadron Ops Building in 2013**

Figures 84 through 92 are copies of original photographs of Bryan AAB facilities taken in the 1950s. Figure 93 shows the current remaining squadron operations facility. Figure 94 shows the re-clad parachute shop in 2013. Bryan AAB was believed to be home to at least three squadrons at one point. This was verified by the discovery of three separate buildings listed on the inventory in the same year. In all likelihood, these buildings were the same design, barring minor interior changes made for specific unit needs. It was also customary for each unit to apply art to the walls reflecting the type of aircraft they were working with or the history of the unit utilizing the facility.

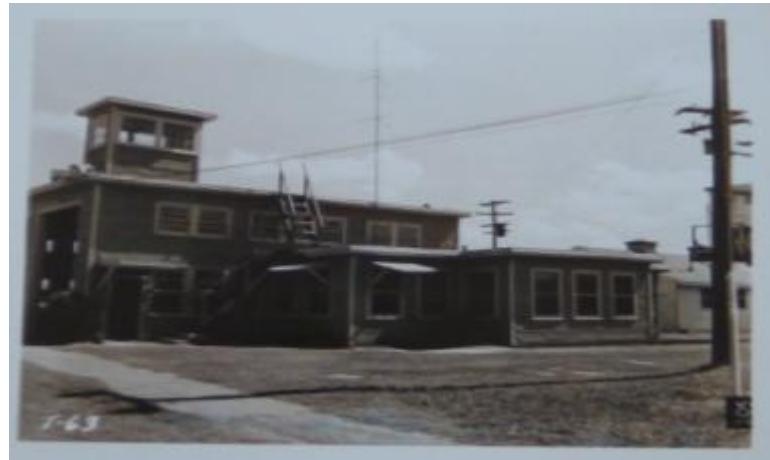
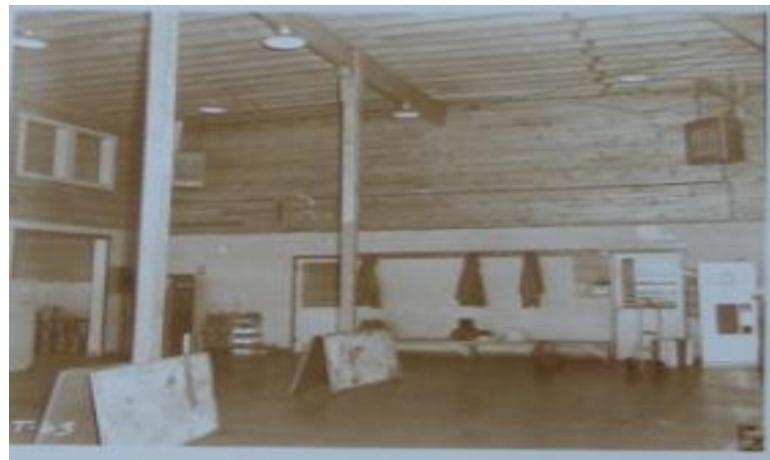
Figures 95 and 96 show the 1956 fire crash facility. Figure 97 is a rare blueprint of part of the building and shows some of the construction details used during the construction of the facility. Figure 98 is a reproduction of an original photograph of the fire crash building under construction. The crash fire station was considered an essential facility and was always built adjacent to the flight line as near to the center of the airfield as possible to minimize travel time to any potential aircraft disaster.

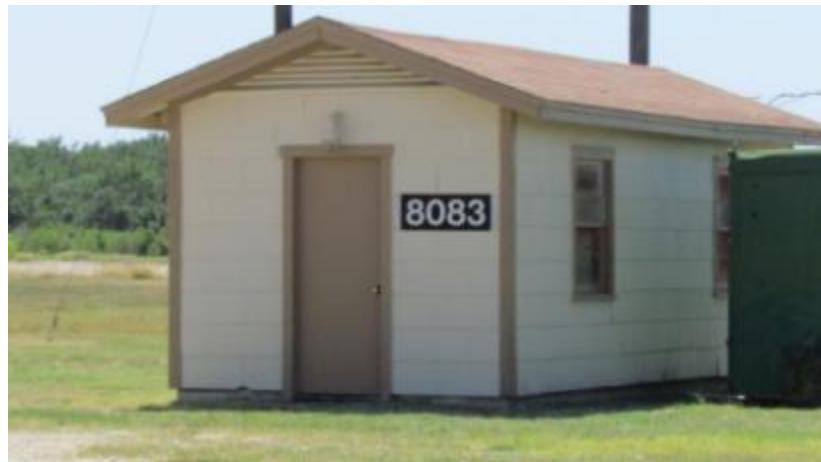
**Figure 104 2013 General Storage Building 8083**

Just as it is today, funding limitations during WWII determined which buildings could be built and who built them. At that time, the base commander could authorize small construction if the funds came from his operational budget. Consequently, there were many small buildings such as general usage storage and office spaces built on

bases. Building 8083 is typical of this type of construction (Figure 104). These smaller buildings had a tendency to proliferate as the needs of the base and the population grew. They were simple, readily funded, and usually not taken care of very well. They slowly disappeared from base inventory after falling into disrepair or being torn down to make way for larger facilities, such as the mess halls shown in Figures 105, 106, and 107.

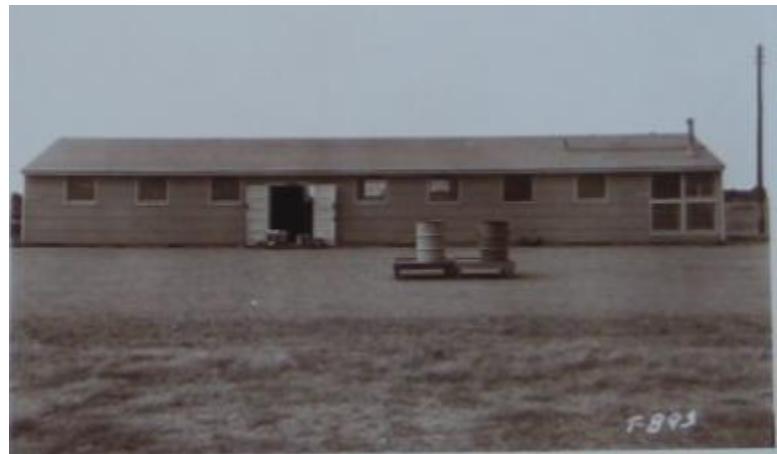
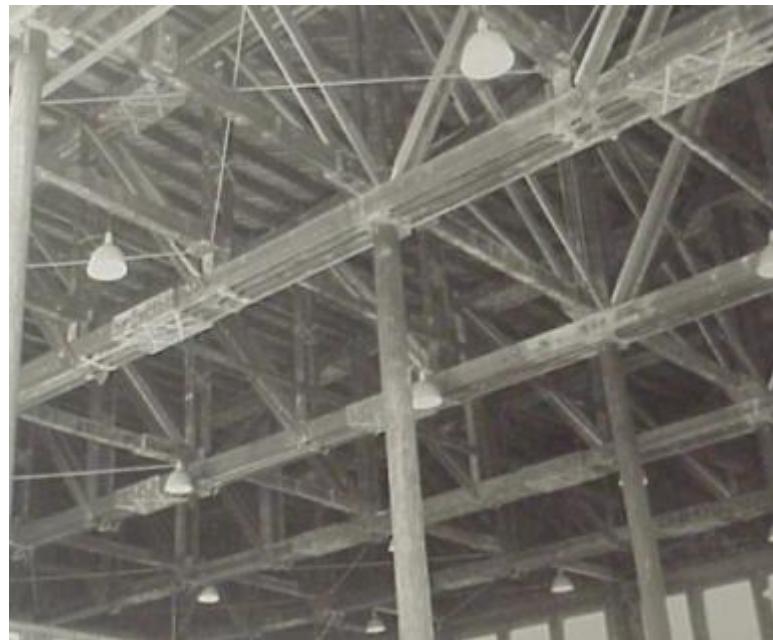
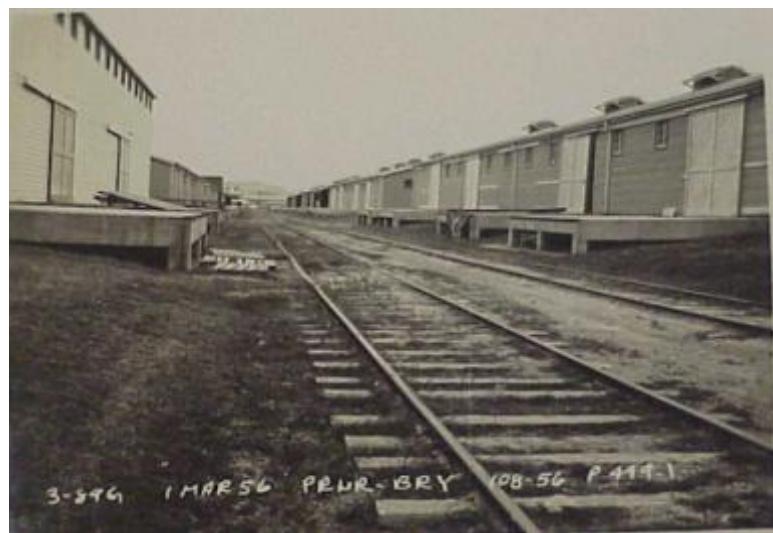
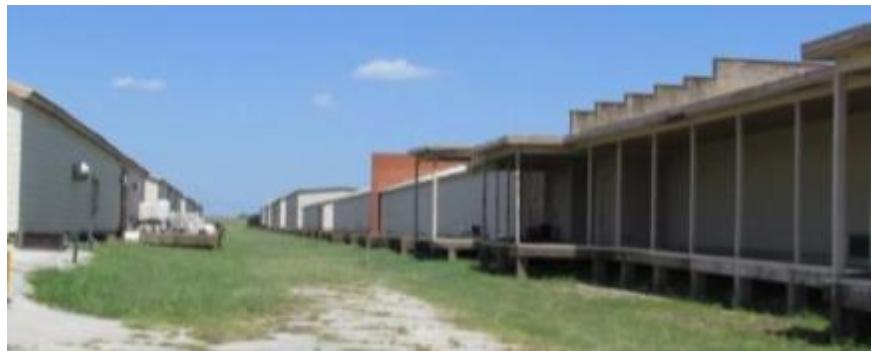
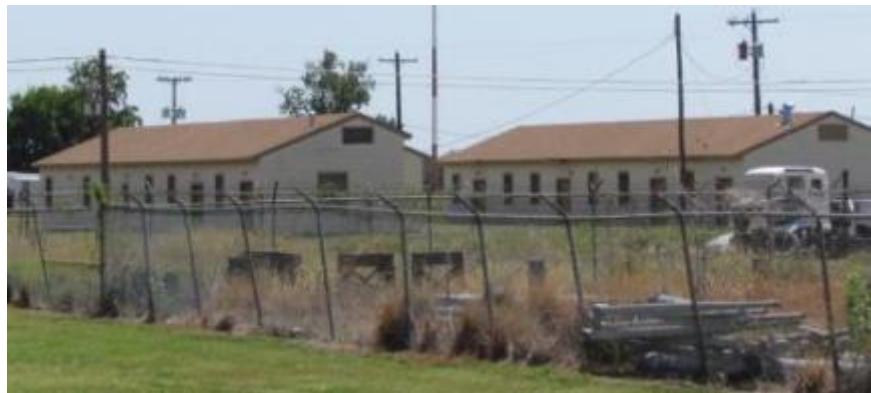
The general warehouses are still used today for storage (Figures 108 through 113). The MEP systems have been upgraded and general maintenance and repairs are made as needed. Some of the railroad tracks and the pavement still exist under the grass. Figures 114 through 117 are drawings and photographs of the water tower, which is still in use at the Riverside Campus.

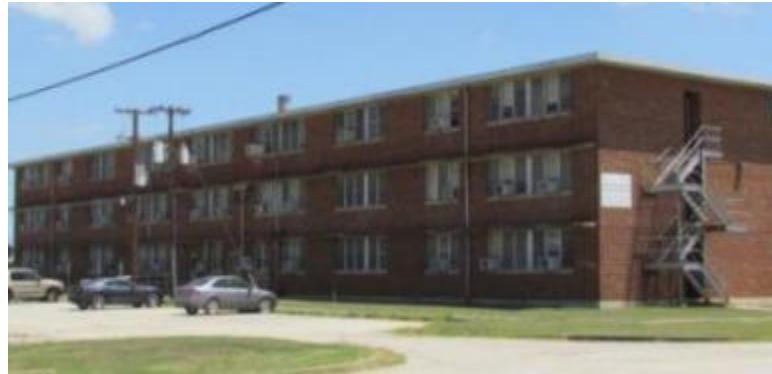
**Figure 122 2013 Dorms Converted to Office Space**

All of the brick dorms built in the 1960s are still on site, but have been adapted for use as office space. Significant changes were made to the configuration of the interior walls. However, the exterior of the building remains the same, minus the original signage. As seen in Figure 122, window unit air conditioners are still installed in the building, which indicates that the MEP equipment at the facility has not been upgraded to central air conditioning.

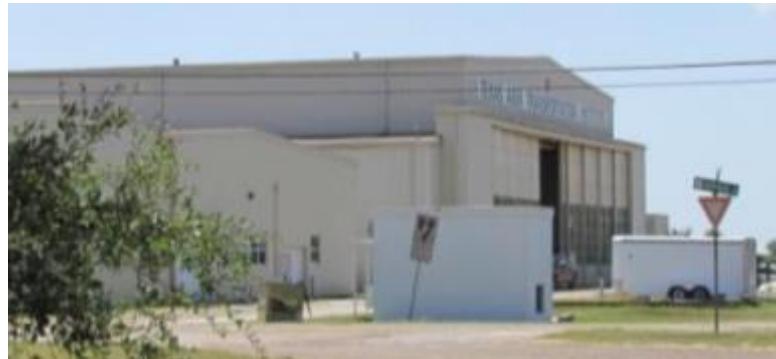
**Figure 123**    TTI Hanger in 2013

When the Texas Transportation Institute renovation of the hangar was planned, the original genotype architectural character of the building was carefully considered (Figures 123/126). The architects are to be complemented on the care they took with the renovation as it clearly shows respect for WWII history and the cityscape of the base. For example, they replicated the elevation of the original hangar doors even though they no longer serve this function.

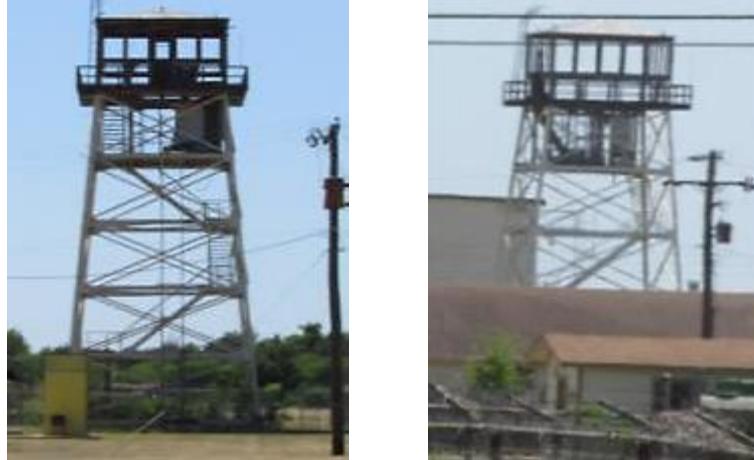
**Figure 127 2013 Air Traffic Control Tower**

There are also several other structures located at the Riverside Campus that are worth considering for preservation. The air traffic control tower was slated for demolition in 2011. Once again, the timely intervention of Professor Woodcock halted the demolition. Although the exterior skin was removed and the cab interior demolished, the structure itself remains. Ironically, it is closer to the original tower construction now than it was before the demolition started (see Figure 127).

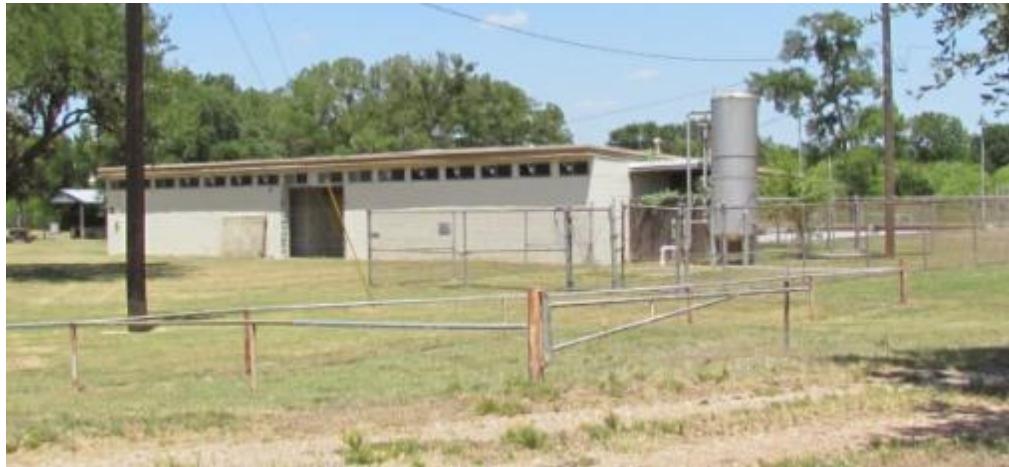
**Figure 128 Swimming Pool Area in 2013**

Both the swimming pool and POV fuel station remain on site (Figures 128 and 129), although the pool has remained empty for years. The gas station was modified significantly for use as a storage building and the gasoline pumps were removed. It should be noted that both facilities were originally paid for by Moral Welfare Recreation (MWR) funds and no tax dollars were used for the construction or maintenance of these facilities. They were considered important for unit moral but not funded by Congress.

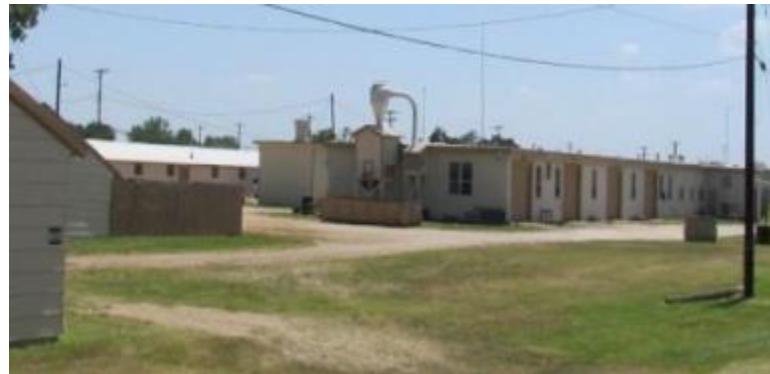
**Figure 130 2013 Civil Engineering Facilities**

The Civil Engineer Shop buildings (Figures 130-132) were utilized by the DOD to provide all the building maintenance and construction planning services for the base. These facilities are still used today for maintenance and storage functions. Although they need minor repairs, most are in good condition and are usable.

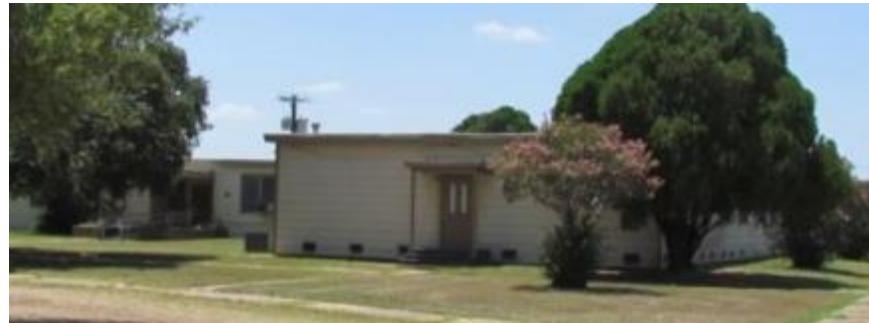
**Figure 133    Headquarters Building 8007 in 2013**

The original Bryan AAB headquarters building is also still on site (Figure 133).

Undoubtedly, it has changed significantly over the course of its existence. As the base population grew, additional space was needed for administrative personnel. Buildings were usually enlarged by building additional wings and or infill spaces in a C-, I-, or H-shaped floor plan. Military regulations permitted maintenance and operations funds to be utilized for limited construction as long as the value of the building was not increased by more than 50%. The original drawings for this building could not be located, but it is likely that it started with a linear floor plan and additional wings were added as needed.

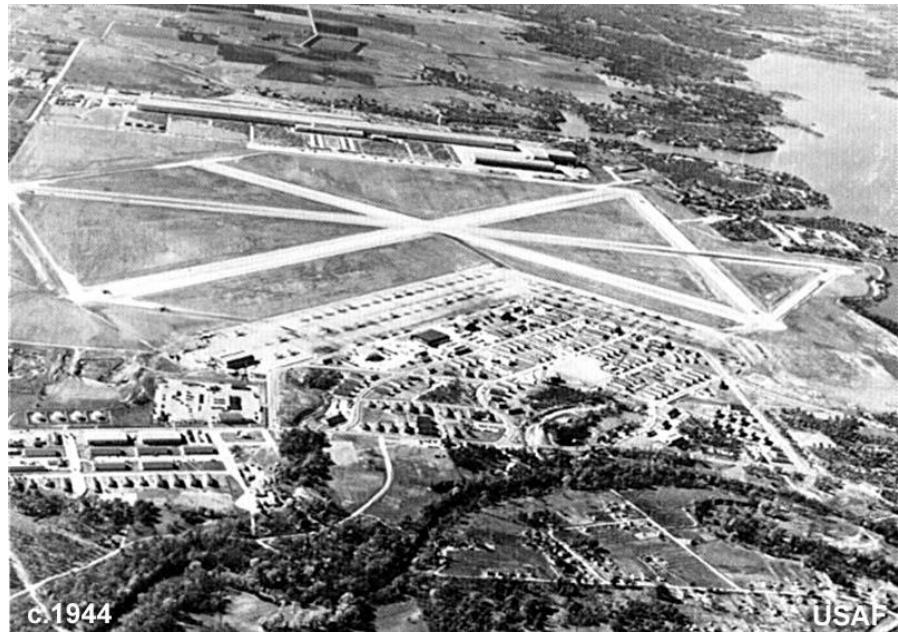
**Figure 137 1944 Fort Worth AAF Built Up Area (Brooks 2011)**

The configuration of the Fort Worth and Carswell AAF runways, ramps, and taxiways remained virtually the same until 1985. One can see from Figures 136 and 137 that much of the star configuration of the runways is still visible. However, changes in the aircraft utilized at the base, including increasingly powerful engines, a need for longer runways, and the reliance on prevailing winds for launch and recovery resulted in the cross-runways and perimeter taxiways becoming less and less useful. Consequently, they were either converted to ramp space for aircraft parking or taxiways to connect the active runways, or removed all together. (THP 2011) In the case of Carswell AAF, two runways were actually lengthened to accommodate the B-36, B-52 and KC-135 (heavy) aircraft stationed there just before the end of the 20th century. Figure 138 shows an aerial view of the airfield.

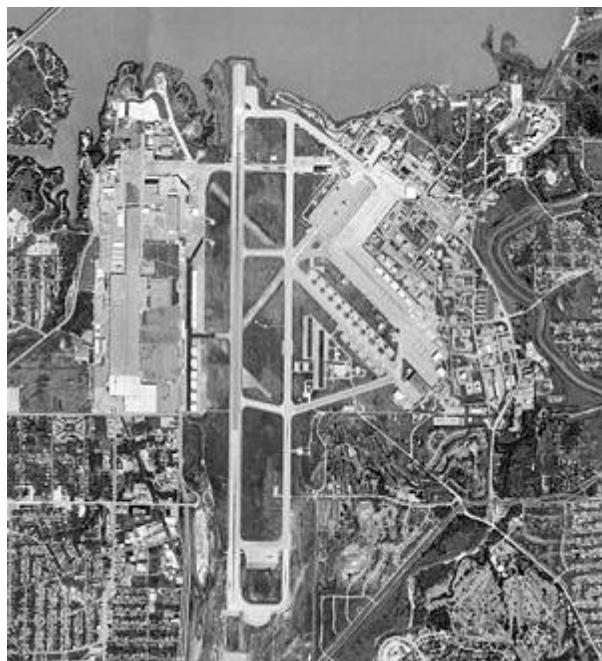
**Figure 141** Carswell AFB 1995 (Window on State Government 2014)

Carswell AFB is now Fort Worth NAS JRB Carswell. It has concrete runways running 7300x150(N/S), 5644x150(NE/SW), 4000x150(E/W), and 7000x150(NW/SE) and is 6.25 miles WNW of Fort Worth, Texas. Additional statistics are given in Figure 139. Figure 140 is a schematic of the base and Figure 141 is an aerial view.

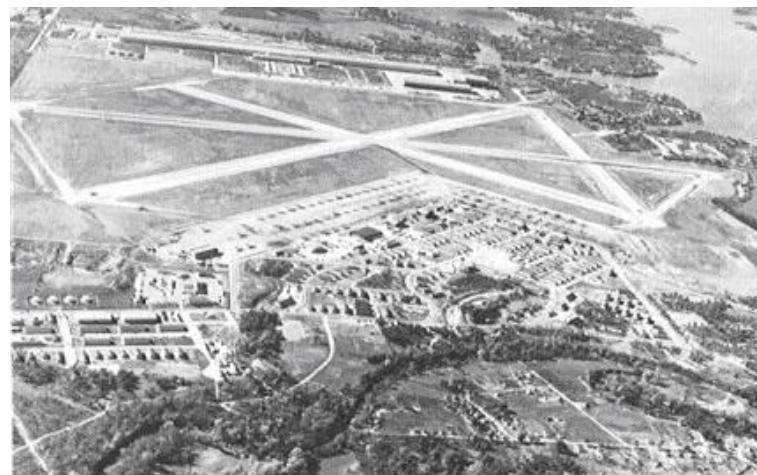
**Figure 143 1945 Photo of Fort Worth AAF (Wikipedia 2011g)**

B-24s at the base. In 1945, the mission was changed again to B-29 aircraft training. (Shaw 2004) Figure 143 shows the 1945 layout of Carswell Field. Figure 144 shows a B-29 bomber, Figure 145 is of a B-36, and Figure 146 shows a Mark 17 30 KT atomic bomb casing. All these weapon systems were stationed at Carswell AFB. To indicate a sense of scale of the bomb, the brick sign in front of it is five feet tall.

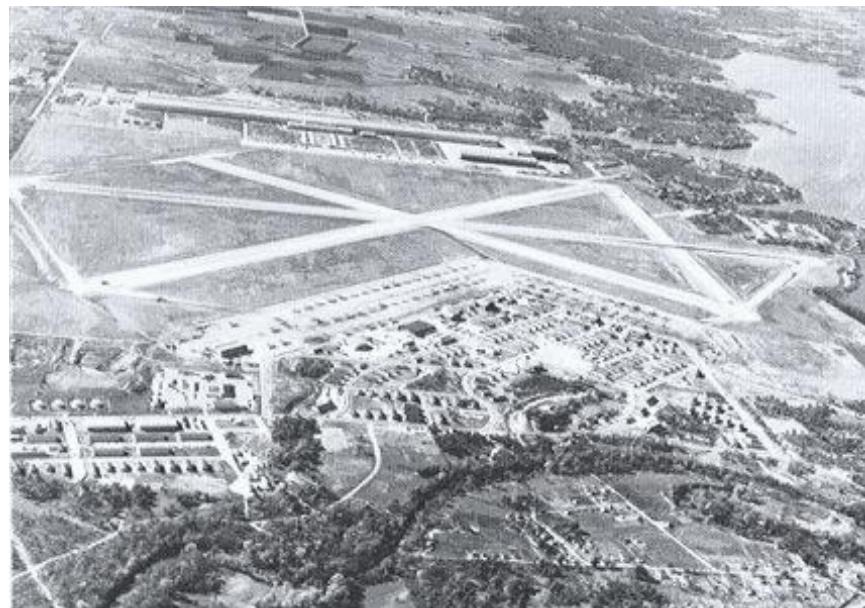
**Figure 156 1945 Carswell AFB (Hankins 2009, 11)**

Throughout Carswell's history, several mission changes occurred that required significant changes in the types of buildings located on the base, as well as the reconfiguration of existing buildings. Yet a dozen WWII buildings remain. Most have been significantly modified, but several warehouses, office buildings, training buildings, aircraft shops, and hangers still serve the same basic functions for which they were originally designed. However, because of these many changes, Carswell AFB no longer looks as it did in 1945 (see Figure 156).

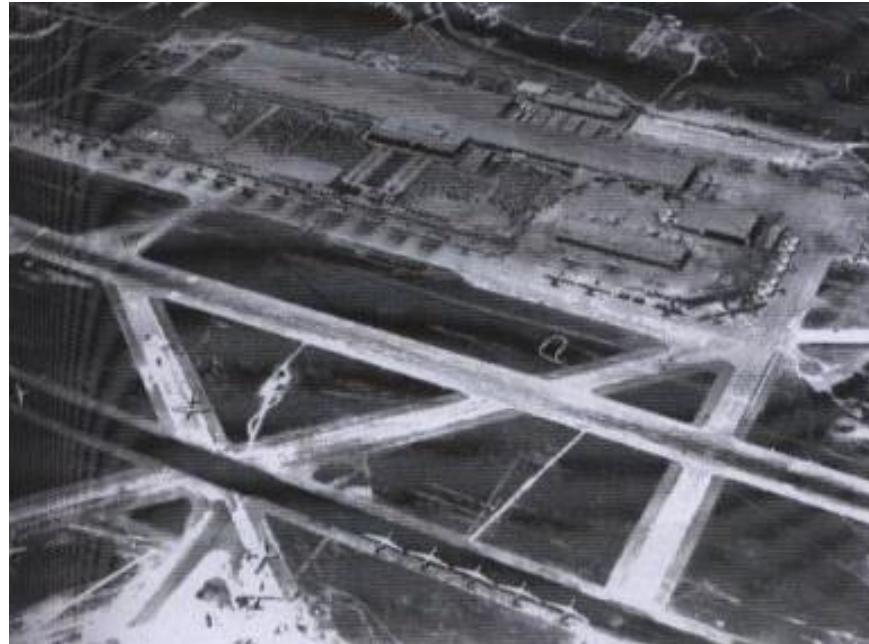
**Figure 157    1947 Flight Line (Hankins 2009, 11)**

Figure 157 is a photo of the Lockheed aircraft manufacturing plant and adjacent parking apron and parallel runways from 1947. B-36 aircraft can be seen at the center bottom portion of the photograph. One can see from Figure 157 that additional cross taxiways and parallel landing strips had already been added at this time.

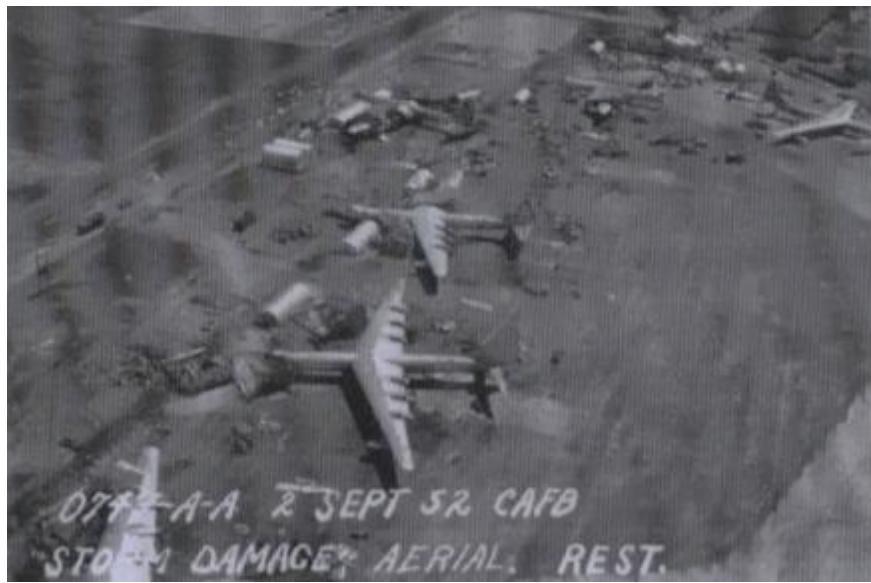
**Figure 159** 1952 Flight Line with B-36 Bombers (Hankins 2009, 151)

The photo in Figure 159, taken in September 1952, shows 7th and 11th Air Force bombers along the flight line, right after a tornado crossed nearby. Support equipment is scattered across the apron. To get a sense of scale, look at the tail of the bomber in the center. The black smudge directly behind it is a full size pickup truck. The aircraft in Figure 159 are B-36 Peacemakers. (More photos of the tornado damage may be found at <http://www.cowtown.net/proweb/tornado/tornado.htm>.) Figure 160 shows a B-52 heavy bomber, which ultimately replaced the B-36 and B-58 aircraft as the mainstay of the Strategic Air Command.

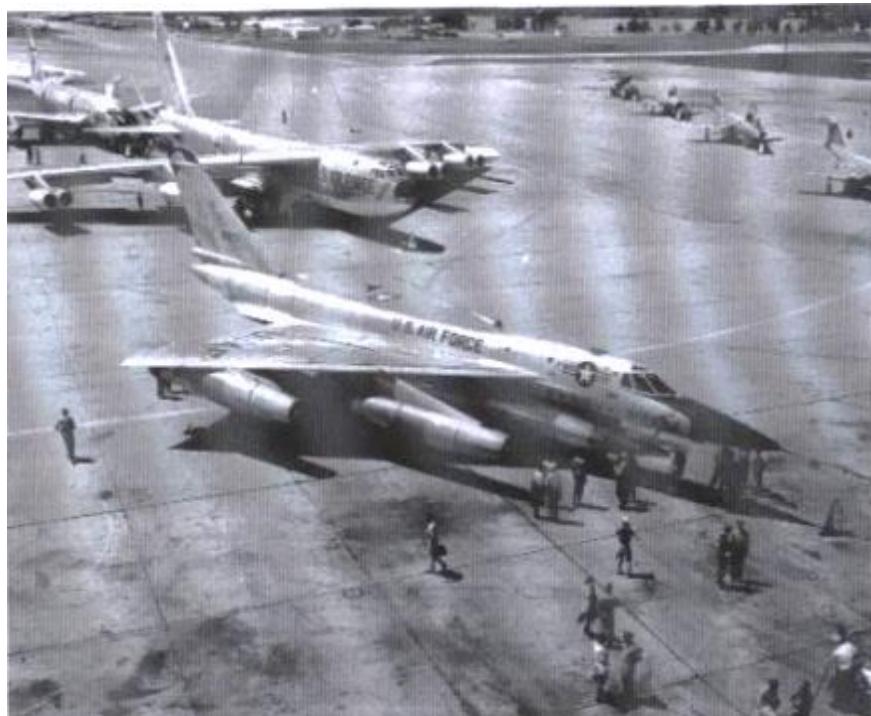
**Figure 160** 1958 Flight Line (Hankins 2009, 108)

The year 1958 was a time of transition at Carswell. At the back of the line in Figure 160 is a KC-135 fuel tanker, with a B-52 Bomber in front of it. A B-58 medium bomber is first in line. There are three F-101 Voodoo fighters at the top right of the picture. The transition from one aircraft platform to another necessitated a multitude of interior changes to buildings including the construction of several larger facilities as well as reconfiguration of ramps and runways.

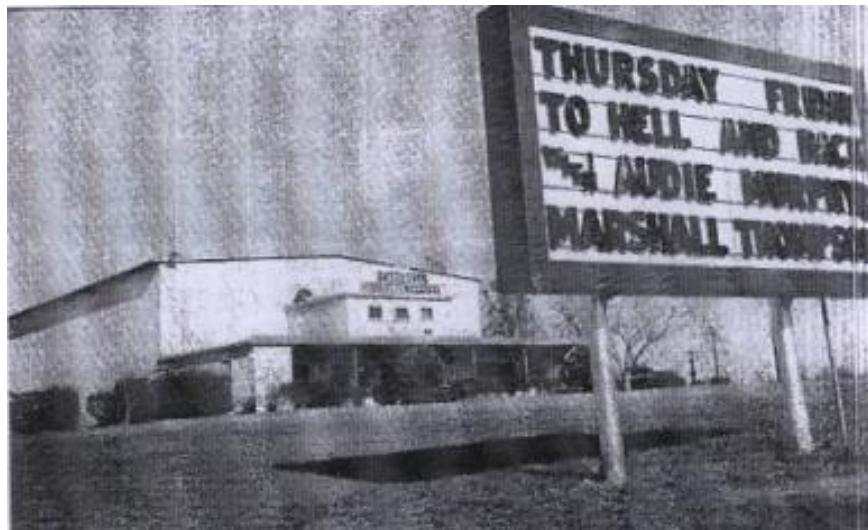
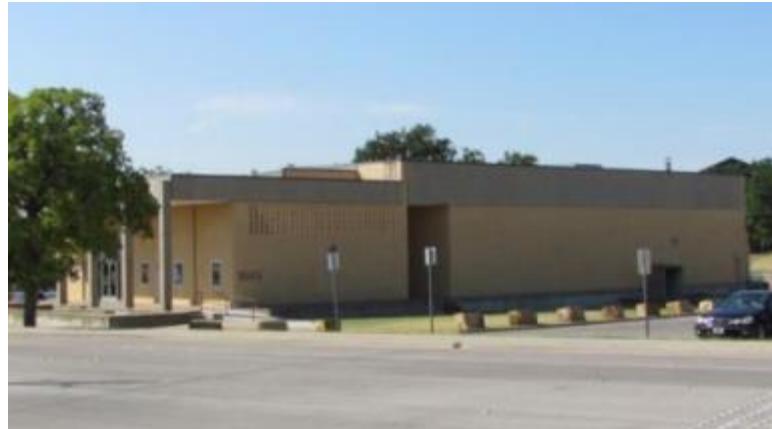
The original base theater was built with wood framing. It had asbestos shingle siding, gypsum rock walls, minimal HVAC, minimum insulation, austere finishes, and a sloped concrete floor. It was refurbished in 1957 and again in 1980. No drawings remain of the original building. However, the floor plan follows the standard floor plan designs used during WWII. Figures 162 through 164 show the theater as it looked in 1942, 1957, and in 2013. It can be seen from the photographs that the base theater/assembly hall has changed little since the 1960s. The DOD upgrades mechanical systems when the equipment wears out, and audio and projection systems are updated as needed. The theater's exterior was replaced with modular brick in the 1960s and the roof has been changed a number of times. However, the building still has the original WWII floor plan and designed genotype uses. The author was stationed at Carswell from 1992 to 2004 and had the opportunity to use the building frequently.

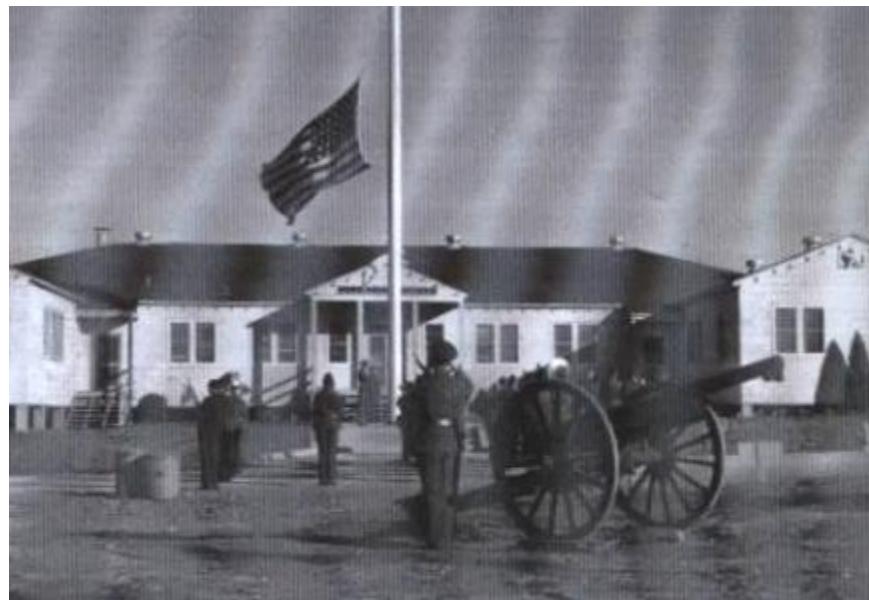
**Figure 165 1943 Headquarters Building (Hankins 2009, 55)**

The 1943 base headquarters building no longer exists (Figure 165). This building had a typical wooden frame, wood sash windows, asphalt shingle roof, and raised floor on two concrete blocks and did not weather the changes of missions. As the base transitioned from airframe to airframe and missions shifted, the size and space requirements of the headquarters building varied significantly. Figure 166 shows the

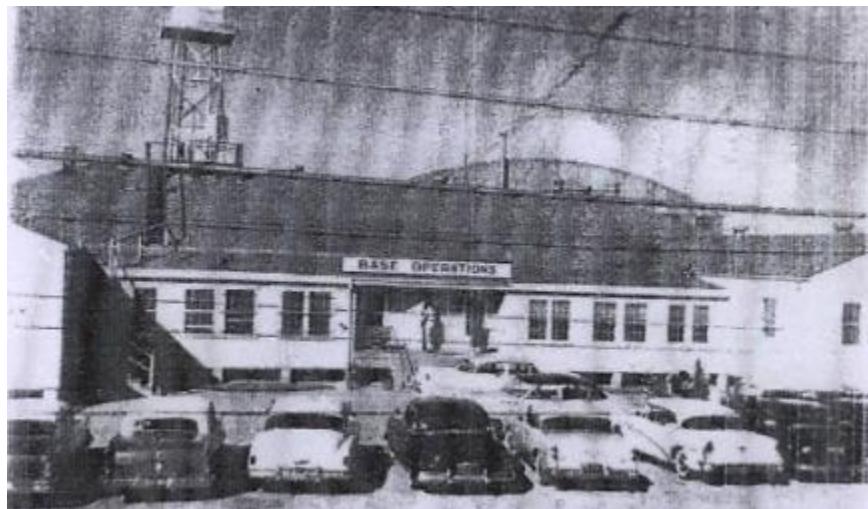
**Figure 166 1948 Base Operations Facility (Hankins 2009, 45)**

base operations facility in 1948, with some changes to the front of the building already evident. The current headquarters building retains the shape of the center portion of the 1943 headquarters building and serves similar management functions today. The exterior was modified so maintenance costs could be reduced. The original wood battens are likely still in place, but it has been re-clad with synthetic stucco, hard board insulation, and a standing seam metal roof. Security concerns prevented the author from taking any photographs of this building.

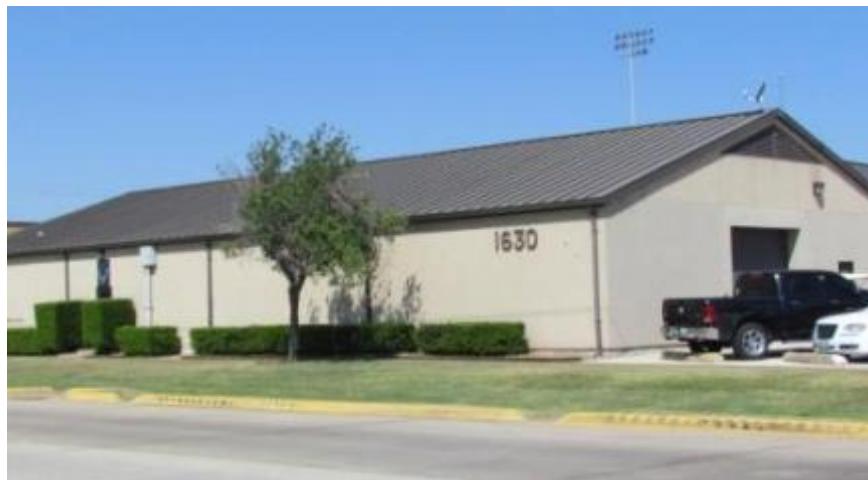
**Figure 167 Fighter Squadron Operations Building 1630**

According to base records, building 1630 (Figure 167), which is used currently as a Squadron Operations building, was built in 1945. Because of its location near the flight line, it is unlikely that it was ever used as the base headquarters. However, it is still used for flight line functions similar to its original purpose. The May 1969 elevation

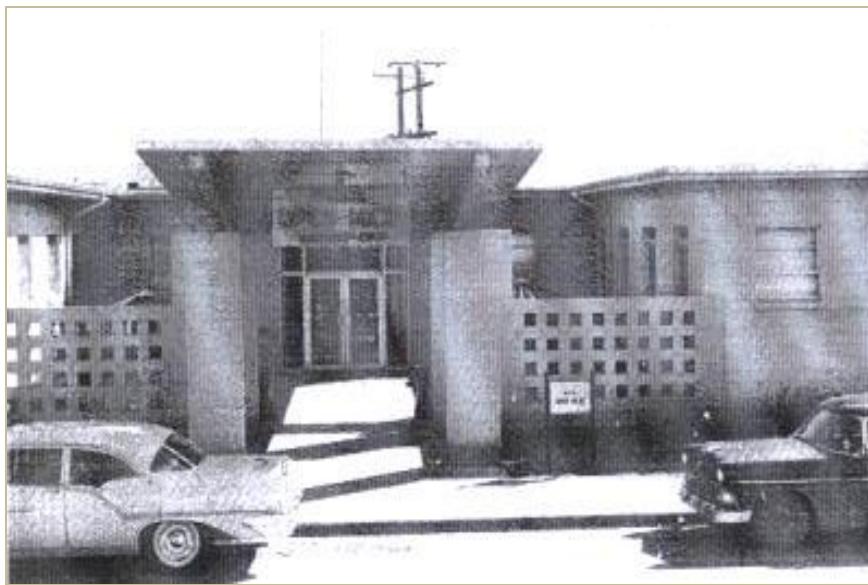
**Figure 171 1956 NCO Club (Hankins 2009, 50)**

The NCO Club building was built in 1956 (Figures 171 and 172). Comparing the second photo to the first reveals that the exterior configuration of the building remains pretty much the same. Today, Building 2570 serves as the consolidated Officers and NCO Club. The current floor plan shows splits at the canopy entry with the NCO entrance to the right and Officers to the left. The two share a common dining room and kitchen. This occurred after BRAC actions recommended the Officers Club be sold to the civilian sector. It was eventually torn down and replaced with apartments. Records on this building were not available during the site survey. However, the author was told by the current Navy resident engineer that his records indicated this particular building was built in the 1950s as a wood frame stucco building with a bitumen and gravel roof. The building was built and supported by user fees and profits from the previous clubs' operations.

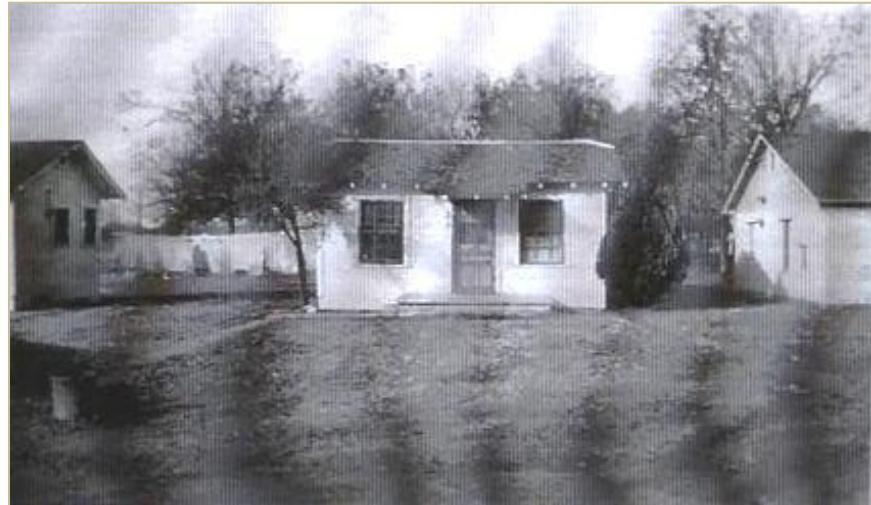
**Figure 173 1953 Enlisted Housing (Hankins 2009, 53)**

In 1953, the enlisted housing facilities provided for our service men were very small (Figure 173). Under the Wherry Act that changed substantially. The act was extended several times and designs improved greatly over time. The older buildings were eventually replaced with larger units. Slightly over half of these were sold to private homeowners and relocated off base following BRAC actions in 1991. At that time, 187 acres of housing were transferred to the Westworth Redevelopment Agency. (Allen 2007) The bulk of the Wherry housing bordered State Highway 183. Today the houses and duplexes have been replaced with three story apartments, strip retail centers, a Lowe's, and a Wal-Mart.
