**THE DEVELOPMENT OF A METHOD FOR THE IDENTIFICATION AND  
SELECTION OF PRESERVATION VALUES FOR THE PROTECTION OF  
WWII UNITED STATES ARMY AIRBASES IN TEXAS**

A Dissertation

MICHAEL ANTHONY BUNCH

December 2014

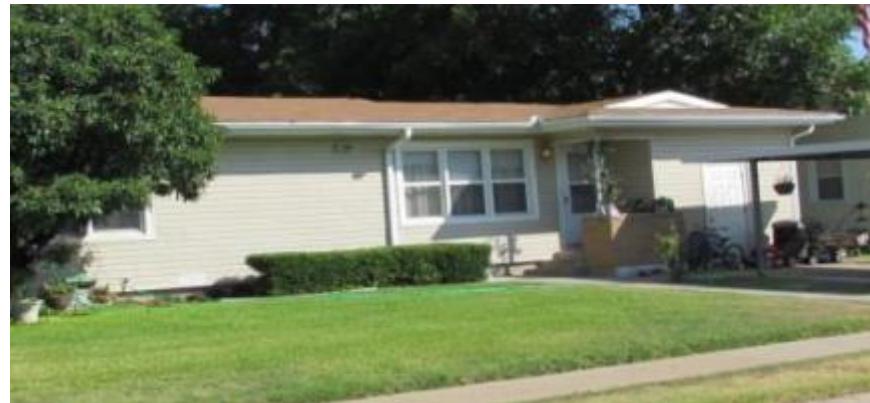
**Figure 174    Typical Wherry Housing in 2013**

main Wherry housing area, only a few homes reserved for senior officers remain, including three on Wasp Court, seven on Hornet Court, and four general grade houses on Captains Row. These were built near and on Lake Worth. Fifty-four buildings remain on Nimitz Drive and Phillips Circle. These are currently used by active duty navy personnel and almost half of these facilities are duplexes. The current state of these housing units is very good. They have been extensively remodeled from the original wood frame, cement stucco, or wooden siding configurations. Their mechanical systems have been upgraded, wooden windows replaced with energy efficient aluminum frame insulated glass, some masonry applied, and vinyl siding and new composite shingle roofs added. It is the trend in DOD to sell off these facilities because they are expensive to maintain as they are also labor intensive (Figure 174).

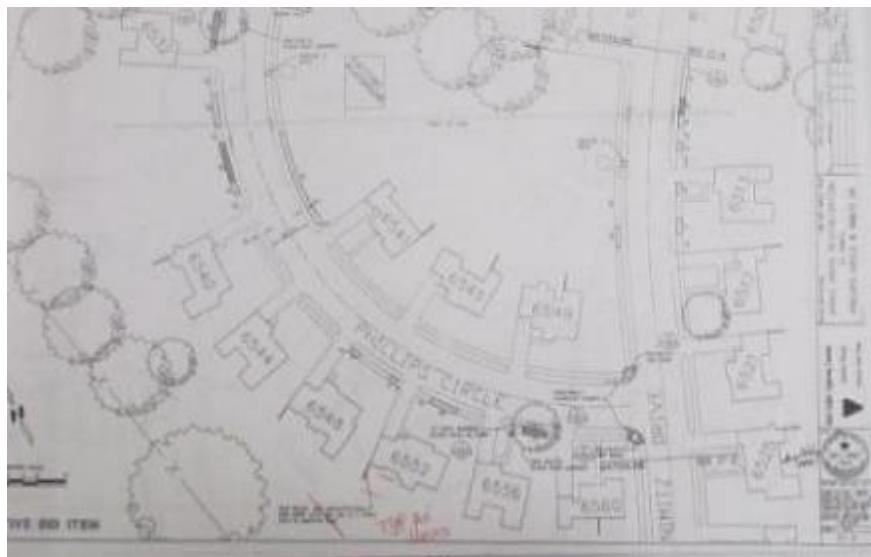
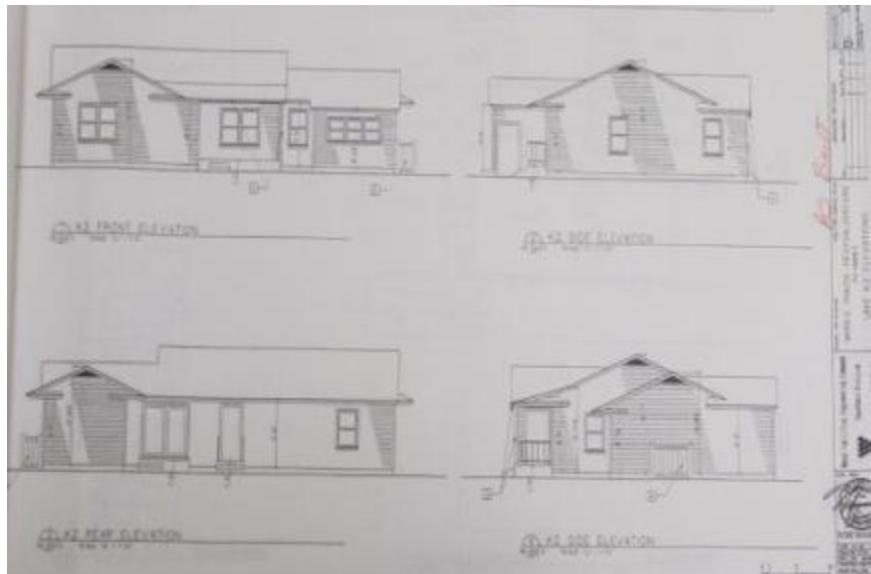
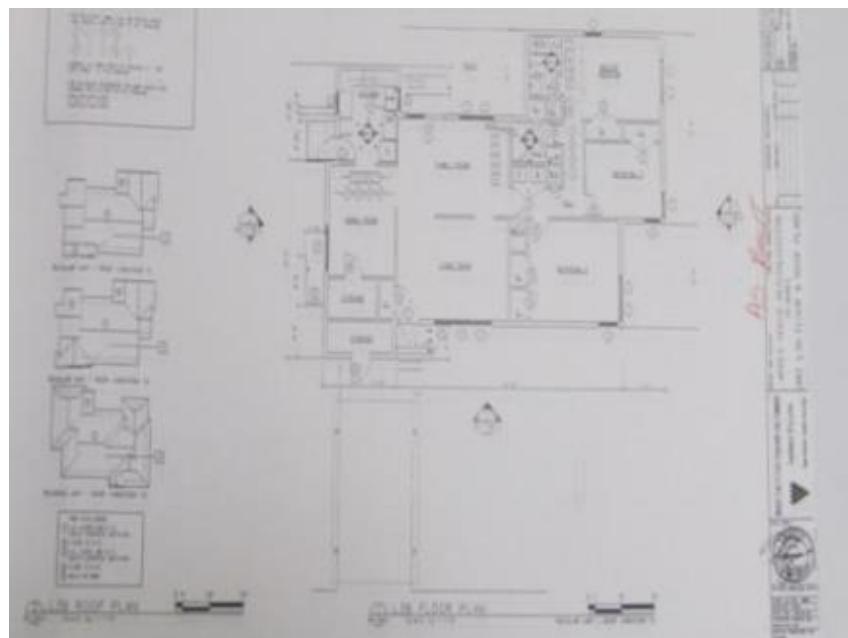
Figures 175-177 show the layout of some of the remaining housing on Phillips Circle. Yards are spacious and trees remain an excellent asset. These houses were built with several standardized floor plans much like those at Bryan AAB. The elevations and floor plans were repeated throughout the neighborhood. As seen in Figures 176-177, elevations have not changed a great deal. When regulations changed, homes were built and/or renovated to meet federally mandated minimum square footage as required by HUD and Title 10 legislation. Patrons were not permitted to make changes to the buildings or to change the colors or materials used on the exteriors. Strict military guidelines are in place for maintenance, which was initially the responsibility of the Base Civil Engineer. This responsibility shifted to civilian contractors, but the maintenance and fenestration change guidelines remain. Great care was taken to preserve trees and the residents are held to a high standard for maintenance of their lawns and gardens. As a result, the residents' environment is both well maintained and aesthetically pleasing.

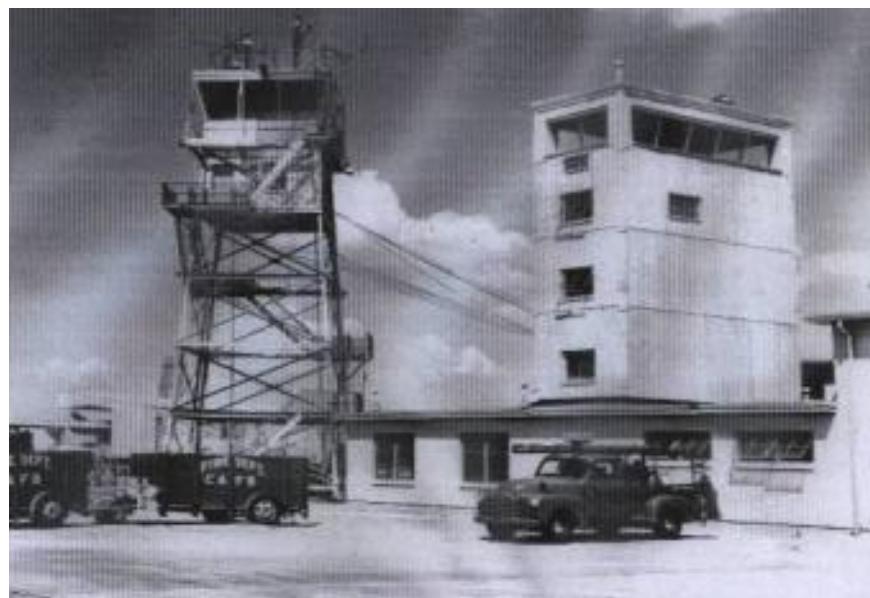
**Figure 178** Flight Tower and Fire Department in 1956

Figure 178 shows the flight tower and fire department in 1956. These are considered mission critical facilities. The fire station is located on the apron immediately adjacent to an active runway so equipment can move as quickly as possible to aid stricken aircraft if a mishap occurs. Because of this and security concerns dealing with the Global War on Terrorism, the researcher was not allowed to photograph the building from the flight line side.

The author was directly involved in the renovation of the fire station when he was stationed at Carswell AFB. The original configuration of the building is the same; changes were made only as needed to fenestration and MEP systems, as well as communications, radar, and aircraft control equipment. The corrugated metal tower in Figure 178 was the original flight line control tower, but was removed in the 1960s when the new concrete and steel air traffic control tower was built. One can see from the photograph that the metal clad tower on the right is the fire station's original control tower. It still exists but is no longer in use. However, the corrugated asbestos siding was replaced with synthetic stucco and the wooden windows with steel frame windows in the early 1990s. Presumably, the floor plan remains the same albeit with periodic changes to toilet fixtures and interior surfaces.

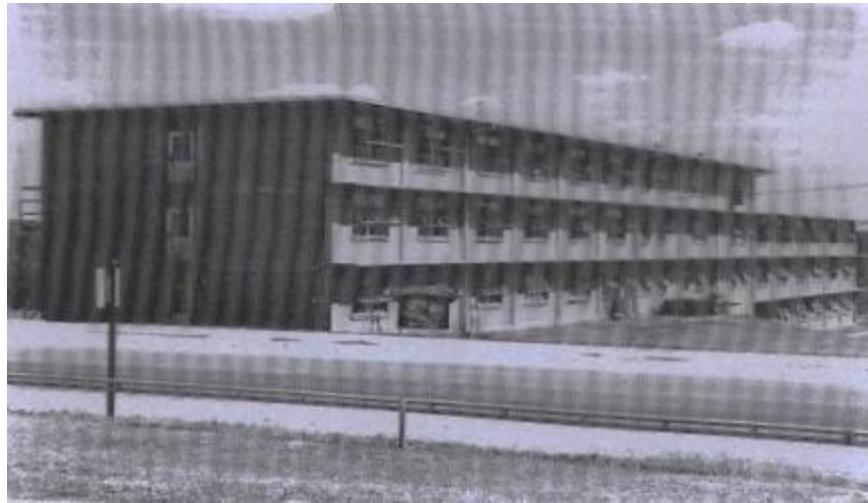
**Figure 179 1956 NCO Preparatory School (Hankins 2009, 12)**

The building in Figure 179 was used as the NCO Preparatory School and for the 824th Food Service Personnel Squadron in 1956. It remains on the site and is currently used for transit billeting. Although the exterior has not changed appreciably, the interior has been extensively upgraded several times because space allocation and aesthetic criteria regulations have changed. Having been billeted in this building as well as taking part in more than one renovation of it, the author can attest to the fact that upgrades were made about once every five to six years. With the passage of Title 10, requirements for billeting military personnel in these dormitory buildings underwent significant changes. They became one and two person rooms with shared toilet facilities. The original 1940s barracks with open bay bedding and gang showers were torn down and replaced with concrete frame and CMU construction.

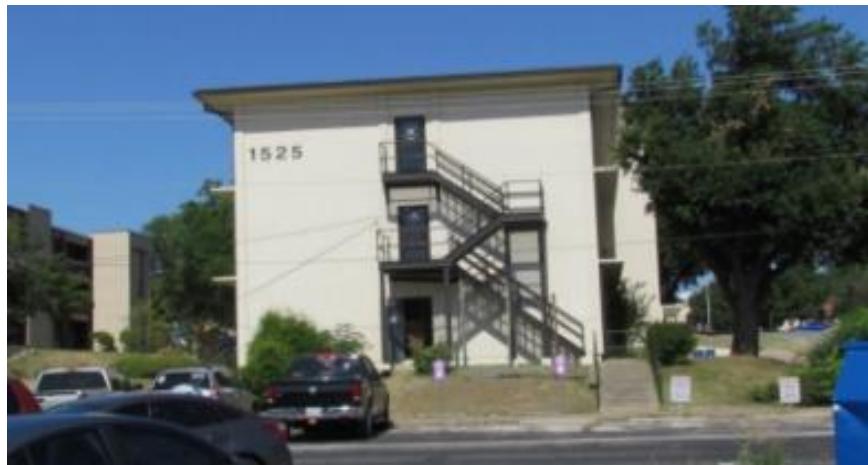
**Figure 180 2013 Dorm 1525**

Building 1525 has also changed significantly over the years (Figures 180 and 181). Exterior fenestration changes included replacement of wooden sash windows with aluminum frame energy efficient windows and the exterior received a coating of stucco over the CMU. MEP systems have been replaced as they wore out and Title 10 regulations required genotype reconfiguration of the interior. Looking at the end of

Building 1525 in Figures 180 and 181, one can see that all of the adjacent dorm facilities have been changed significantly to include exterior walks on all floors and enclosing stair towers to meet the new standards. These buildings are currently used for bachelor enlisted and transit personnel quarters.

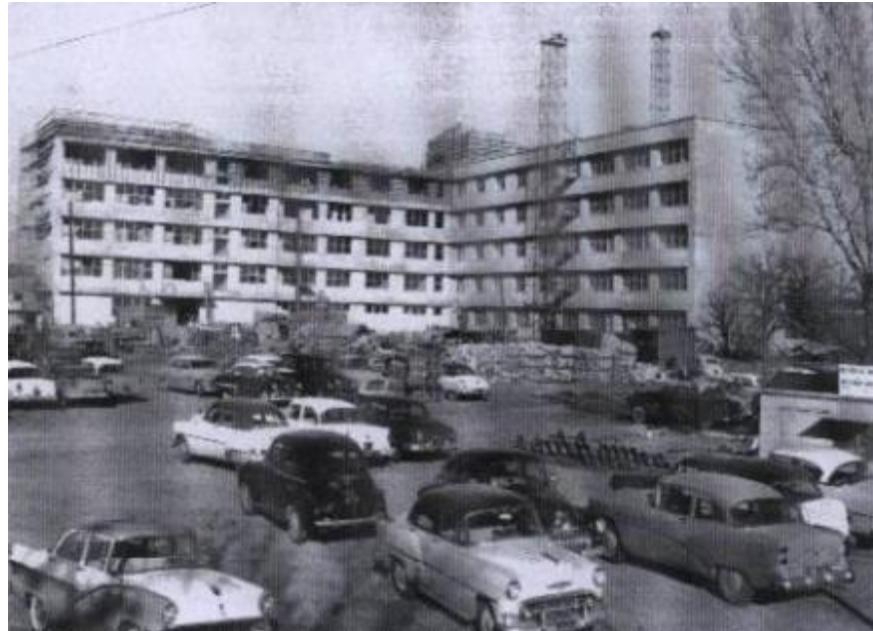
**Figure 182 1957 Base Hospital under Construction (Hankins 2009, 44)**

The base hospital (Figures 182 and 183) was built in 1957 as a major military regional hospital because the base population at the time included several thousand personnel. The construction consisted of a reinforced concrete frame with CMU infill and steel frame windows. The interior corridors were glazed tile and base with VAT flooring. The mission of the hospital changed significantly following BRAC recommendations. It is currently used as a female prison. Phenotype changes to the

interior reflect the current usage. However, the exterior remains much the same except for heavy galvanized wire mess screens and bars on windows. Because of its current function, the researcher was not permitted to photograph the building. The site foliage obscured the building from the road, which prohibited peripheral photography.

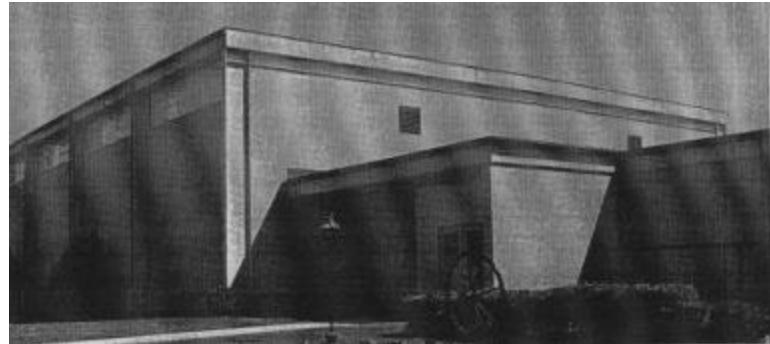
**Figure 188 1968 Physical Fitness Facility (Hankins 2009, 36)**

The physical fitness facility (Figures 188 and 189) is still used for the same genotype function for which it was designed with only minor revisions and upgrades. The floor plan remains unchanged from its original design. The shower areas have been refurbished and the exterior concrete frame painted several times. The weight rooms and gymnasium are still used by base personnel daily. The gym with its folding bleachers and high quality, maple basketball court are in continual use and good condition.

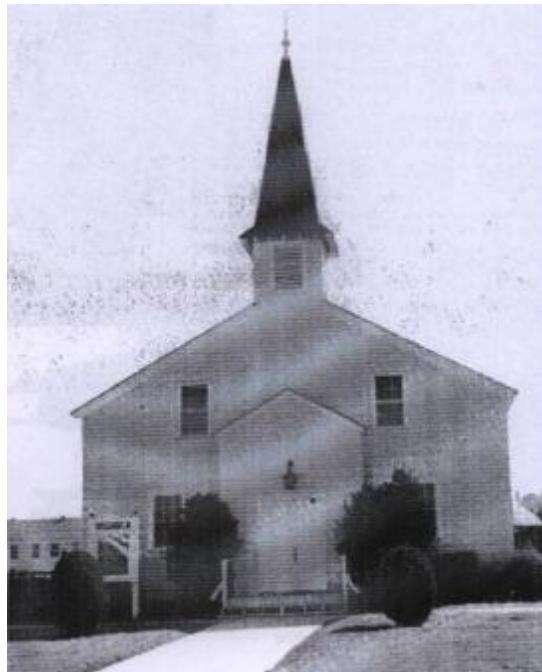
**Figure 190    1968 Base Chapel (Hankins 2009, 34)**

In 1968 the base chapel was configured according to Corps of Engineers drawings, which are strikingly similar to the original designs of the 1930s (Figures 190-194). Comparing Figure 190 to the chapel at Bryan Army Airbase, one can see that they are the same, although the chapel at Bryan Airbase no longer has a steeple. The chapel at JRB Fort Worth has been upgraded significantly. Two large wings were added in the 1970s. The north wing contains a large meeting space. The south wing includes various offices and administrative spaces. The phenotype considerations of the exterior of the building were changed when it was sheathed in modular red brick. The steeple was covered with bronze roofing materials and the windows were upgraded to be more energy efficient. MEP systems were repaired and upgraded as needed. However, the genotype floor plan remains the same.

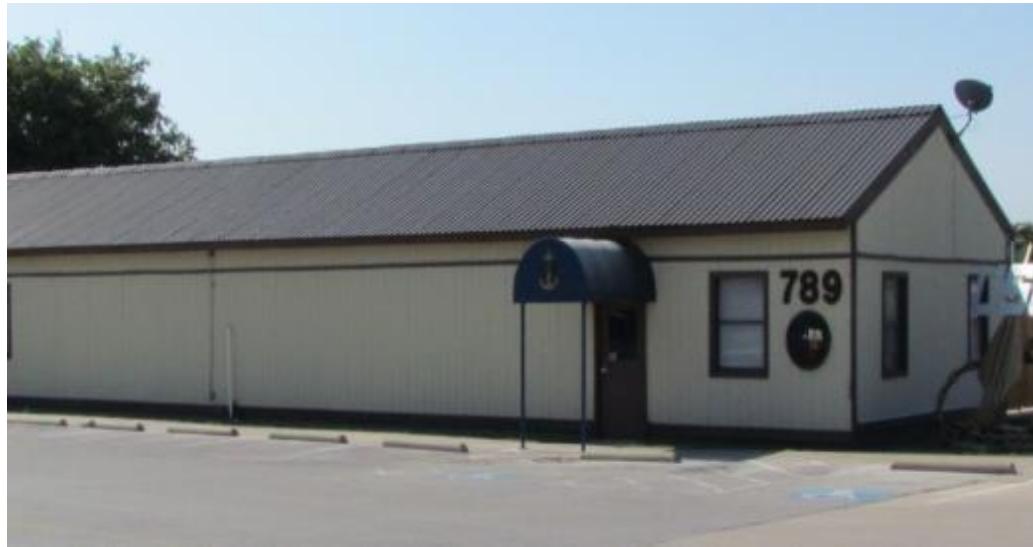
**Figure 196    Building 789 in 2013**

It was unclear at the time of this study if Building 691 (the weather building) is the same as Building 789. However, it appears to be similar in construction (see Figure 196 for more detail). The location of this building near the flight line indicates that this is likely the case. It also appears that at one time it may have been used as the NCO club. Building 789 is used currently as the senior enlisted navy training center. It has been re-roofed with standing seam metal roofing and the exterior siding was upgraded from horizontal clapboard to vertical plywood paneling. The author was the project officer for the renovation of this building in 1995.

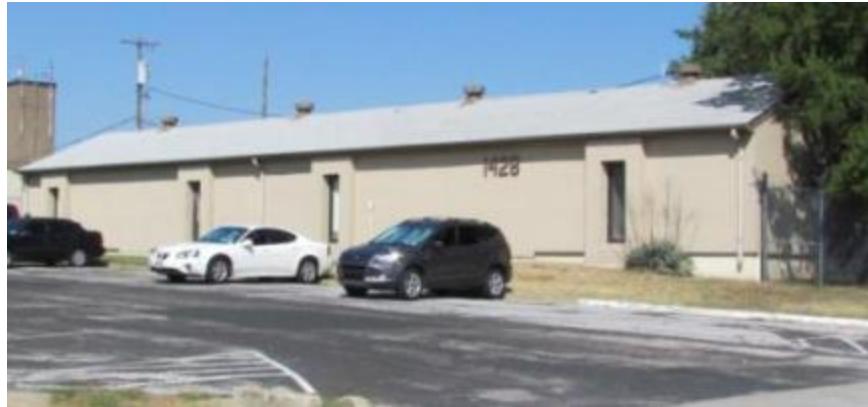
**Figure 202** Building 1428 in 2013

Building 1428 was originally built during the WWII era and has been renovated several times (Figure 202). It was originally configured as a warehouse but is currently used as the USAF Security Forces office. Synthetic stucco walls and new aluminum frame windows and doors were added recently. It retains its asphalt shingle roof. At the top left of Figure 202, one can see the back of the fire station observation tower, which

has been renovated in a similar manner. The drawings for Building 1428 have disappeared. However, it is likely it was configured in the same manner as Building 1229.

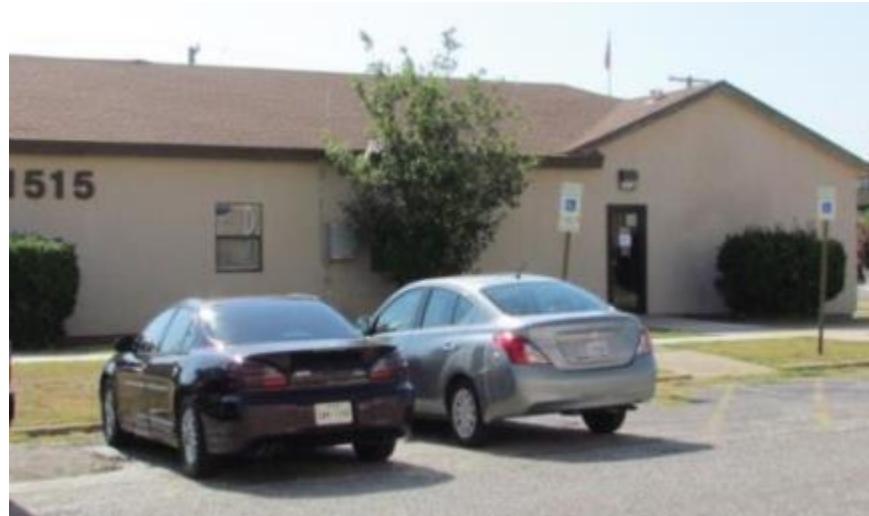
**Figure 203    Front Elevation of Building 1515 in 2013**

Building 1515 was built in 1942 with an addition in the late 1970s (Figures 203 and 204). Looking at Figure 204, one can see the firewall protruding above the roof. The section to the left of that firewall is the newer part of the building. It serves as the Navy and Marine Relief Agency, which is similar to a Red Cross function at a local level. It appears this building has always served an office function.

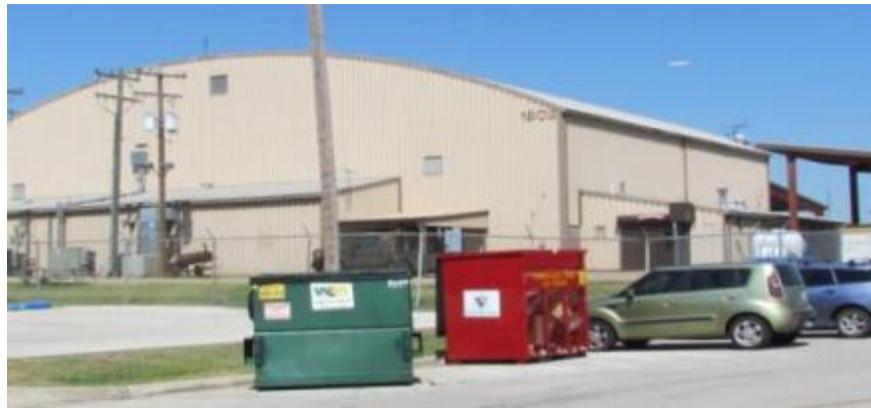
**Figure 205 Rear of Building 1602 in 2013**

Building 1602 was built in 1942 (Figure 205). The author provided architectural service for this building while at Carswell AFB. Aircraft maintenance requires a large open space so the entire fighter aircraft can be brought into the building during inclement weather. This building is a wood frame structure with a 150-foot clear span built-up wooden bowstring truss. The bowstring truss is built up of individually cut pieces of 2 x 8 lumber bolted together using gusset plates, bolts, and washers (Figure 206). This building remains essentially the same as when originally designed; however, the exterior of the building was recovered with corrugated metal siding when the original asbestos shingles were removed. It operates in an associated function as the AGE shop where electrical equipment that supports the aircraft is maintained and stored. Earlier in its career, the building was used to maintain fighter aircraft, which were much smaller than today's jet fighters. However, should it be necessary to do a complete depot-maintenance level repair on an aircraft, the entire aircraft can still be placed inside the building to be repaired once the AGE equipment is relocated.

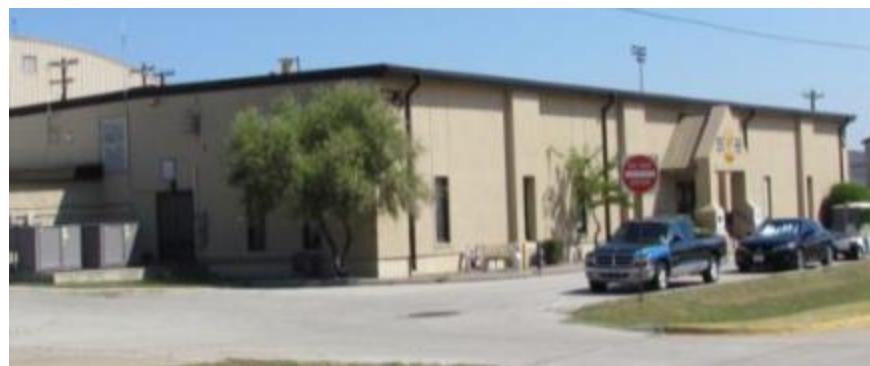
**Figure 207 Building 1615 Front Elevation in 2013**

Building 1615 is used currently as the Aerial Port (Figure 207). In the top left corner appears a building that is very similar to the AGE shop. Four of these types of buildings remain in use on the base. Building 1615 was built in 1943. Once again, the exterior has undergone significant phenotype renovations. Windows, siding, and doors have been replaced in a similar manner as other buildings already discussed. The roof of this building was originally gravel ballast. However, due to the low angle of the roof and its proximity to the flight line, it was changed to a membrane roof in May 1989. Figure 208 is a drawing of the plans used for Building 1615 in 1989.

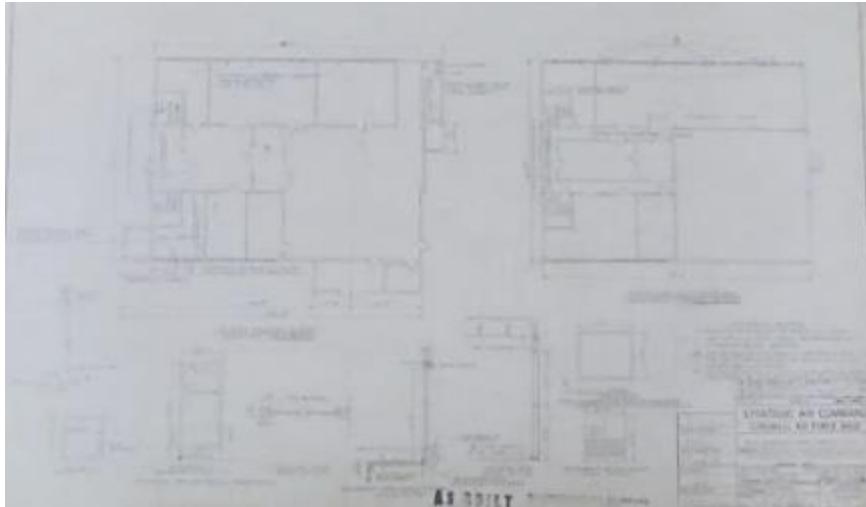
**Figure 209    Building 1619 Floor Plan**

Building 1619 was also built in 1945. During renovations performed in May 1968, alternate air traffic aids and maintenance training shops were added. The exterior of the building did not receive significant changes, but the interior of the facility did. There were also numerous MEP upgrades. Due to security concerns, the author was not permitted to photograph this building. From the road, it appeared Building 1619 had many of the same types of changes as other buildings located near the flightline. However, it is believed Building 1619 had significant upgrades. In addition, MEP changes were made as the security work accomplished in this building requires the most current systems to accommodate the mission requirements. The as-built drawings of building 1619 (Figure 209) show how the floor plan was modified. Smaller details indicate toilet, door frame, and cabinet changes. The changes to the fenestration were limited to maintenance items during this renovation cycle.

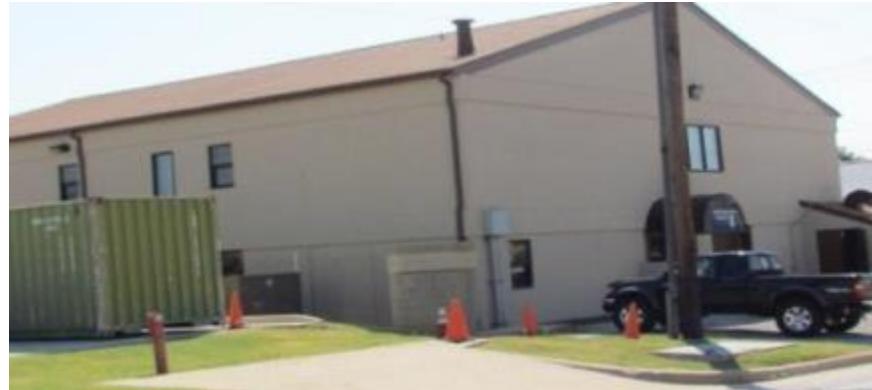
**Figure 211 Building 2525 in 2013**

Figure 211 depicts Building 2525, which resembles a WWII barracks, does occupy the previous location of the WWII aviator billeting site. The base civil engineer records show that it was built in 1945. However, the site survey was unable to verify its construction date because the drawings for this building for that era no longer exist. Today it is used as the Security Police Headquarters. It has changed significantly from its original configuration and fenestration. When originally built, it would have had a wooden frame with wooden trusses. The interior would have been open bay sleeping with gang showers and toilets at each end on each floor. It would have been covered initially only with tarpaper that was eventually replaced with either asbestos shingles or wooden clapboard. The roof had asphalt shingles and the building would have been insulated. Today the exterior is covered with synthetic plaster, but the roof is the same. Phenotype apertures are now steel doors and aluminum frame windows. While stationed

at Carswell JRB, the author worked on this specific building and several others used for Security Forces administration. However, due to security concerns he was not allowed to photograph the interior. The normal configuration for such buildings has offices on a double-loaded corridor, a section for a jail, and a control desk at the entry control point.

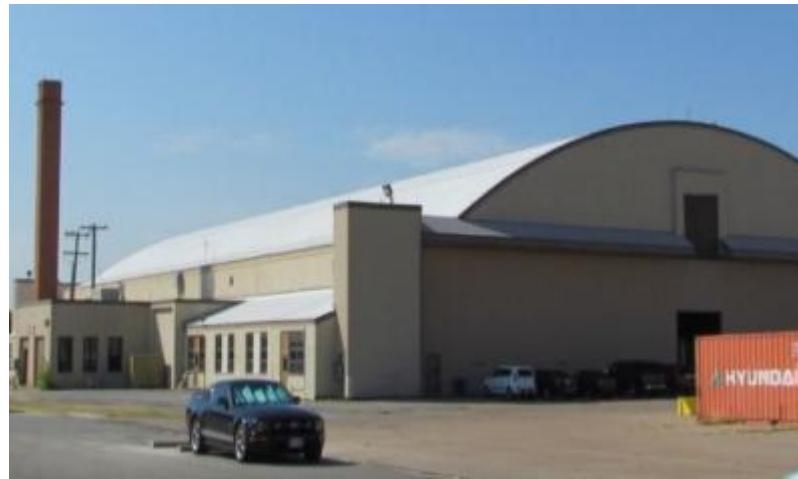
**Figure 214 Building 1410 Hangar in 2013**

Building 1410 is an aircraft hangar (Figure 214). There are four of these buildings remaining at the base. The site survey was not able to locate drawings for these buildings, nor was the investigator permitted to photograph the interiors for security

reasons. However, the classical shaped roof and the massive rail-mounted bypass hangar doors in the front are consistent with other WWII aircraft hangers. Over time, the size and configuration of aircraft has increased, rendering these buildings obsolete for bomber aircraft use. Therefore, they have been torn down or converted to aircraft maintenance functions for fighters and support equipment. Building 1410 is still used for fighter aircraft repair. During the primary investigator's USAF career, he executed dozens of projects in buildings of this type all over the continental United States and Europe, the last of which was to change a similar building into a repair shop for the Predator aircraft, a pilotless drone built of a classified plastic substance. The tall smoke stack in Figure 214 was once used to burn classified documents and manuals. Today such smokestacks go unused or function as outgassing vents for filtered air used in the maintenance activities.

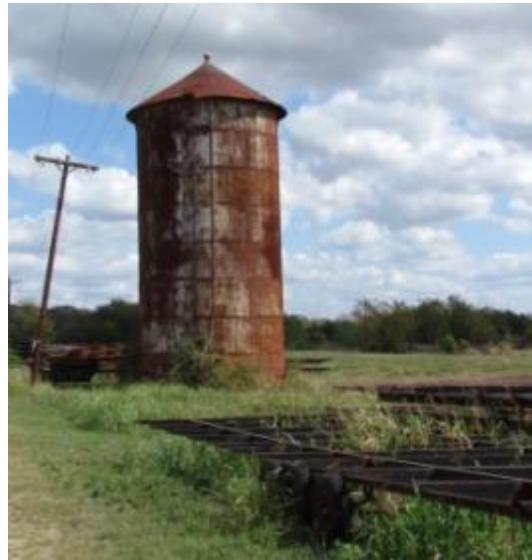
**Figure 215    Camp Hearne Water Tower in 2011**

The facilities at the Hearne Army Auxiliary Airbase and POW camp are completely gone except for the pump house, water tower, conference building, foundations, roads, underground utilities, and the cityscape layout. However, one can access a rich source of information simply by observing the cityscape and talking with the avocational archeologist and historic preservationist who are active at the site. Figure 215 shows the water tower in 2011.

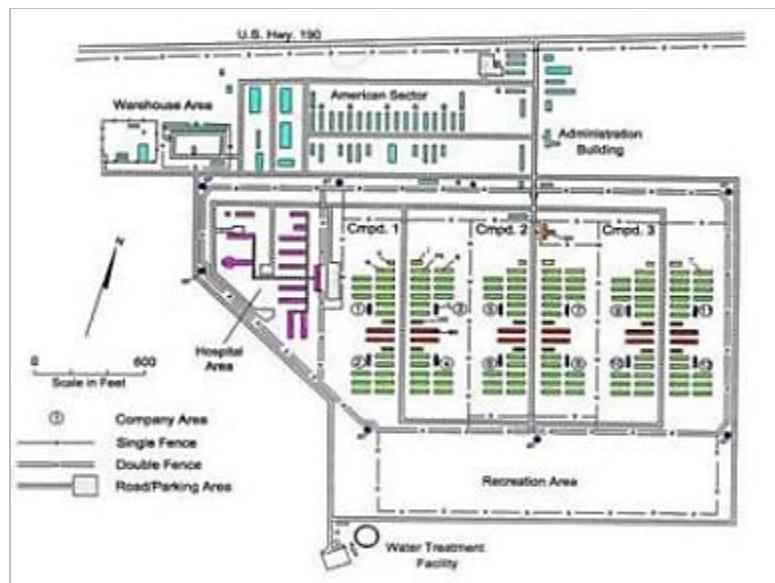
**Figure 221 Layout of German POW Camp**

Figures 221-223 show the layout of the POW camp as well as the remains of the facilities that existed in 2011. These plans were prescribed by the Department of War. According to Waters et al., Camp Hearne followed the standard camp layout approved by the Provost Marshal General's Office (2006). The camp was divided into three compounds with each compound subdivided into four companies with 400 prisoners each. Each company area had a mess hall, lavatory, company office, and eight barracks. Barbed wire fences isolated the camp and each compound was enclosed with fencing.

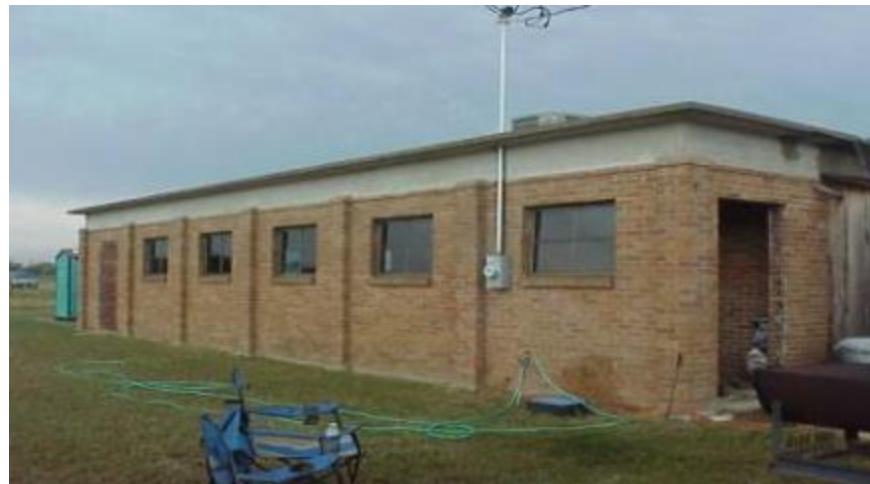
**Figure 245    Original Conference Building**

been preserved. Of the 130 buildings and seven guard towers in existence at the height of the camp's occupation, only two buildings remain. The conference building and the pump house continue to be used. Unfortunately, the rear wall of the pump house was damaged by the city when they enlarged the pump, associated water well, and water line.

Figures 245 and 246 are of the most complete remaining original building, which is now used as a conference room. The reconstructed barracks are shown in Figures 247 and 248 and Figure 249 depicts examples of original construction drawings used to construct the barracks. Fortunately, a small cadre of dedicated, avocational archeologists and preservationists worked to preserve what remains of Hearne POW Camp. They sponsor an annual WWII living history demonstration during the third week of October. The event is located at Camp Hearne Historic Site, 12424 Camp Hearne 3rd Street, Hearne, Texas 77859. Additional information can be found at their website, <http://campHearne.com>.

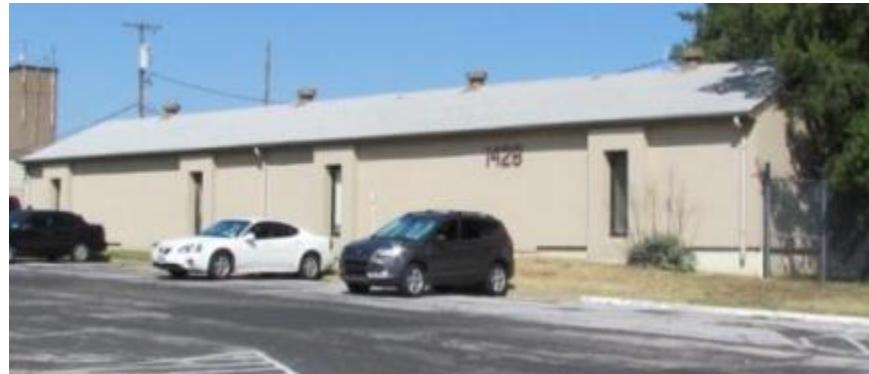
**Figure 267 Building 1428**

Carswell AFB has been in continuous use since its original construction. The author was stationed at this base for many years and was active in the renovation of many of the existing buildings including the security police office, Building 1428 (see Figure 267).

Building 1428 is the building chosen to test the OCI evaluation. It was built during WWII as a general administrative building. It retains its general character, although the fenestration has been significantly changed (due in part to some of the author's architectural work). The following four objectives were developed to guide conservation and restoration efforts at Carswell AFB.

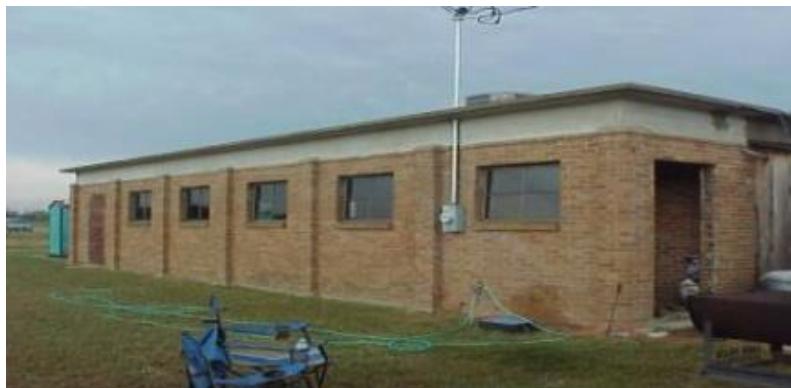
**Figure 269 Original Conference Building at Hearne**

The Hearne AAB conference building was selected for evaluation (Figure 269) because it is one of the few remaining structures on site. Originally used for on-base briefings and official military receptions, it has been partially reconstructed. The roof leaks and requires repairs. The rear door is missing, but the main conference room has been developed into an excellent display for information and historical artifacts found on the site.
