CYCLIC LOADING OF FIBER-CONTAINING CEMENT SHEATHS IN HPHT
CONDITIONS

A Thesis

Major Subject: Petroleum Engineering

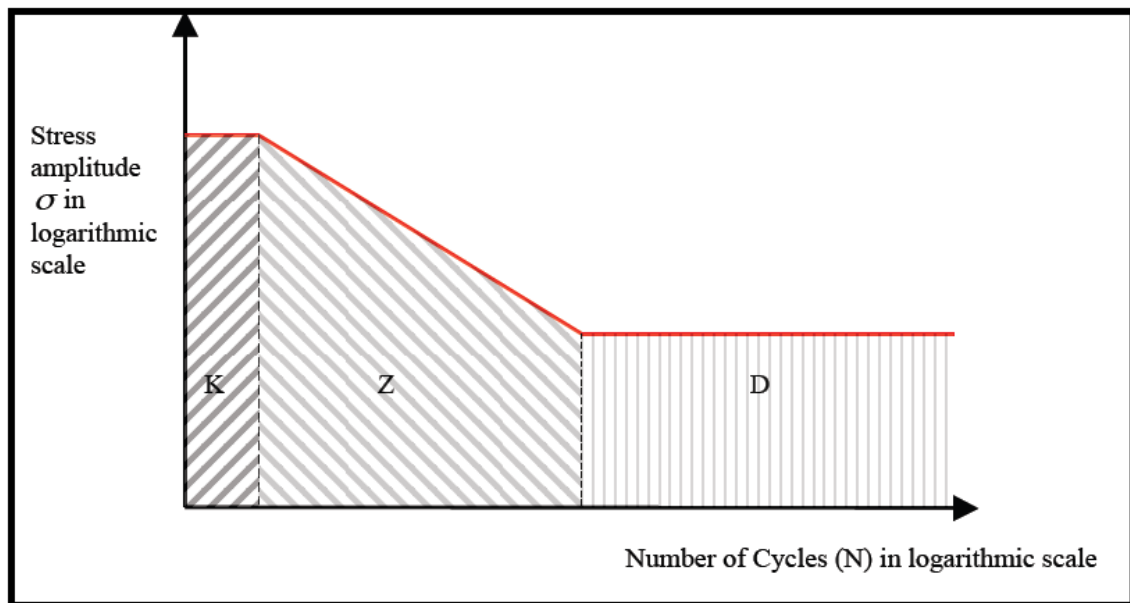
Figure 4: S/N Diagram (Ugwu, 2008)

at the molecular level. When additional loads are applied, the cracks propagate and the object can reach its failure point before its theoretical yield strength. The Stress/Number of Cycles (S/N) is a fatigue model that shows three regions (Figure 4). As the number of cycles increases, the amplitude of stress required to cause failure decreases. Zone K is $10^0 - 10^3$ cycles, Z is $10^3 - 10^8$ cycles, and D is over 10^9 cycles. This is significant because high amplitude stress translates to low cycle failure. In oilfield operations, cement sheaths are subjected to a wide range of stresses. Large differentials in stress magnitudes will cause failure within the low cycle region.

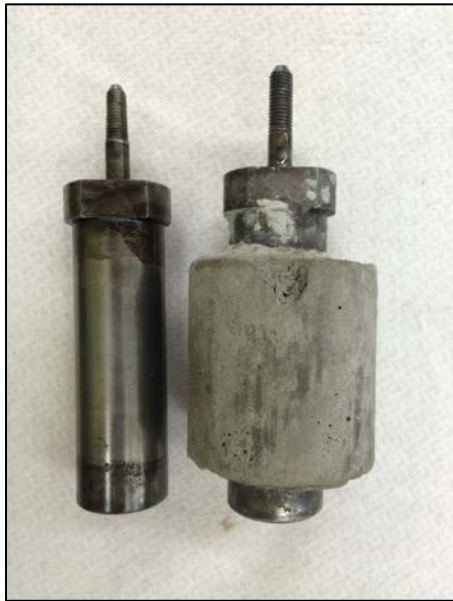
Figure 8: Casing Cell and Cement Sheath

As shown in Figure 8, the lower part of the HPHT cell consists of small metal cell that simulates the casing in a wellbore. As mentioned in the Literature Review, casing is cemented in the well to establish complete zonal isolation, and it is of paramount importance that the annular space is isolated from formation fluids. In this experiment, a cement sheath is molded around the “casing” and the sheath is cured for 12 hours at 330°F and 15,000 psi. The preparation of the sample will be mentioned in further detail in the Procedures section.

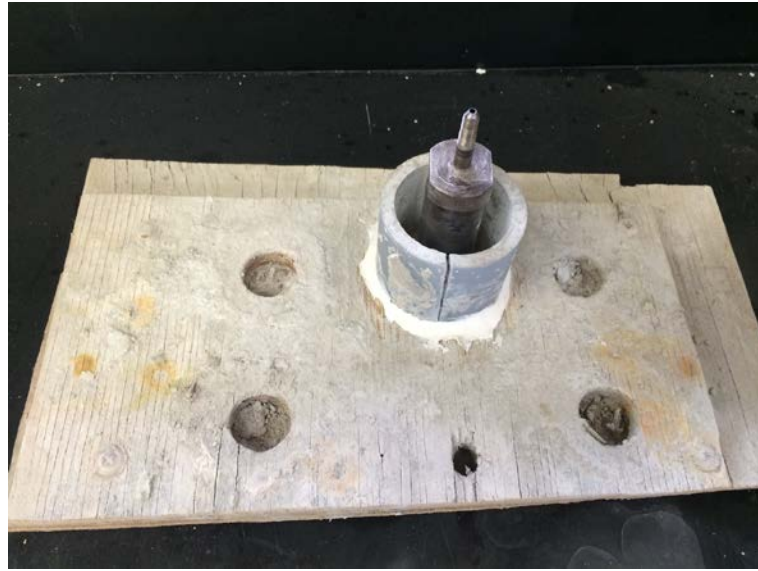
Figure 9: Cement Sheath Mold

The first step in conducting the experiment was to prepare the samples. A ½ inch thick board with 1 inch drilled holes was used to hold the cells in place. The cells were cleaned with acetone and scrubbed with a steel wire brush. It was important that the cells were free of oil as it would interfere with the bonding between the cement and metal cell. Clear 2 ½ inch PVC pipe was cut into 2 inch sections and glued with silicone caulk around the cells. A seam was cut across the PVC pipe to facilitate removal of the completed sheath. The caulk prevents cement from flowing out of the PVC mold. The mold insures the consistency of cement sheaths and facilitates the creation of sheaths that are compatible with the HPHT cell and the Chandler 7600 (Figure 9). Once the mold was prepared and the silicone caulk was dry, the cement slurry was mixed.

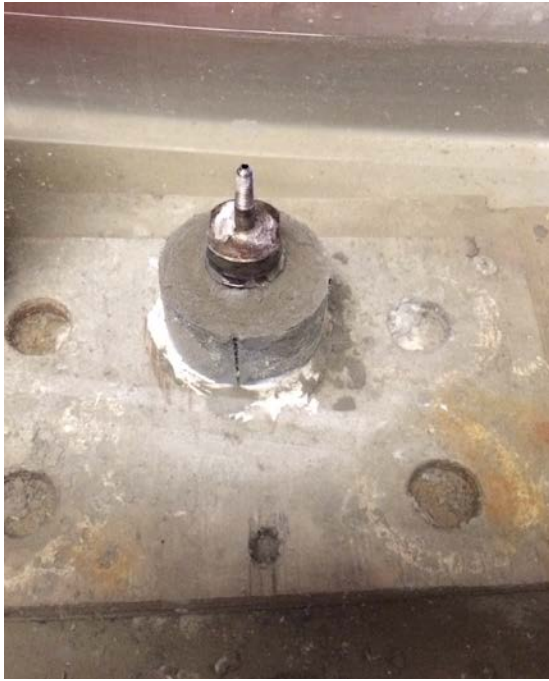
Figure 10: Curing at Surface Conditions

After mixing was complete, the cement slurry was poured into the mold and placed underwater at 72°F (Figure 10). It was important to insure that the casing cell nozzle remained above the surface of the water, as oxidation of the interior of the cell would weaken its integrity. It was also imperative to clean the nozzle threads of any debris so that the glands and collar could be installed once surface curing was complete. The cement was cured for 12 hours at surface conditions and then removed from the mold.

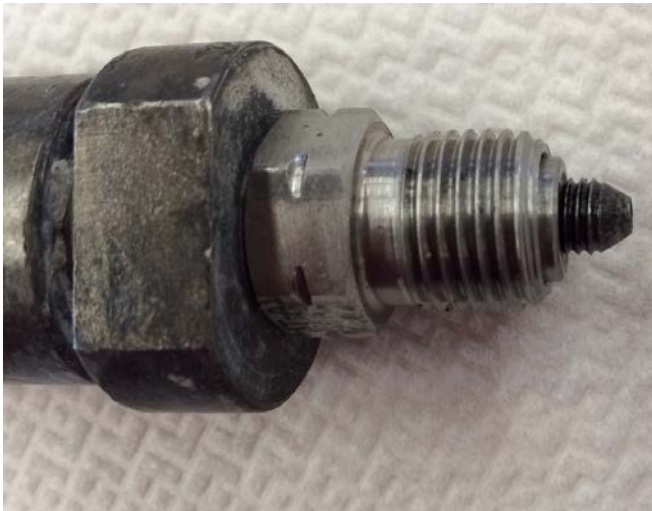
Figure 11: Cell Glands and Collar: Correct Positioning

Once removed from the mold, the cement sheath and cell were assembled with the HPHT cell. This required a gland and collar to be installed on the cell, and then the gland was threaded into the HPHT cell. It is critical to insure that the collar is threaded at least half way down the cell shaft; otherwise the cell nozzle will not make an adequate seal when the cell gland is tightened (Figure 11). A quick way to determine if the cell is sealed properly with the HPHT cell is to place the bottom of a casing cell against a surface and rotate the top of the HPHT cell. If the assembly moves as one, the casing cell is adequately sealing, otherwise additional tightening and repositioning of the cell collar is required.

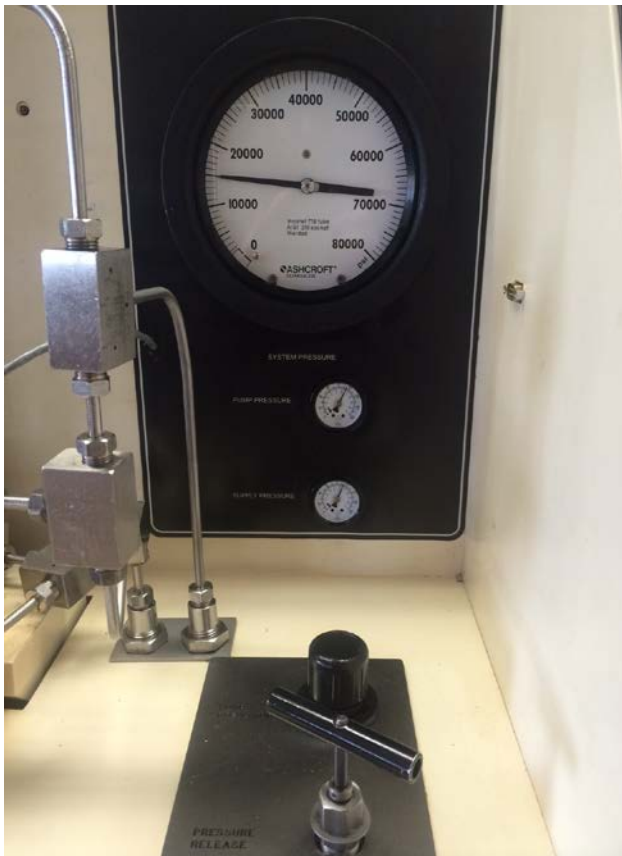
Figure 12: Pressurized System

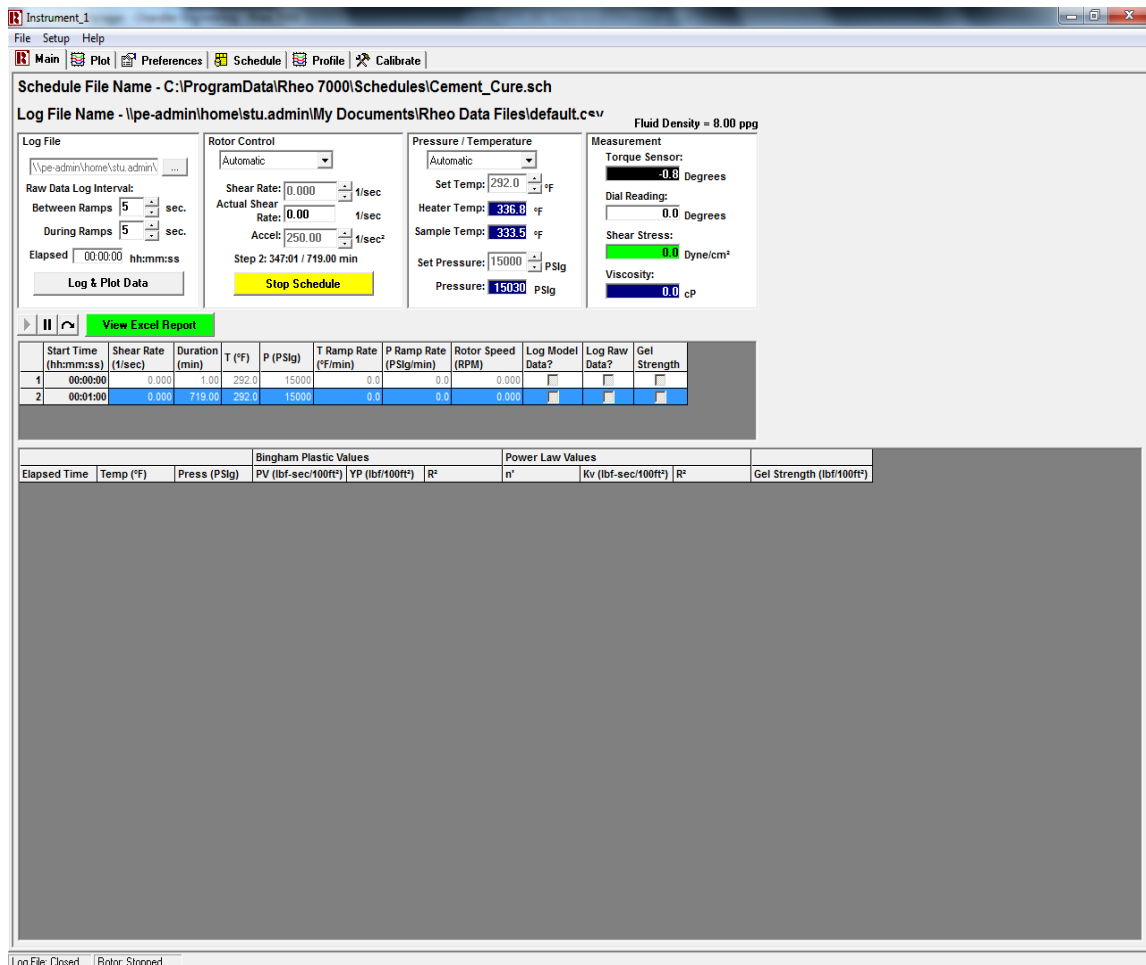
Figure 14: RHEO 7000 Main Operation Screen

Once powered on with the switches in the proper orientation, the Chandler 7600 could be controlled by the RHEO 7000 software on a Windows 7 based operating system. It was paramount to insure that COMM ports were plugged into the USB serial hub, which was in turn connected to the PC. Once opened, the software required the user to start and save a new instrument in the “File” options before going to the main screen seen in Figure 14.

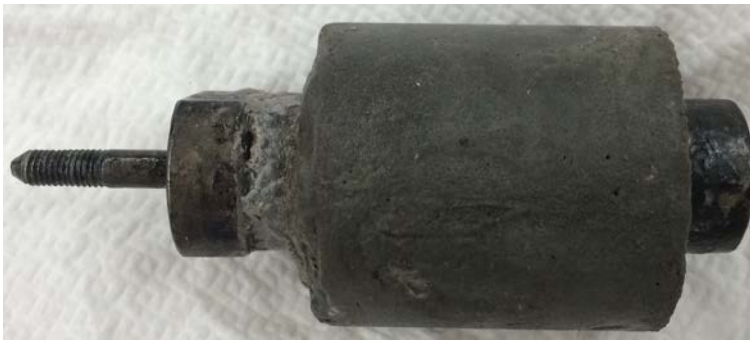
Figure 17: Sample I-A, No Cracks

The first sample (Figure 17) was tested under the conditions defined in Set A found in Table 2. The pressure and temperature were defined in RHEO, however no real time data was recorded due to operator error. It was discovered that after 14 cycles of 1,000 psi differentials, the cement sheath was not fractured. The second sample (Figure 18) was tested and pressure and temperature data was gathered. The data is shown in Figure 19. A third sample shown in Figure 20 was conducted and data was gathered to verify the results (Figure 21). It was revealed that there was an offset error in the sample temperature set point, as the sample temperature was above the desired temperature. Even though the schedule was programmed to maintain a sample temperature of 330°F, the heater would overcompensate and heat the sample to approximately 370°F.

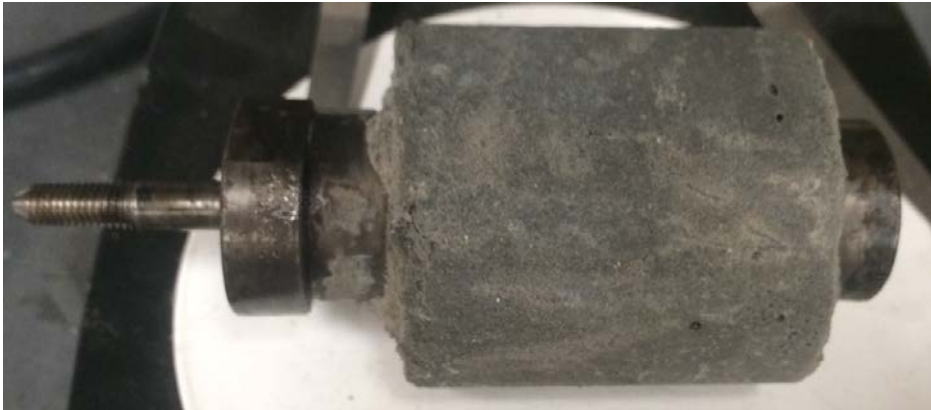
Figure 18: Sample II-A, No Cracks

and marks the need for calibration of the Chandler 7600 by a certified technician. Both tests II-A and III-A revealed identical results to test I-A, that is, there were no cracks in the cement sheath after 14 cycles of 1,000 psi differentials. As mentioned previously, the sample temperature exceeded the desired set point for the first three tests of Set A. To help find the set point value that would achieve the desired sample temperature a calibration curve was plotted. As seen in Figure 22, a temperature set point of 291°F was estimated to yield the desired sample temperature. In order to determine the fatigue endurance limit, the number of cycles which the sample first begins to fail must be found. The samples did not fail after 14 cycles, so the cycle number was raised to 15 cycles for the next few samples of Set A.

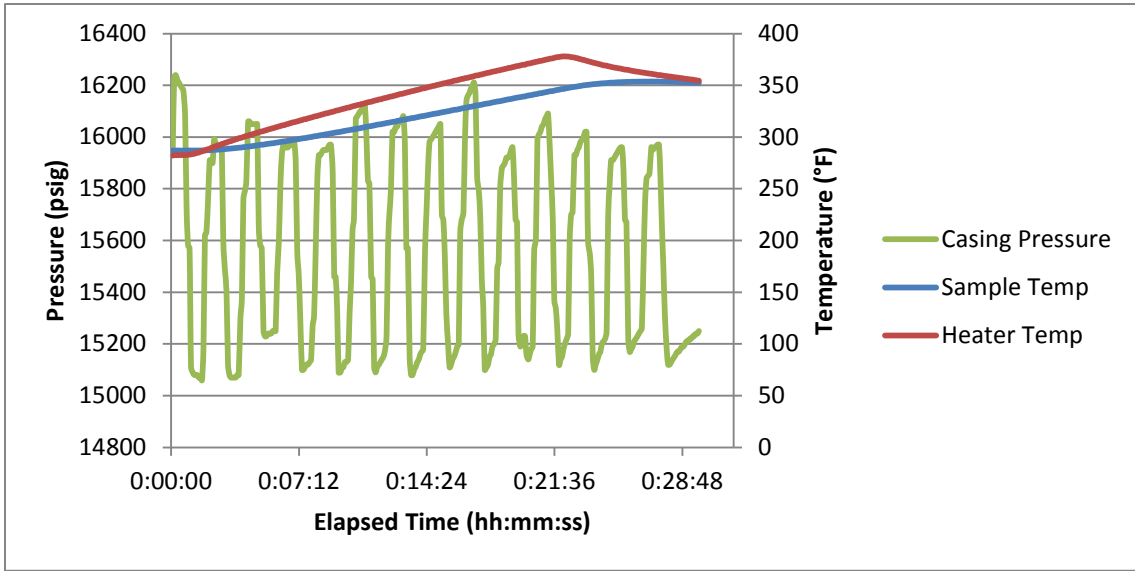
Figure 19: Real Time Data from Test II Set A

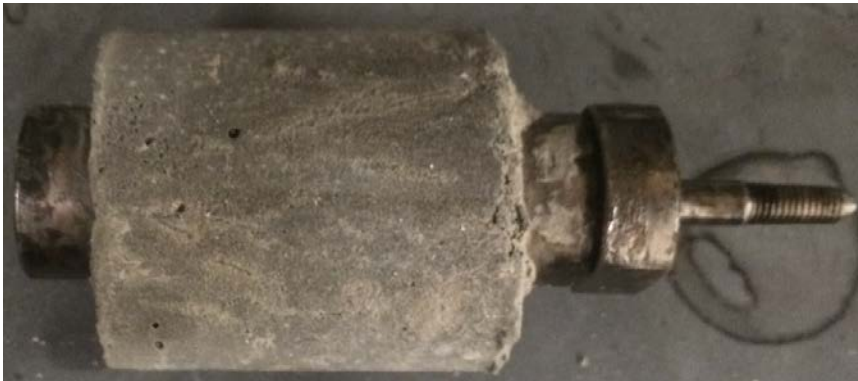
Figure 20: Sample III-A, No Cracks

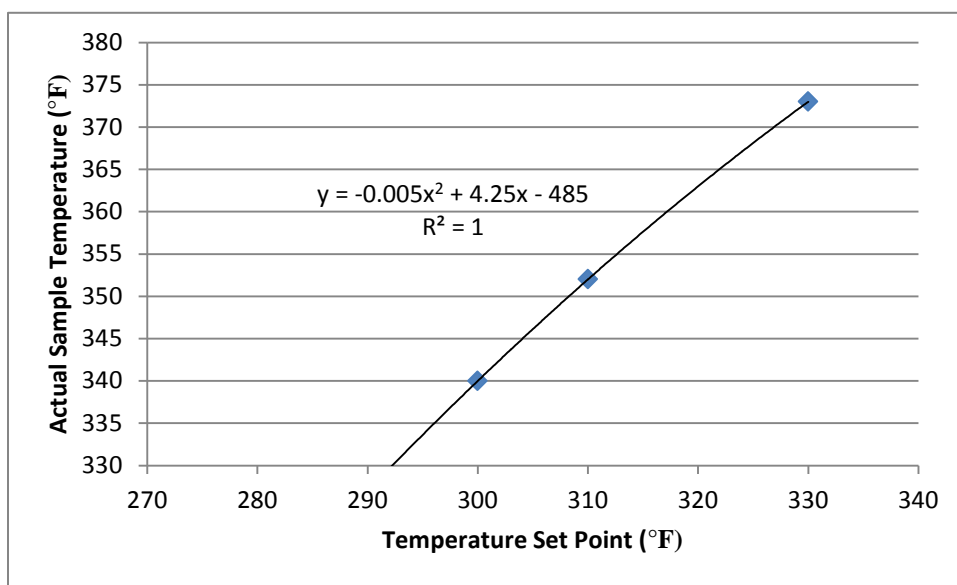
Figure 22: Temperature Calibration Curve

Throughout several experiments the set point was varied until the sample was at the desired temperature. It was found that the programming the sample temperature to 291°F would actually yield the desired sample temperature of 330°F. The disparity in temperature set point and actual sample temperature could be the result of sensor error

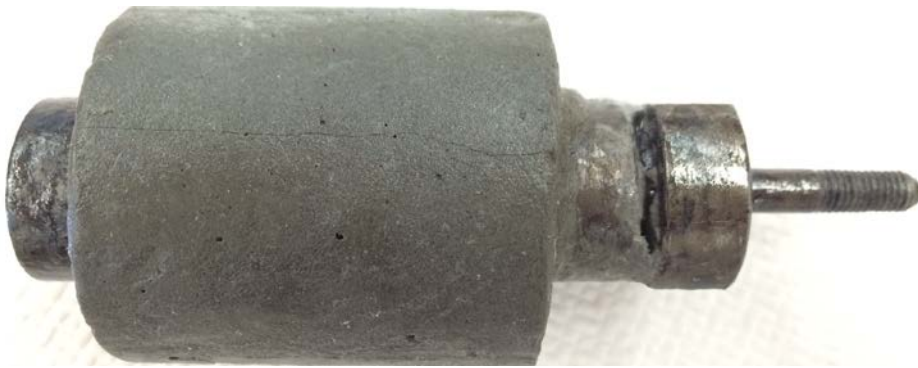
Figure 24: Sample IV-A, Single Radial Crack

The second set of tests were conducted at the same conditions outlined in Set A, however the cycle number was increased to 15. Sample IV-A was removed from the HPHT cell and it was immediately clear that failure had occurred. The cement sheath had a single radial crack that extended from the top of the cell to the bottom. In addition to real time pressure and temperature data capture via excel, the test was monitored with the data plotting system in RHEO. Both the data and plot revealed that the test was conducted at the desired pressure and temperature conditions.

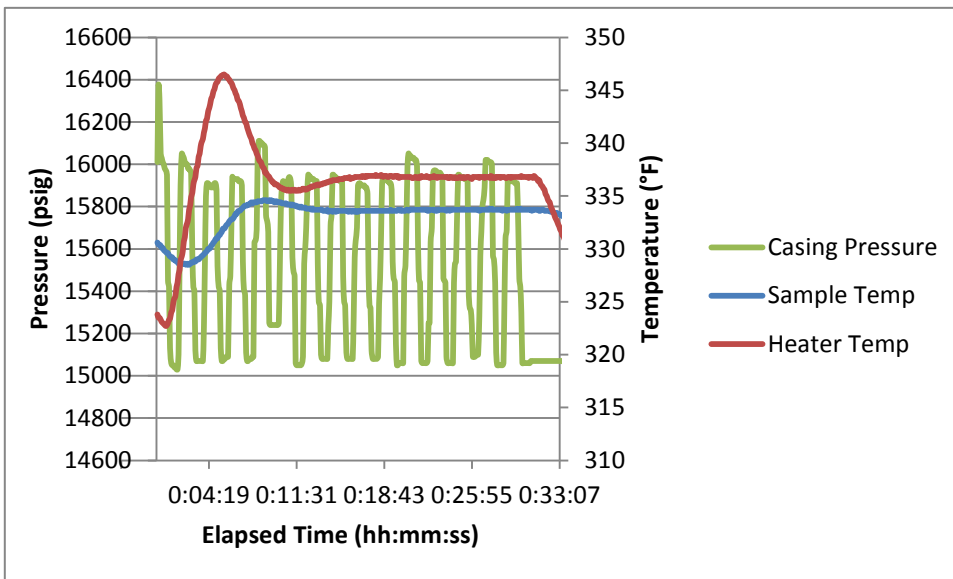
Figure 25: Real Time Data Plot from Test IV Set A

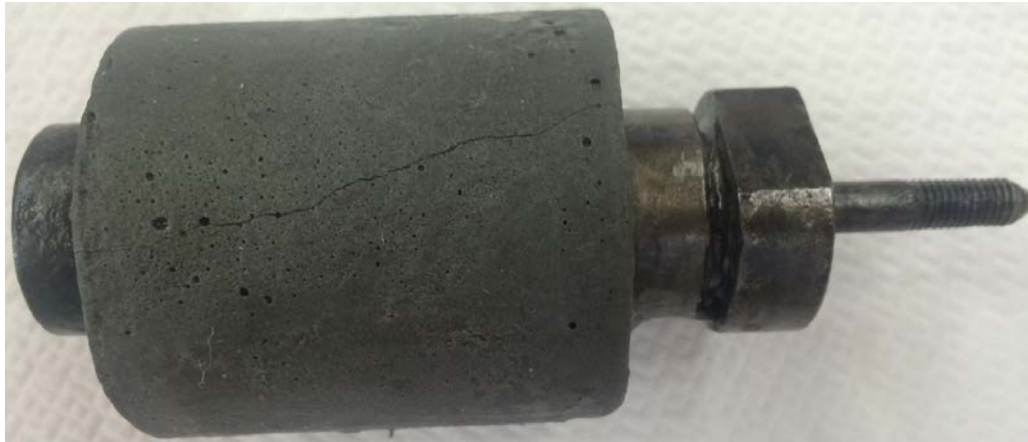
Figure 26: Sample V-A, Single Radial Crack

Additional tests were conducted at Set A conditions at 15 cycles to verify the experimental results. The physical results can be found in Figures 23-29. Both V-A and VI-A displayed signs of failure. V-A had a radial crack extending from the top to the bottom of the sheath, whereas VI-A had a more subtle crack that appeared to be propagating from the top of the sheath to the bottom. It is clear that the fatigue endurance limit of Class H cement at 1,000 psi pressure differentials is 15 cycles. This is a significant result, as Class H Cement without fiber failed one cycle sooner than cement with the added nylon fiber (Table 3).

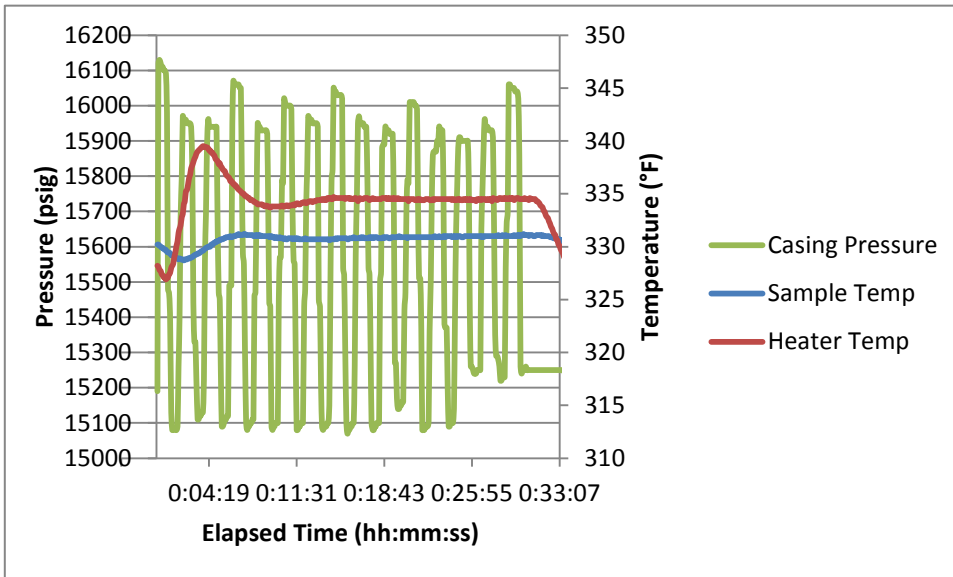
Figure 27: Real Time Data from Test V Set A

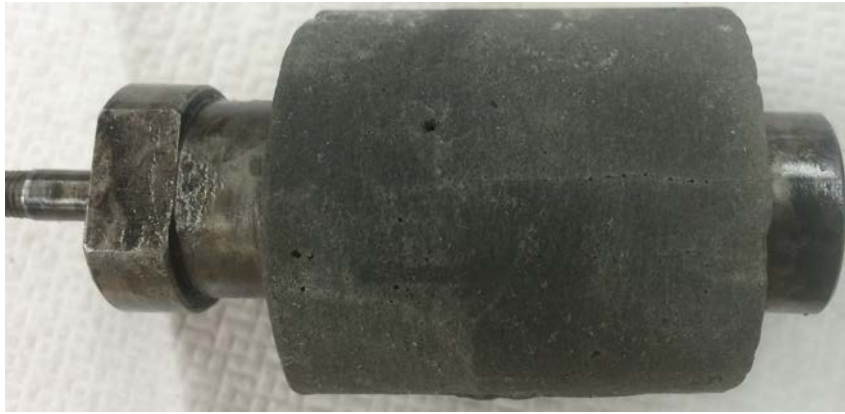
Figure 28: Sample VI-A, Propagating Radial Crack

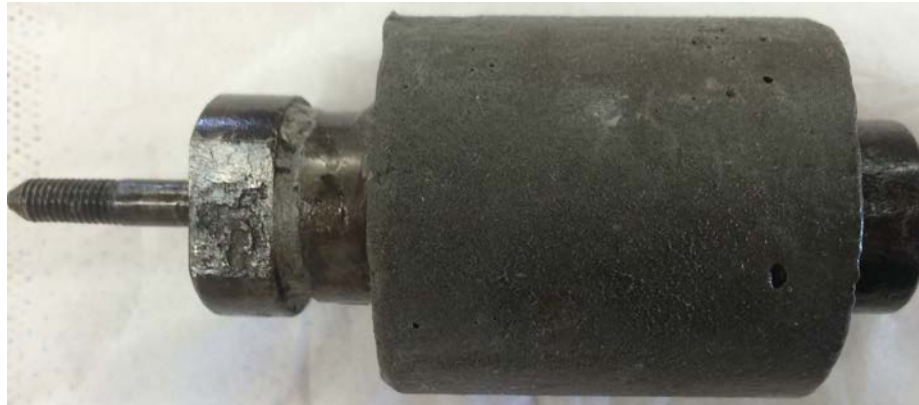
Figure 30: Sample I-B, No Cracks

Set B trials were conducted at the conditions outline in Table 2. The physical results can be found in Figures 30, 32, 33. Cyclic testing was started at 13 cycles which was the fatigue endurance limit of Class H cement with no fiber for 2,000 psi differentials. Test I-B was conducted in the same manner as the tests in Set A. According the real time data in Figure 31, I-B had various pressure spikes, where the pressure exceeded the desirable maximum pressure of 17,000 psi. The Chandler 7600 appeared to be operating normally, and it was unknown why this occurred. Despite this setback, the test was ended after 13 cycles, and the sample did not show signs of failure.

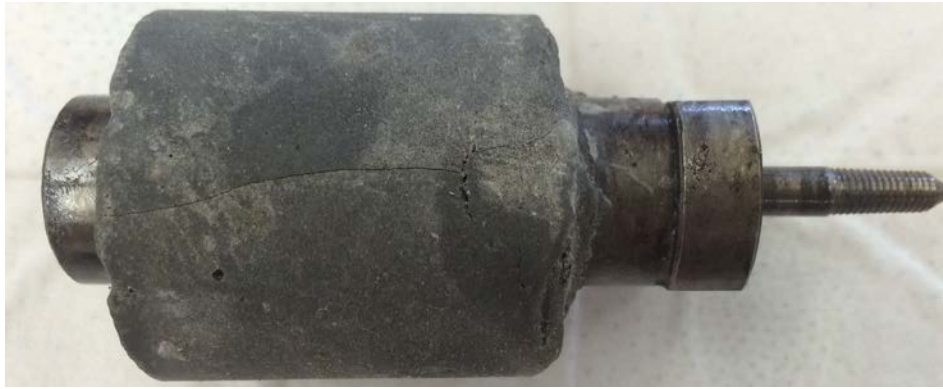
Figure 32: Sample II-B, Single Radial Crack and Disking

Test II-B was tested at 2,000 psi differentials for 14 cycles. This test went smoothly with no large pressure spikes, however it was noted that the confining pressure started to vary at the end of the test. This phenomenon could have occurred due to the fatigue of the casing cell. It is probable that the metal seal between the casing cell and HPHT cell failed due to continuous use. It was discovered that the cement sheath fractured with severe radial cracking and some disking. Additional testing was unable to be conducted to verify the test results of Set B because differential pressure between the casing pressure and confining pressure was unable to be established. In addition, mechanical failure in the pump exhaust and fatigue in several key components halted the experiment. The experimental apparatus had been use rigorously for three independent experiments without recalibration or maintenance by a certified technician. It therefore became a safety concern and the project was ended.

The results of Set B are displayed in Table 4. Once again, the Class H cement with added fiber fared better under cyclic conditions. The failure type of radial cracking and diskings was the prominent indicator that the cement integrity was compromised. Tests at 5,000 psi differentials (Set C) with Class H cement with 0.5% fiber were unable to be conducted due to mechanical failure of the Chandler 7600 and the loss of a pressure seal between the casing cell and HPHT cell.

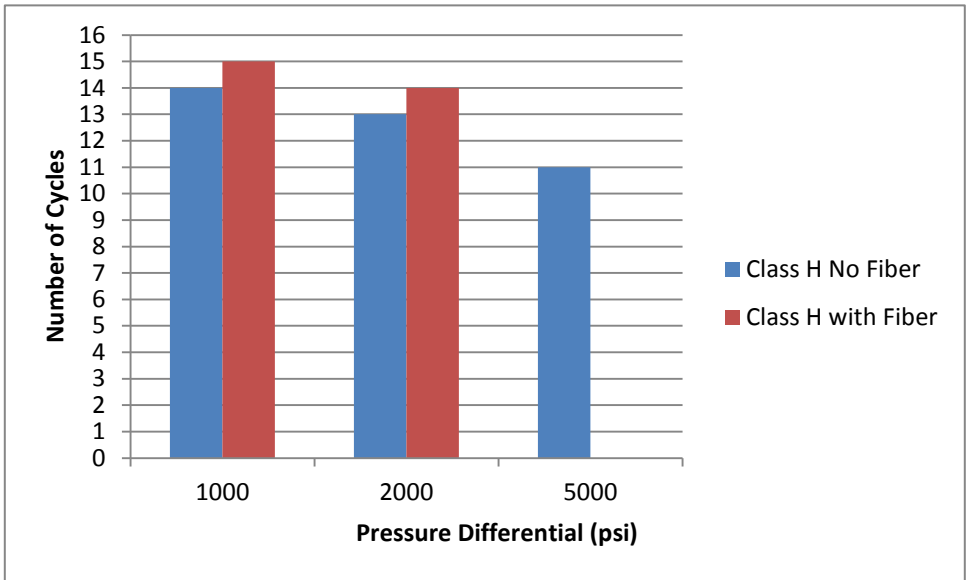
Figure 34: Comparison between Class H Cement Experiments

In comparison with Set A, Set B failed at fewer cycles and had more prominent radial cracking and diskings present. Figure 34 displays the results of the Class H cement experiments and it is clear that the added fiber increased the durability of the cement under cyclic loading.

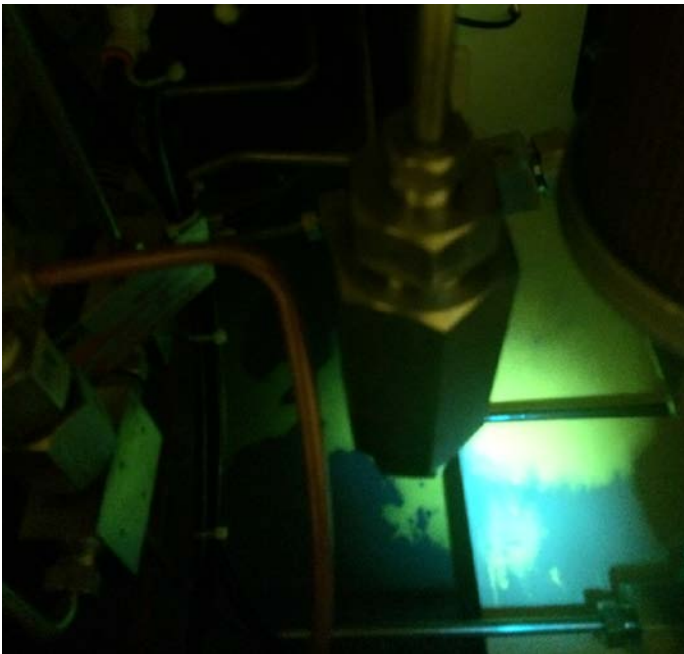
Figure 36: Leaking from Air Operated Valve

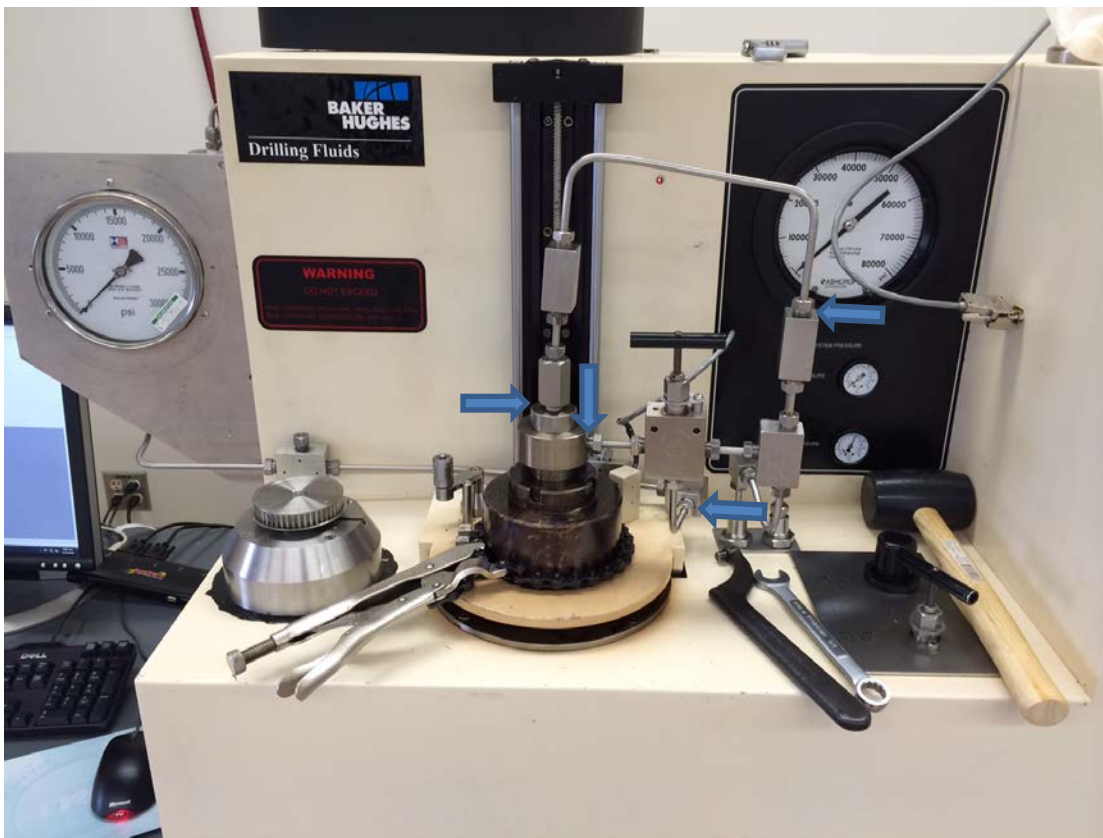
Figure 38: Common Leak Points in HPHT Cell Setup

After the completion of two experiments at 2,000 psi differentials, the HPHT cell was unable to isolate the confining pressure from the casing pressure. As mentioned earlier, this could have been a result of fatigue in the small casing cells, or the failure of the new isolation valve. Additional investigation and repair was not carried out because there were safety concerns about the integrity of the HPHT cell setup.
