***AN ARCHAEOLOGICAL EVALUATION
OF 41BX784 A HISTORIC HOMESTEAD
IN BEXAR COUNTY TEXAS***

***Brazos Valley Research Associates
Contract Report Number 162***

AN ARCHAEOLOGICAL EVALUATION OF 41BX784
A HISTORIC HOMESTEAD IN BEXAR COUNTY, TEXAS

BVRA Project 06-02

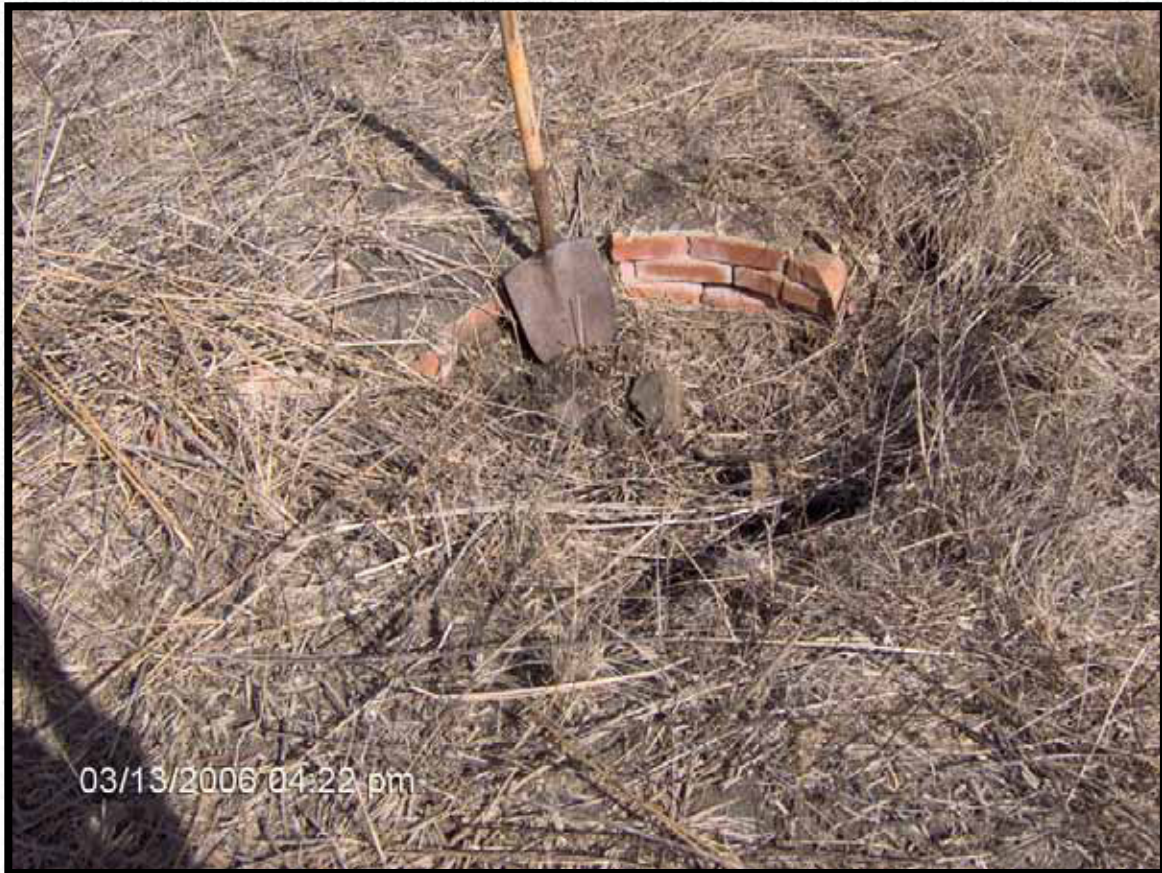
Figure 5. Feature D

Brick-lined cistern (4 feet in diameter). This cistern was filled in with dirt. No artifacts were observed in or around this feature (Figure 5). The bricks were identified as Williams. A plastic pipe was observed near feature, and it may have been used as a replacement for an earlier iron inlet pipe. Voellinger observed this feature.

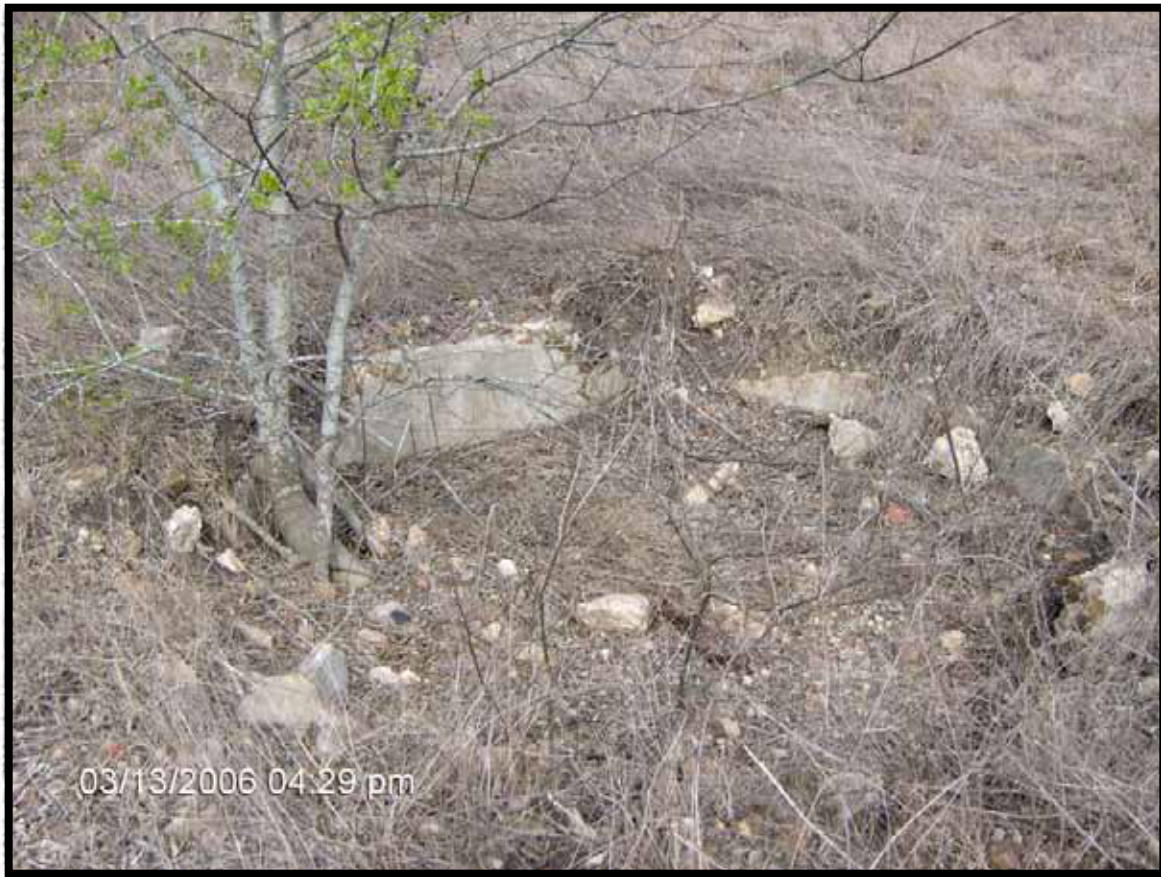
Figure 6. Feature E

Circular brick water trough (8 feet in diameter) (Figure 6). This trough was lined with brick using Portland mortar and plaster and filled in with dirt. No artifacts were observed in or around this feature. The bricks were identified as Alamo. BVRA believes this is one of the cisterns observed by Voellinger.

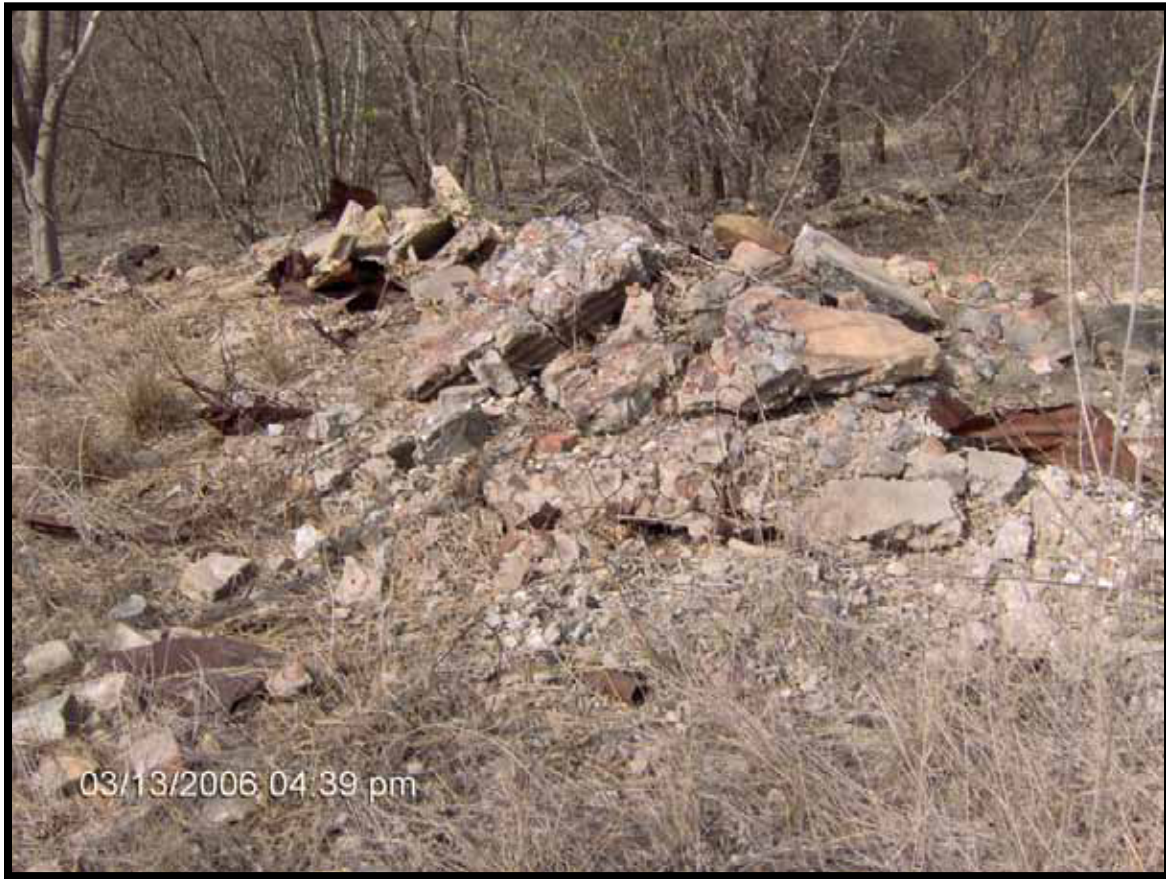
Figure 7. Feature G

Concrete and brick rubble pile (40 feet in diameter) (Figure 7). Based on the presence of fire brick (D'Hanis and Loclede St. Louis), a firebox with a chimney was once present at this location. The size of the rubble pile and the presence of the brick suggests this was the location of a residence. BVRA believes this is one of the rubble piles observed by Voellinger.

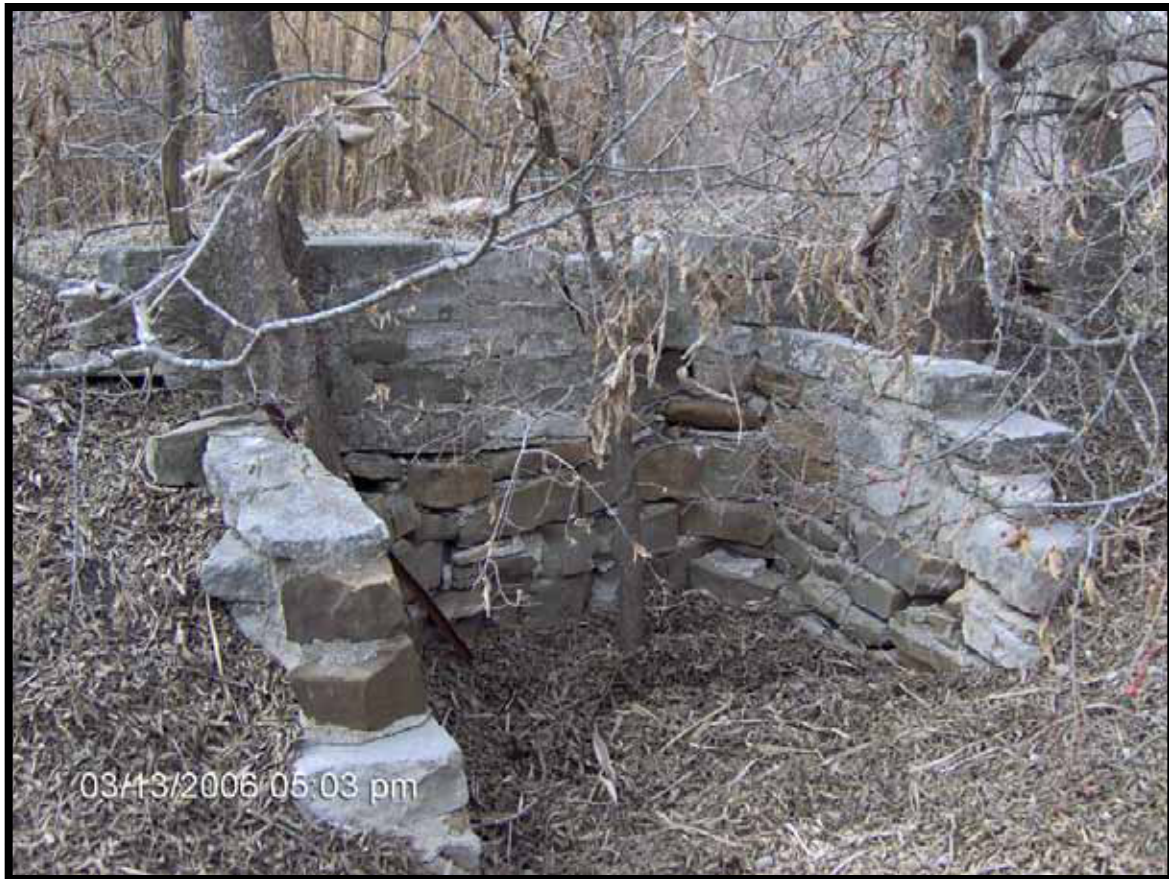
Figure 8. Feature N

Sandstone structure plastered with Portland cement (Figure 8). It is approximately 8 feet x 8 feet in plan and 5 feet tall. It was built into an earthen embankment below the two earthen ponds. The hackberry tree to the left was already in place when the feature was constructed; otherwise, there would be cracks or movement of the left wall. This feature is not believed to be very old because of the use of Portland cement and the absence of mold or fungus on sandstone that occurs over time. It did not appear to be weathered. The function of this unusual feature is unknown. Voellinger does not mention this feature.
