**AN ARCHAEOLOGICAL SURVEY FOR THE
DCP MIDSTREAM THREE RIVERS PLANT TO CGP 51 PROJECT
IN LIVE OAK COUNTY, TEXAS**

Contract Report Number 251

AN ARCHAEOLOGICAL SURVEY FOR THE
DCP MIDSTREAM THREE RIVERS PLANT TO CGP 51 PIPELINE PROJECT
IN LIVE OAK COUNTY, TEXAS

BVRA Project Number 11-03

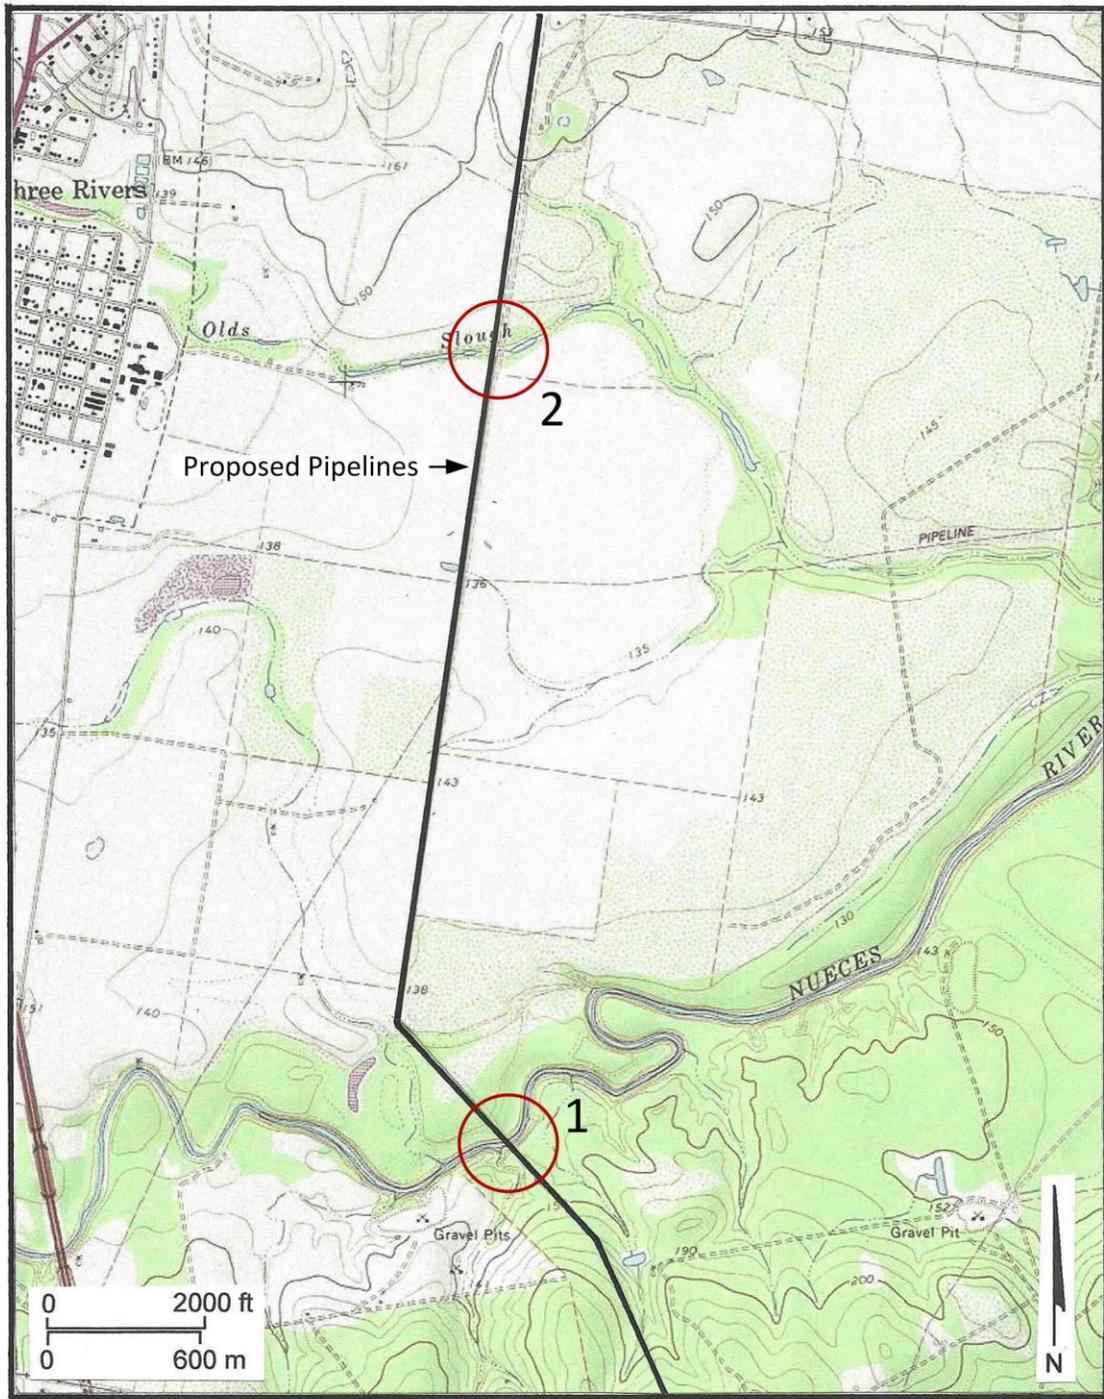
Figure 3. Areas 1 and 2

The following discussion presents specific methods used and dimensions for each area. Figure 3 depicts the crossings at the river and Olds slough where the investigation took place. The Nueces River crossing was designated in the field as Area 1, and Olds Slough is Area 2.

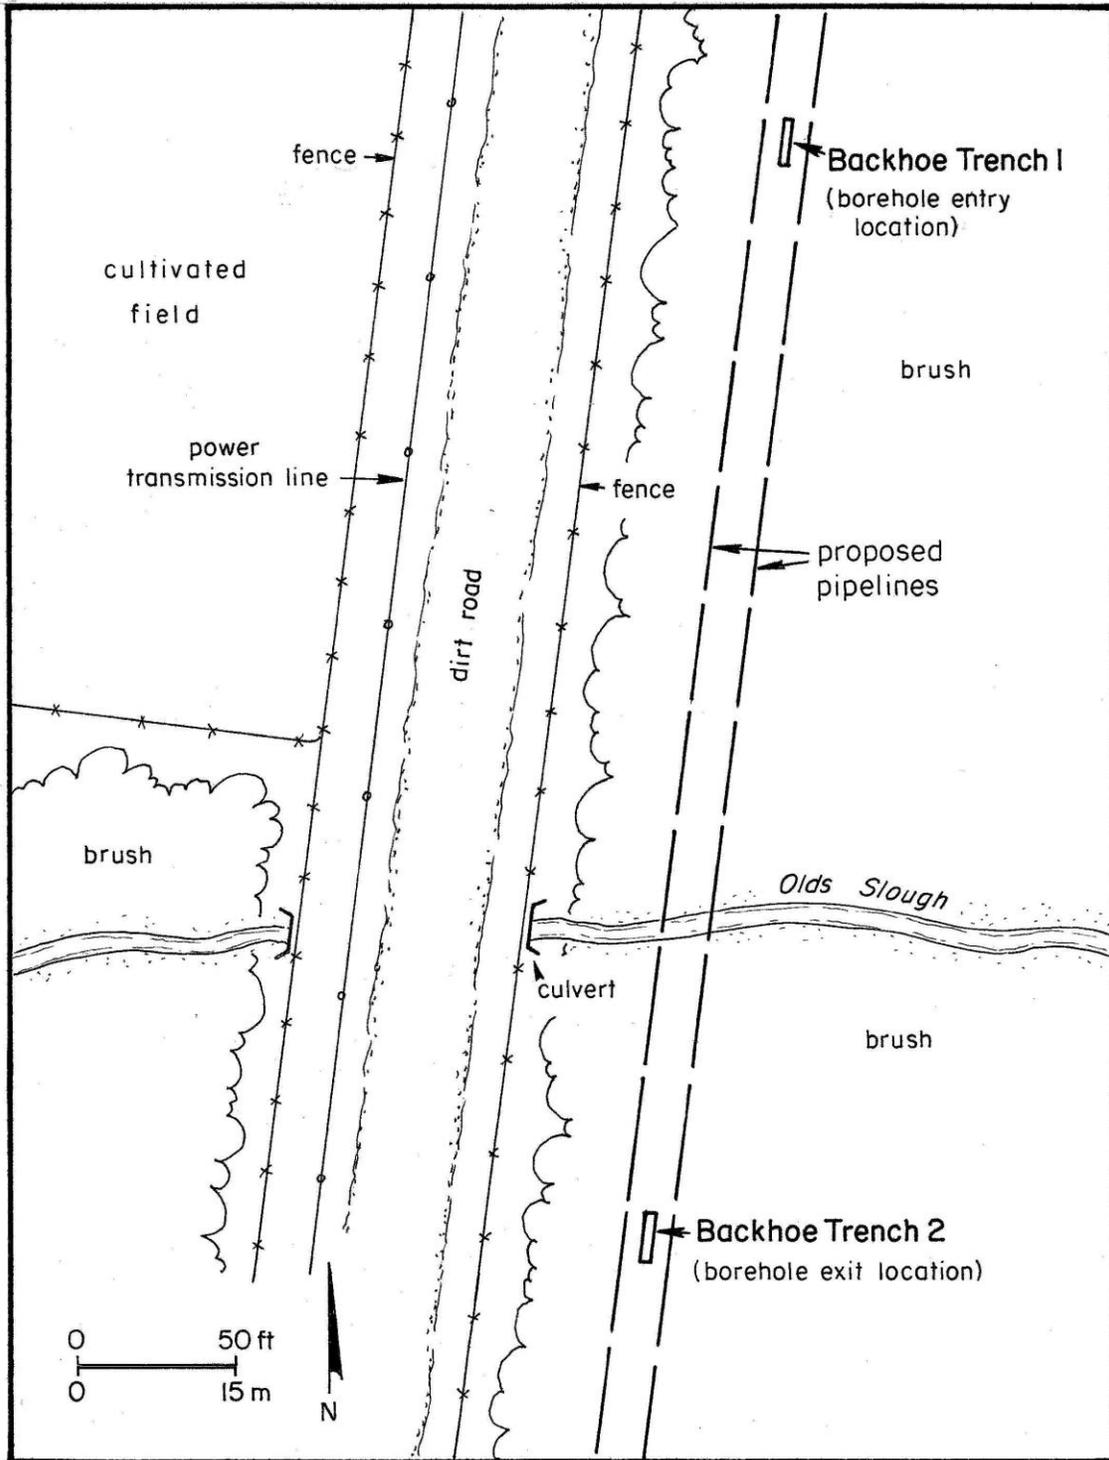
Figure 4. Backhoe Trenches 1 and 2

Backhoe Trench 1 was dug in thick brush at the entry point on the north bank of the slough and oriented north south (Figure 4). It was located 250 feet from the water and 50 feet from the dirt road that parallels the proposed pipeline. The trench was dug through clay to a depth of 178 centimeters below the existing ground surface. Its dimensions are 5 meters long and 85 centimeters wide. The east profile of the trench is depicted in Appendix I (Backhoe Trench Profiles), and a photograph of the trench during excavation is depicted in Appendix II entitled Backhoe Trench Photographs.

Backhoe Trench 2 was dug in thick brush at the exit point on the south bank of the slough and oriented north south (Figure 4). It was located 92 feet from the water and 50 feet from the dirt road that parallels the proposed pipeline. The trench was dug through clay to a depth of 182 centimeters below the existing ground surface. Its dimensions are 5 meters long and 85 centimeters wide. The east profile of the trench is depicted in Appendix I (Backhoe Trench Profiles), and a photograph of the trench during excavation is depicted in Appendix II entitled Backhoe Trench Photographs.

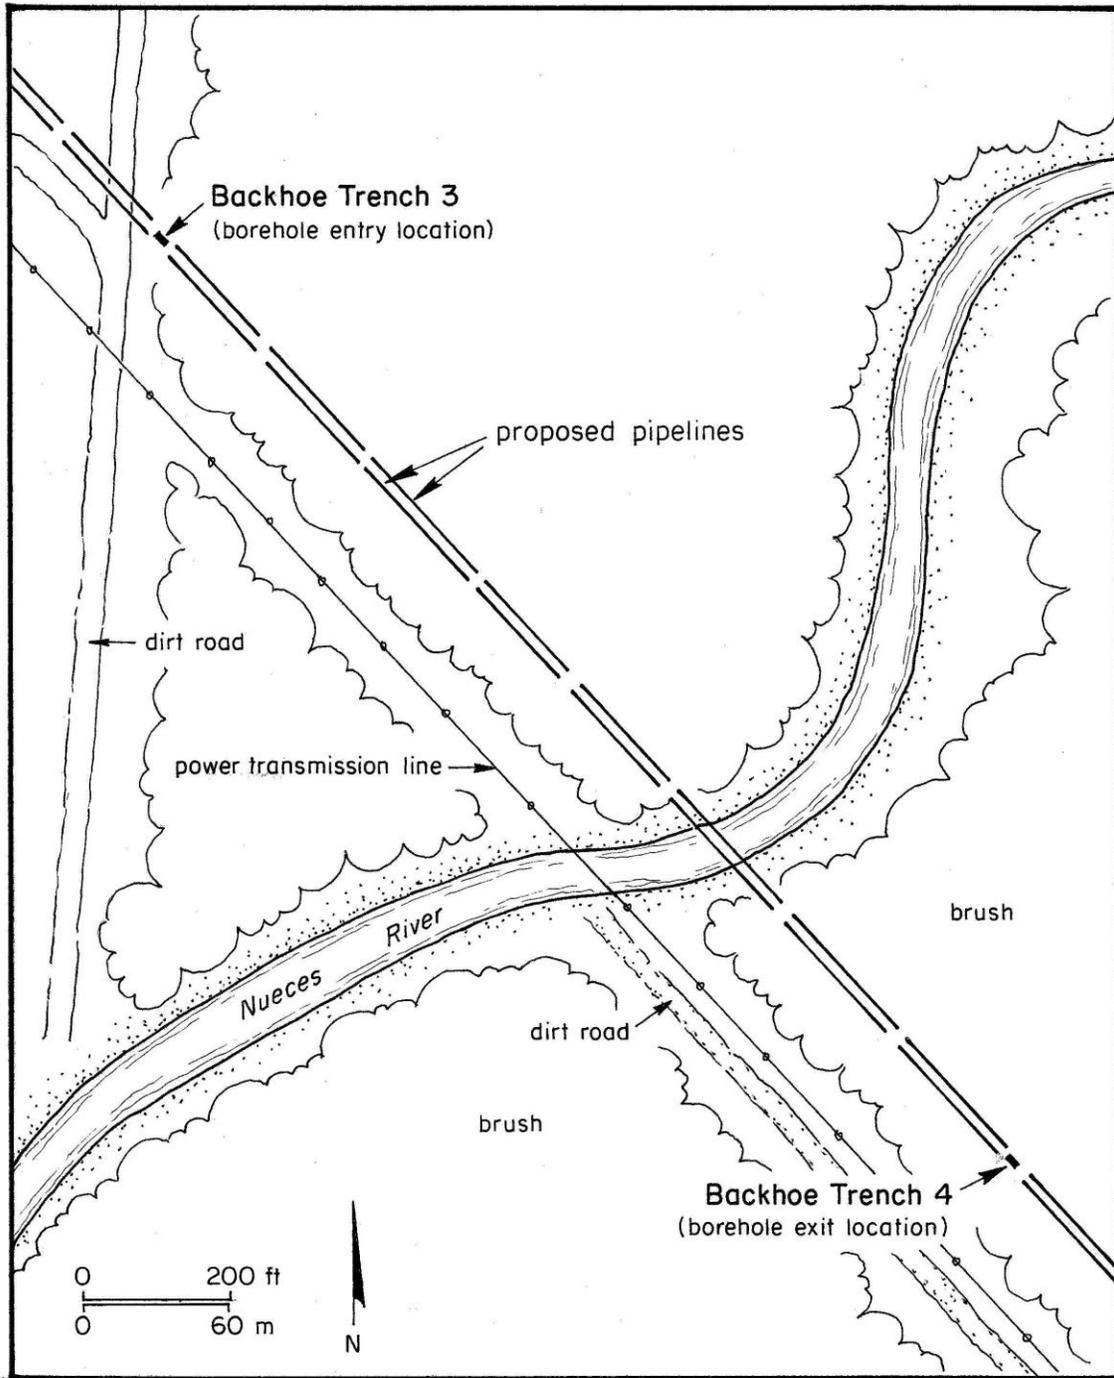
Figure 5. Backhoe Trenches 3 and 4

Backhoe Trench 3 was dug in thick brush at the entry point on the north bank of the river in thick brush and oriented north south (Figure 5). It was located 1125 feet from the river and 50 feet from the dirt road that parallels the proposed pipeline. The trench was dug through clay to a depth of 170 centimeters below the existing ground surface. Its dimensions are 5 meters long and 85 centimeters wide. The north profile of the trench is depicted in Appendix I entitled Backhoe Trench Profiles, and a photograph of the trench during excavation is depicted in Appendix II entitled Backhoe Trench Photographs.

Backhoe Trench 4 was dug in thick brush at the exit point on the south bank of the river in thick brush and oriented north south (Figure 5). It was located 565 feet from the river and 50 feet from the dirt road that parallels the proposed pipeline. The trench was dug to a depth of 160 centimeters below the existing ground surface. Its dimensions are 5 meters long and 85 centimeters wide. The soil at this location is clay over caliche with two narrow lenses of calcium carbonate at 65 centimeters and 110 centimeters below the surface. When the caliche was encountered, the excavation was terminated since this soil type pre-dates human occupation. The east profile of the trench is depicted in Appendix I entitled Backhoe Trench Profiles, and a photograph of the trench during the field excavation is depicted in Appendix II entitled Backhoe Trench Photographs.
