THE CAREENING AND BOTTOM MAINTENANCE OF
WOODEN SAILING VESSELS

A Thesis

May 1986

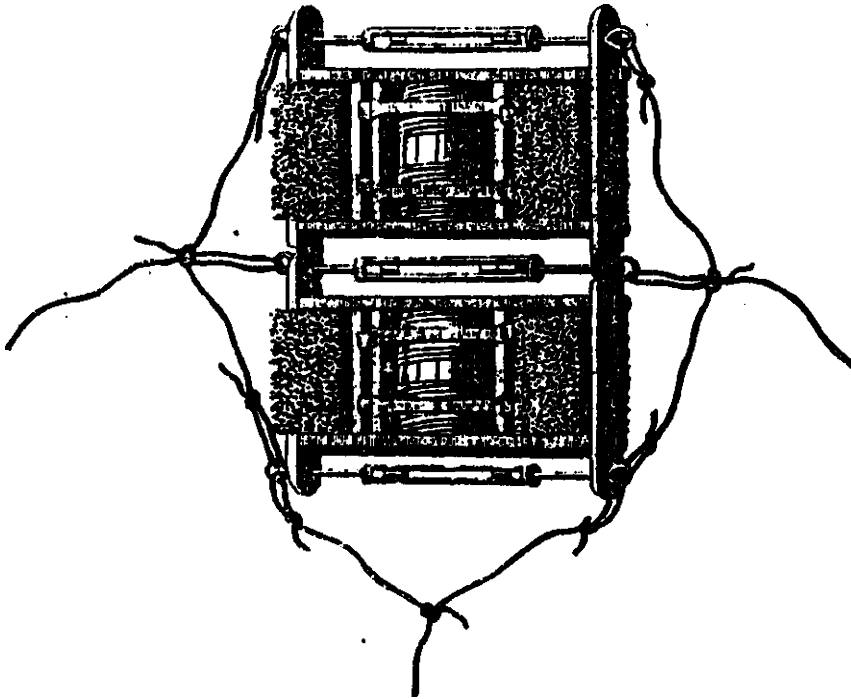
Figure 6. Bottom scrubbing device. From Hutchinson (1777: pl. 9).

provide bouyancy, with birch broom stuff secured on either side of each cask to provide the scouring medium. The two parts were joined by ironwork so they could better conform to the shape of the hull. Slings and rope were fastened to draw the device along the ship's bottom.

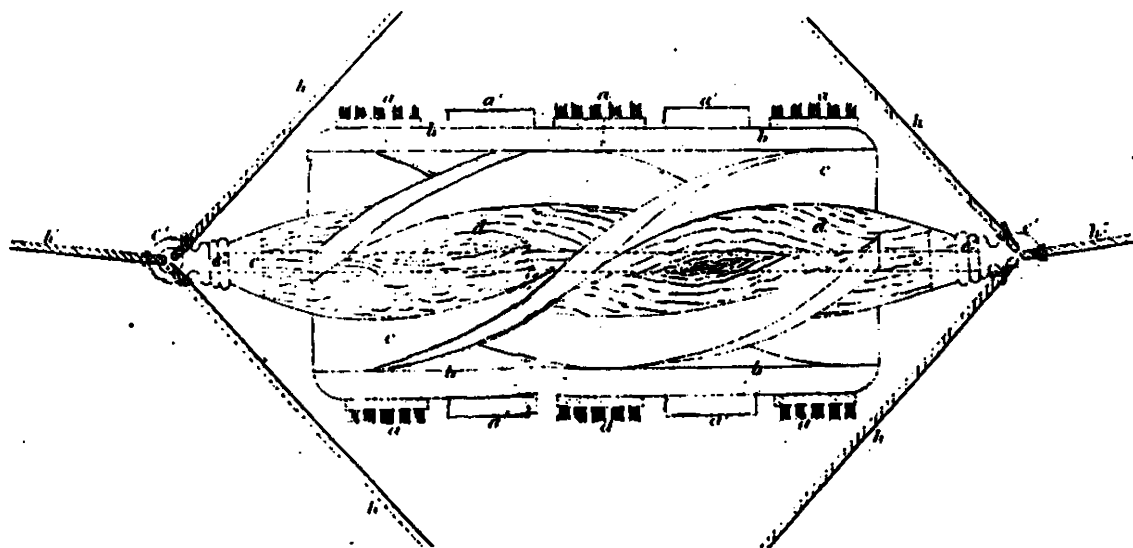
Figure 7. Design from a patent application for a bottom scrubbing device. From Phillips (1863: fig. 4).

In 1863, the patent for a somewhat similar device (Fig. 7) was applied for by another Englishman, William H. Phillips. His invention differed from Hutchinson's in that the scrubbing portion revolved freely on a central axis when drawn through the water by control chains or ropes. It was designed to rotate by tidal action while

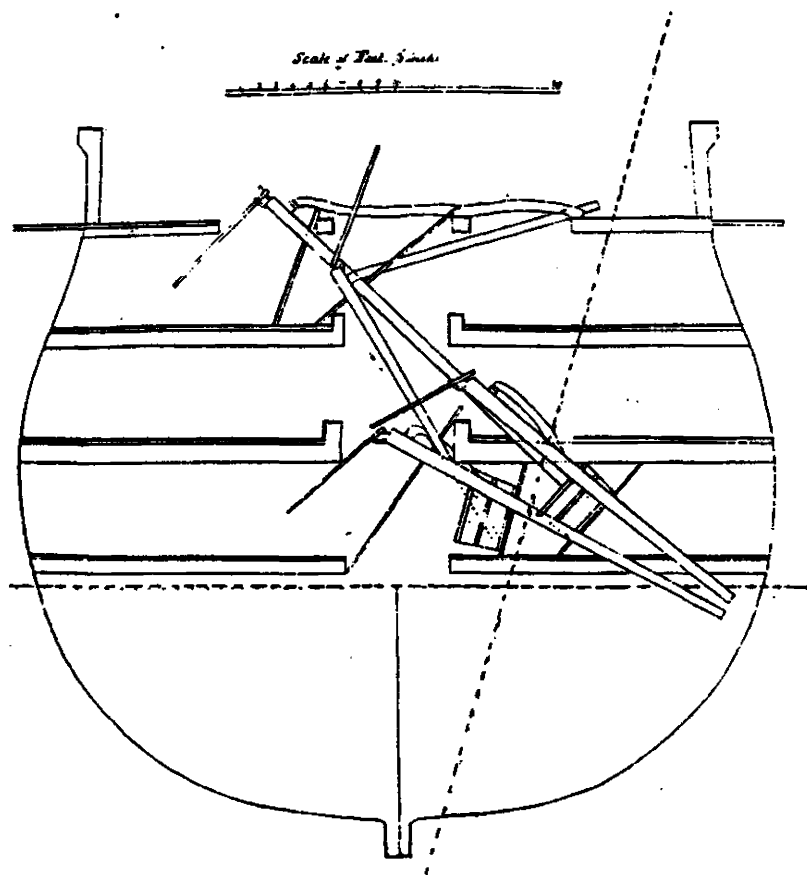
Figure 25. Diagram of the pumping system used aboard the Melville while careening. From Harris (1841: pl. 1).

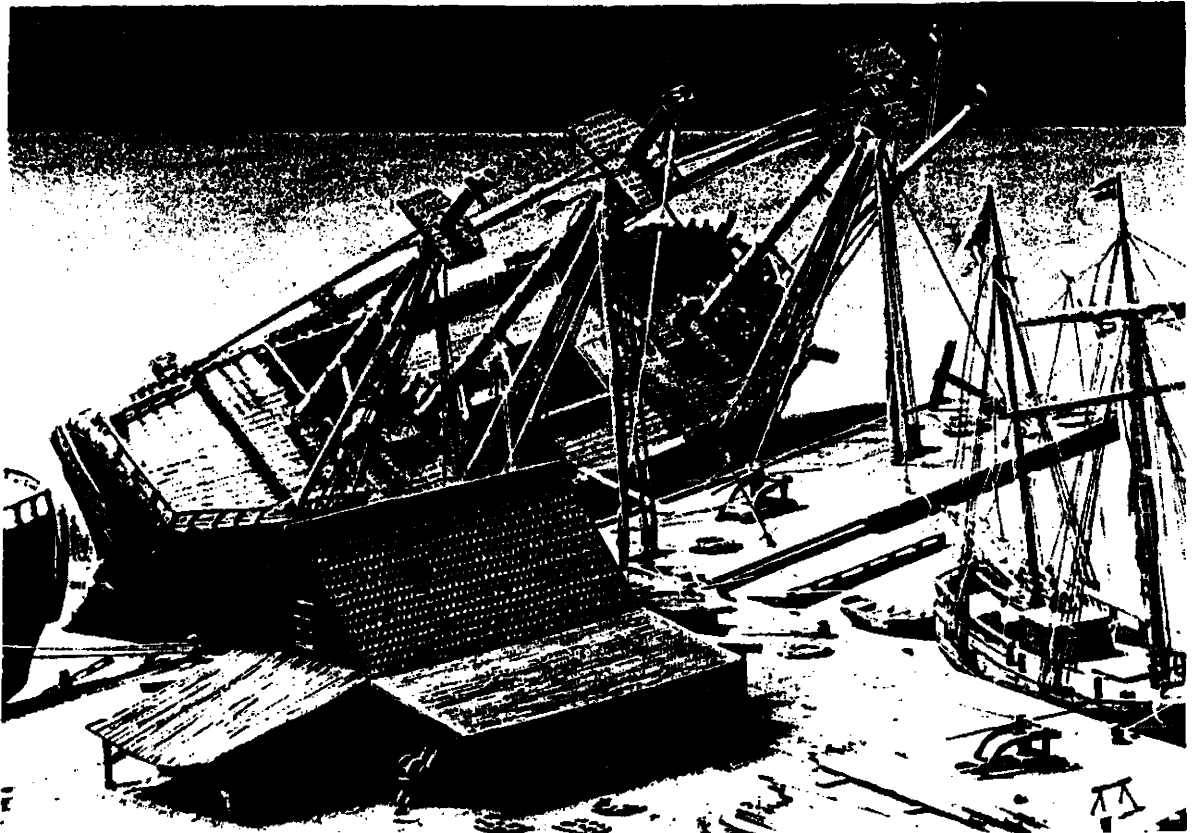
Figure 30. Detail of a diorama portraying a late-18th-century Swedish vessel careened. The jibboom has been removed. Photograph courtesy of the Statens Sjöhistoriska Museum, Stockholm.

Occasionally, the jibboom and the flying-jibboom, if there was one, were removed (Fig. 22, p. 41, Figs. 30 and 31, and Fig. 32, p. 53). The entire bowsprit of the

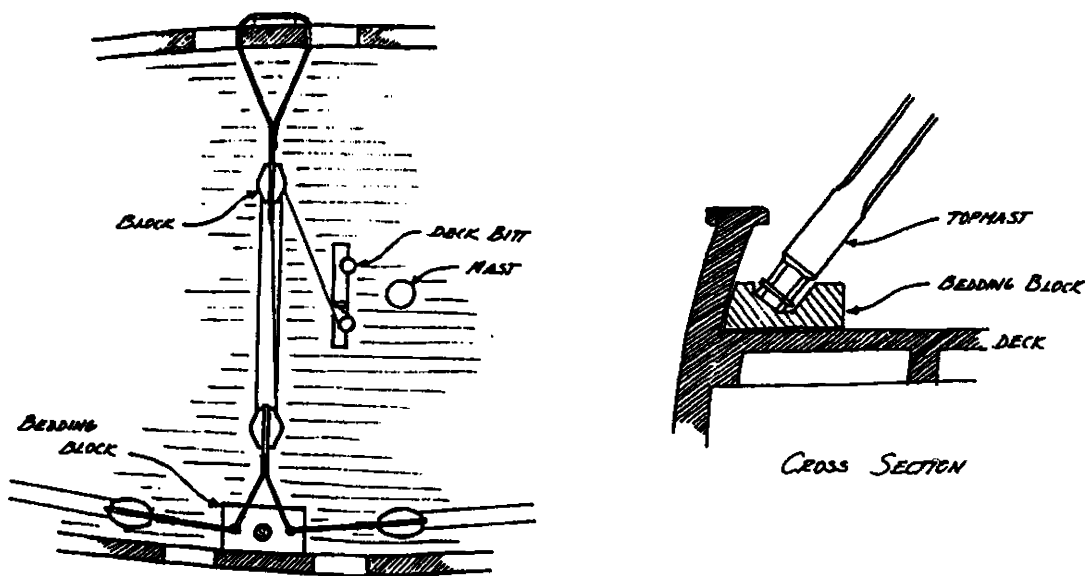
Fig. 38. Tackles rigged to the bedding block of the foremost mast shore on the Artemise. Note the use of the topmast for the shore. Interpretive sketch by J. Taylor.

As previously stated, a prime reason for removing a vessel's upper spars and rigging was to gain their use for other purposes. A case in point was the Artemise whose crew was forced to use its own resources to careen the ship after it sustained keel damage on a reef near Tahiti. This required using the vessel's spars as shores for her lower main- and foremasts. The two major shores for either appeared to be made of each mast's topmast and a spare (see cross section Fig. 38, p. 66). These were lashed to the fore and after side of either mast about 10 ft (3.048 m) below the lower trestletrees. A smaller third shore, possibly a topgallant mast, was lashed to the forward side of either mast approximately 10 ft (3.048 m) further down.

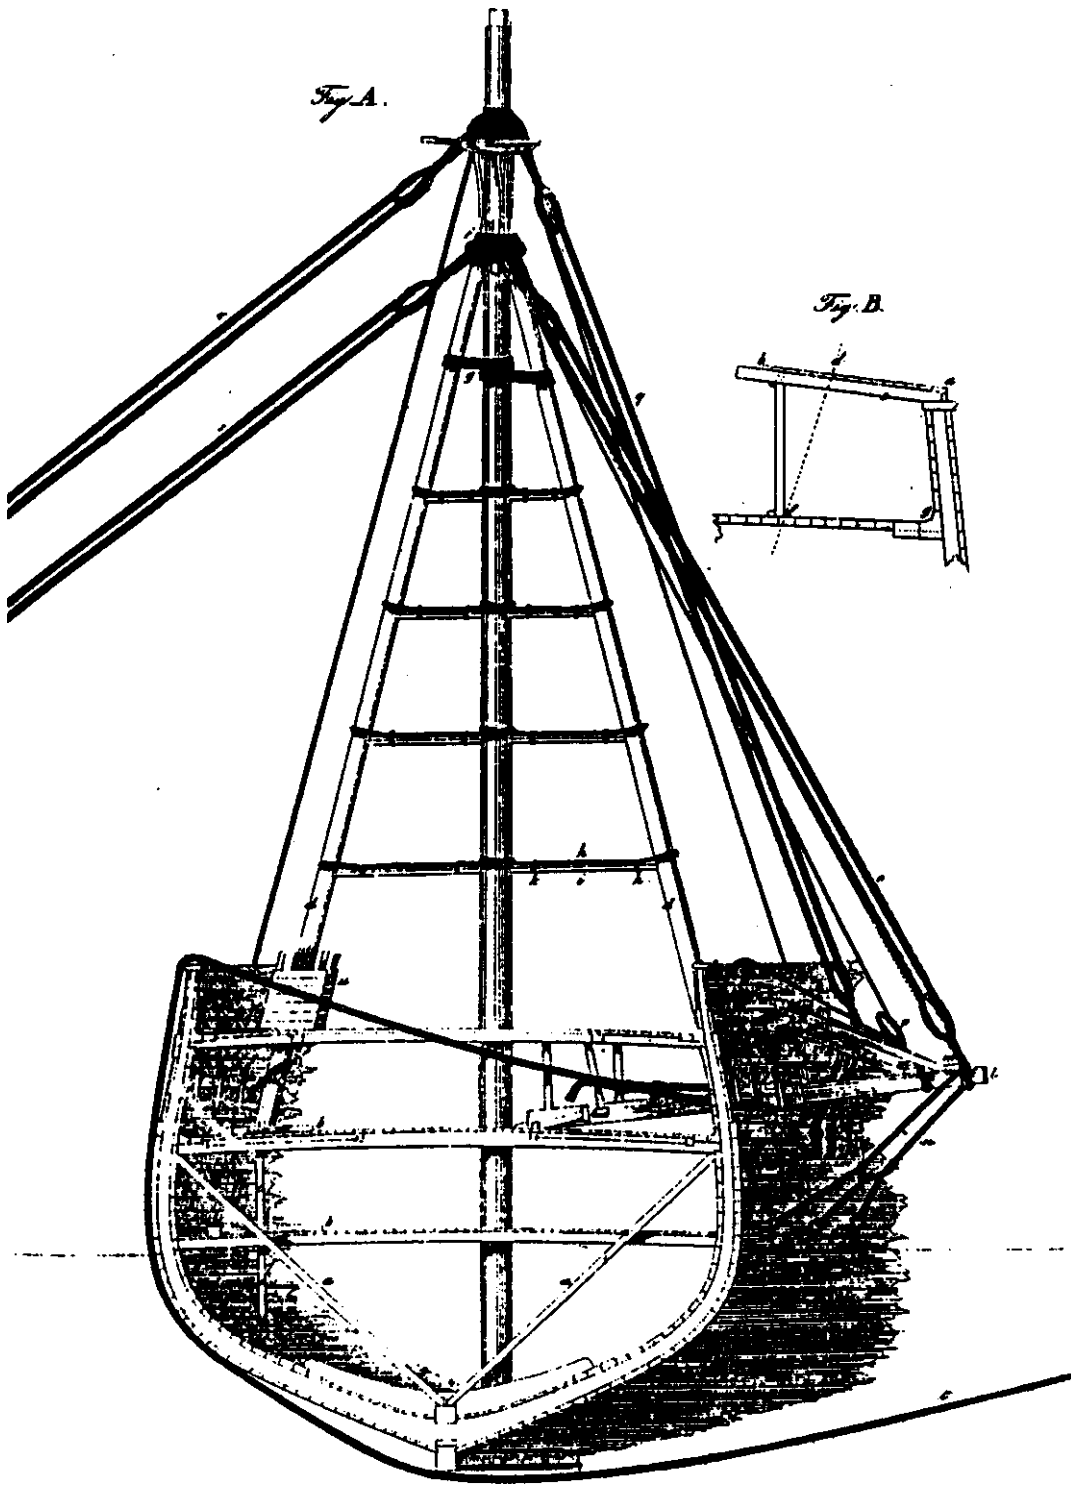
Figure 40. Illustration of the careening systems on a mid-19th-century Danish warship. From Funch (1846: pl. 4).

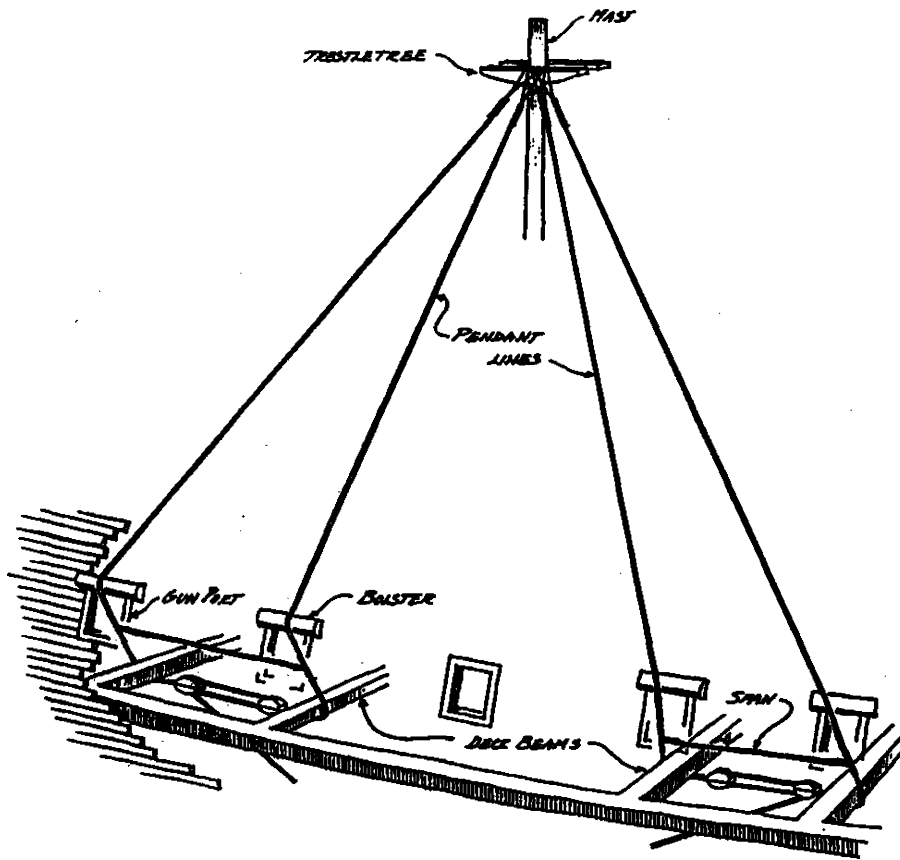
Figure 42. A possible arrangement of the preventer shrouds during the careening of the Courageux. Drawing by J. Taylor.

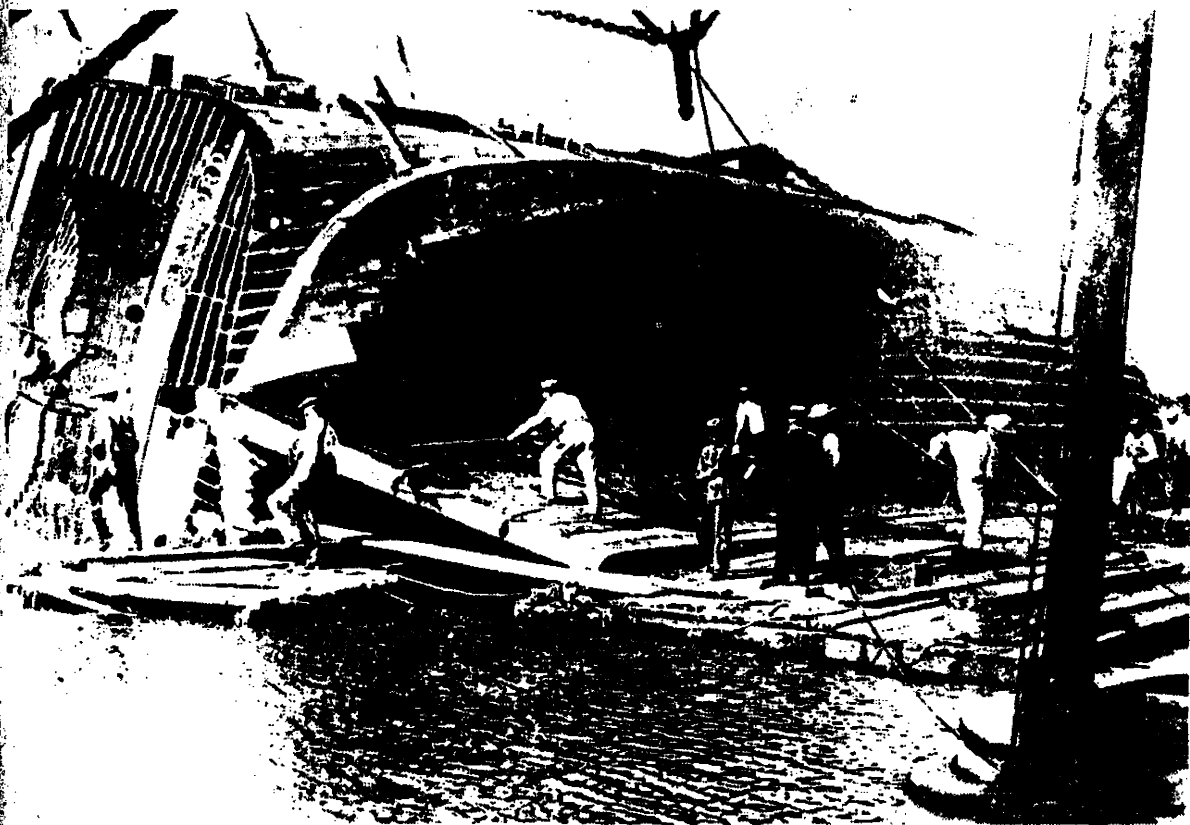
Figure 49. The whaleship Sunbeam hove down. Notice chain passing over balk laid against ship's side, upper right. Courtesy Peabody Museum, Salem. Negative No. 9,347.

With the exception of Harris's reference to setting up the chain, none of the three aforementioned examples of chain preventer gear showed or described how it was tensioned. In Henningsen's description of the Helsingor diorama, he noted that wedges were placed under the chain where it passed over the timber balk (1959: 31-32). These may have been used to tension the chain on that vessel, and wedges may have been used on American whaleships as well for that purpose.

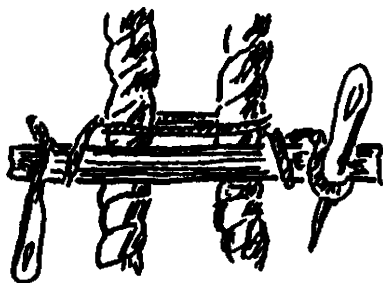
Figure 50. An example of a Spanish windlass. After Luce (1863: pl. 15, fig. 125a).

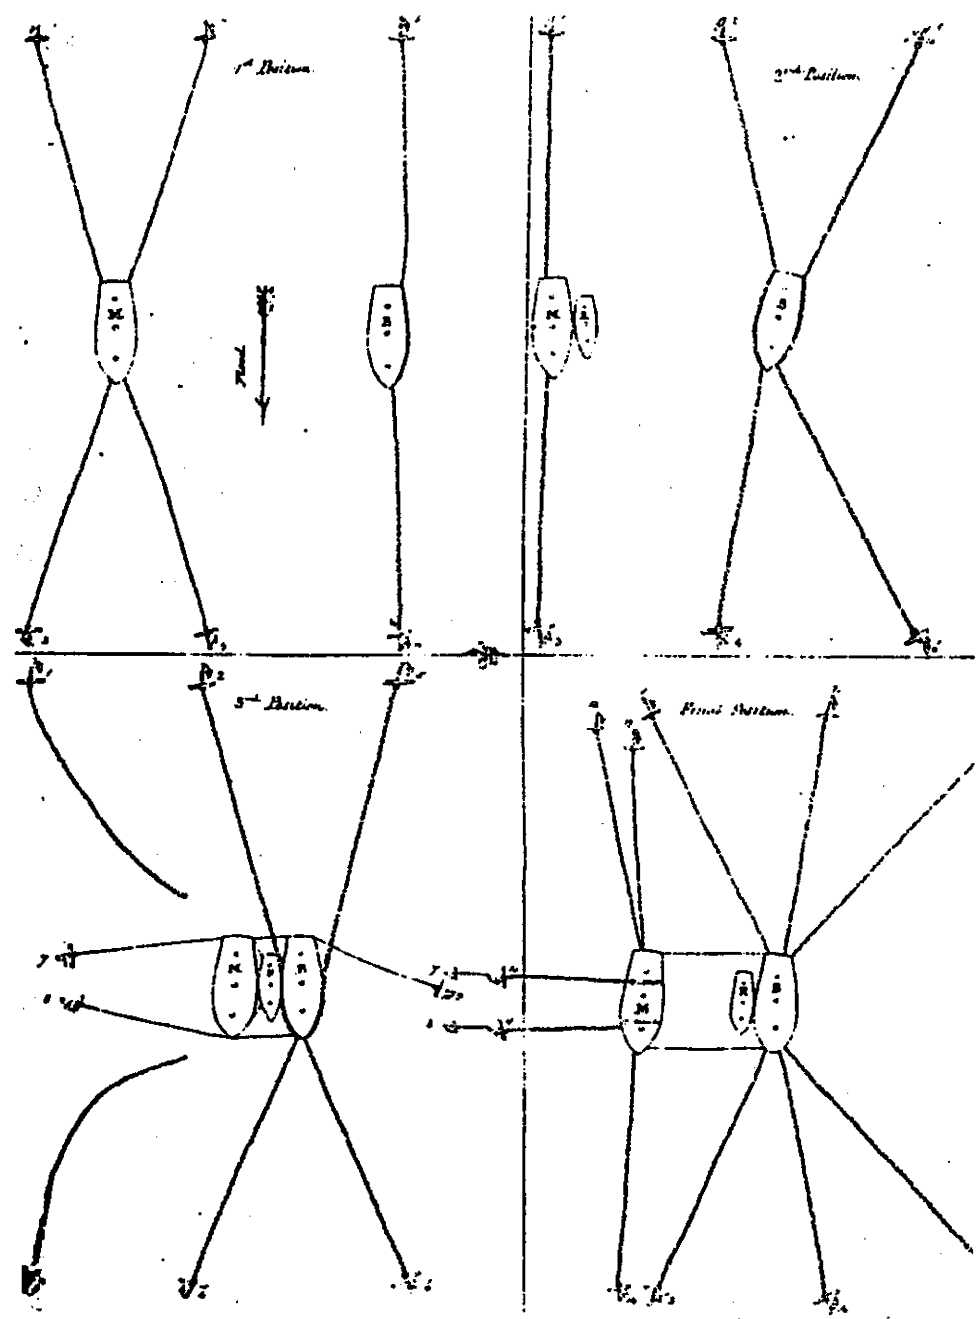
Figure 61. Diagram showing the relative positions of the three ships during various stages of careening the Melville. From Harris (1841: pl. 3).

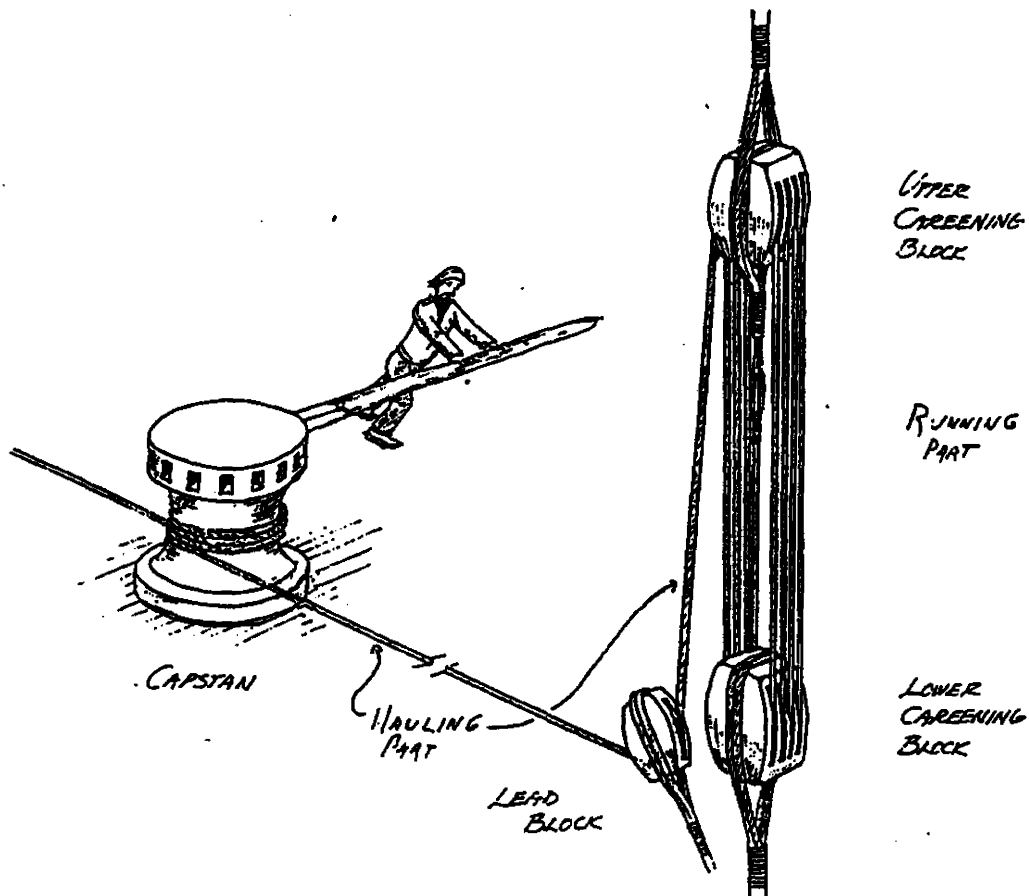
Figure 62. A careening tackle with a power of 9, showing the various parts. J. Taylor.

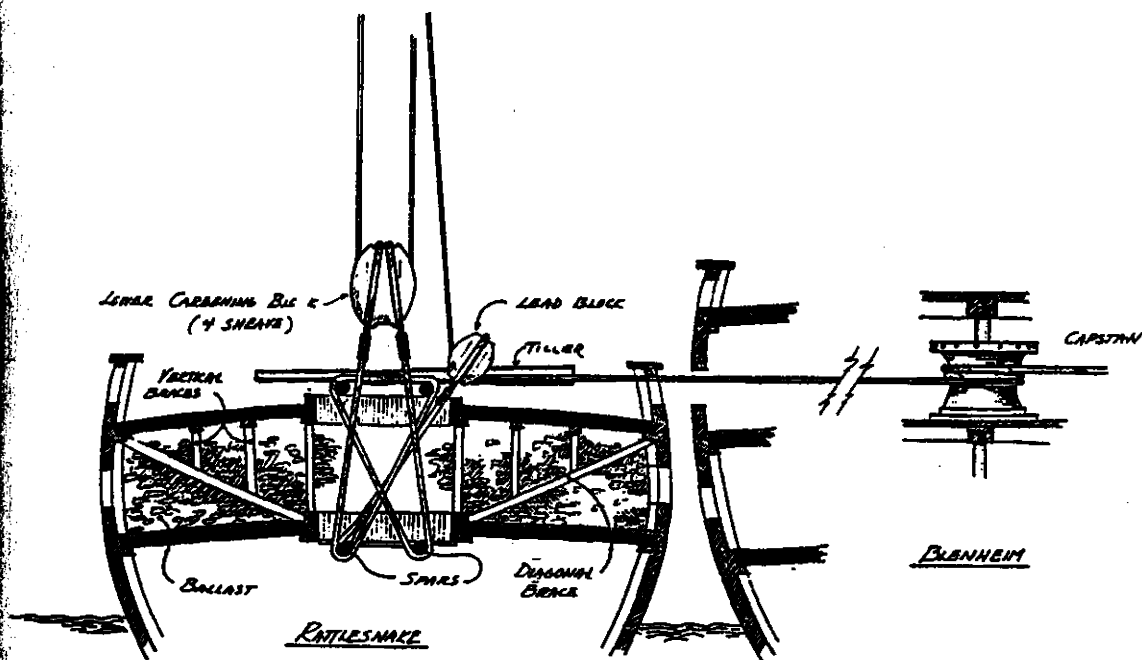
Figure 75. The arrangement aboard the Rattlesnake for the careening of the Melville. Interpretive drawing by J. Taylor.

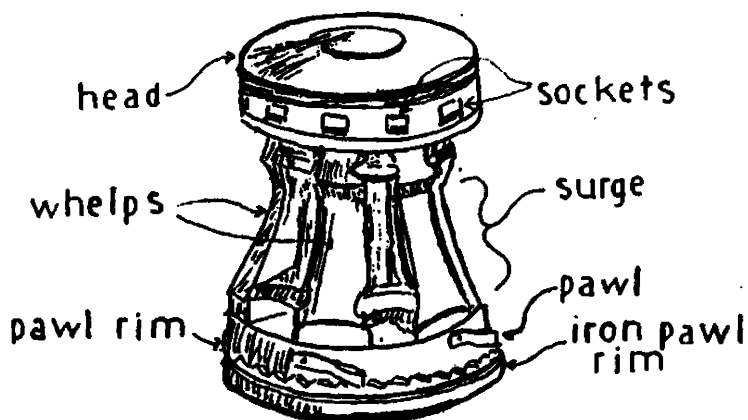
Figure 77. An 18th- to early 19th-century capstan. After Stevens (1949: 36).

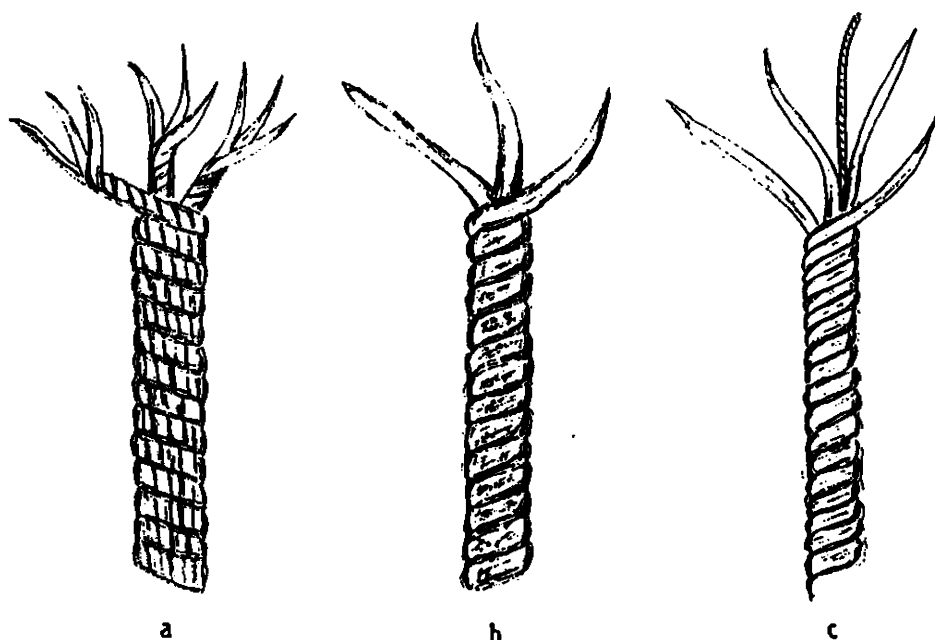
Figure 80. From left to right, cable-laid, hawser-laid, and shroud-hawser-laid rope.

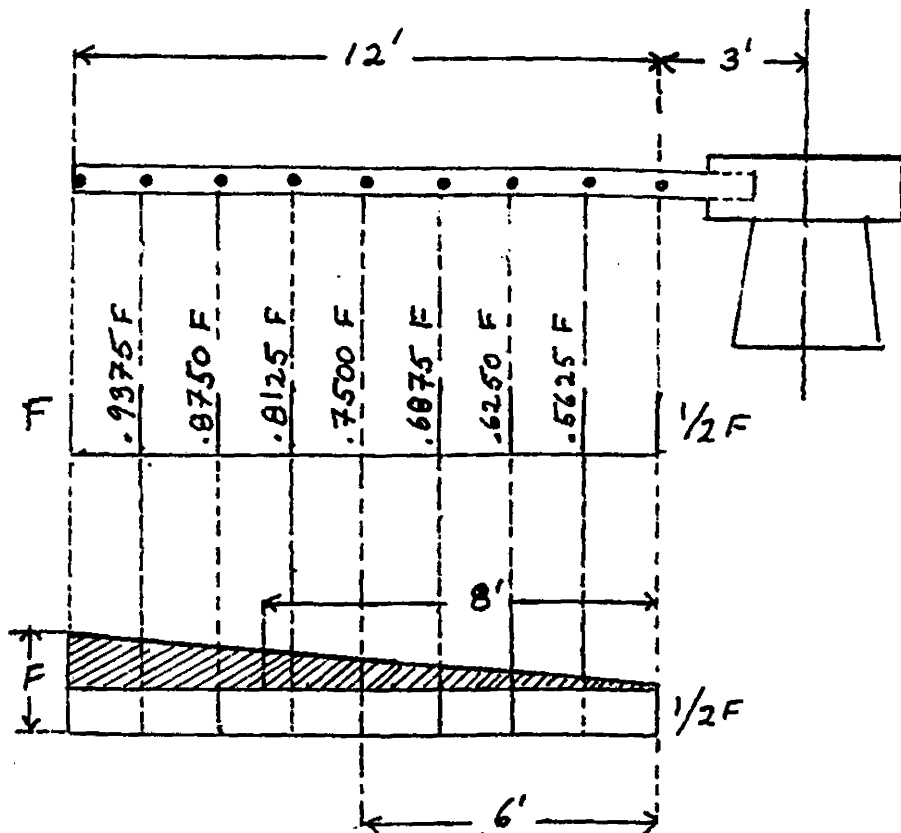
Figure 81. Diagram of moment arms and forces on one of the Blenheim's main capstan bars during the careening of the Melville. After a sketch by Prof. C. Long.

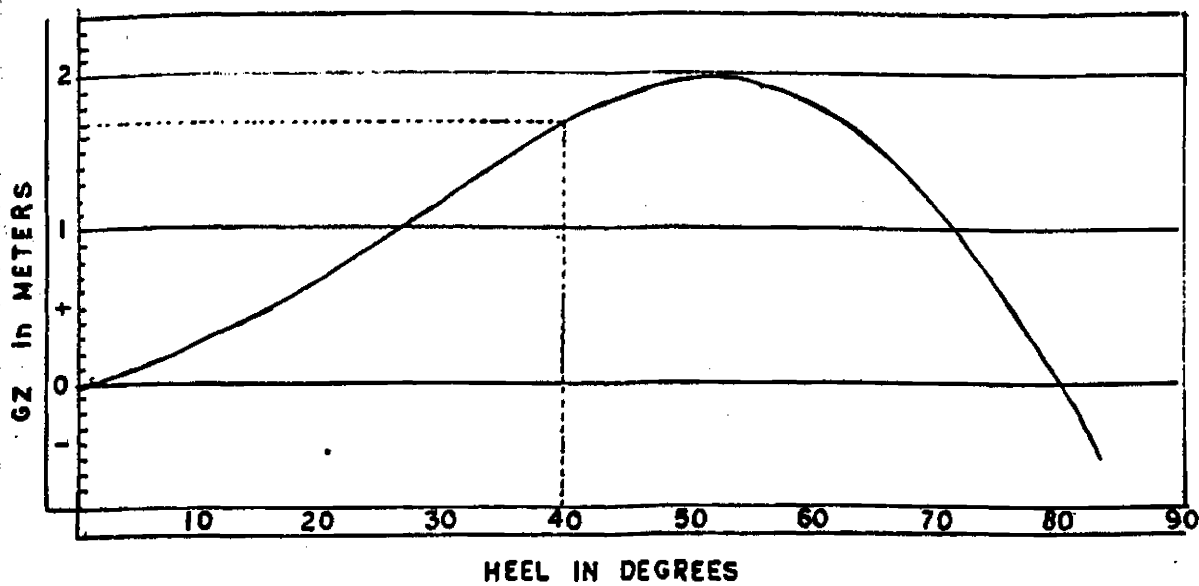
Figure 85. An example of a curve of stability. M. Goelet.

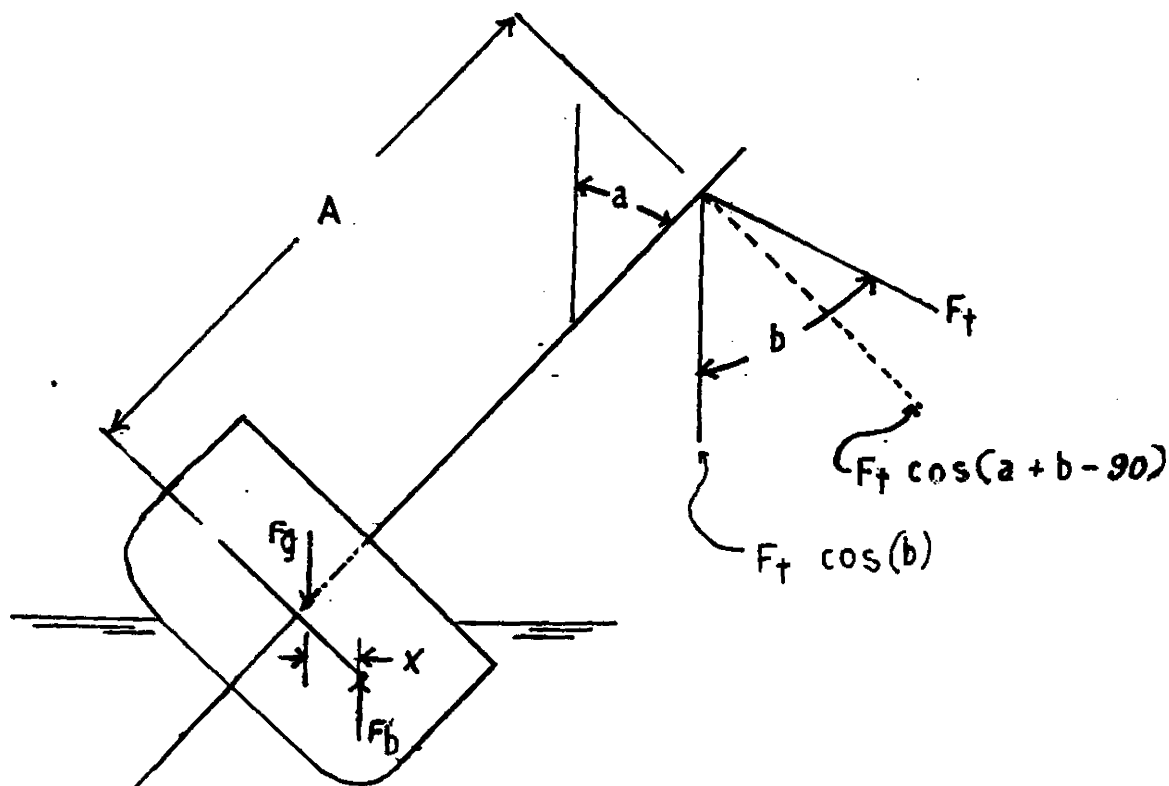
Figure 86. Forces and distances determining upsetting and righting moments. F_t stands for tackle force. X is the horizontal distance between perpendiculars through F_b and F_g . After a sketch by J. Waterhouse.

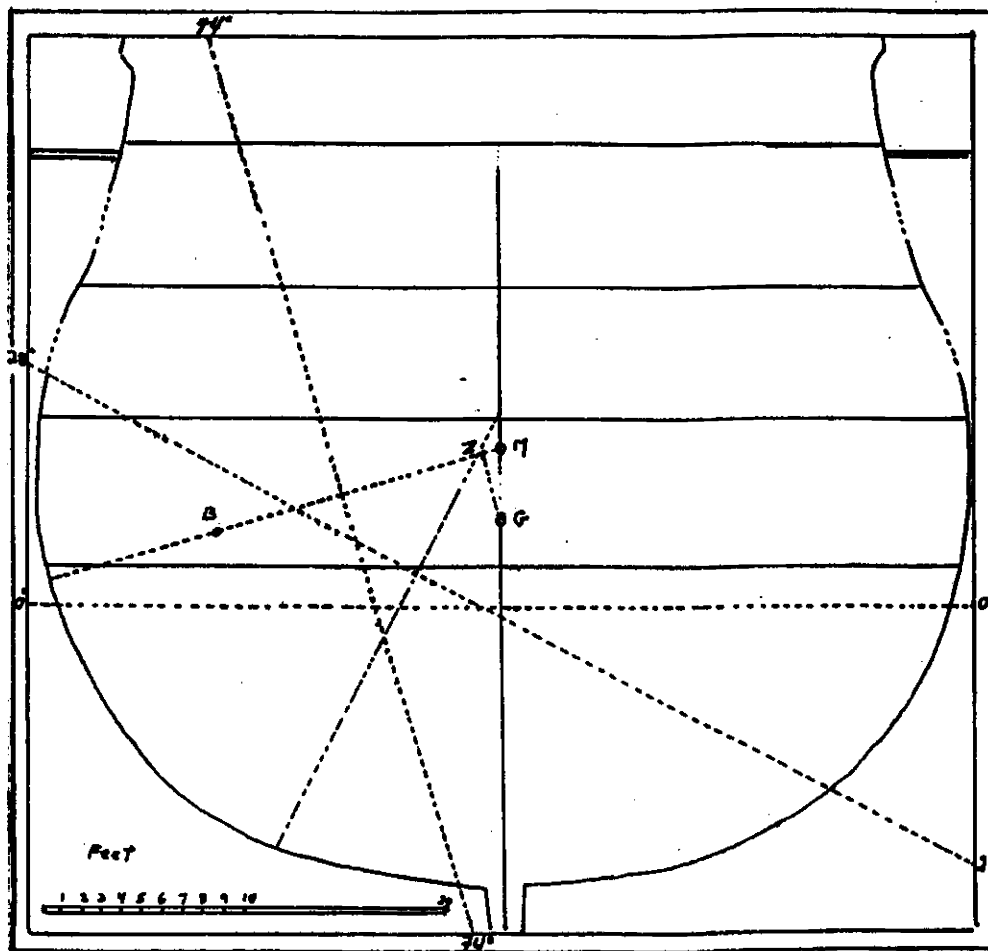
Figure 88. The Melville careened to 28° and 74° inclination. After Harris (1841: pl. 2).

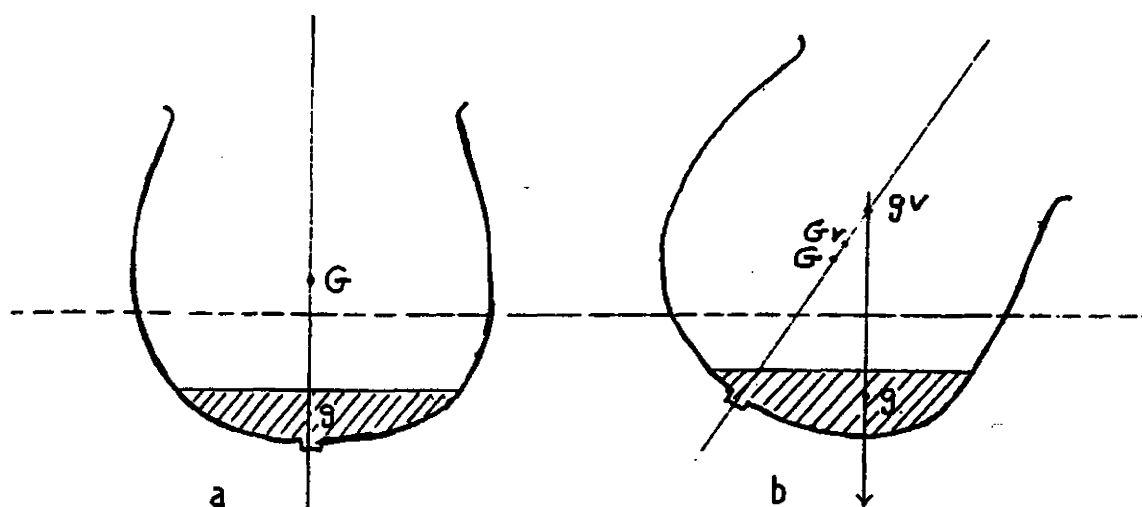
Figure 89. Free-surface effect. M. Goelet.

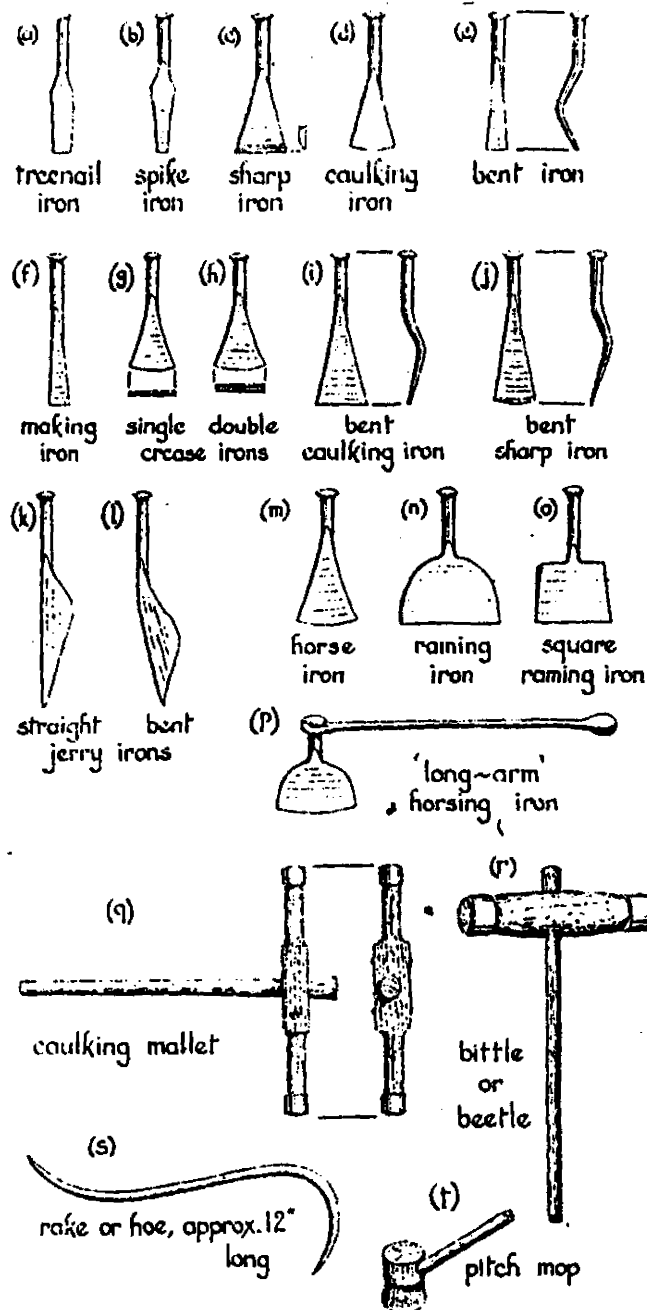
Figure 96. Caulking tools. From Horsely (1978: fig. 39 I, II).

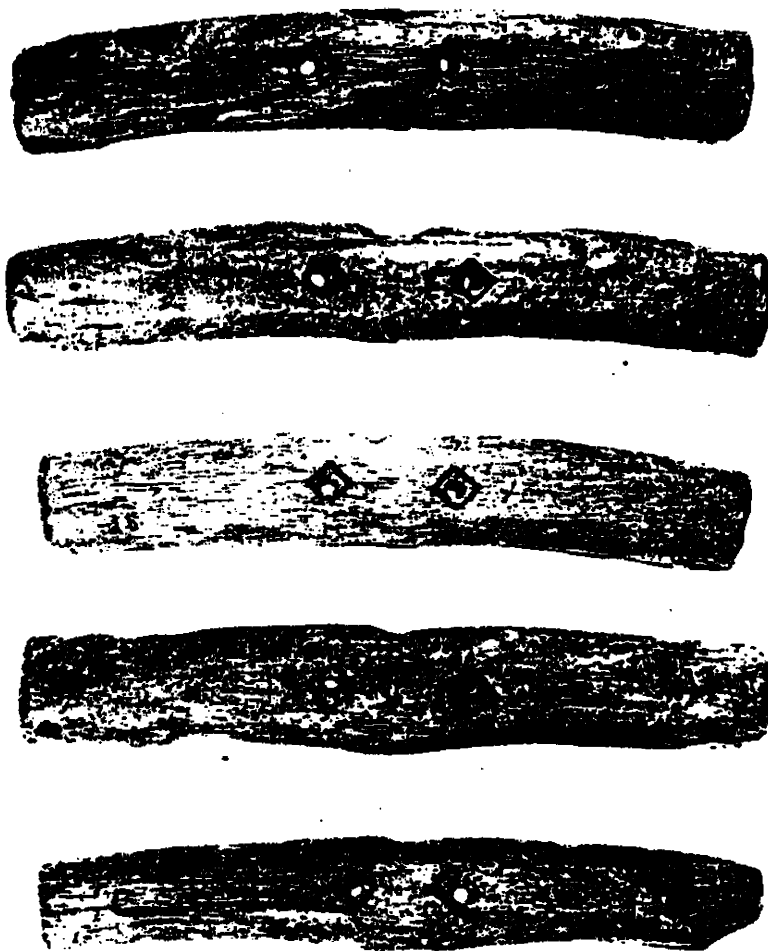
Figure 98. Caulking mallet heads from Le Machault.
From Ross (1981: 66, fig. 7).
