**AN ANALYSIS OF THE PORT ROYAL SHIPWRECK AND ITS ROLE
IN THE MARITIME HISTORY OF SEVENTEENTH-CENTURY
PORT ROYAL, JAMAICA**

A Thesis

**Submitted to the Office of Graduate Studies of
Texas A&M University
in partial fulfillment of the requirements for the degree of**

MASTER OF ARTS

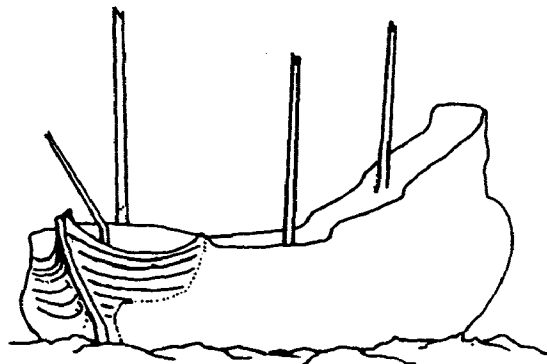
FLUYT (Figure 11)

Figure 11. A Fluyt. After de Groot (1980:98).

The fluyt (or flyboat) was the cornerstone of Dutch seaborne trade supremacy from the end of the 16th century through the 17th century. Furthermore, one of the ways by which the English co-opted this supremacy in the mid to late 17th century was through the adoption of aspects of the fluyt's design into the English shipbuilding repertoire (Davies 1974:33; Davis 1975:11-17).

Davies (1974:33) describes the fluyt as "the most notable development in merchant shipbuilding in the later sixteenth century." The Dutch built these vessels with similar designs and scantlings, thus facilitating repair, especially overseas (Wilcoxon 1991:57).

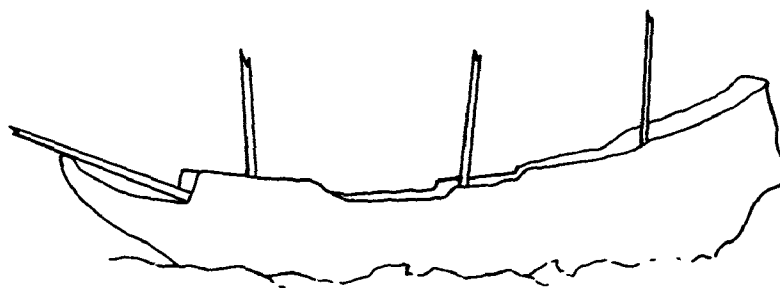
FRIGATE (Figure 12)

Figure 12. A Frigate. After de Groot (1980:76).

The term "frigate" is especially ambiguous. Lavery (1983:19) states that, in terms of English maritime history, it was only during the years 1645-49 that the term was used in its "pure" form, signifying a lightly armed, single-decked vessel with no forecastle. Square-rigged with three masts, these vessels were fairly small and fast, and had a length to beam ratio of 10:3, whereas beamier purpose-built merchant vessels such as the Adventure of Ipswich had length to beam ratios of 10:4 or a little more (Lavery 1988:10).

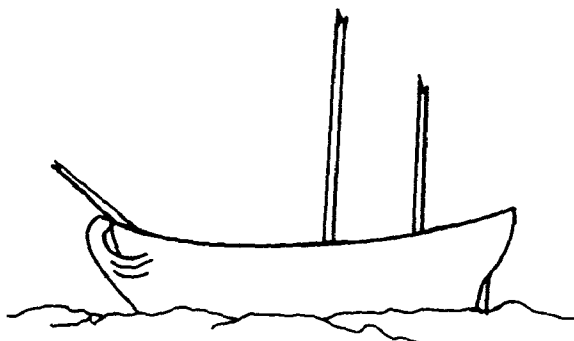
KETCH (Figure 13)

Figure 13. A Ketch. After Grant in Culver (1924:148).

Ketches, barks, snows, pinks, and sloops comprise a group of intermediate size trans-Atlantic and coastal trading vessels. In terms of expenses, it seems that these vessels were more easily owned and operated by the majority of 17th-century merchants than were the larger vessels discussed above, as Bridenbaugh (1972:323) discusses a group of business partners who owned "...several ketches and brigs...".
